Tech Talk with Brad Hillhouse

In the preparation of a 1960 Corvette for Performance Verification (PV) judging at the Heartland Regional, we spent hours testing all the functions of the car trying to get all the “bugs” out. As with any old Corvette, we found many issues that may have caused a PV failure and one of those that needed repair was the cigarette well lighter bulb.

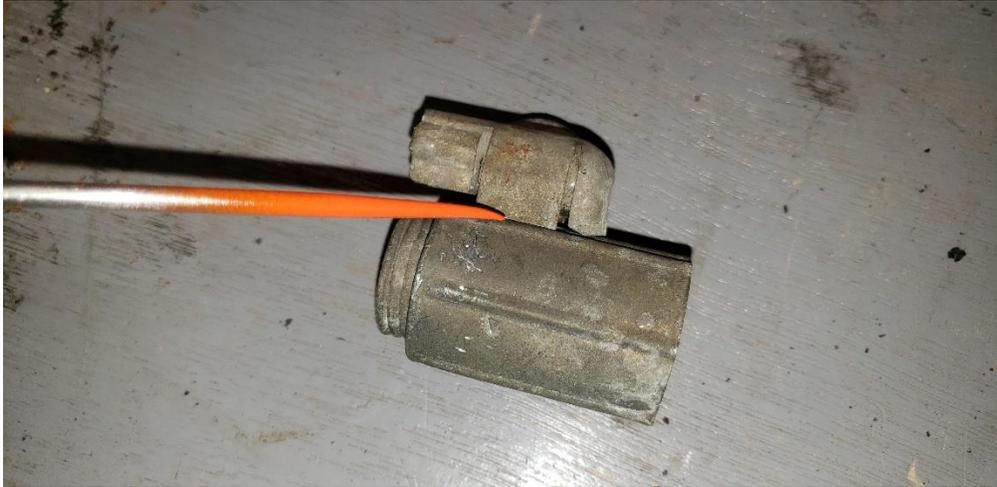
This is the bulb holder on the top and the point it attaches to the housing. This one is dirty and has corrosion but the one we were using was clean. The bulb holder would just lose good contact from time to time causing lack of ground and light bulb going off

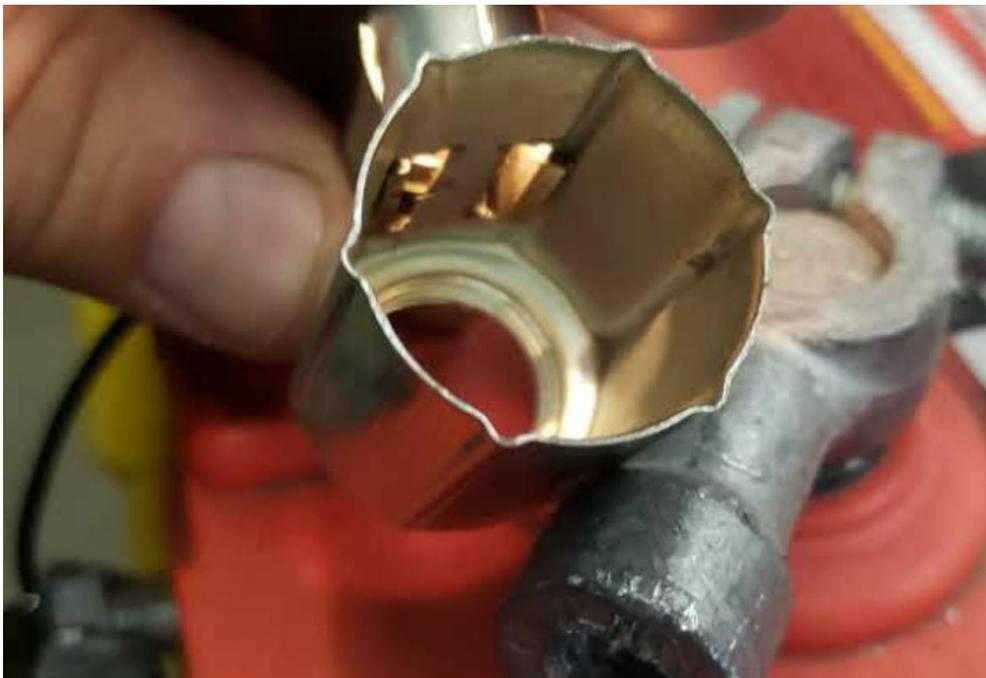
This is the lighter housing and shows how the clips of the light bulb holder attach. This is also where the light from the bulb enters the cigarette lighter housing and it glows in the dash at night when the dash lights are turned on

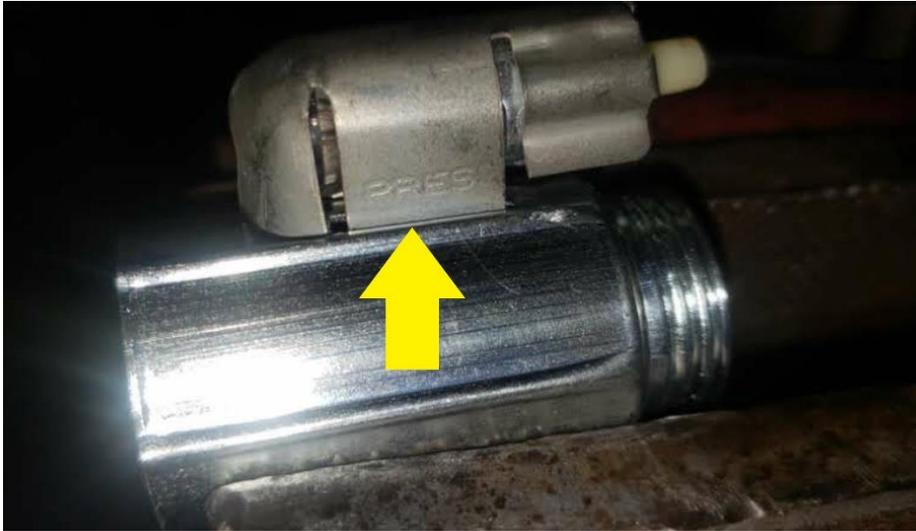
This is where I added solder so that the bulb housing would make good electrical connection. You can see the holder is stamped "PRESS". You pinch both sides and it compresses so it can be removed from the lower housing. After replacing the bulb, the holder would not spring back strong enough to maintain good connection to ground

The repair I chose was to use solder to hold the bulb holder securely to the housing. Solder is a good electrical conductor as well as keeping the two pieces of metal from separating. This made a 100% solid electrical connection. The cigarette lighter assembly was reinstalled and tested again to make sure the bulb was still good, and that was one more item off the list.

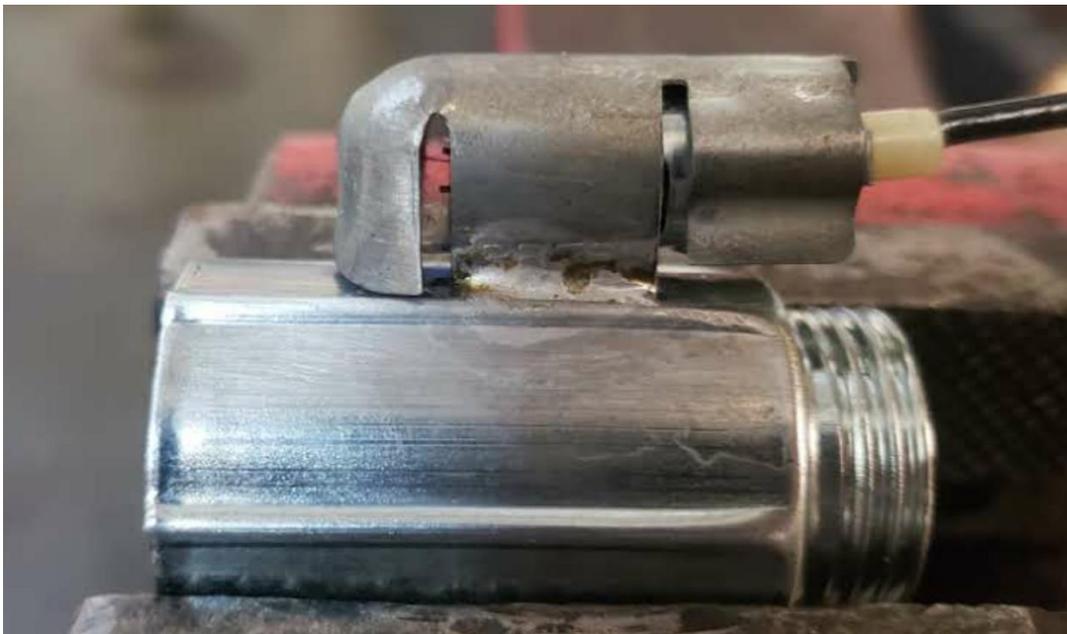
You can see the newly soldered joint. This maintains 100% electrical connection. When installed in the car, this solder is not visible for inspection by the judges.
