# Kopeopeo Canal Remediation Project

Whakatāne District Council

18 September 2019

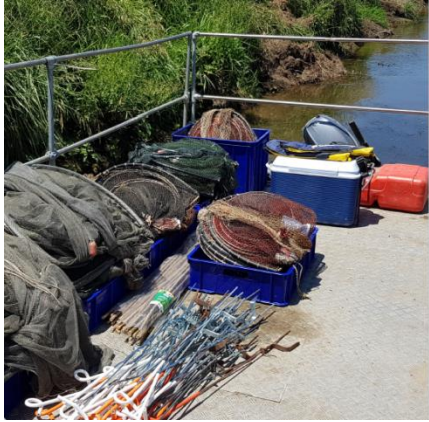
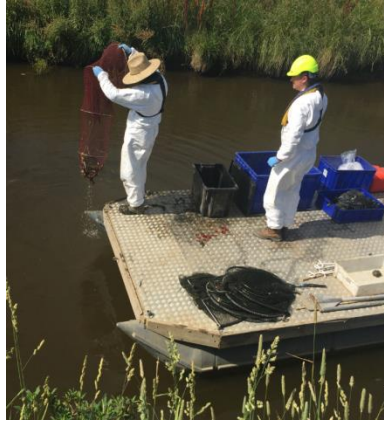
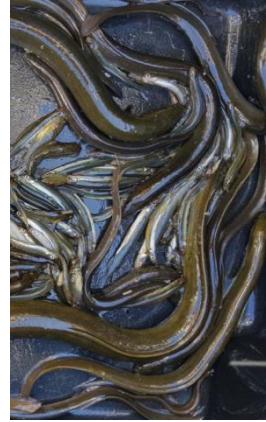
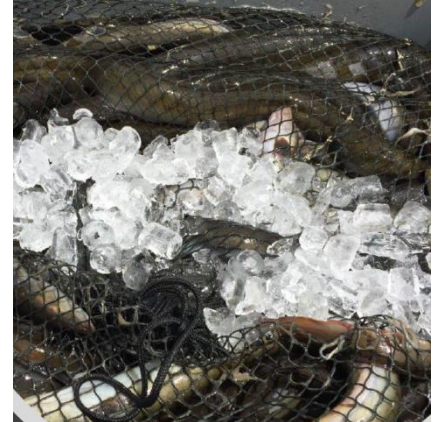
- Baited Fyke nets over 5.1km of canal – under MPI permit
- Over 1.1 tons of eel caught
- Eel euthanized and frozen into 20kg blocks
- Processed through industrial mincer & blended into canal sediment for containment in geobags

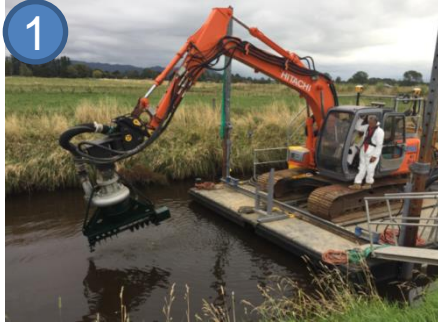
Dredging

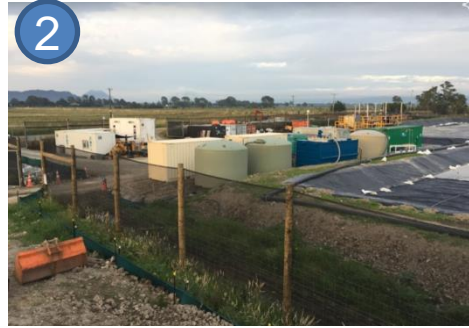
Water treatment

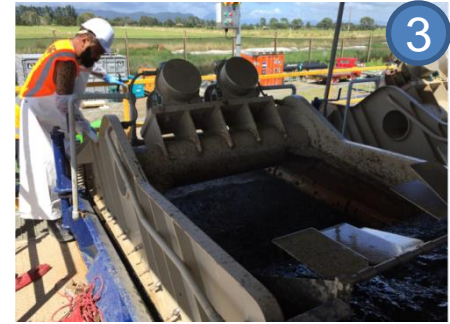
Monitoring across shakers

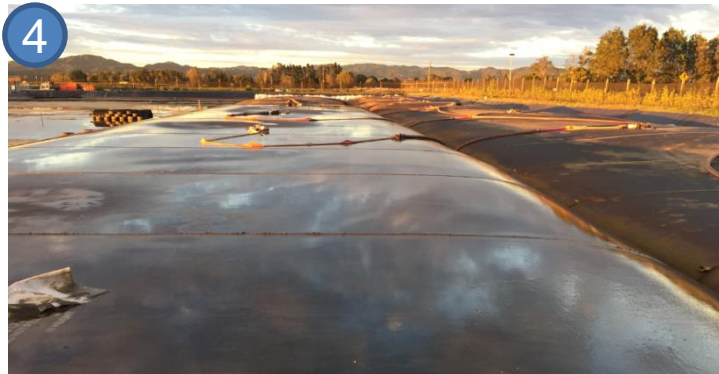
Safe containment in geobags

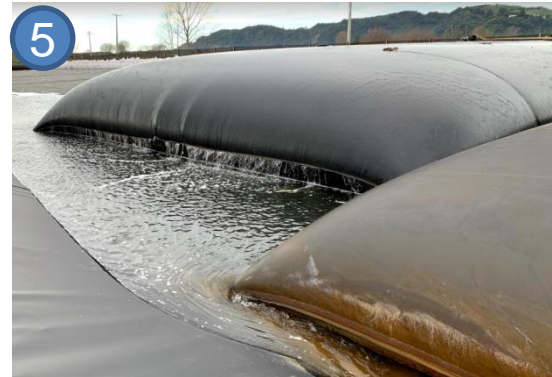
Return of clean water to canal

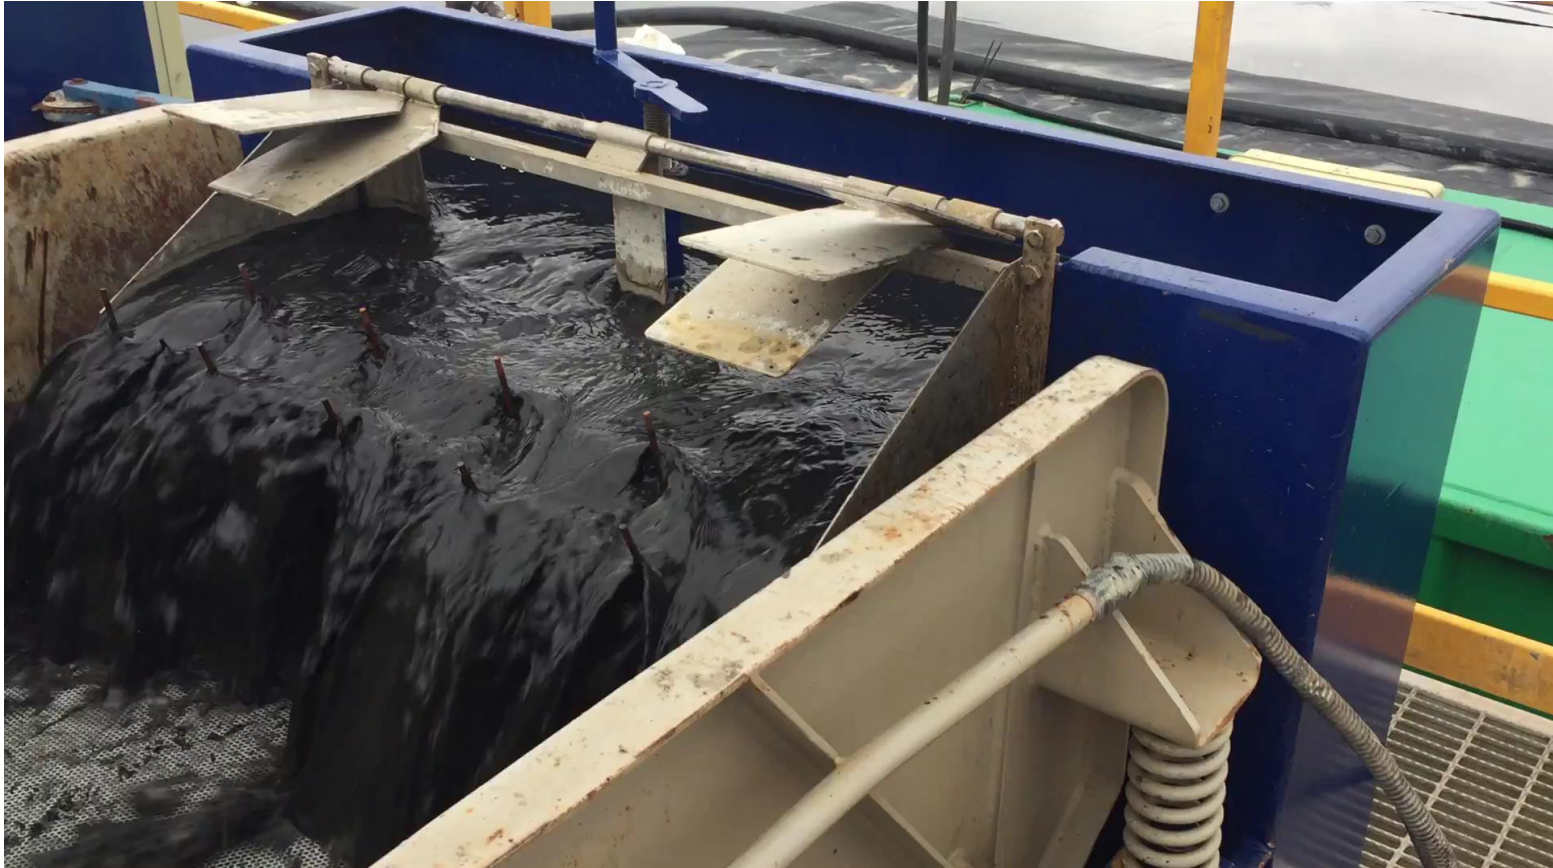
# Contaminated sediment coming in from dredge

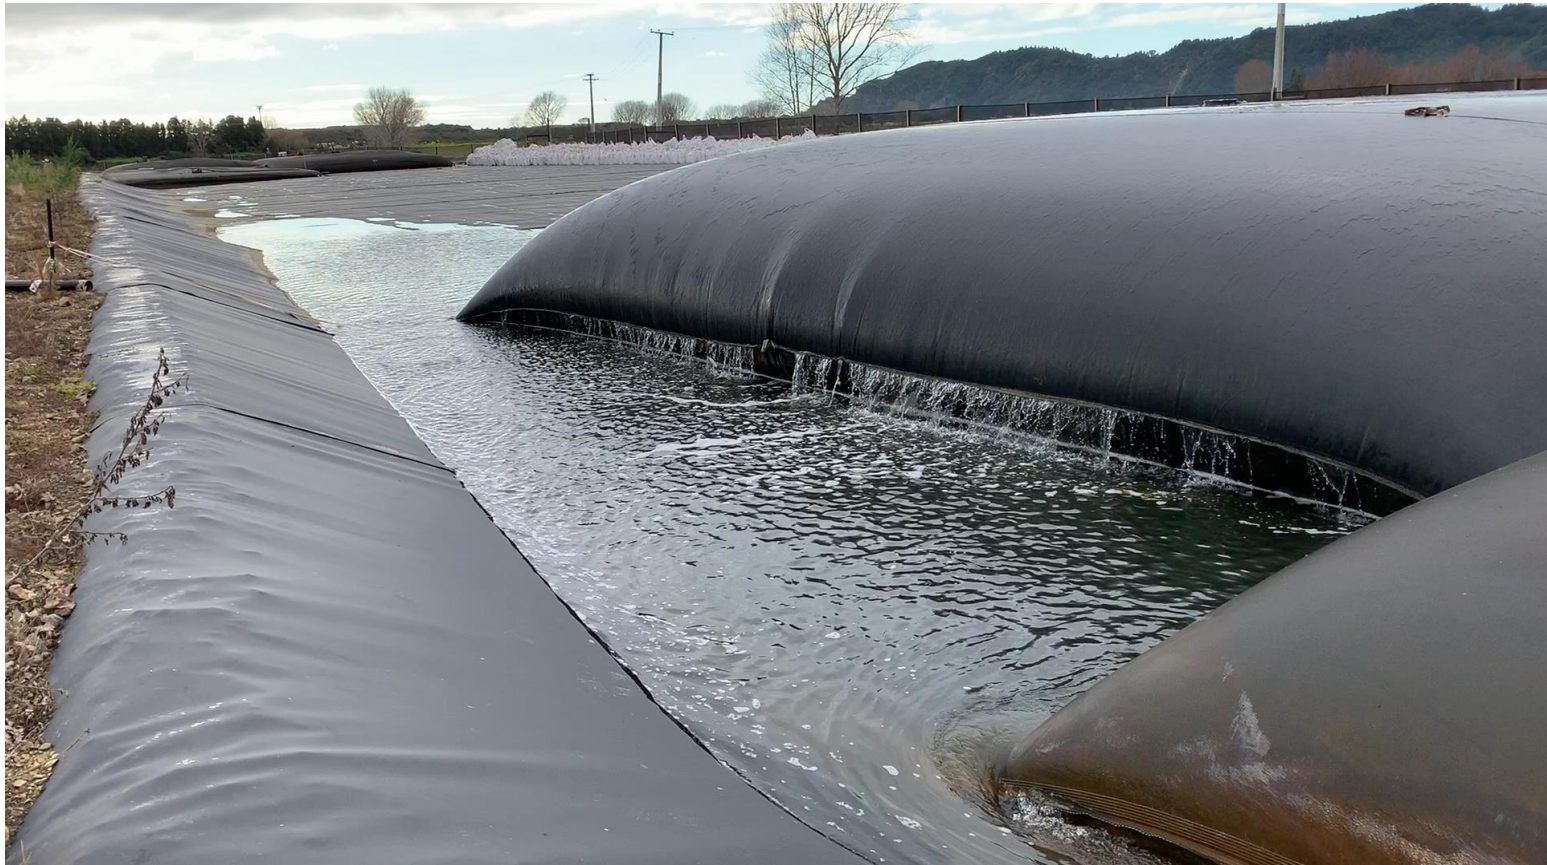
# Clean water returned to canal

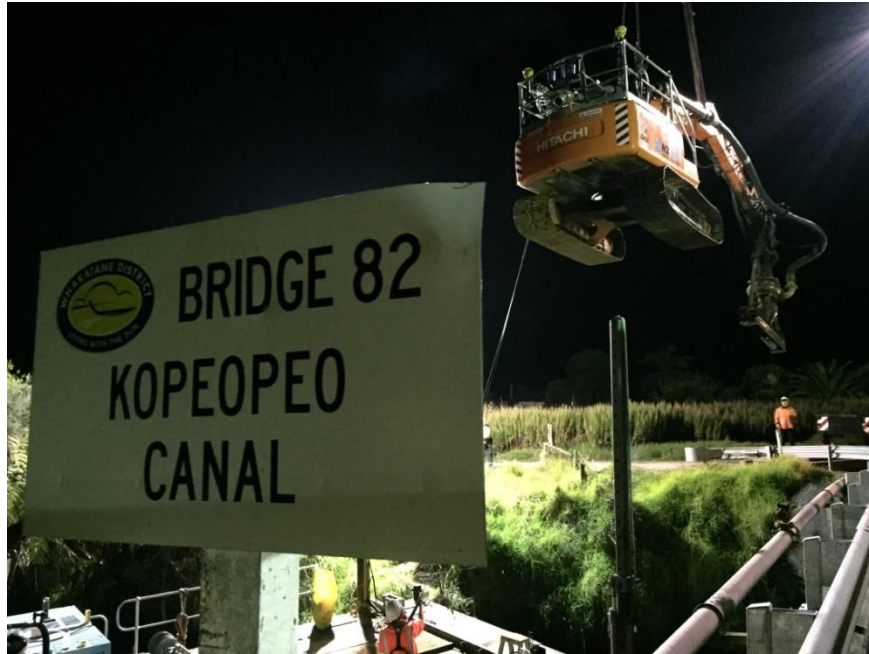
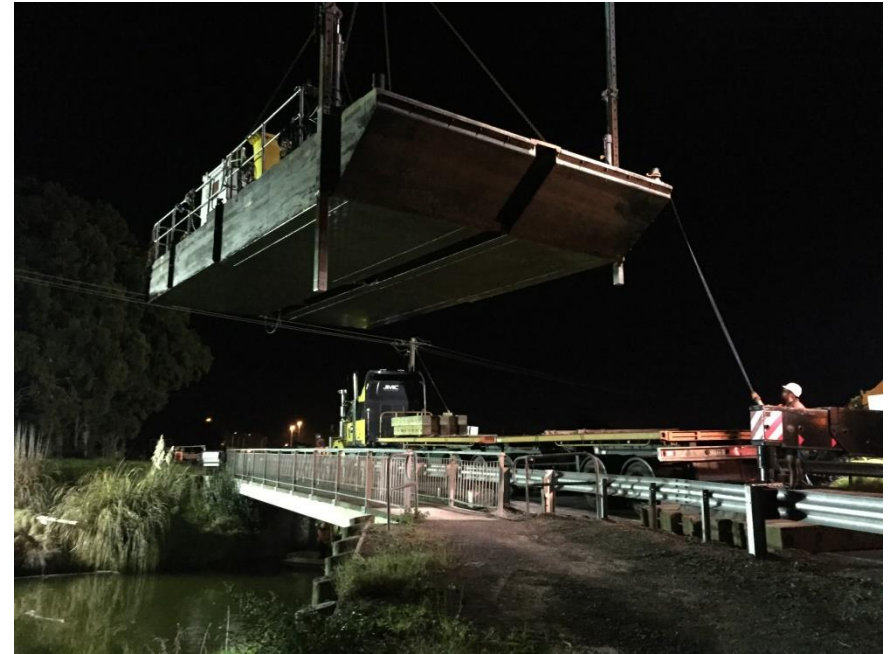
# 6 major lifts over internal bridges

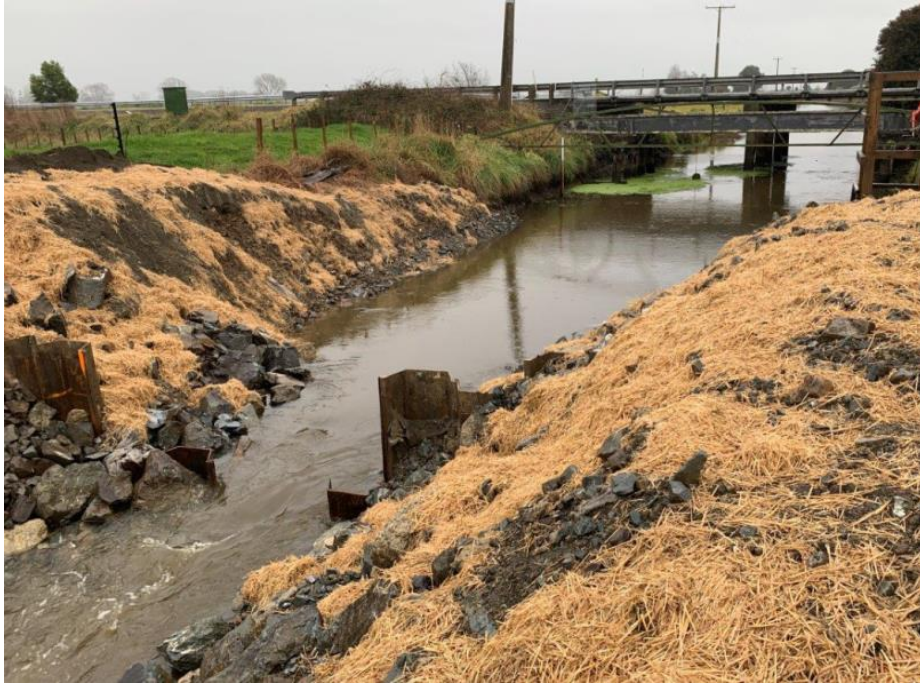
FCS- West modified to prevent sediment transport from W to E and allow drainage

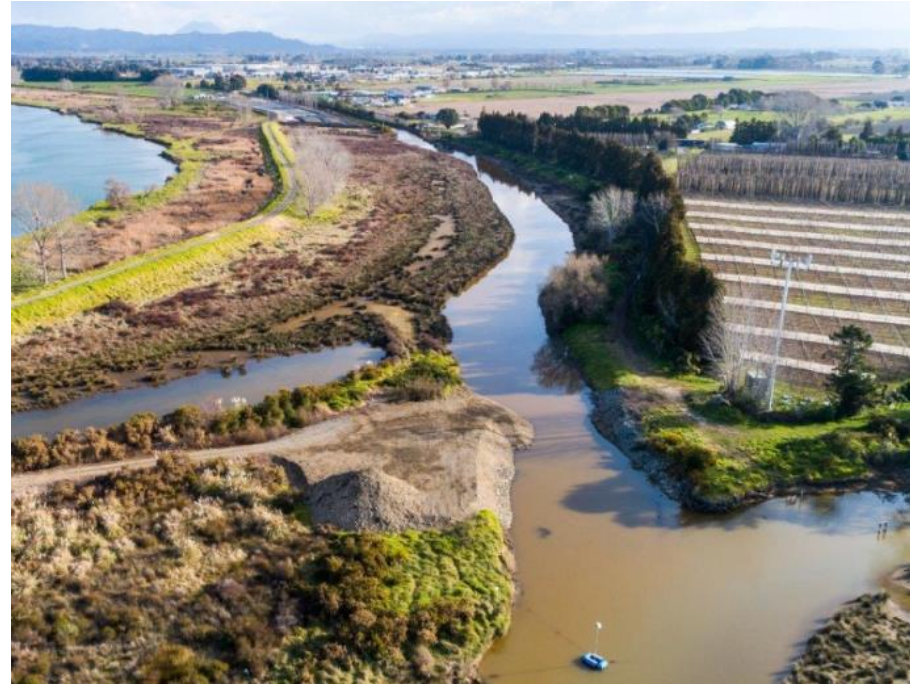
FCS- East removed restoring full connectivity to Orini

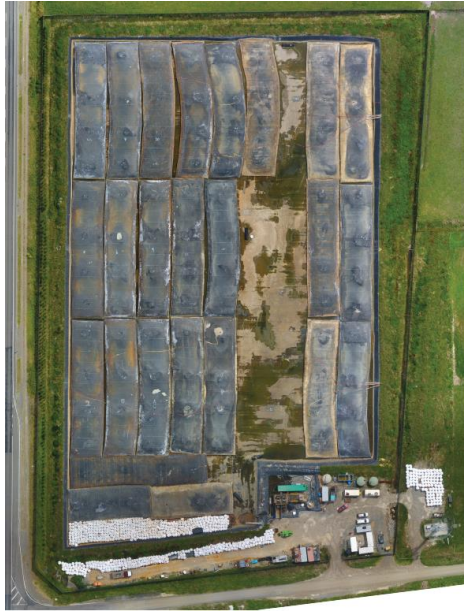
CS1

- 26 geobags filled
- 22,350 cubic metres
- 1,125 oversize bags

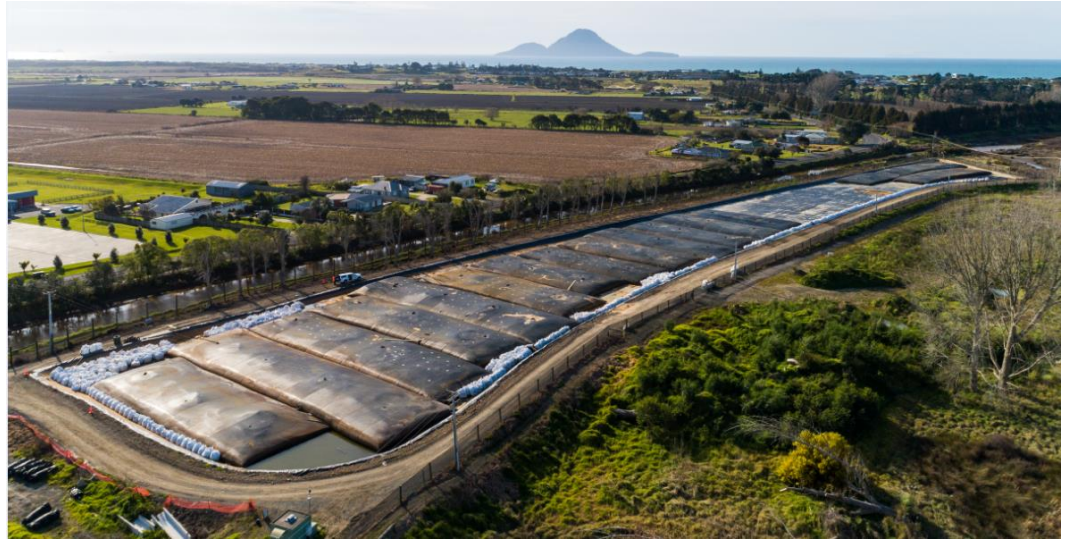
CS3

- 17 geobags filled
- 12,120 cubic metres
- 592 oversize bags

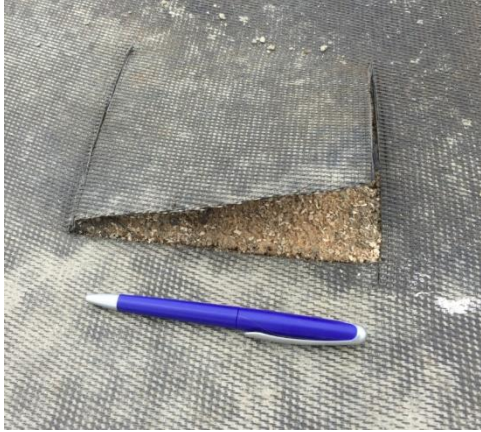
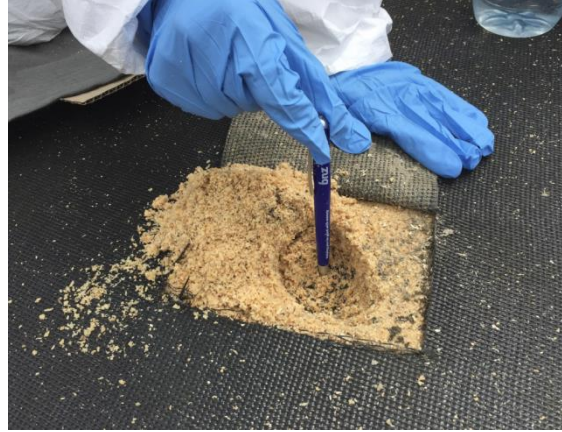
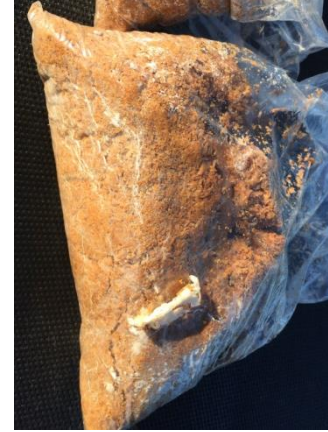
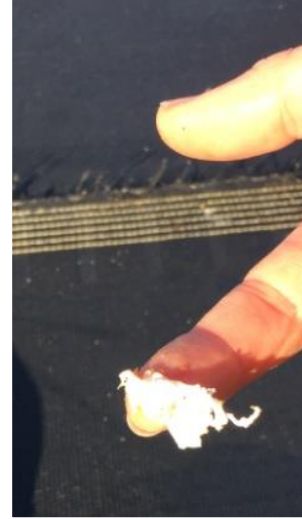
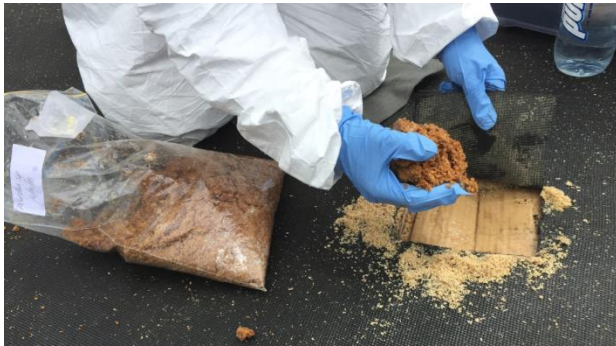
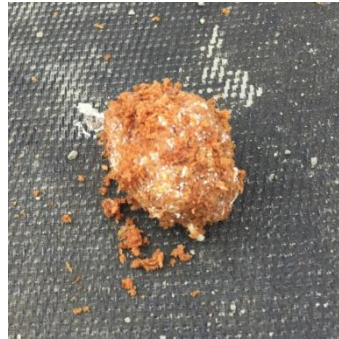
White-rot fungus  
inoculation into  
wood-pellet  
topping layer

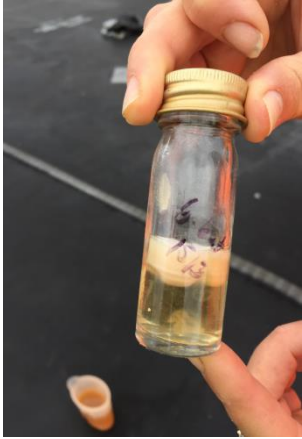
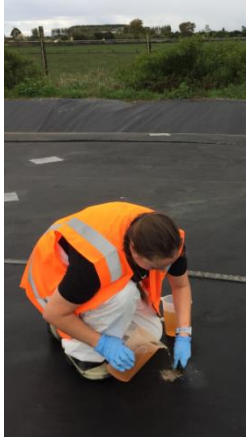
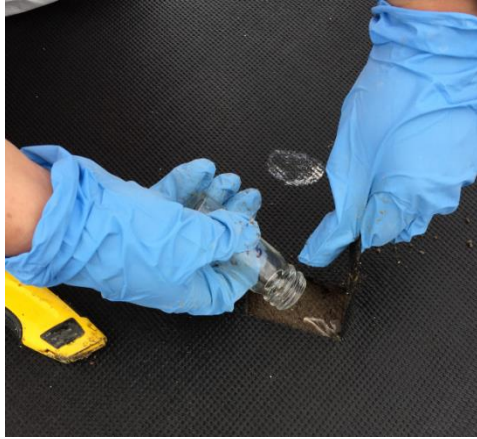
Second inoculation with "*Gongronella butleri*"- fungus isolated from heavily PCP contaminated soil at former Mill site

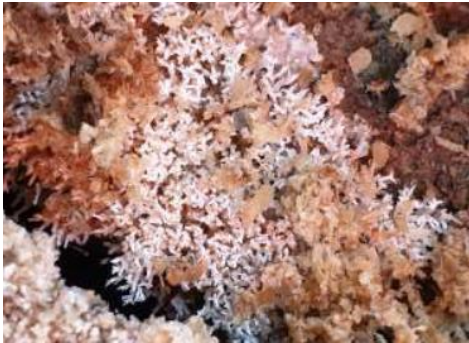
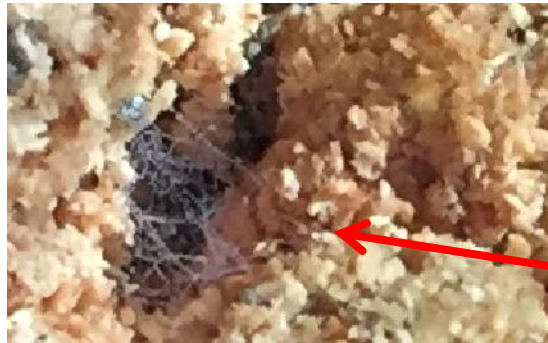
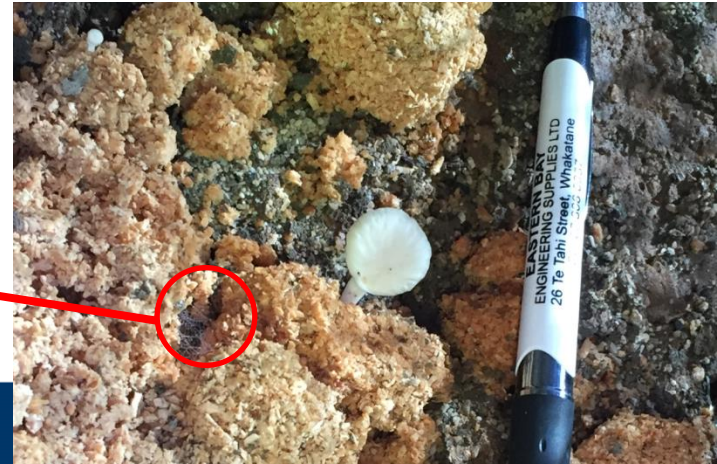
Fungus, already observable stimulates bacteria wars

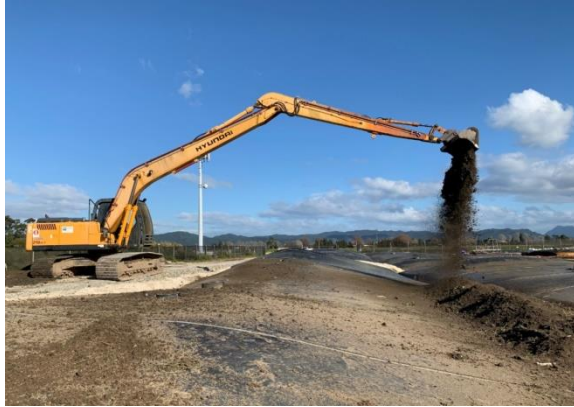
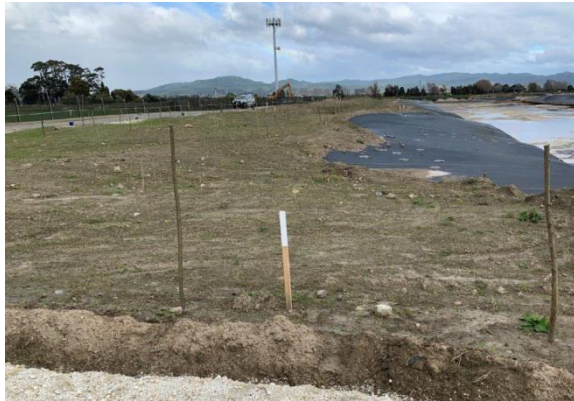
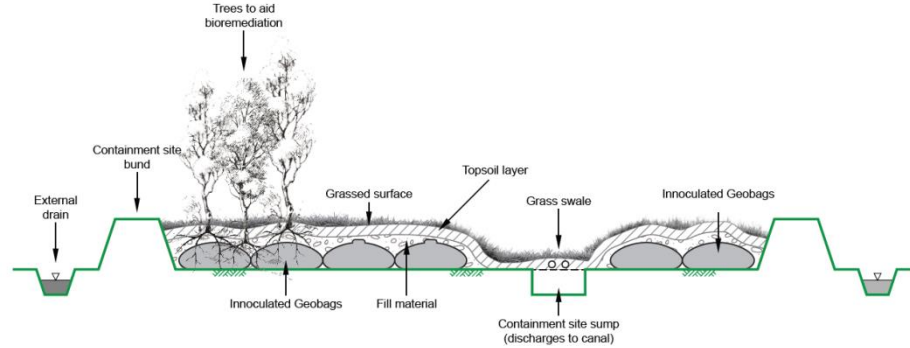
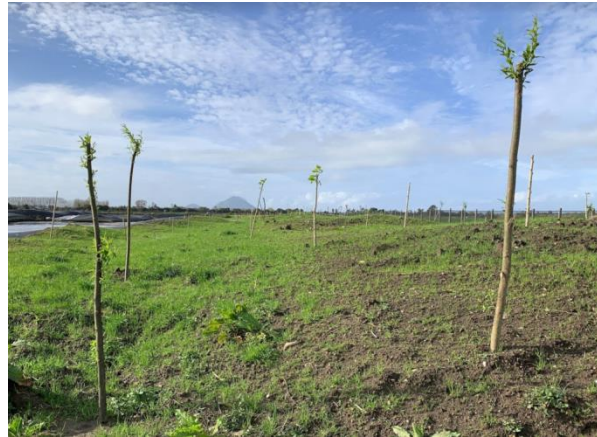
# Geobag capping & tree planting

- Release sugars into soil → feed bacteria
- Regulate  $O^2$  and  $H_2O$  levels in sediment
