Canterbury 2021 Flood Recovery Update 1

Ken Tarboton (Aqueus Consulting)
Shaun McCracken (Environment Canterbury)

10 August 2021

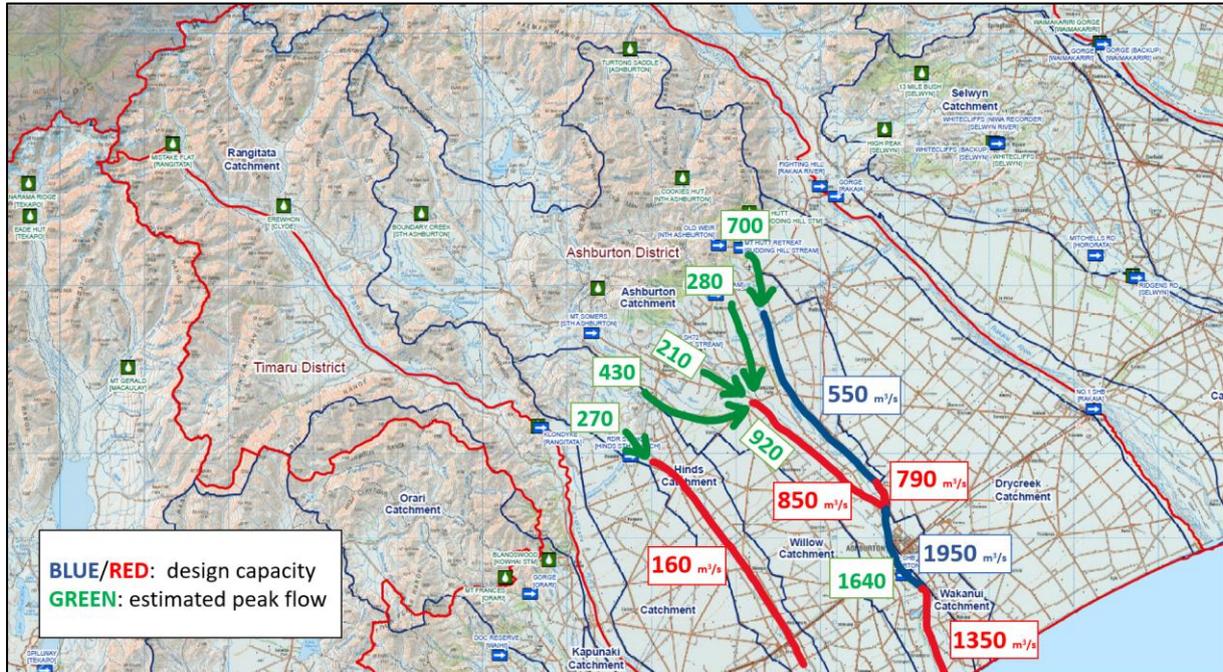
Figure 2-1: Preliminary peak river flow data for the Ashburton area.

It is within the Ashburton District that the flood damage is concentrated. River flows significantly exceeded design capacities in a number of reaches of the rivers in the catchment as shown in Figure 2-1 below. Estimated peak flows are shown in green and the design capacities of different reaches are shown in red and blue. At State Highway 1, this was the biggest flood on record for the Ashburton River.

The damage to ECan assets within the Ashburton catchment is widespread and large scale. Stopbanks have been breached, many kilometres of erosion control vegetation has been completely destroyed.

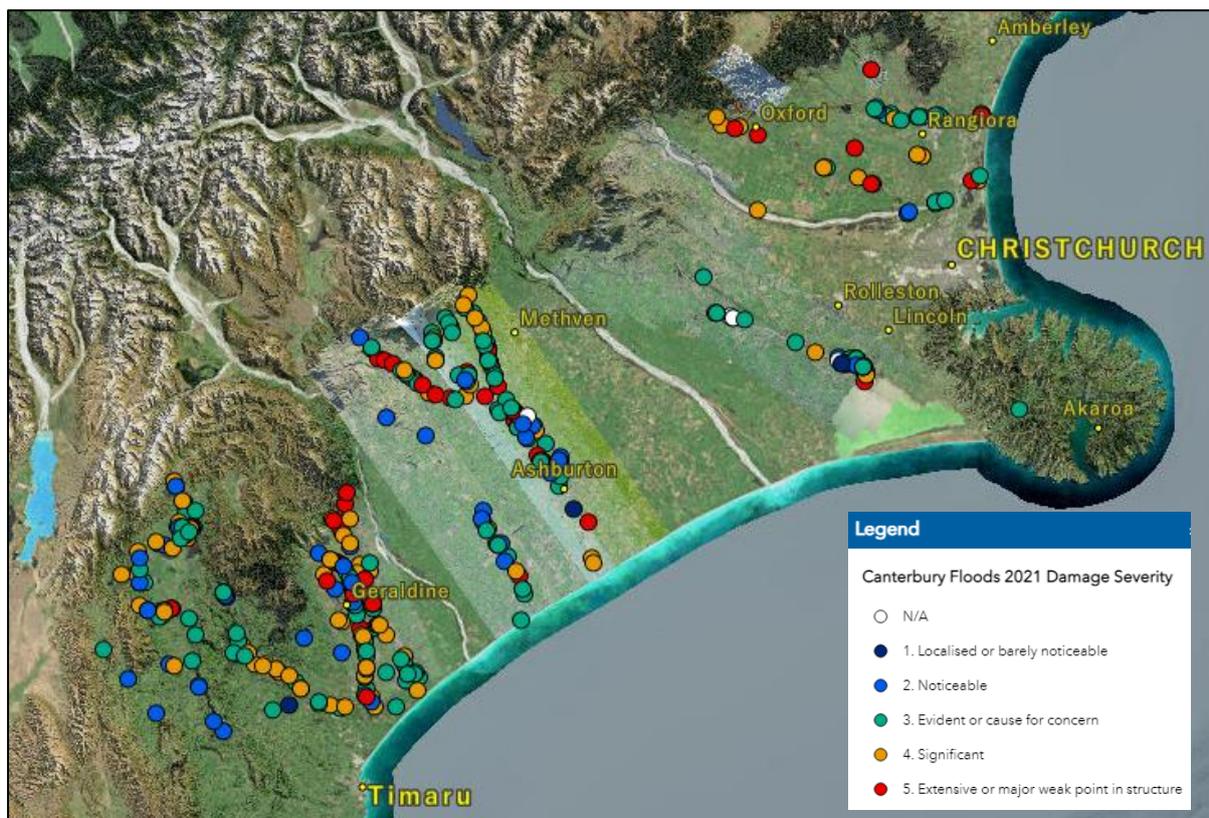
Figure 4-1: Mapped Environment Canterbury Asset Damage Sites

ECan's flood protection assets (stopbanks, tree edge protection, groynes, rock protection, culverts etc) are all available within the ECan asset management and GIS system. This has facilitated the checking of each identified site against the asset register.

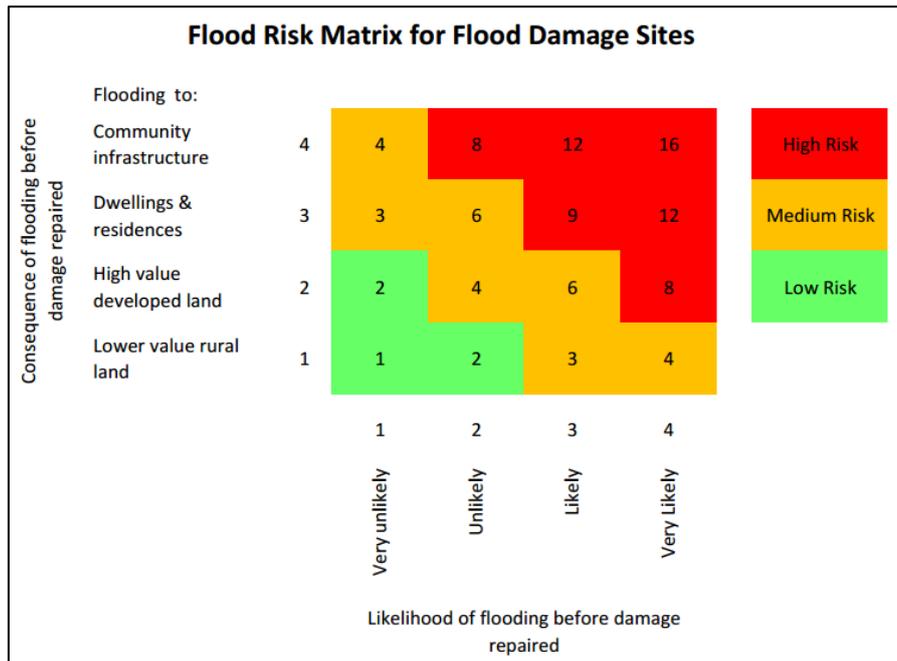
Figure 4-2: Flood Damage Risk Assessment Matrix

A risk-based approach was used to prioritise flood damage repair using following the matrix below. This risk-based approach has been applied to both temporary (response) and permanent (recovery) works.

Of all the flood damage sites identified, 281 sites have been assessed as requiring permanent repairs. For replacement of river edge tree protection, tree loss has been grouped into a single repair for several sites along reaches of rivers. Of the sites requiring permanent repair, 23% were deemed high risk 51% medium risk and 26% low risk. Repairs will be prioritised accordingly.

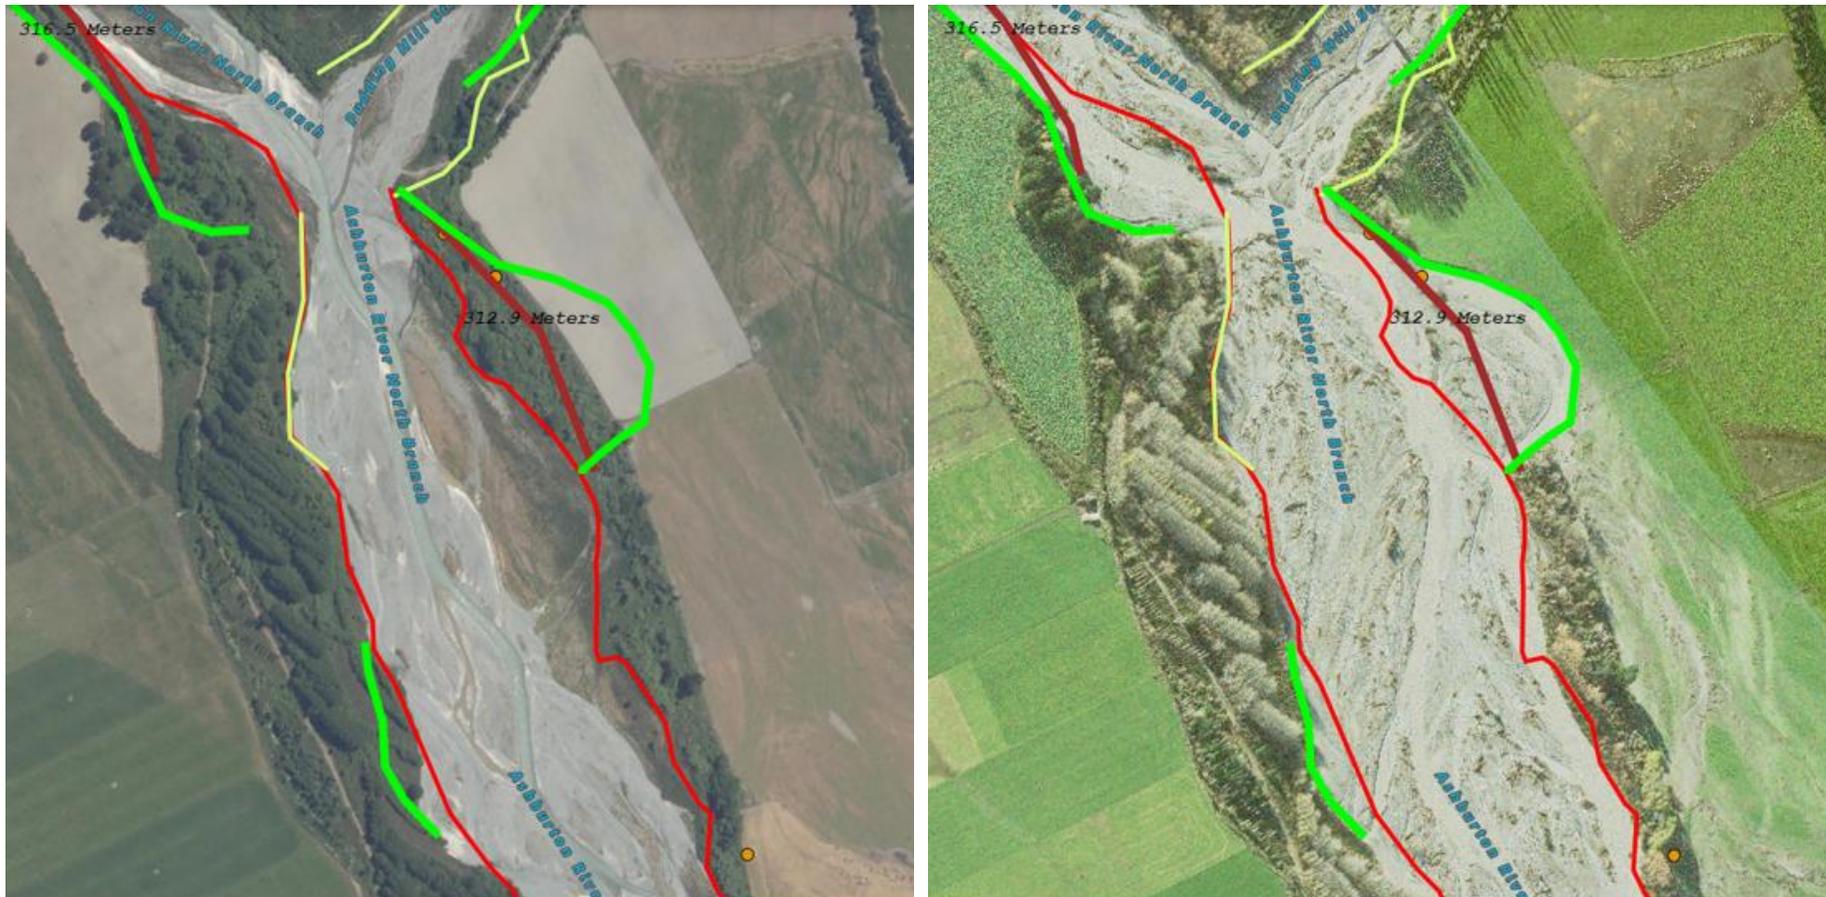
River edge protection – tree loss.

Figure A2-1: Ashburton River North Branch downstream of Pudding Hill Stream confluence. Tree loss and river blow-out on true left bank. Aerial image before flood (left) and after flood (right)

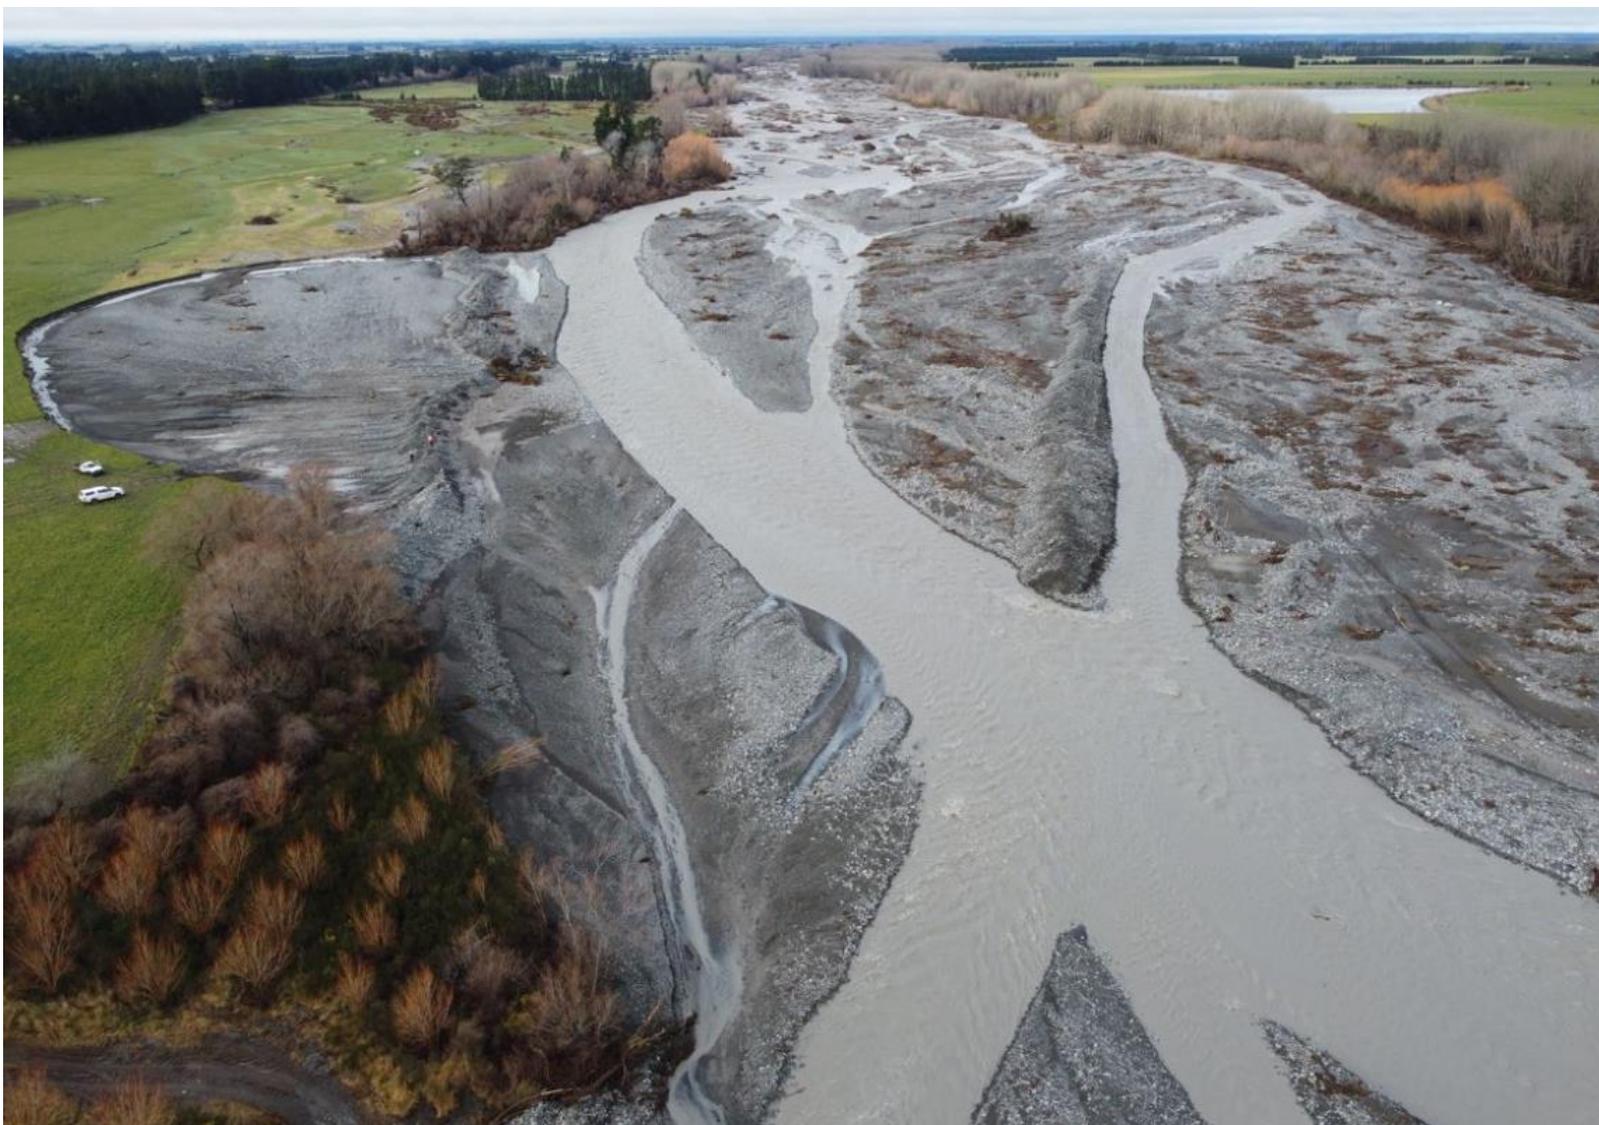
Figure A2-2: Aerial view of Ashburton River North Branch downstream of Pudding Hill Stream after flood. Note loss of tree edge protection on true left bank and some temporary bunding

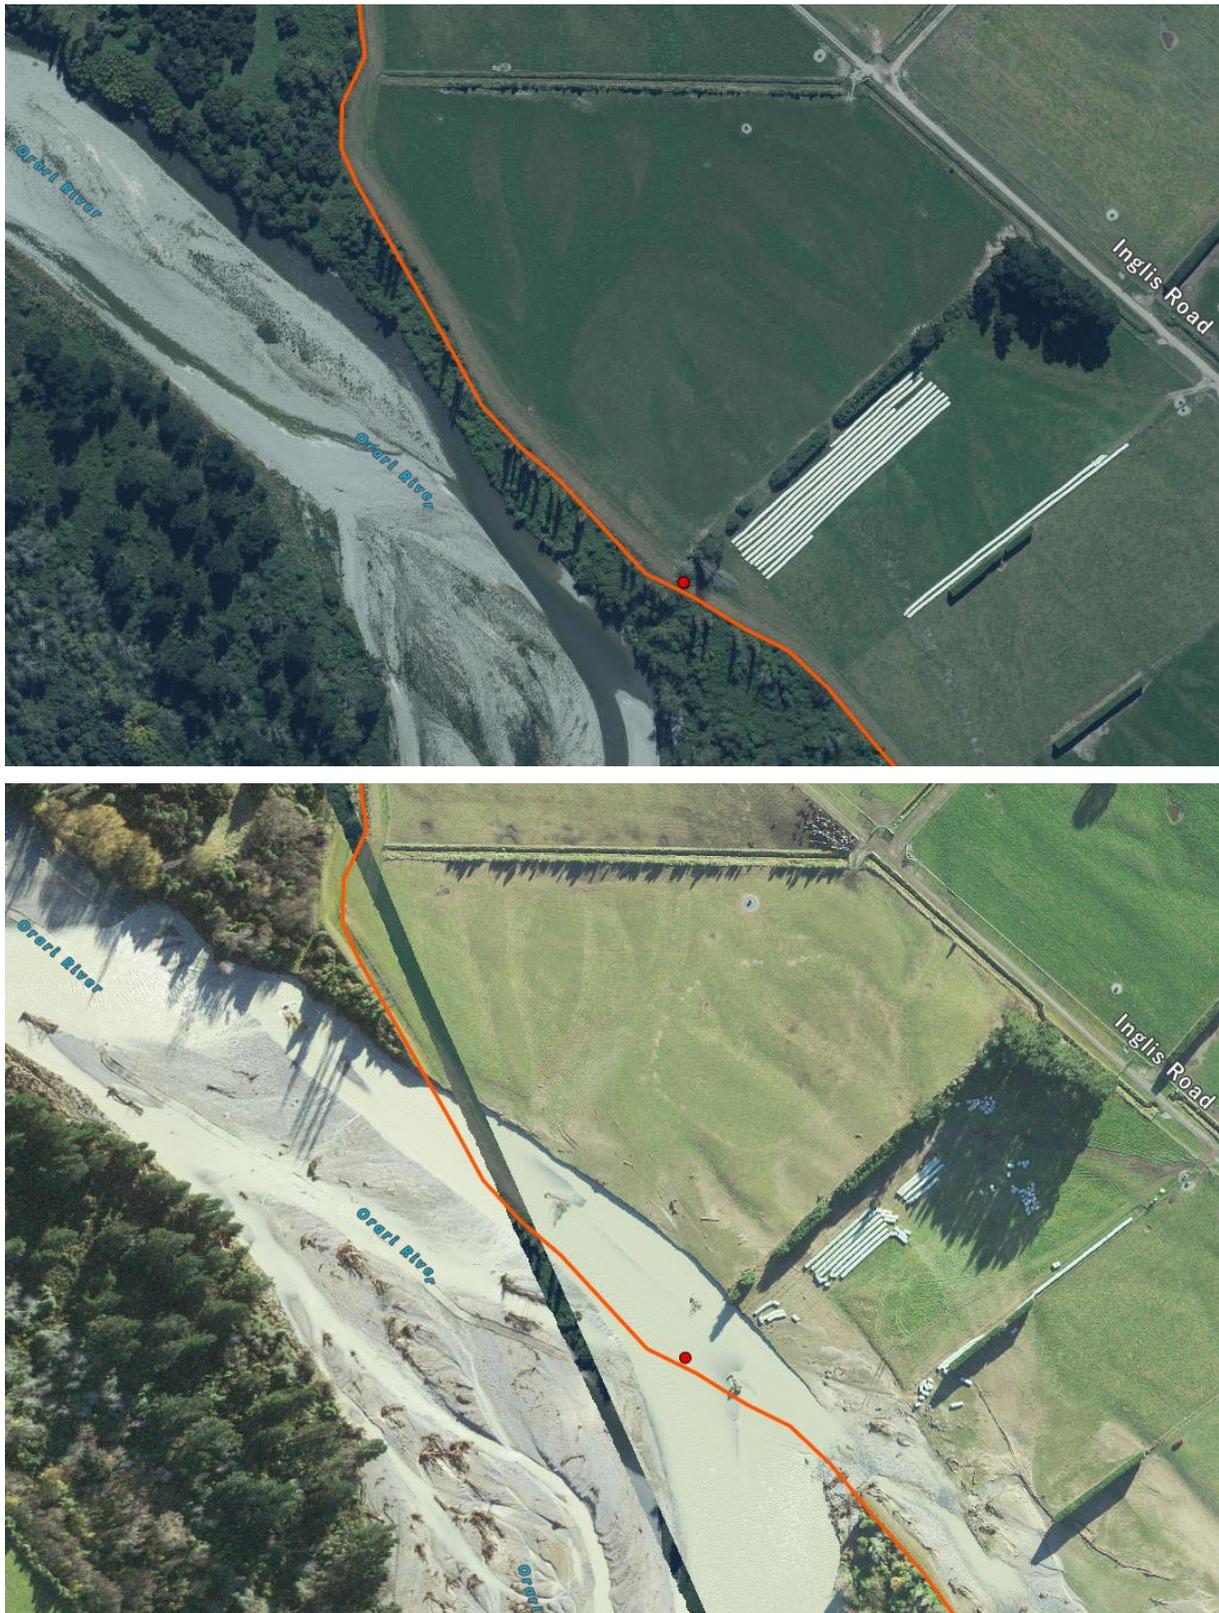
Stopbank Loss (Orari River example)

Figure A2-3: Upper Orari River. Stopbank Asset before flood (above) and loss of stopbank asset after flood (below).

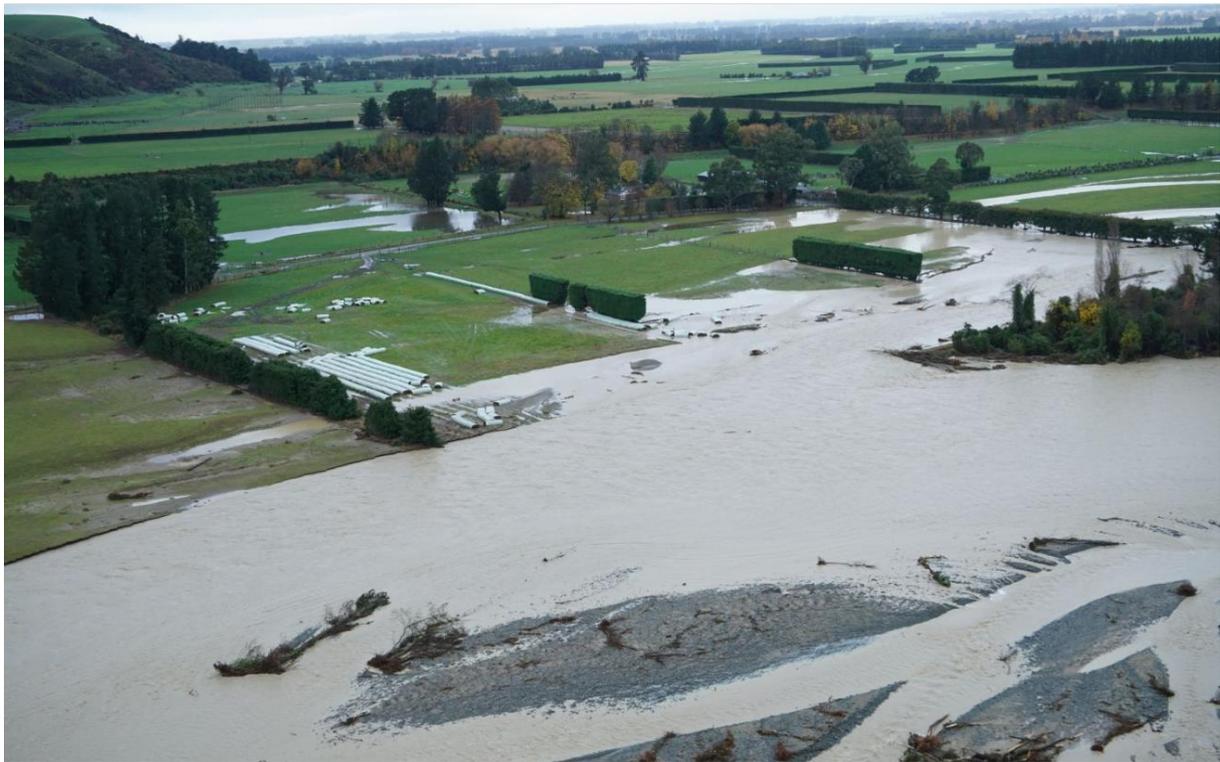
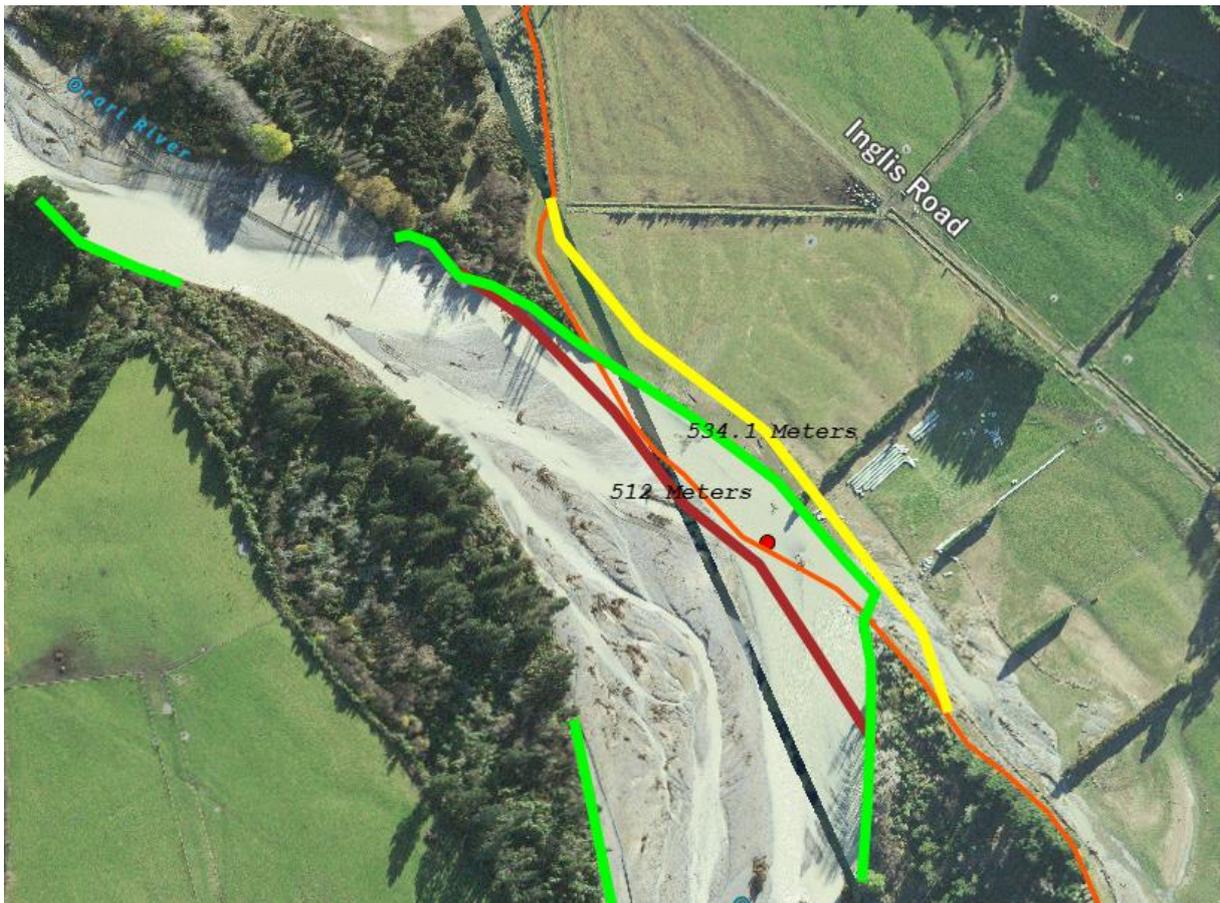
Stopbank Loss (Orari River example)

Figure A2-4: Upper Orari River. Stopbank breakthrough during flood (above) and estimate of river edge protection and stopbank asset loss (below).

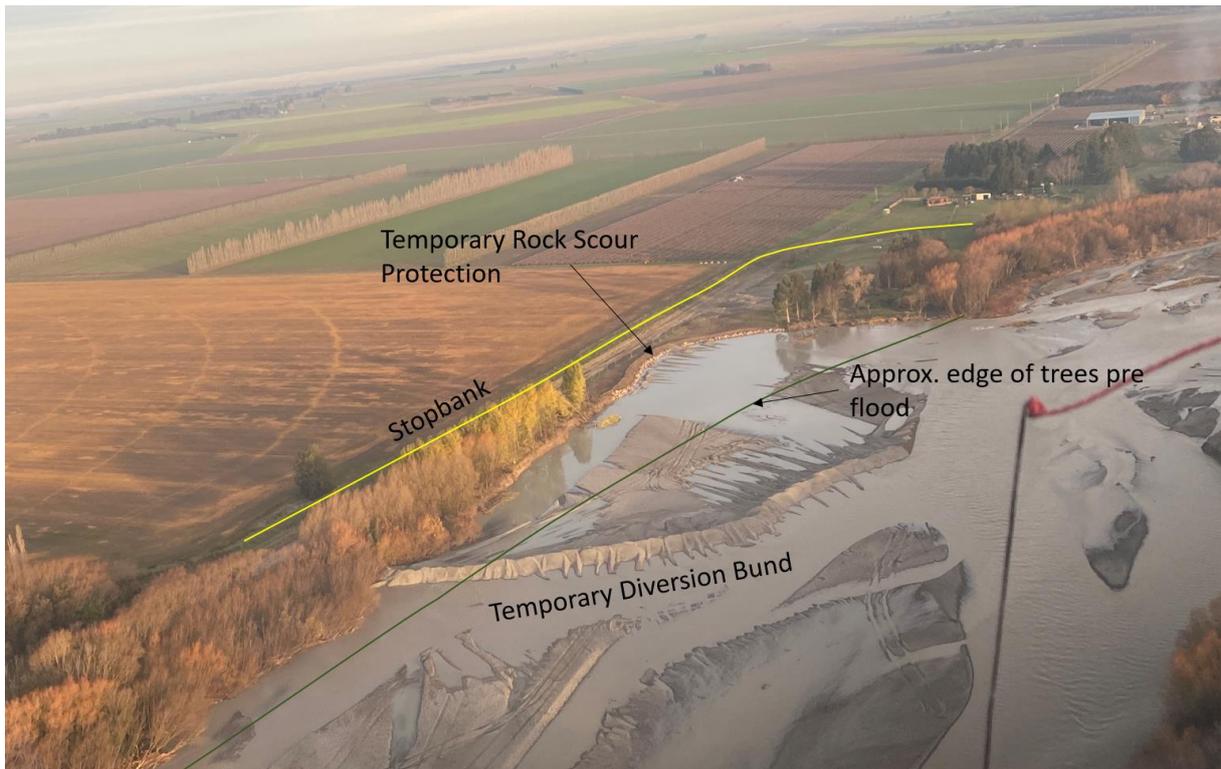
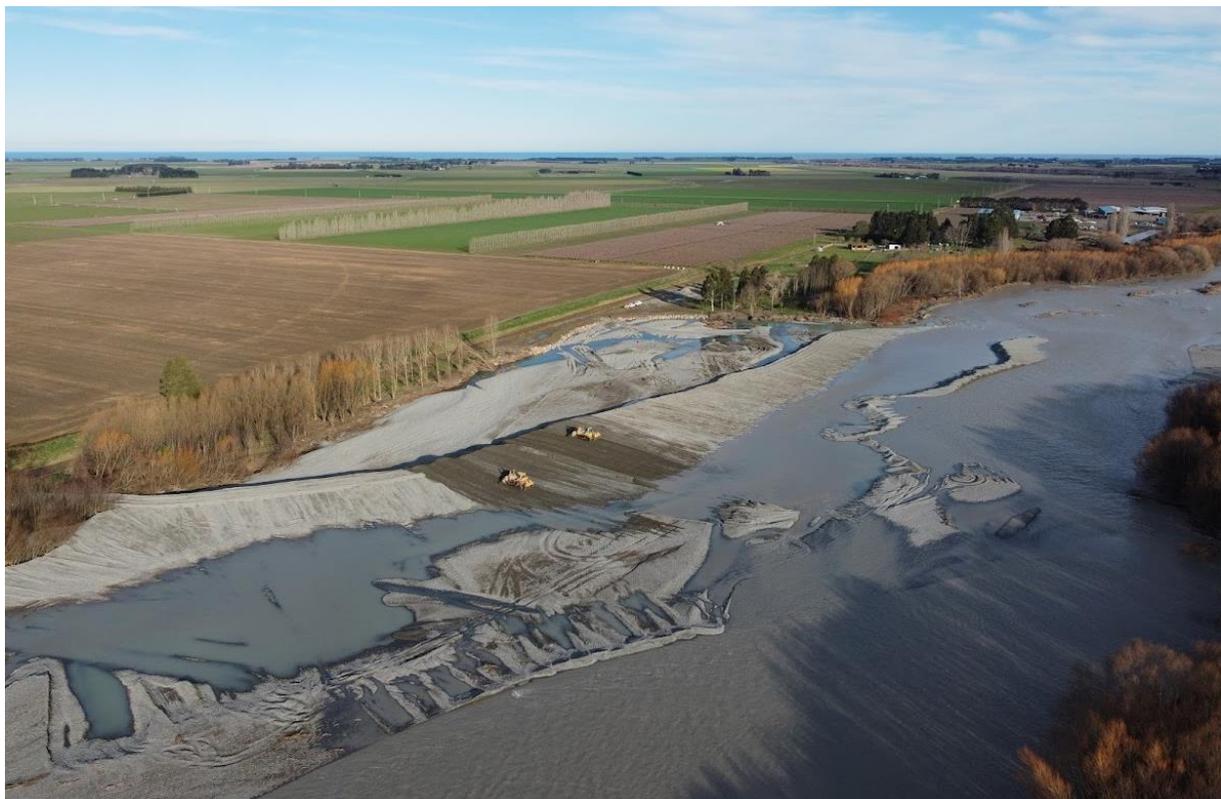
Temporary Repair Bunding (Ashburton River at River Road example).

Figure A2-5: Temporary repair at River Road, Ashburton River on 9 June 2021 (above) and 27 July 2021 (below).
