# **Canterbury 2021 Flood Recovery Update 2**

Ken Tarboton (Aqueus Consulting)  
Shaun McCracken (Environment Canterbury)

19 November 2021

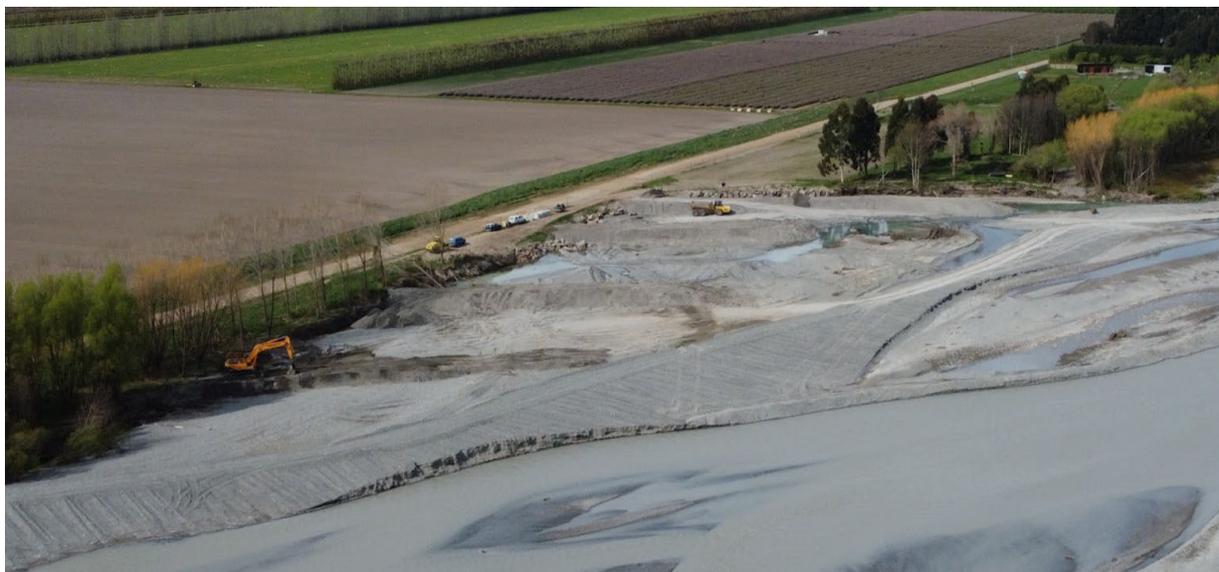
Figure 2-1: Erosion Protection Bunds under construction with tree edge replacement (Anchored Tree Protection) yet to start. Ashburton River. Job 23545.

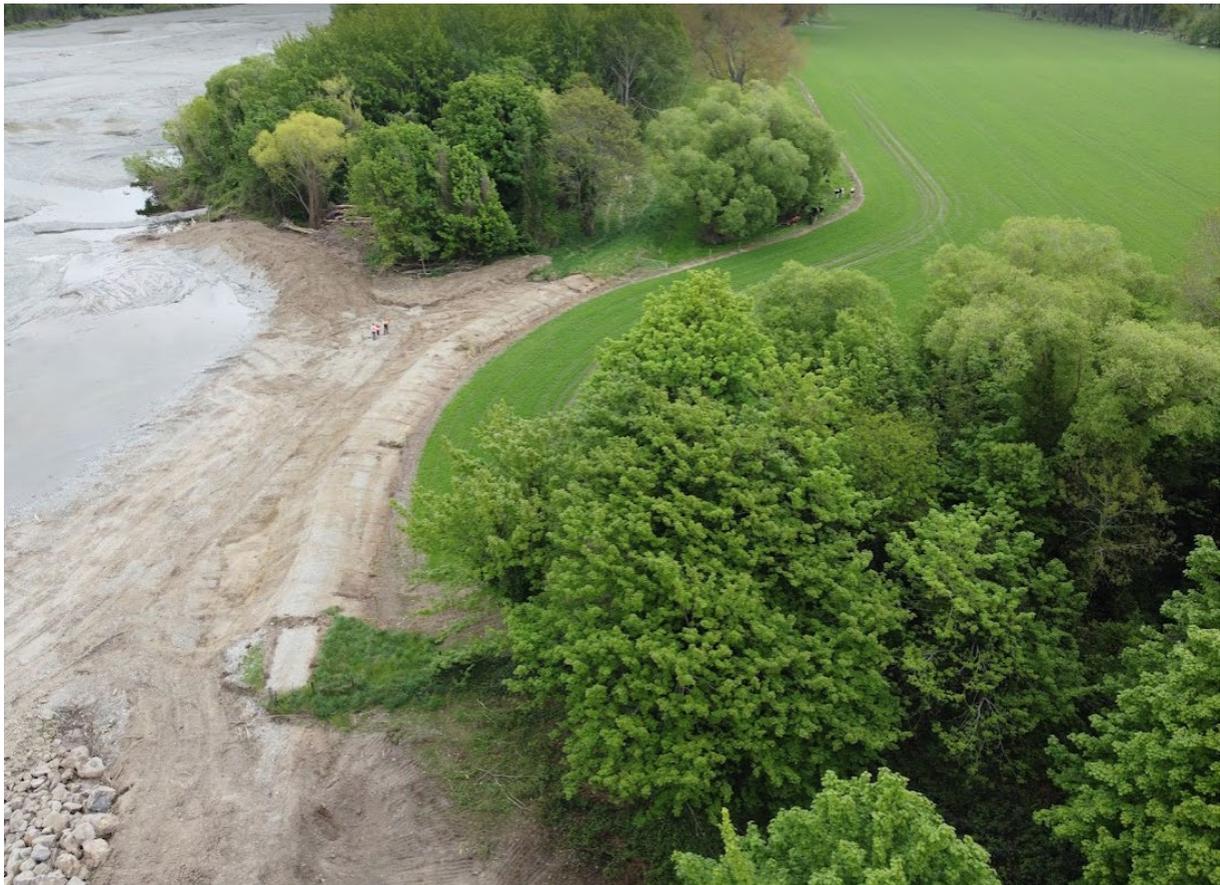
Figure 2-2: Stopbank repair underway with tree edge replacement yet to start. Orari River at Railway Bridge. Job 23718.

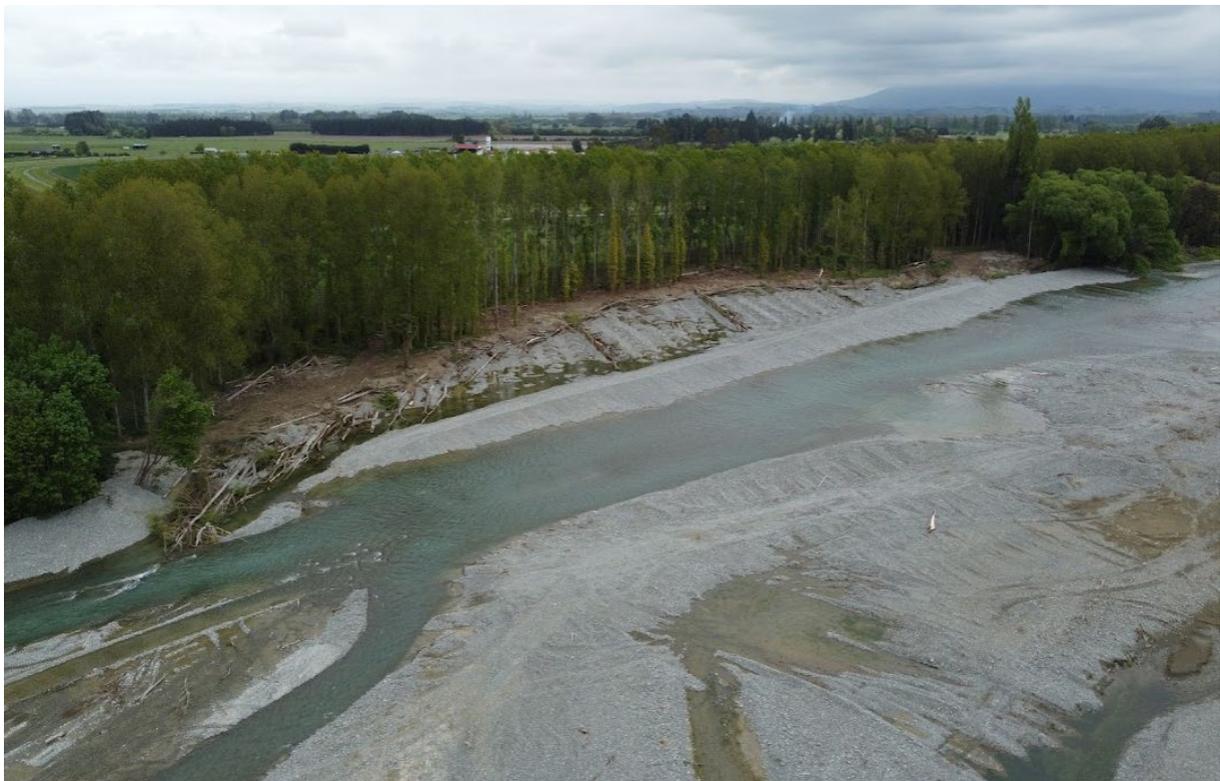
Figure 2-3: Anchored tree edge protection replacement repair where erosion was within 30m of stopbank edge. Orari River at Racecourse. Job 23715.

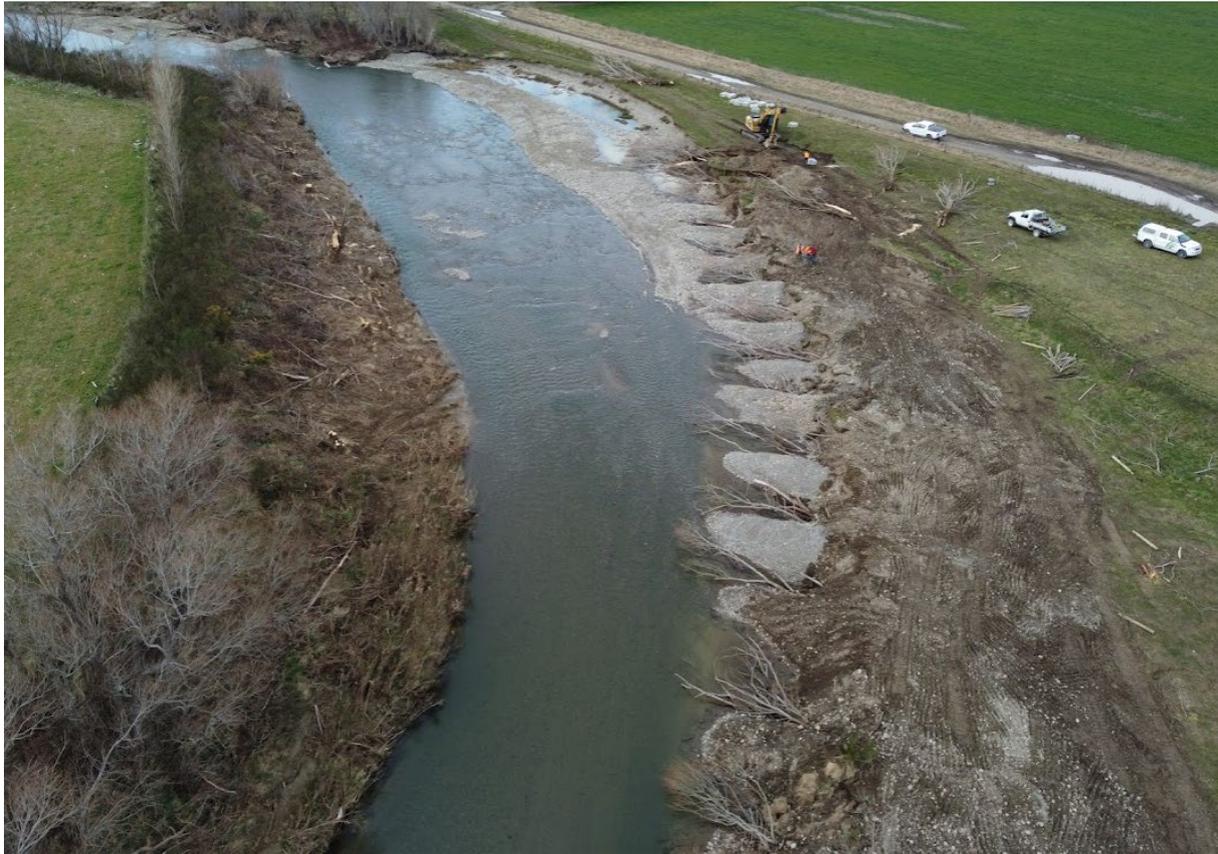
Figure 2-4: Anchored Tree Protection installation underway. Bowyers Stream. Job 23871.

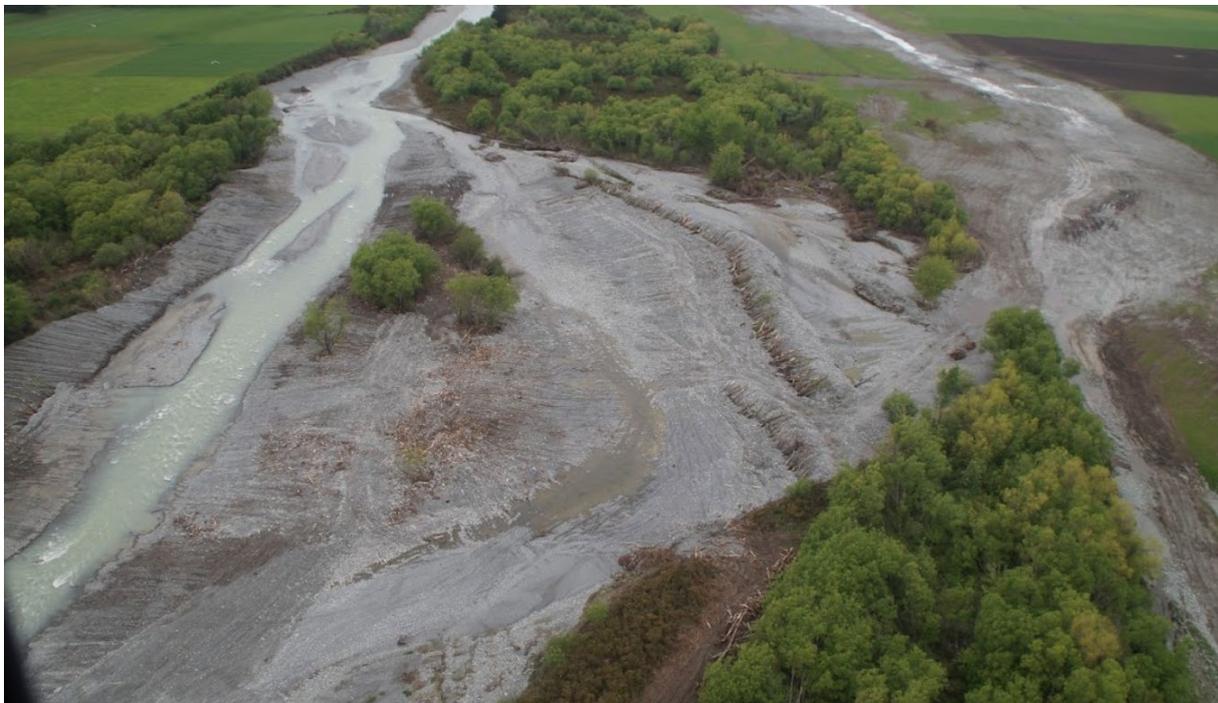
Figure 2-5: Completed stream diversion, buried tree line, deflection bunds. South Ashburton River. Jobs 23632 & 23633.

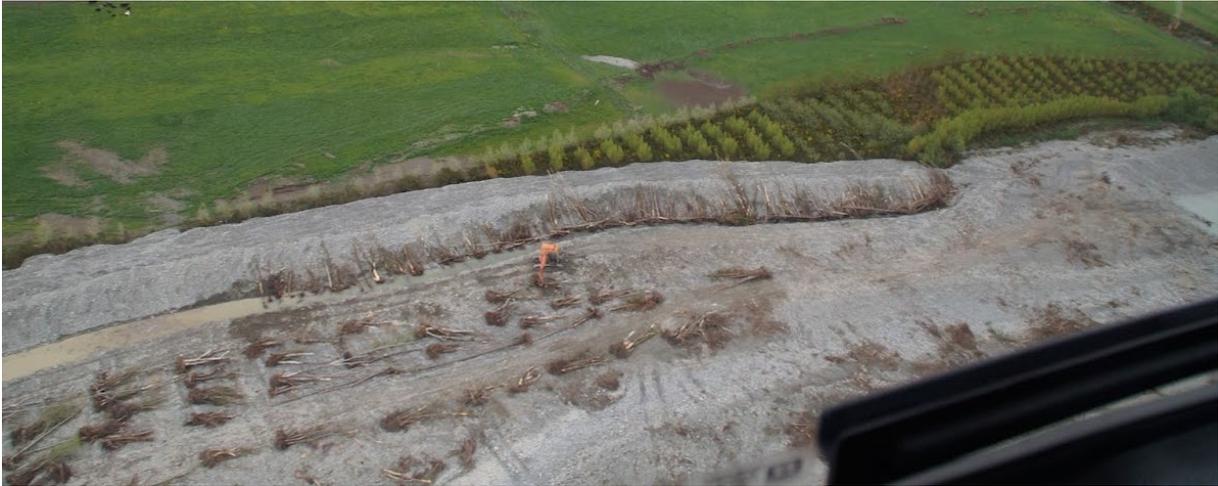
Figure 2-6: Buried Tree line during installation. South Ashburton River. Job 23628.

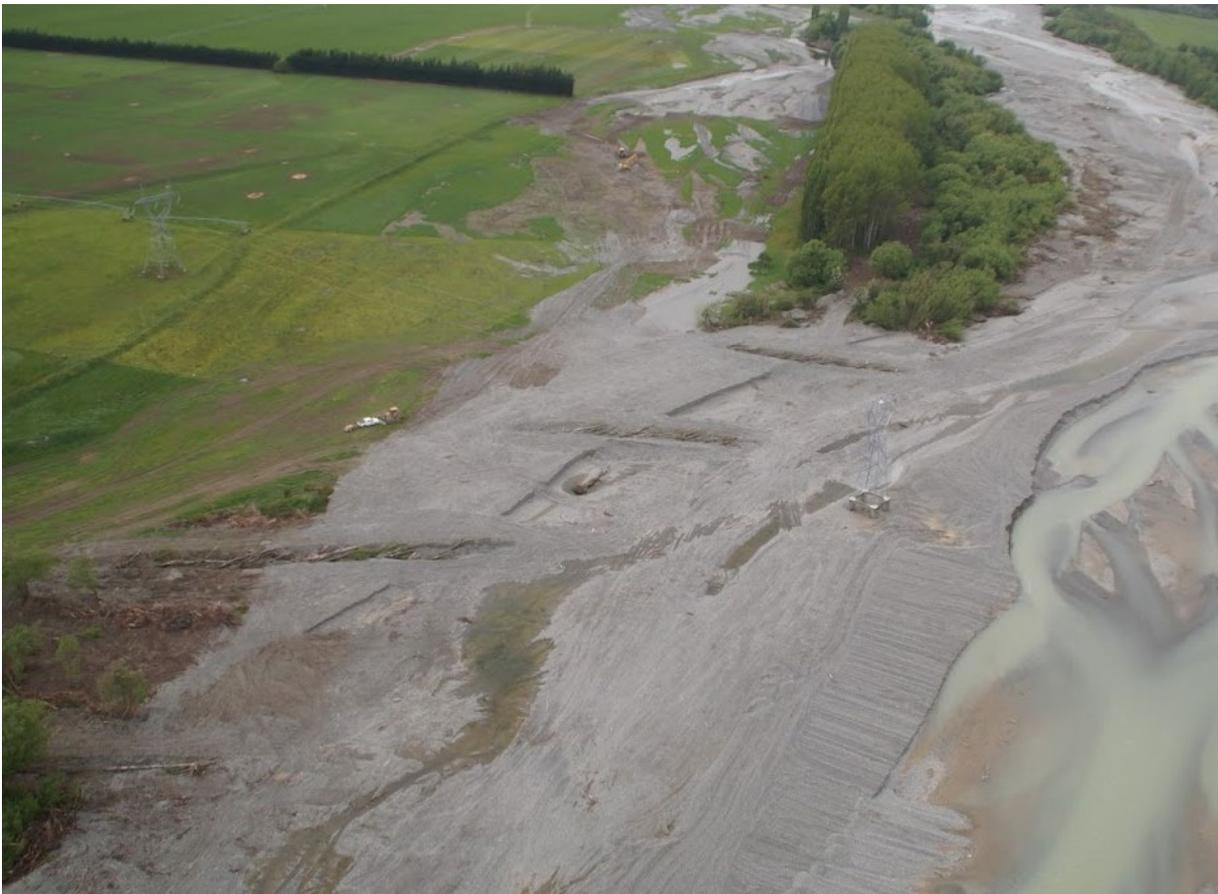
Figure 2-7: Completed Anchored Tree Protection Groynes. South Ashburton River. Job 23590.
