Canterbury 2021 Flood Recovery Update 4

Ken Tarboton (Aqueus Consulting)
Shaun McCracken (Environment Canterbury)

5 August 2022

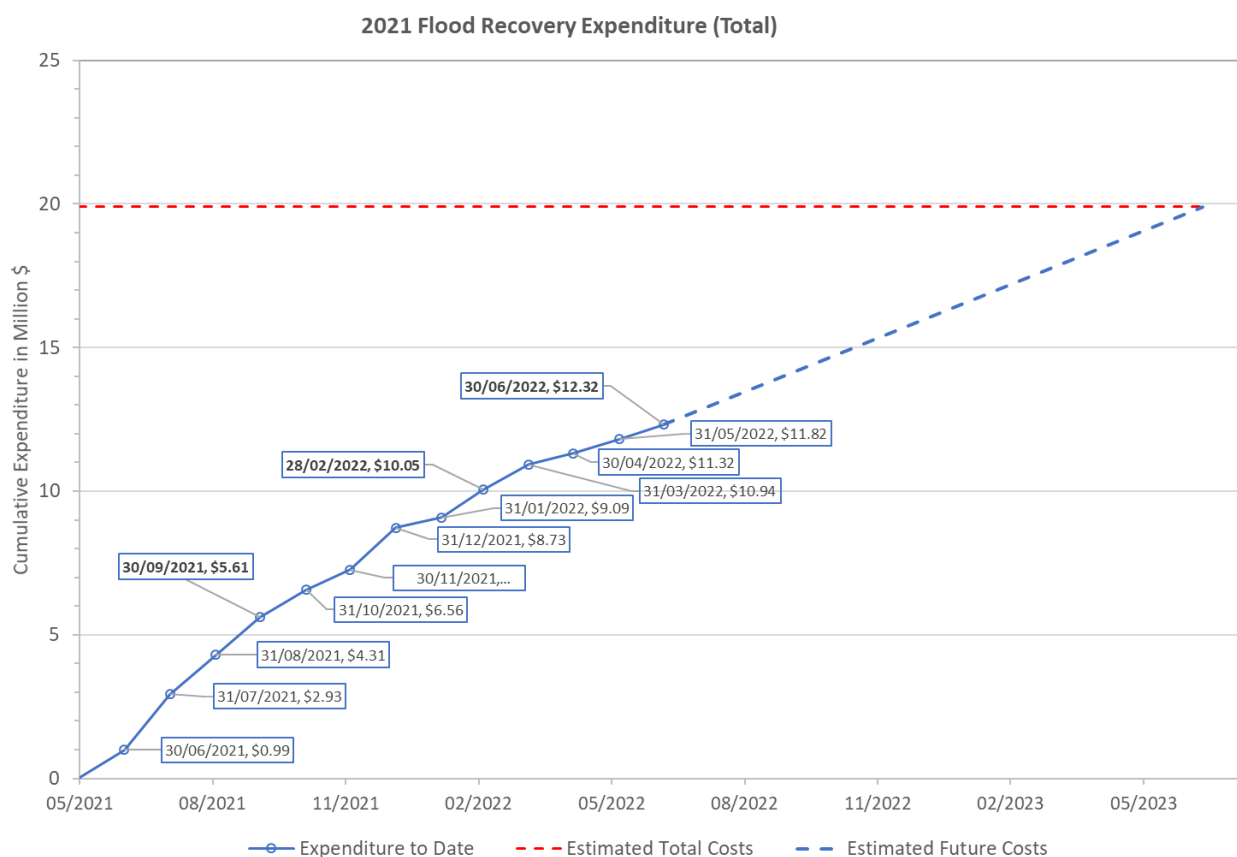
Figure 4-1: Summary of flood recovery expenditure profile.

Figure 4-1 below shows the expenditure profile to date. The profile of expenditure over the past four months from March to June has tracked very closely the expected spend profile. Temporary works and the majority of large stopbank rebuilds have now been completed. Tree edge reinstatement is expected to comprise most to the expenditure moving forward.

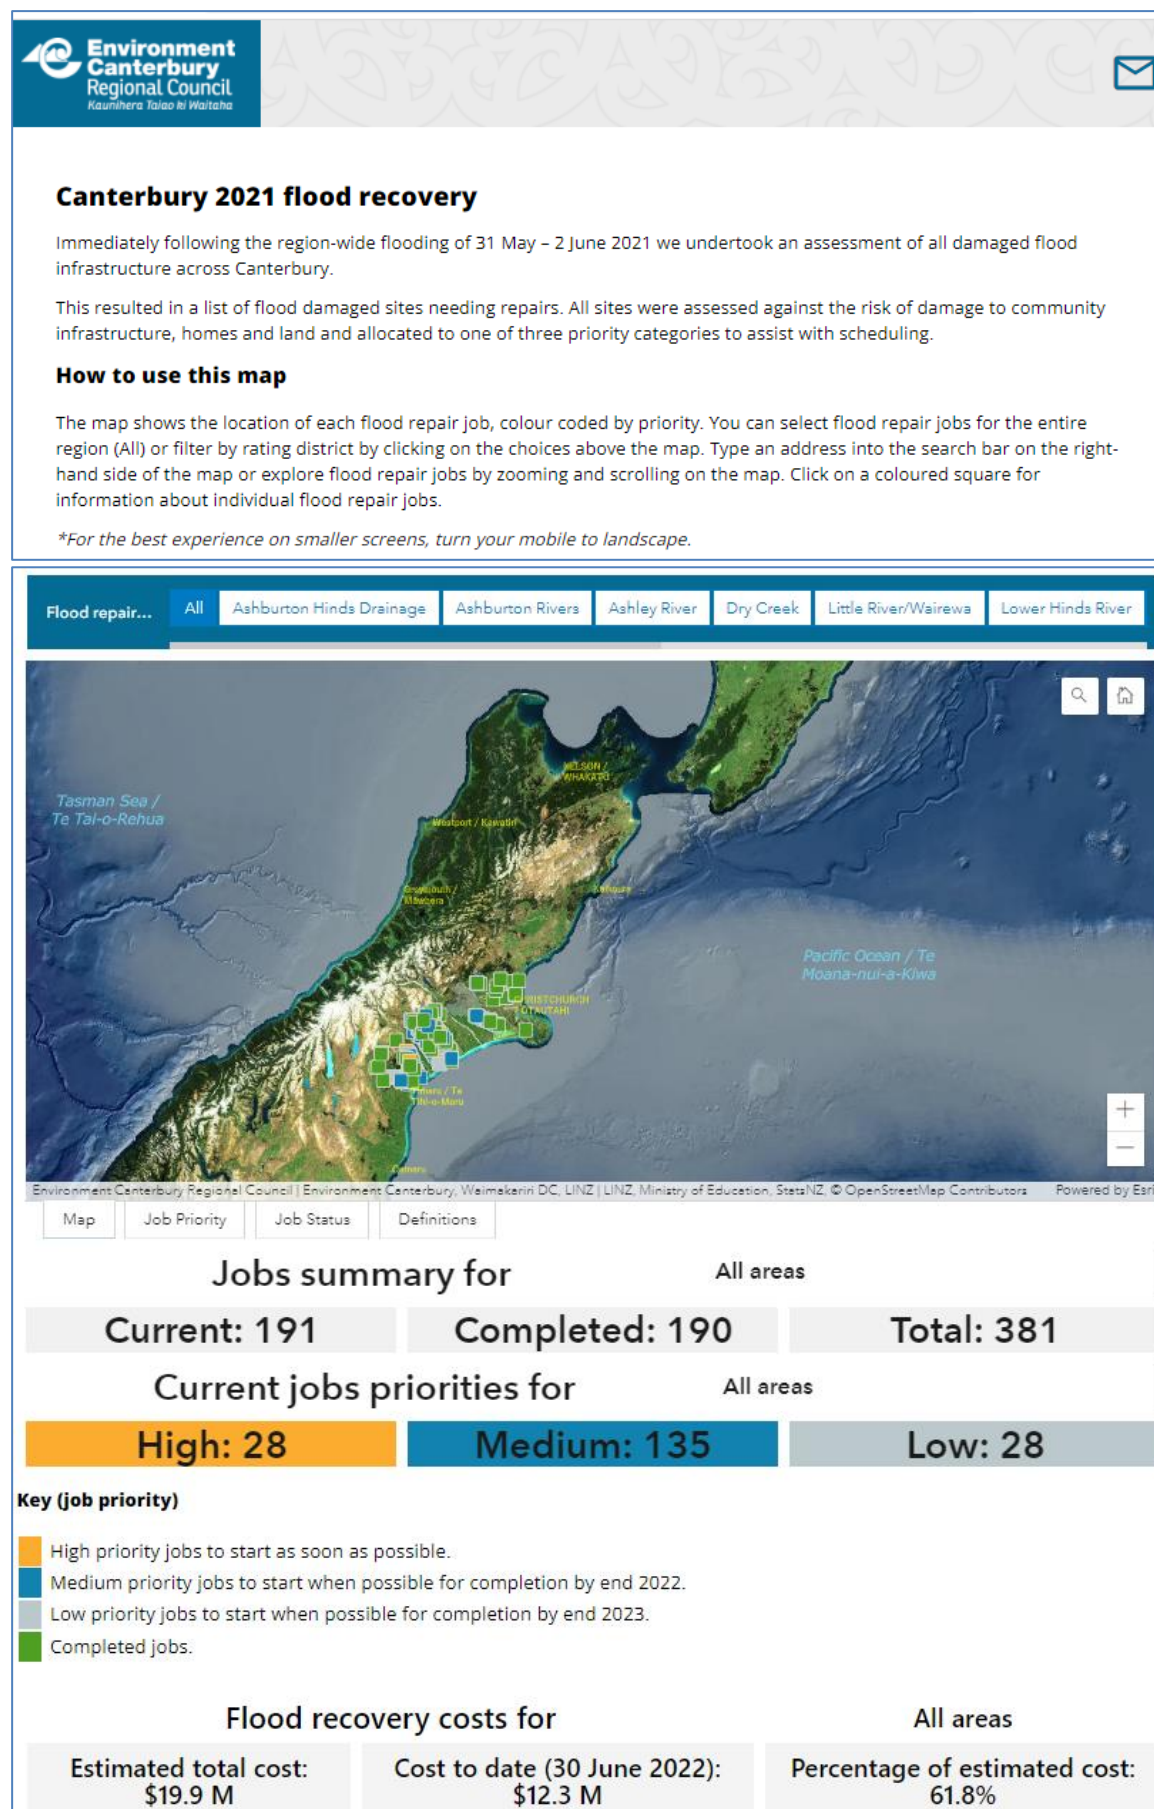
Figure 6-1: Screen clip of flood recovery interactive job status web page at 30 June 2022.

This map and its associated summary tables provide information on all flood damage repair jobs for the affected Canterbury districts. Summaries can be viewed based on user selection either of "All" areas, or by selecting a specific district. Clicking on each individual repair site on the map gives high-level information about the nature of the repair at that location and its status. A screen clip of the website is included in Figure 6-1 below.

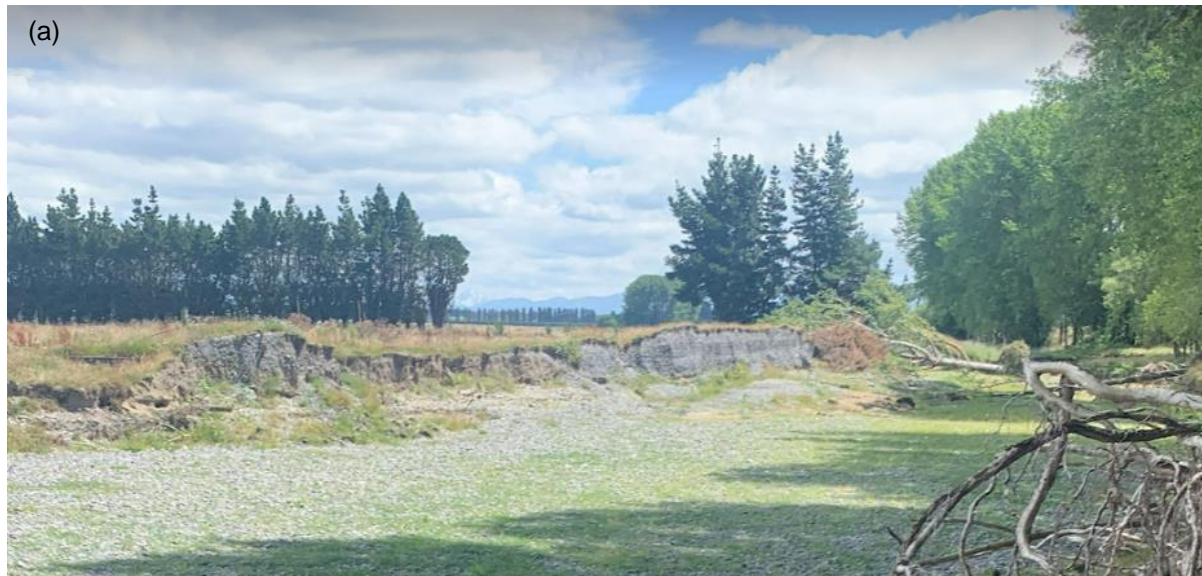
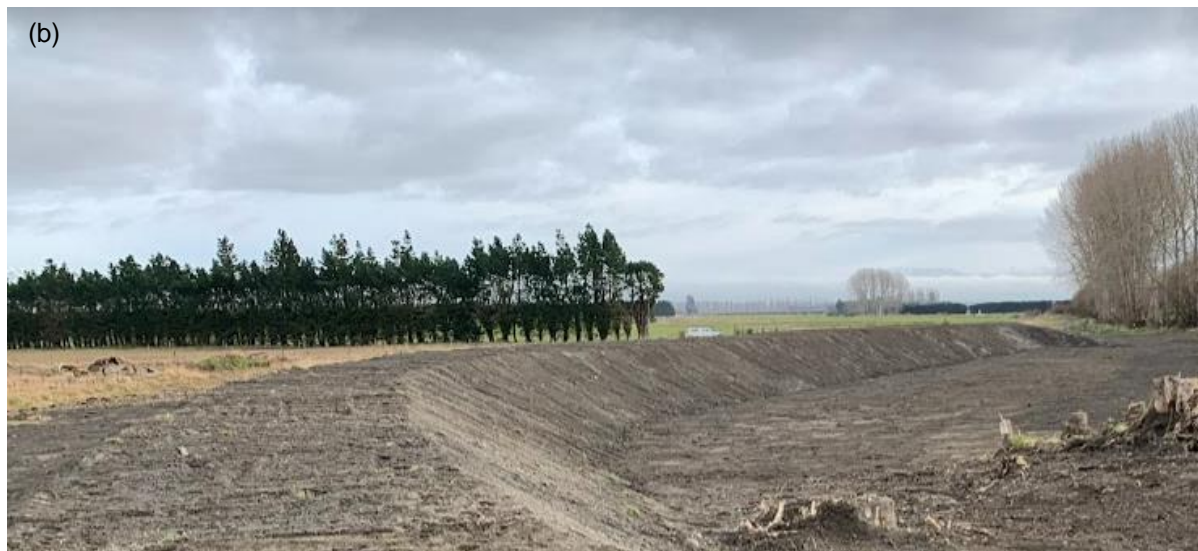
Figure A-1: Ashburton North Branch at Walkhams Road (a) before and (b) after floodbank reinstatement.

Two major stopbank repairs were completed during this period in addition to those previously completed. These were the stopbanks on the Waihi River at Beeby Road and the Ashburton North Branch upstream of Walkhams Road. Details are included in Table 2-2 below and photos included in Appendix A.

Location	Sites repaired	Stopbank length (m)	Erosion Protection Bunds (m)	Tree edge protection to follow (m)	Status at 30 June 2022 (Job numbers)
Ashburton North at Walkhams Road	2	290	none	none	Completed rebuild at Site A (210m, job 23612) and repair at Site B (20m, job 23614). Rebuild at Site C (60m job 23611) still to do.
Waihi at Beeby Road	1	190	120	190	Completed job 23750 including ATP and pole infill planting.
Total	3	480	120	190

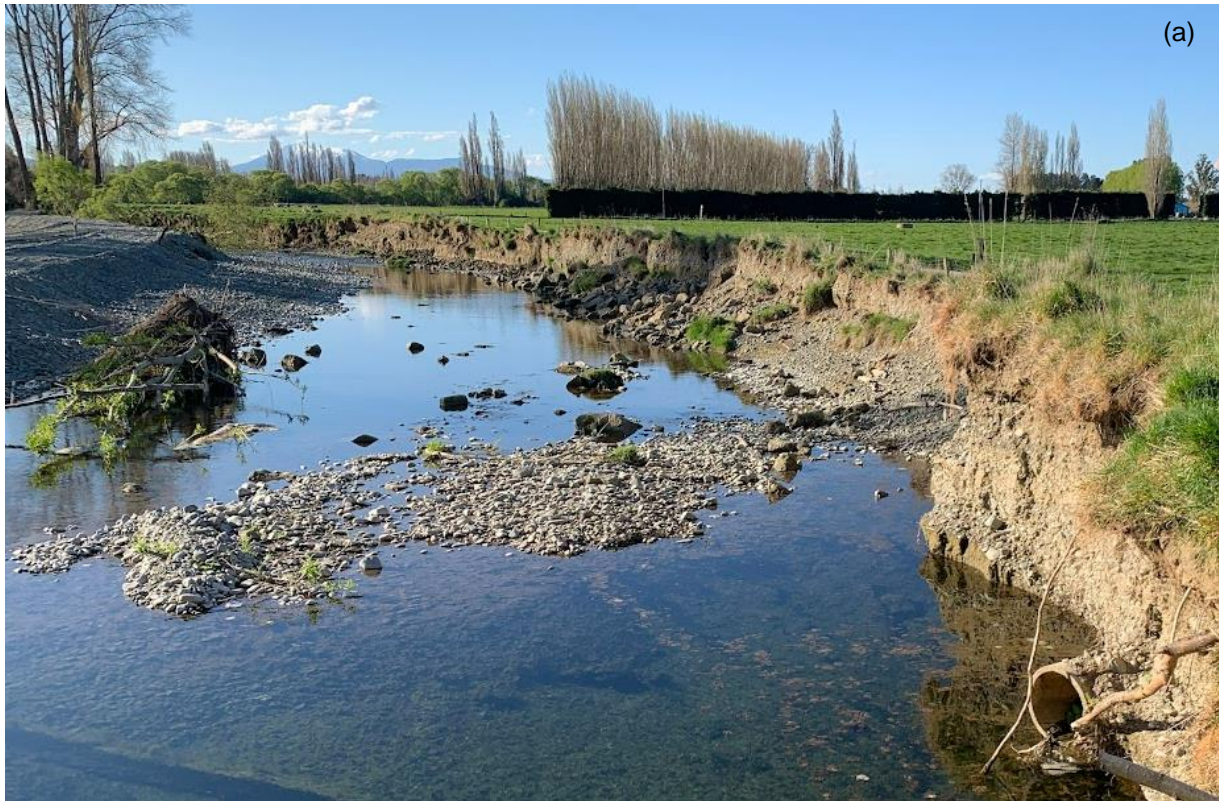
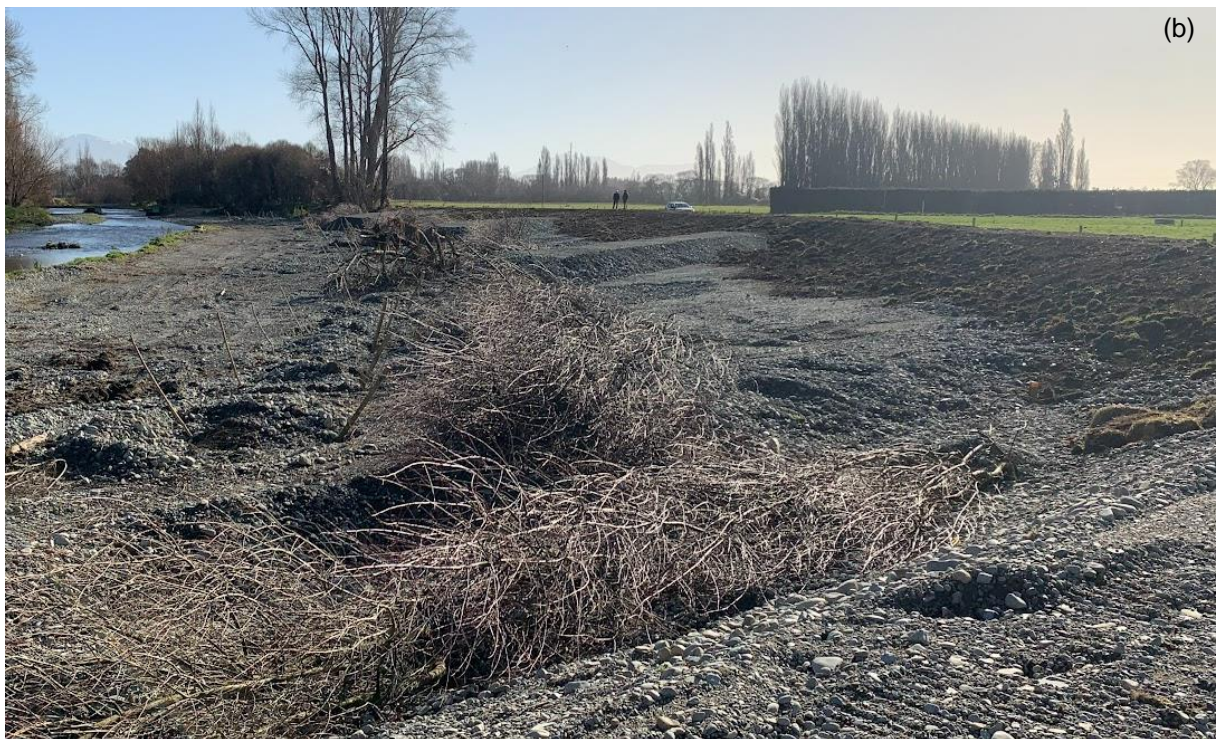
Figure A-2: Waihi at Beeby Rd (a) before repair, (b) after stopbank reinstatement and installation of anchored tree protection.

At the Beeby Road site on the Waihi River, both the stopbank and the tree edge protection assets were washed out. Because the stopbank repair was undertaken at the end of the summer, the anchored tree protection (ATP) and tree infill planting were undertaken at the same time.

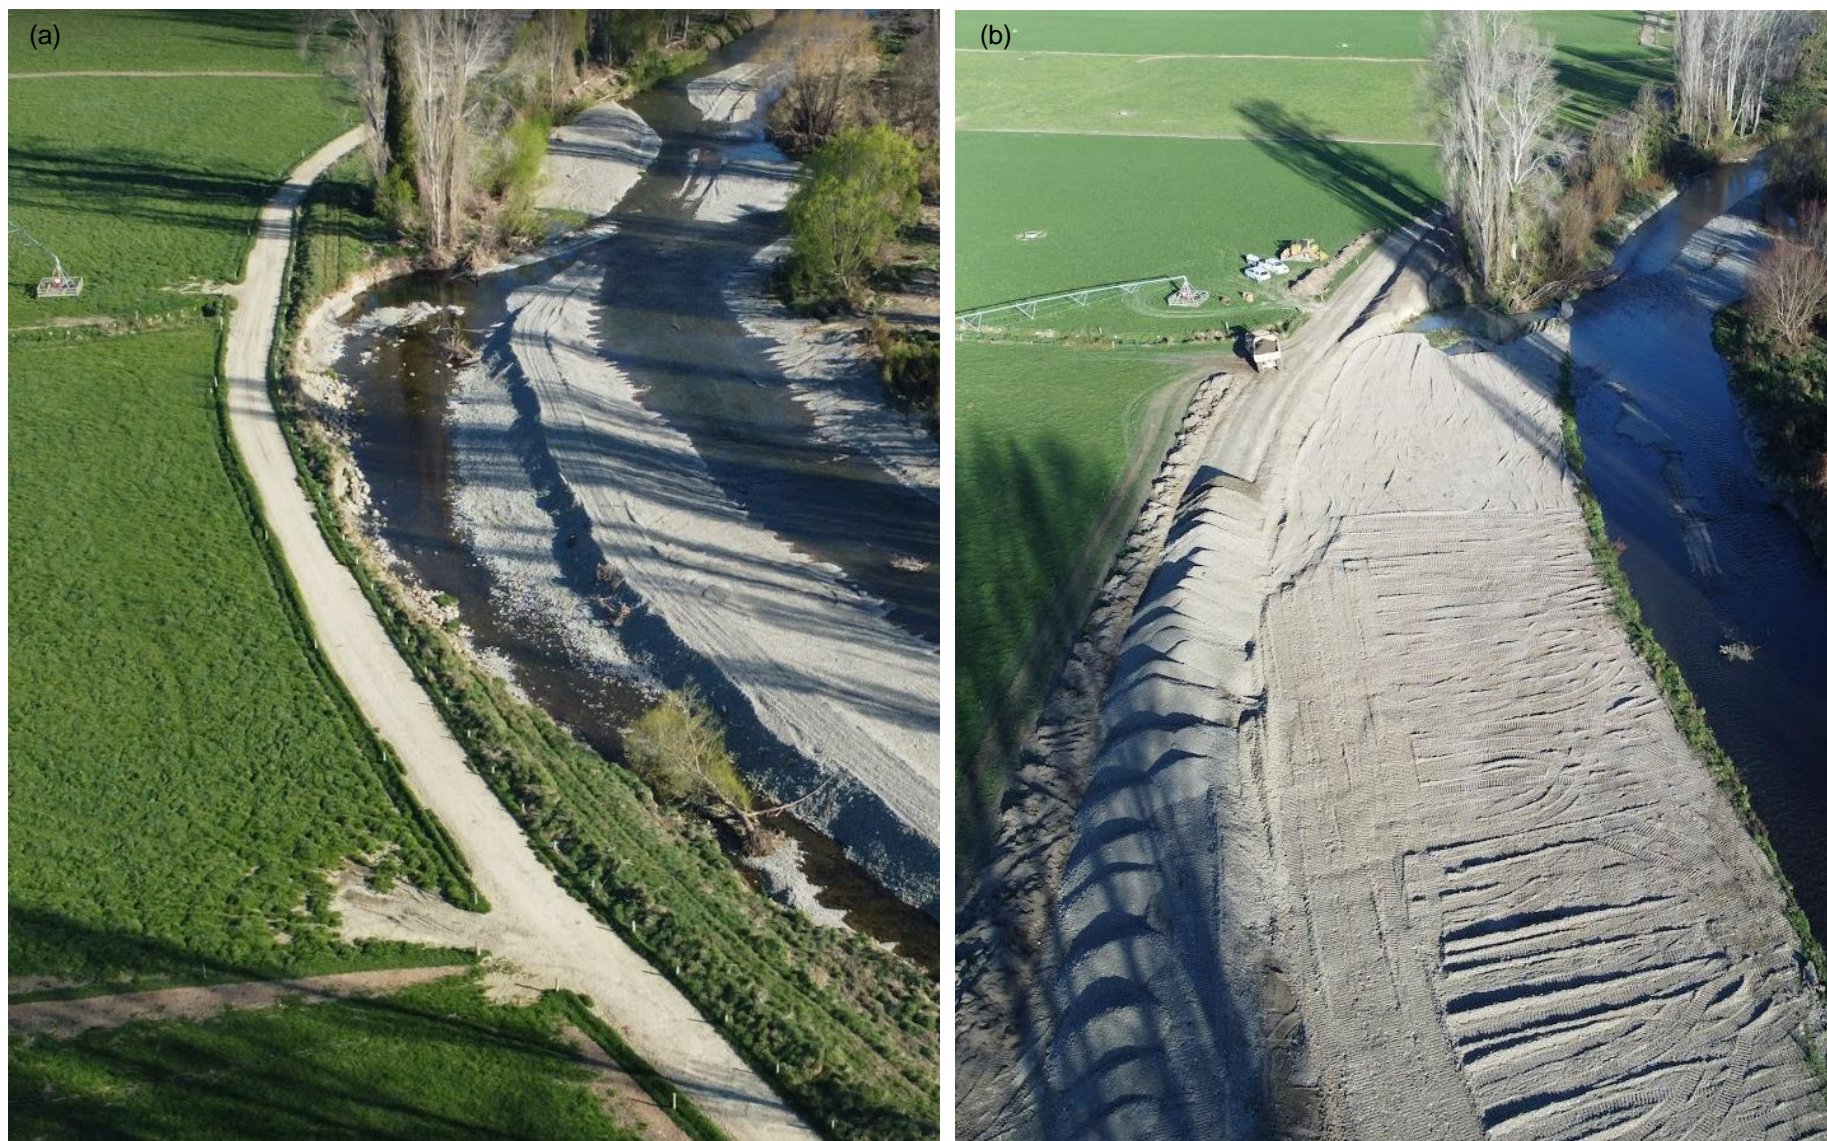
Figure A-3: Aerial of Waihi at Beeby Rd (a) after temporary repairs and (b) during stopbank reinstatement.

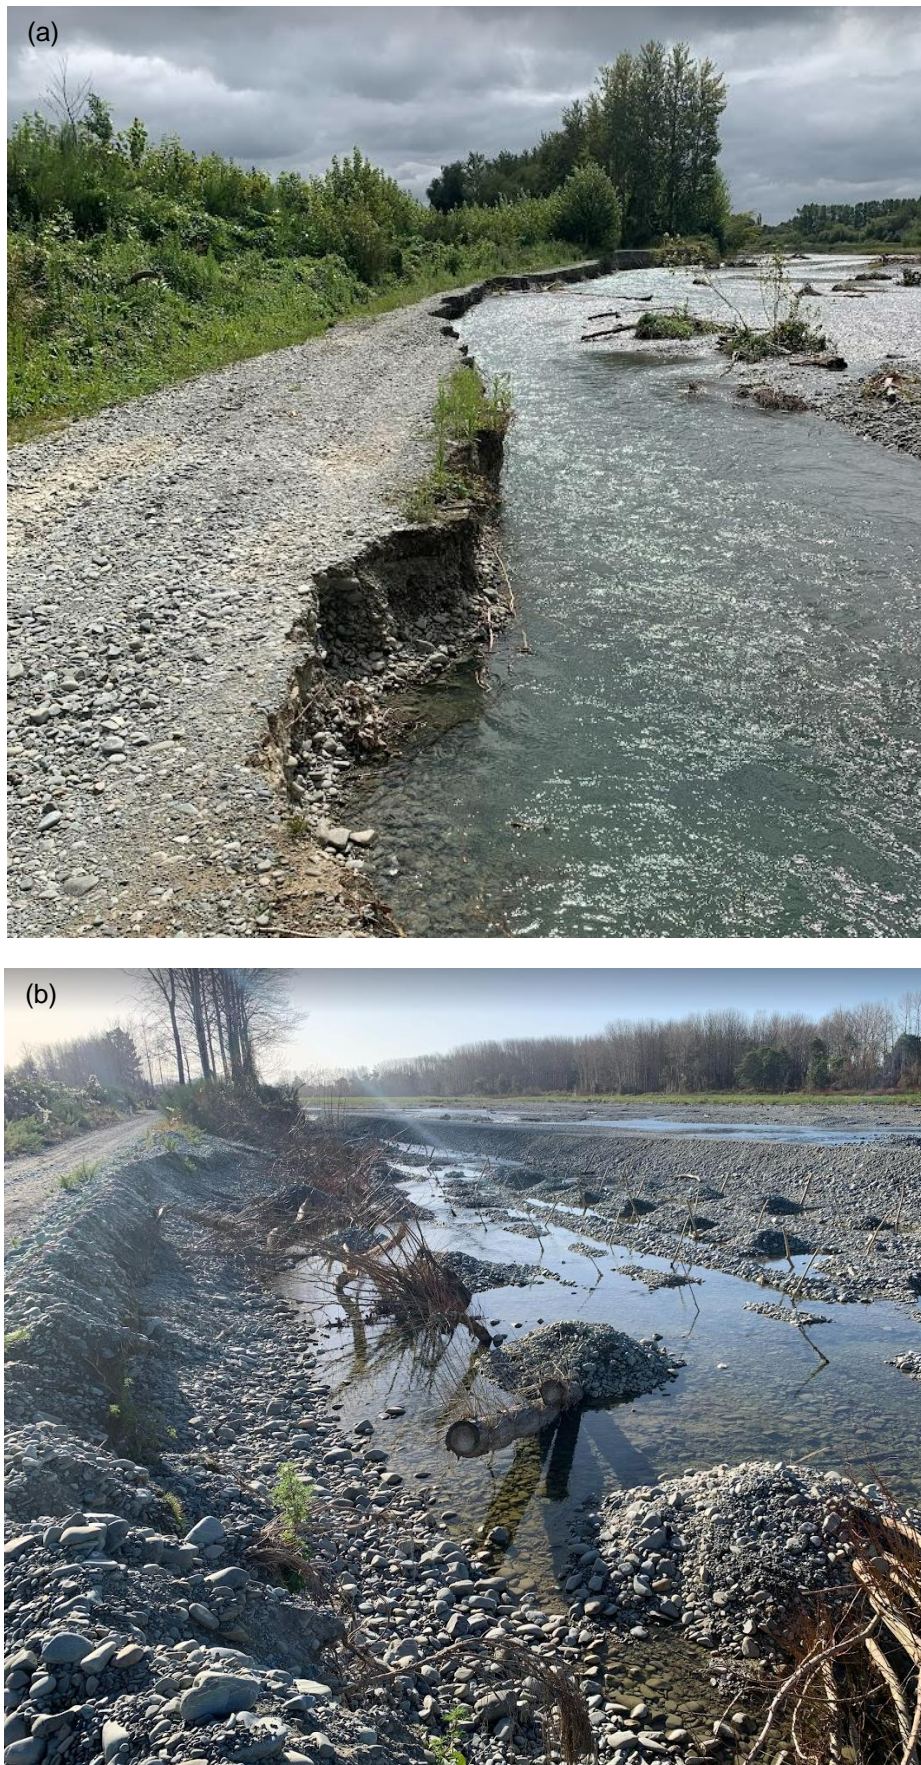
Figure A-4: Orari true right bank upstream of Vance Road quarry, (a) before repair and (b) after infill planting.

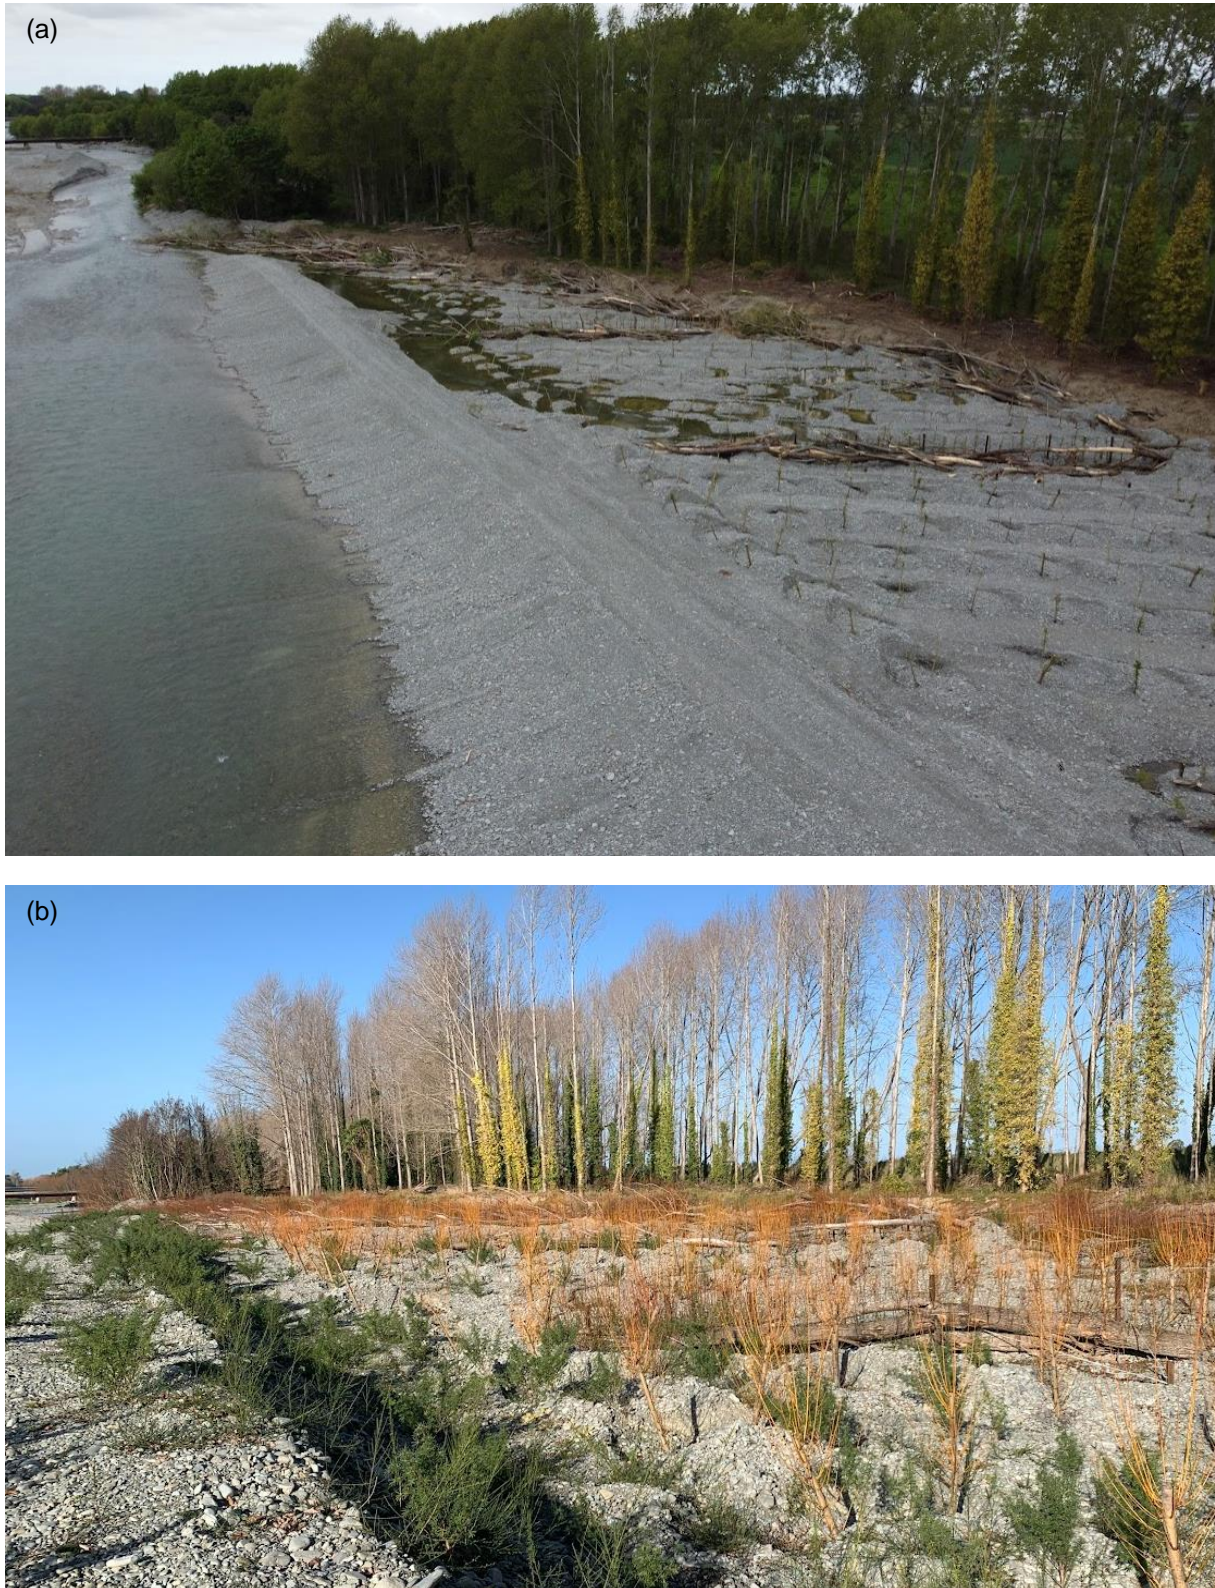
Figure A-5: Orari at racecourse (a) after completion of rope and rail lines (October 2021) and (b) showing growth of poles by June 2022.

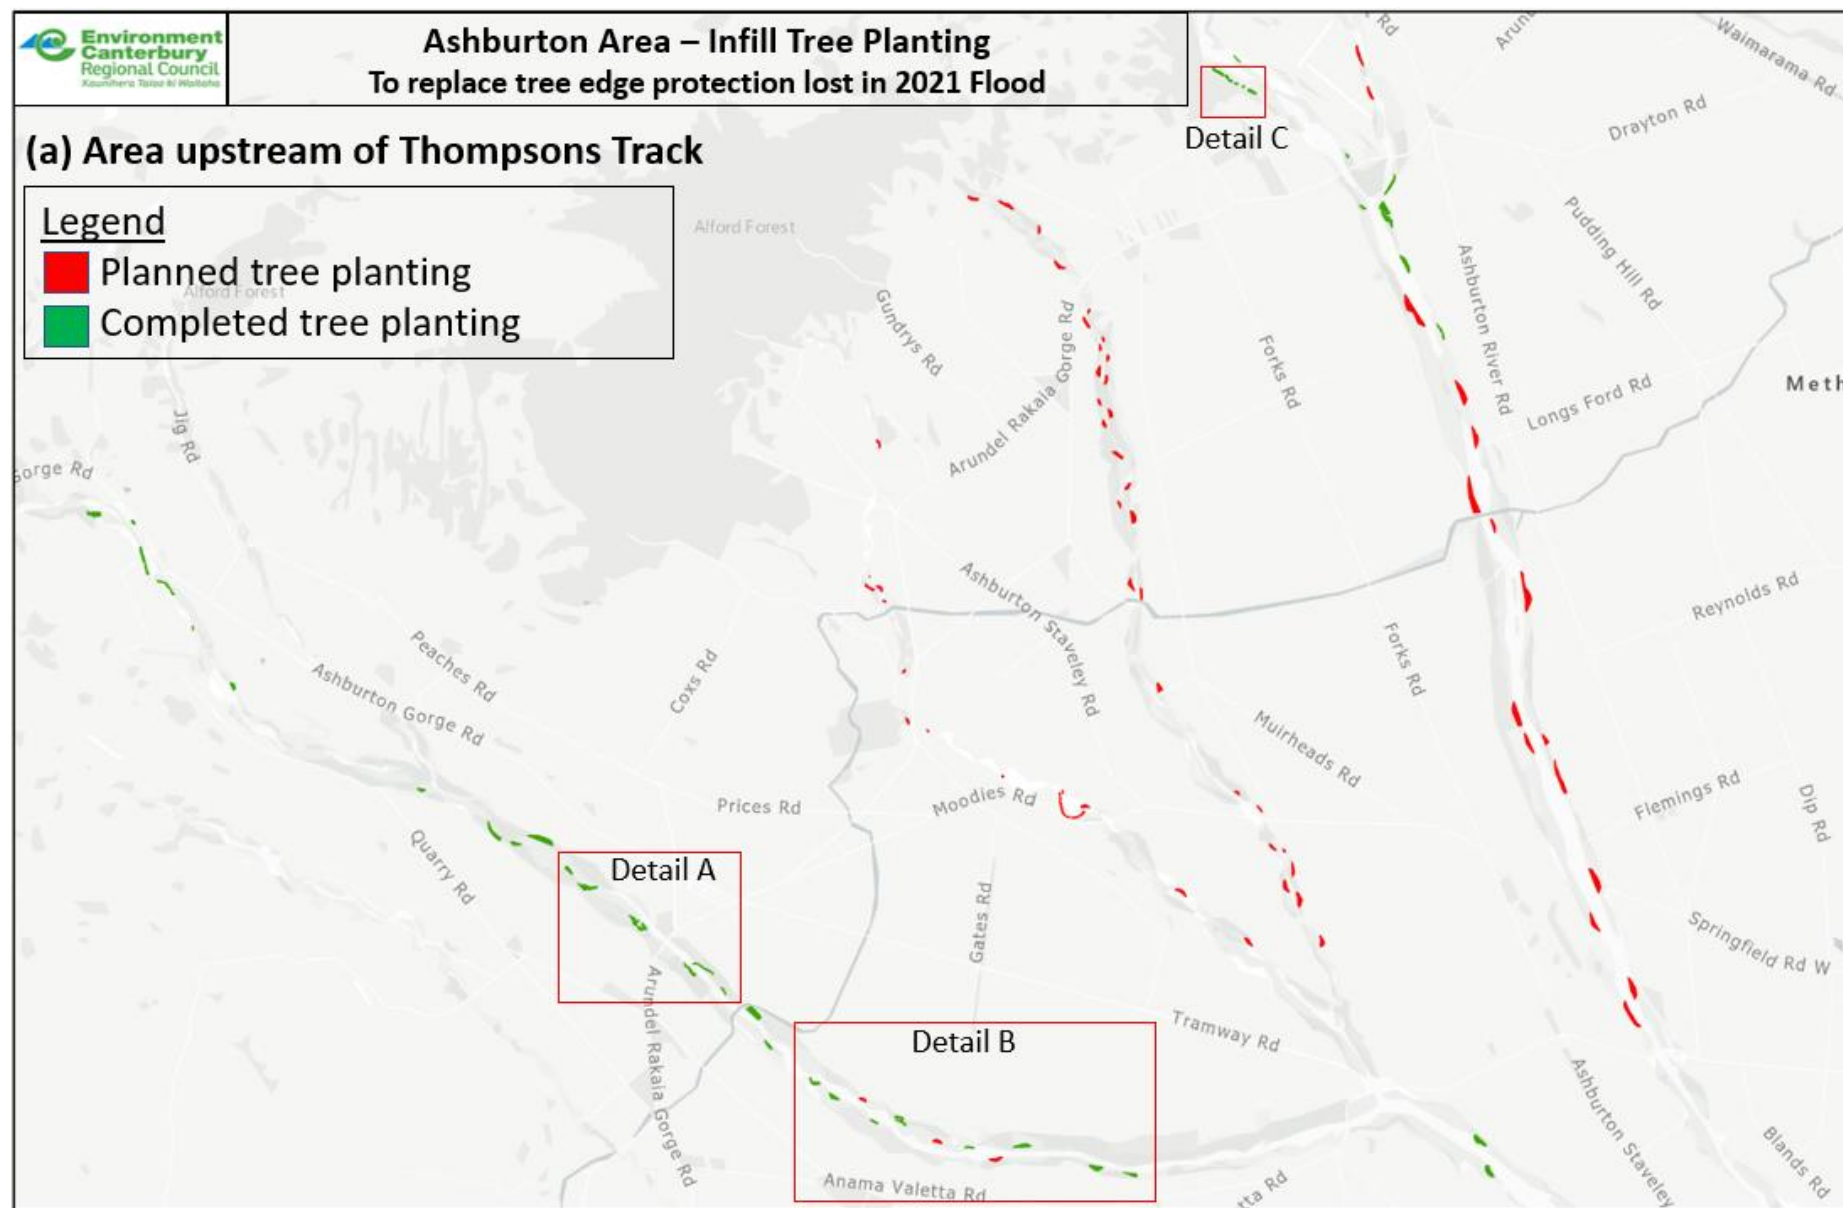
Figure B-1: Ashburton Area – Infill Tree planting (a) Upstream of Thompsons Track.

As indicated in the legend on the maps, areas still to be planted are shaded red, while those completed are shaded green.

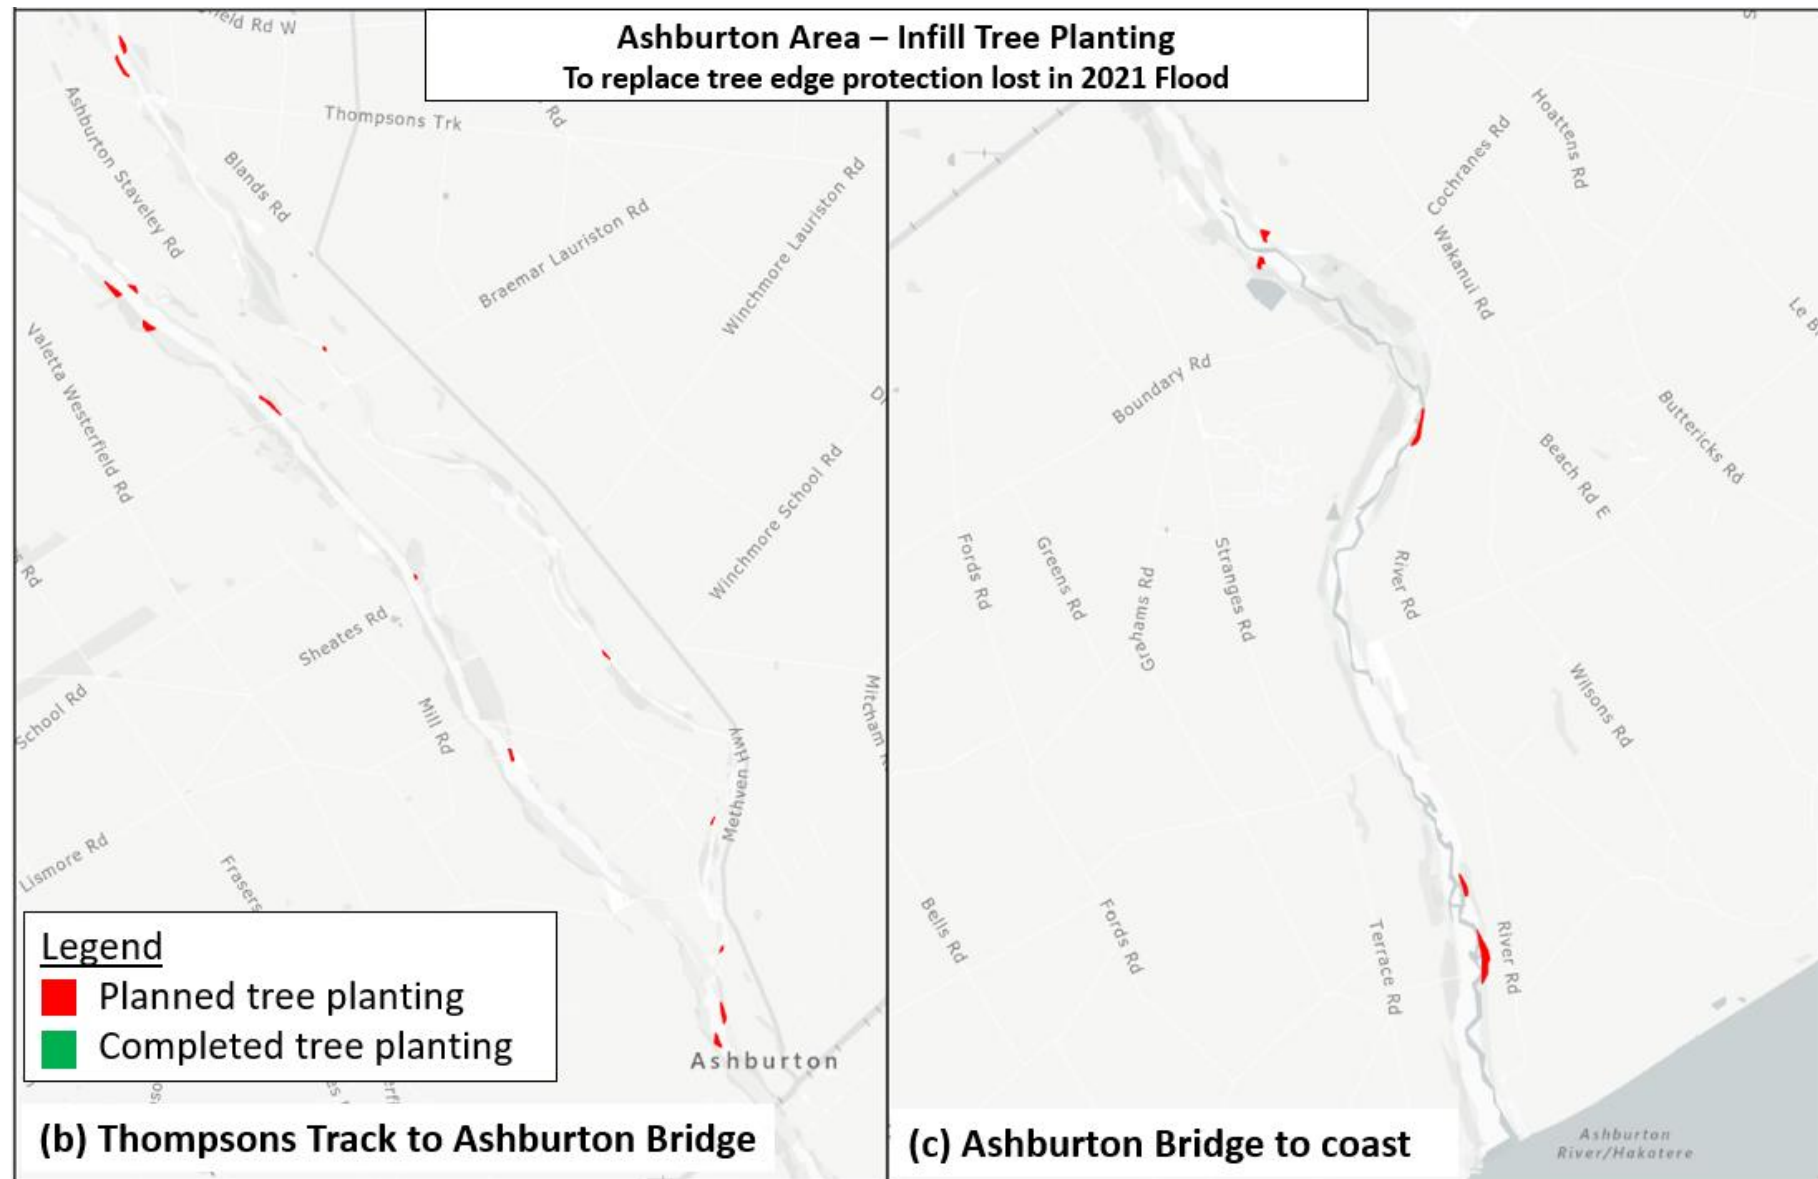
Figure B-2: Ashburton Area – Infill Tree planting (b) Thompsons Track to Ashburton Bridge and (c) Ashburton Bridge to coast.

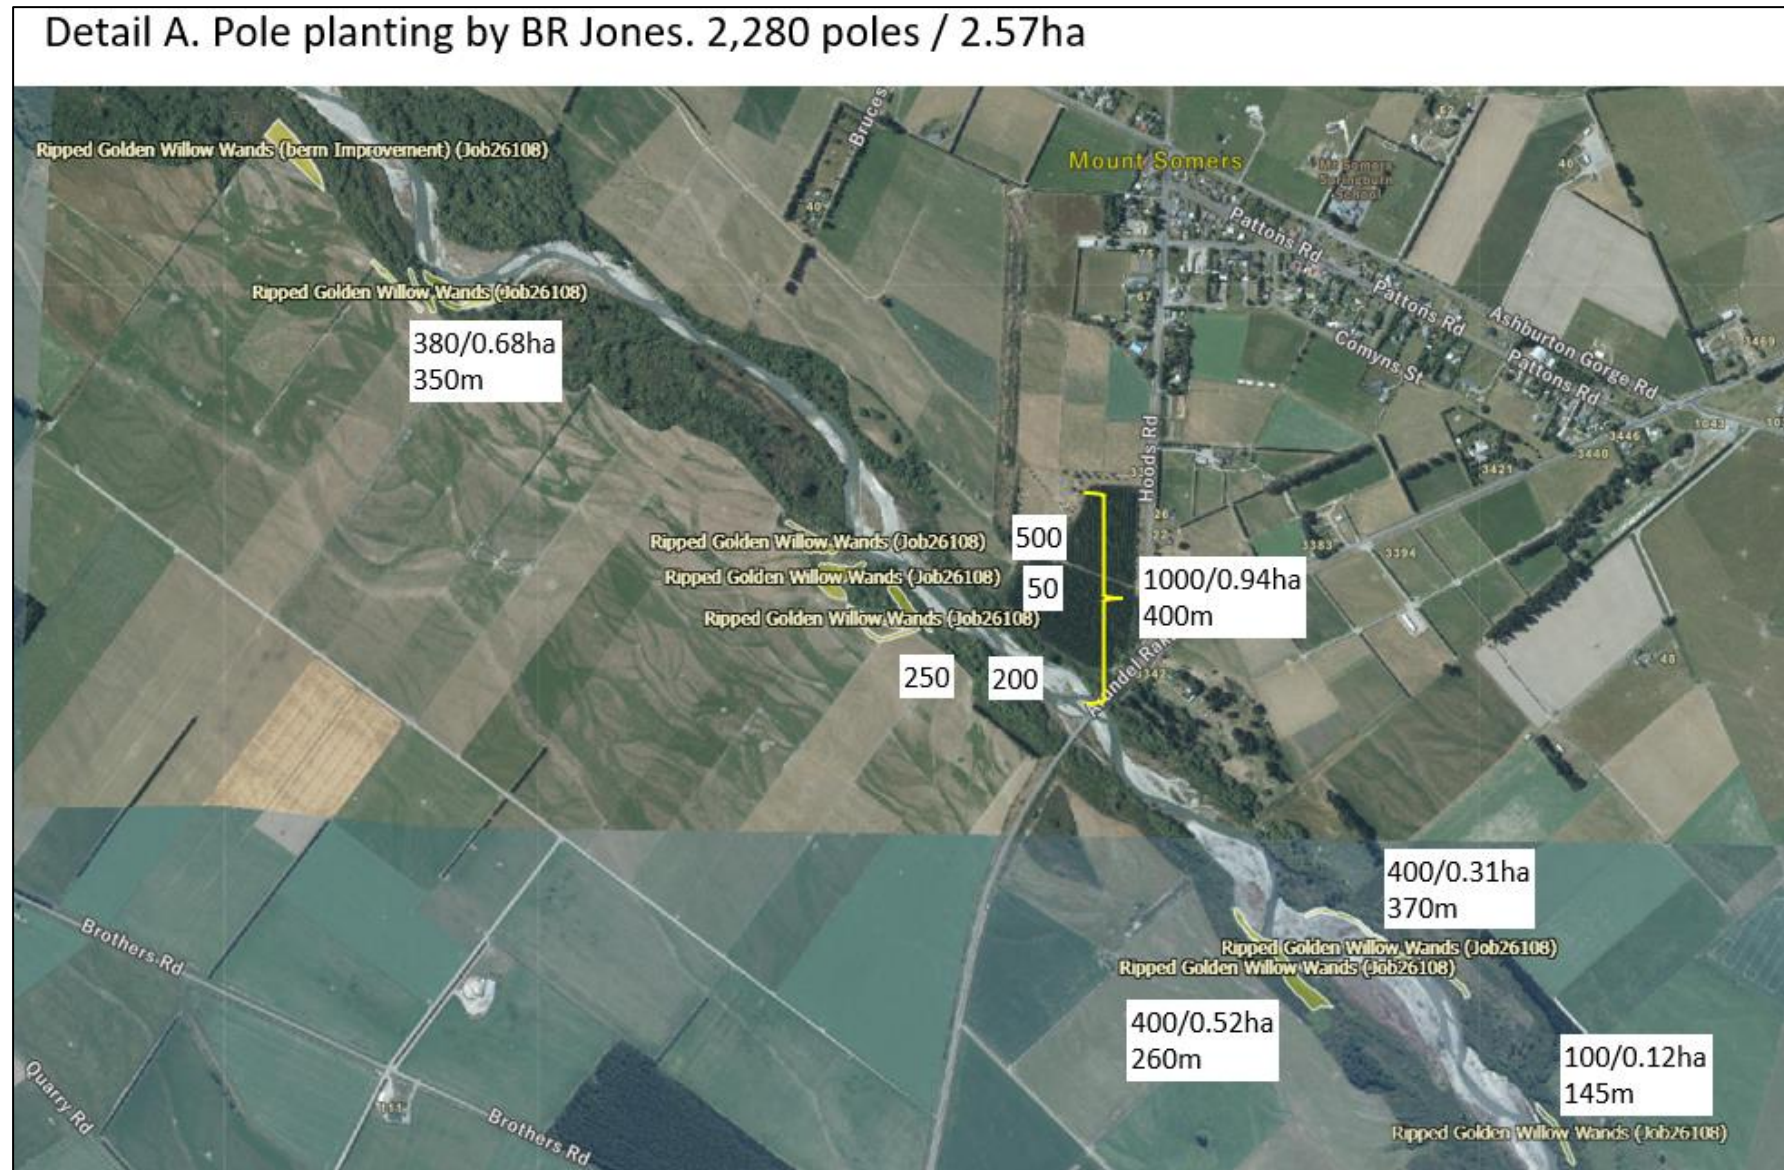
Figure B-3: Ashburton area, detail A – pole planting by BR Jones.

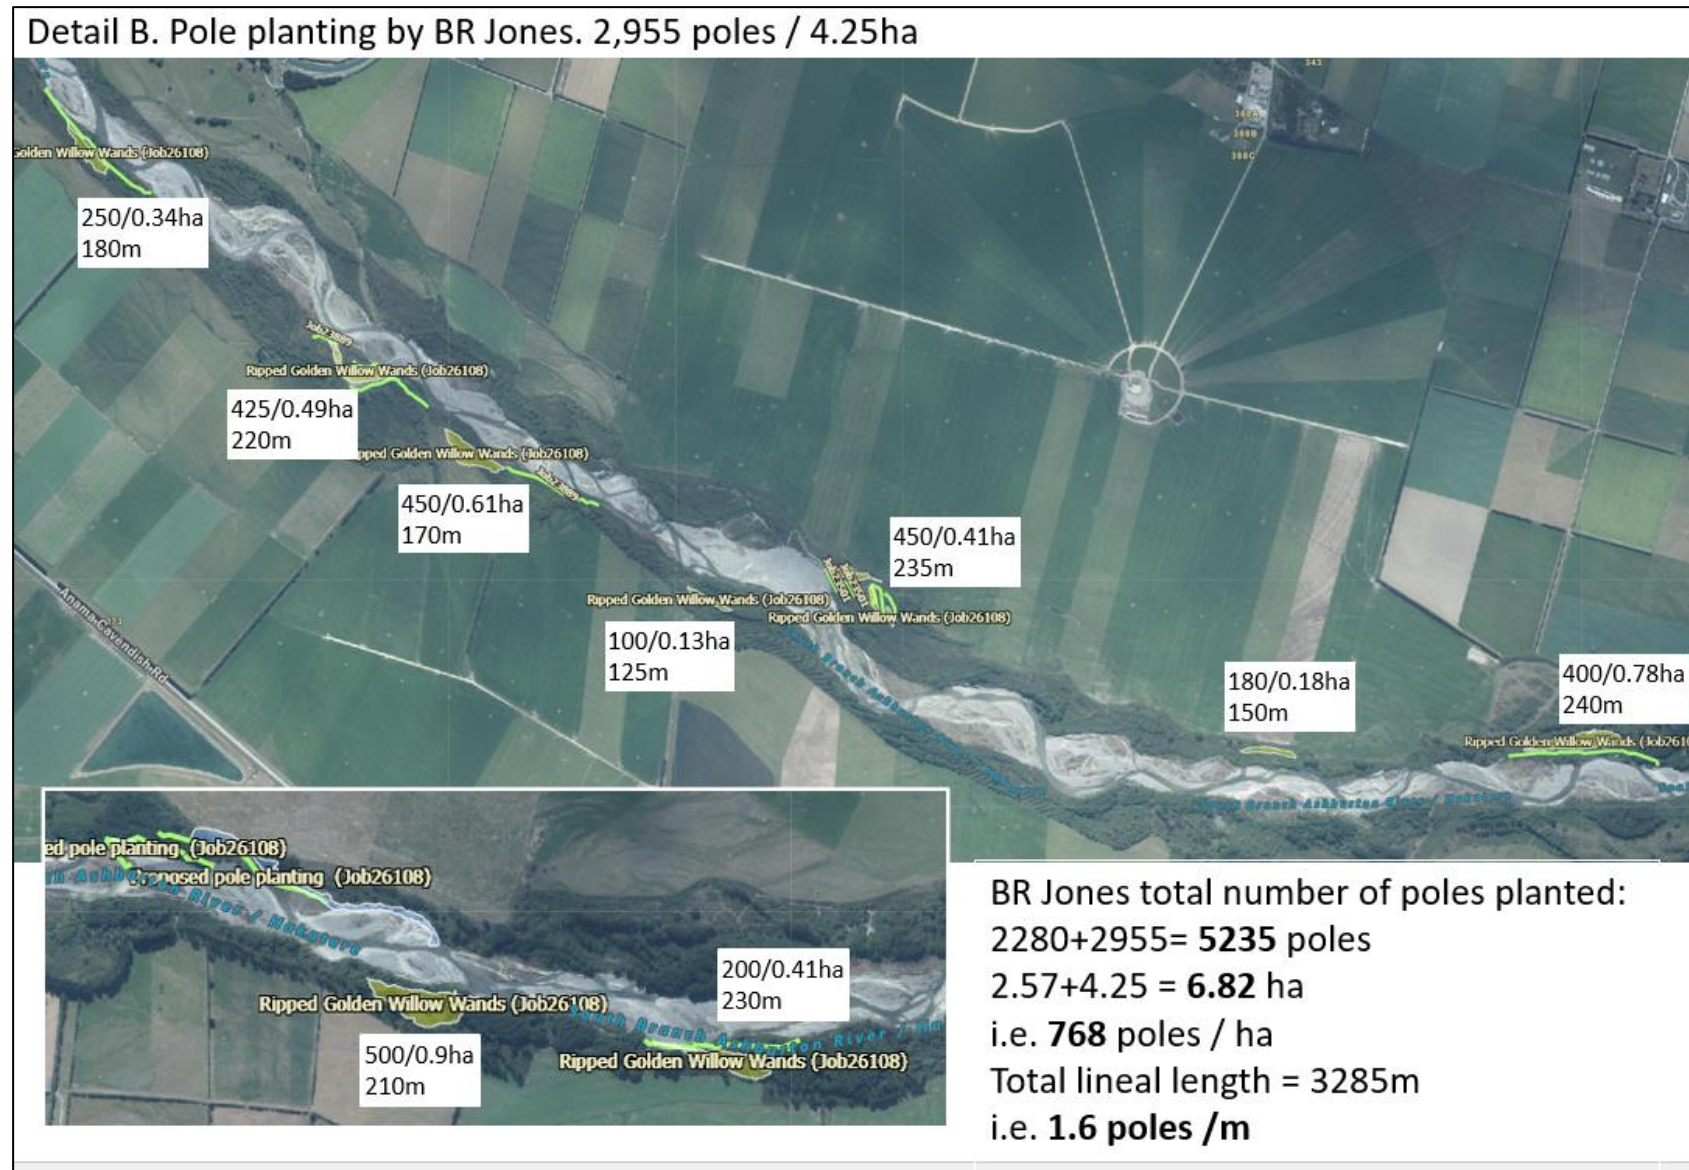
Figure B-4: Ashburton area, Detail B – pole planting by BR Jones.

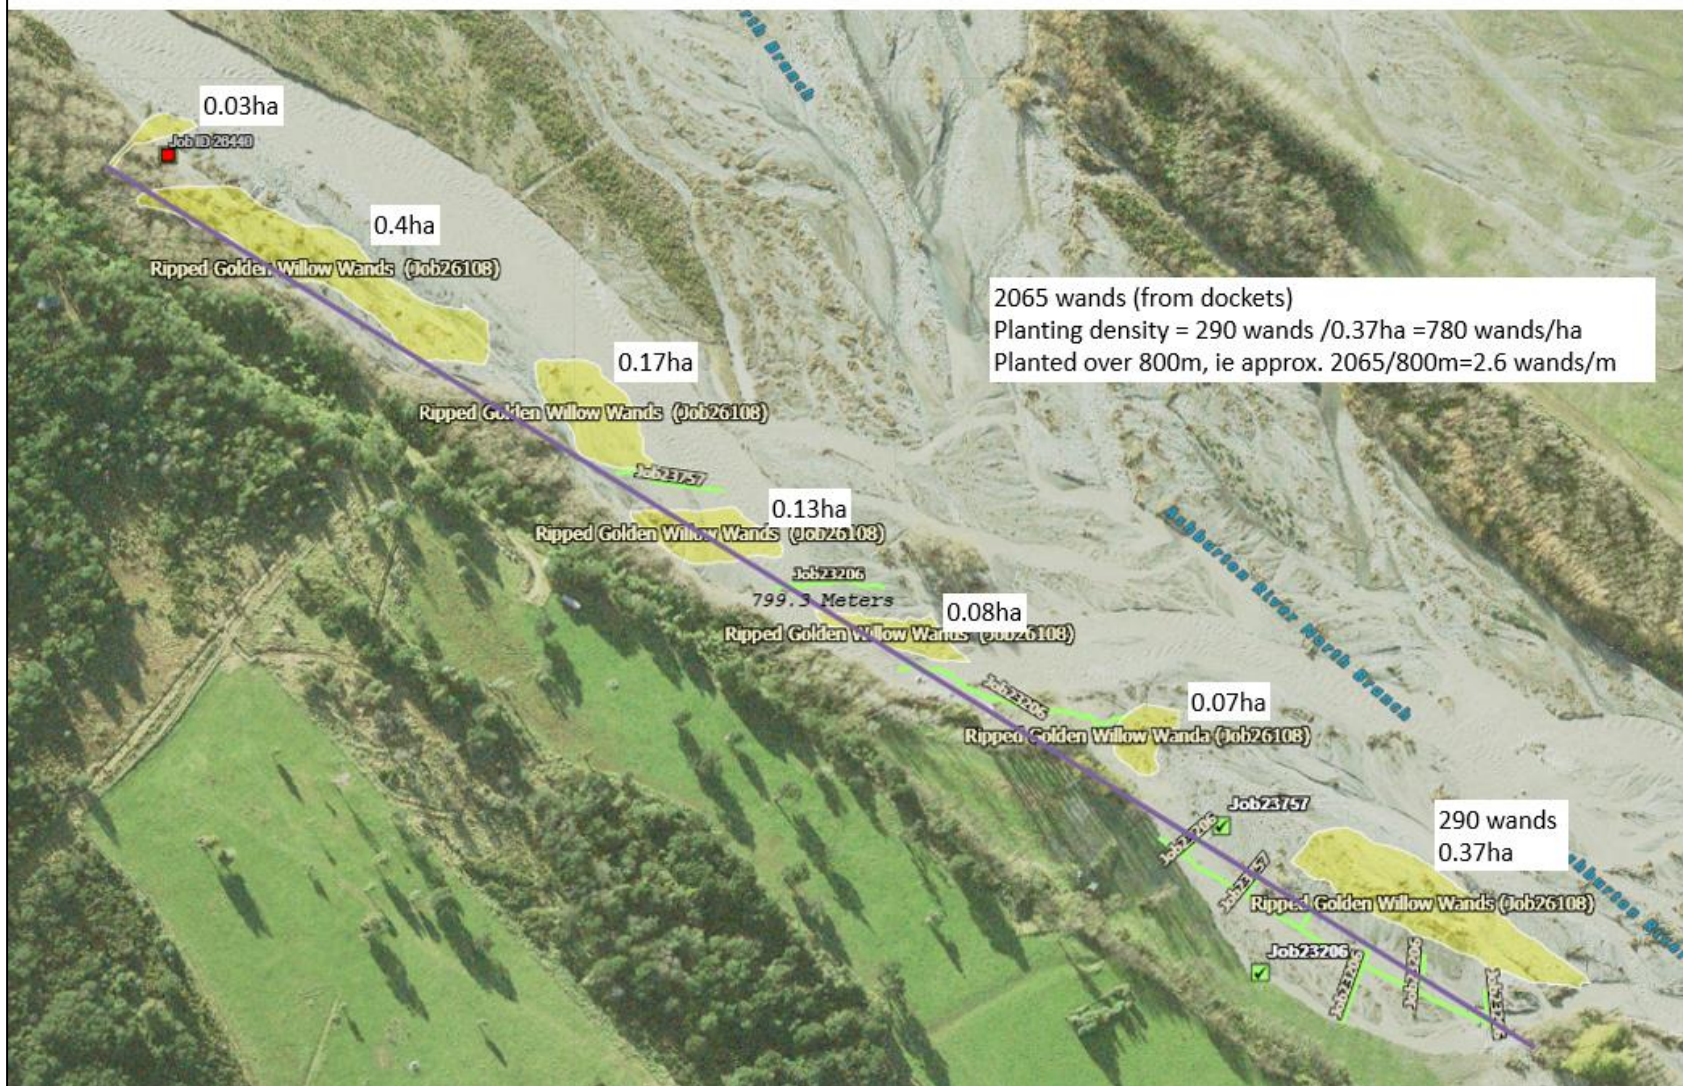
Detail C. Wand ripping by Gallagher. 2,955 poles / 4.25ha

Figure B-5: Ashburton area, Detail C – wand ripping by Gallagher.
