Canterbury 2021 Flood Recovery Update 4

Ken Tarboton (Aqueus Consulting)
Shaun McCracken (Environment Canterbury)

5 August 2022

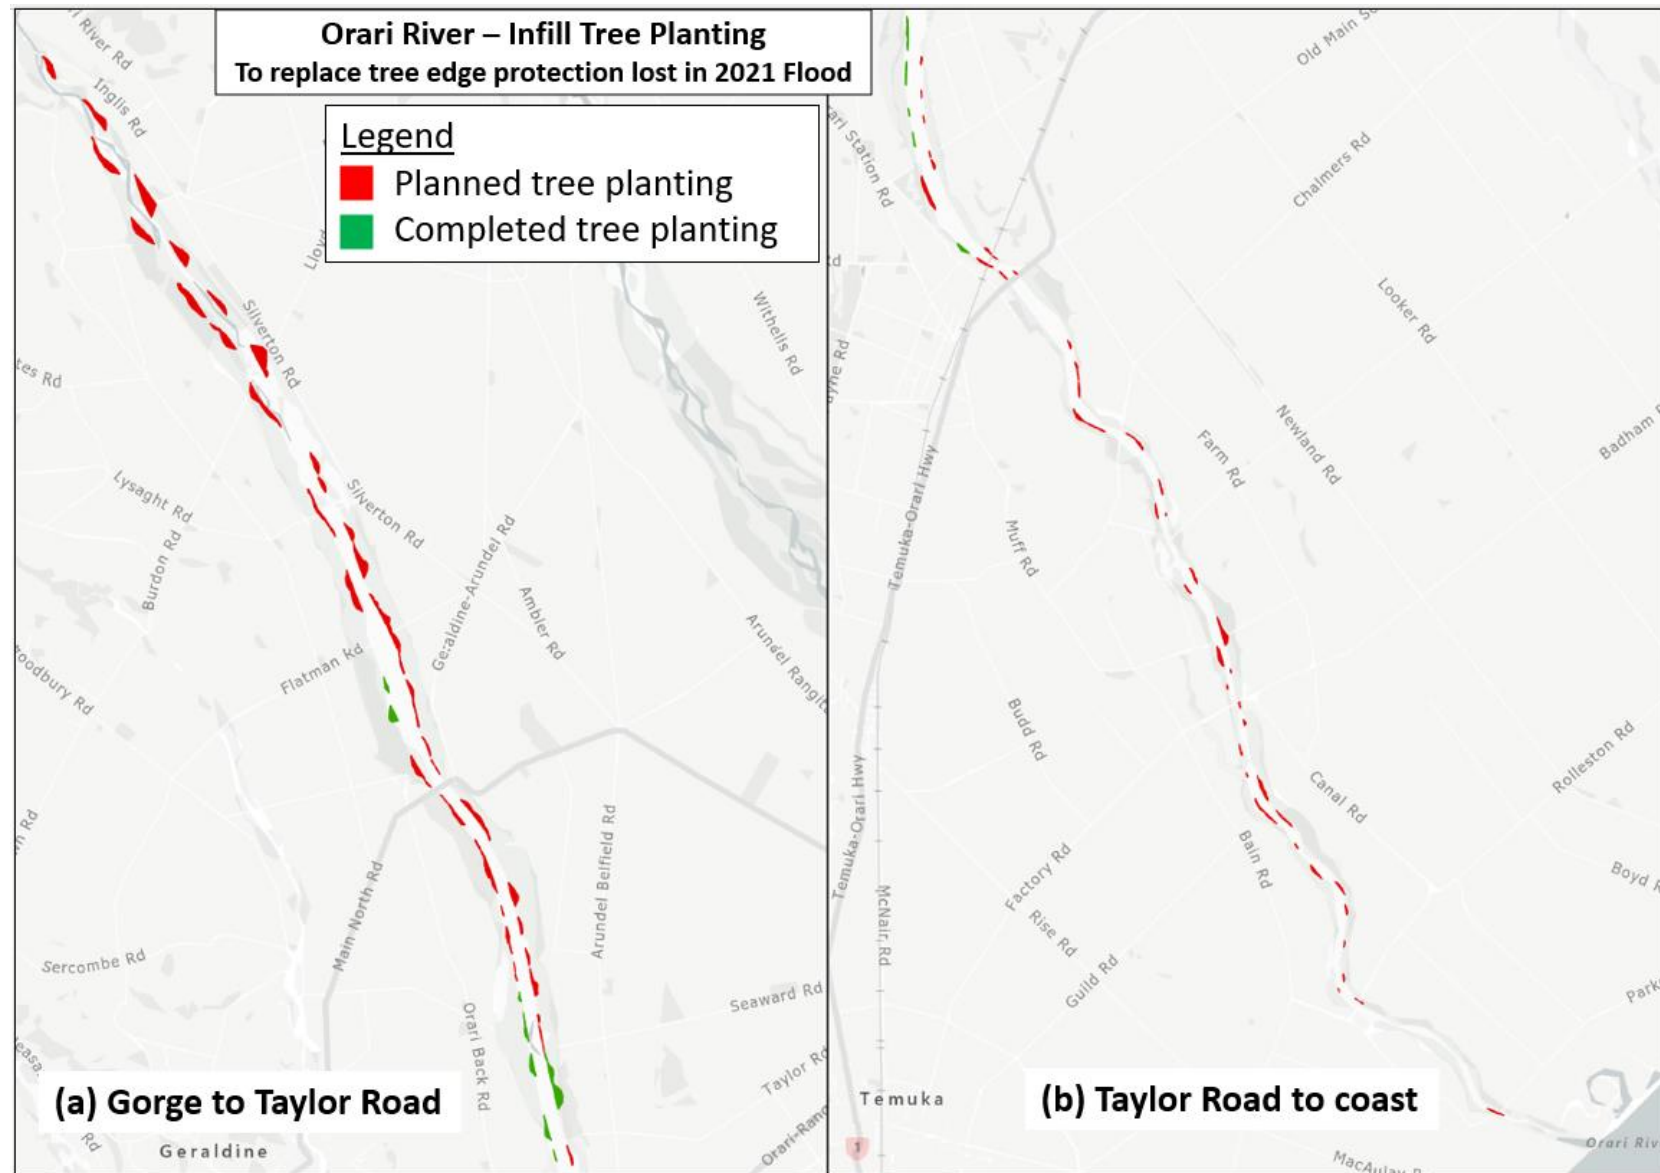
Figure B-6: Orari River – Infill Tree Planting.

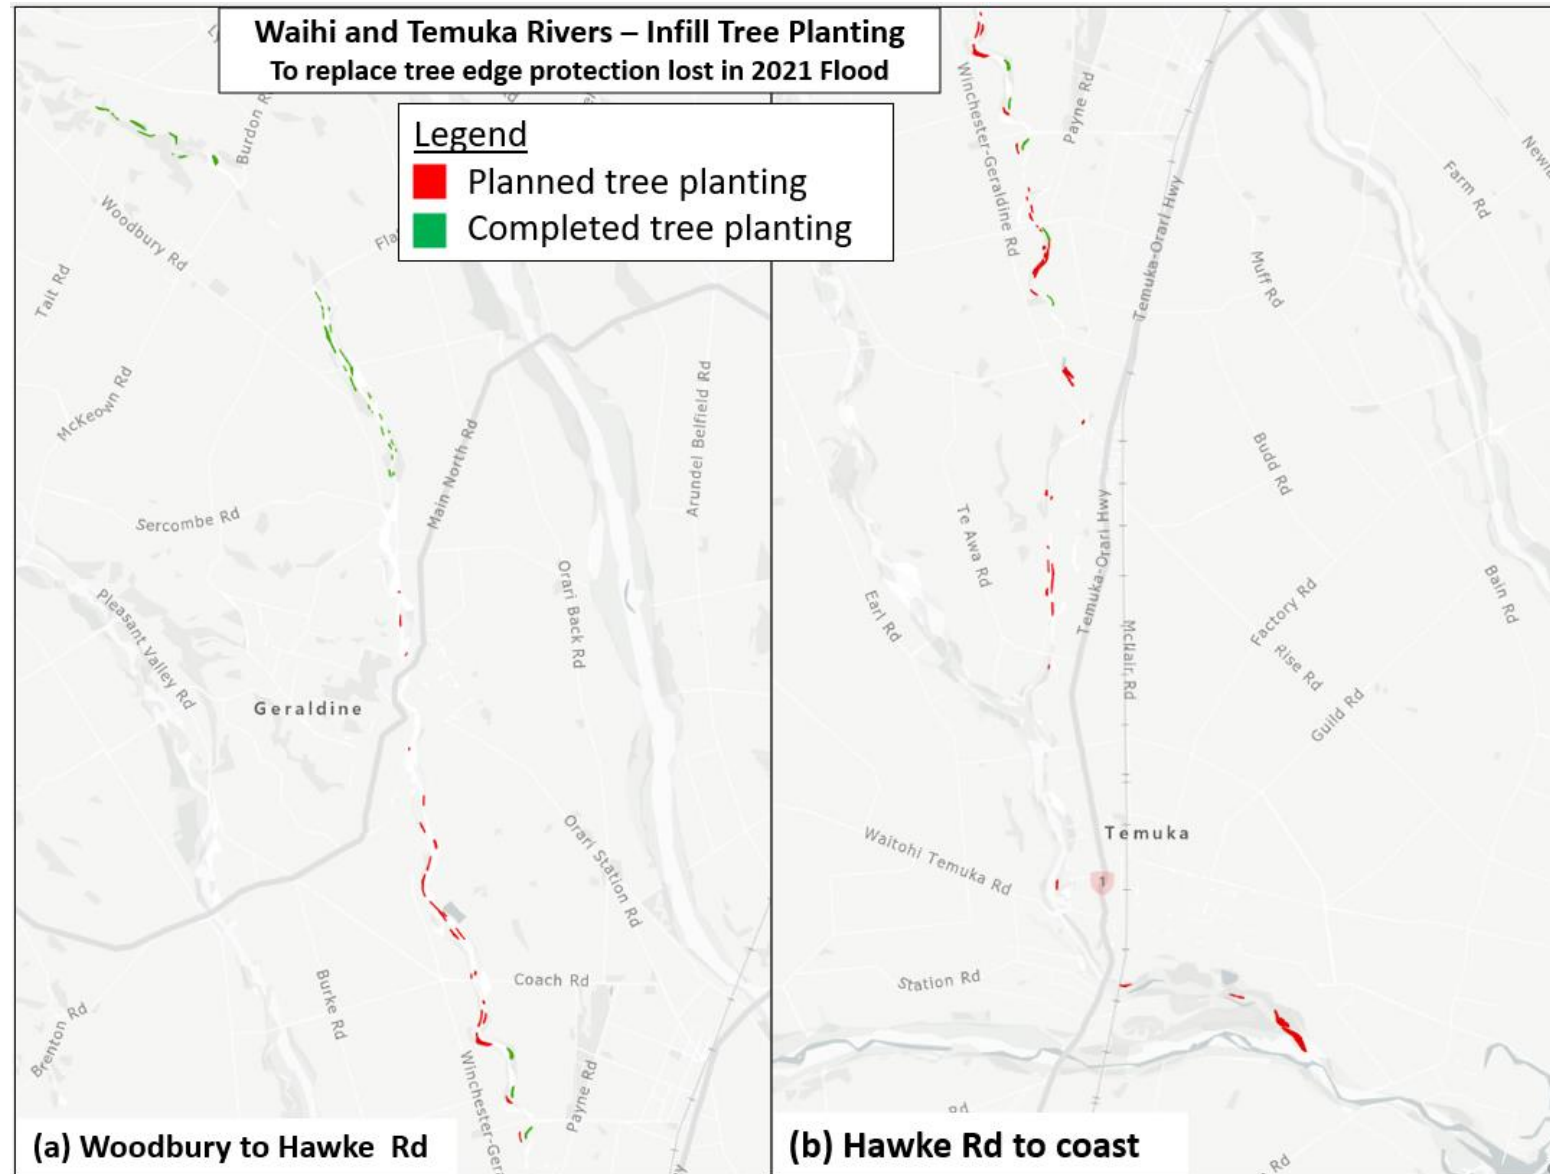
Figure B-7: Waihi and Temuka Rivers – Infill Tree Planting.

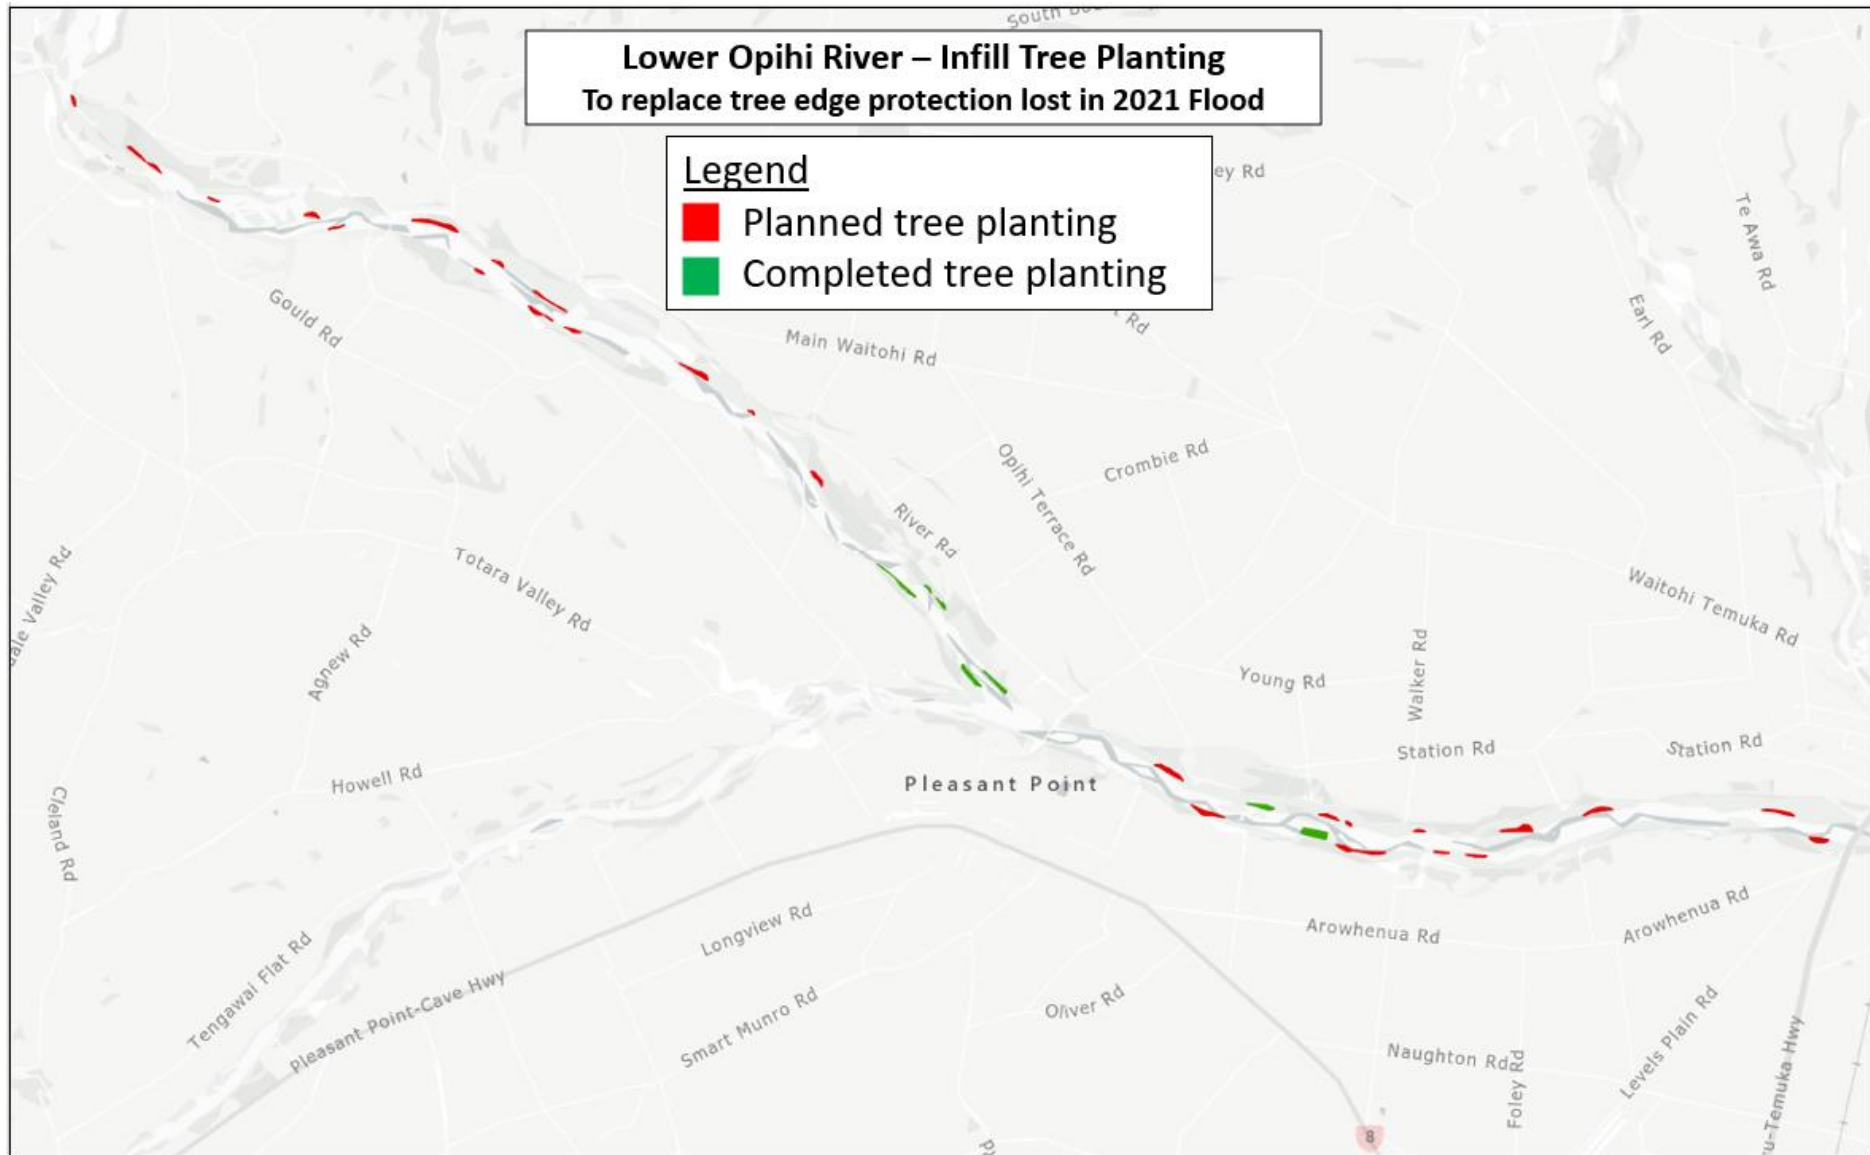
Figure B-8: Lower Opihi River – Infill Tree Planting.
