Canterbury 2021 Flood Recovery Update 5

Ken Tarboton (Aqueus Consulting)
Shaun McCracken (Environment Canterbury)

31 October 2022

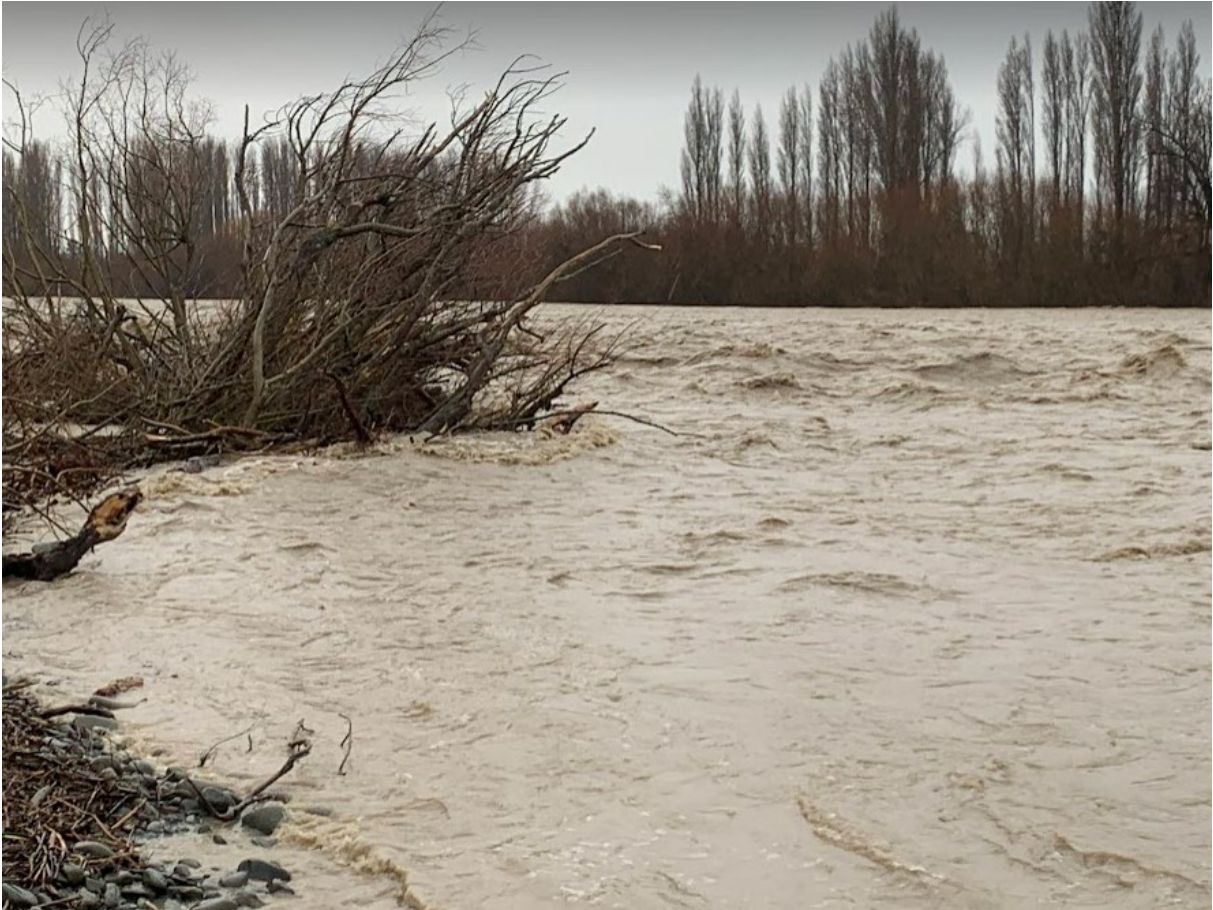
Figure A-3: Ashburton South Branch at Walkhams Road, operation of ATP during high flow (19 July 2022).

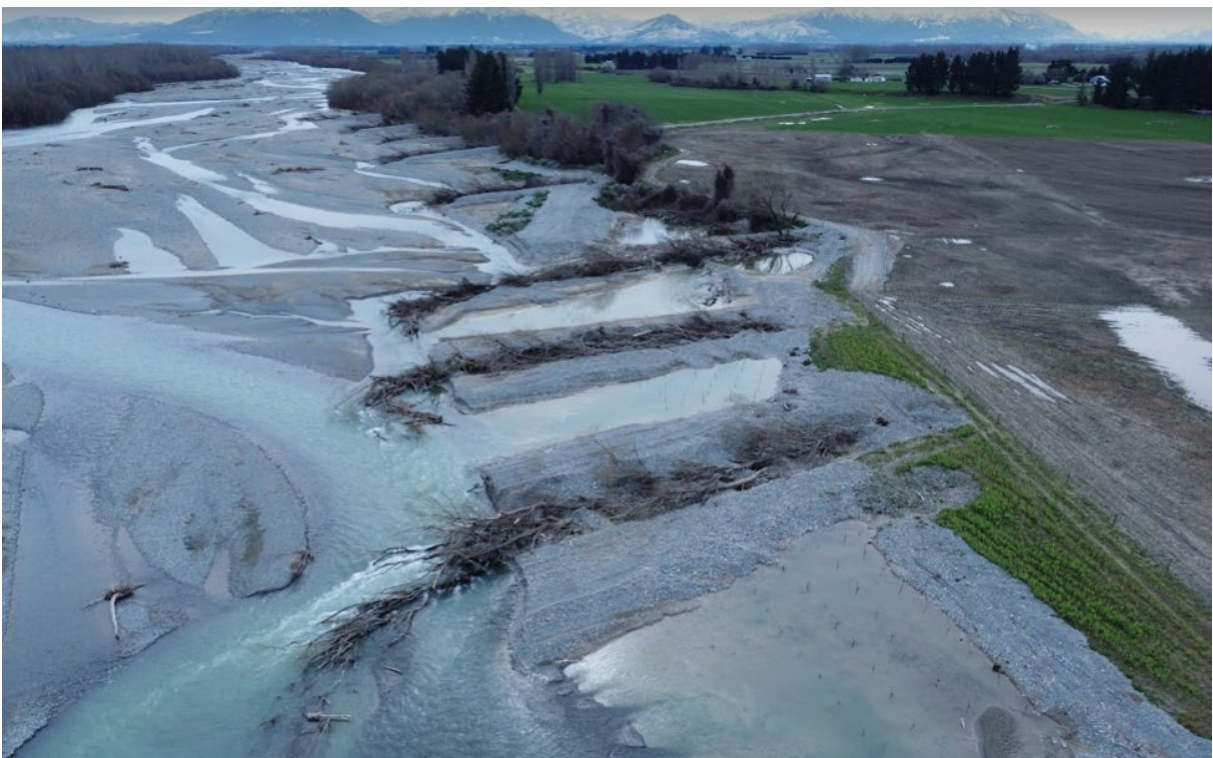
At sites where the erosion protection buffers had been established, trees tied in and poles planted, there was very little further damage during the winter 2022 high flows. Examples of these are on the Waihi River at Beeby Rd (Figure A-6) and the Ashburton River South Branch at Walkhams Rd (Figure A-4).

Figure A-4: Ashburton South Branch at Walkhams Road, ATP following high flows of July/August 2022.

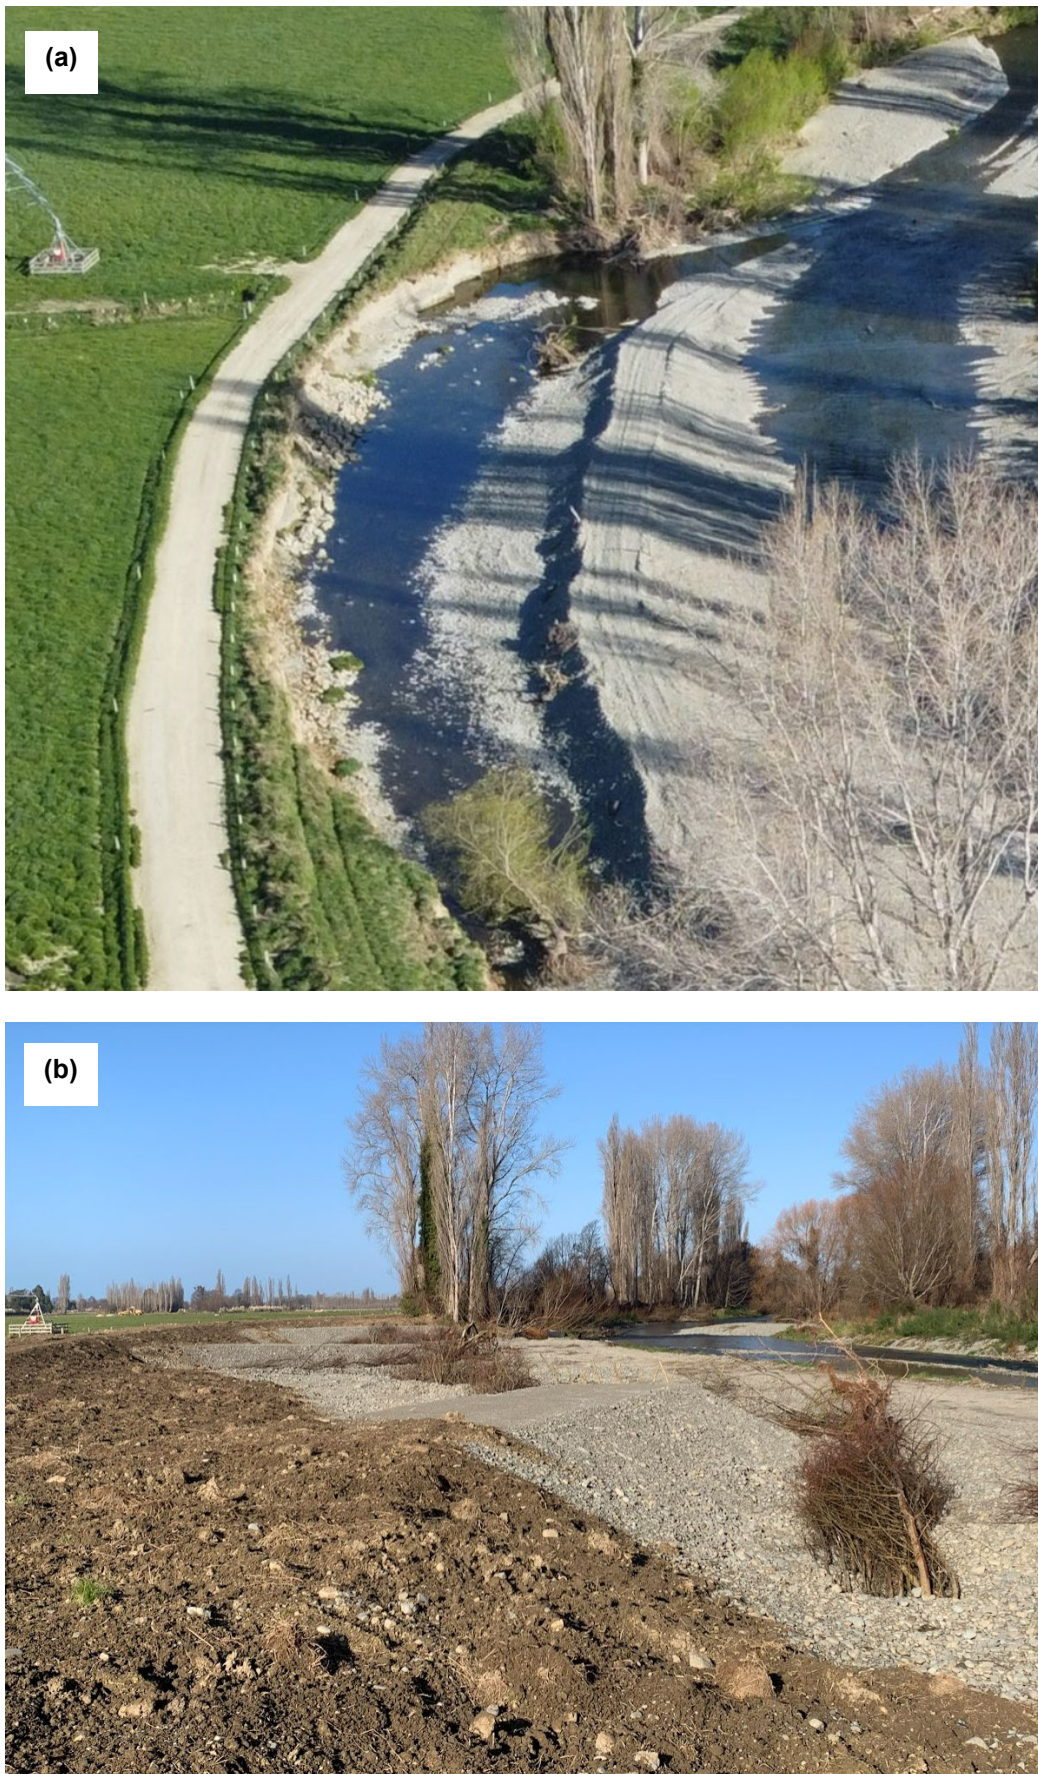
Flood damage on the Waihi River at Beeby Rd consisted of stopbank scour and loss of tree edge protection (see Figure A-5, a). Repairs, consisting of reconstructing the stopbank, with erosion protection bunds and ATP, were complete in July 2022 just days before the winter high flows (Figure A-5, b). The repairs performed very well with the erosion protection bunds and ATP remaining in-tact through the high flows (Figure A-6).

Figure A-5: Waihi River at Beeby Rd, (a) after 2021 flood with temporary bund, and (b) following completion of stopbank repair, erosion protection bunds and ATP (6 July 2022).

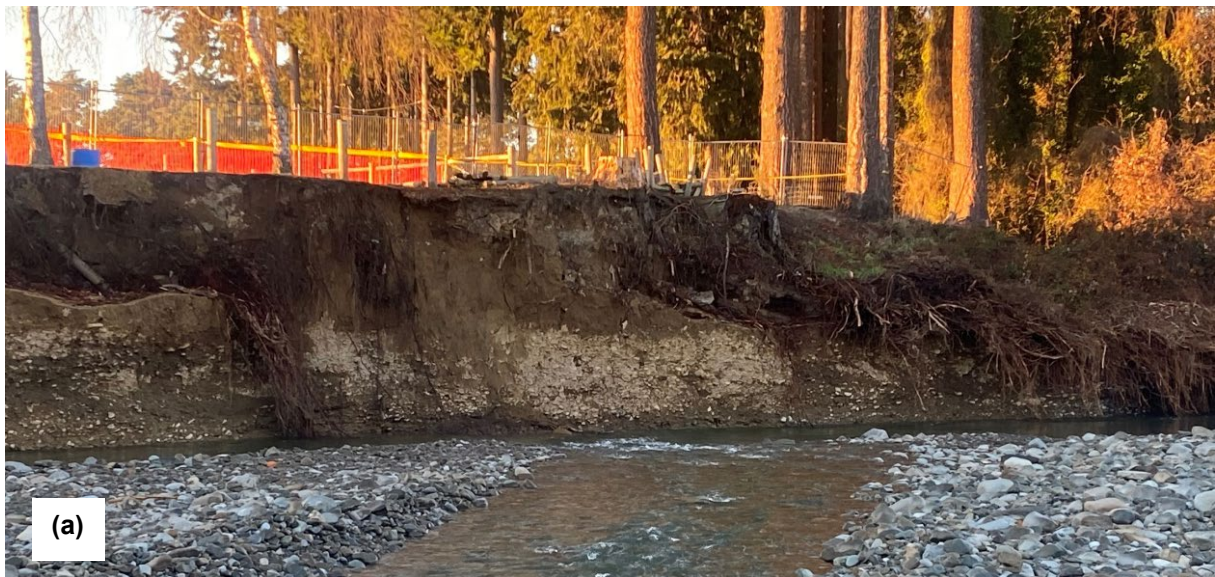
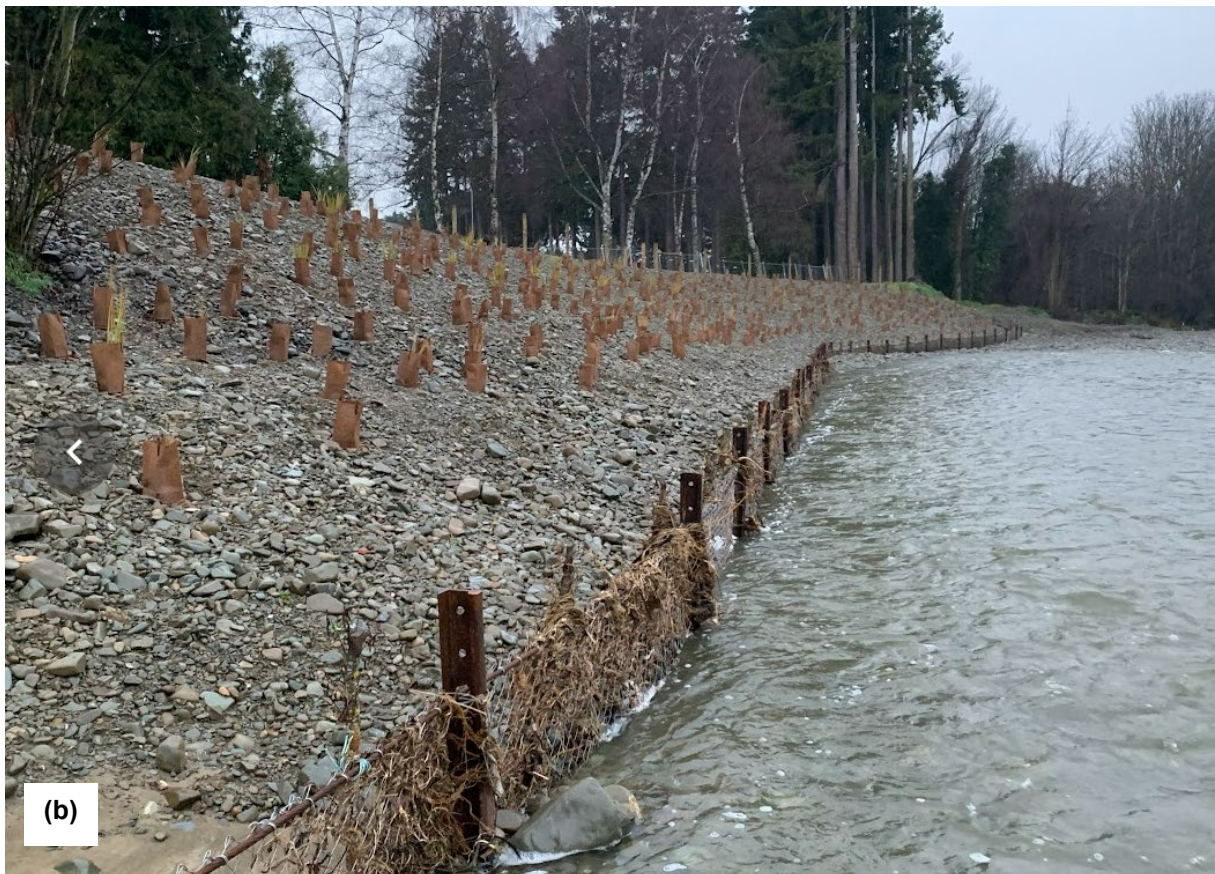
At this location severe bank scour and tree edge protection loss occurred, placing the high school property at risk. Figure A-7 (a) shows the extent of this scour which was repaired with a Heyman Fence and native vegetation planting on the shaped embankment above the Heyman Fence. Figure A-7(b) shows the repairs performing well during high flows on 9 August 2022.

Figure A-7: Waihi at Geraldine High School (a) following flood damage before repair, (b) after repair of embankment with Heyman Fence and native planting on bank holding up well in 2022 high flows (9 August 2022).

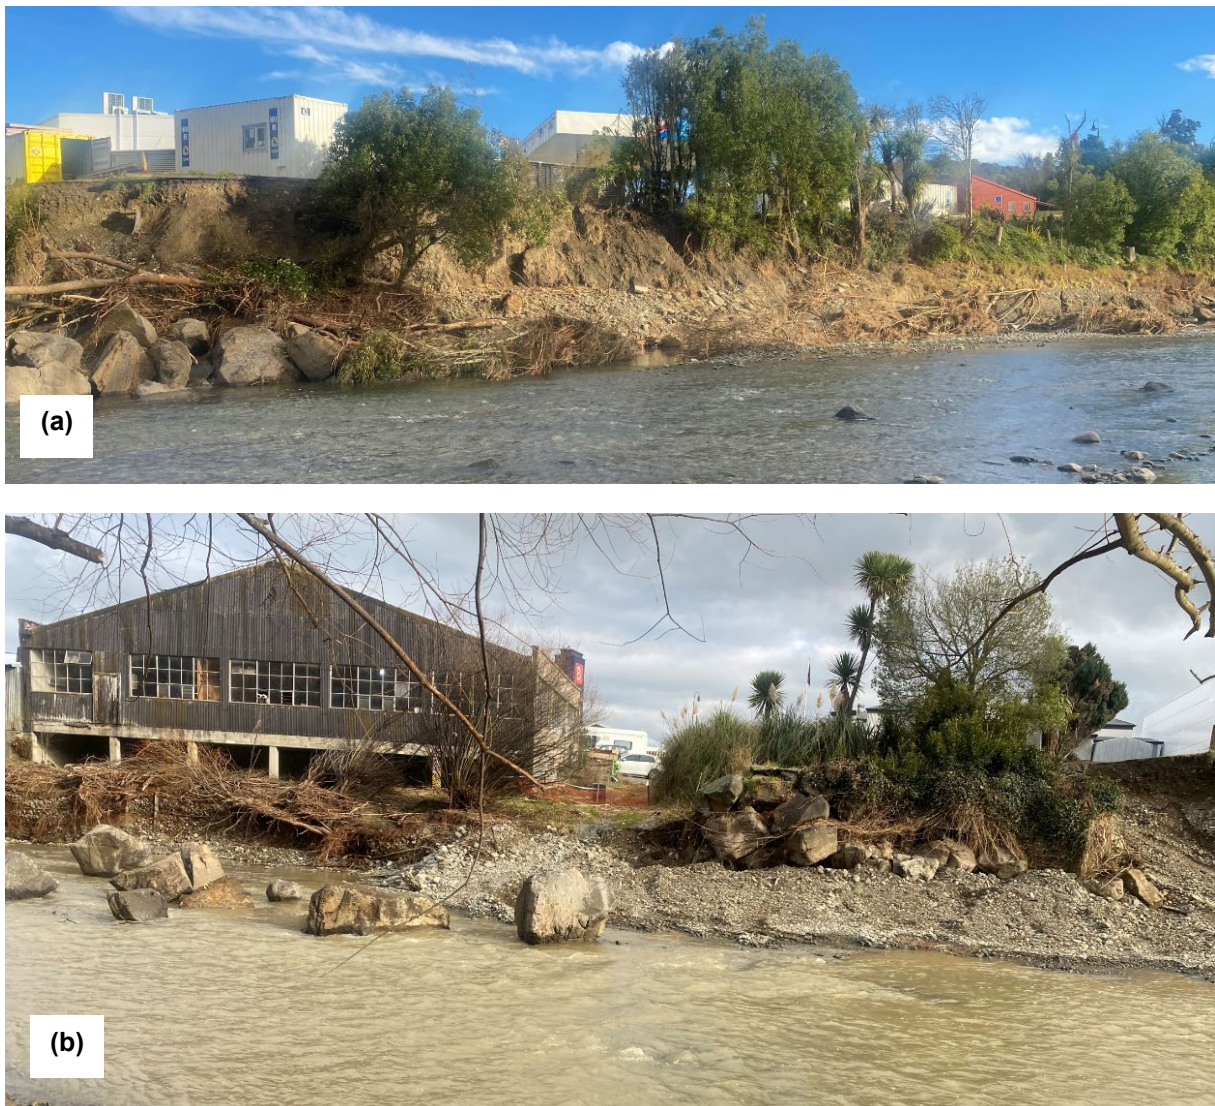
The rock groynes protecting a multi-use access path and industry (NPD filling station) were damaged placing infrastructure at risk (Figure A-8). Repair to the rock groynes was successfully completed in April 2022 (Figure A-9, a). These repairs held up exceptionally well to the 2022 winter flows as shown in Figure A-9 (b) taken on 9 August 2022.

Figure A-8: Waihi at Geraldine NPD following 2021 flood showing (a) bank scour and (b) displacement of rock groyne.

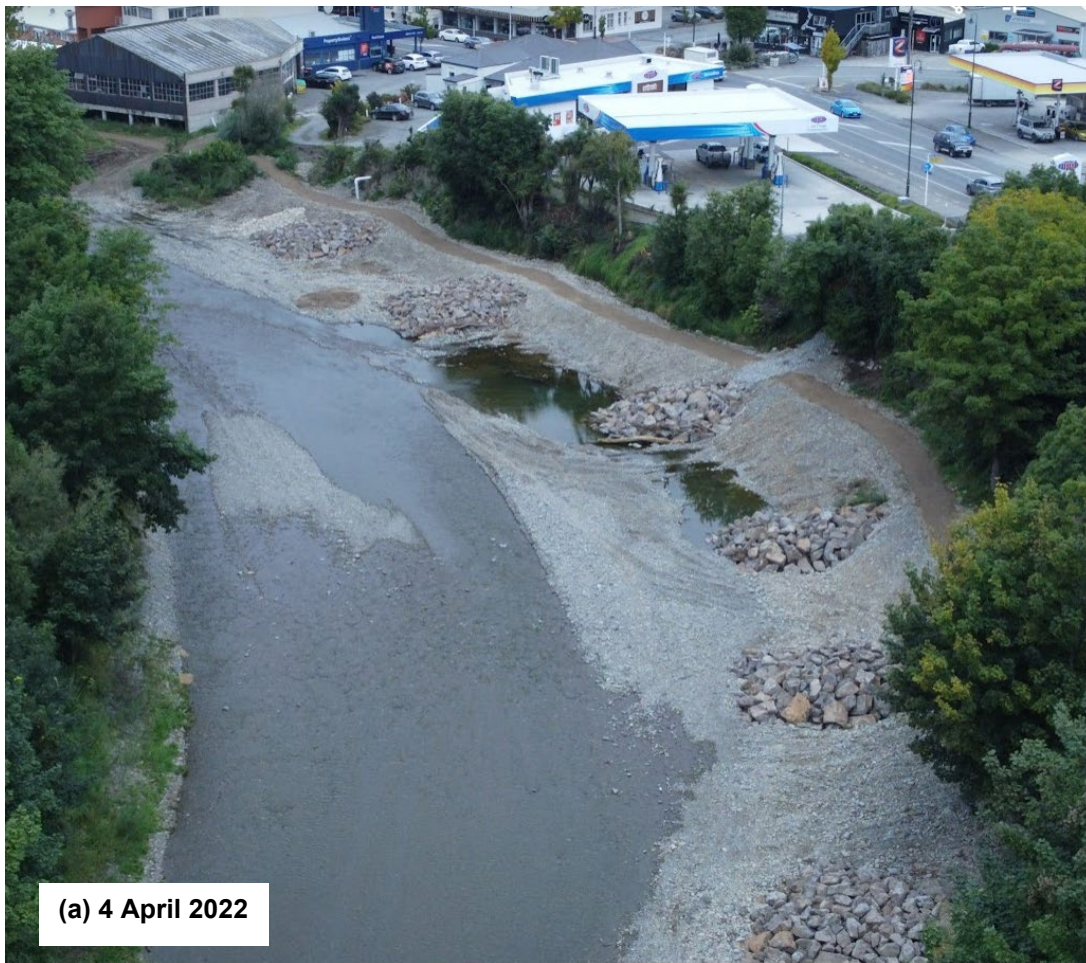
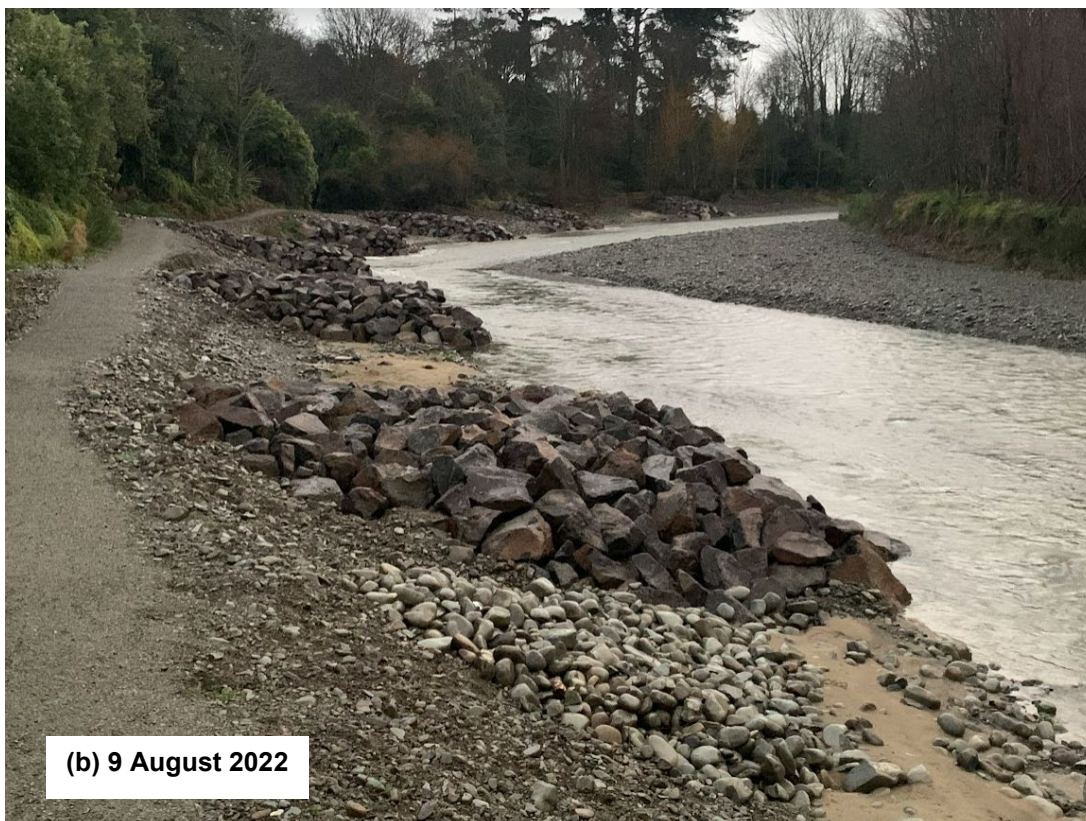
Figure A-9: Waihi at Geraldine NPD showing rock groyne repair (a) after completion and (b) after high July/August high flows (9 August 2022).

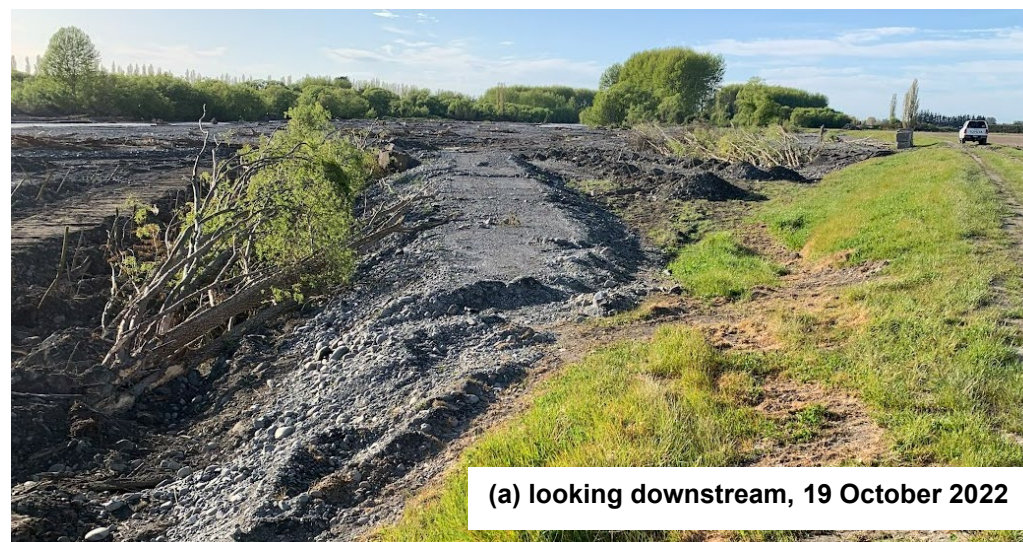
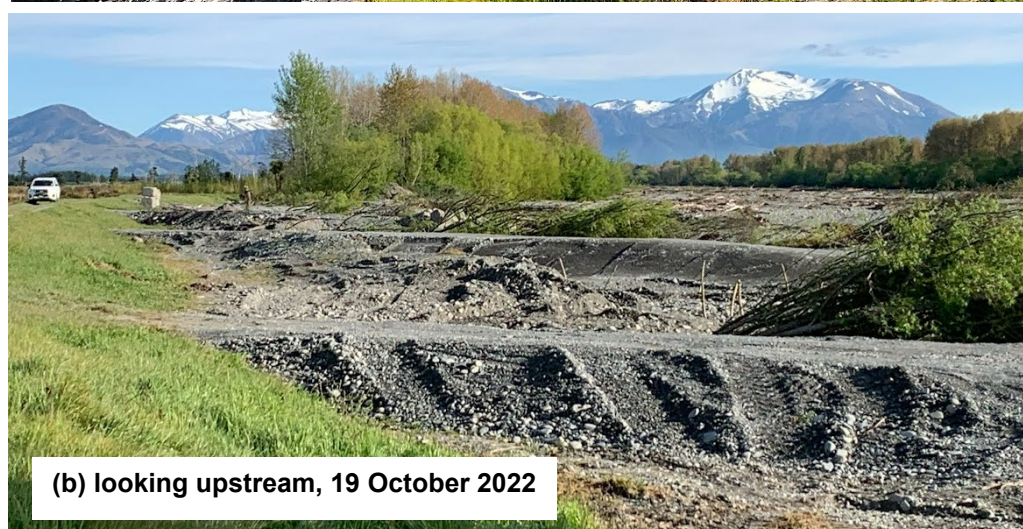
Figure B-3: Ashburton North at Thompsons Track, plan of repairs following 2022 high flows, and completed damage-on-damage repairs (a) looking downstream, and (b) looking upstream (19 October 2022).

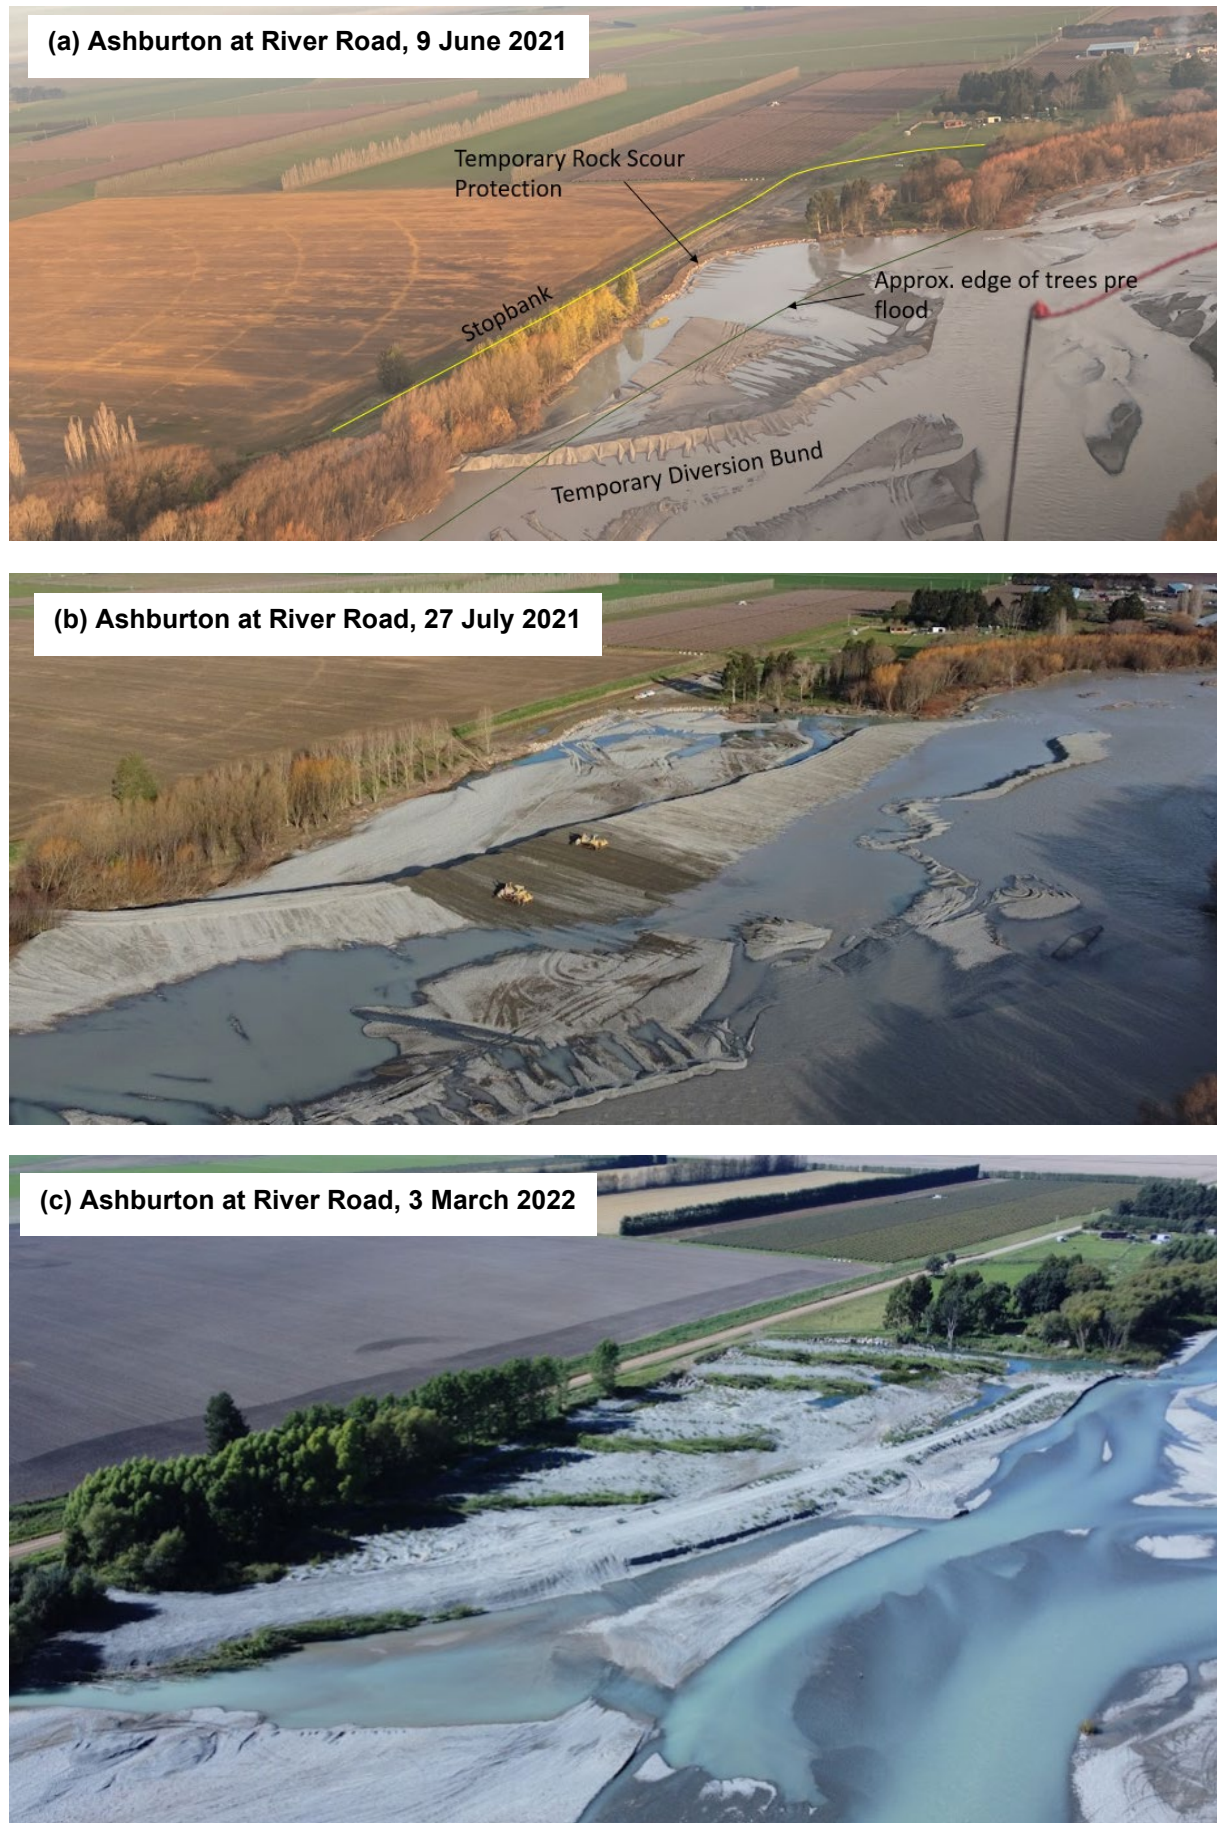
Figures B-4 and B-5 show the sequence of repairs on the Ashburton main stem at River Road, including 2022 damage-on-damage in the aerial taken in September 2022 following the winter high flows. The lateral bund in front of the erosion protection bunds was completely washed away, however the ATP on the upstream edge of each erosion protection bund performed relatively well with only the tips of the erosion protection bunds being washed downstream (but remaining attached). The ATP was bent downstream (Figure B-6), and repairs have been planned (Figure B-7) to re-instate the tips of the erosion protection bunds and tie the ends of the ATP to concrete block anchors upstream of each ATP line. This approach was not originally used in the ATP on River Road because it was one of the first 2021 flood damage repairs undertaken. The method of using upstream ATP anchors has been successfully used in other 2021 flood damage repairs, that fared well in the winter 2022 high flows. These included ATP at several sites on the Waihi and Opihi Rivers.

Figure B-5: Ashburton at River Road sequence of flood damage repairs.

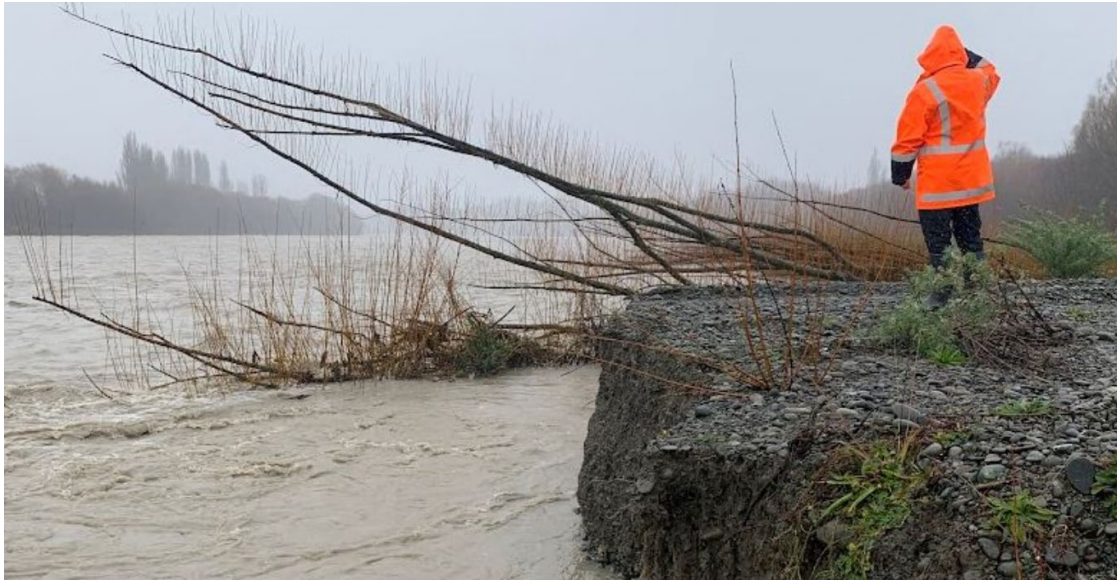
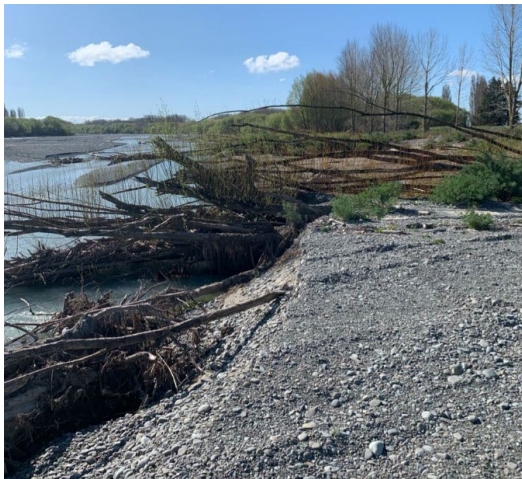
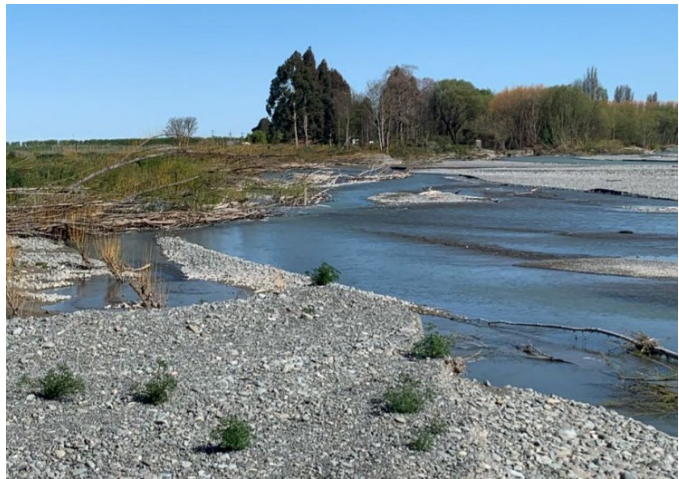
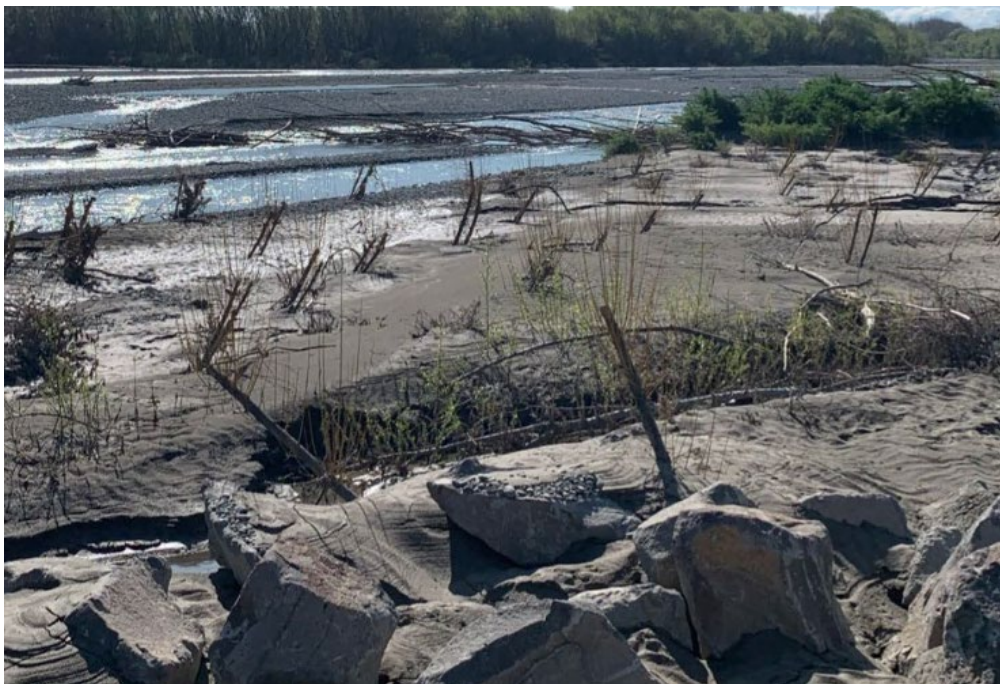
Figure B-6: Ashburton at River Road during and immediately following winter 2022 high flows.

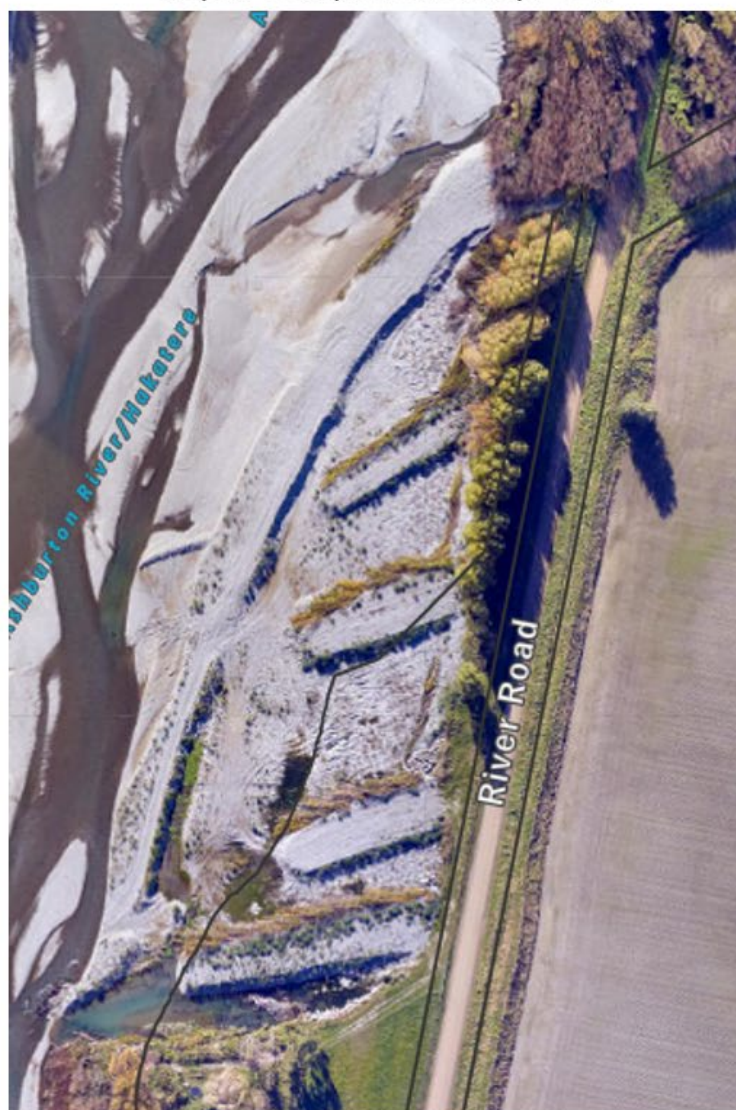
Repair complete 26 May 2022

Proposed repair following July/Aug 2022 damage

Figure B-7: Ashburton at River Road, planned repairs to 2022 damage-on-damage.

Rebuild ends of erosion protection groynes

Attach trees that are not attached to cables and buried concrete blocks on upstream edge of bunds

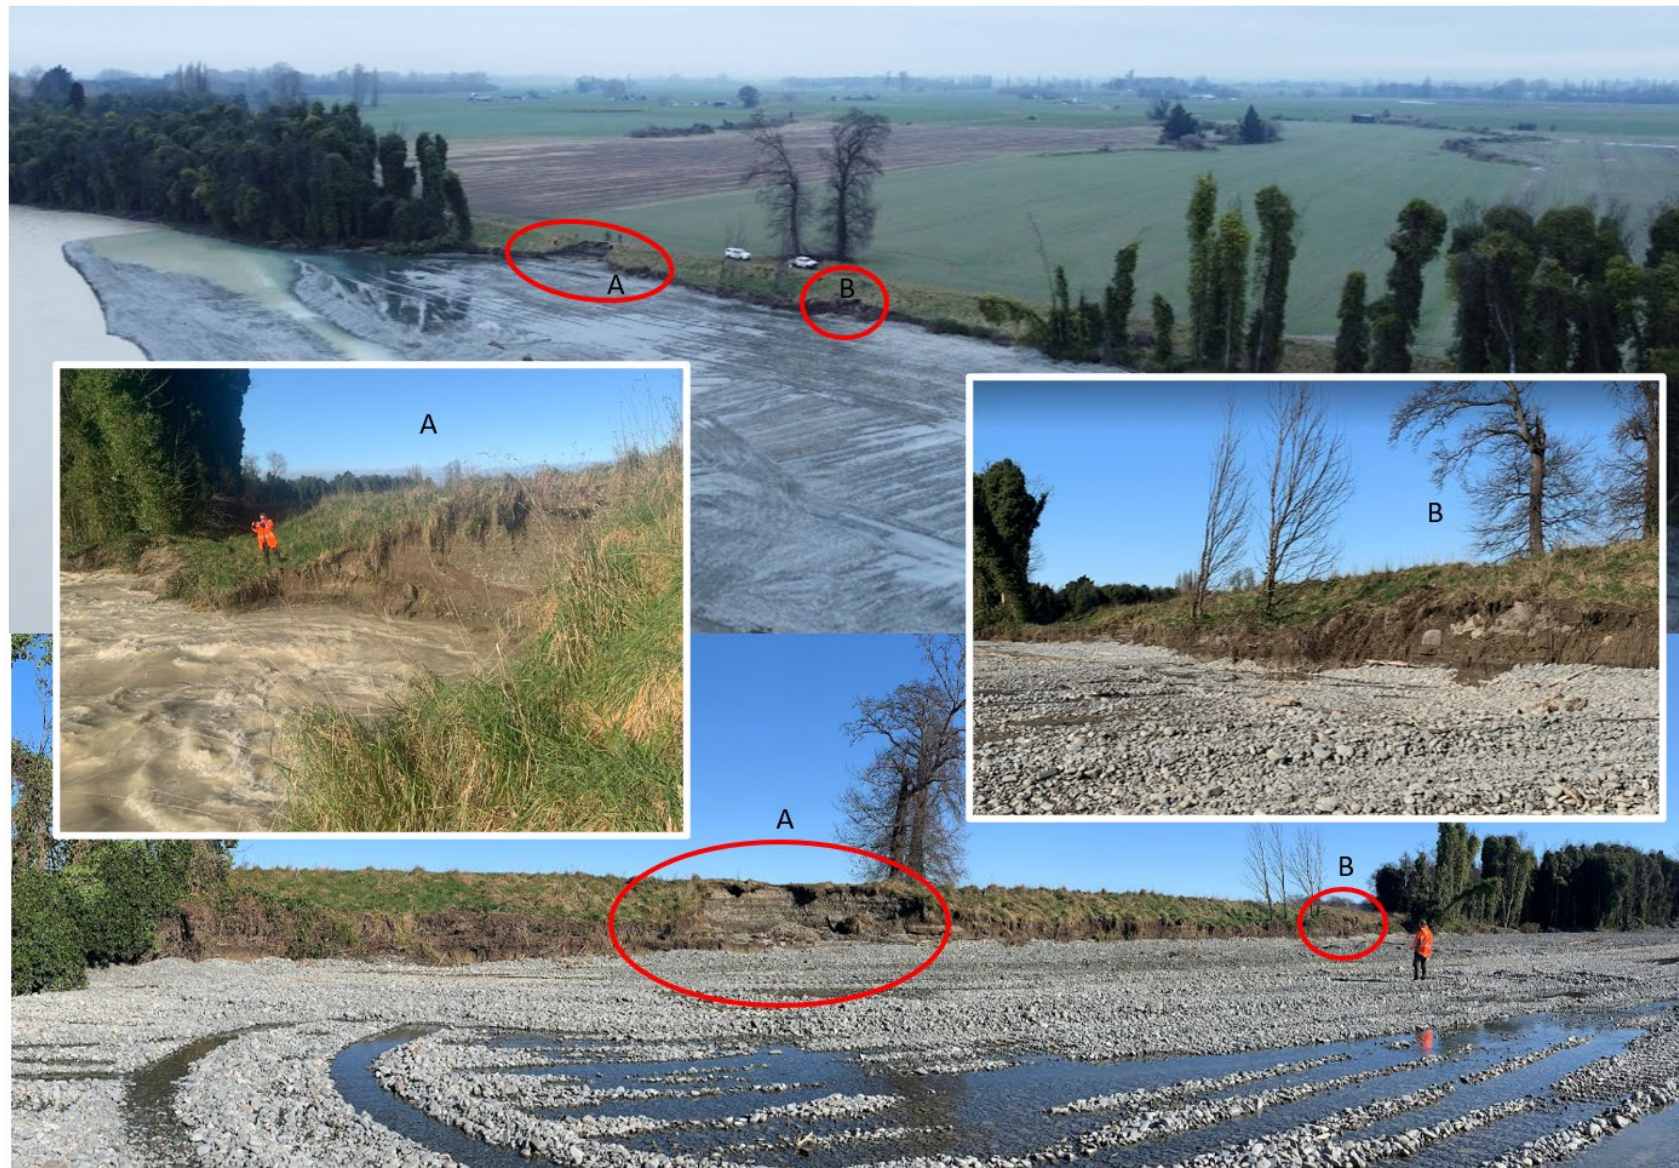
Figure B-9: Orari at Stewart Road, stopbank damage at A and B and scour of 230m length of stopbank berm.

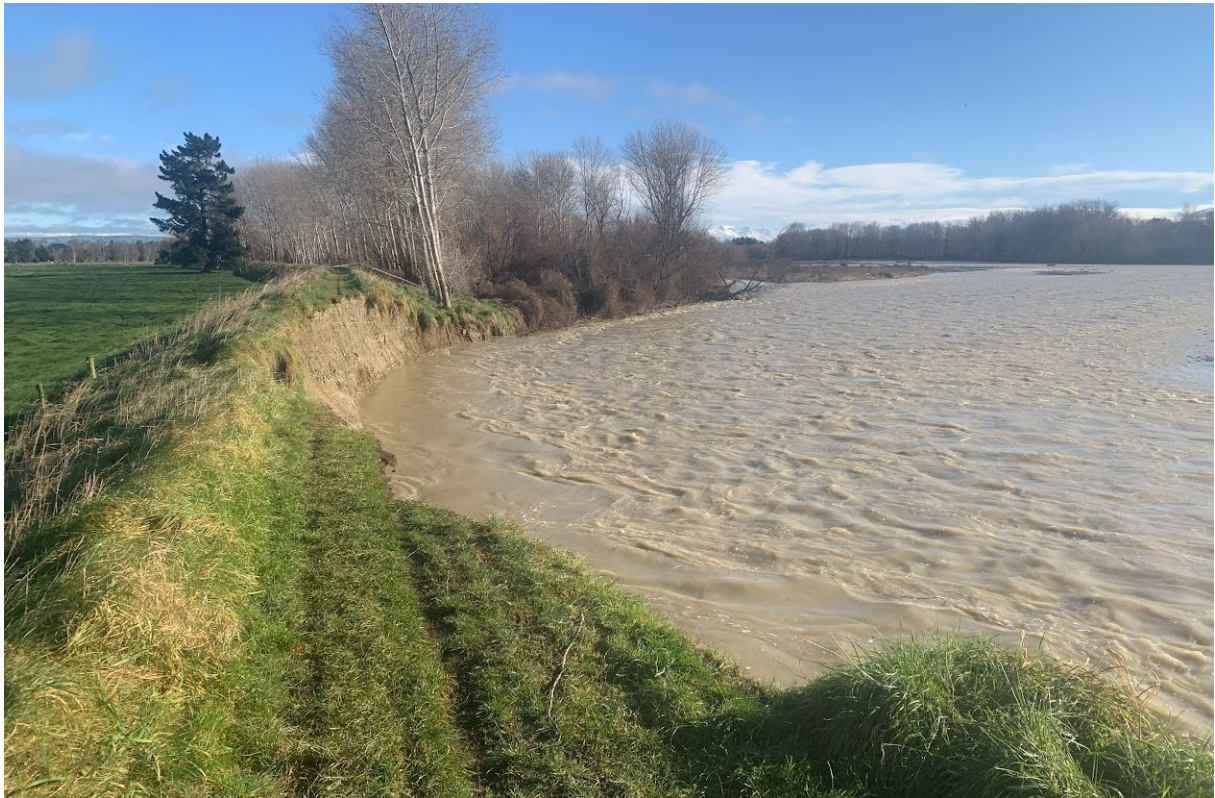
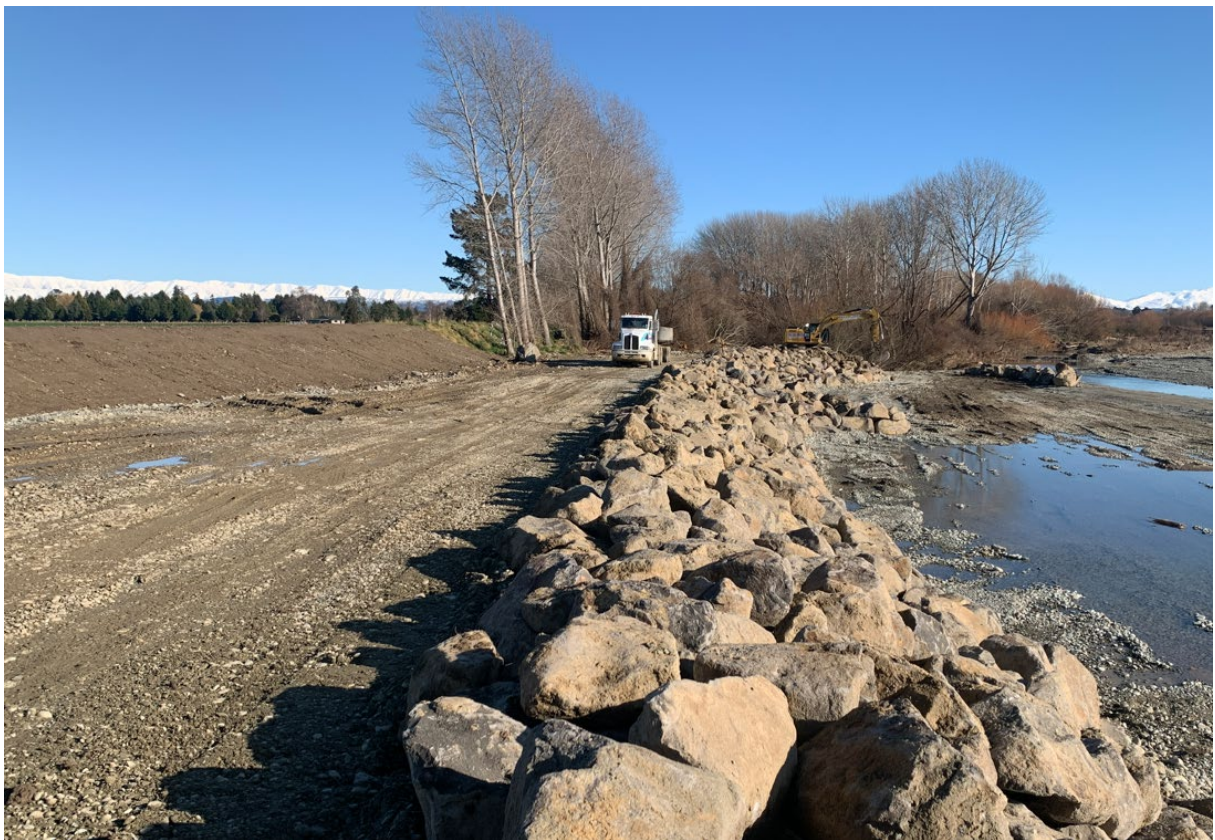
Much of the new flood damage was sustained in the Opihi River catchment. The most significant damage was to a stopbank on the Opihi River just upstream of a small group of dwellings at the end of Mill Road. Due to the high risk of stopbank failure, the dwellings were temporarily evacuated, and repair works undertaken with urgency.

Figure C-1: Opihi at Mill Road during flooding on 20 July 2022 (above) and following urgent repairs on 9 August 2022 (below).

Photos showing damage to the stopbank (20 July) and the completed repairs (9 August 2022) are included Appendix C, Figure C-1
