Canterbury 2021 Flood Recovery Update 6

Ken Tarboton (Aqueus Consulting)
Shaun McCracken (Environment Canterbury)

10 May 2023

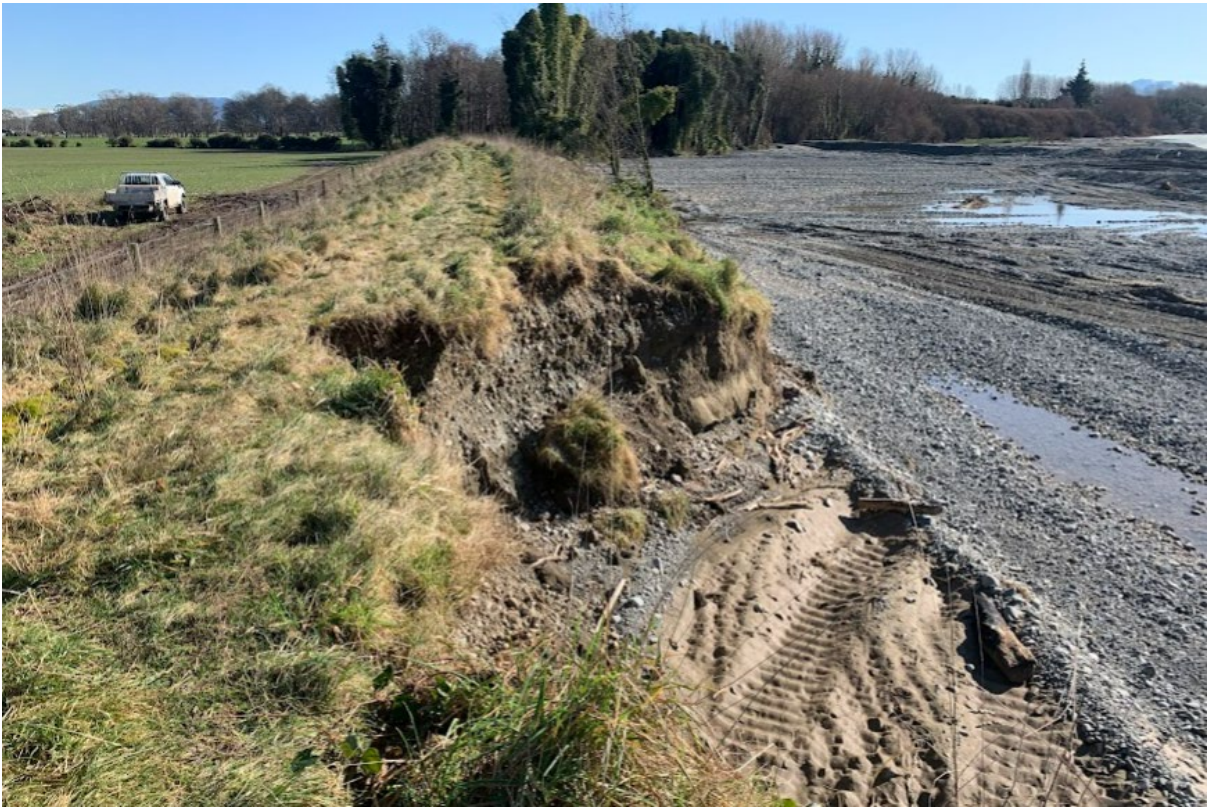
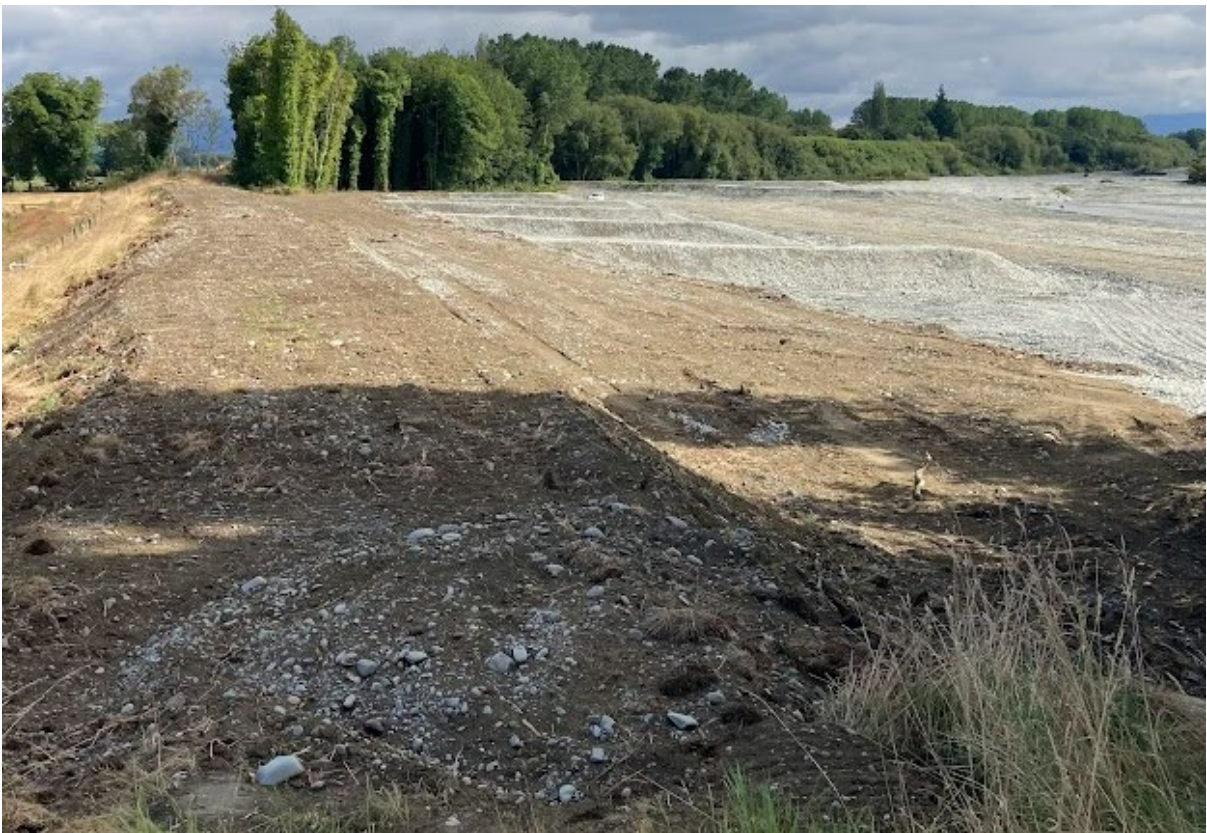
Figure A-1: Orari at Stewart Road (a) tree edge protection loss and stopbank scour, (b) repaired stopbank, berm and erosion protection bunds, awaiting ATP and infill planting.

The extent of 2021 damage which was exacerbated during the 2022 high flows was previously reported in Update 5. A contract for repairs was awarded in October 2022 with work continuing through to January 2023 to complete repairs to the stopbank, the berm in front of it and to establish erosion protection groynes (Figures A-1 and A-2). Installation of ATP on the upstream side of the groynes and infill pole planting has been left to the winter of 2023.

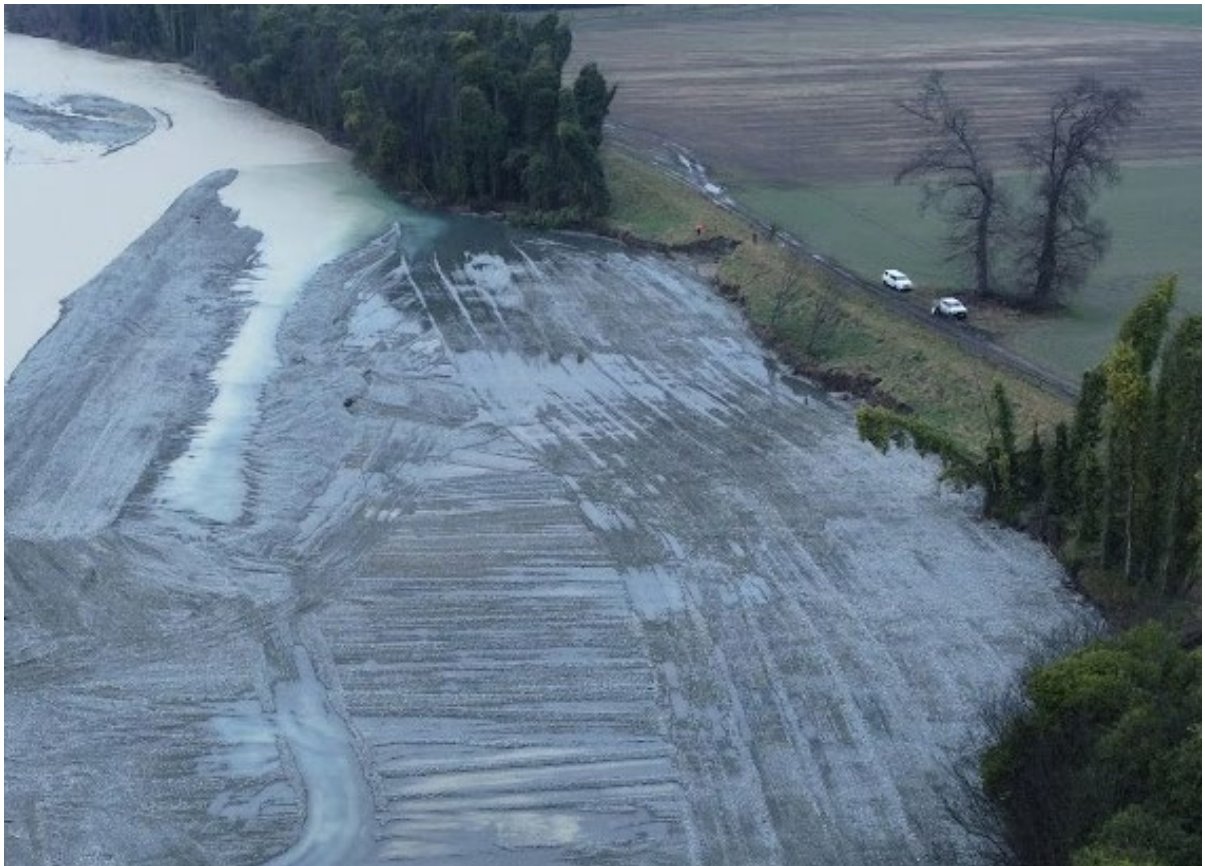
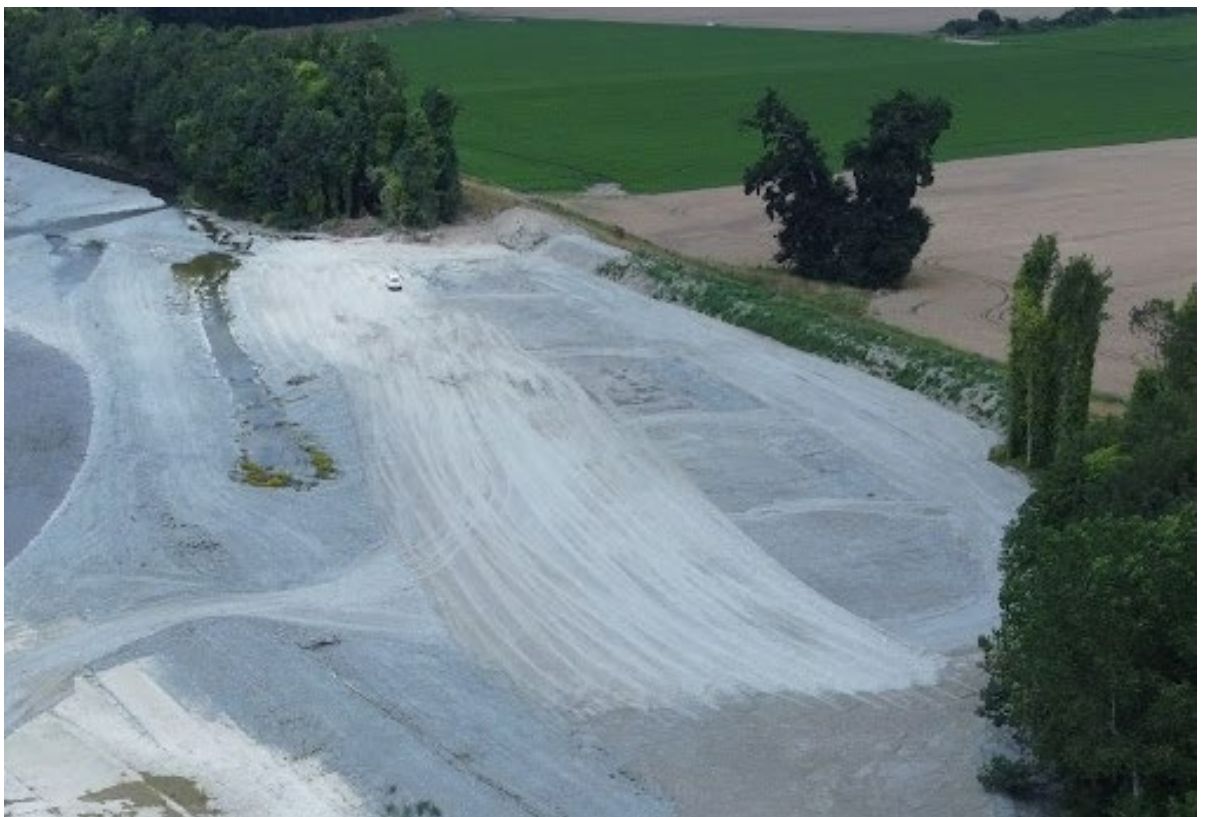
Figure A-2: Orari at Stewart Road aerials of (a) flood damage, (b) repaired stopbank, berm and erosion protection bunds, awaiting ATP and infill planting.

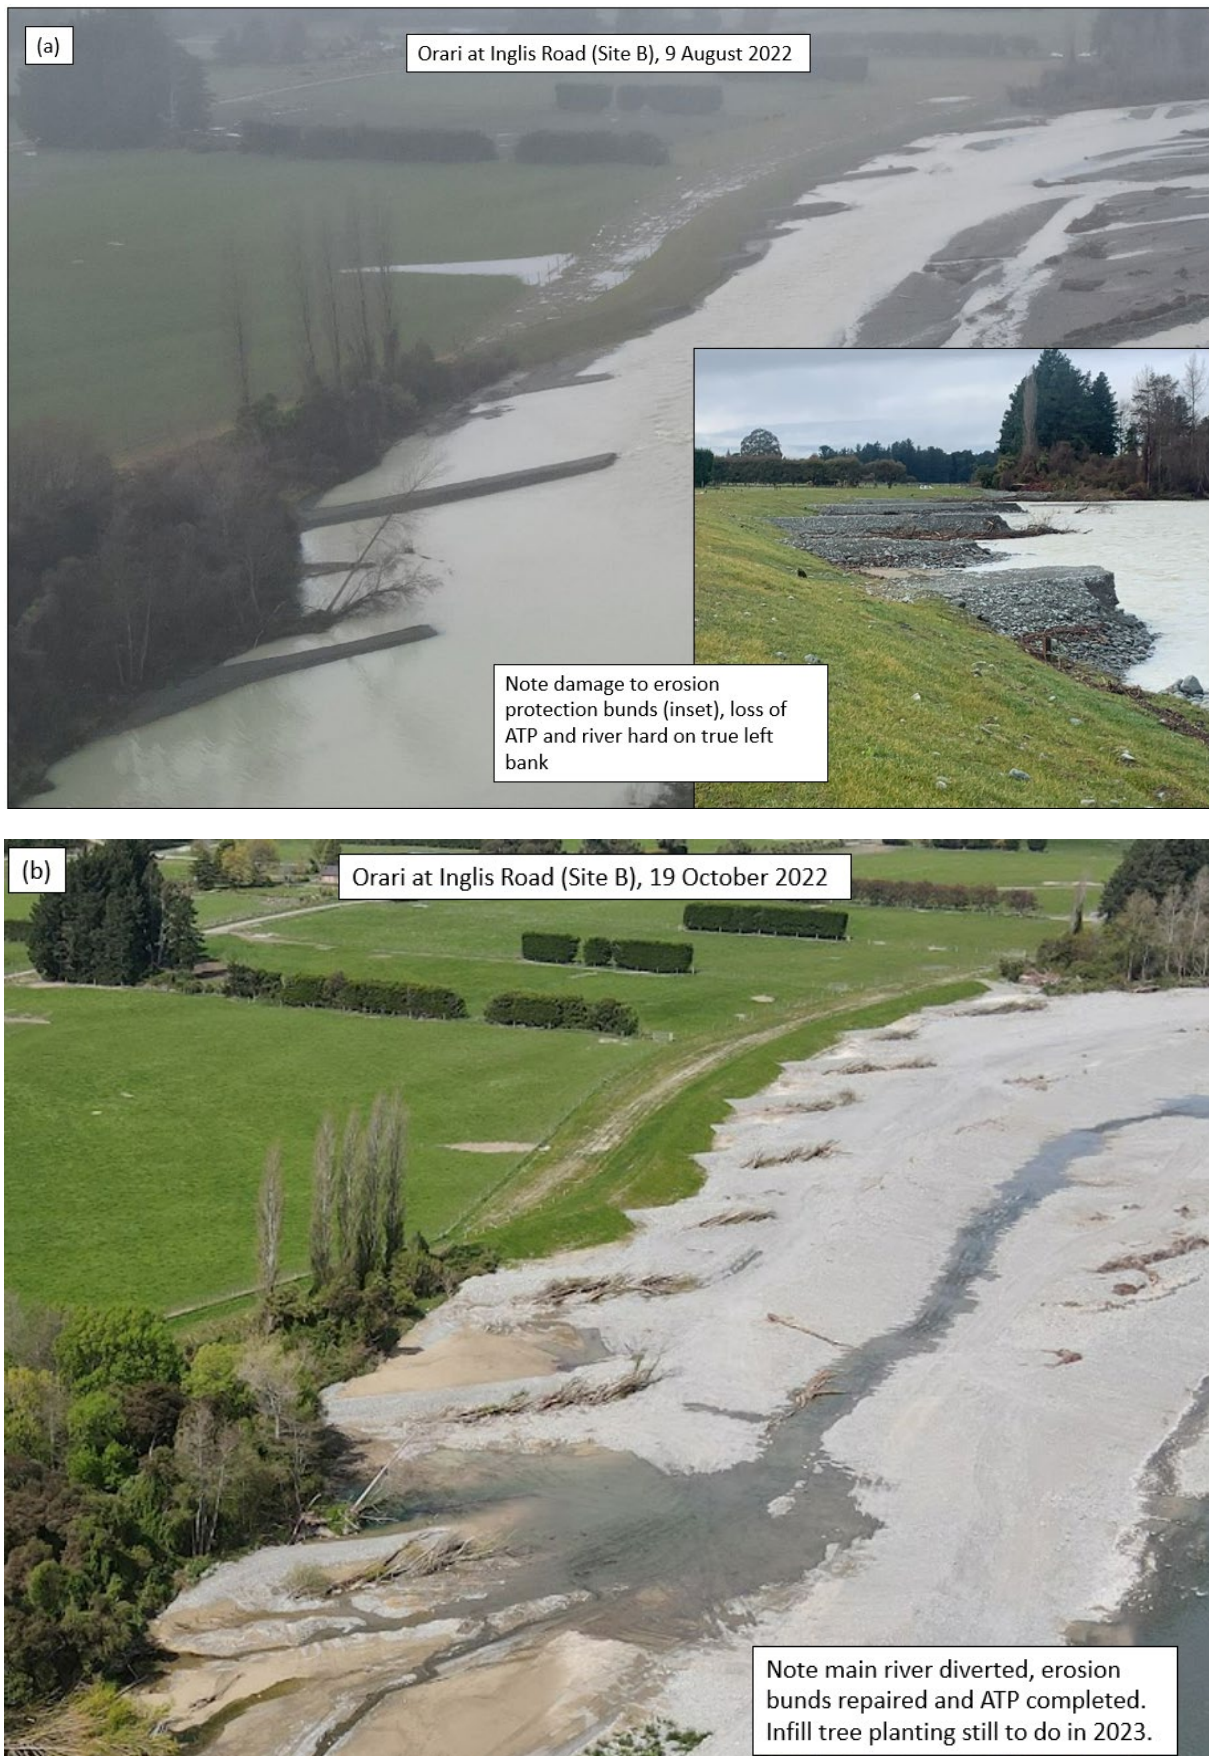
Figure A-6: Orari at Inglis Road, Site B: (a) damage to erosion protection bunds July/Aug 2022, (b) erosion bunds repaired and ATP complete, October 2022.

Following channel realignment repairs to the damaged erosion protection bunds were undertaken at Sites B and C (Figure A-6 and A-7). ATP was also re-instated at these sites. Infill pole planting is required in the winter of 2023.

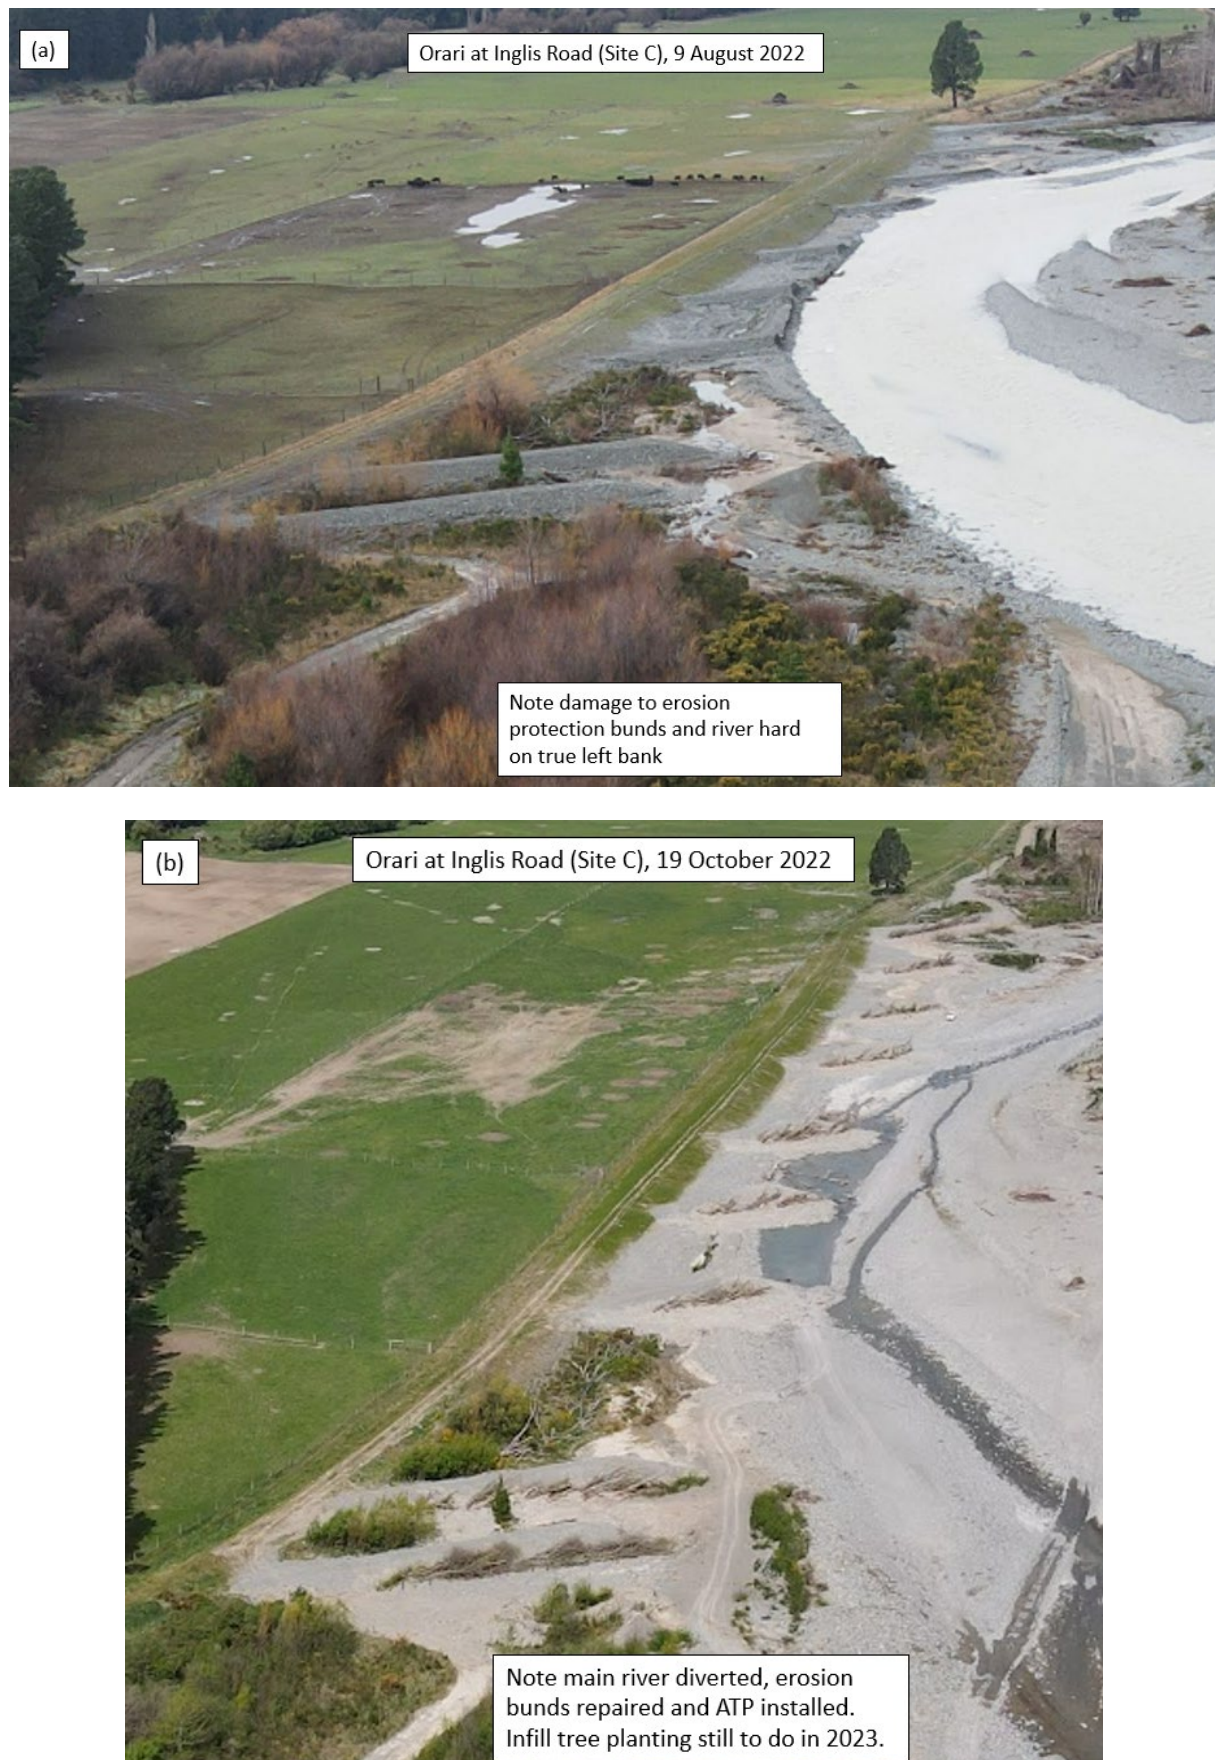
Figure A-7: Orari at Inglis Road, Site C: (a) damage to erosion protection bunds July/Aug 2022, (b) erosion bunds repaired and ATP complete, October 2022.

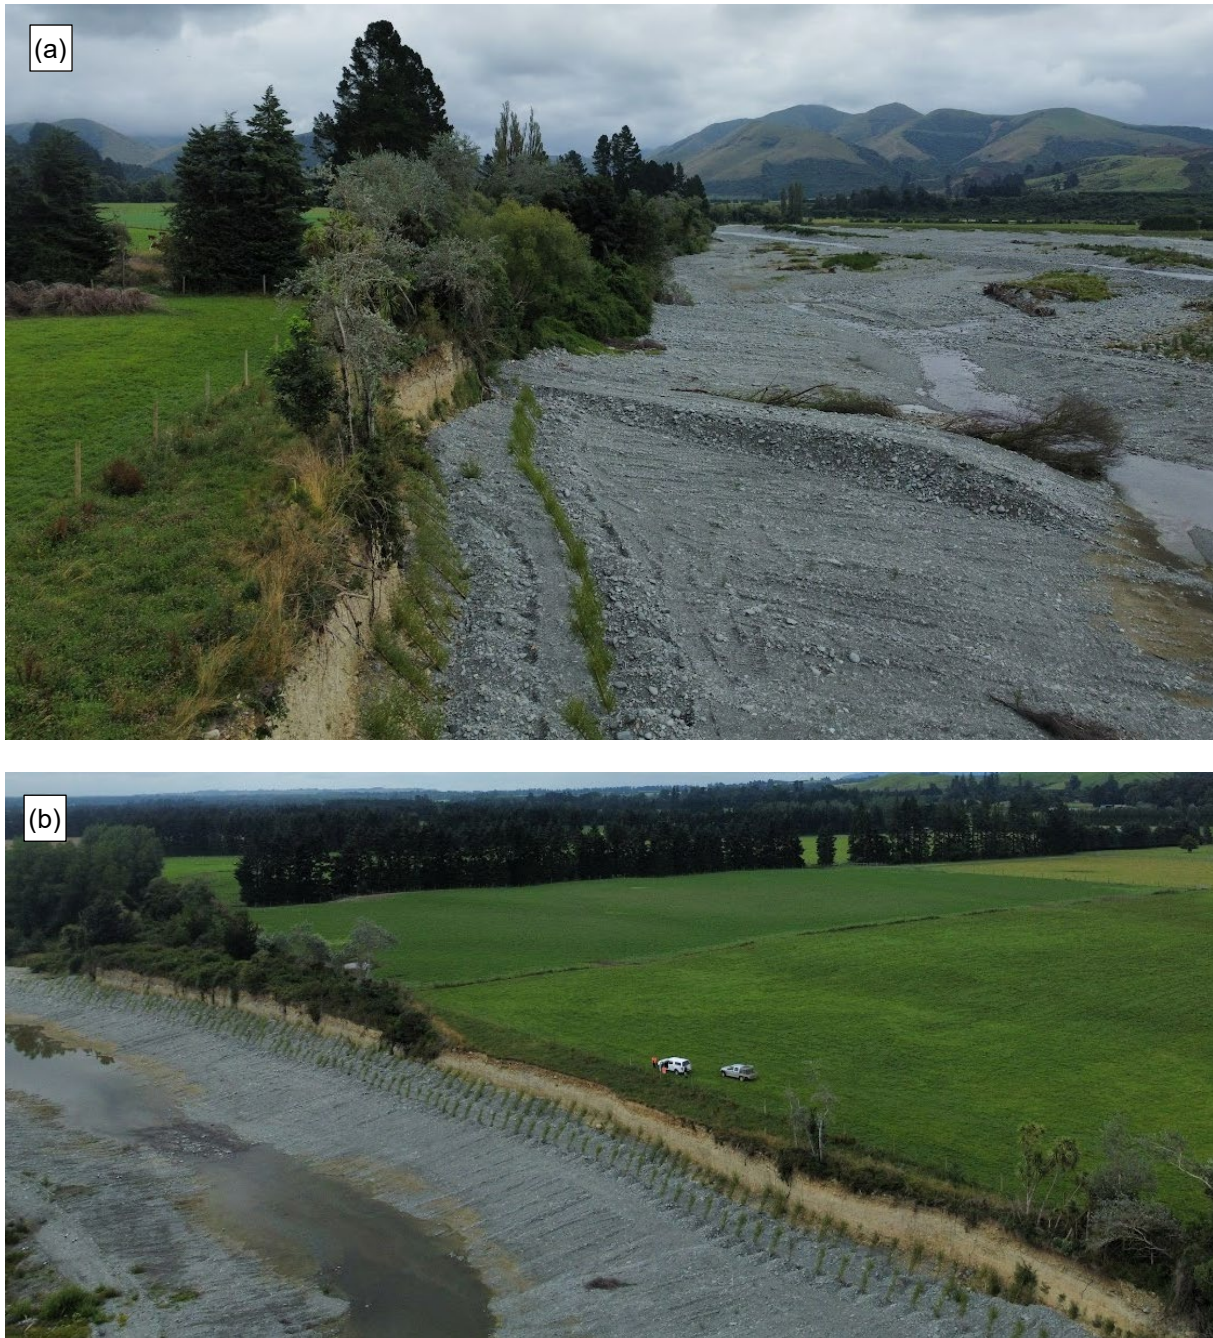
Figure A-8: Orari at Peacocks showing rows of infill planting along edge of eroded high berm in January 2022, (a) looking upstream, (b) looking downstream.

Following channel realignment, a deflection bund with ATP on its upstream edge was constructed and two rows of tree edge protection planted along the high eroded berm in an attempt to prevent further erosion of this high berm and private land loss. The trees have taken well (Figure A-8). The success of this repair remains to be tested with expected high flows in the winter of 2023.

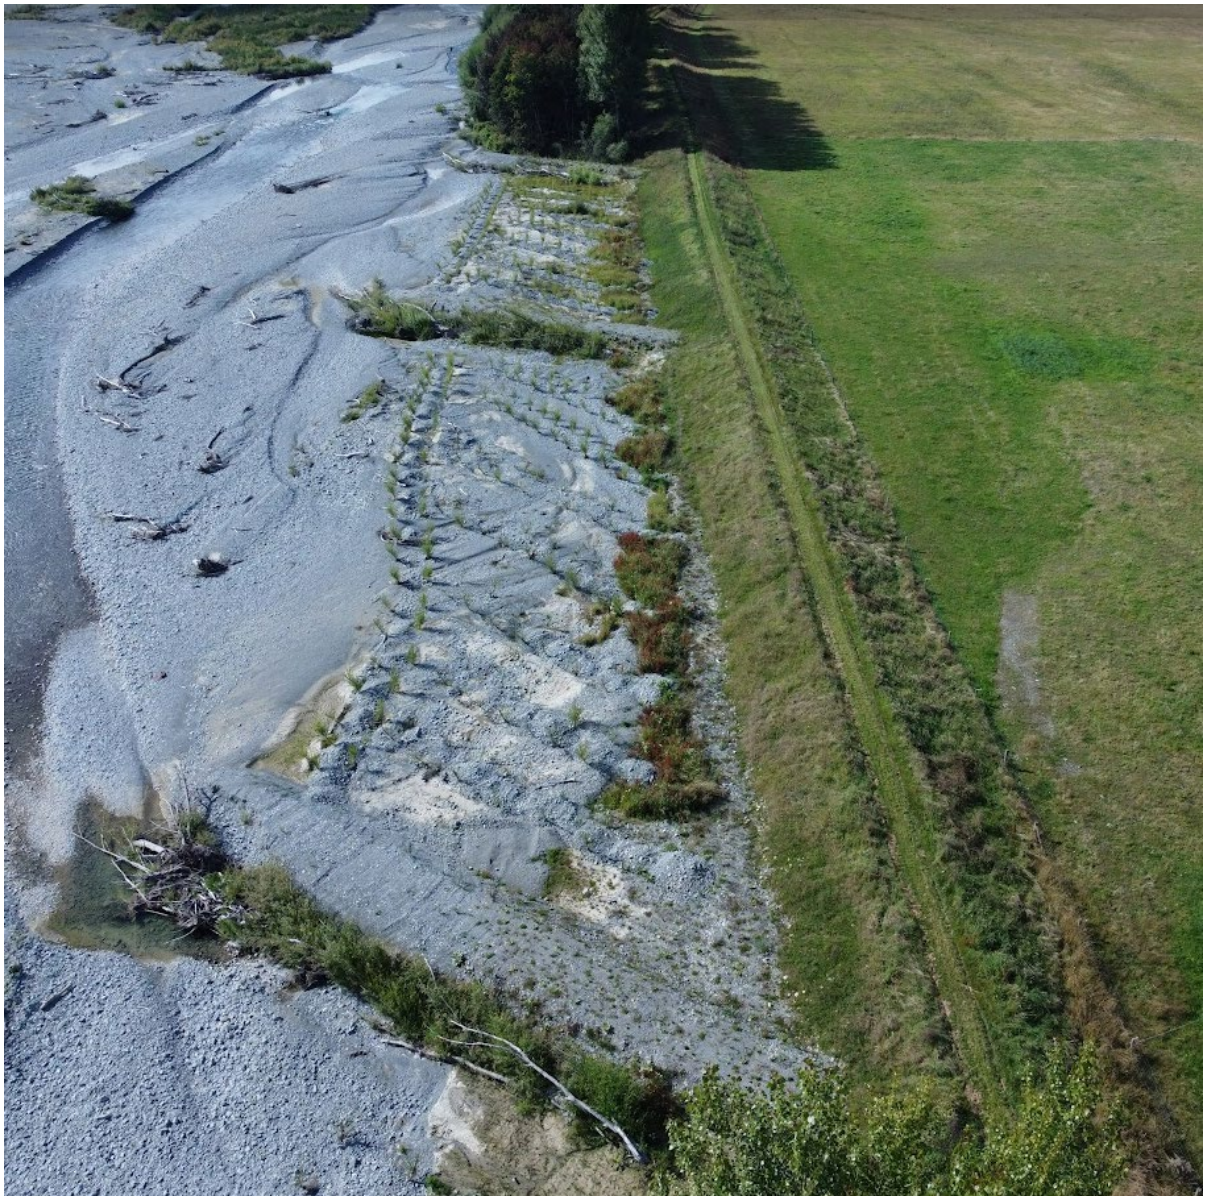
Figure A-9: Orari at SH79 showing completed ATP and infill planting (January 2023).

Stopbank and erosion bund work was completed and reported in Flood Recovery Update 3 (March 2022). ATP work undertaken in May-June 2022 was partially washed out in the July/Aug 2022 high flows and the tips of the erosion protection bunds were also washed away. Since then the erosion protection bunds have been repaired, ATP restored and infill planting undertaken (Figure A-9).

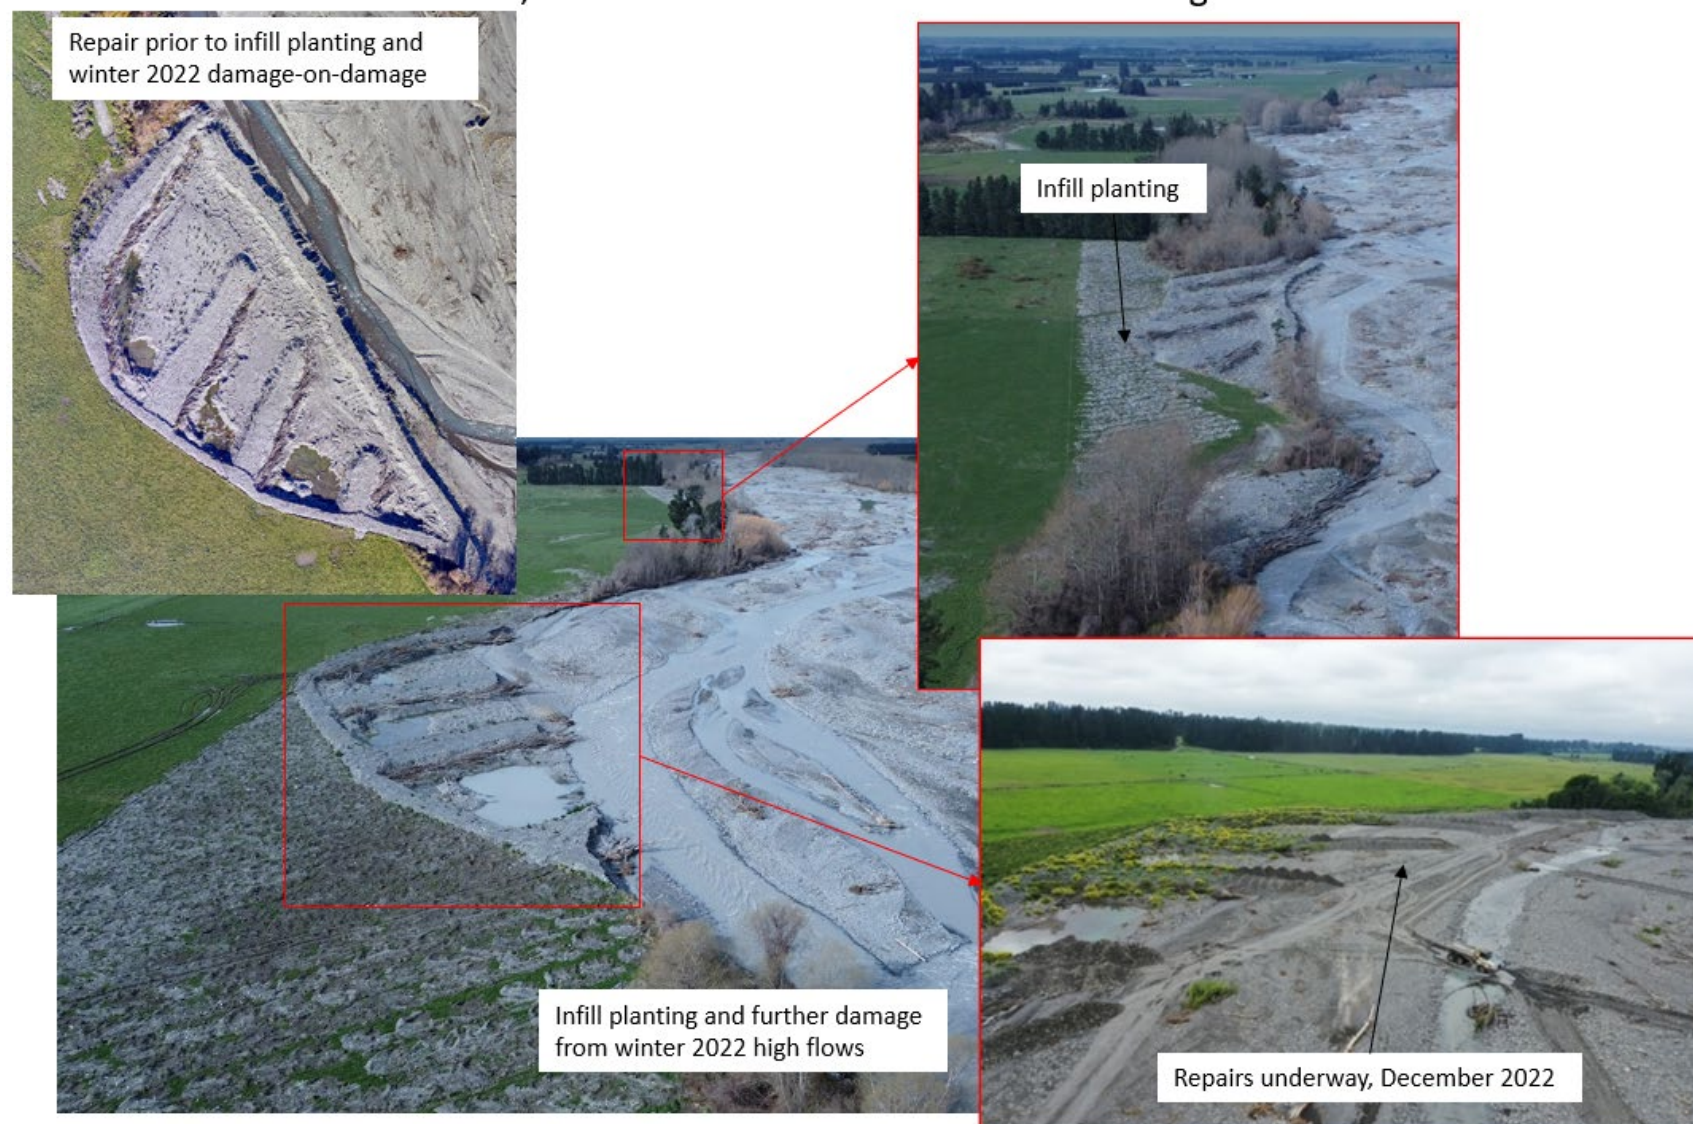
Figure A-11: Ashburton North Branch downstream of confluence with Pudding Hill Stream, details of repairs and infill planting.

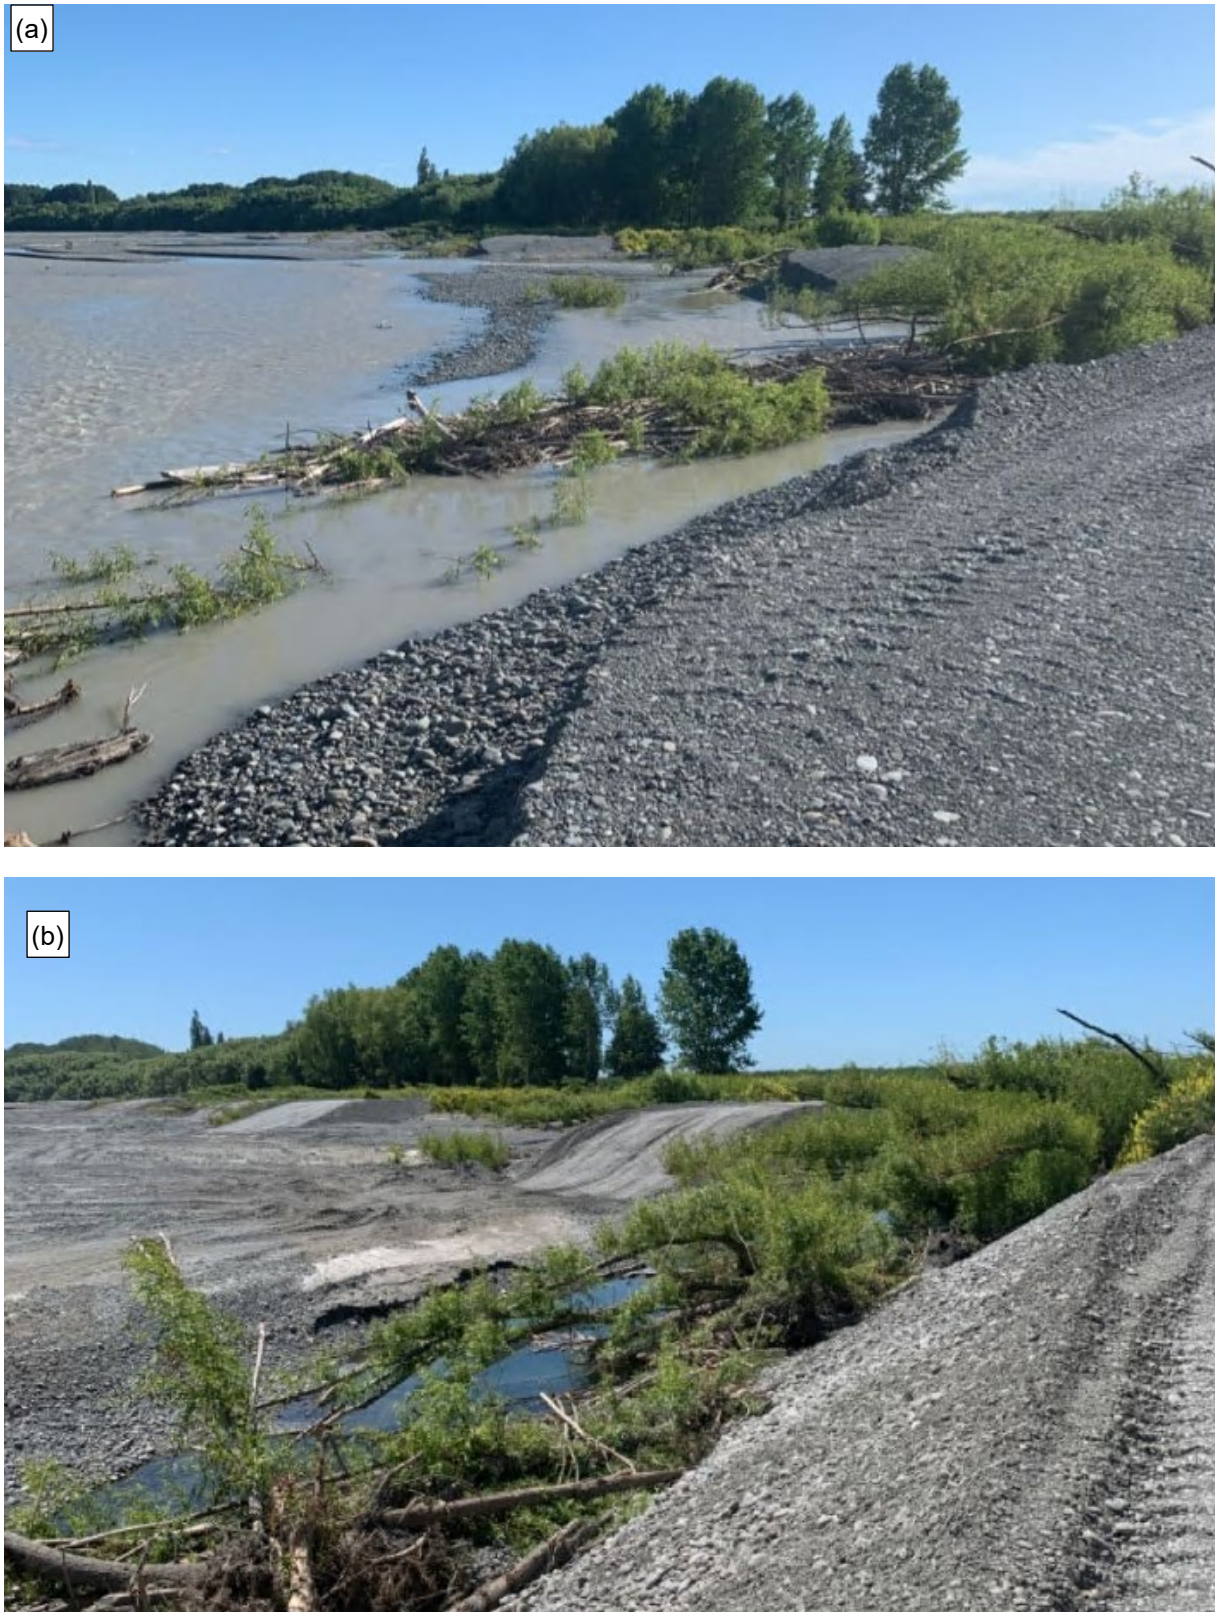
Figure A-1213: Ashburton main stem at River Road, (a) following winter 2022 damage-on-damage, and (b) after minor repairs undertaken in November 2022.

Further damage to the repair on the Ashburton main stem at River Road was reported in Update 5 together with a plan for a proposed repair. Those repairs were undertaken in November 2022 (see Figure A-12).

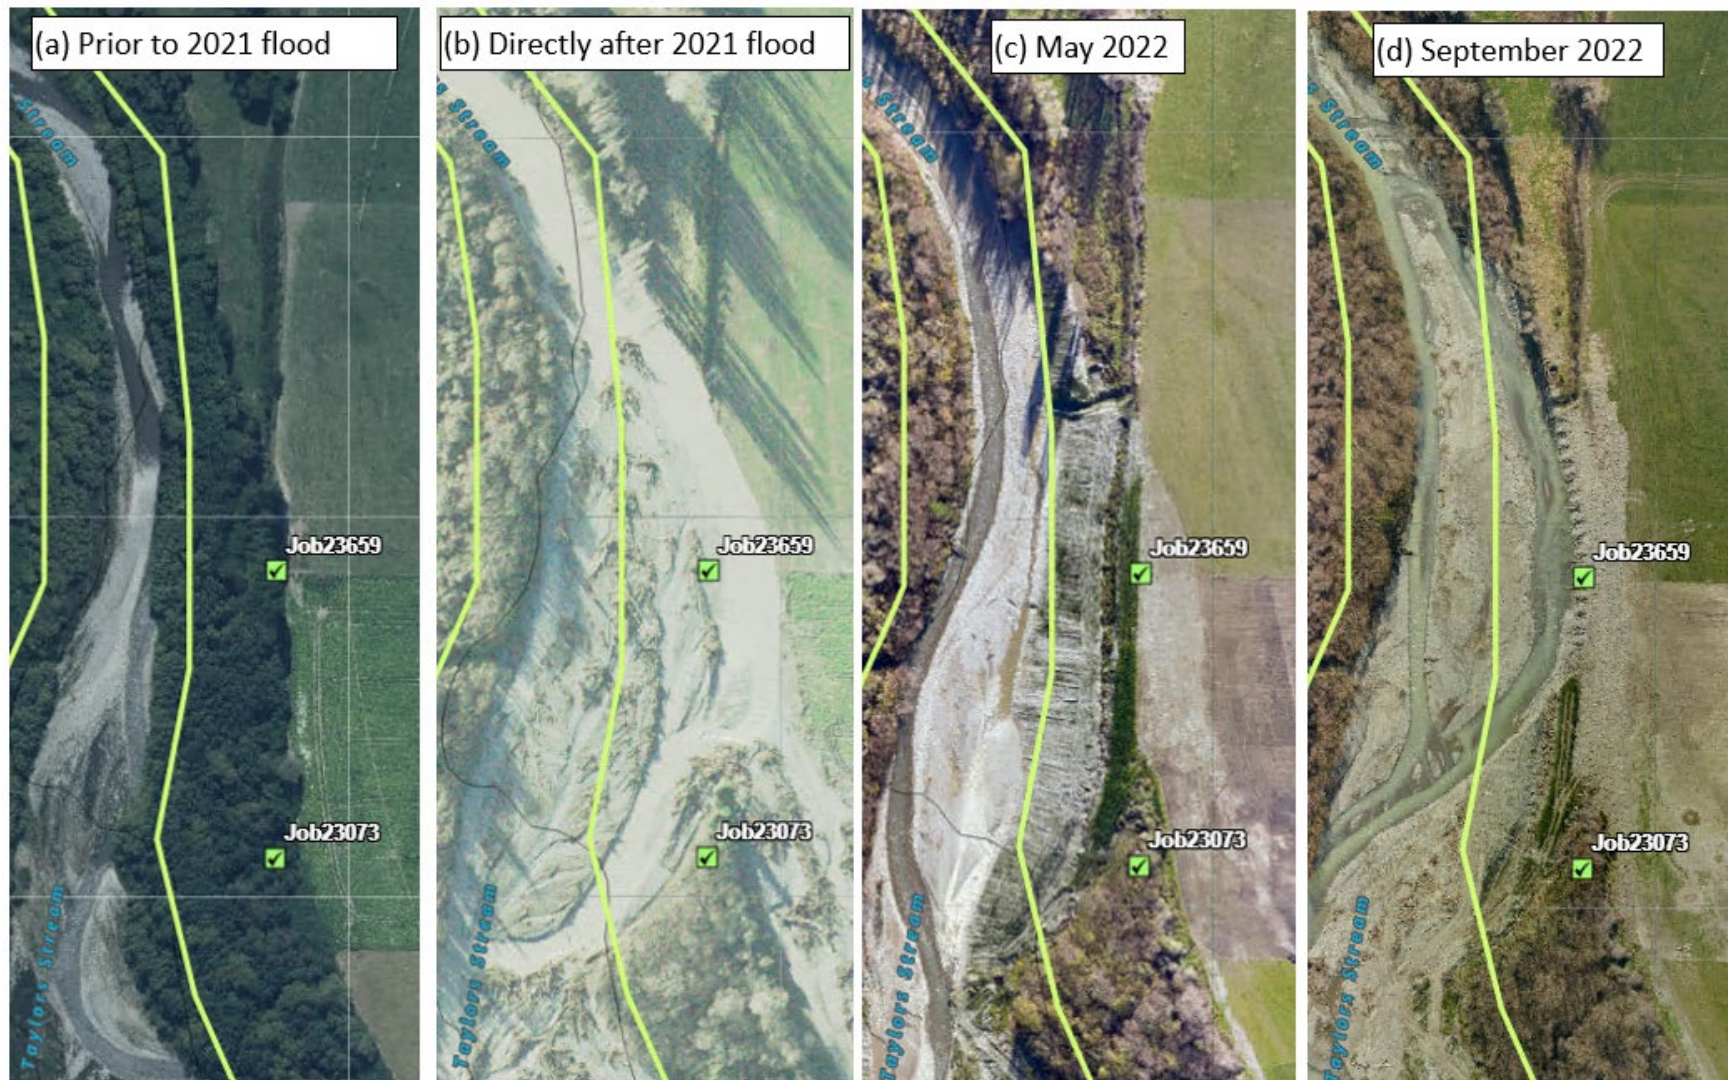
Figure A-13 shows the pre-flood light anchored bank protection (LABP) washed out during the 2021 flood and subsequent flow over private land. Initial repairs were made in March 2022 with a line of anchored trees, then following the winter 2022 high flows more substantial anchored tree protection was installed (Figure A-14).

Figure A-14: Taylor's Stream showing (a) pre-flood light anchored bank protection, (b) loss of LABP and flood breakout, (c) bunding and treed trees to stabilise bank, May 2022, and (d) more substantial treed trees, September 2022.

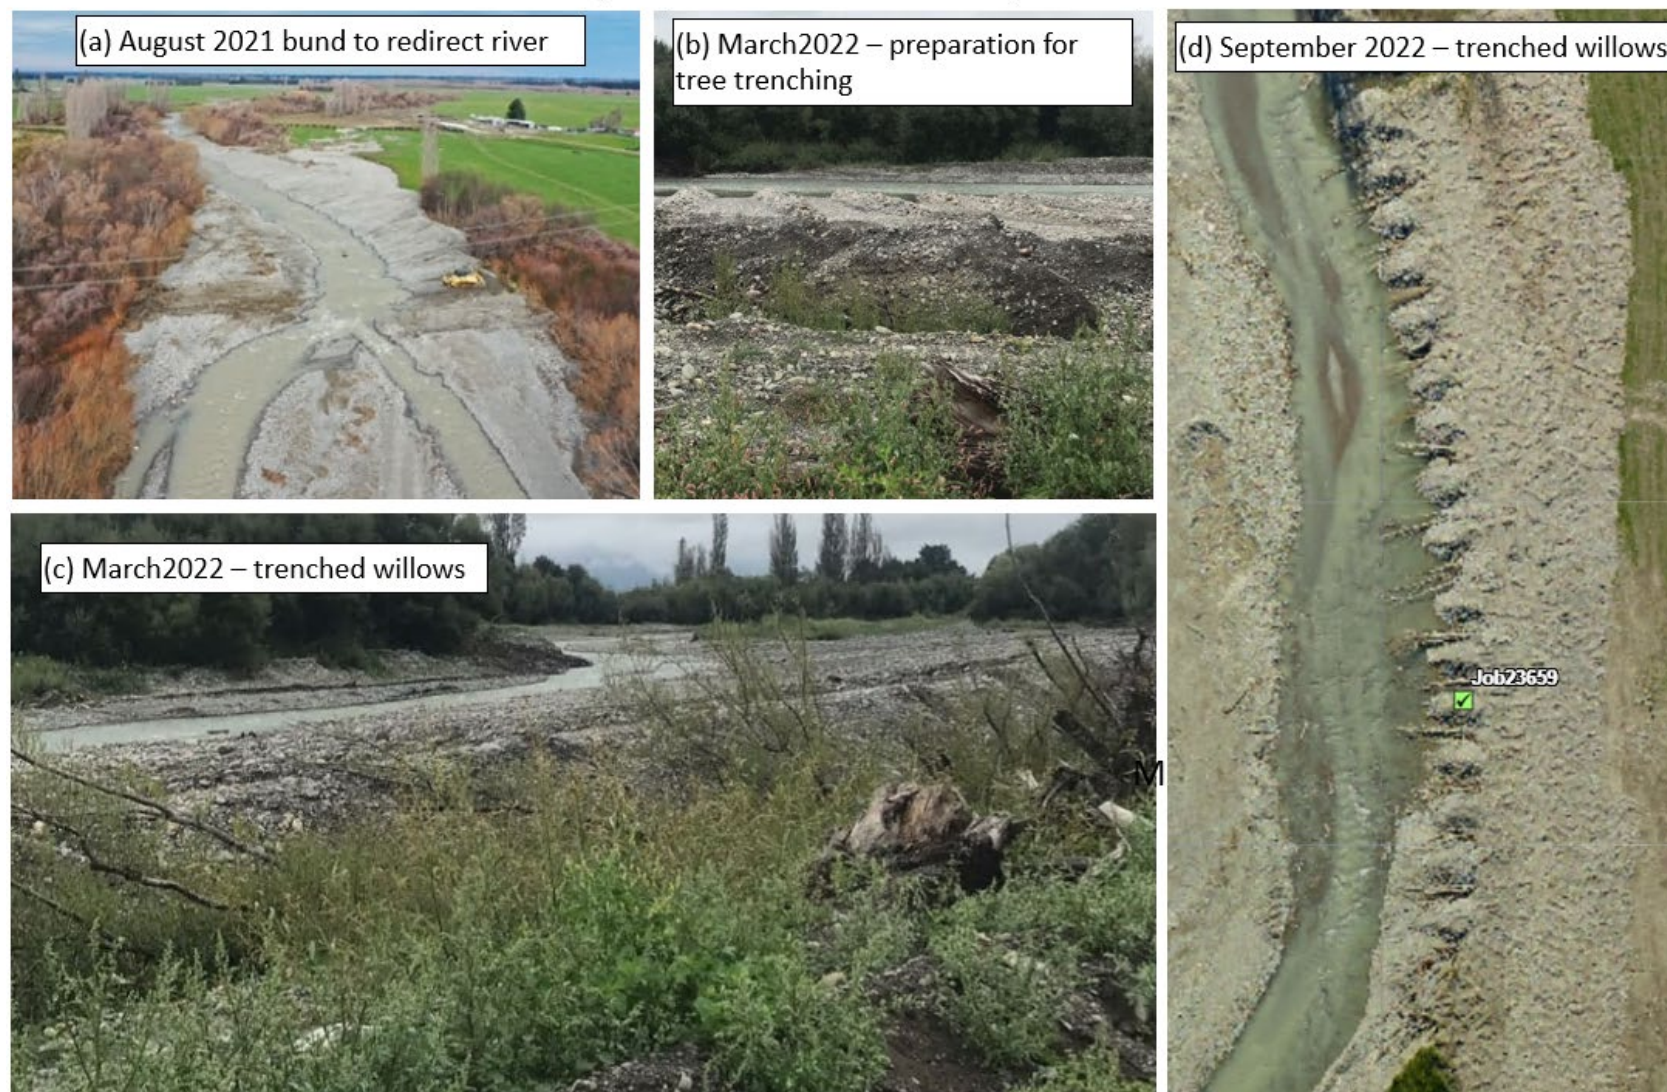
Figure A-15: Taylors Stream repair details (a) in August 2021, (b) and (c) trenched willows in March 2022, and (d) more substantial trenched willows, September 2022.

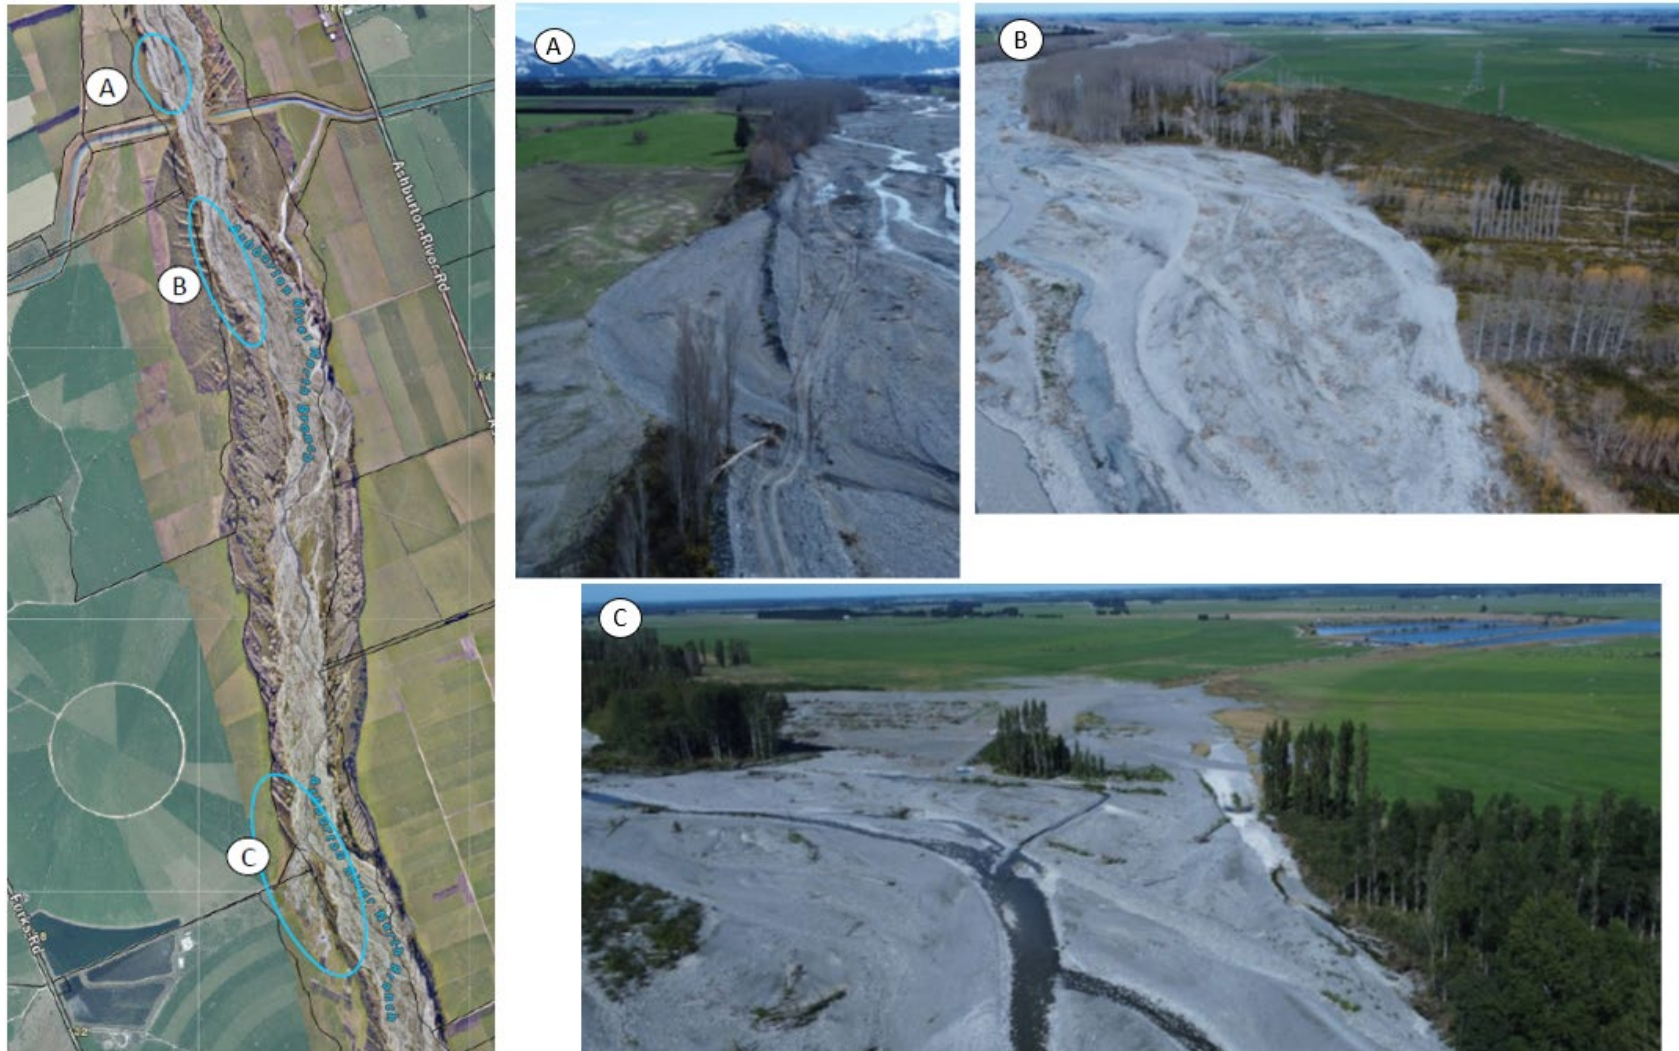
Three sites in the vicinity of the RDR on the Ashburton North Branch had severe scour in the 2021 flood that was exacerbated in the 2022 high flows. Damage to these sites is shown in Figure B-1. Procurement for this work was completed in March 2023 and the work is currently underway.

Figure B-1: Ashburton North in vicinity of RDR, 2021 flood scour damage at three sites.
