Canterbury 2021 Flood Recovery Update 6

Ken Tarboton (Aqueus Consulting)
Shaun McCracken (Environment Canterbury)

10 May 2023

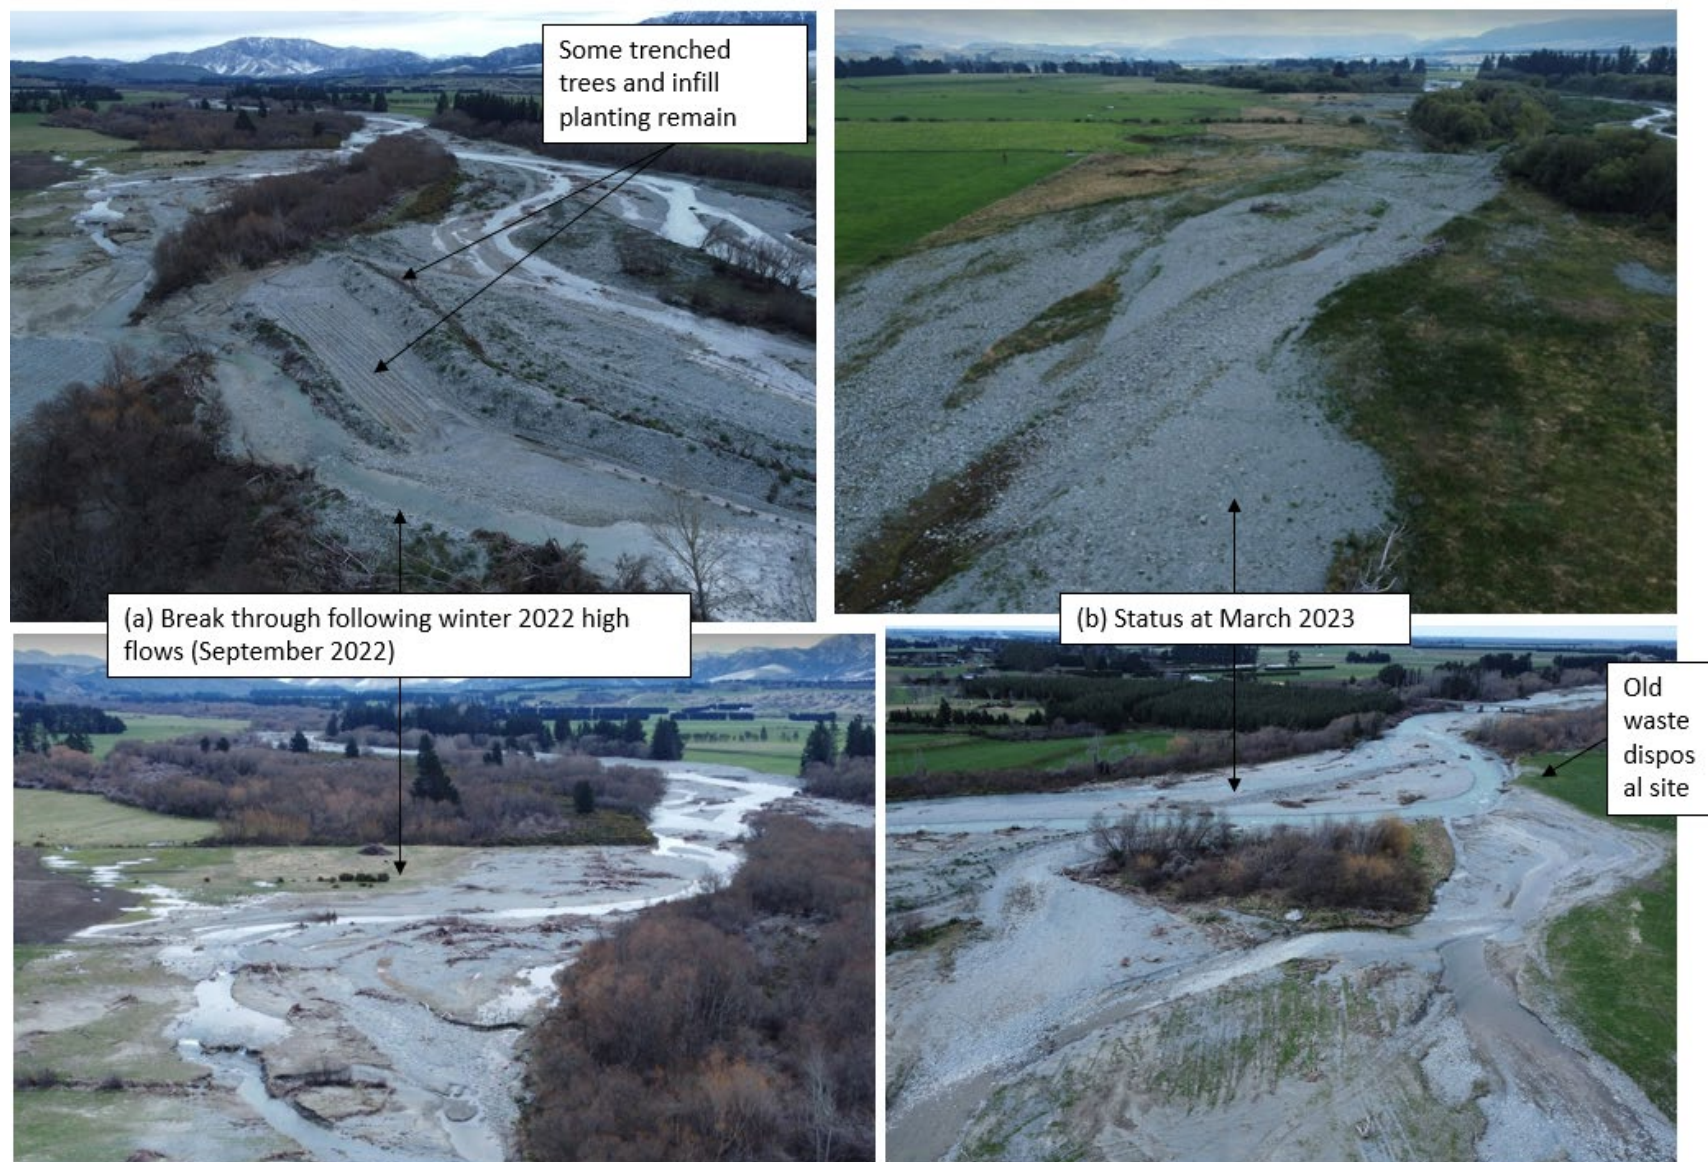
Figure B-3: Ashburton South at Mount Somers, status and illustration of issues.
