Canterbury 2021 Flood Recovery Update 7

April-September 2023

Ken Tarboton (Aqueus Consulting)
Shaun McCracken (Environment Canterbury)

27 October 2023

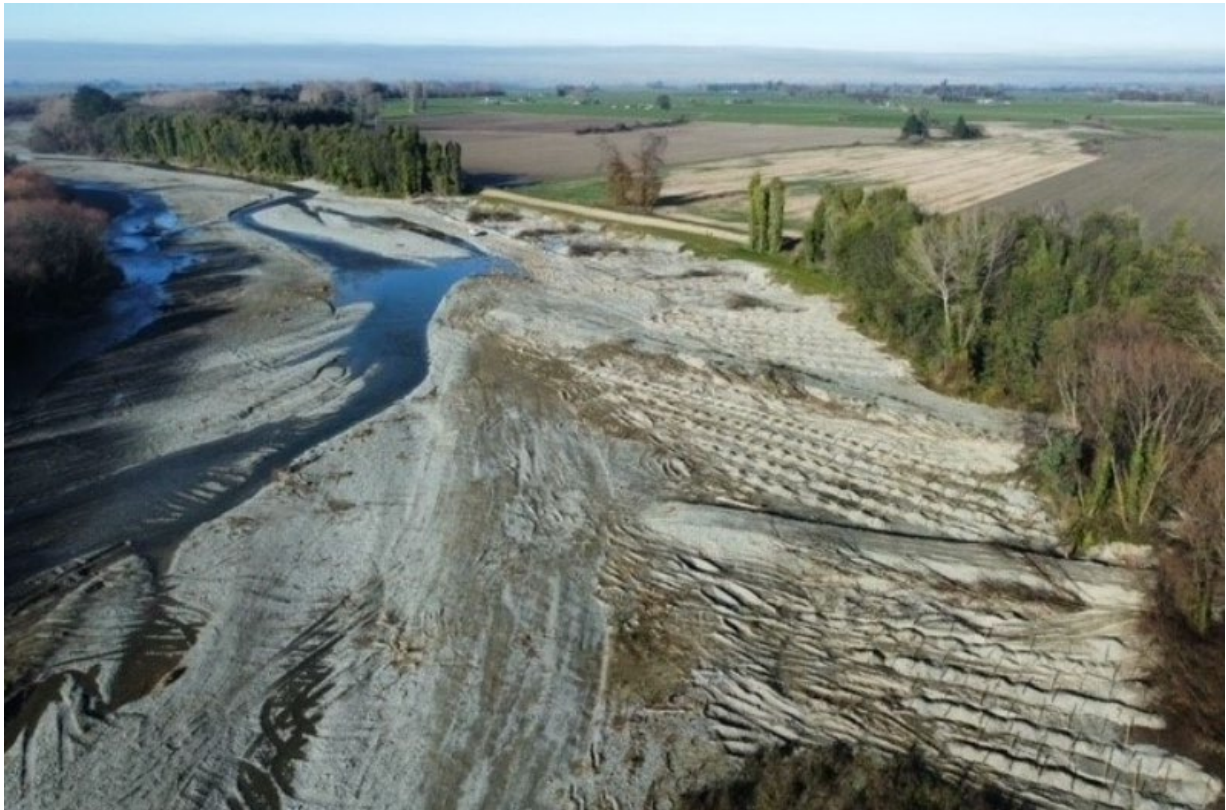
Figure B-1: Orari at Stewart Road after completion of ATP and infill planting (8 June 2023).

Further to the work undertaken prior to March 2023 (previously reported), during this period anchored tree protection (ATP) was installed along the front edges of the erosion protection bunds and infill pole planting completed between the bunds. The high flows of July 2023 caused some minor damage to the erosion protection bunds and displaced some of the concrete block anchors. Minor repairs to address this damage-on-damage have been completed (see Figures B-1 to B-5).

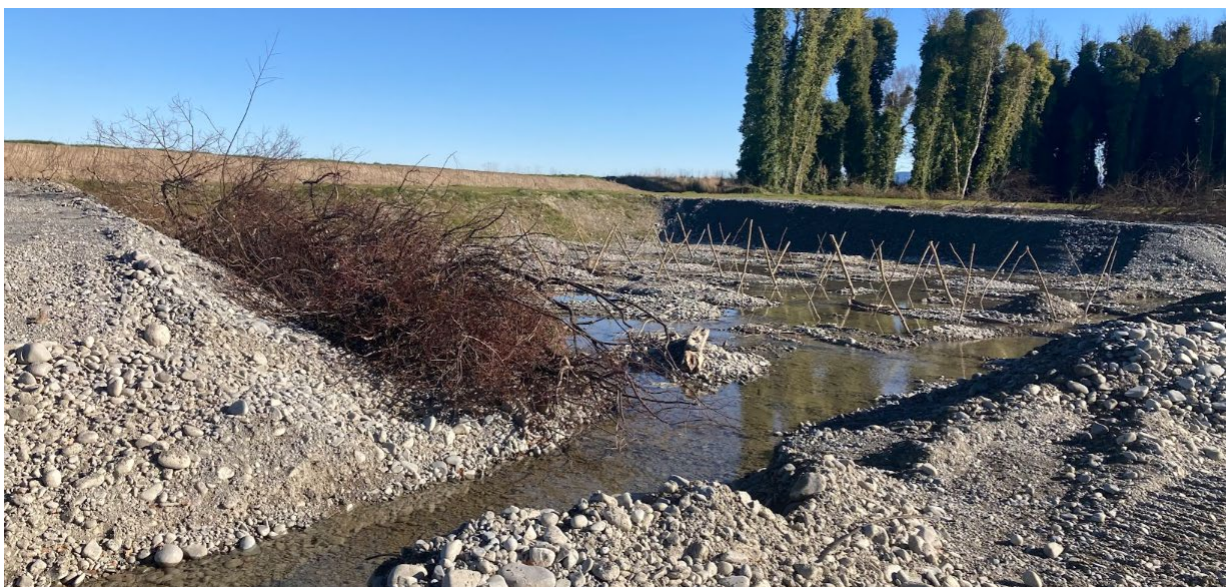
Figure B-2: Orari at Stewart Road, detail of ATP and infill planting (8 June 2023).

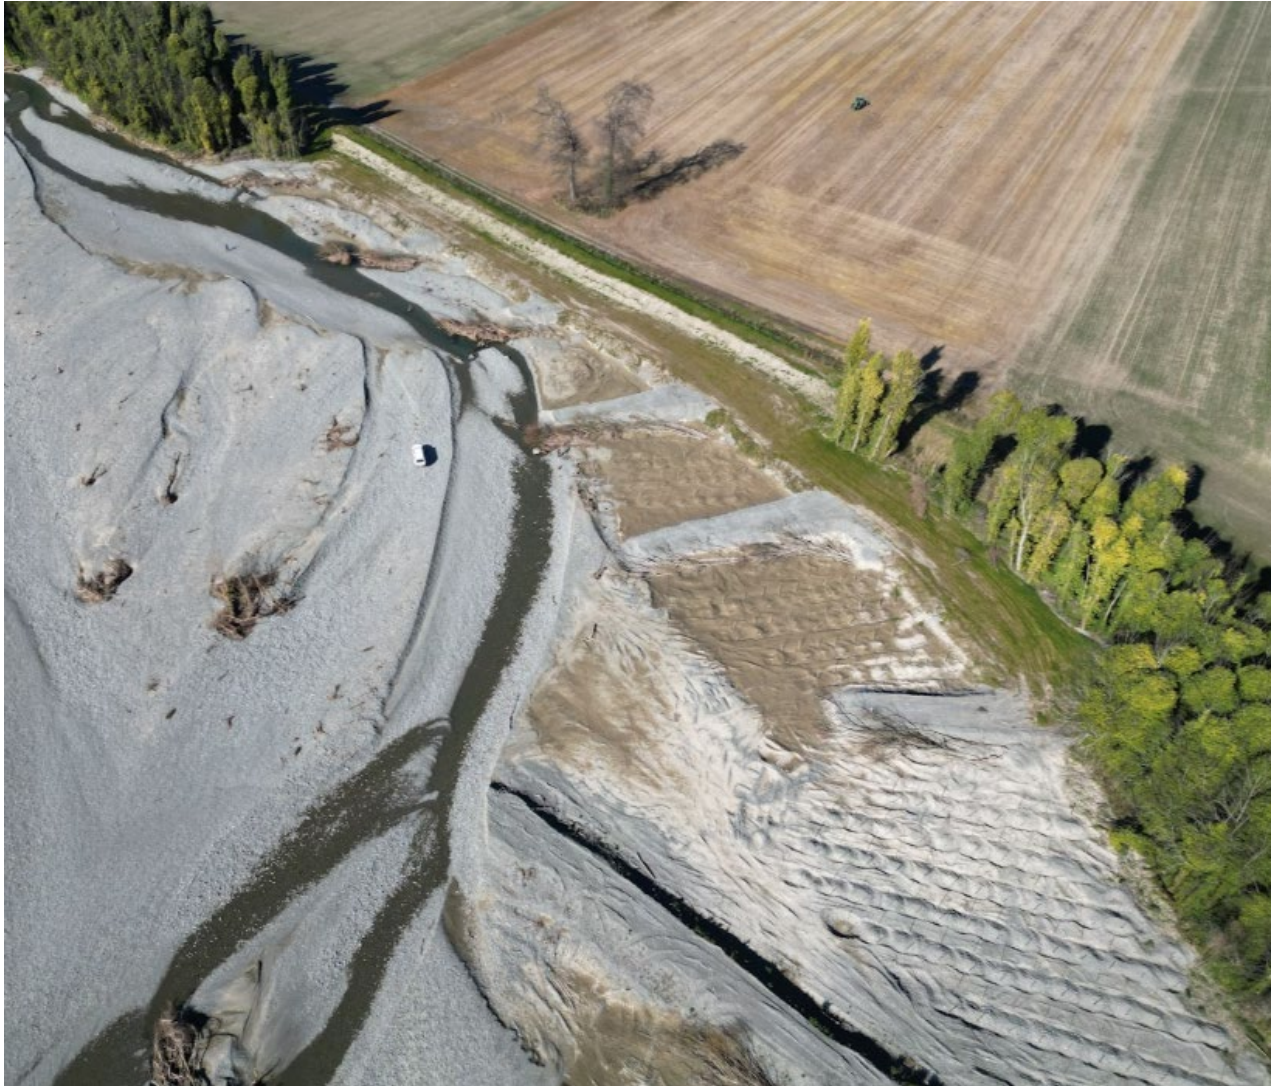
Figure B-3: Orari at Stewart Road, minor damage after July 2023 high flows (23 August 2023).

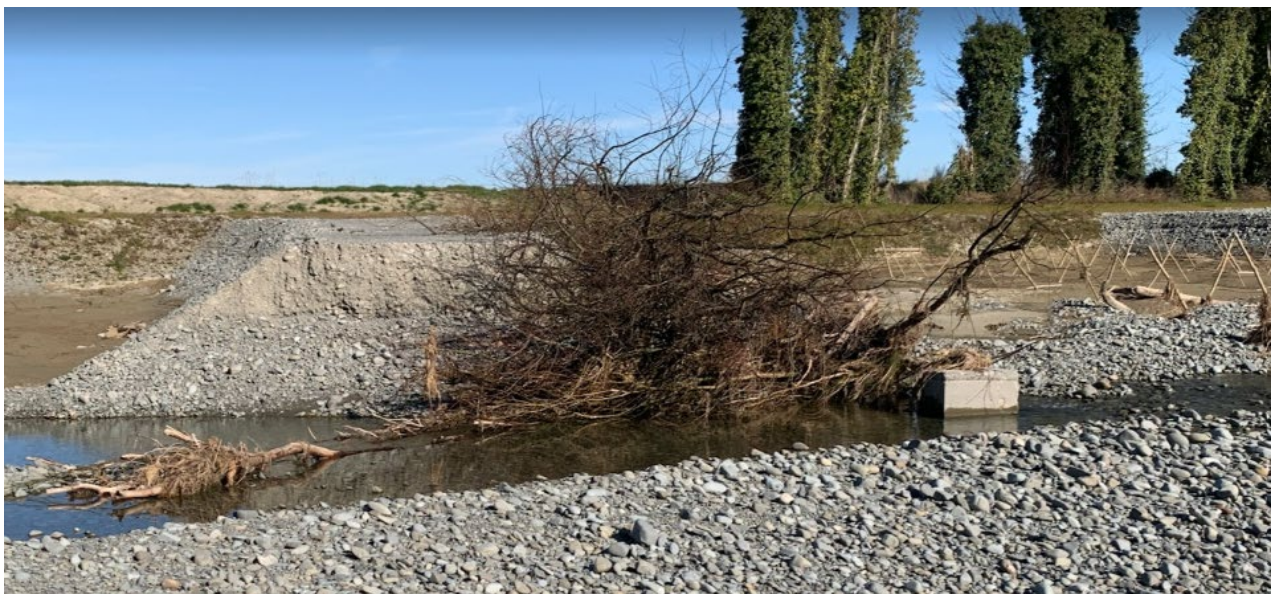
Figure B-4: Orari at Stewart Road, minor damage detail (23 August 2023).

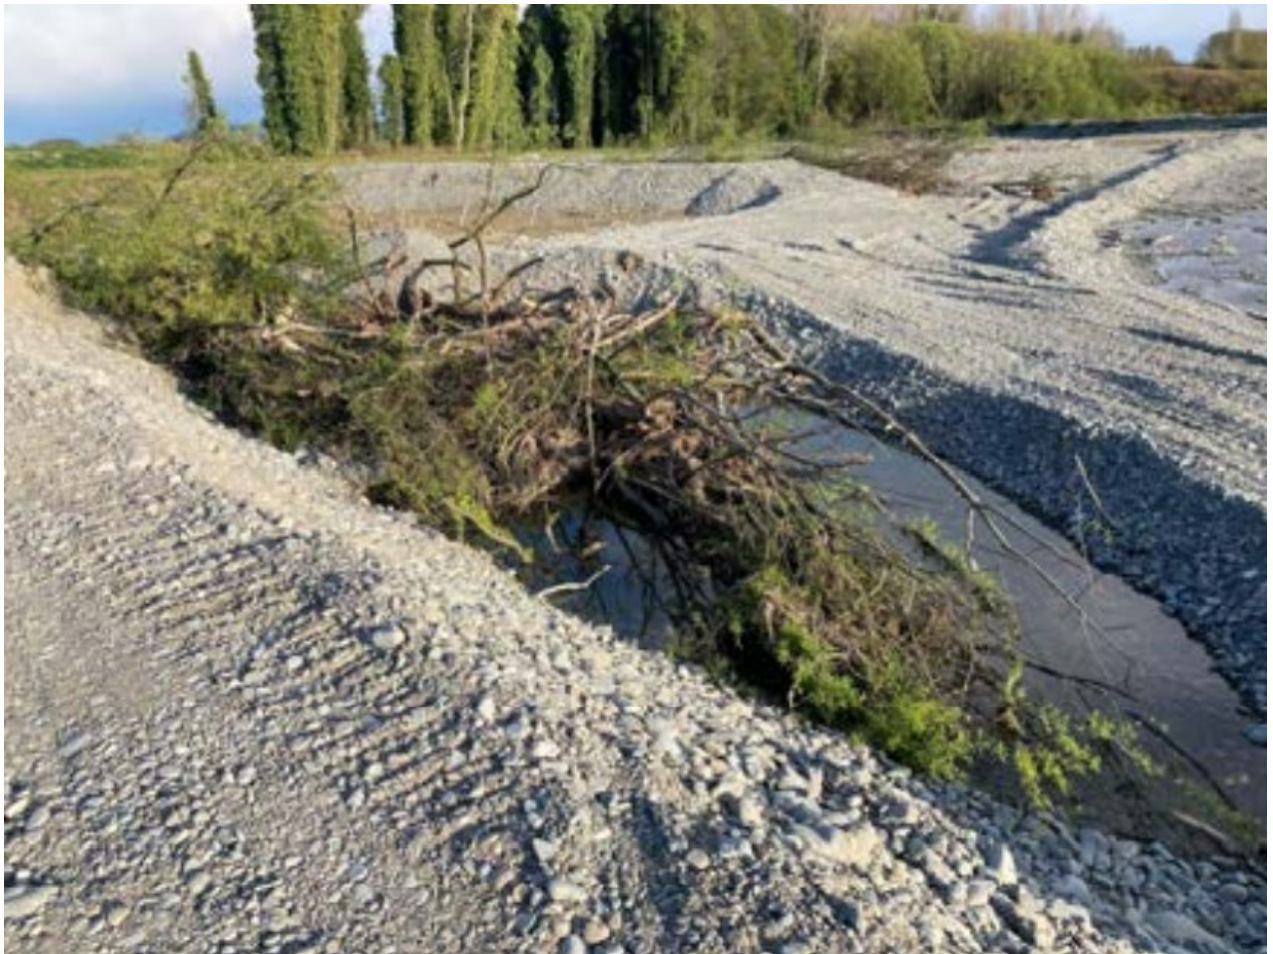
Figure B-5: Orari at Stewart Road after minor repairs (26 September 2023).

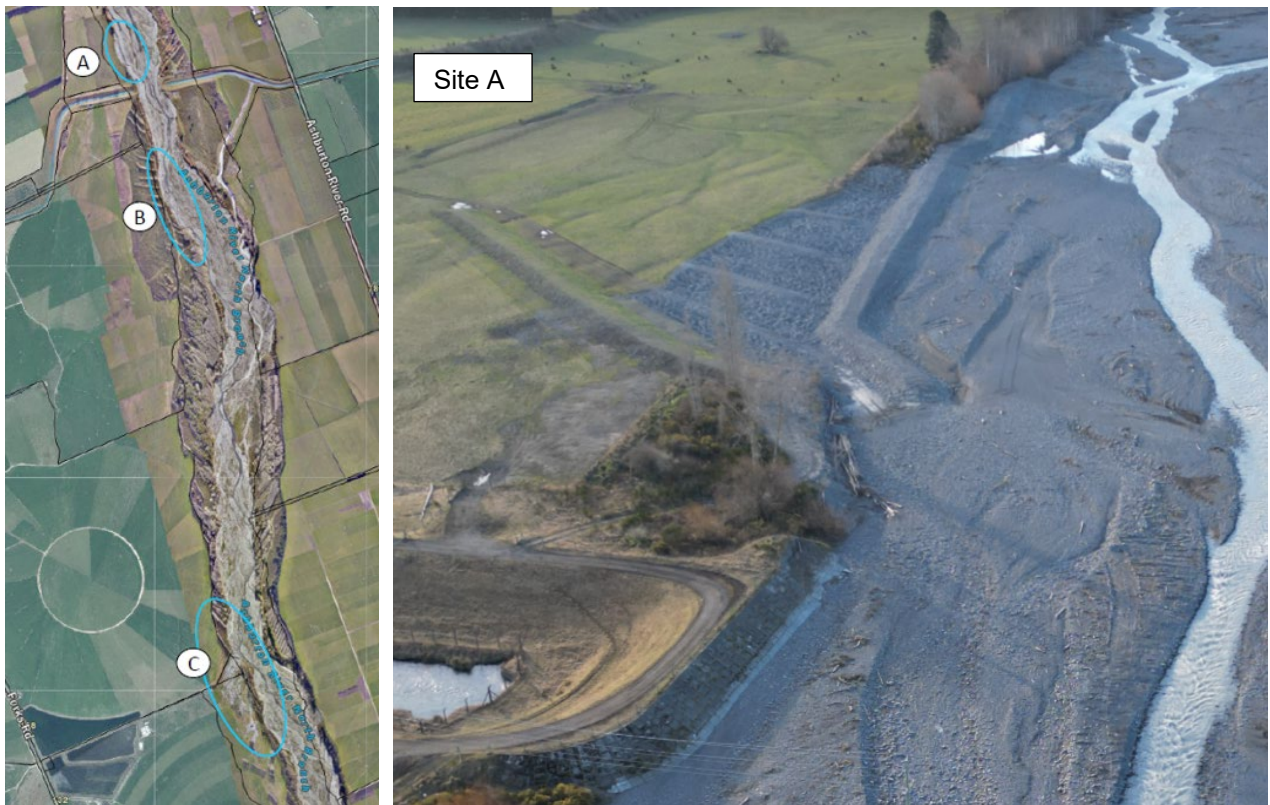
Figure B-6: Ashburton North at RDR, location of sites (left) and completed repairs at site A (right), 23 August 2023.

Repairs to three sites (A, B and C) with severe scour in the vicinity of the RDR on the Ashburton North Branch were completed. This included infilling the scour areas, creating erosion protection bunds and installing ATP along the river-edge bund. Infill pole planting was completed at each site. Again, as a result of the July 2023 high flows, there was some minor damage to the ATP and river-edge bunds at sites B and C, which has since been repaired. Refer to Figures B-6 to B-8.

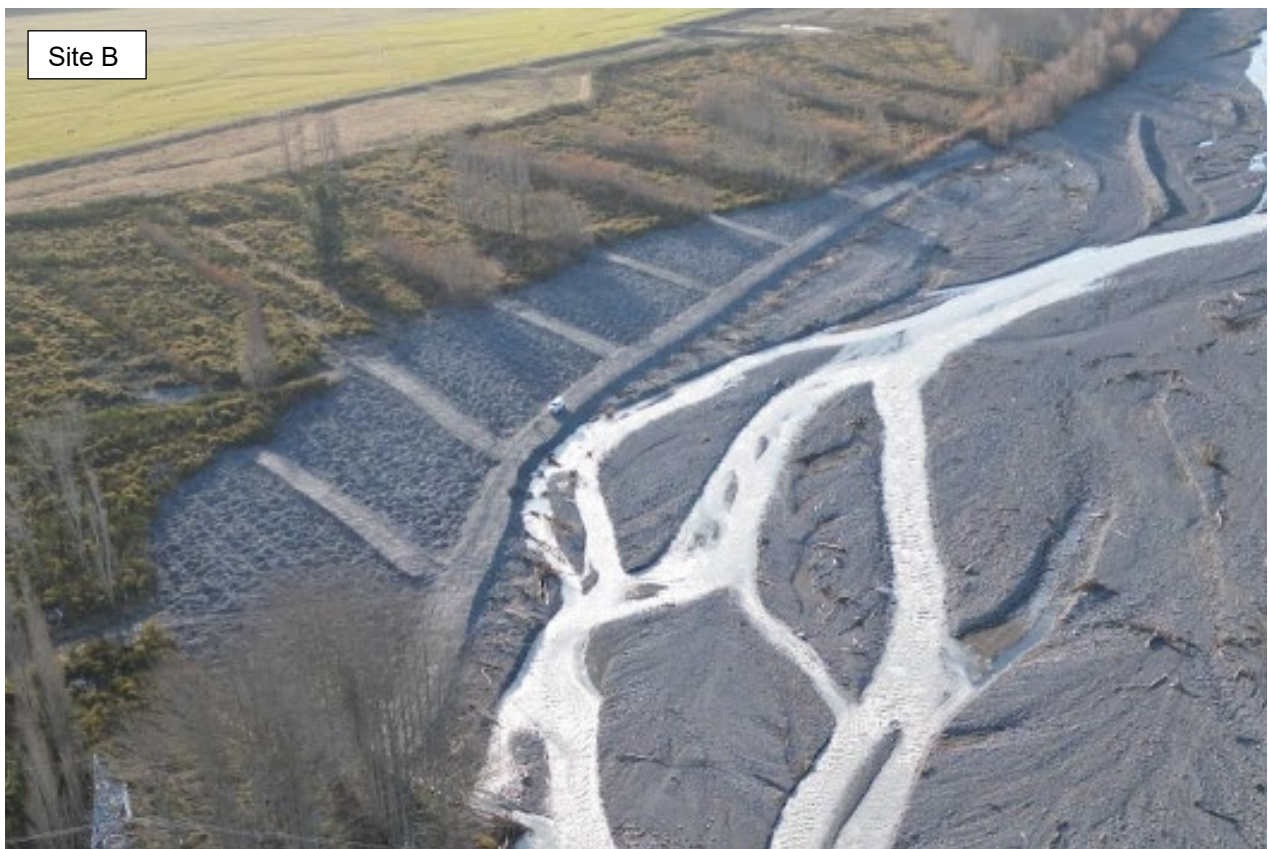
Figure B-7: Ashburton North at RDR, completed repairs at Site B, showing minor damage following July 2023 high flows (photos 23 August 2023).

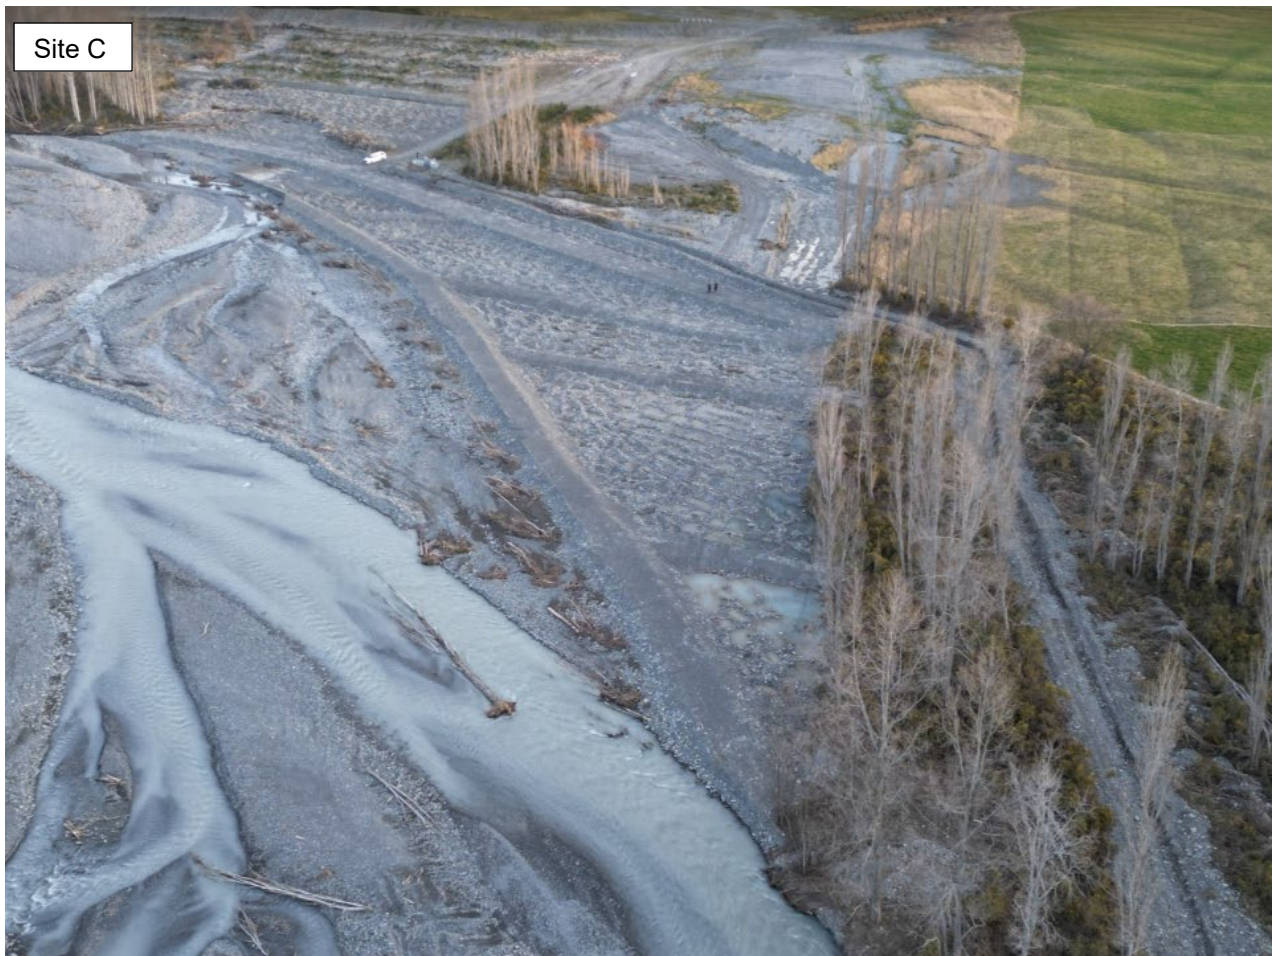
Figure B-8: Ashburton North at RDR, completed repairs at Site C, showing minor damage following July 2023 high flows (photos 23 August 2023).

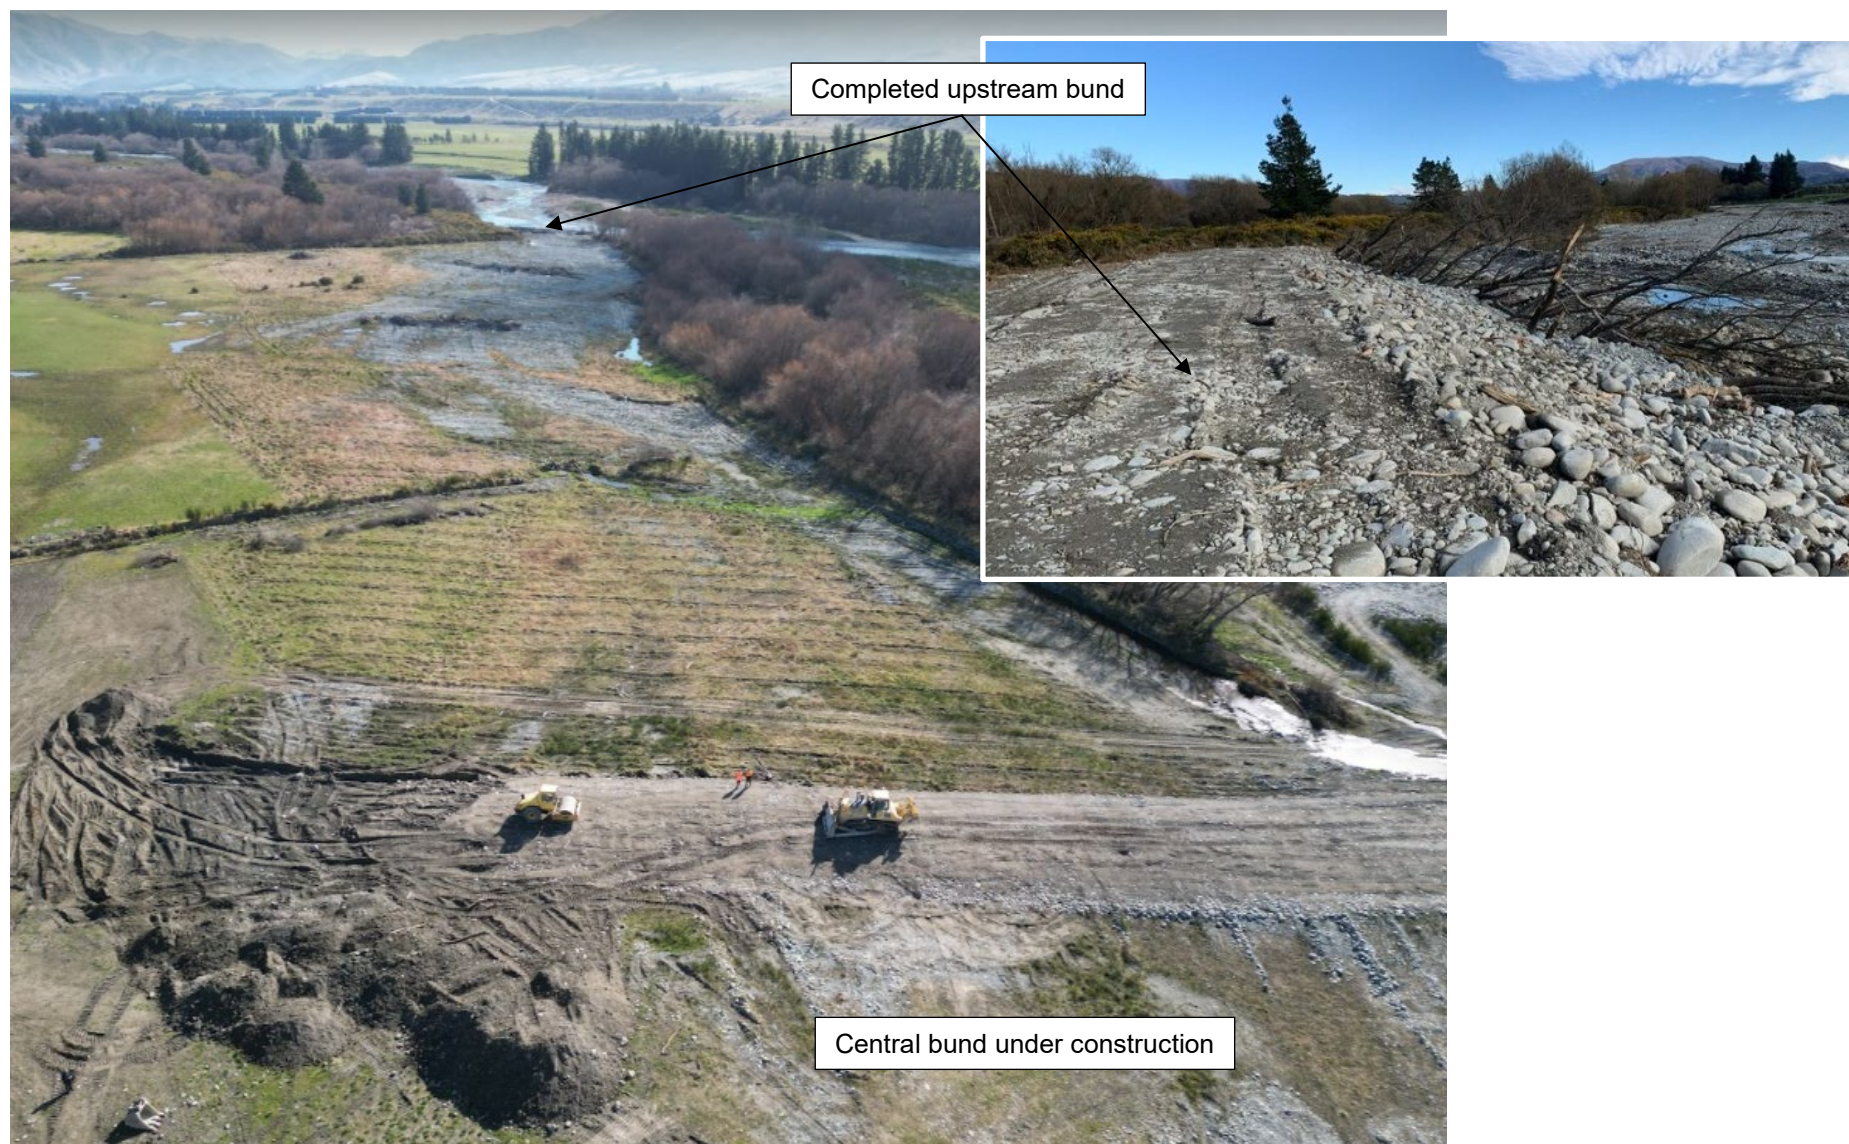
Figure B-10: Ashburton South at Mount Somers, central bund under construction (22 Aug 2023), with completed upstream bund with ATP (inset), early October 2023.

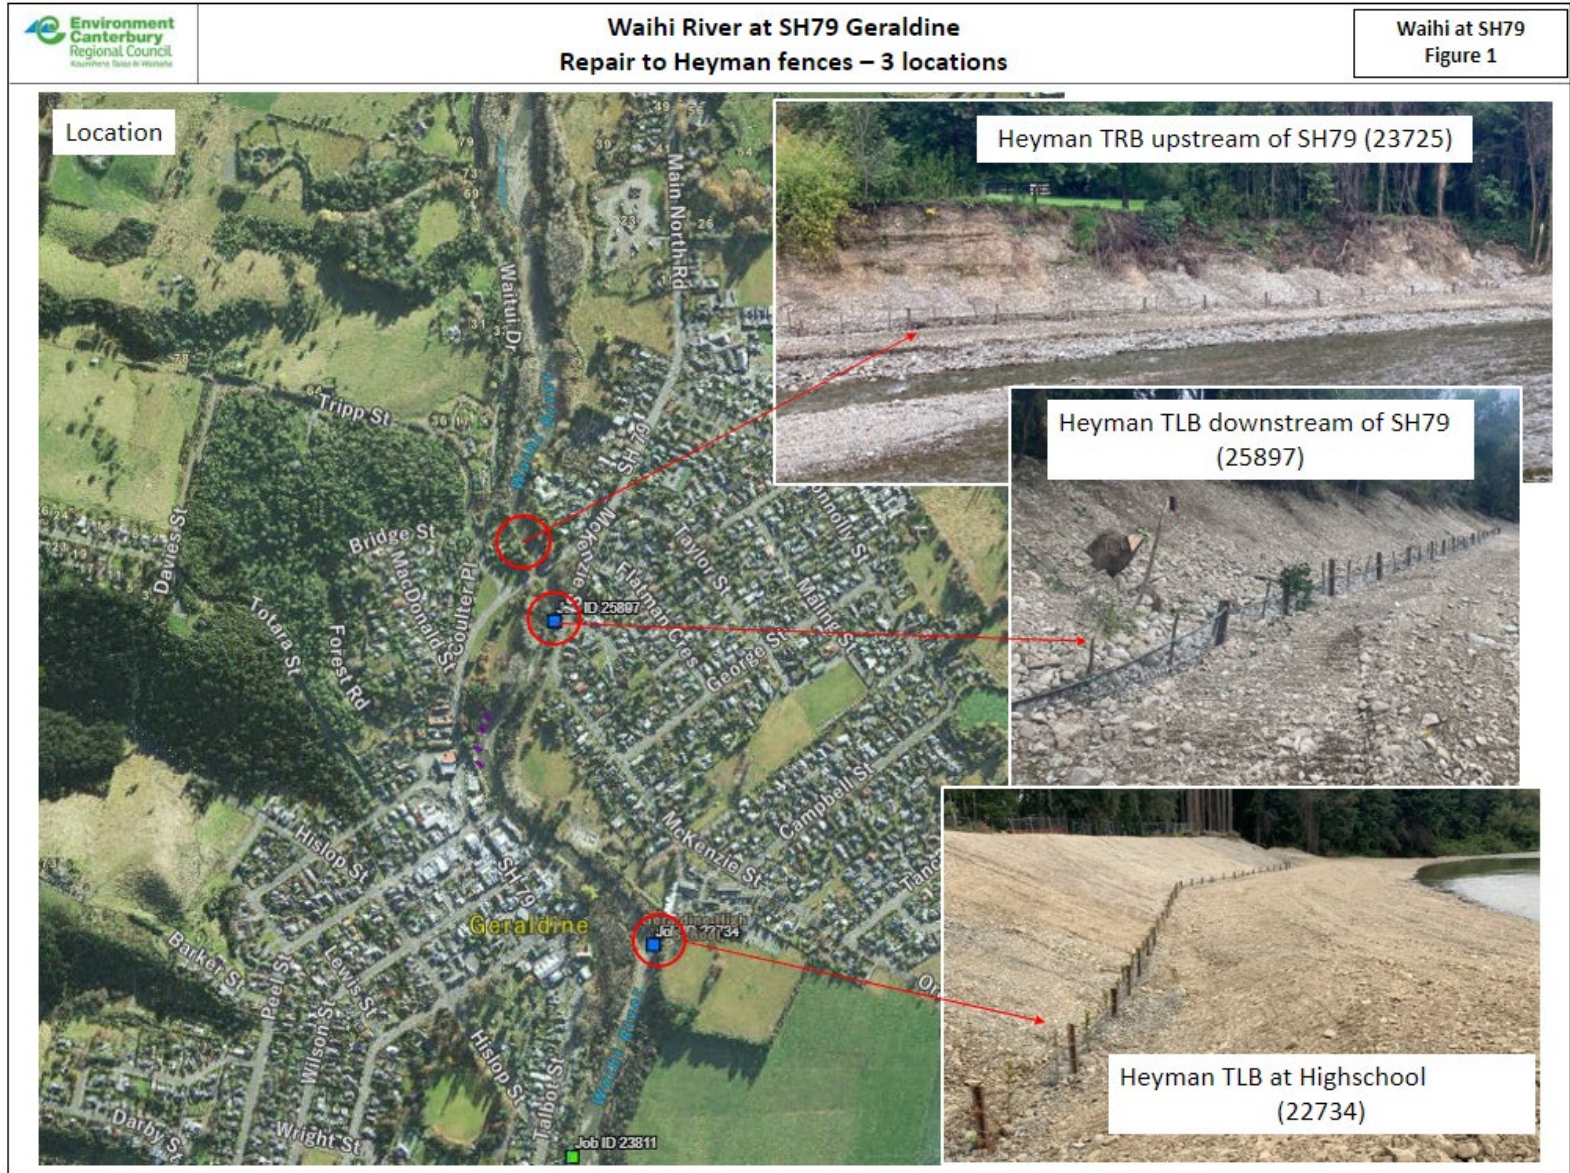
Figure C-7: Waihi at Geraldine, completed Heyman fences following 2021 flood damage.

Heyman fences were installed at three locations in Geraldine to repair 2021 flood scour (Figure C-7). Before the willow poles planted along the Heyman fences could grow sufficiently to provide adequate tree edge protection, high river flows in the winters of 2022 and 2023 scoured out the river rock infill from behind the Heyman fences (Figures C-8 to C-10). More robust repair solutions have been designed that include the installation of stub rock groynes at the central and lower site in conjunction with backfilling with river rock behind the Heyman fences. Infilling with larger rock as well as river rock is proposed for the upper site. These repairs are planned to be implemented over the summer or 2023-24.

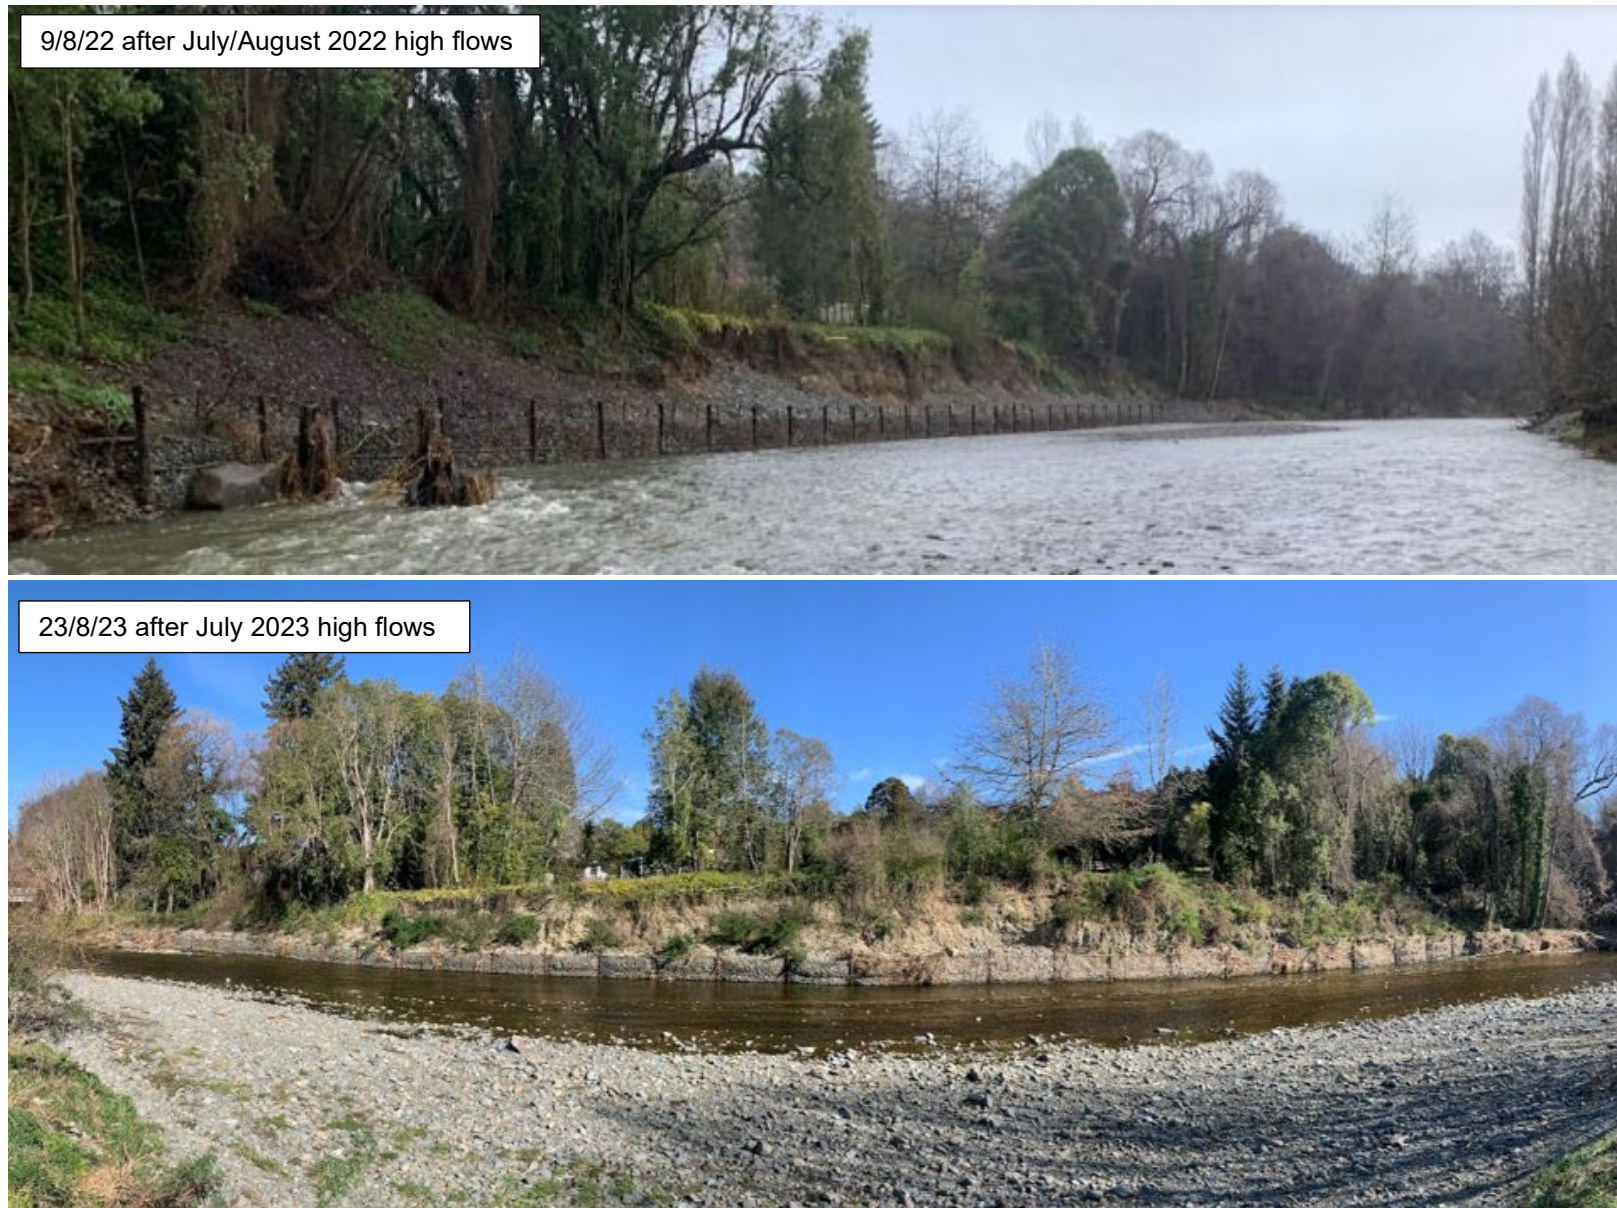
Figure C-8: Waihi at Geraldine upstream of SH79 showing damage-on-damage scour due to winter high flows in 2022 and 2023.

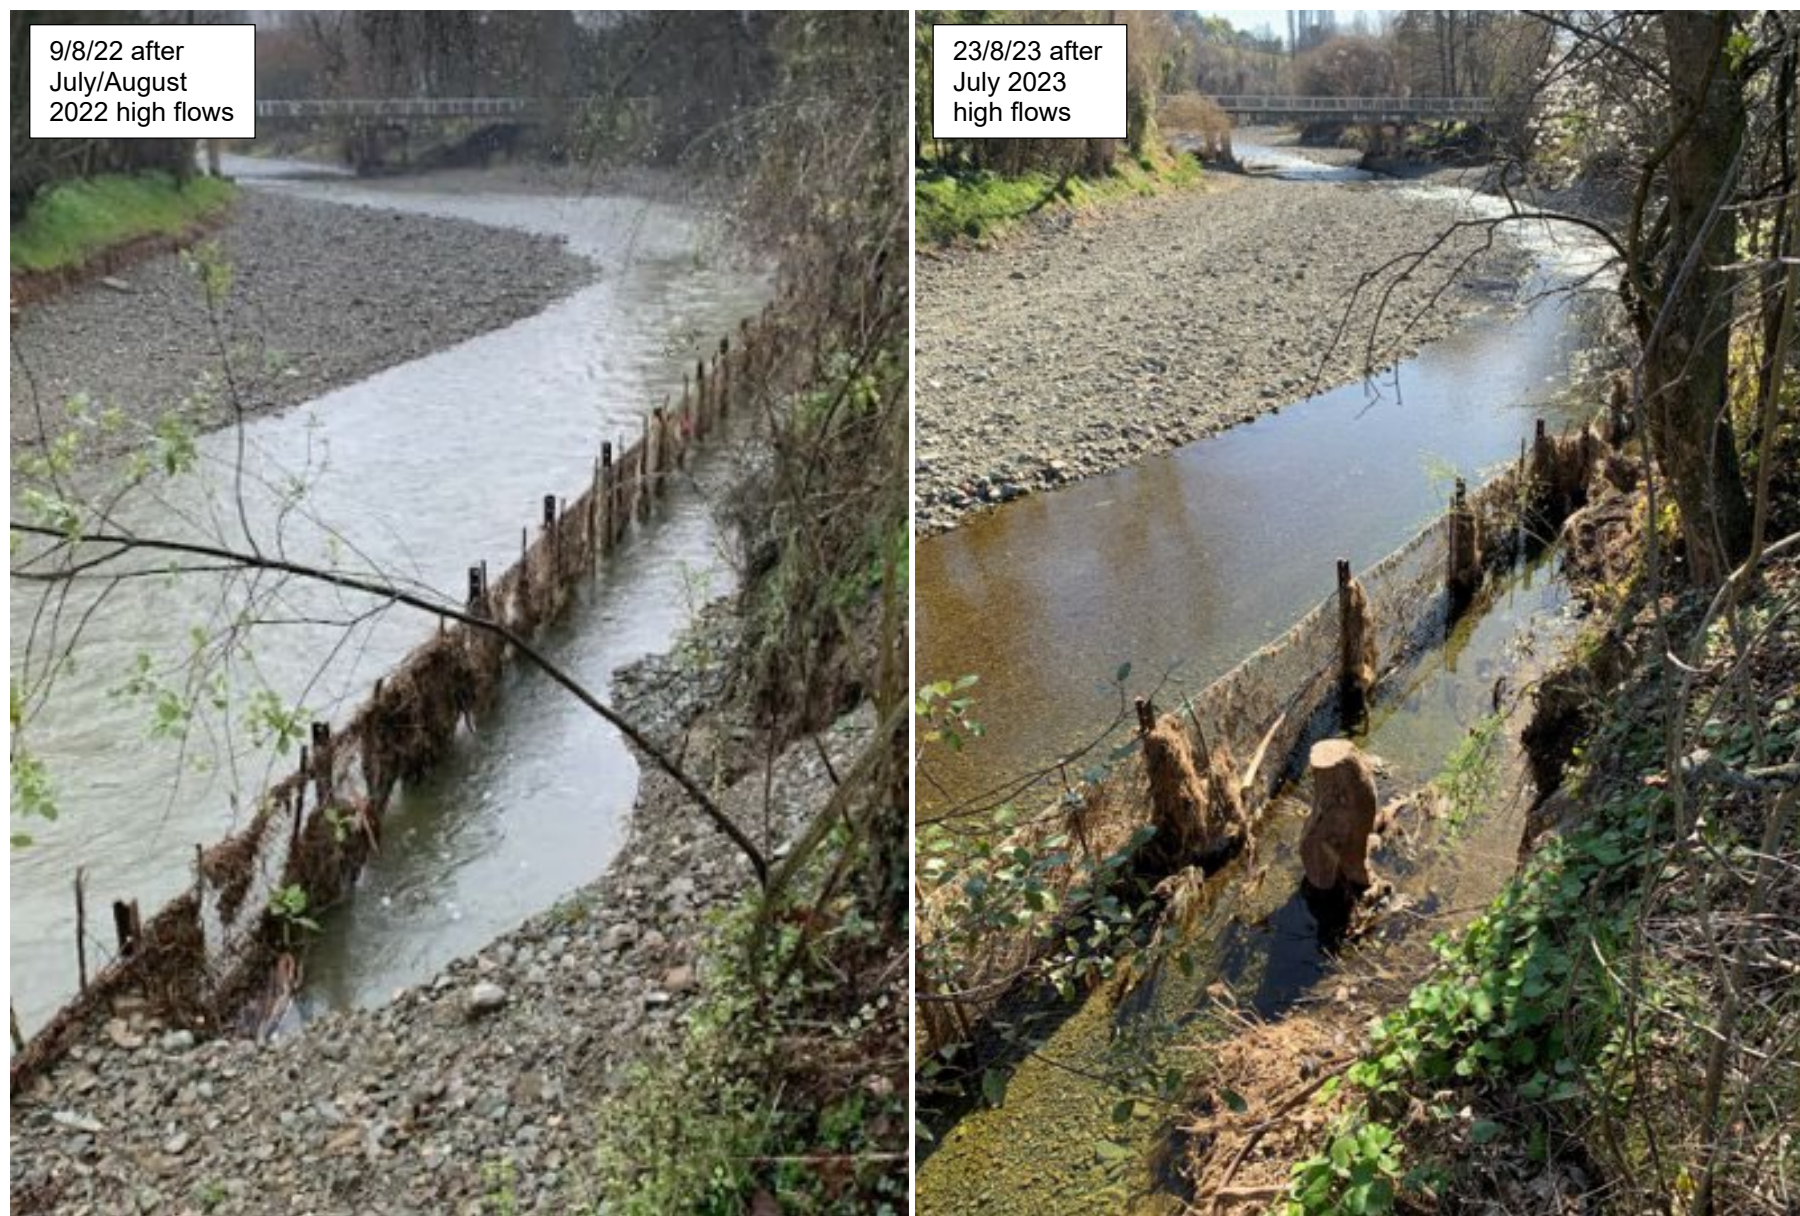
Figure C-9: Waihi at Geraldine, Heyman fence downstream of SH79 showing damage-on-damage due to winter high flows in 2022 and 2023.

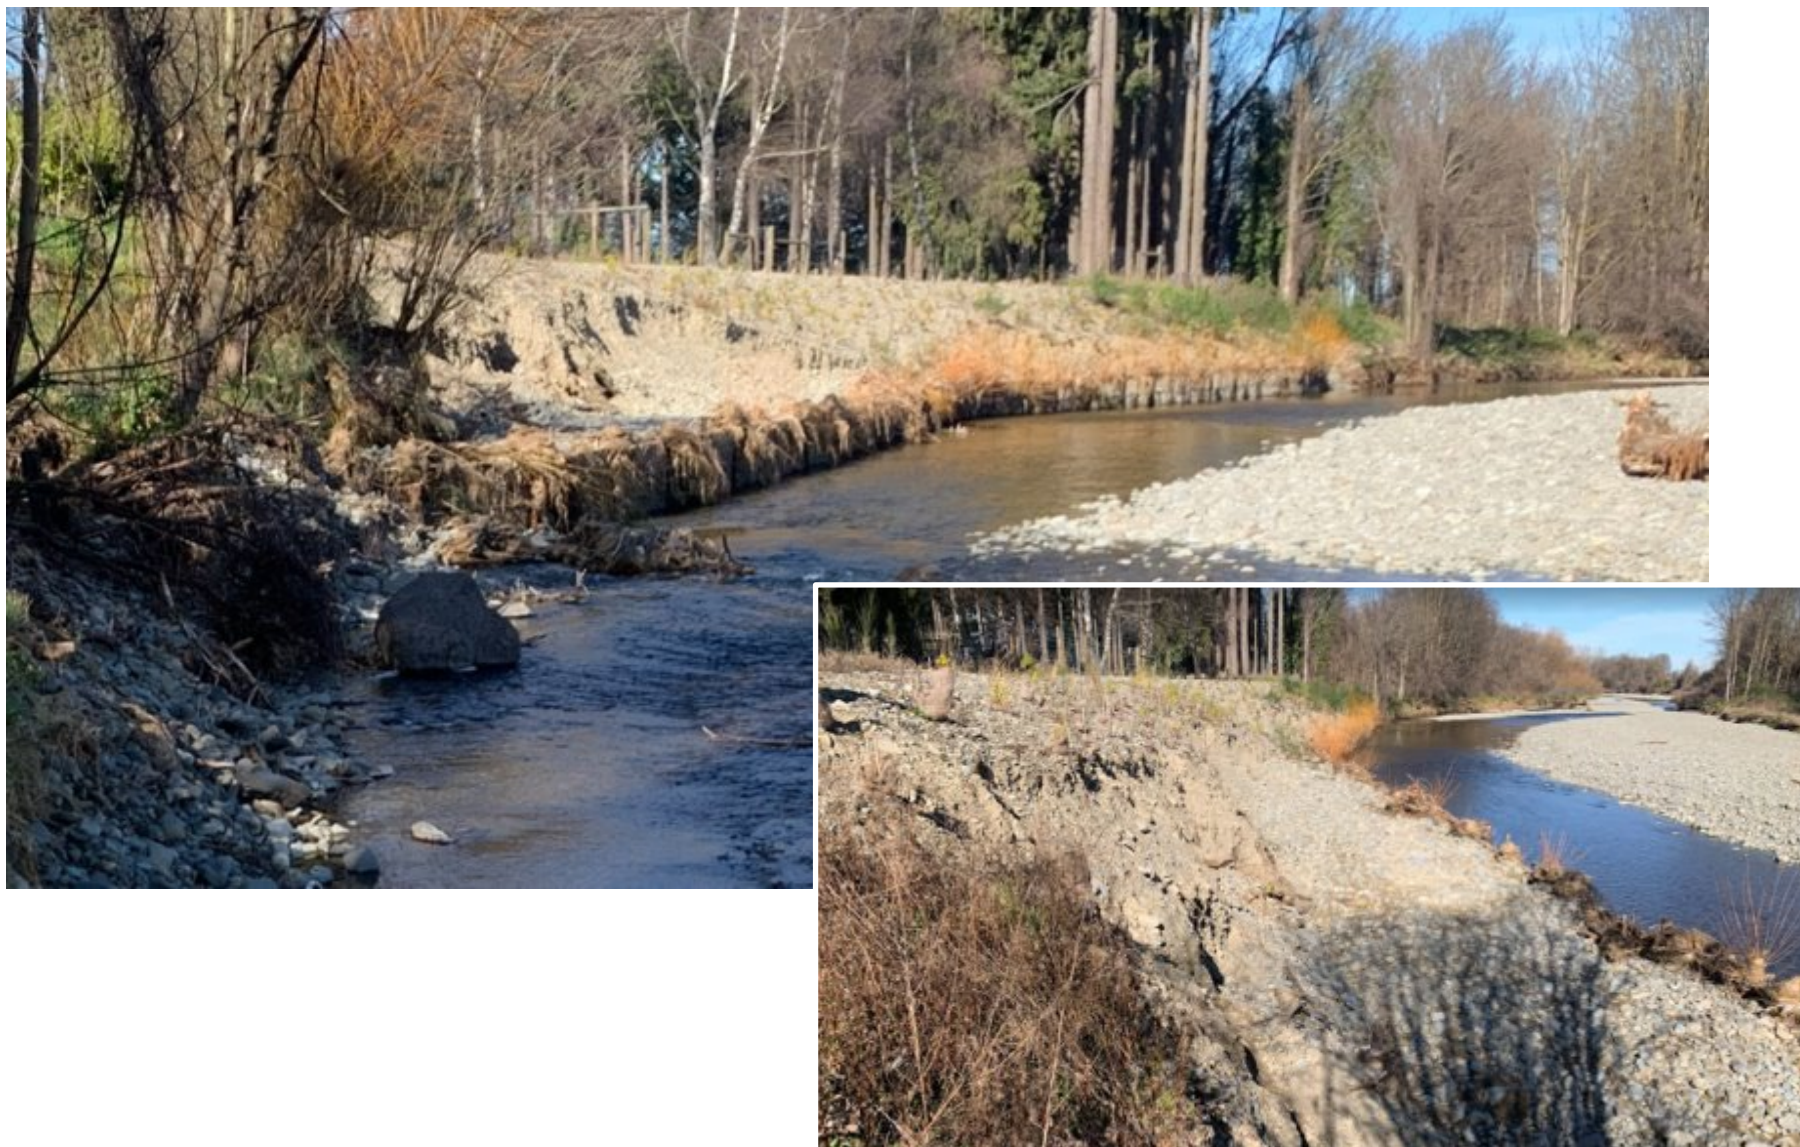
Figure C-10: Waihi at Geraldine High School, Heyman fence at showing damage-on-damage due to winter 2023 high flows.

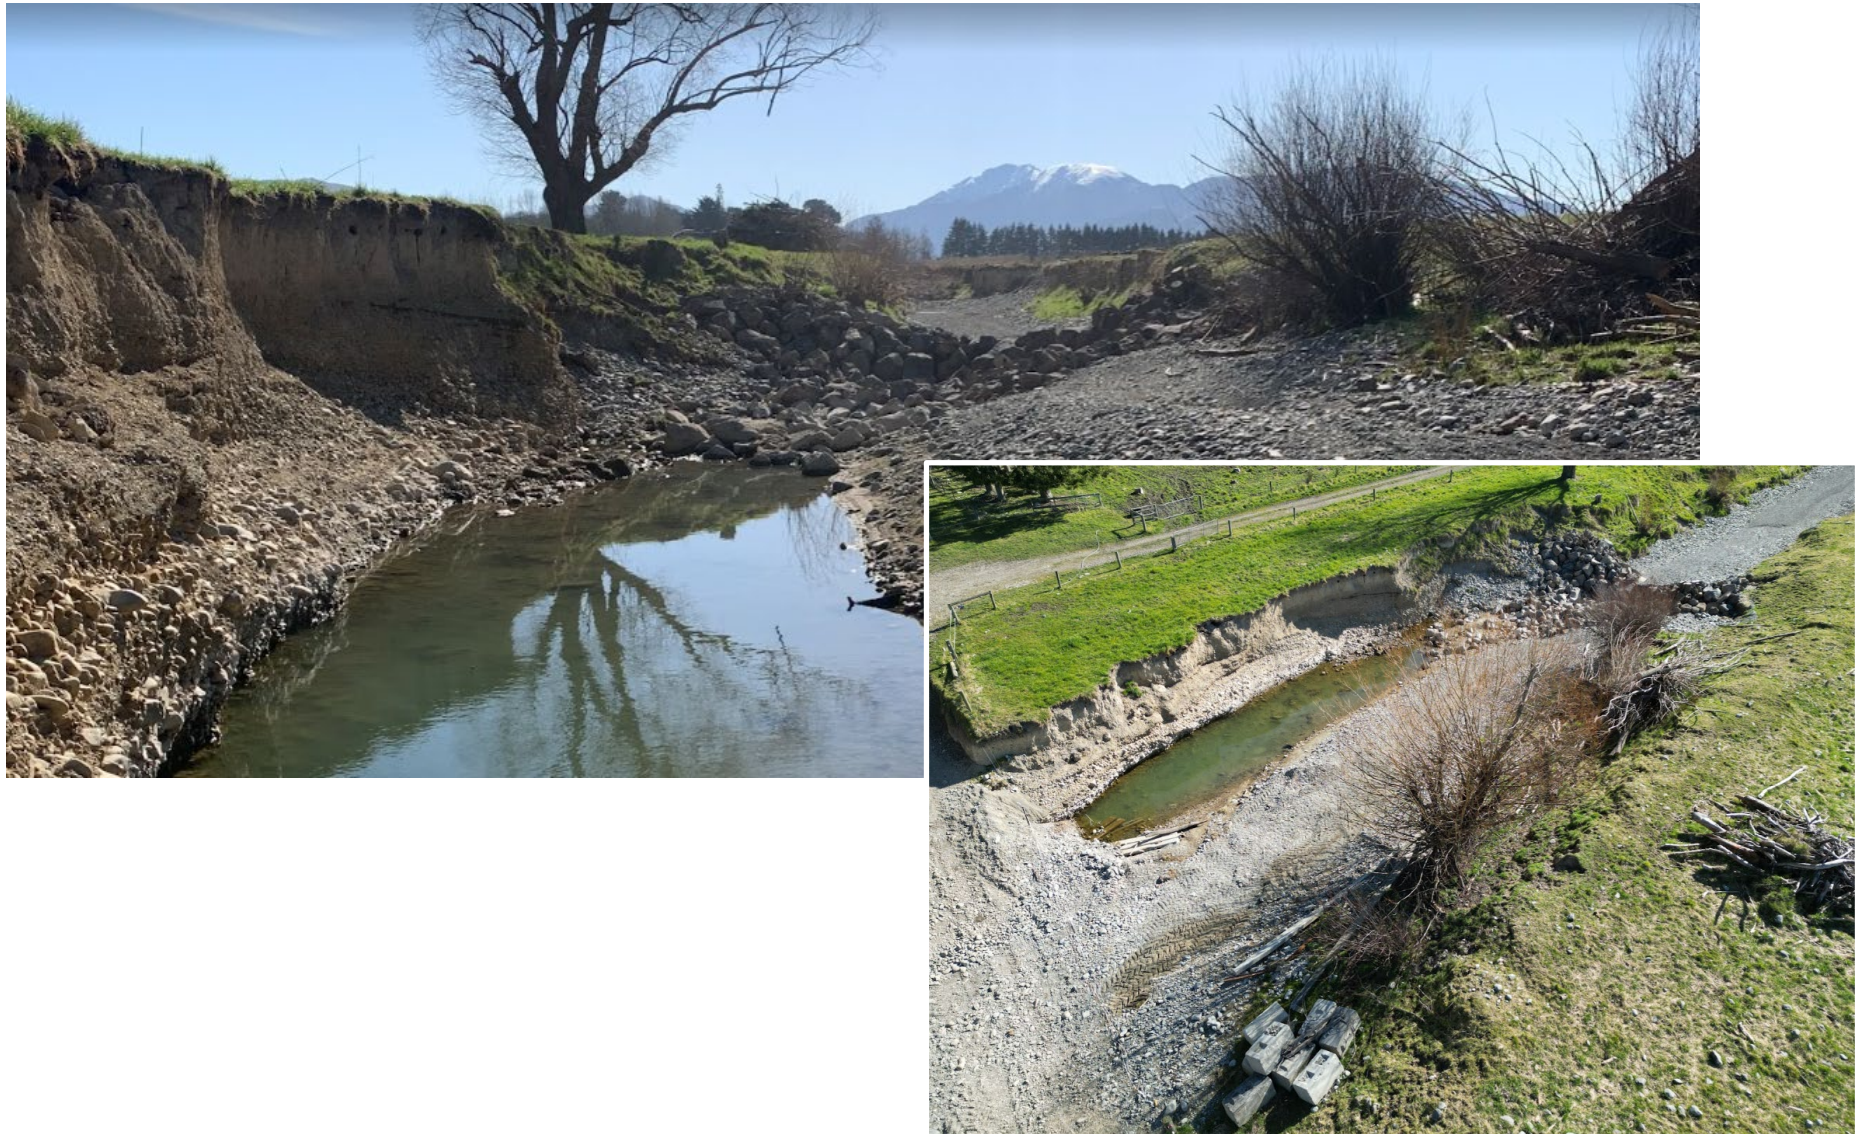
Repairs on Sweetwater Creek completed in June 2023, fared well in the 2023 high flows except for extensive scour downstream of weir 6 and minor scour downstream of weir 7 (see Figure B-13). The damage to weir 6 is illustrated in Figure C-11. Mitigation works are currently being designed to be implemented over the summer of 2023-24.

Figure C-11: Sweetwater Creek, weir 6 requiring mitigation following damage-on-damage due to winter 2023 high flows.
