# **Canterbury 2021 Flood Recovery Update 8**

October-December 2023

Ken Tarboton (Aqueus Consulting)  
Shaun McCracken (Environment Canterbury)

26 January 2024

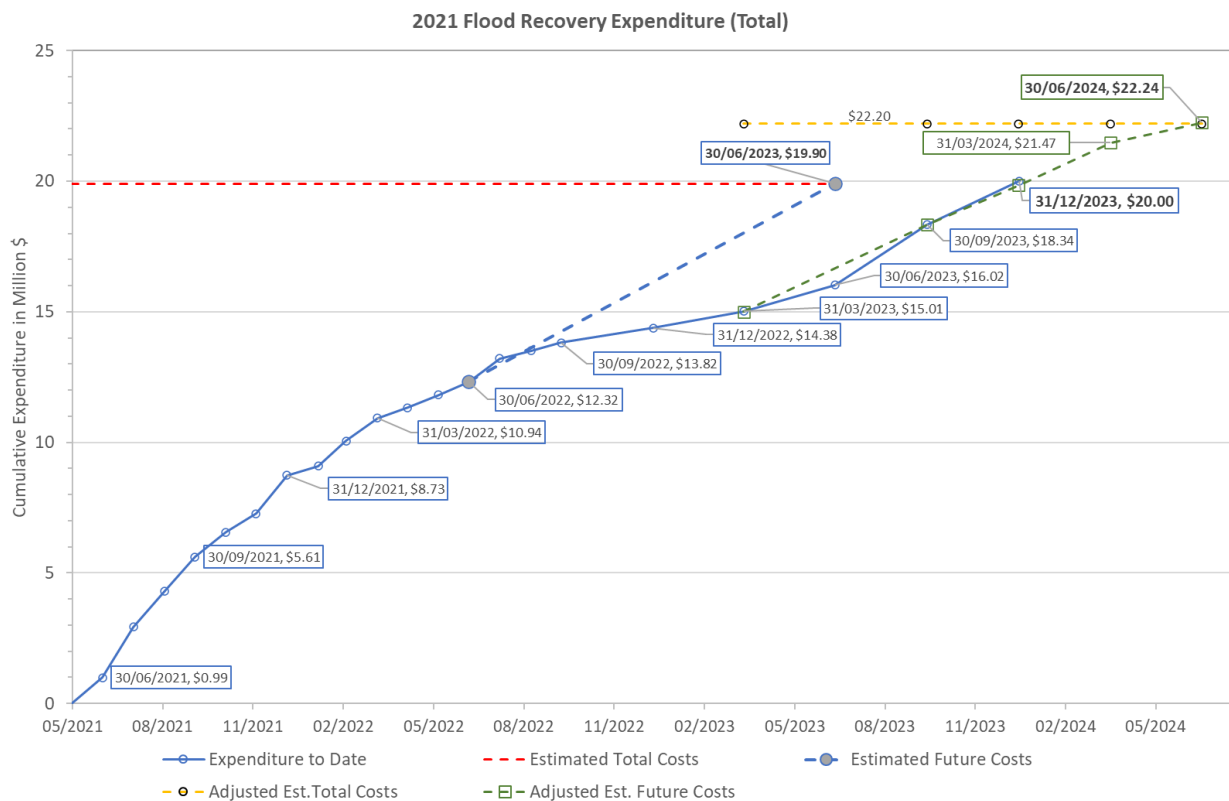
Figure 4-1 below shows the 2021 flood recovery expenditure profile to date as well as the forecast expenditure through to the end of the project. The rate of spending in the October to December quarter matched very closely the projected costs (Figure 4-1).

**Figure 4-1: 2021 flood recovery expenditure profile.**

Forecast flood recovery expenditure by quarter, including physical works, pole planting and other costs (contingency, design, staff, plant etc) are shown in Table 4-3 which feeds into the forecast expenditure graphic in Figure 4-1.

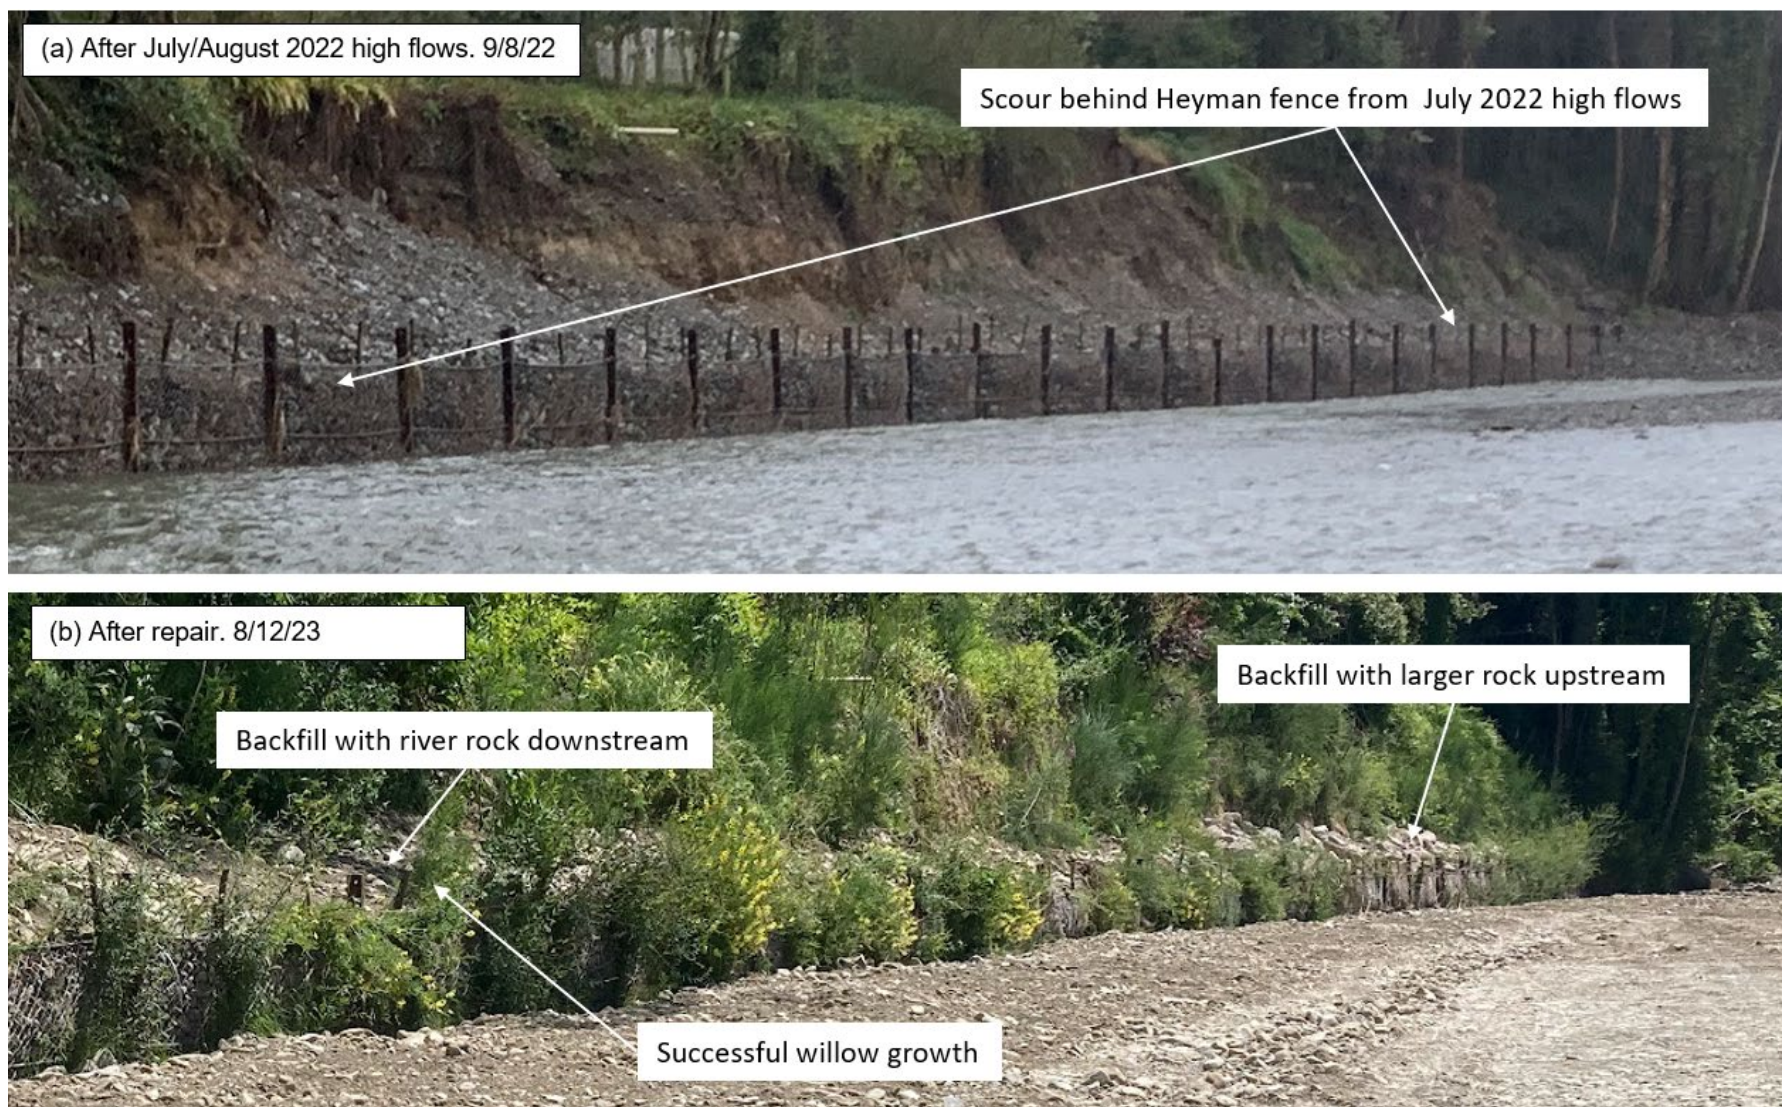
**Figure A-1: Waihi at Geraldine, Heyman fence on left bank upstream of SH79, (a) before and (b) after repair.**

At the site on the right bank directly upstream of the SH79 bridge, repairs included bringing in larger rock to fill behind the Heyman fence at the upstream edge, while river stone was used in areas where washout was not as pronounced. Good growth of the willow poles in the Heyman fence was noted (Figure A-1).

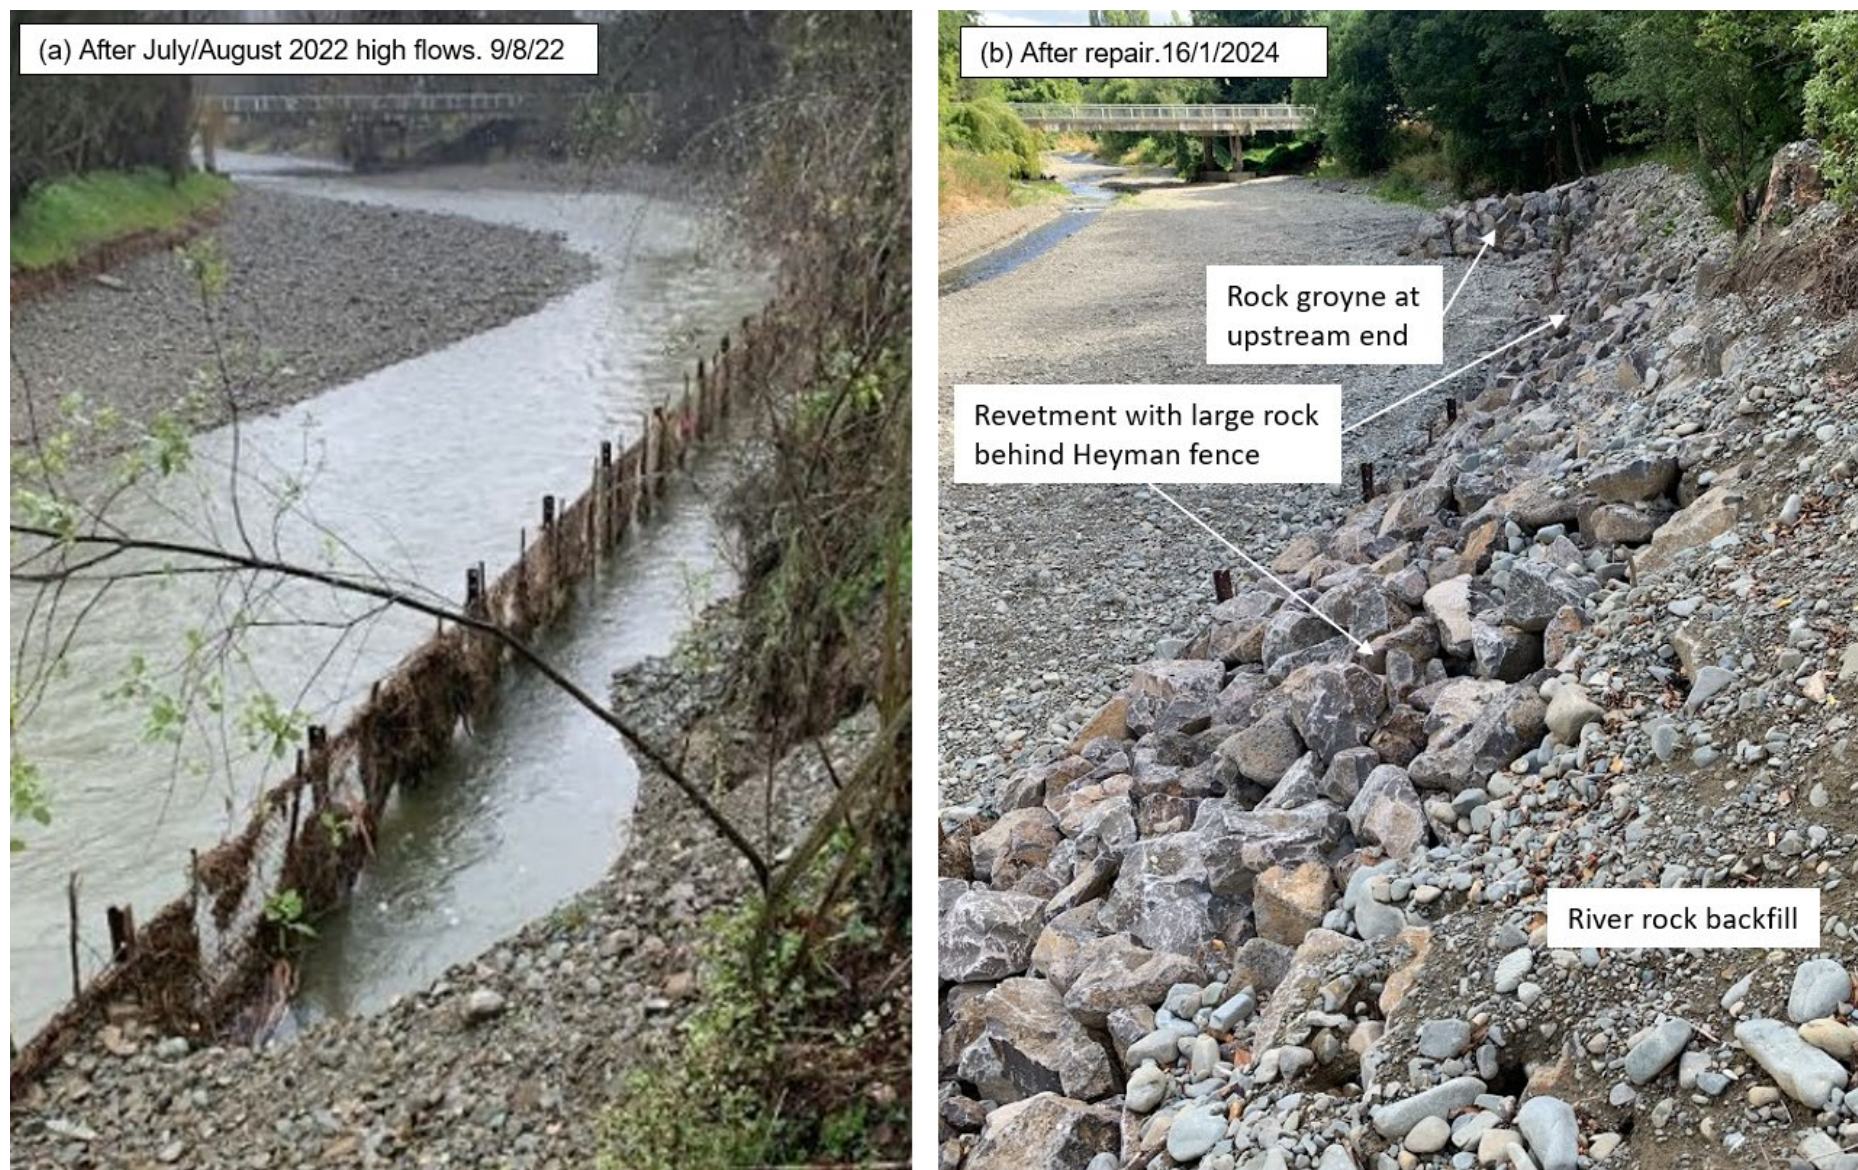
Figure A-2: Waihi at Geraldine, Heyman fence on left bank downstream of SH79, (a) before and (b) after repair.

The site on the left bank downstream of the SH79 bridge was more severely scoured with the bank supporting a footpath and road at risk of collapse. Repair included backfilling with river rock overlaid with a revetment of large rock. A groyne was also constructed at the upstream end of the Heyman fence (Figure A-2).

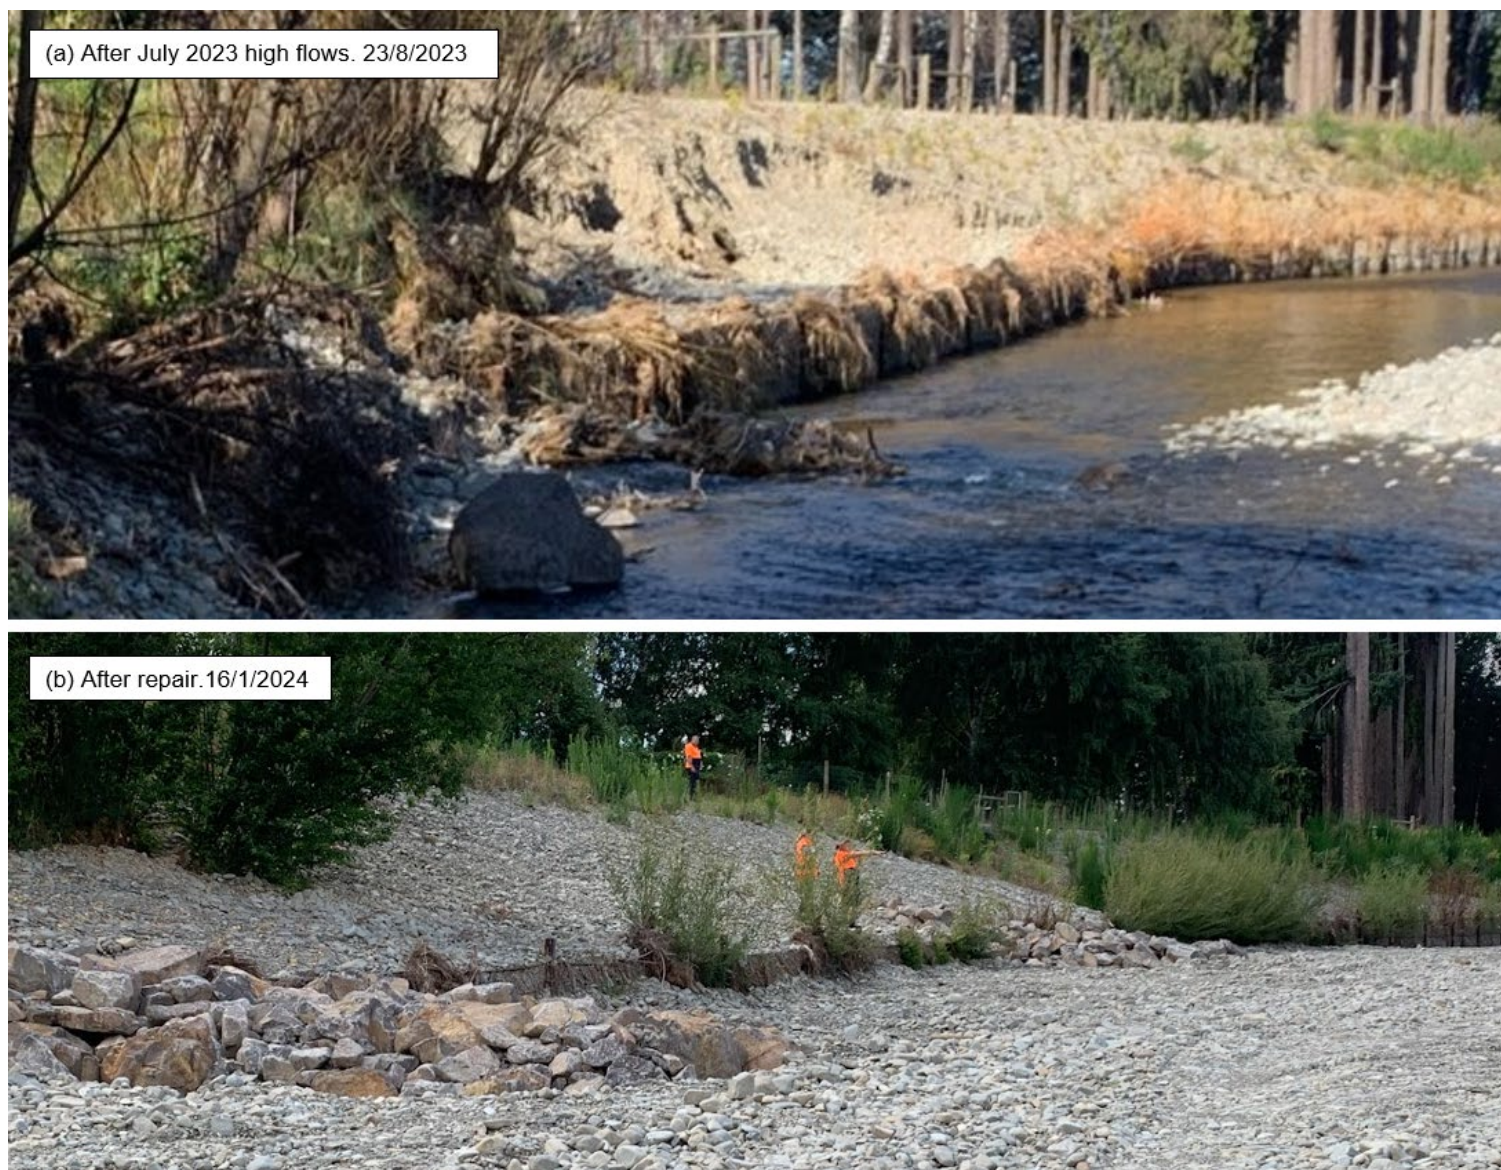
**Figure A-3: Waihi River at Geraldine, Heyman fence on left bank at Geraldine High School, (a) before and (b) after repair.**

At the site further downstream on the left bank at Geraldine High School, scour behind the Heyman fence was backfilled with river stone. Groynes of large rock were constructed abutting out from the Heyman fence to reduce scour in future (Figure A3).

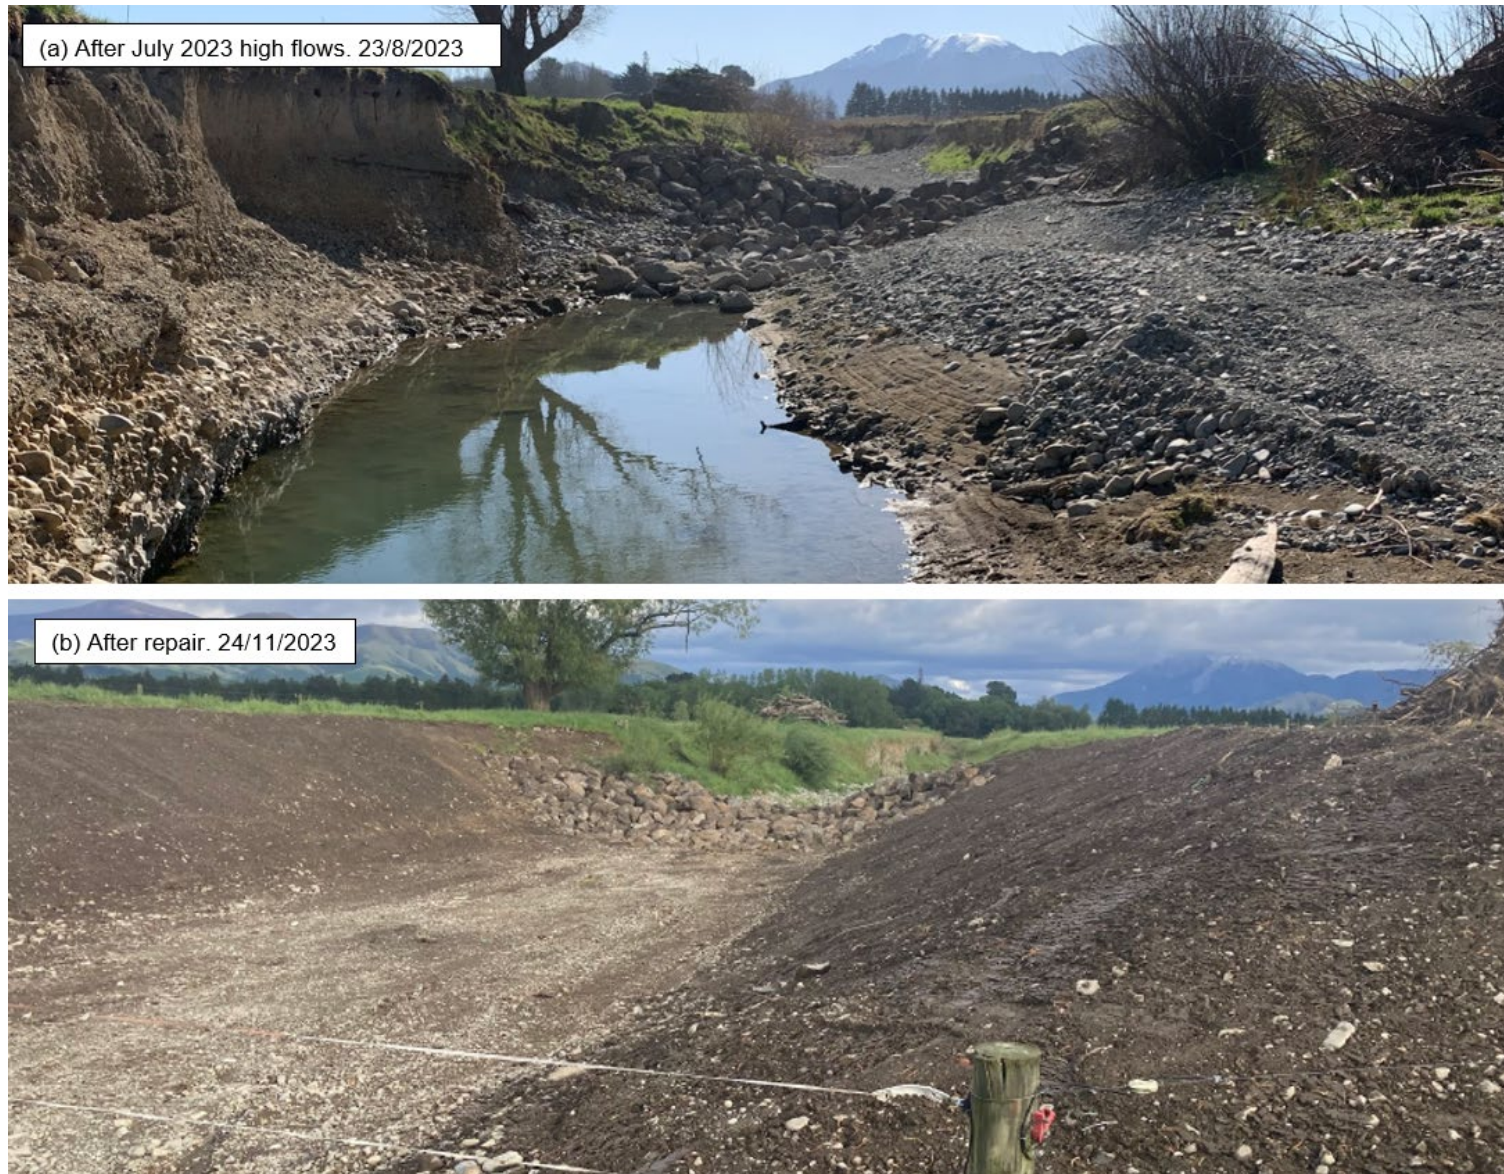
**Figure A-4: Sweetwater Creek rock weir, (a) following 2023 high flow, and (b) after repair.**

Repairs to the rock weirs on Sweetwater Creek were previously reported (Update 7) including the damage-on-damage to one of the weirs. During this period scour downstream of the damaged weir was repaired with additional rock on the weir apron and shaping of the banks downstream of the weir (Figure A4).

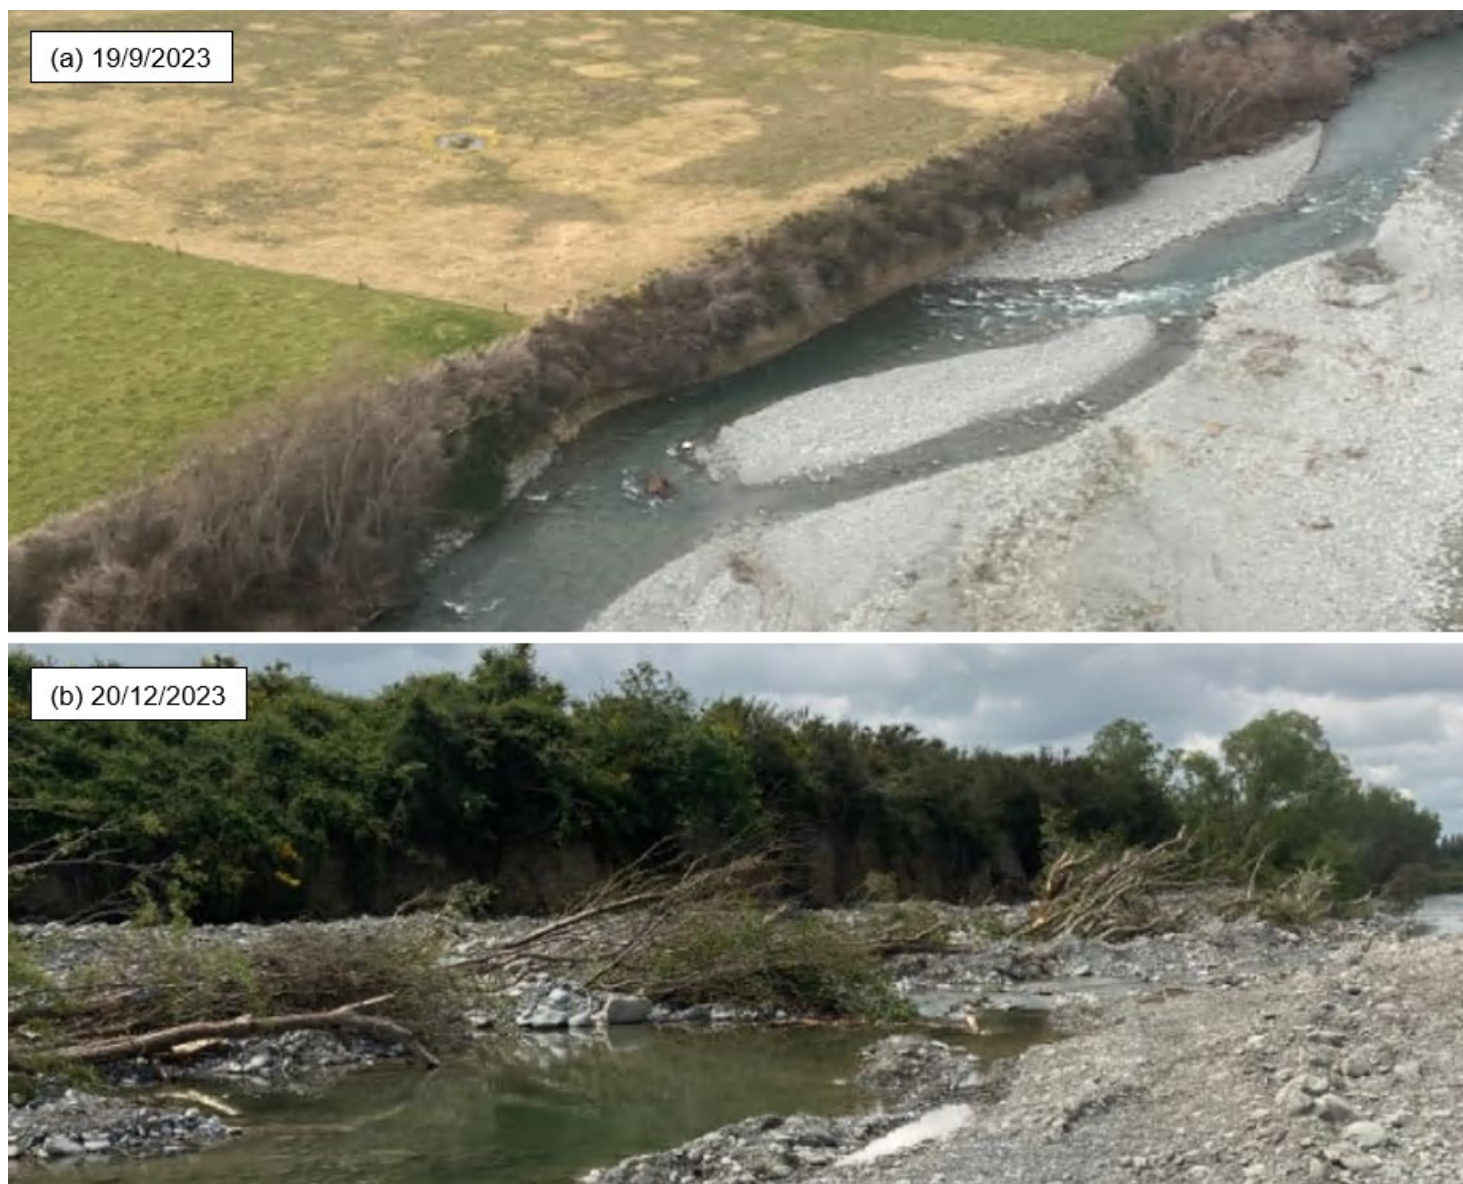
**Figure A-5: Ashburton River South Branch at Mount Somers, (a) prior to repair, and (b) after repair.**

Two high eroded vertical faces on the true left bank of the Ashburton South Branch at Mount Somers were repaired during this period. This involved river diversion and installation of anchored tree protection along the steep scour face to replace washed out tree edge protection (Figure A5).

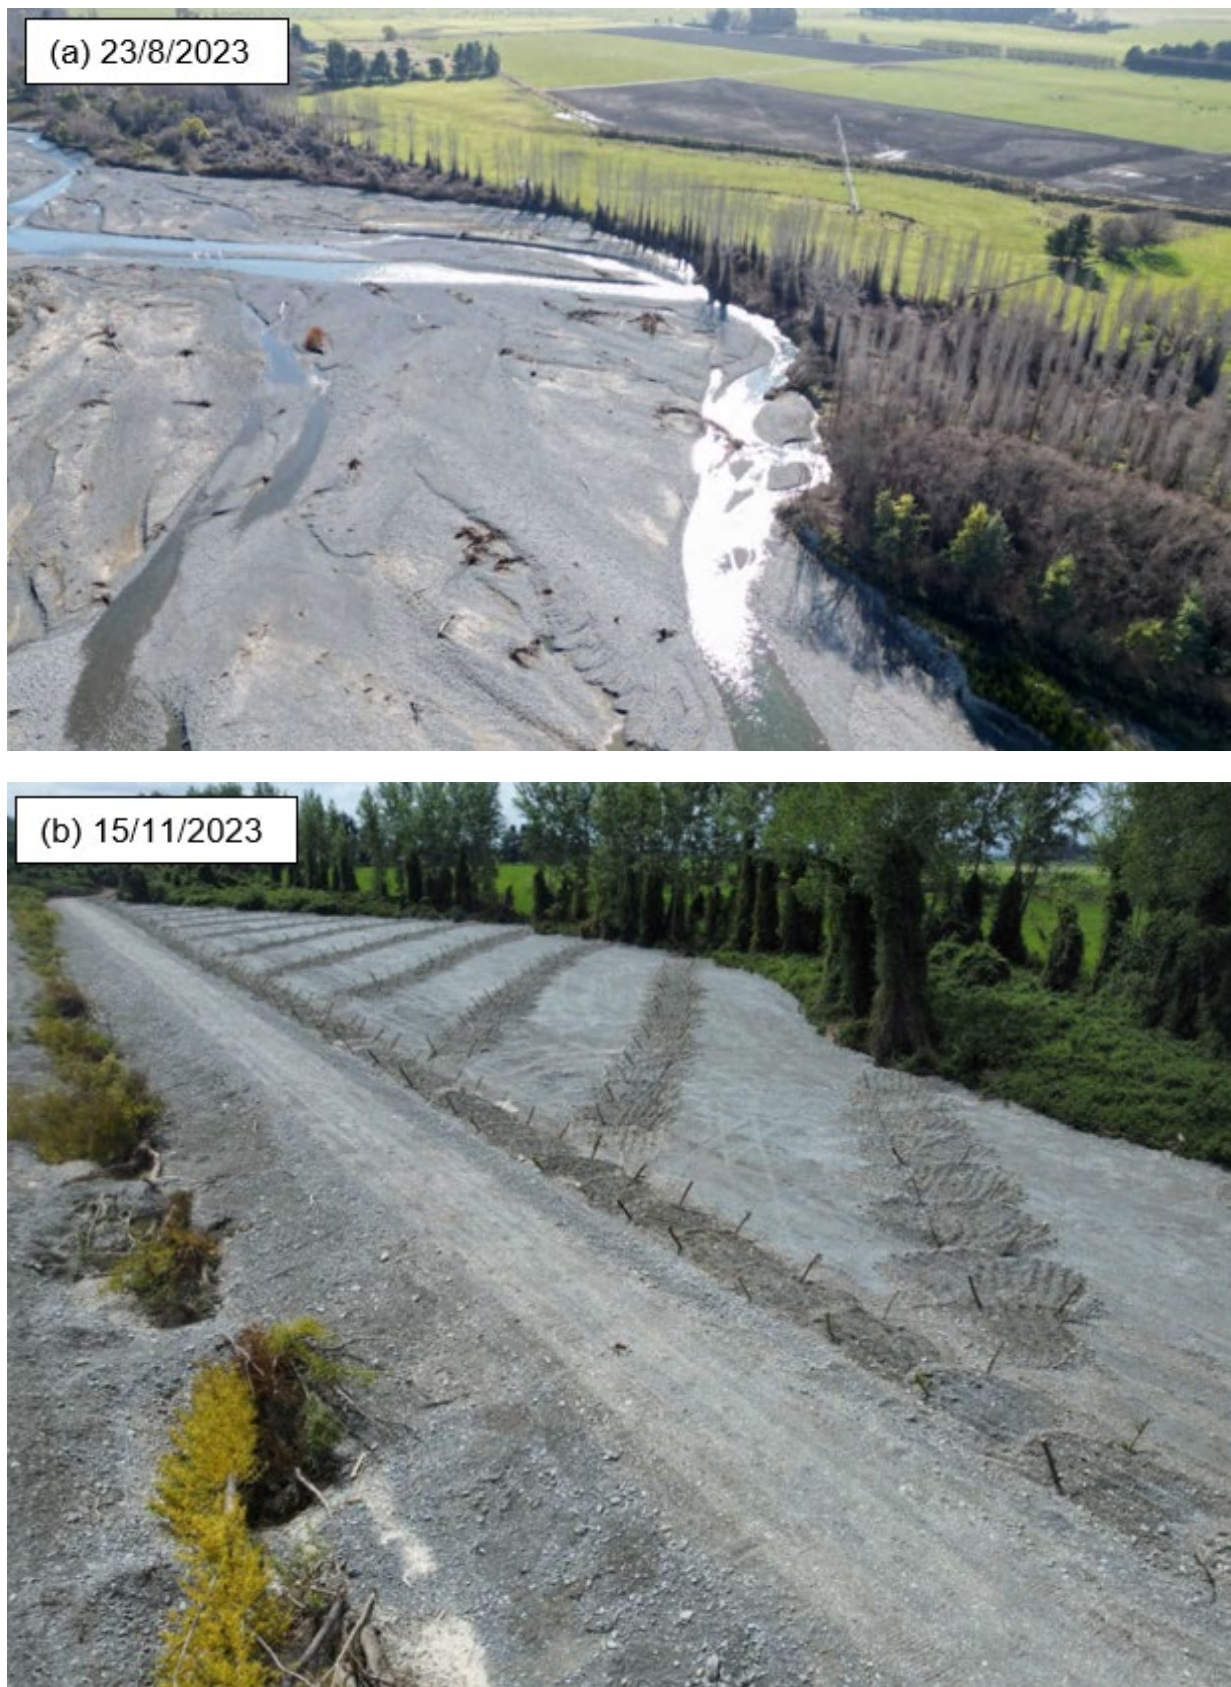
**Figure A-7: Orari River at Taylors Road TLB (a) following flood damage in 2021 exacerbated in 2022 and 2023 and (b) after repair in 2023.**

Challenges on the Orari River in the vicinity of Taylor Road were reported previously in Report Update 6 and these included the narrowing of the riverbed in this area and previous repairs undertaken in May 2022 that were completely washed away in the winter 2022 high flows. A more robust repair design was reported in Report Update 7. These repairs have now been completed (Figure A-7). They included reinstating washed out tree edge protection further inland to give the river more room.

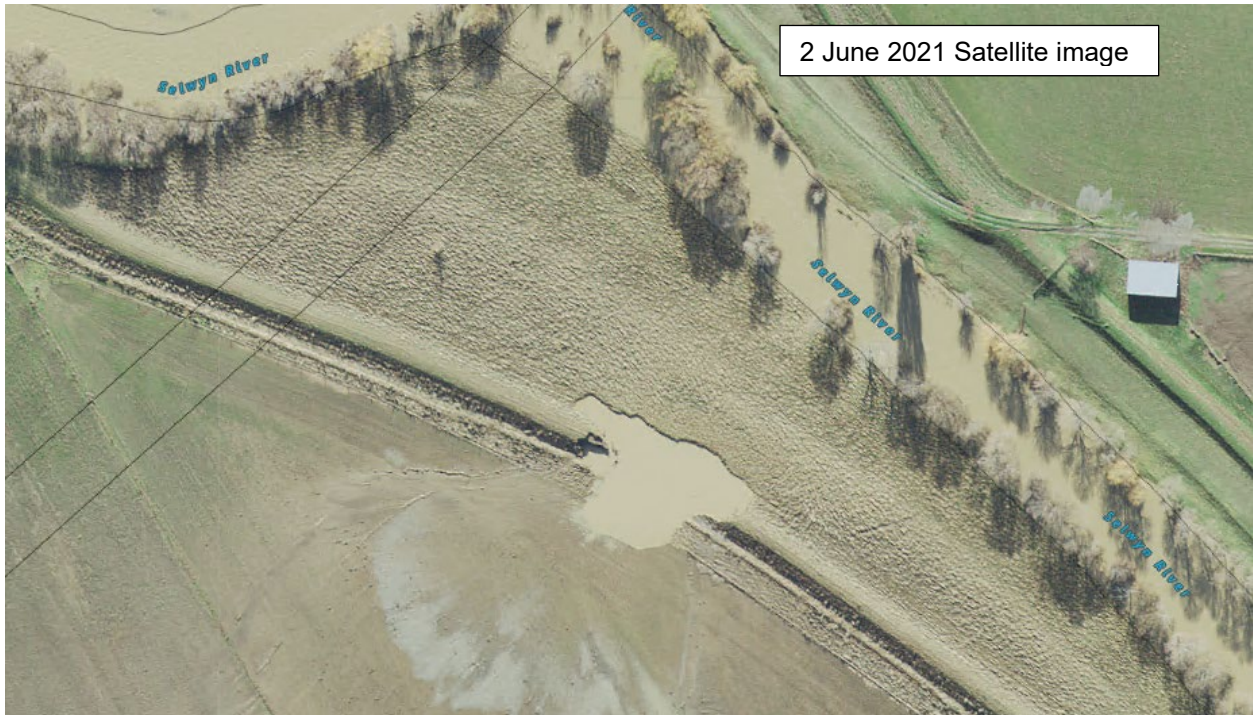
A 70m breach occurred in the lower Selwyn River right bank in the 2021 flood (Figure A-8). This was initially repaired in early 2022 (Figure A-9), however seepage was detected in the high flows of July/August 2022 and the stopbank failed again in the high flows of July 2023 (Figure A-10). A temporary flood barrier was installed following the 2023 breach. The temporary flood barrier remains in place while further investigation, design and landowner consultation is underway. Costs for the temporary barrier, the detailed investigation and the estimated cost of a significant stopbank rebuild at this location have increased the overall 2021 flood damage cost estimate. Repair is expected to be undertaken by once landowner access agreement is in place.

**Figure A-8: Selwyn River stopbank breach immediately after 2021 flood.**

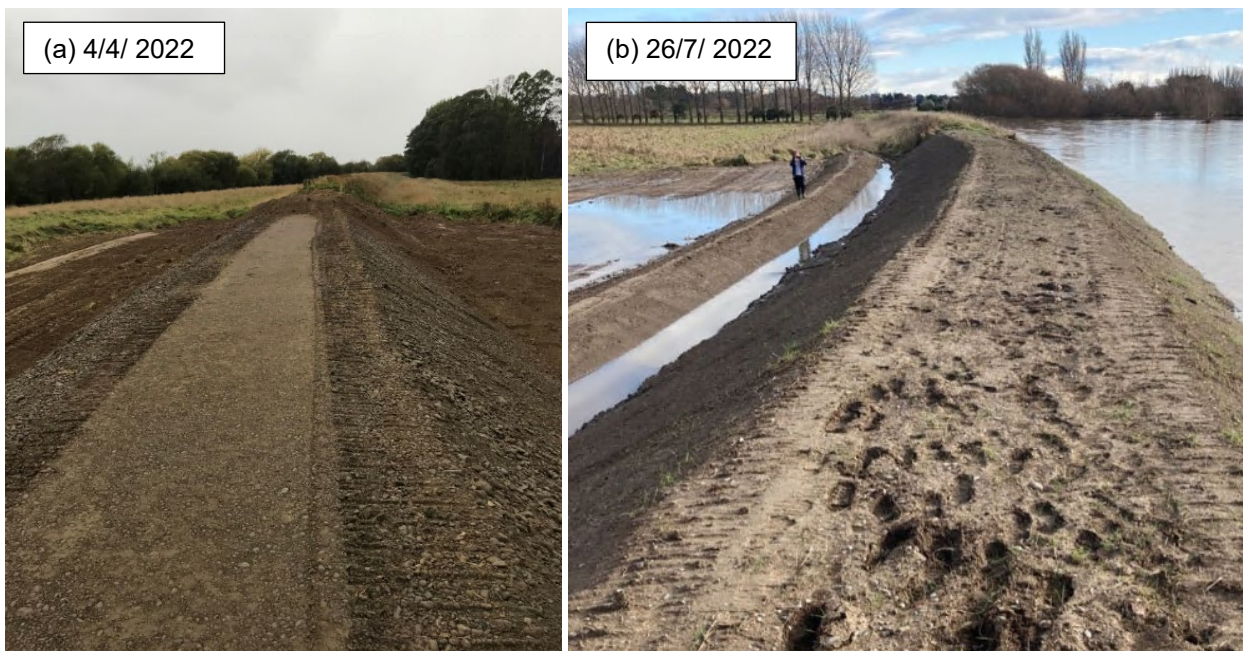
**Figure A-9: Selwyn River stopbank following initial stopbank repair (a) April and (b) July 2022.**

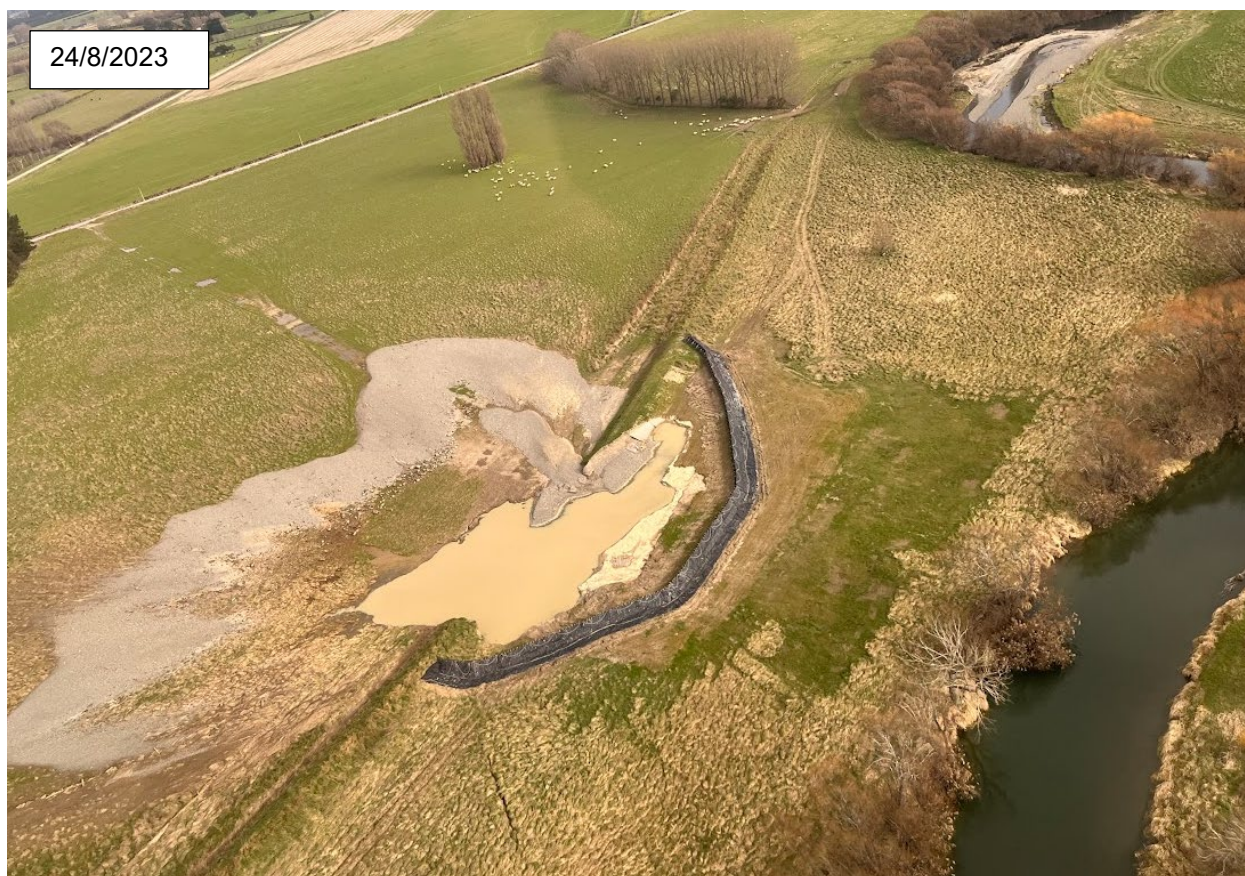
**Figure A-10: Selwyn River failure of stopbank and temporary flood barrier. 24/8/2023.**
