The Wireless

July 2025

Mat-Matics #120: Astron RS-35M Repair and Modifications

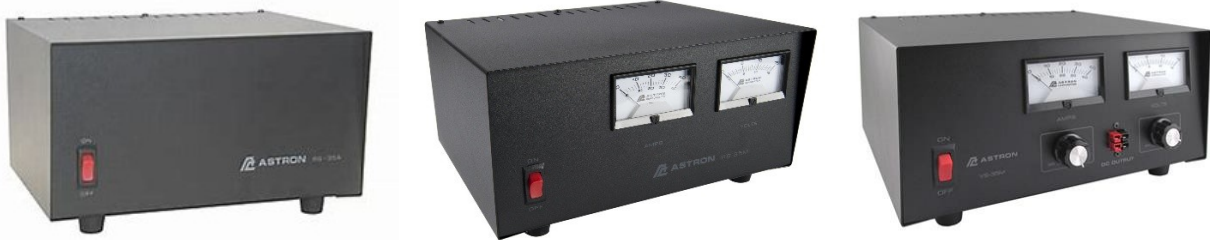
RS-25A, RS-35M, VS-35M

Advertised as capable of 35Amps in ICS (Intermittent Communication Service ,which is defined as 50% duty cycle), the continuous current specification is actually 25Amps. This is significantly more than my FDX-10 required (which is 6923Amps ICS, 14Amps Continuous).

Theory and Operation: The basic design is based on the Fairchild UA723 regulator chip which came out in the 1970’s. The Astron design is very close to the set of Fairchild reference designs shown for a positive floating supply with overvoltage protection (OVP) and overcurrent protection (OCP).

To save money they current sampling is only done across one ballast resistor. Since there will be differences in tolerance and balance between the four parallel transistors/ballast-resistors this will limit the accuracy of the meter display to some degree. This, input filtering strategy, and the potential for exposed voltage on the bottom of the chassis (from transistors, diodes, and an SCR) are my only design critiques.

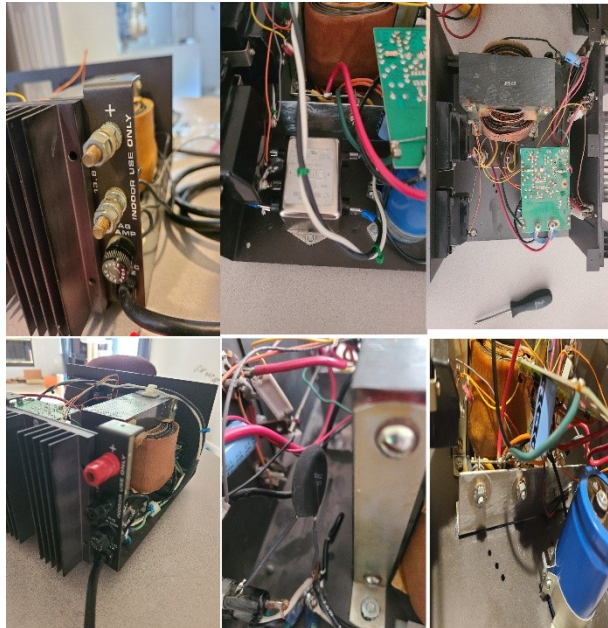
6. Input Filter: The unit arrived with a single (asymmetric) filter capacitor between the 120Vac hot and Ground. I could not verify if this capacitor was Class-Y (required for this application). I added a monolithic single-stage input filter containing both X and symmetric Y-capacitors as well as a common mode choke. Although input filtering is not as critical as with switching supplies this filter will offer some isolation for conducted emissions from the monitor which is on the same supply. I installed on the far-side of the on/off switch so it does not “leak” power when switched off.
