MAYES TESTING ENGINEERS, INC.

Re: Anchor Tab in Concrete Panel Load Testing
Mayes Testing Engineers Project Number Q14017

CONCRETE LABORATORY TEST REPORT

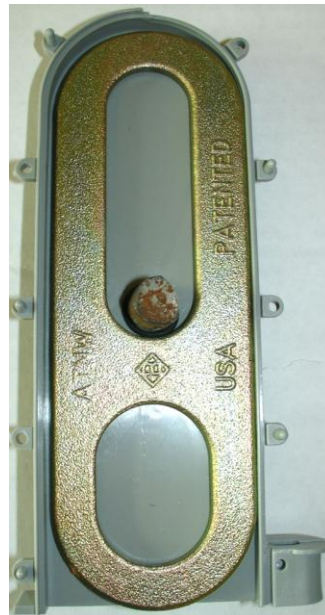
Anchor Tab in
Cast Position
(Cutaway View)

The particular version tested is encased in a plastic housing secured to the formwork during concrete placement. The tab has one long-slotted hole, allowing it to be installed flush with the concrete surface then project beyond the formed surface when deployed.

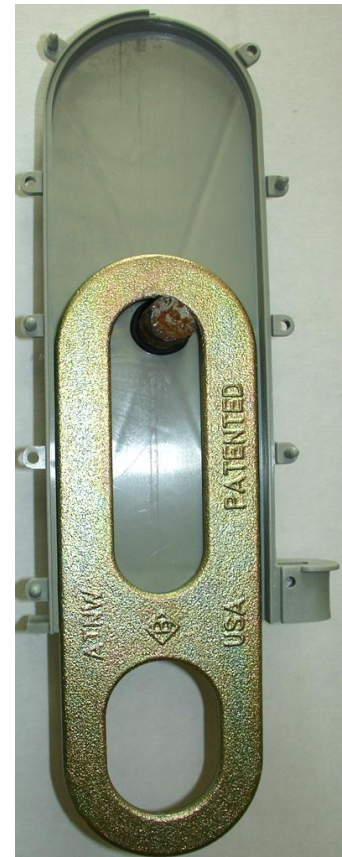
Anchor Tab in
Deployed Position
(Cutaway View)

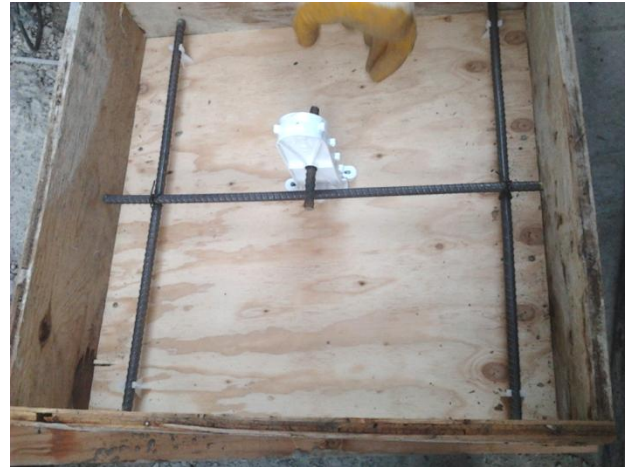
In order to demonstrate the capacity of the Anchor Tab, you provided a test specimen consisting of an Anchor Tab cast into a concrete mockup slab 2-feet by 2-feet by 7-inches thick. The Anchor Tab had a 6-inch long #4 ($\frac{1}{2}$ -inch diameter) reinforcing bar passed through the opening provided in the plastic case. Three other perpendicular #4 bars were also included to represent typical slab reinforcement, as shown in the photo (right).

Anchor Tab in Test Panel Form

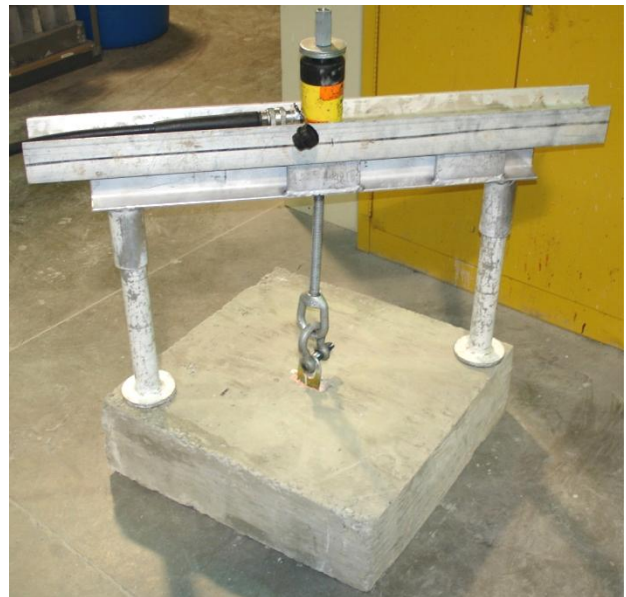
The test load was applied in direct tension to the exposed end of the deployed Anchor Tab via a calibrated hydraulic ram and digital pressure gauge assembly. A reaction beam assembly was used to provide clearance around the Anchor Tab to allow the possibility of concrete breakout as a failure mechanism and to also allow sufficient space for connecting hardware between the Anchor Tab and the hydraulic ram.

Anchor Tab Mockup in Direct Tension

The Anchor Tab was subjected to a direct tension load of 5,000 lb-f, which was maintained for 5-minutes without indication of damage or overstress. The load was then increased to 10,000 lb-f which was also maintained for 5-minutes without indication of damage or overstress. Review of the mockup after completion of the testing did not indicate any notable cracking or other damage.
