MAYES TESTING ENGINEERS, INC.

Re: Anchor Tab in Slab-on-Metal Deck Load Testing
Mayes Testing Engineers Project Number Q14017

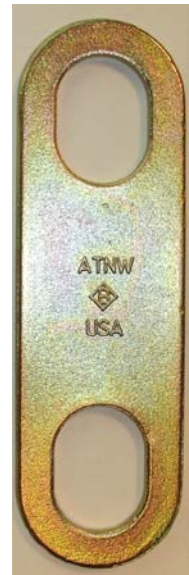
Per ANSI / WISHA / OSHA standards, we understand that an anchorage used for personal fall arrest must be designed for or demonstrate a minimum ultimate capacity of 5,000 pounds-force (lb-f). In order to demonstrate the capacity of the Anchor Tab, you provided a test specimen consisting of a tab cast into a mockup section of concrete slab-on-metal deck, similar to what is commonly used in steel framed buildings. We understand that the end cast into the slab had a single 2-foot long #4 (1/2-inch diameter) reinforcing bar tied through the tab opening, and that with the exception of the metal deck itself there was no other reinforcement in the mockup deck panel.

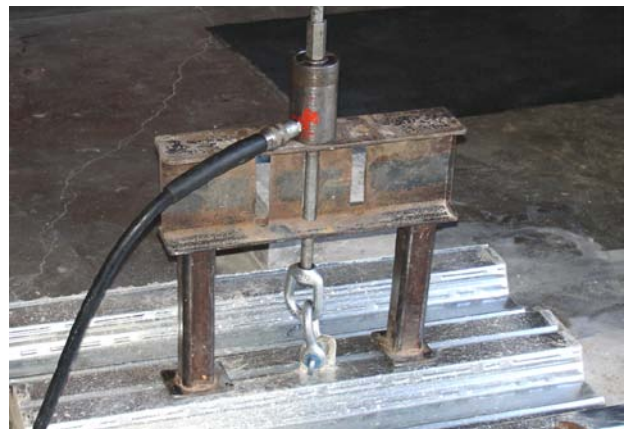
The test load was applied in direct tension to the exposed end of the Anchor Tab via a calibrated hydraulic ram, digital pressure gauge and hand pump. The Anchor Tab was connected to the hydraulic system by a shackle, eye-nut and threaded rod. A reaction beam was used to distribute the load back to the mockup panel and was oriented perpendicular to the #4 bar that was cast-in-place with the Anchor Tab.

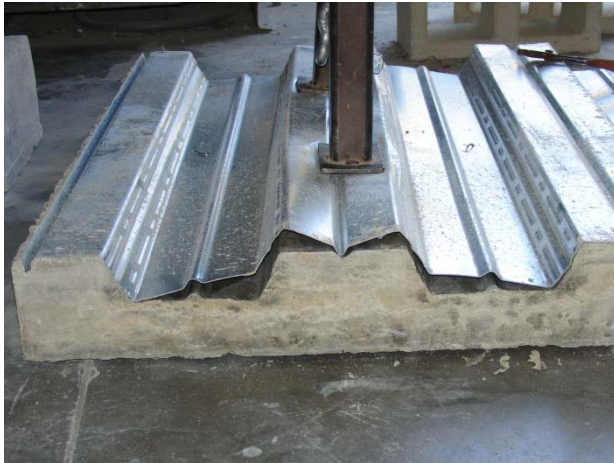
Deformation / separation of metal deck

The Anchor Tab was subjected to a direct tension load of 5,000 lb-f which was maintained for 5-minutes without indication of damage or overstress. The load was then increased to approximately 8,000 lb-f, at which point deformation / separation of the metal deck was observed, indicating likely damage to the concrete underneath, and the test halted. Review of the mockup after completion of the testing revealed a significant crack had developed along the bottom and one edge of the specimen.

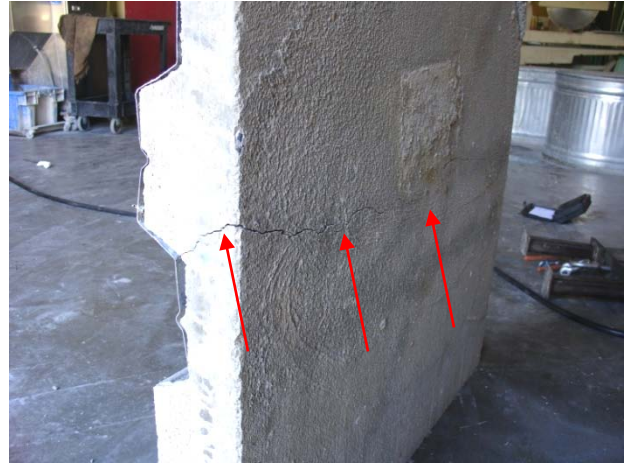
Crack (red arrows) along bottom and edge
