## Draft Tier 2 Geotechnical and Geoenvironmental Report

Site: Wolf's Castle Public House,  
Llanishen, Cardiff

Prepared For: Cardiff City Council

Job No: TF-24-310

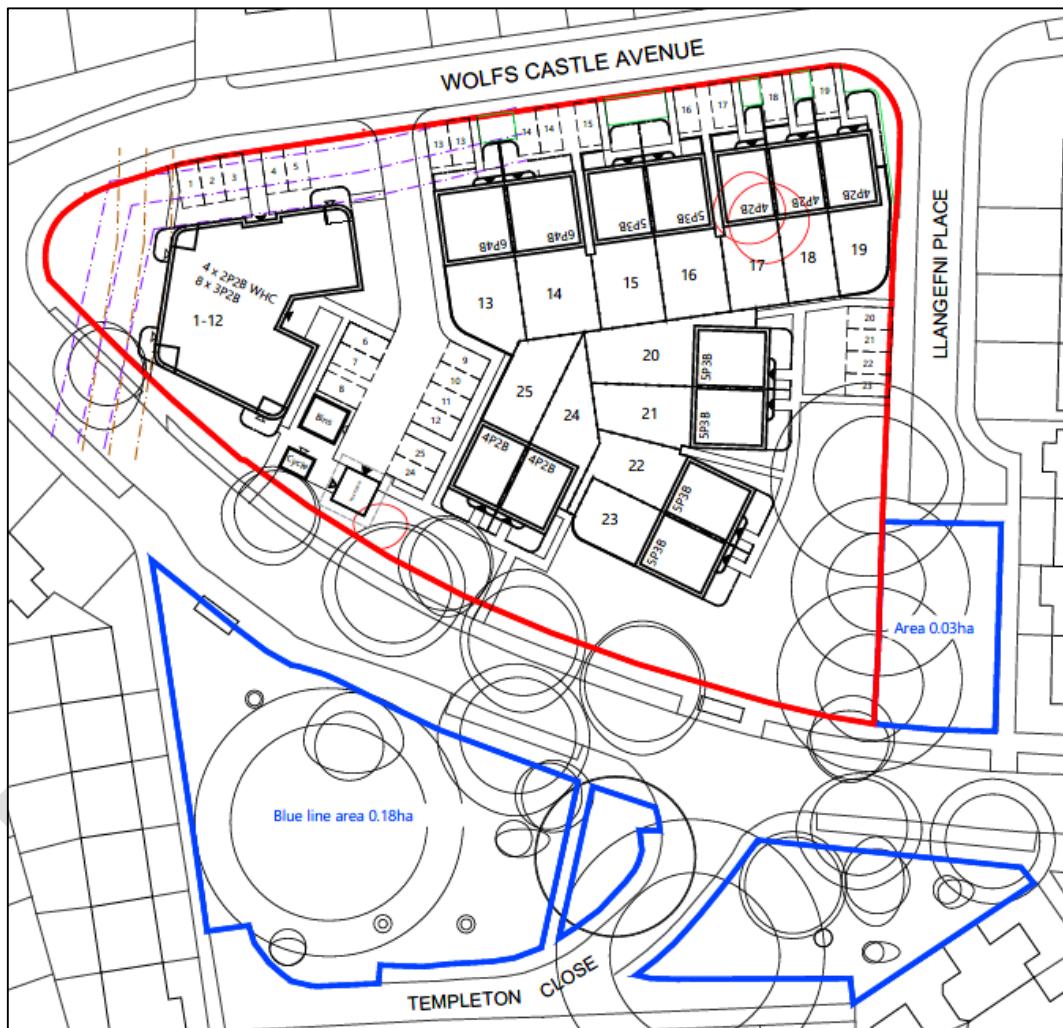
**Figure 1.1 Proposed Site Layout**

Cardiff City Council (the Client) is proposing the construction of a new residential development at Wolf's Castle Public House on the corner of Templeton Avenue and Wolf's Castle Avenue in Llanishen, Cardiff, CF14 5JS. The proposed development will consist of 12No. apartments contained within a low rise building, 13No. semi-detached and terrace houses, and associated infrastructure including access road, car parking, soft landscaping and gardens. The proposed layout can be seen within the red line boundary on **Figure 1.1**.

- client provided information, plans etc. (**Figure 1.1**); and

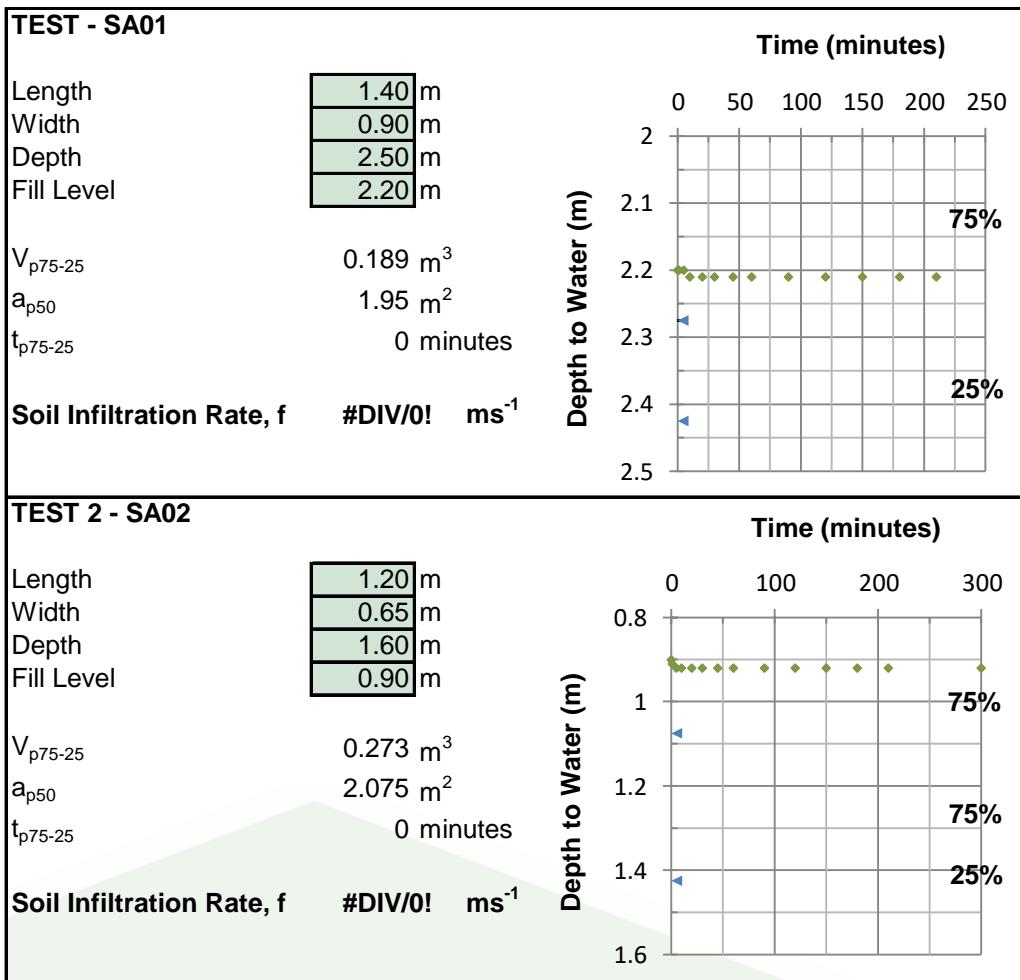
**REMARKS:**  
 Test carried out in accordance with BRE Digest 365 (2016)

The soakaway test recorded insufficient infiltration and were subsequently terminated early. It is considered that given the negligible rates of infiltration and the cohesive soils at the site, traditional soakaway drainage is unsuitable for the site.

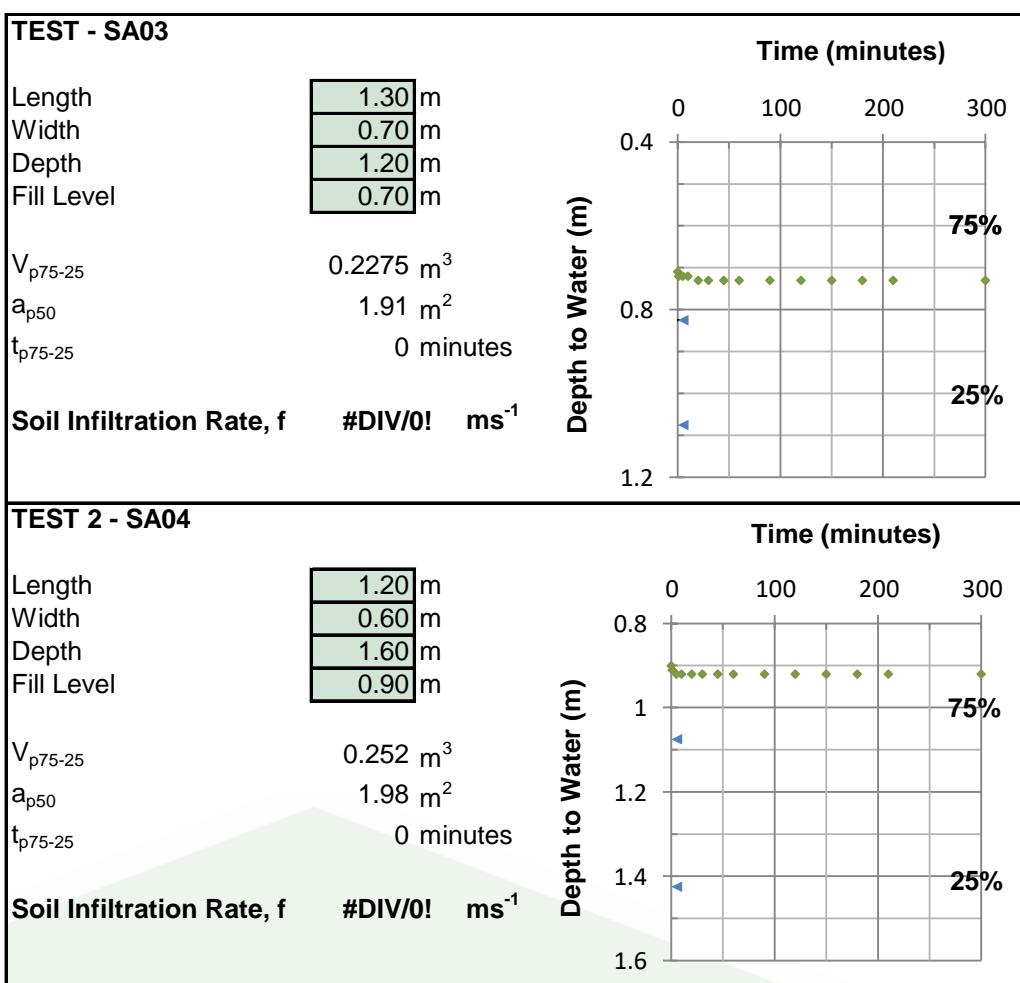
**REMARKS:**  
Test carried out in accordance with BRE Digest 365 (2016)

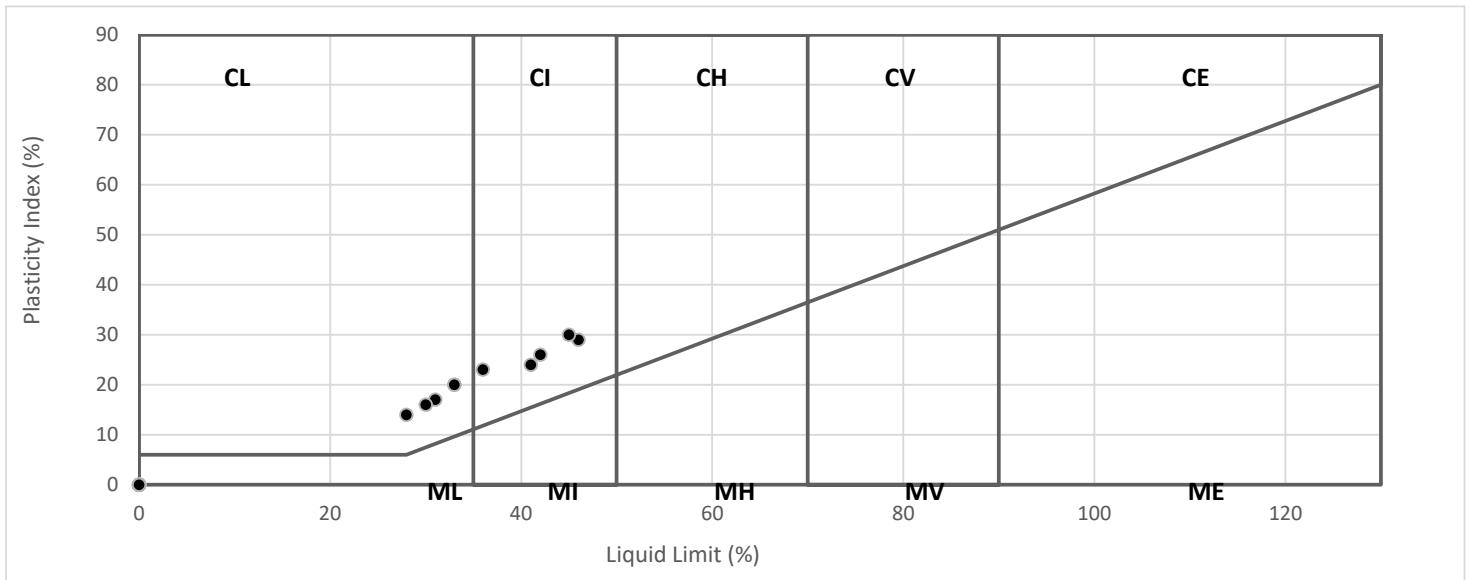
## PLASTICITY CHART FOR CASAGRANDE CLASSIFICATION

BS 5930:2015+A1:2020

The plasticity index (PI), derived from the liquid and plastic limits, indicates the soil's susceptibility to shrink-swell behaviour in response to moisture fluctuations. Given these factors, appropriate foundation design considerations and drainage measures should be implemented to mitigate potential ground movement and associated structural risks.
