# Geotechnical & Geo-environmental Site Investigation Report:

Proposed Residential Development Former Social Club Fairwater Cardiff

July 2020

**Report No. 16155**

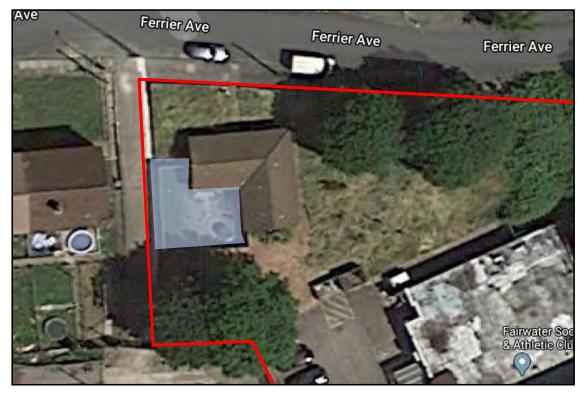
Figure 6.1: Area of Required Remediation

In order to protect future site residents it is recommended that the soils in the private garden area defined in **Figure 6.1** on the following page (shaded blue) be removed and/or capped, which may comprise hardstanding, buildings or 600mm of clean soils.

Any soils removed may be disposed of off-site or re-used in garden or landscaped areas at a depth more than 600mm below finished ground level.

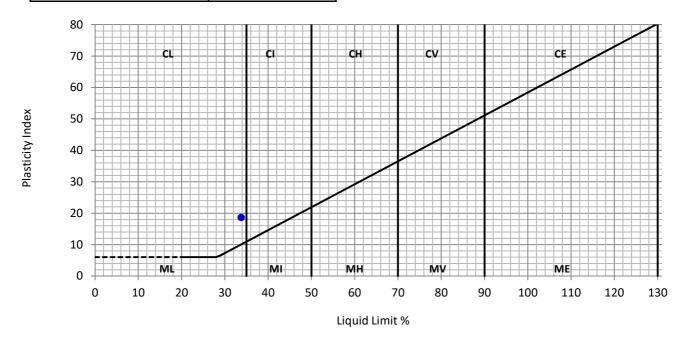
Liquid Limit	34	%
Plastic Limit	15	%
Plasticity Index	19	%

Preparation:	4.2.4 Sieved Spe	cimen	
Proportion retaine	d on 425µm sieve:	14	%

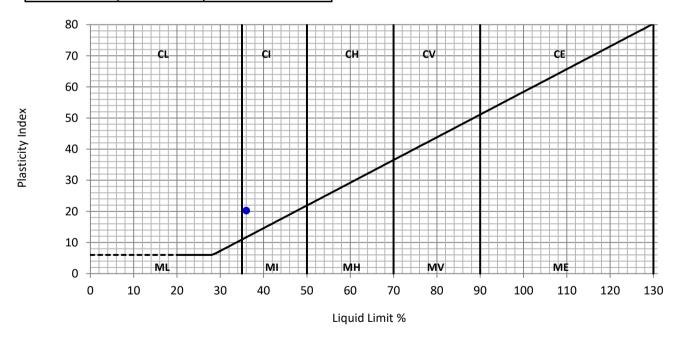
Liquid Limit	36	%
Plastic Limit	16	%
Plasticity Index	20	%

Preparation:	4.2.4 Sieved Sp	ecimen	
Proportion retained	on 425µm sieve	: 29	%

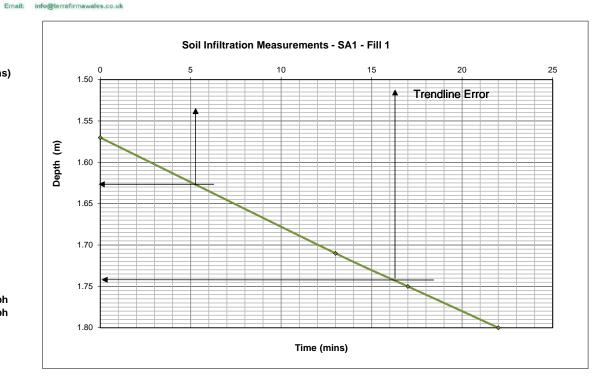
Test No.: Sa1 - Fill 1

1.57	Time (Mins)
	0
4 74	Ŭ
1.71	13
1.75	17
1.80	22
1.60	
0.45	
1.80	
0.23	•
1.6275	
1.7425	
0.083	
100	
0.115	
1.192	
5.3	From Graph
16.3	From Graph
11	•
000105291	
	1.80 1.60 0.45 1.80 0.23 1.6275 1.7425 0.083 100 0.115 1.192 5.3 16.3 11

Soil Infiltration Worksheet: This worksheet has been produced in combination with the document 'BRE Digest 365- September 1991'
This worksheet can be used to determine soil infiltration rates from trial pit field measurements
Worksheet options are identified by a green background

Table 7.2 Soakaway Test Results				
Test Fill	Infiltration Rate	Comments			
SA1					
Fill 1	1.05 x 10 <sup>-4</sup> m/s	-			
Fill 2	1.69 x 10 <sup>-5</sup> m/s	-			
Fill 3	1.30 x 10 <sup>-5</sup> m/s	-			
SA2					
Fill 1	2.49 x 10 <sup>-5</sup> m/s	-			
Fill 2	9.59 x 10 <sup>-6</sup> m/s	-			
Fill 3	7.80 x 10 <sup>-6</sup> m/s	Final infiltration rate based on extrapolated results

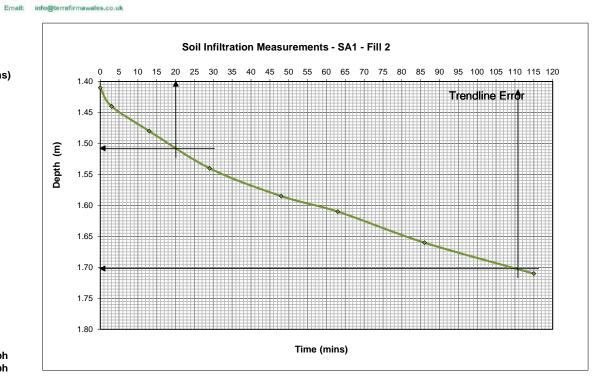
Test No.: SA1 - Fill 2

Depth to Water (m)	Time (Mins)
(effective depth - 100%)	1.41	0
	1.44	3
	1.48	13
	1.54	29
	1.59	48
	1.61	63
	1.66	86
(effective depth - 0%)	1.71	115
Length of Trial Pit (m)	1.60	
Width of Trial Pit (m)	0.45	
Depth of Trial Pit (m)	1.80	
Effective Storage Depth (m)	0.39	
Vp25	1.5075	
Vp75	1.7025	
Vp75-25	0.140	
Outflow (%)	77	
50% effective depth (m)	0.195	
Mean Surface area ap50 (m2)	1.520	
Time for 25% <b>Outflow</b> (tp25)	20	From Graph
Time for 75% <b>Outflow</b> (tp25)	111	From Graph
tp75 - 25	91	Trom Stapin
Soil Infiltration Rate (m/s)	1.69229E-05

Soil Infiltration Worksheet: This worksheet has been produced in combination with the document 'BRE Digest 365- September 1991'
This worksheet can be used to determine soil infiltration rates from trial pit field measurements
Worksheet options are identified by a green background

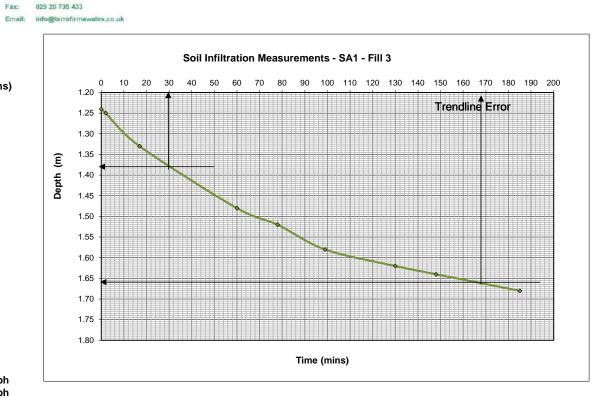
Test No.: SA1 - Fill 3

Depth to Water (m)	Time (Mins)
(effective depth - 100%)	1.24	0
	1.25	2
	1.33	17
	1.48	60
	1.52	78
	1.58	99
	1.62	130
	1.64	148
(effective depth - 0%)	1.68	185
	4.00	- -
Length of Trial Pit (m)	1.60	
Width of Trial Pit (m)	0.45	
Depth of Trial Pit (m)	1.80	
Effective Storage Depth (m)	0.56	
Vp25	1.3800	
Vp75	1.6600	
Vp75-25	0.202	
Outflow (%)	79	
50% effective depth (m)	0.280	
Mean Surface area ap50 (m2)	1.868	
Time for 25% Outflow (tp25)	30	From Graph
Time for 75% Outflow (tp75)	168	From Graph
tp75 - 25	138	
Soil Infiltration Rate (m/s)	1.30342E-05

Soil Infiltration Worksheet: This worksheet has been produced in combination with the document 'BRE Digest 365- September 1991'
This worksheet can be used to determine soil infiltration rates from trial pit field measurements
Worksheet options are identified by a green background

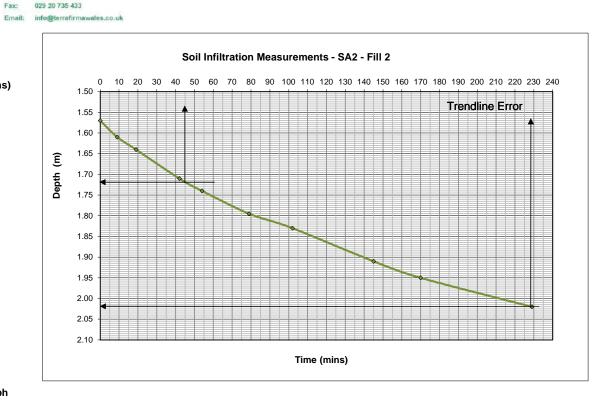
Test No.: SA2 - Fill 2

Soil Infiltration Worksheet: This worksheet has been produced in combination with the document 'BRE Digest 365- September 1991'

This worksheet can be used to determine soil infiltration rates from trial pit field measurements
