# Geotechnical and Geoenvironmental Report:

Proposed Development Lon Cardi Bach, Cilgerran.

Wales and West Housing Association

Job No: 16166

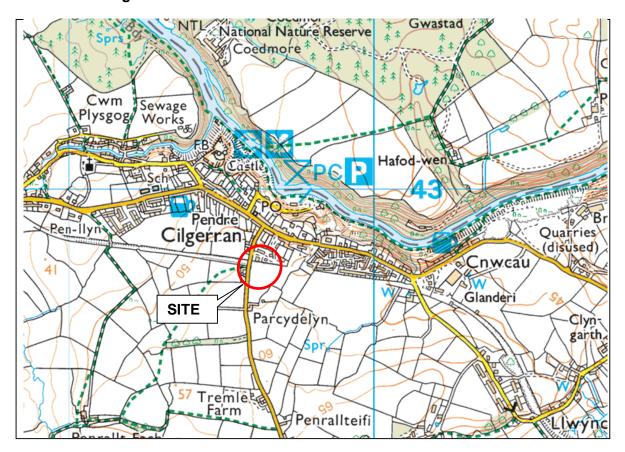
Figure 2.1 Site Location

The site location can be seen on **Figure 2.1** along with the proposed site layout on **Drawing 01** and **Drawing 02**.

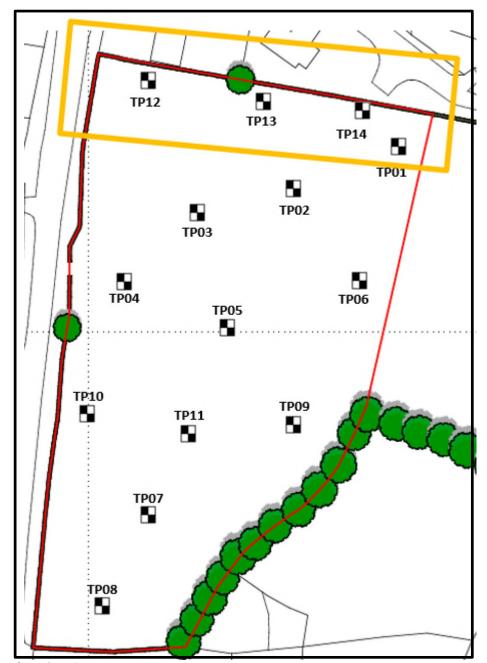
Figure 7.1 Capping Area

Remedial measures will be required with regards to site soils which have been found to contain elevated levels of contaminants. The affected soils are the Made Ground present in the north of the site.

**Figure 7.1** shows the area where capping is required.

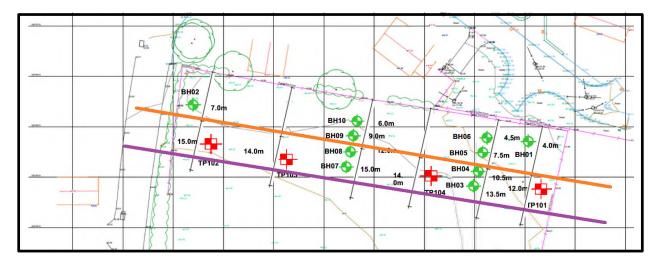
Figure 8.1 Foundation locations

For the area affected by the deep fill over the former railway line made ground was found to be up to 4.30m deep reducing southwards. **Figure 8.1** on the following page shows the extent of the made ground. The purple line shows the approximate extent of the made ground increasing to the maximum depth of up to 4.3m along the orange line. It is recommended that a combination of piled foundation north of the orange line and mass concrete strip/trench fill foundation south of the orange line both found within the competent mudstone be used. For the piled foundations for a 275mm square concrete pile founded within the competent mudstone bedrock with an appropriate set a safe working load of 400kN should be achieved. Plies lengths should be in the order of 4/5m measured form the existing ground.

In the area within the infilled railway between the orange and purple lines as seen below in **Figure 8.1**, it is recommended that a combination of mass concrete strip and trench fill foundations founded within the competent weathered mudstone bedrock as described above, with the depth to the in-situ founding horizon will typically 2.00m.

In the area within the infilled railway between the orange and purple lines as seen below in <b>Figure 8.1</b> , it is recommended that a combination of mass

concrete strip and trench fill foundations founded within the competent weathered mudstone bedrock as described above, with the depth to the in-situ founding horizon will typically 2.00m.

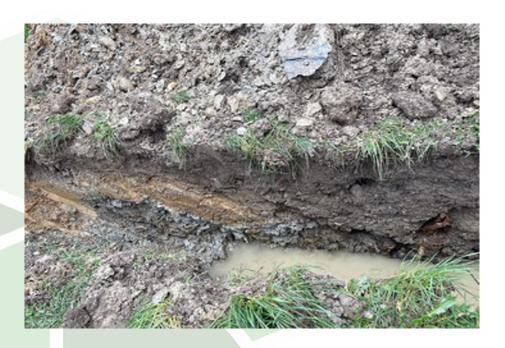
## TRIAL PIT SKETCH

- A A MADE GROUND soft dark brown slightly sandy slightly gravelly CLAY. Gravel is angular fine to coarse including mudstone and wood
- B Firm orangish brown CLAY.
- C Medium dense light grey slightly clayey sandy GRAVEL with . Gravel is angular fine to coarse of mudstone.

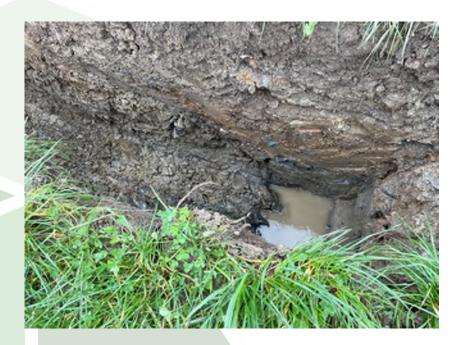
- A MADE GROUND soft to firm brown slightly sandy slightly gravelly CLAY. Gravel is angular fine to coarse including mudstone and plastic
- B Medium dense light grey slightly clayey sandy GRAVEL with . Gravel is angular fine to coarse of mudstone.

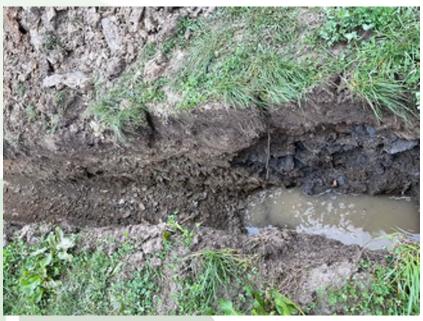
## TRIAL PIT SKETCH

- A MADE GROUND soft dark brown slightly sandy slightly gravelly CLAY. Gravel is angular fine to coarse including mudstone.
- B Firm orangish brown CLAY.
- C MADE GROUND loose brownish grey sandy GRAVEL. Gravel is angular fine to coarse of mudstone.
- D MADE GROUND loose grey sandy GRAVEL with high cobble content. Gravel and cobbles are angular of mudstone.
- E Medium dense light grey slightly clayey sandy GRAVEL with . Gravel is angular fine to coarse of mudstone.

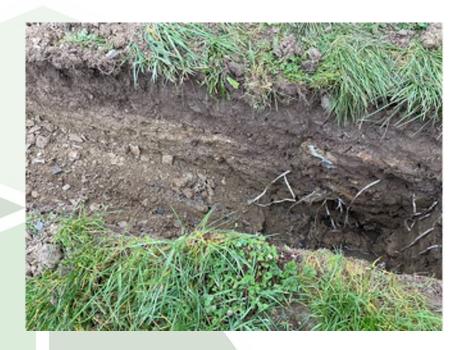
- A A MADE GROUND soft dark brown slightly sandy slightly gravelly CLAY. Gravel is angular fine to coarse including mudstone and wood
- B Firm orangish brown CLAY.
- C Medium dense light grey slightly clayey sandy GRAVEL with . Gravel is angular fine to coarse of mudstone.

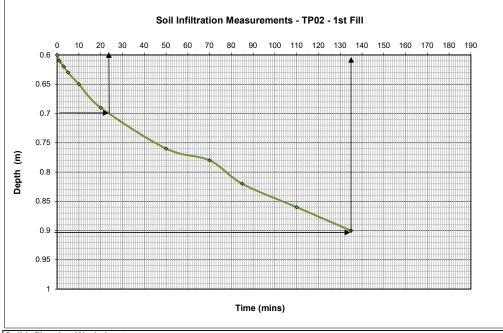
Soil Infiltration Worksheet:

Length of Trial Pit (m)	1.20
Width of Trial Pit (m)	0.65
Depth of Trial Pit (m)	1.00
Effective Storage Depth (m)	0.40
Vp25	0.7000
Vp75	0.9000
Vp75-25	0.156
Outflow (%)	75
500/ - # - + + - / )	1 0.000
50% effective depth (m)	0.200
Mean Surface area ap50 (m2)	1.520

Time for 25% Outflow (tp25)	24	From Graph
Time for 75% <b>Outflow</b> (tp75)	135	From Graph
tp75 - 25	111	
Sail Infiltration Data (m/a)	1 E4101E 0E

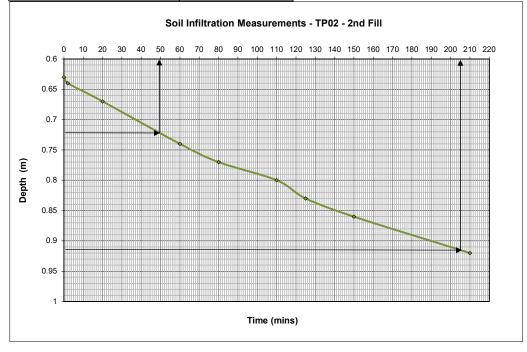
Soil Infiltration Worksheet:

Soil Infiltration Rate (m/s)	1.05608E-05
tp75 - 25	155.5
Time for 75% Outflow (tp75)	205
Time for 25% Outflow (tp25)	49.5

•	•
Trial Pit	Depth Range of Test (m)	Infiltration Rate (ms <sup>-1</sup> )
TP02	0.60 - 1.00	1.05 x 10 <sup>-05</sup>
TP03	0.93 - 1.40	9.02 x 10 <sup>-06</sup>
TP04	0.82 - 1.20	No infiltration
TP06	1.24 - 1.70	8.20 x 10 <sup>-06</sup>
TP08	1.40 - 1.80	No infiltration
TP09	0.89 - 1.40	4.91 x 10 <sup>-06</sup>
TP11	0.45 - 0.85	2.31 x 10 <sup>-05</sup>

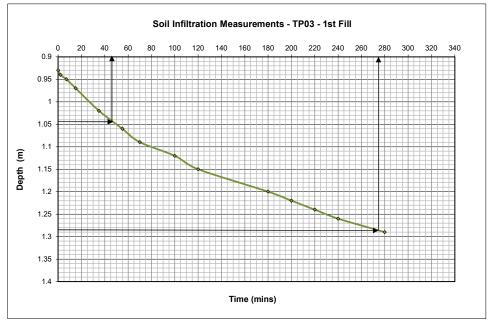
Soil Infiltration Worksheet:

2.10
0.70
1.40
0.47
1.0475
1.2825
0.345
77
0.235
2.786

Time for 25% Outflow (tp25)	46	From Graph
Time for 75% Outflow (tp75)	275	From Graph
tp75 - 25	229	
Soil Infiltration Rate (m/s)	9.02438E-06	1

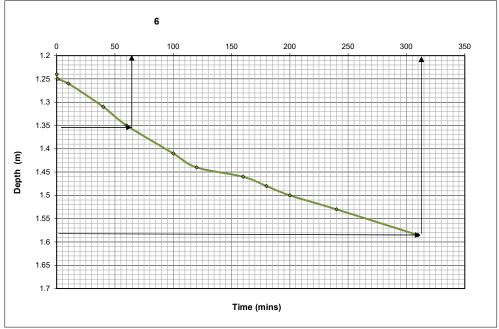
Soil Infiltration Worksheet: This worksheet has been produced in combination with the document 'BRE Digest 365'. This worksheet can be used to determine soil infiltration rates from trial pit field measurements. Worksheet options are identified by a green background.

Time for 25% Outflow (tp25)	62.5	From Graph
Time for 75% Outflow (tp75)	310	From Graph
tn75 - 25	247.5

Soil Infiltration Rate (m/s) 8.20723E-06

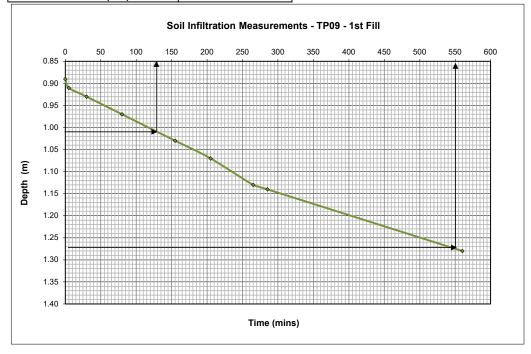
Soil Infiltration Worksheet: This worksheet has been produced in combination with the document 'BRE Digest 365'. This worksheet can be used to determine soil infiltration rates from trial pit field measurements. Worksheet options are identified by a green background.

Time for 25% Outflow (tp25)	130	From Grap
Time for 75% <b>Outflow</b> (tp75)	545	From Grap
tp75 - 25	415	
Soil Infiltration Rate (m/s)	4.91264E-06

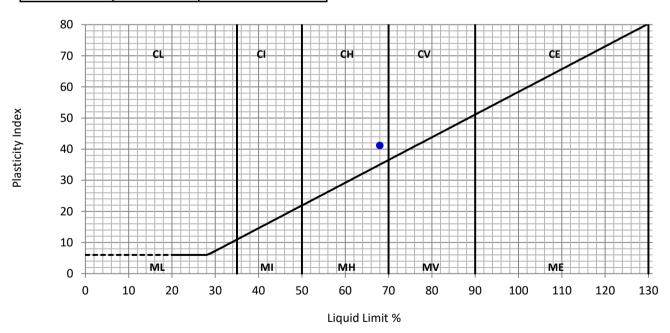
Liquid Limit	68	%
Plastic Limit	27	%
Plasticity Index	41	%

Preparation:	4.2.4 Sieved Spe	ecimen	
Proportion retained	d on 425µm sieve:	6	%

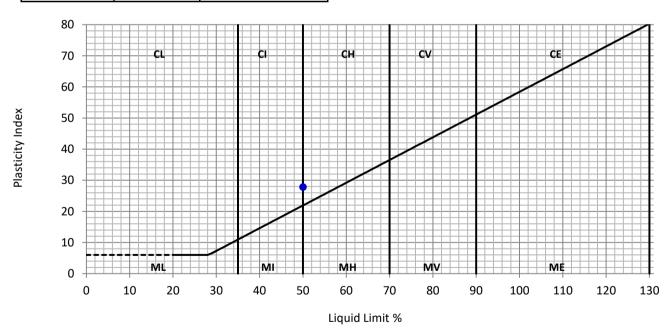
Liquid Limit	50	%
Plastic Limit	22	%
Plasticity Index	28	%

Preparation:	4.2.4 Sieved Sp	ecimen	
Proportion retained	on 425µm sieve:	25	%
