**Bat Survey:** Former Magnet Premises, East Tyndall Street, Cardiff, CF24 5EA

**Instructed by:** Interstrand

**Reported by:** Ecological Services Ltd  
10 Mount Pleasant, Llanelly Hill, Abergavenny, Monmouthshire, NP7 0NT

Author	Date	Version
Richard Watkins	October 2024	V3.0

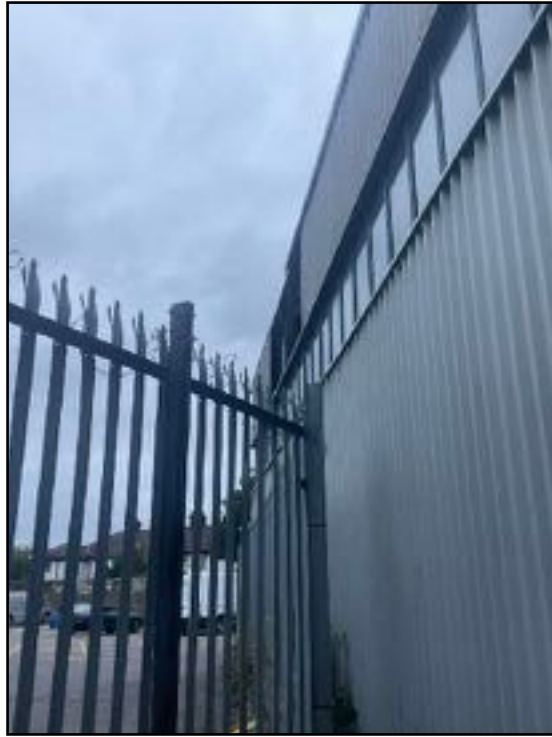
**6.3** Due to the age and condition of the building, there were a limited number of opportunities present for bats to access and use the building and due to the height of the building and the proximity of the building to neighbouring properties, the roof could not be visualised. Therefore, following the survey guidelines, although the visualised aspects of the building appeared to have low potential, the building was actually classed as having moderate potential for roosting bats to conform to survey guidelines. There was a large area of missing metal cladding to the south western elevation of the main building.

**6.6** Examples of apertures allowing access to cavities in the building:

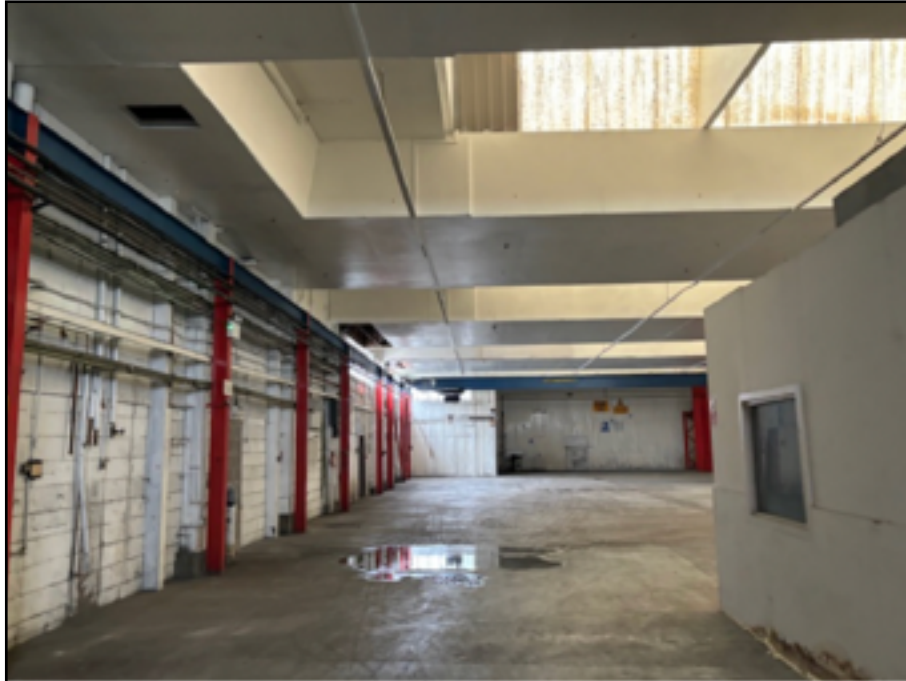
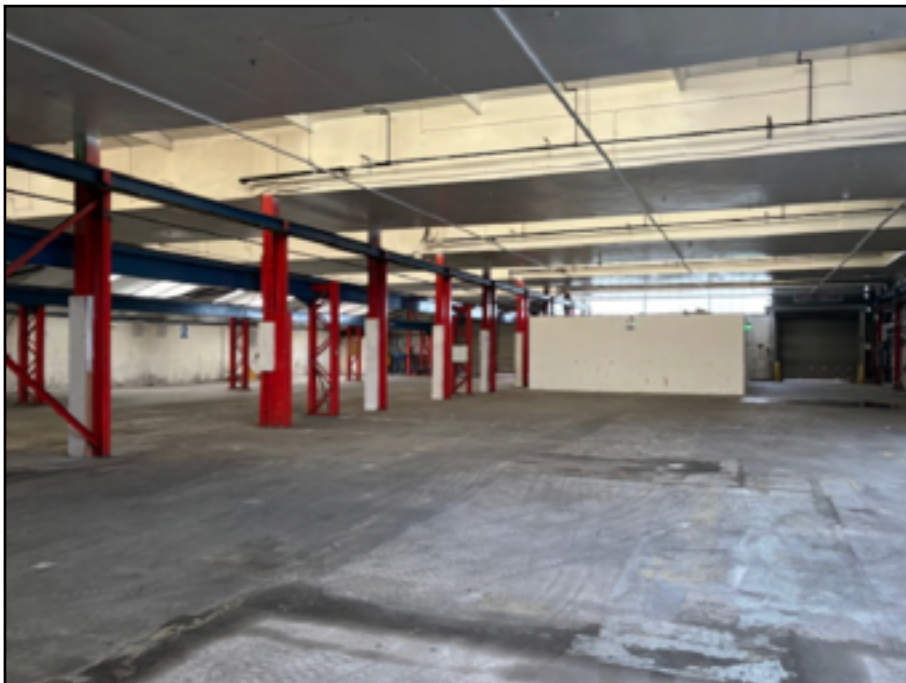
7.2 There was no internal attic space within the building. The building was open plan and open to the roof.

**9.8 Due to the constraints listed in Section 3.4 of this report, it is proposed that a soft strip methodology be adopted on the areas of internal timber clad roof surfaces. The internal timber cladding will be soft stripped under direct supervision of a suitably qualified ecologist. If at anytime bats or evidence of bats are discovered then works must immediately stop and a European Protected Species Licence application be made to Natural Resources Wales. In this instance, no works will continue until a licence is issued sanctioning works ongoing. The results of the soft strip will be returned to the LPA ecologists for their records.**

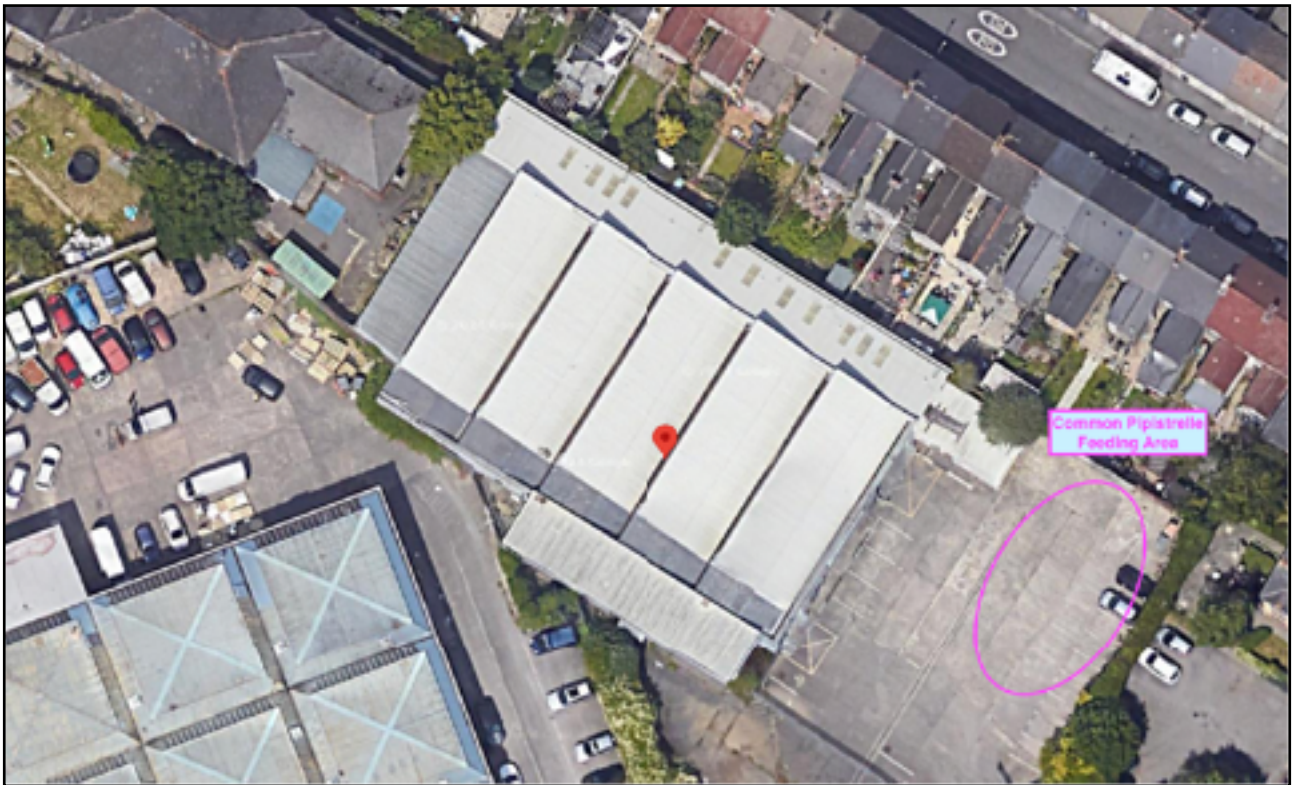
#### 8.11 NVA Still Shot Examples:

**8.9** During the first emergence survey, only a single Common Pipistrelle bat call was detected but the bat was not observed.

**8.10** During the second emergence survey, a small number of Common Pipistrelles were observed foraging around the site but did not emerge from the building.
