CLARENCE EMBANKMENT, BUTETOWN, CARDIFF

BUILDING INSPECTION AND BAT SURVEY REPORT

Document Ref: E1988501 Doc 01 – 15 JULY 2019

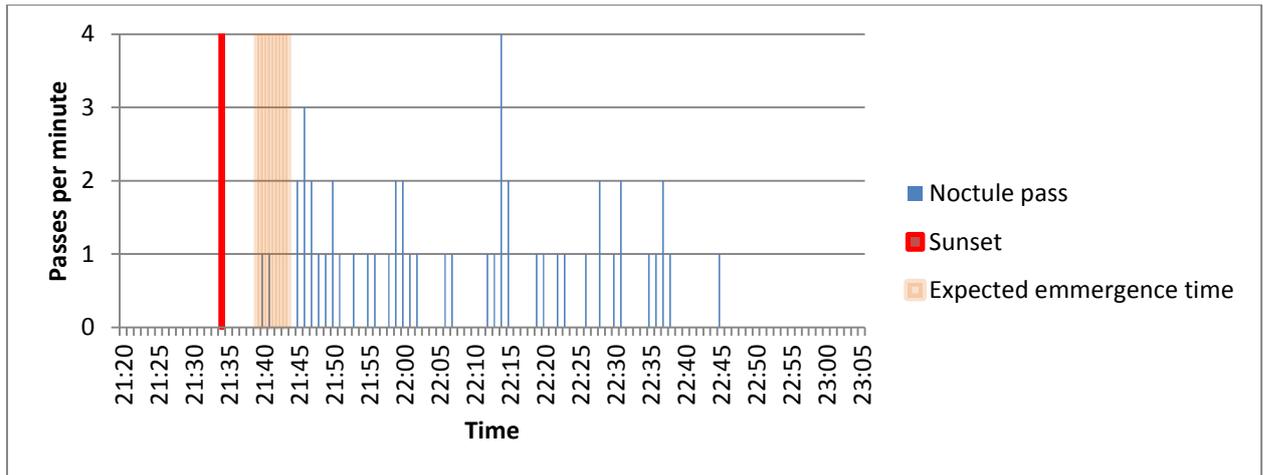
Chart 1 Surveyor/Location 1 - Noctule

- 3.13 The Charts 1-4 below illustrate the bat passes recorded at location 1. These are given as an example as all four survey locations experienced similar results. The species emergence times are taken from British Bat Calls; A Guide to Species Identification (Russ, 2012). By far the most numerous passes were made by Noctule (Chart 1). The majority were observed foraging out over the adjacent river but there were several commuting backwards and forwards across and around the site towards and from the direction of Hamadryad Park and the Wetlands Reserve. The earliest observed timings would support the idea that there are roosts in the immediate vicinity.

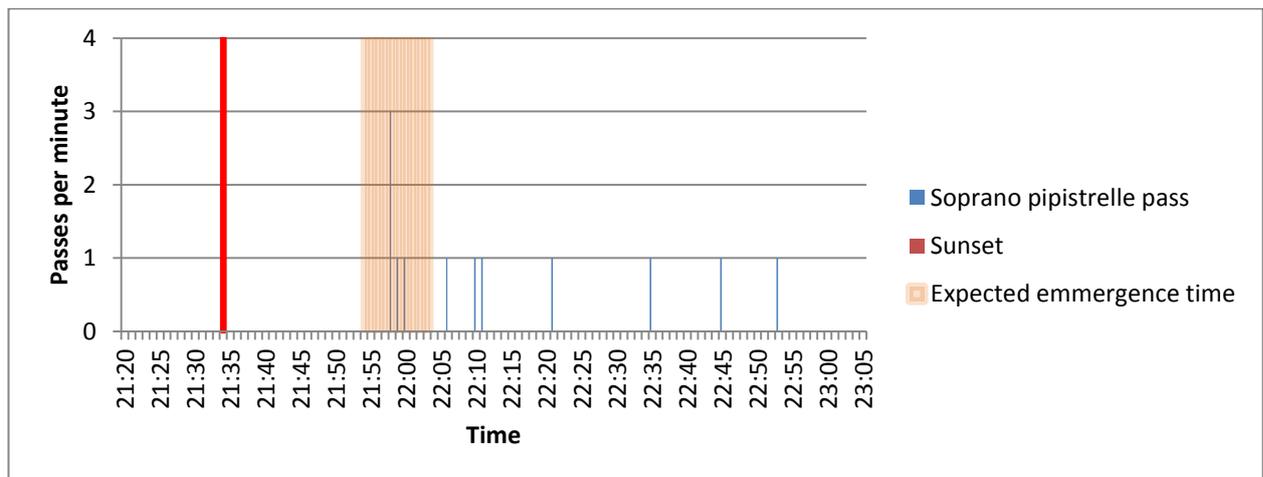
Chart 2 Surveyor/Location 1 - Soprano pipistrelle

- 3.14 Soprano pipistrelle were the next most numerous and again based on the timings it is likely that as well as the roost observed there are others in the immediate vicinity.

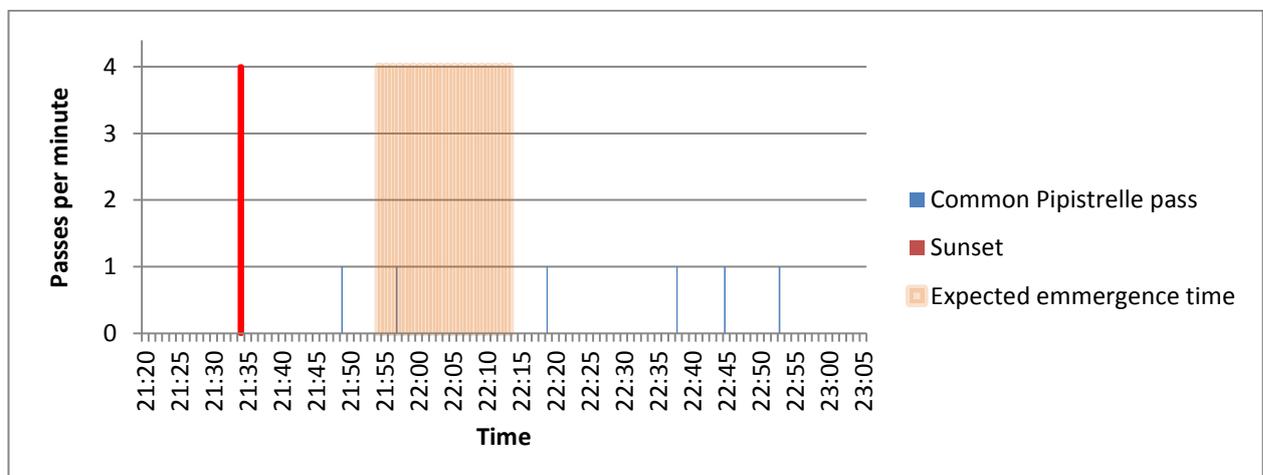
Chart 3 Surveyor/Location 1 - Common pipistrelle

- 3.15 There were occasional passes by common pipistrelle and Serotine (Chart 3 & 4). Common pipistrelle are likely to roost in the surrounding buildings and again timings suggest a roost in very close proximity to the proposed development site. The Serotine calls are from a foraging individual/s but the timings do not provide any indication as to the proximity or direction of a roost.

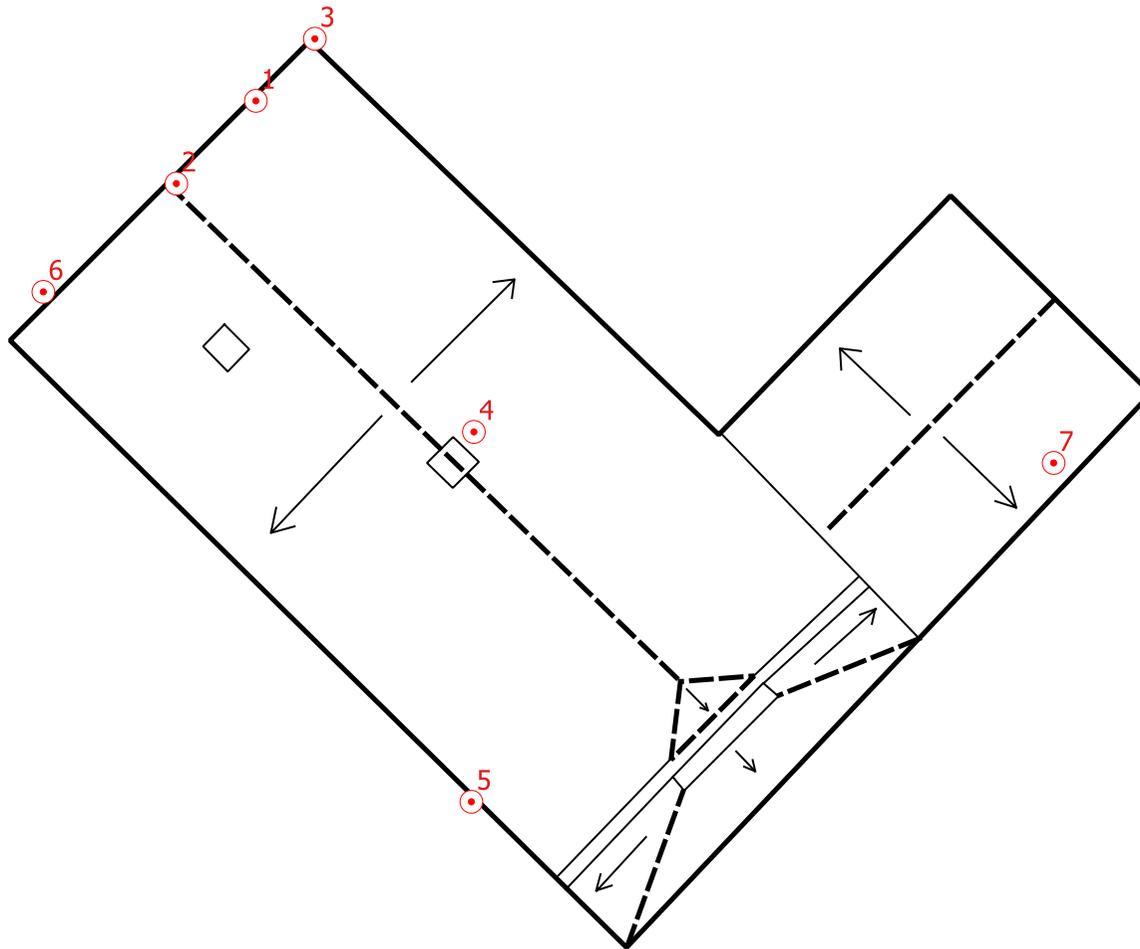
- 3.6 The roof ridge tiles are in generally good repair but there are some slipped and missing slates on the roof face itself. The fascias and soffits are painted timber and they are weathered in places causing cracks and warping which have created some suitable features for bats to use. The basement entrance is open allowing free flight if bats are present. No evidence of use by bats was observed externally.

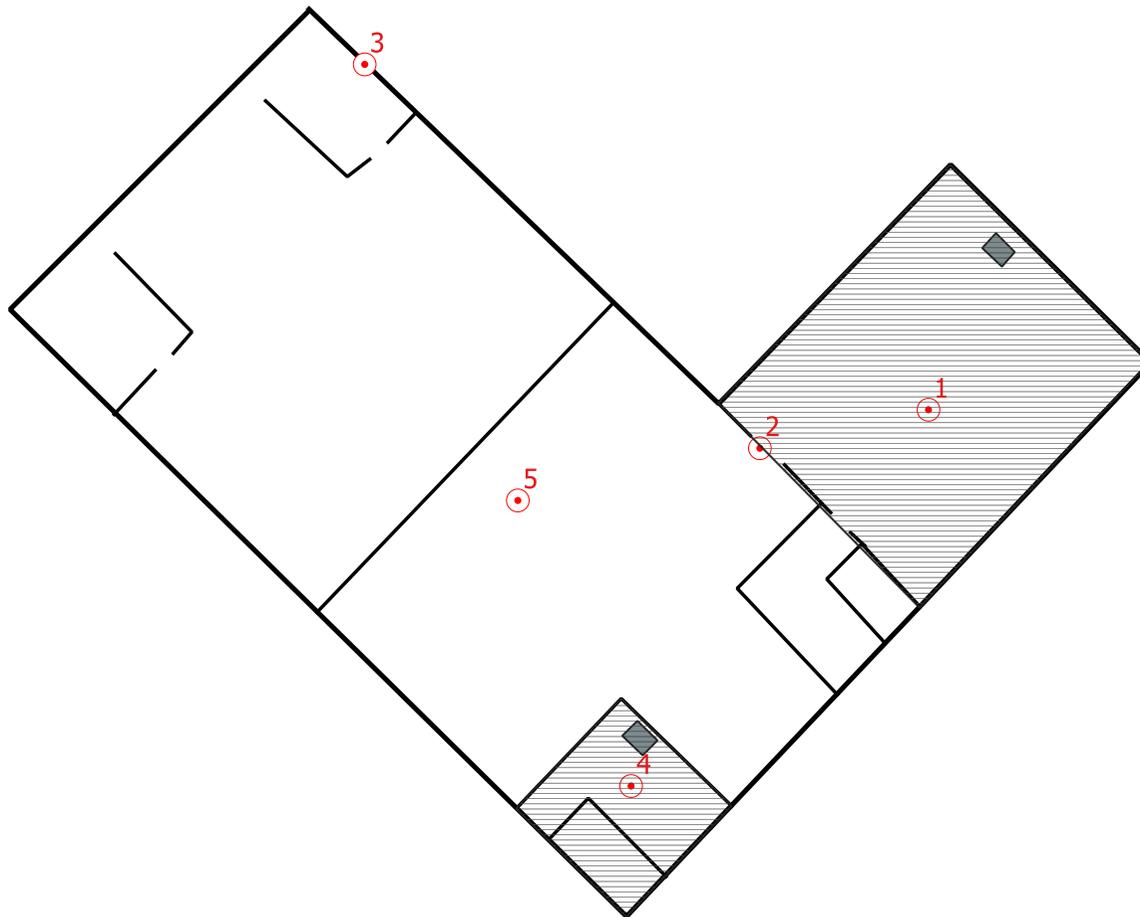
Client: Amity Planning Consultants Project: Clarence Embankment	Drawing Title: Appendix II - Building Inspection - Internal
Project Code: E1988501 Doc01	Initials DF 08 July 2019

- 3.7 Internally the main building is open to the eaves and apex which are timber clad and painted with the exception of the small room which contains the prayer room immediately to the left of the main entrance. There is a false ceiling here and an enclosed loft space. The loft space was accessible through a loose ceiling board and the loft space was un-boarded and the roof was timber clad and painted as throughout the rest of the main building. The inspection observed no evidence of internal use by bats.

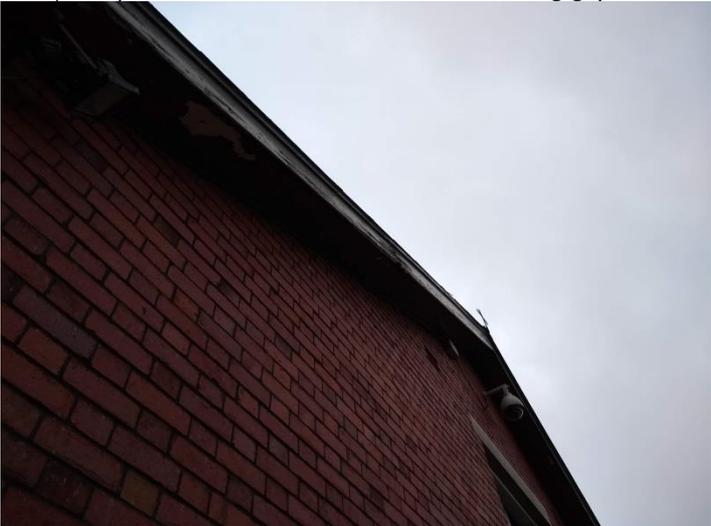
Target Note	Description/ Comment
External Features	
1	<p>Rotten/warped fascia where it meets soffit creating gap.</p>

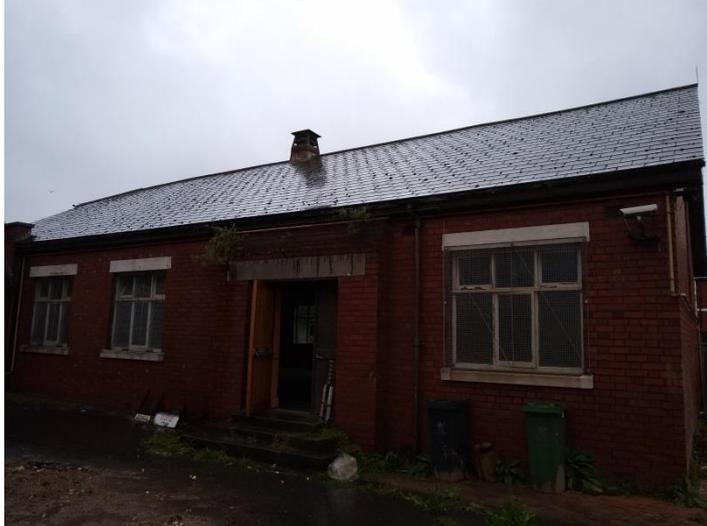
4

Tiniest bit of lifted flashing at base of chimney/vent. Otherwise flashing flat and in good condition.

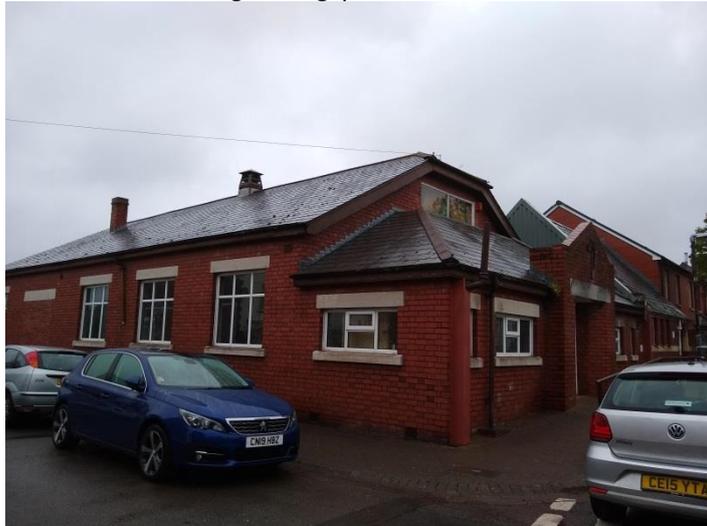
5

Rotten fascia creating small gaps.

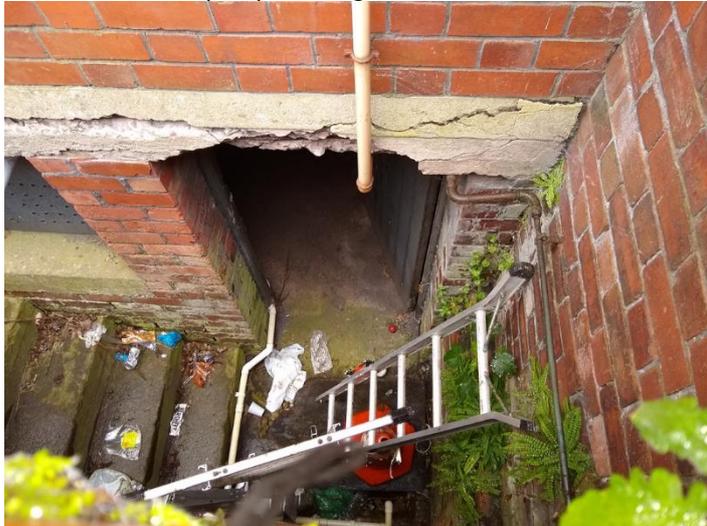
6

Basement door open providing access.

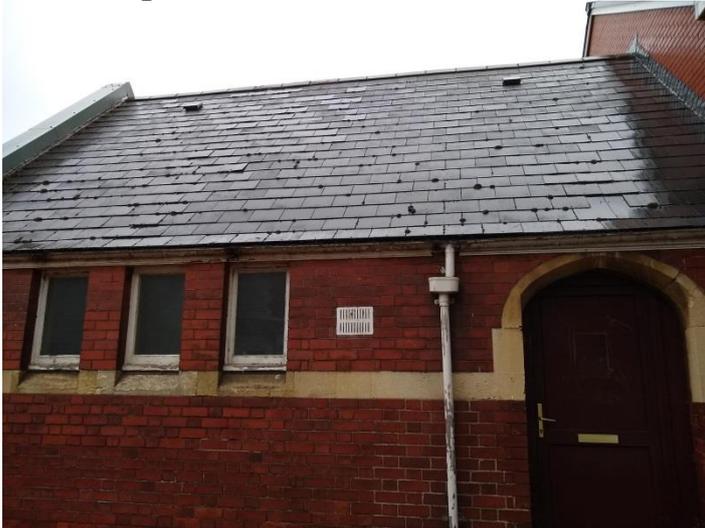
7

Two missing slates, some lifted.

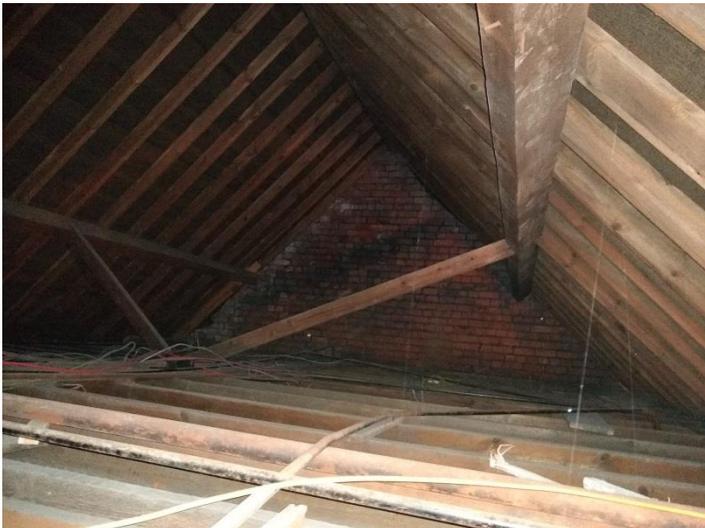
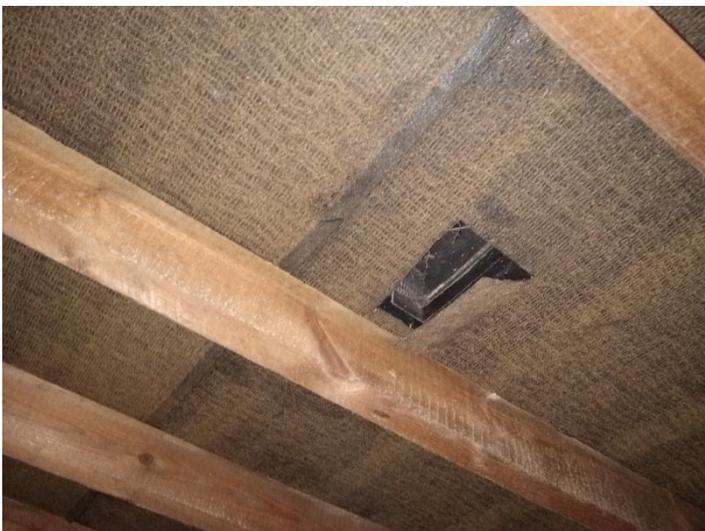
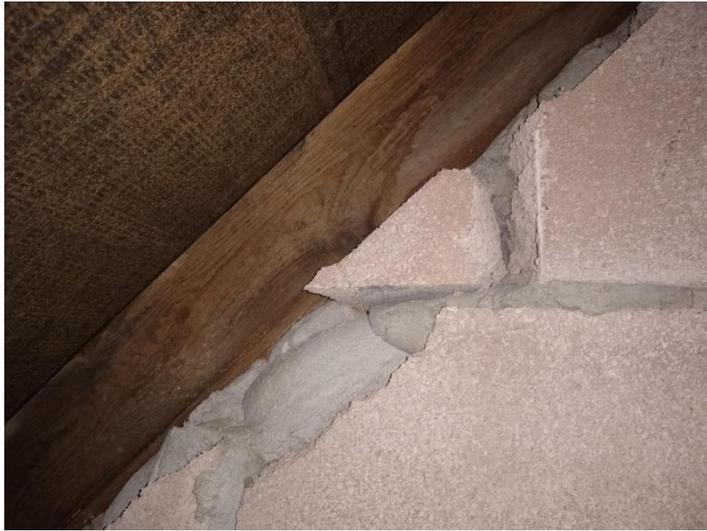
1

- 3.8 The extension element to the building has an enclosed loft space along its entire length. This was accessible through a loft hatch. The construction is timber with roof felt present. The space is very clean and tidy and there were no obvious access points. A sparse scattering of mouse dropping was observed throughout the space. No evidence of bats was observed within this loft space.

Small number of scattered mouse droppings observed in loft space. Holes in felt where vents are but cobwebby. Otherwise loft space is well sealed. No evidence of use by bats observed.

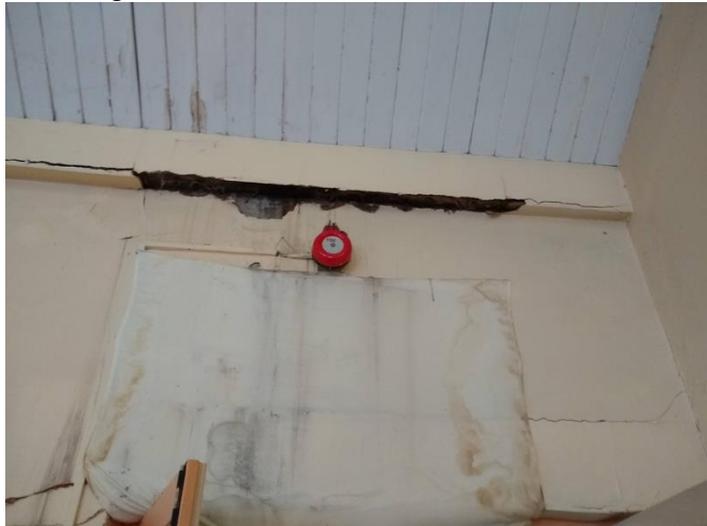
2

- 3.9 Where the main building and the extension meet, internally there is water ingress and this is causing damage to the fabric of the building. It may highlight an area where bats could find access externally.

Water ingress. Plaster has failed.

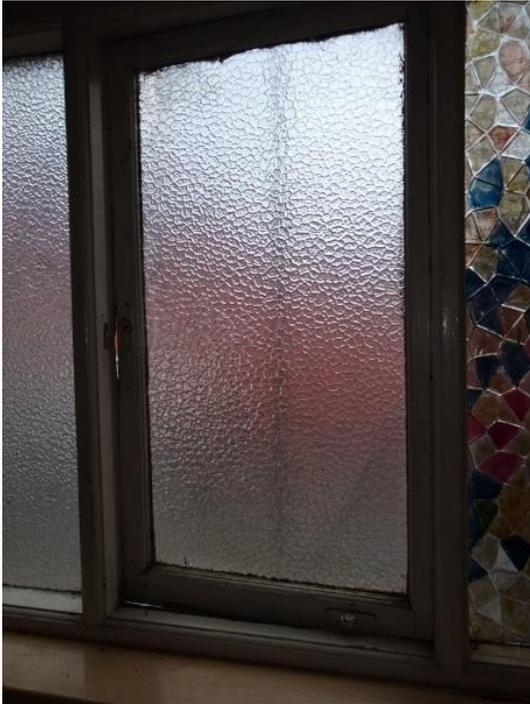
3

Window does not shut fully. Very narrow (2mm) gaps around frame. Wire mesh on outside but gaps large enough for bats to enter.

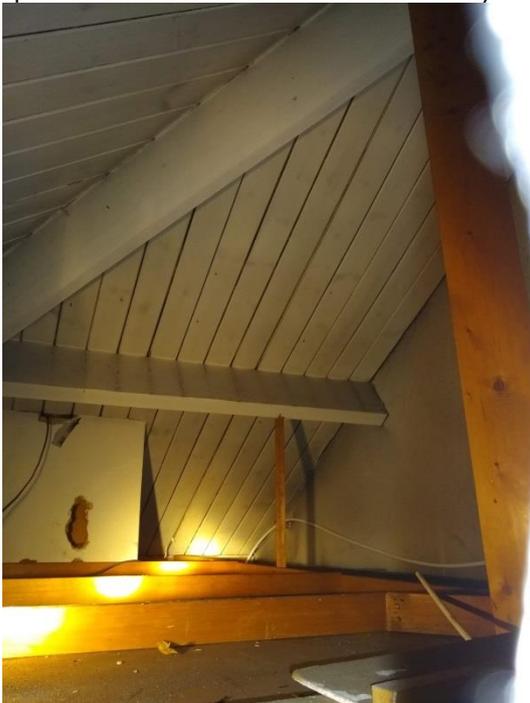
4

Loft space at eaves. Painted timber cladding on eaves with very small gaps between, otherwise loft space is well sealed. No evidence of use by bats observed.

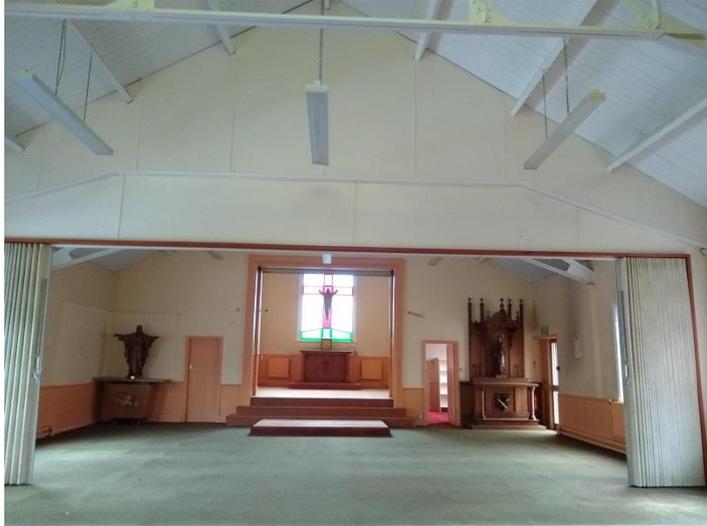
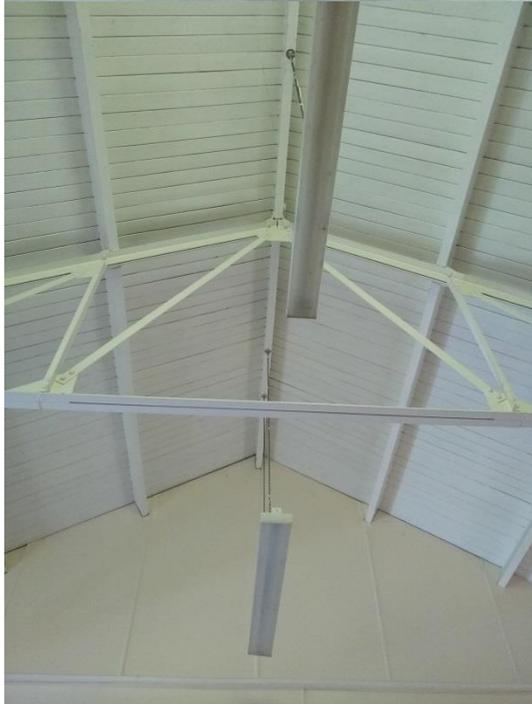
5

Main body of the building open to the eaves.

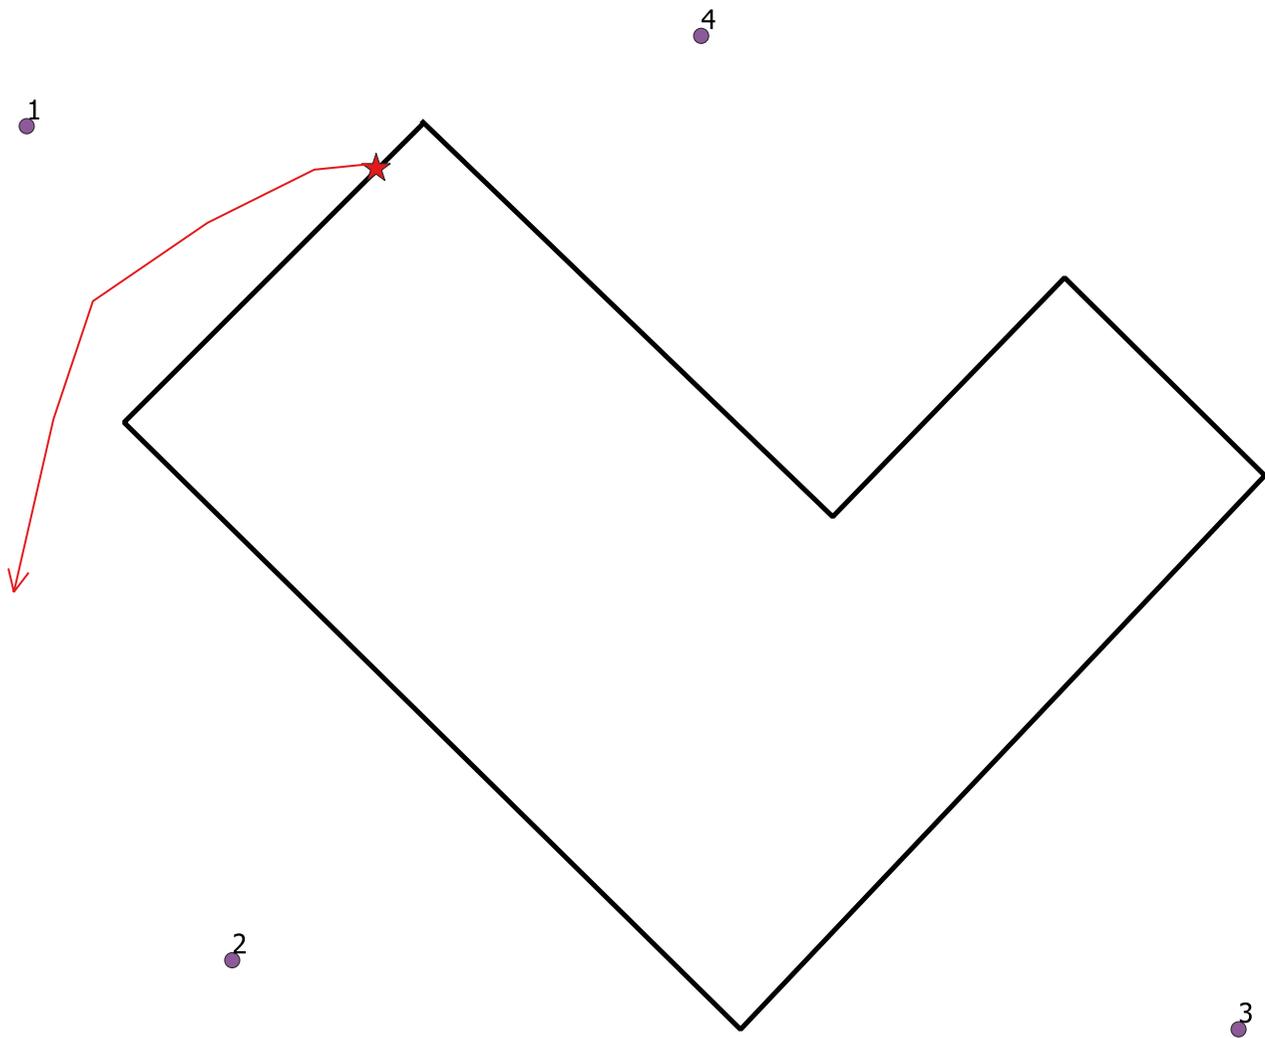
Client: Amity Planning Consultants Project: Clarence Embankment	Drawing Title: Activity survey
Project Code: E1988501 Doc01	Initials DF 03 July 2019

- 3.11 Surveyor locations for the survey period are illustrated in Appendix III. A single bat was observed to exit the property during the dusk survey. The location of this roost exit was on the north-west gable end of the main building where there is an observable gap between the fascia and the soffit (Target Note 1 in Appendix II & Appendix III). The bat was seen to emerge by the surveyor at location 1 but it was not calling and no recording was made. The surveyor at location 2 observed this bat coming over the wall and reliably identified it as a Soprano pipistrelle.

- 3.12 The surveyor at location 4 may have had an individual emerge either from the extension element of the building or the adjacent residential property but this was not conclusive.
