GROUND INVESTIGATION REPORT

MKR PROPERTIES LTD

PROPOSED COMMERCIAL DEVELOPMENT

Project No: 19-1012

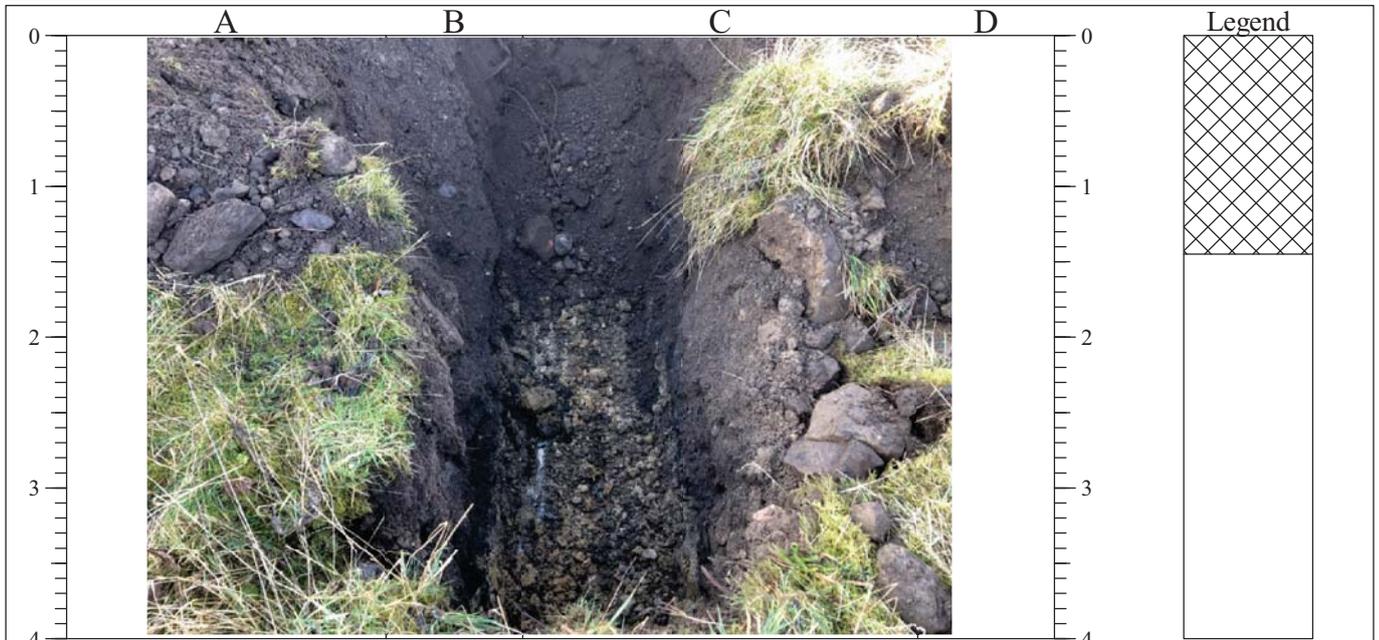
Project Pant Industrial Estate, Merthy Tydfil				TRIAL PIT No TP02
Job No 19-1012	Date 05-02-20	Ground Level (m)	Co-Ordinates ()	
Contractor Arc Environmental Limited				Sheet 1 of 1

STRATA			SAMPLES & TESTS		
Depth	No	DESCRIPTION	Depth	No	Remarks/Tests
0.00-1.45		Brown grey and black sandy gravelly clay / clayey sandy gravel. Gravel is fine to coarse comprising fragments of brick concrete sandstone and ash. Cobbles and boulders noted (MADE GROUND).	0.40	J/D	
1.45		Trial pit terminated at 1.45m due to refusal on relic concrete structure. Brick wall in side of pit.

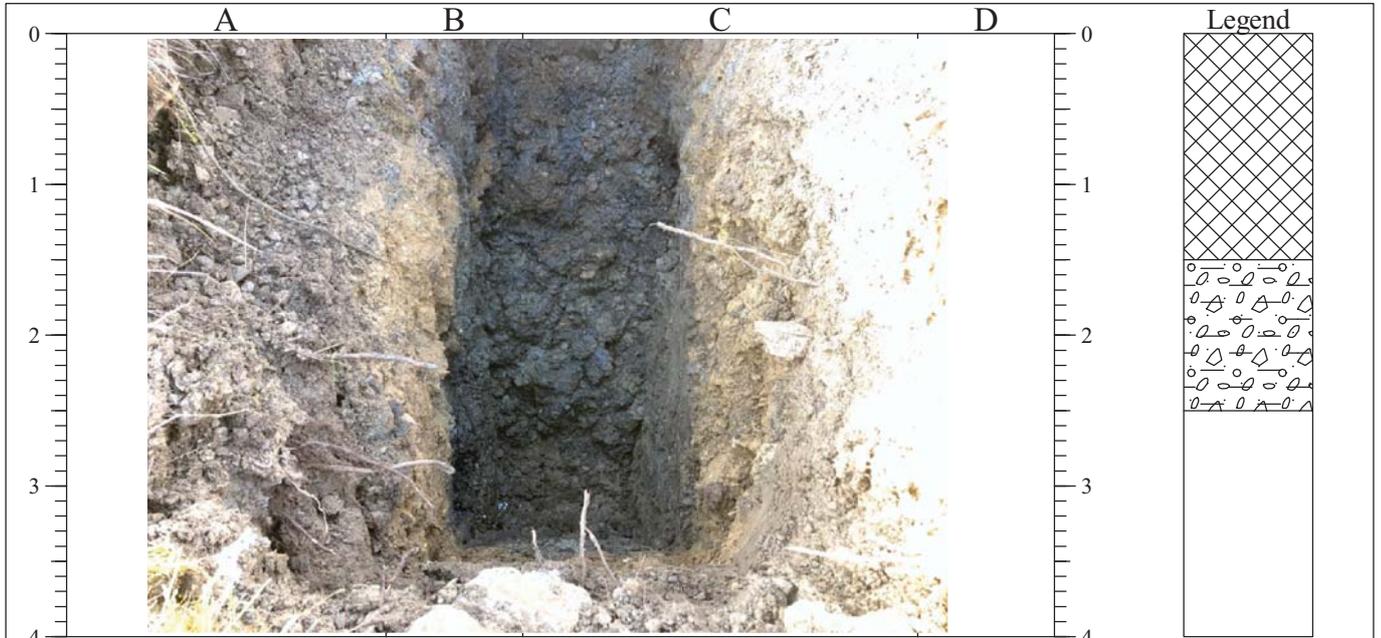
Project Pant Industrial Estate, Merthy Tydfil				TRIAL PIT No TP03
Job No 19-1012	Date 05-02-20	Ground Level (m)	Co-Ordinates ()	
Contractor Arc Environmental Limited				Sheet 1 of 1

STRATA			SAMPLES & TESTS		
Depth	No	DESCRIPTION	Depth	No	Remarks/Tests
0.00-1.50		Brown grey and black sandy gravelly clay / clayey sandy gravel. Gravel is fine to coarse comprising fragments of brick concrete sandstone breeze block and ash with some plastic. Cobbles and boulders noted (MADE GROUND).	0.30	J/D	
1.50-2.50		Brown and grey very clayey sandy GRAVEL. Becoming firm very sandy gravelly clay in places. Gravel is fine to coarse. Cobbles and boulders noted.	2.00	B	
2.50		Trial pit terminated at 2.50m.

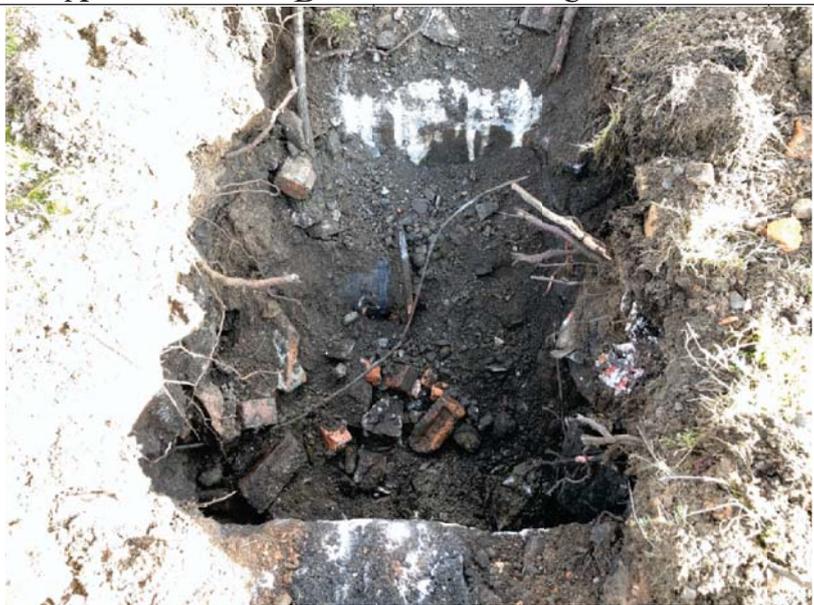
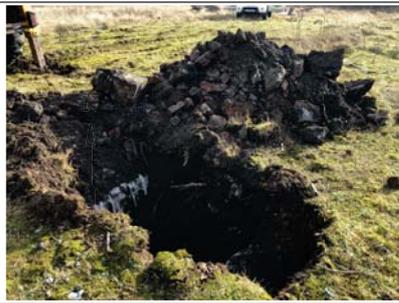
STRATA			SAMPLES & TESTS		
Depth	No	DESCRIPTION	Depth	No	Remarks/Tests
0.00-1.80		Brown grey and black sandy gravelly clay / clayey sandy gravel. Gravel is fine to coarse comprising fragments of brick concrete sandstone and ash with some metal and wire rope. Cobbles and boulders noted (MADE GROUND).			
1.80		Trial pit terminated at 1.80m due to refusal on relic concrete structure. Relic concrete structures in ends of pit.

GENERAL REMARKS
Trial pit collapsing throughout.

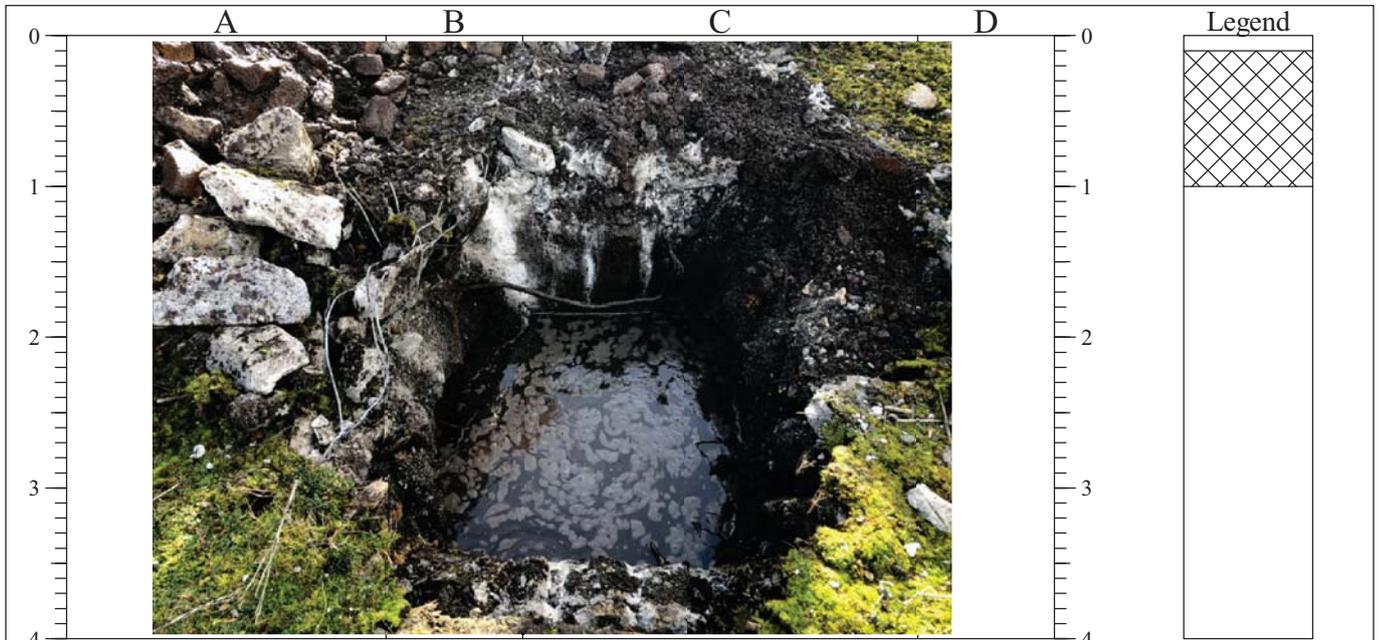
Project Pant Industrial Estate, Merthy Tydfil				TRIAL PIT No TP05
Job No 19-1012	Date 05-02-20	Ground Level (m)	Co-Ordinates ()	
Contractor Arc Environmental Limited				Sheet 1 of 1

STRATA			SAMPLES & TESTS		
Depth	No	DESCRIPTION	Depth	No	Remarks/Tests
0.00-0.10		Concrete with rebar (MADE GROUND).			
0.10-1.00		Brown grey and black sandy gravelly clay / clayey sandy gravel. Gravel is fine to coarse comprising fragments of brick concrete sandstone breeze block and ash with some plastic. Cobbles and boulders noted (MADE GROUND).			
1.00		Trial pit terminated at 1.00m due to refusal on relic concrete structure. Relic concrete structures in side of pit.

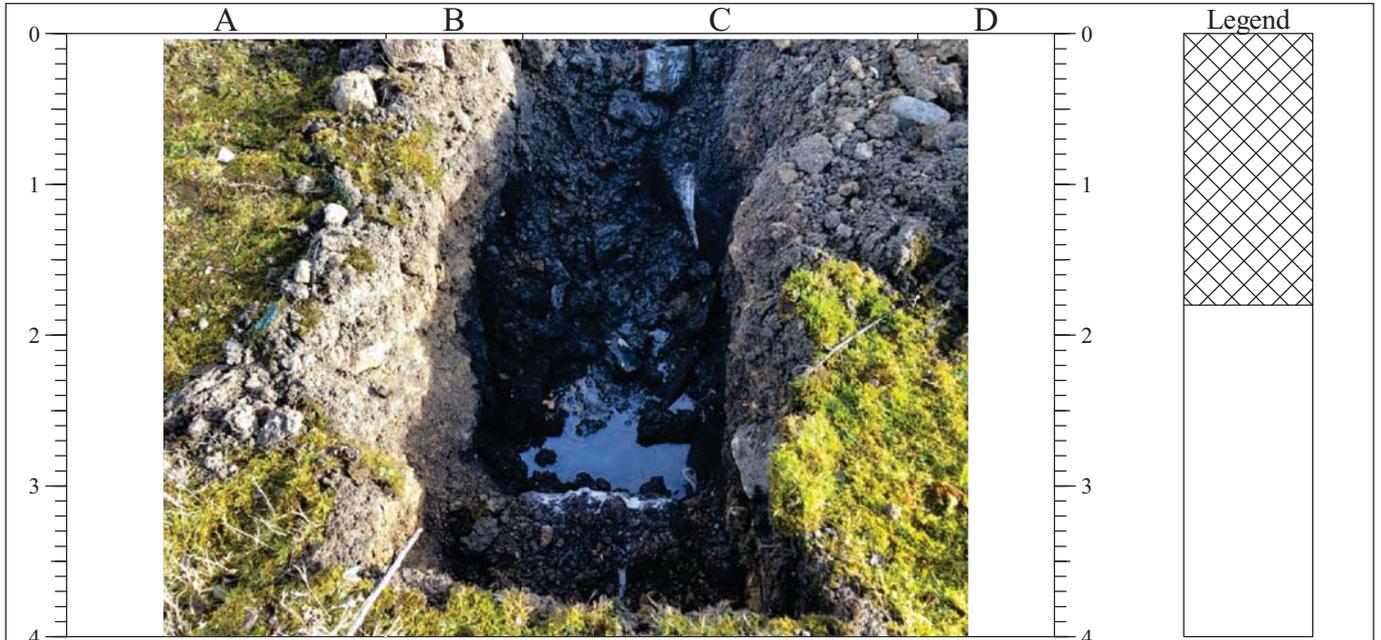
Project Pant Industrial Estate, Merthy Tydfil				TRIAL PIT No TP06
Job No 19-1012	Date 05-02-20	Ground Level (m)	Co-Ordinates ()	
Contractor Arc Environmental Limited				Sheet 1 of 1

STRATA			SAMPLES & TESTS		
Depth	No	DESCRIPTION	Depth	No	Remarks/Tests
0.00-1.80		Brown grey and black sandy gravelly clay / clayey sandy gravel. Gravel is fine to coarse comprising fragments of brick concrete sandstone and ash with some metal and wire rope. Cobbles and boulders noted (MADE GROUND).	0.50	J/D	
1.80		Trial pit terminated at 1.80m due to refusal on relic concrete structure. Relic concrete structures in ends of pit.

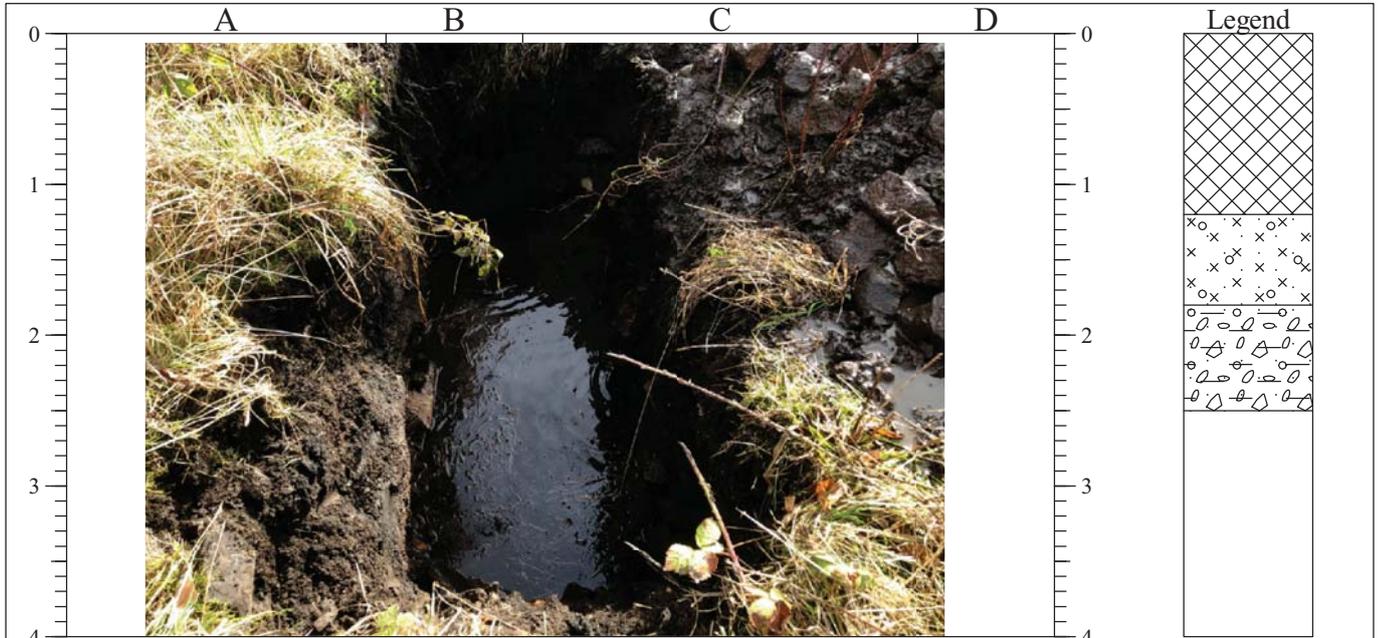
Project Pant Industrial Estate, Merthy Tydfil				TRIAL PIT No TP07
Job No 19-1012	Date 05-02-20	Ground Level (m)	Co-Ordinates ()	
Contractor Arc Environmental Limited				Sheet 1 of 1

STRATA			SAMPLES & TESTS		
Depth	No	DESCRIPTION	Depth	No	Remarks/Tests
0.00-1.20		Black sandy gravel. Gravel is fine to coarse comprising fragments of ash concrete and brick. Cobbles and boulders noted (MADEGROUND).	0.50	J/D	20kN/m ²
1.20-1.80		Very soft brown and medium brown slightly sandy gravelly SILT. Gravel is fine to coarse of sandstone.	1.50	V	
1.80-2.50		Brown and grey very clayey sandy GRAVEL. Becoming firm very sandy gravelly clay in places. Gravel is fine to coarse. Cobbles and boulders noted.			
2.50		Trial pit terminated at 2.50m.

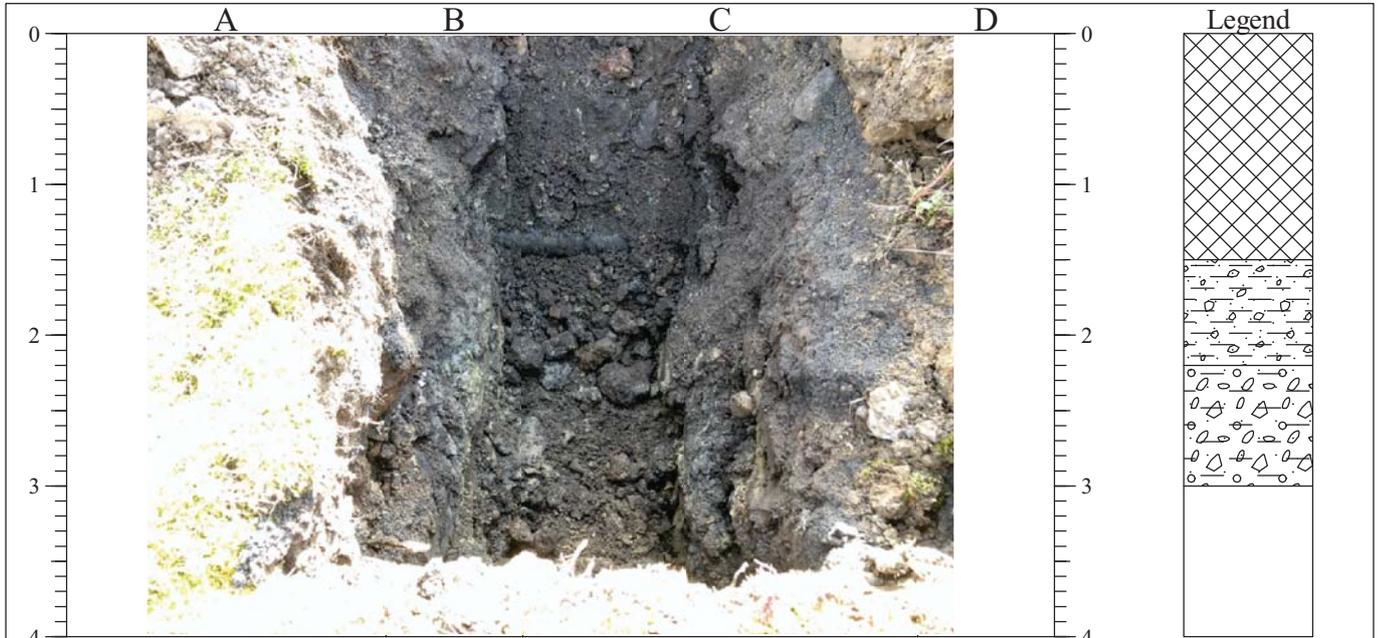
Project Pant Industrial Estate, Merthy Tydfil				TRIAL PIT No TP08
Job No 19-1012	Date 05-02-20	Ground Level (m)	Co-Ordinates ()	
Contractor Arc Environmental Limited				Sheet 1 of 1

STRATA			SAMPLES & TESTS		
Depth	No	DESCRIPTION	Depth	No	Remarks/Tests
0.00-1.50		Brown grey and black sandy gravelly clay / clayey sandy gravel. Gravel is fine to coarse comprising fragments of brick concrete sandstone and ash with some metal. Cobbles and boulders noted (MADE GROUND).	0.40	J/D	
1.50-2.20		Stiff (high strength) brown and grey sandy gravelly CLAY.			
2.20-3.00		Brown and grey very clayey sandy GRAVEL. Becoming firm very sandy gravelly clay in places. Gravel is fine to coarse. Cobbles and boulders noted.	2.00 2.00	B V	80kN/m ²
3.00		Trial pit terminated at 3.00m. C.200mm diameter cast iron pipe in end of pit.

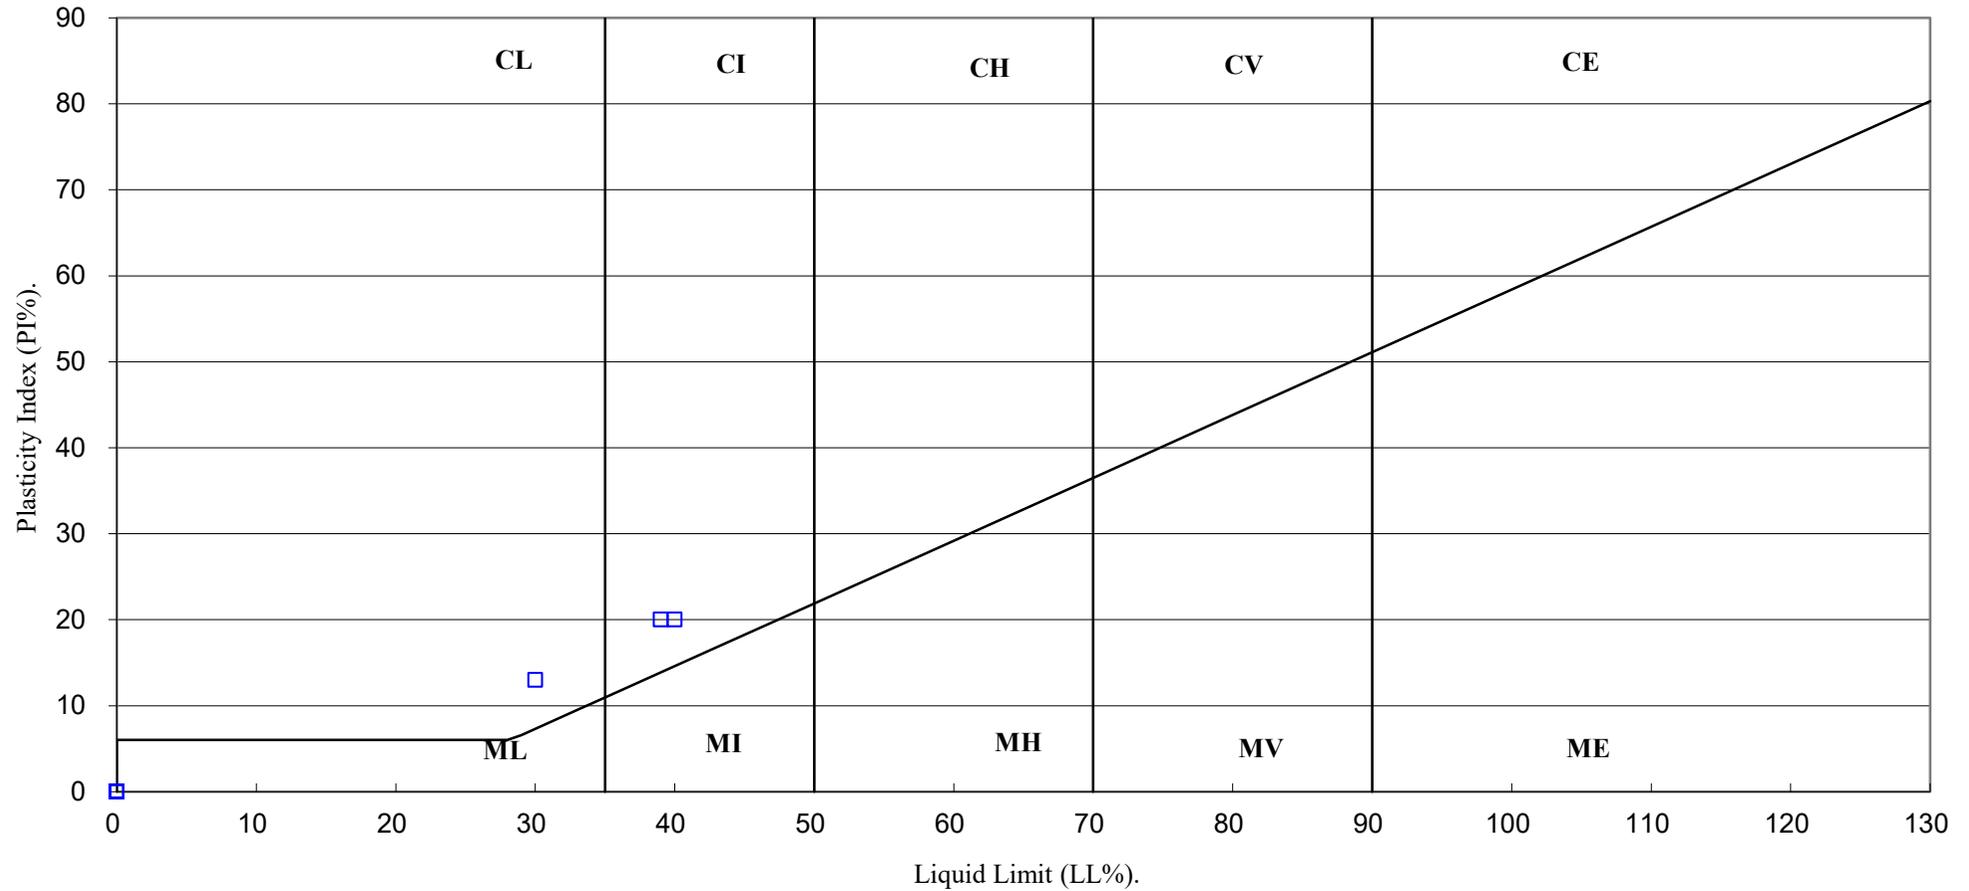
PLASTICITY CHART FOR CASAGRANDE CLASSIFICATION.

Representative samples of the cohesive natural deposits recovered from the trial pits and boreholes were tested in order to determine their liquid and plastic limits, so these materials could be classified. The results can be seen in Table 6.1 below, and are also contained in the PSL analytical report ref no. PSL20/1060 a copy of which can be found in Appendix IV.

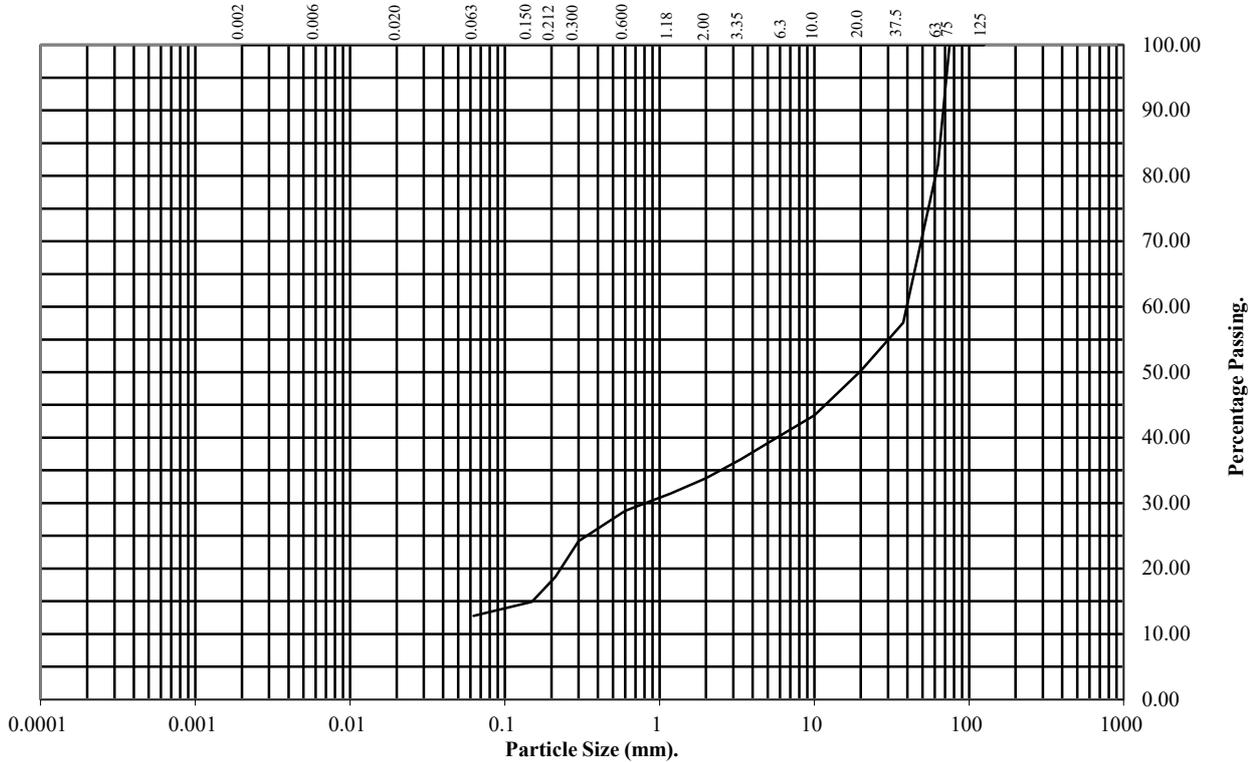
BS Test Sieve (mm)	Percentage Passing
125	100
75	100
63	82
37.5	58
20	50
10	43
6.3	41
3.35	37
2	34
1.18	31
0.6	29
0.3	24
0.212	19
0.15	15
0.063	13

Soil Fraction	Total Percentage
Cobbles	18
Gravel	48
Sand	21
Silt/Clay	13

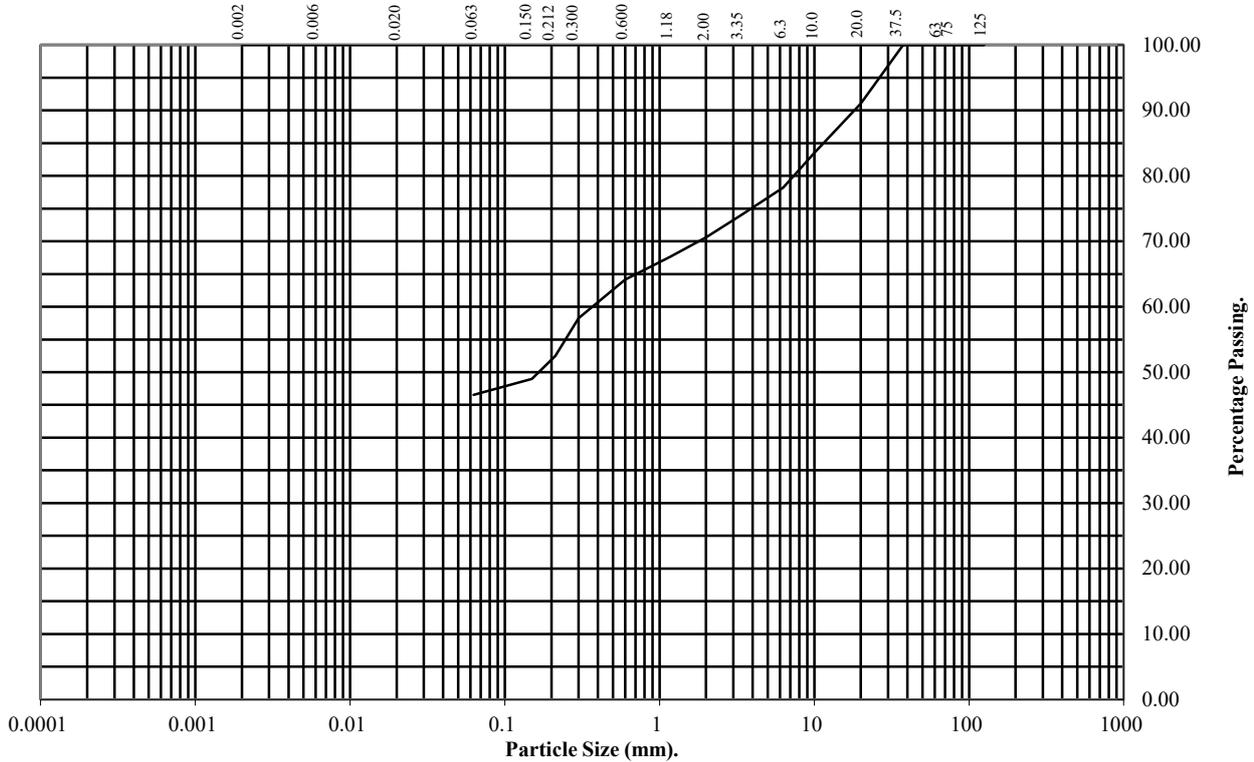
BS Test Sieve (mm)	Percentage Passing
125	100
75	100
63	100
37.5	100
20	91
10	84
6.3	78
3.35	74
2	71
1.18	68
0.6	64
0.3	58
0.212	53
0.15	49
0.063	47

Soil Fraction	Total Percentage
Cobbles	0
Gravel	29
Sand	24
Silt/Clay	47

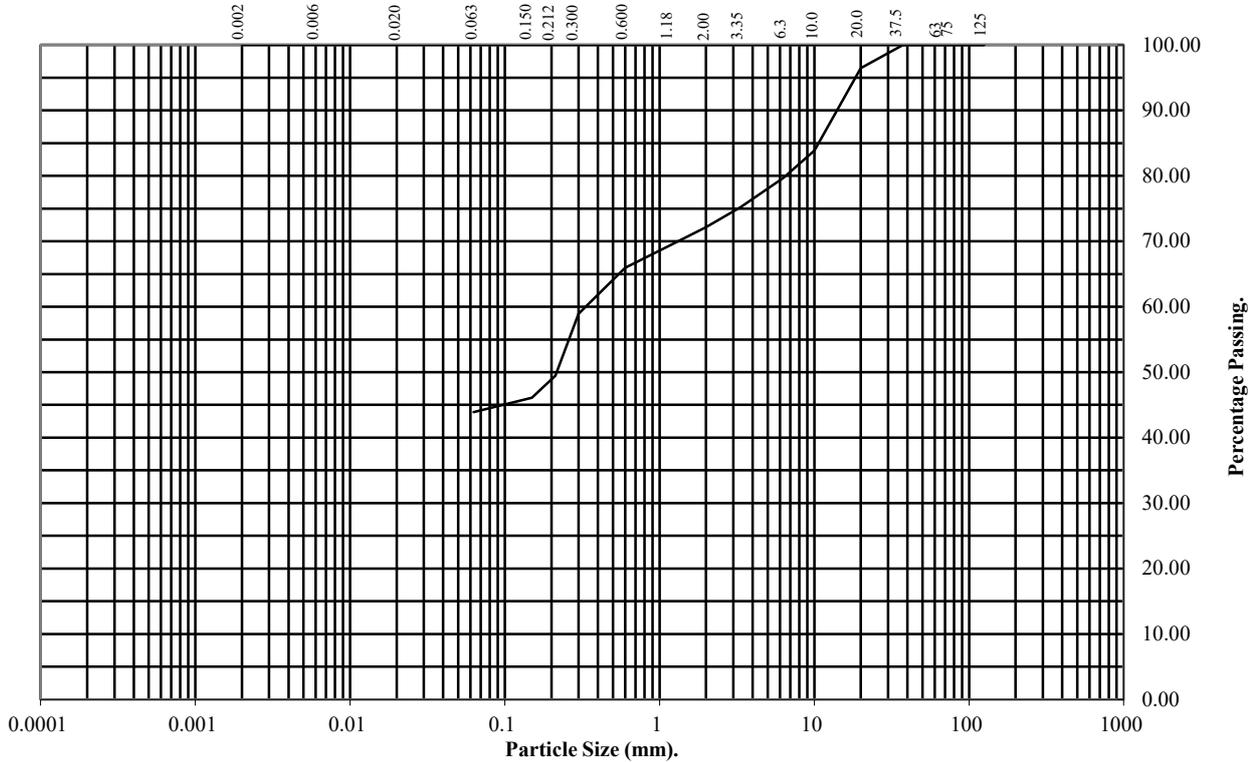
BS Test Sieve (mm)	Percentage Passing
125	100
75	100
63	100
37.5	100
20	96
10	84
6.3	80
3.35	75
2	72
1.18	69
0.6	66
0.3	59
0.212	49
0.15	46
0.063	44

Soil Fraction	Total Percentage
Cobbles	0
Gravel	28
Sand	28
Silt/Clay	44
