Combined Arboricultural Impact Assessment/ Method Statement Land Adjacent to Brynheulog St Clears Carmarthenshire SA33 4ER

Conducted By: Ben Clark TechArborA

16/07/24

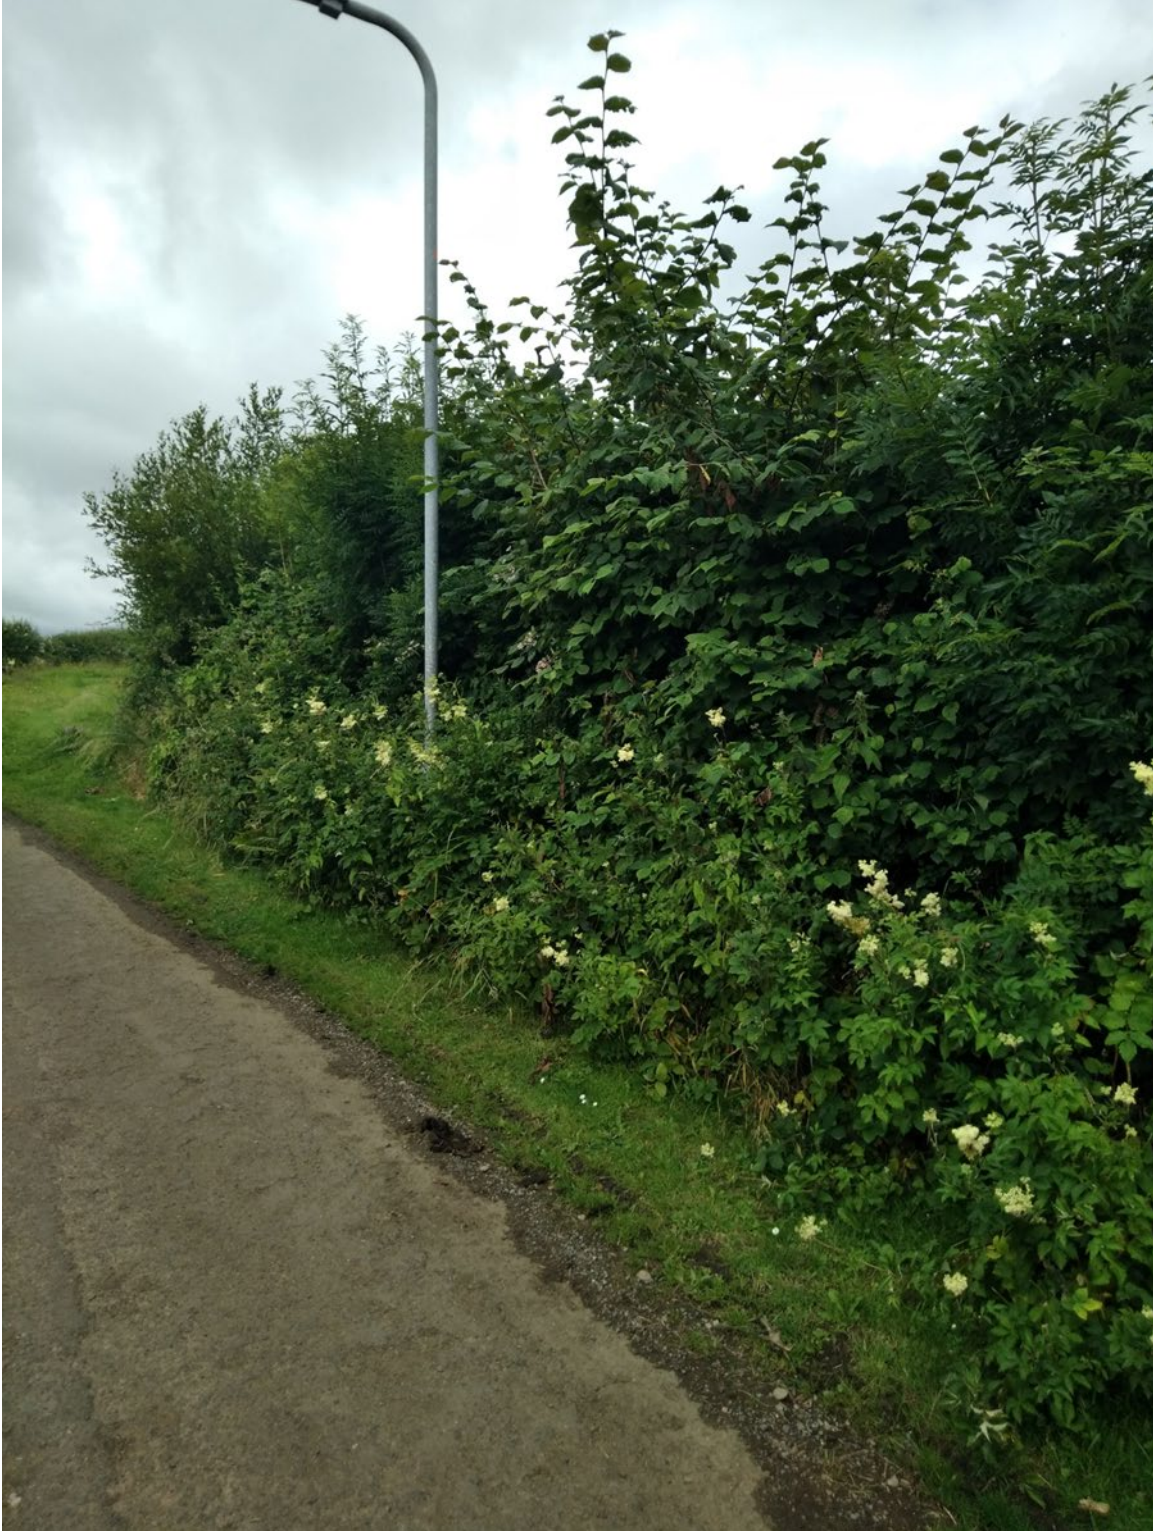
Photo I- [HI](#)- Small hedge between site and narrow road.

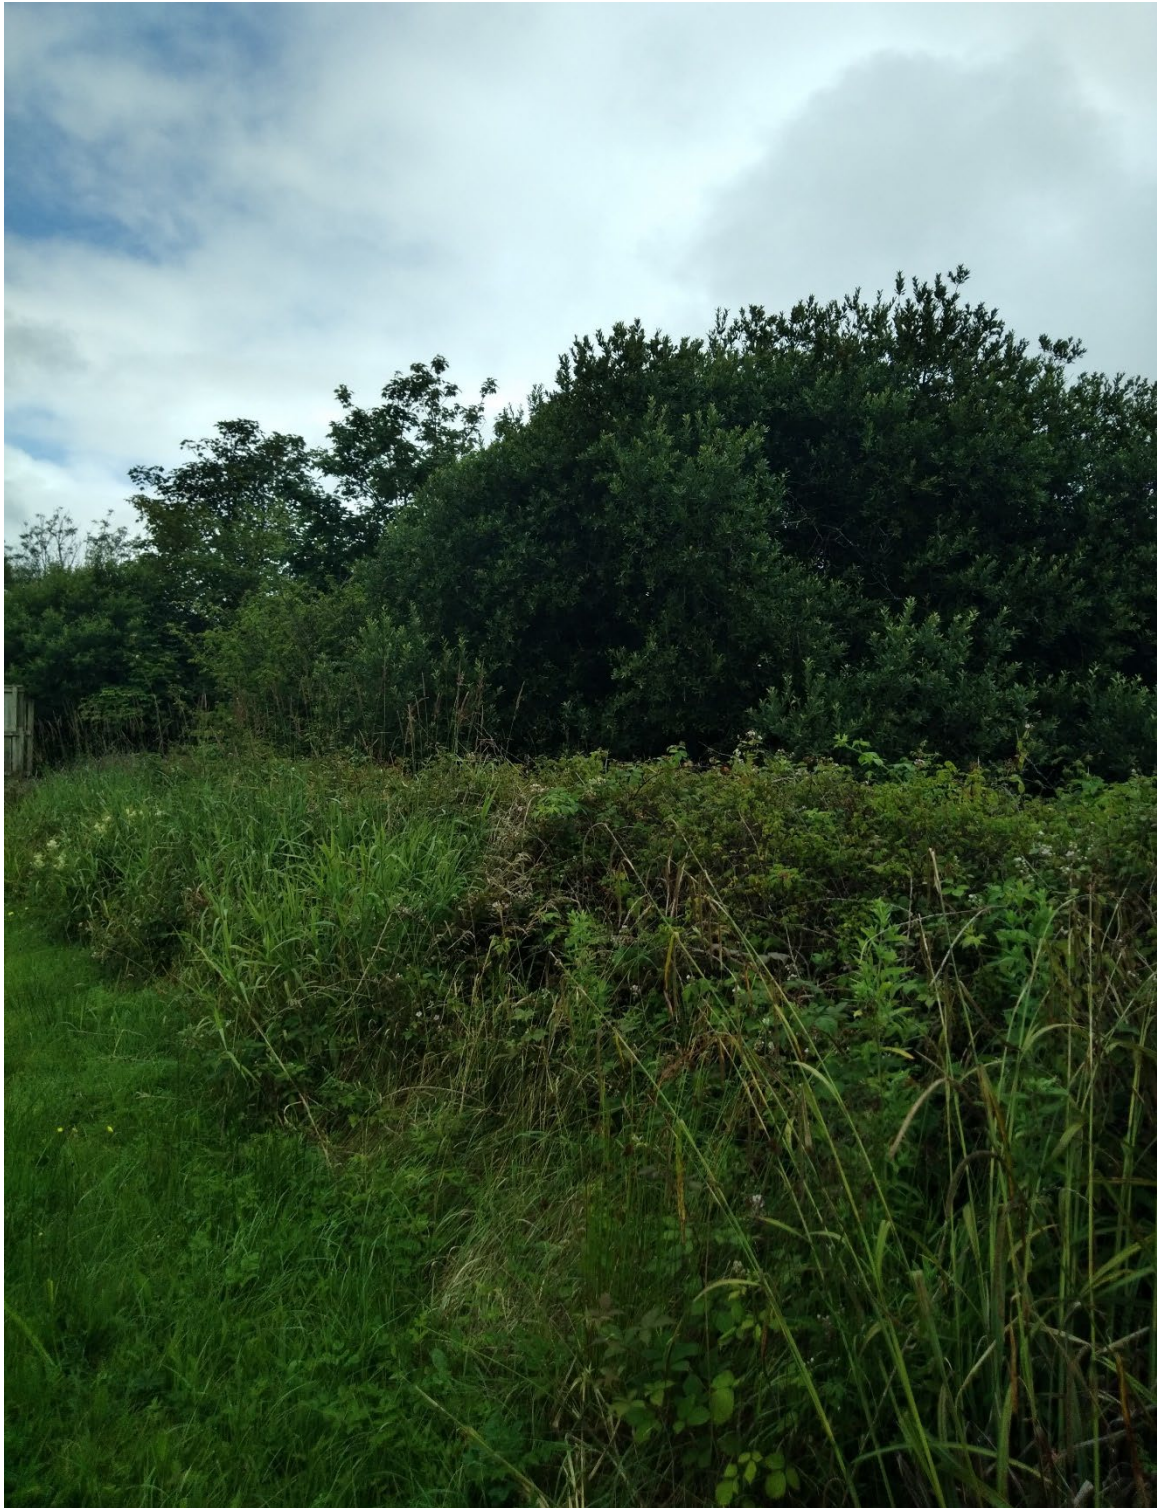
Photo 2 – G1- Group of trees between site and main road.

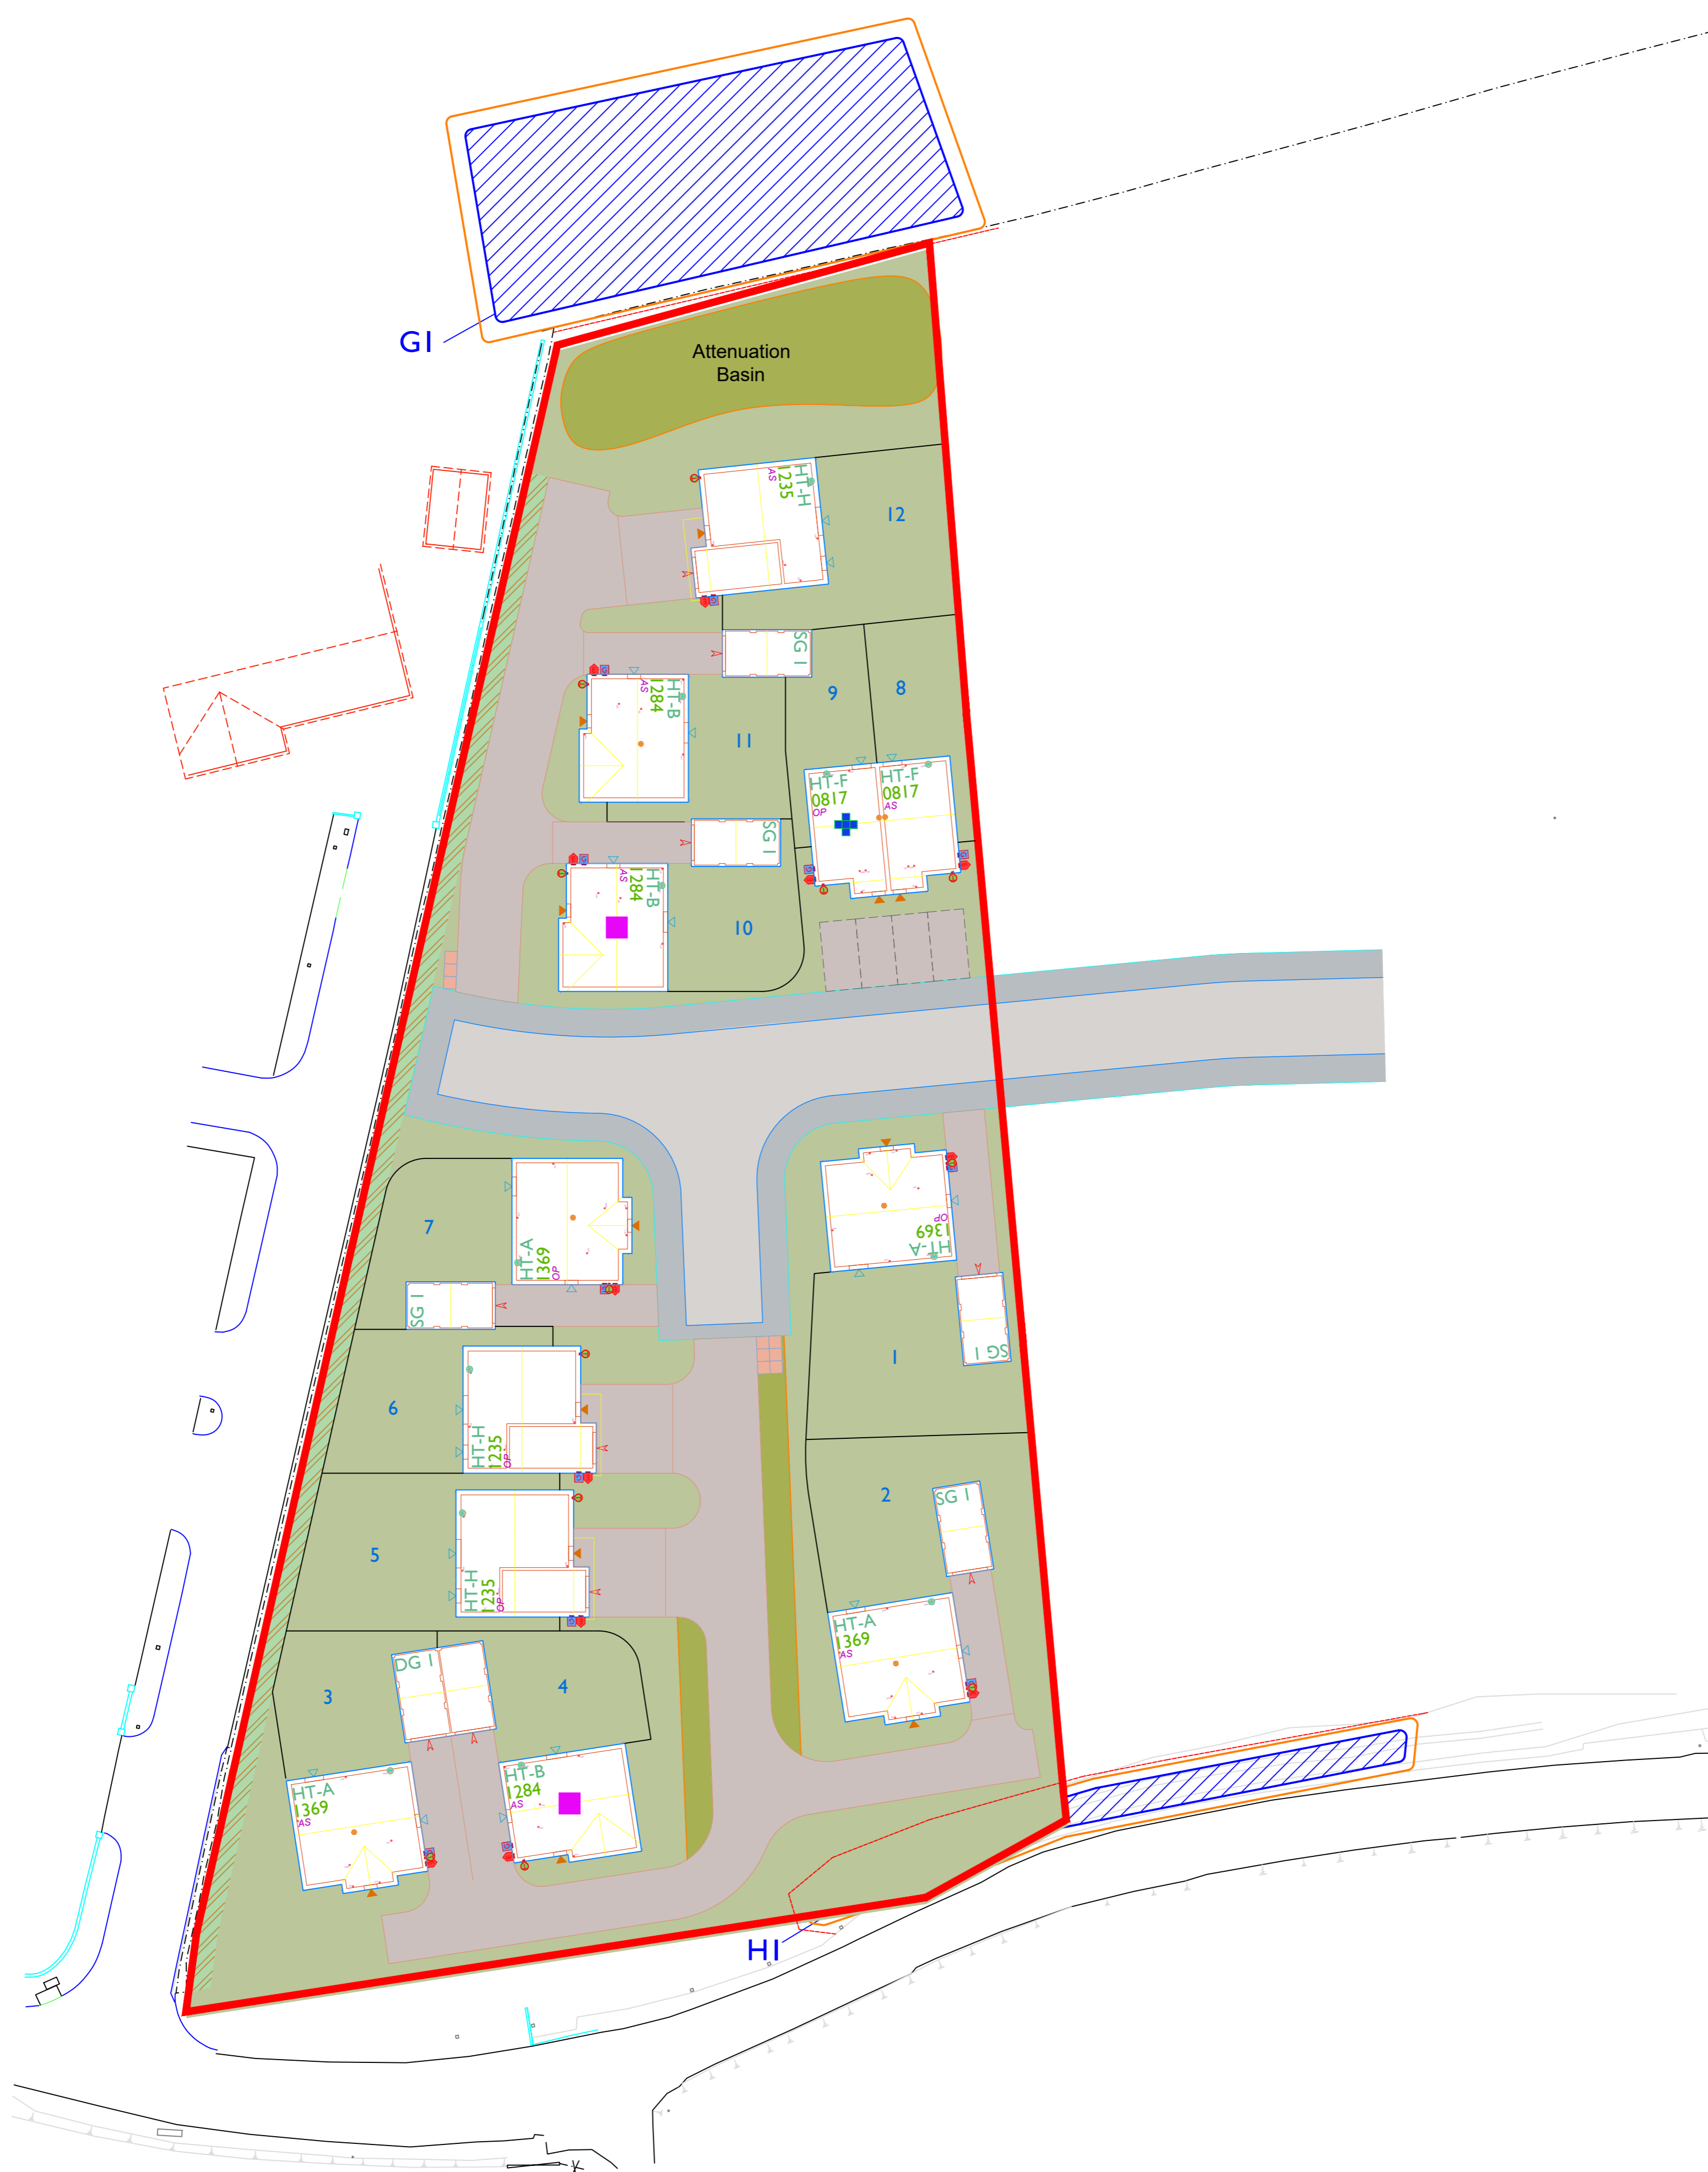
Appendix ii: Tree Protection Plan 17

Drawing designed to be viewed in colour.
Indicative only, check all RPA's on site in accordance with table.

A number of areas on site have been highlighted as areas of caution, these are areas where there is a heightened risk of damage to the above ground structure or root system of retained trees through the proposed works. Certain methodologies in this document will state that they must be followed within areas of caution. The location of all areas of caution can be found on the [Tree Protection Plan](#) within the appendix section of this report.

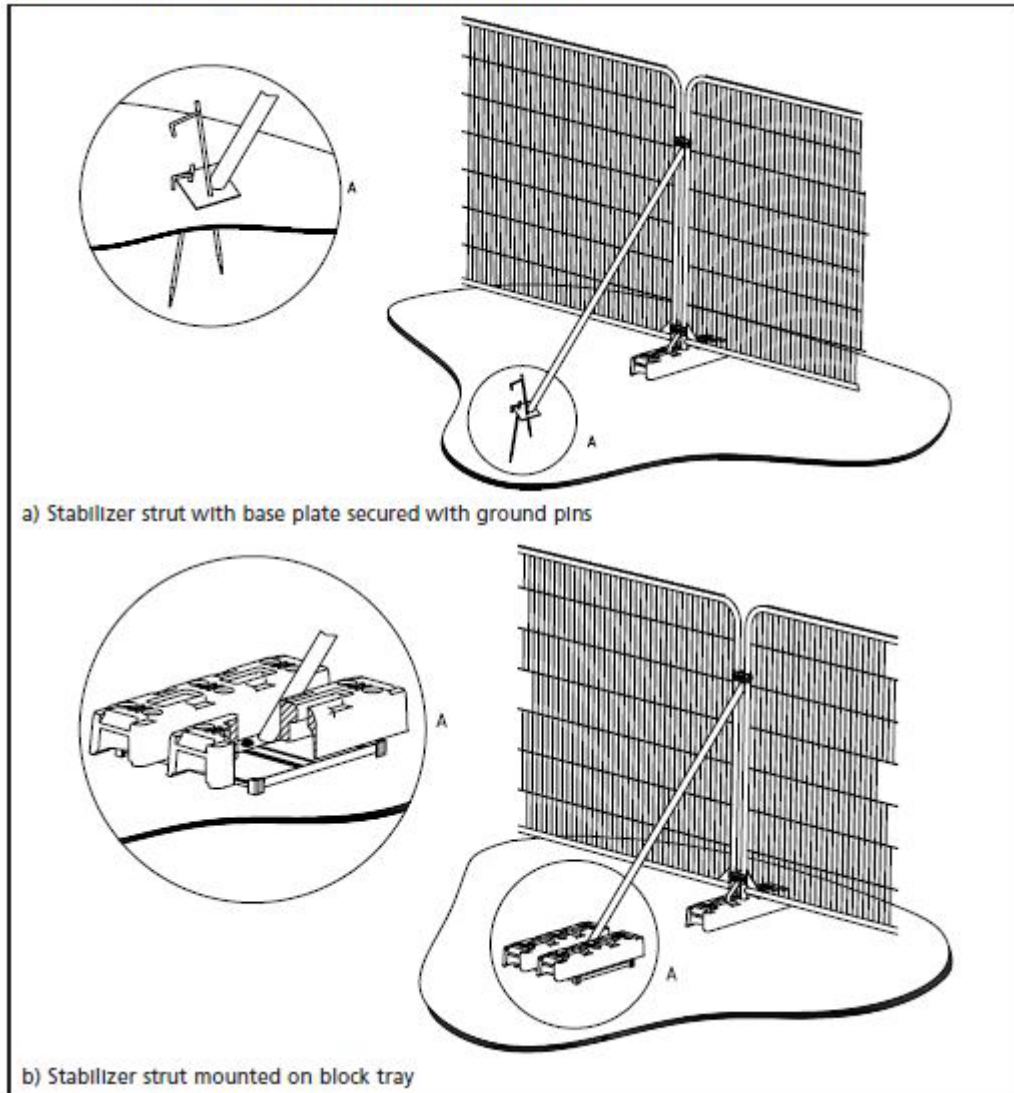
Figure 3 Examples of above-ground stabilizing systems

Appendix iv: A diagram showing the recommended configuration for tree protective fencing, from BS5837: 2012- Trees in relation to design, demolition, and construction– Recommendations.

- Tree protective barrier fencing must be installed in the configuration outlined in the [Tree Protection Plan](#).
- The standard level of tree protective fencing ([figure 3](#)) as outlined in BS5837 is preferable for this site due to volume of plant and vehicle movement expected on site. This configuration avoids driving posts into the ground, thus reducing root disturbance.
