**CARDIFF CITY COUNCIL**

**FORMER NEW PENNSYLVANIA PUBLIC HOUSE**

**PHASE I DESK STUDY & SITE INVESTIGATION WORKS**

**NOVEMBER 2022**

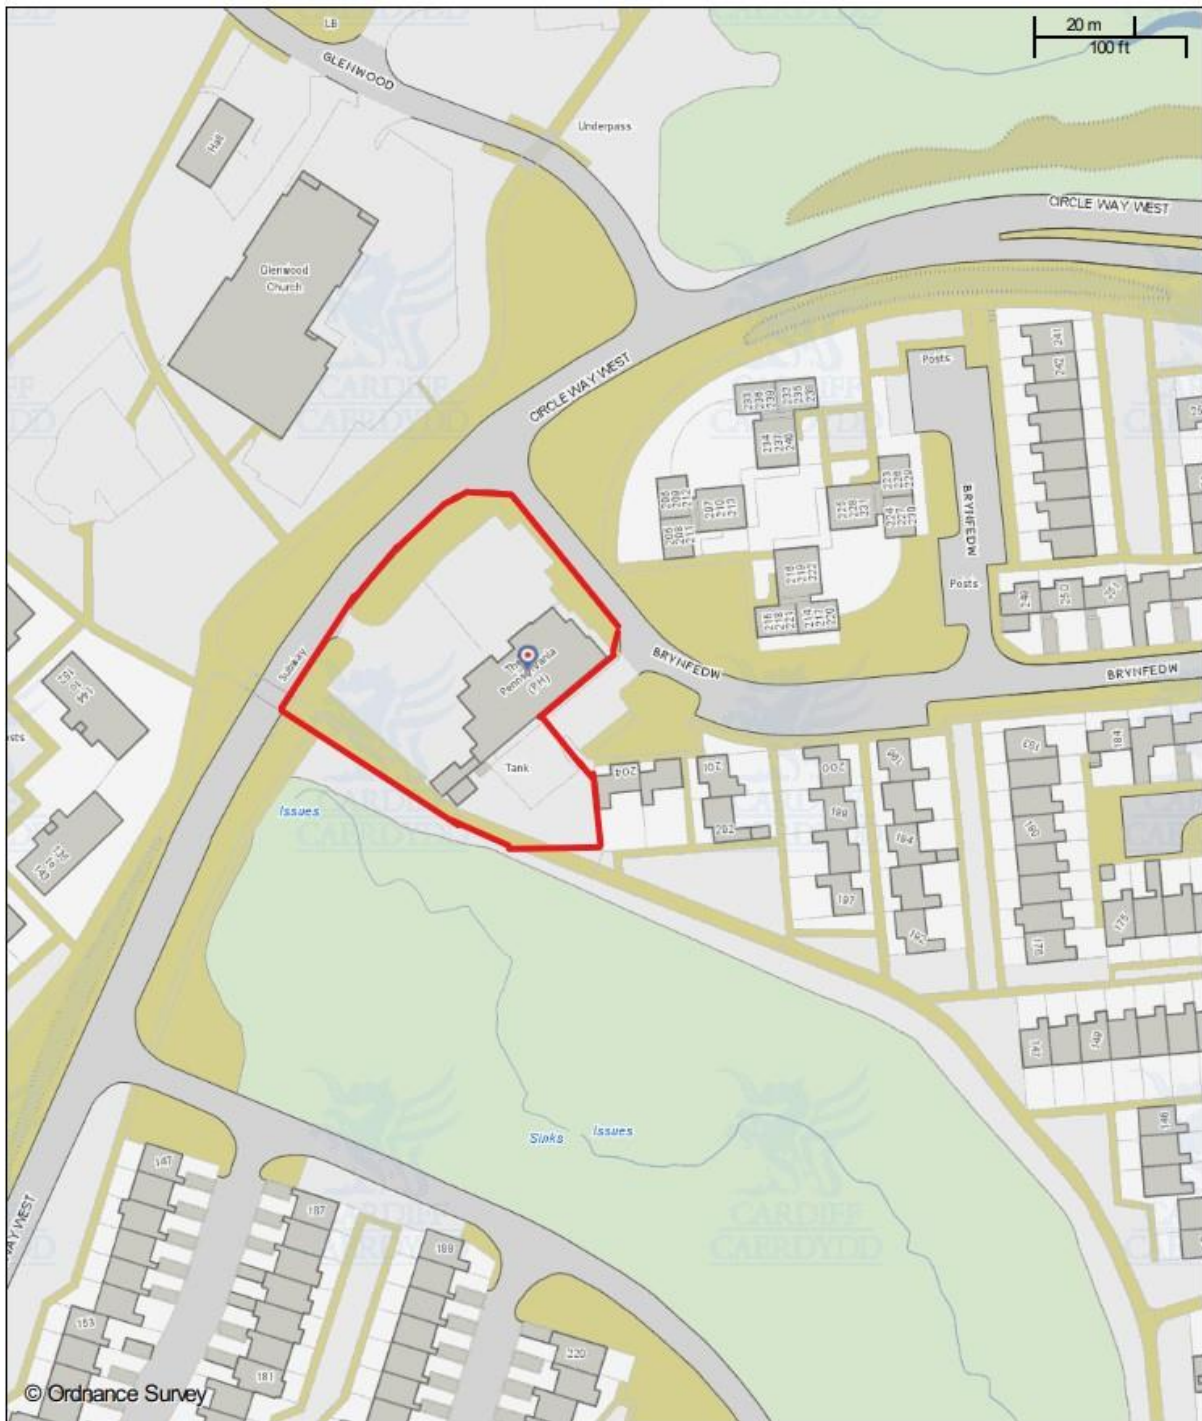
Figure 1: Plan Showing the Approximate Site Boundary (not to scale) (OS Maps)

- 1.3 The site is located off Cardiff West Way Road, Cardiff, Wales. The site covers an area of approximately 0.29 hectares and is centred at National Grid Reference 319872 E, 180522 N. The site boundary is shown on Drawing no. *CA12409-002A*.
- 1.4 The site is derelict, comprising a two-storey building (former New Pennsylvania public house) with an above-ground storage tank located on the buildings southern exterior wall, hardstanding (former car parking), grassland to the south of the building and several trees along the site boundary. The site is within a residential area.
- 1.5 Topographically, the site slopes gently from north (c.49m AOD) to south (c.49m AOD).
- 1.6 A site boundary is shown in **Figure 1**.

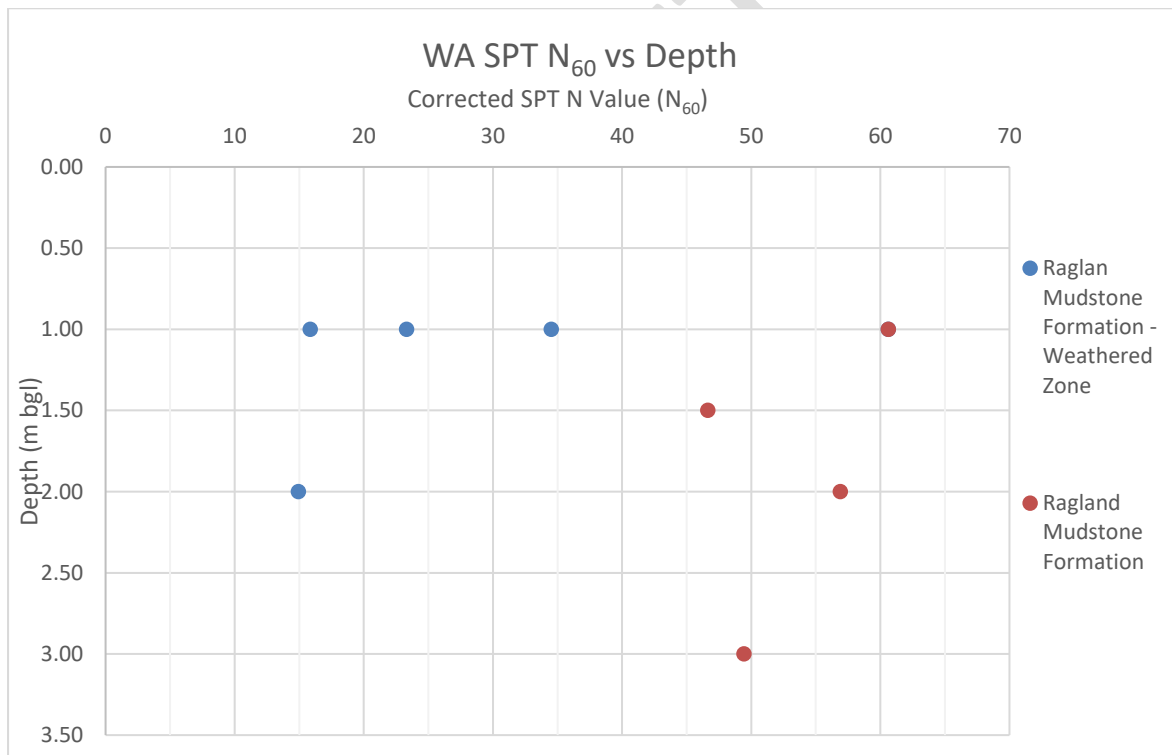
- 15.1 In addition to laboratory geotechnical testing, in-situ standard penetration tests (SPTs) were carried out within the boreholes during the ground investigation. The results are presented in **Figure 2**.
- 15.2 Raw SPT N values have been corrected to 60% of the theoretical free fall hammer energy. SPT Calibration Certificates were obtained for the drilling rigs utilised during the ground investigation works.
- 15.3 The SPT N<sub>60</sub> values presented in Figure 2 indicates a notable difference in the relative strength between the weathered zone (SPT N<sub>60</sub> 14-34) and the bedrock (SPT N<sub>60</sub> 46-61) of the Raglan Mudstone Formation.

**Figure 2: Graph of N<sub>60</sub> values against depth**

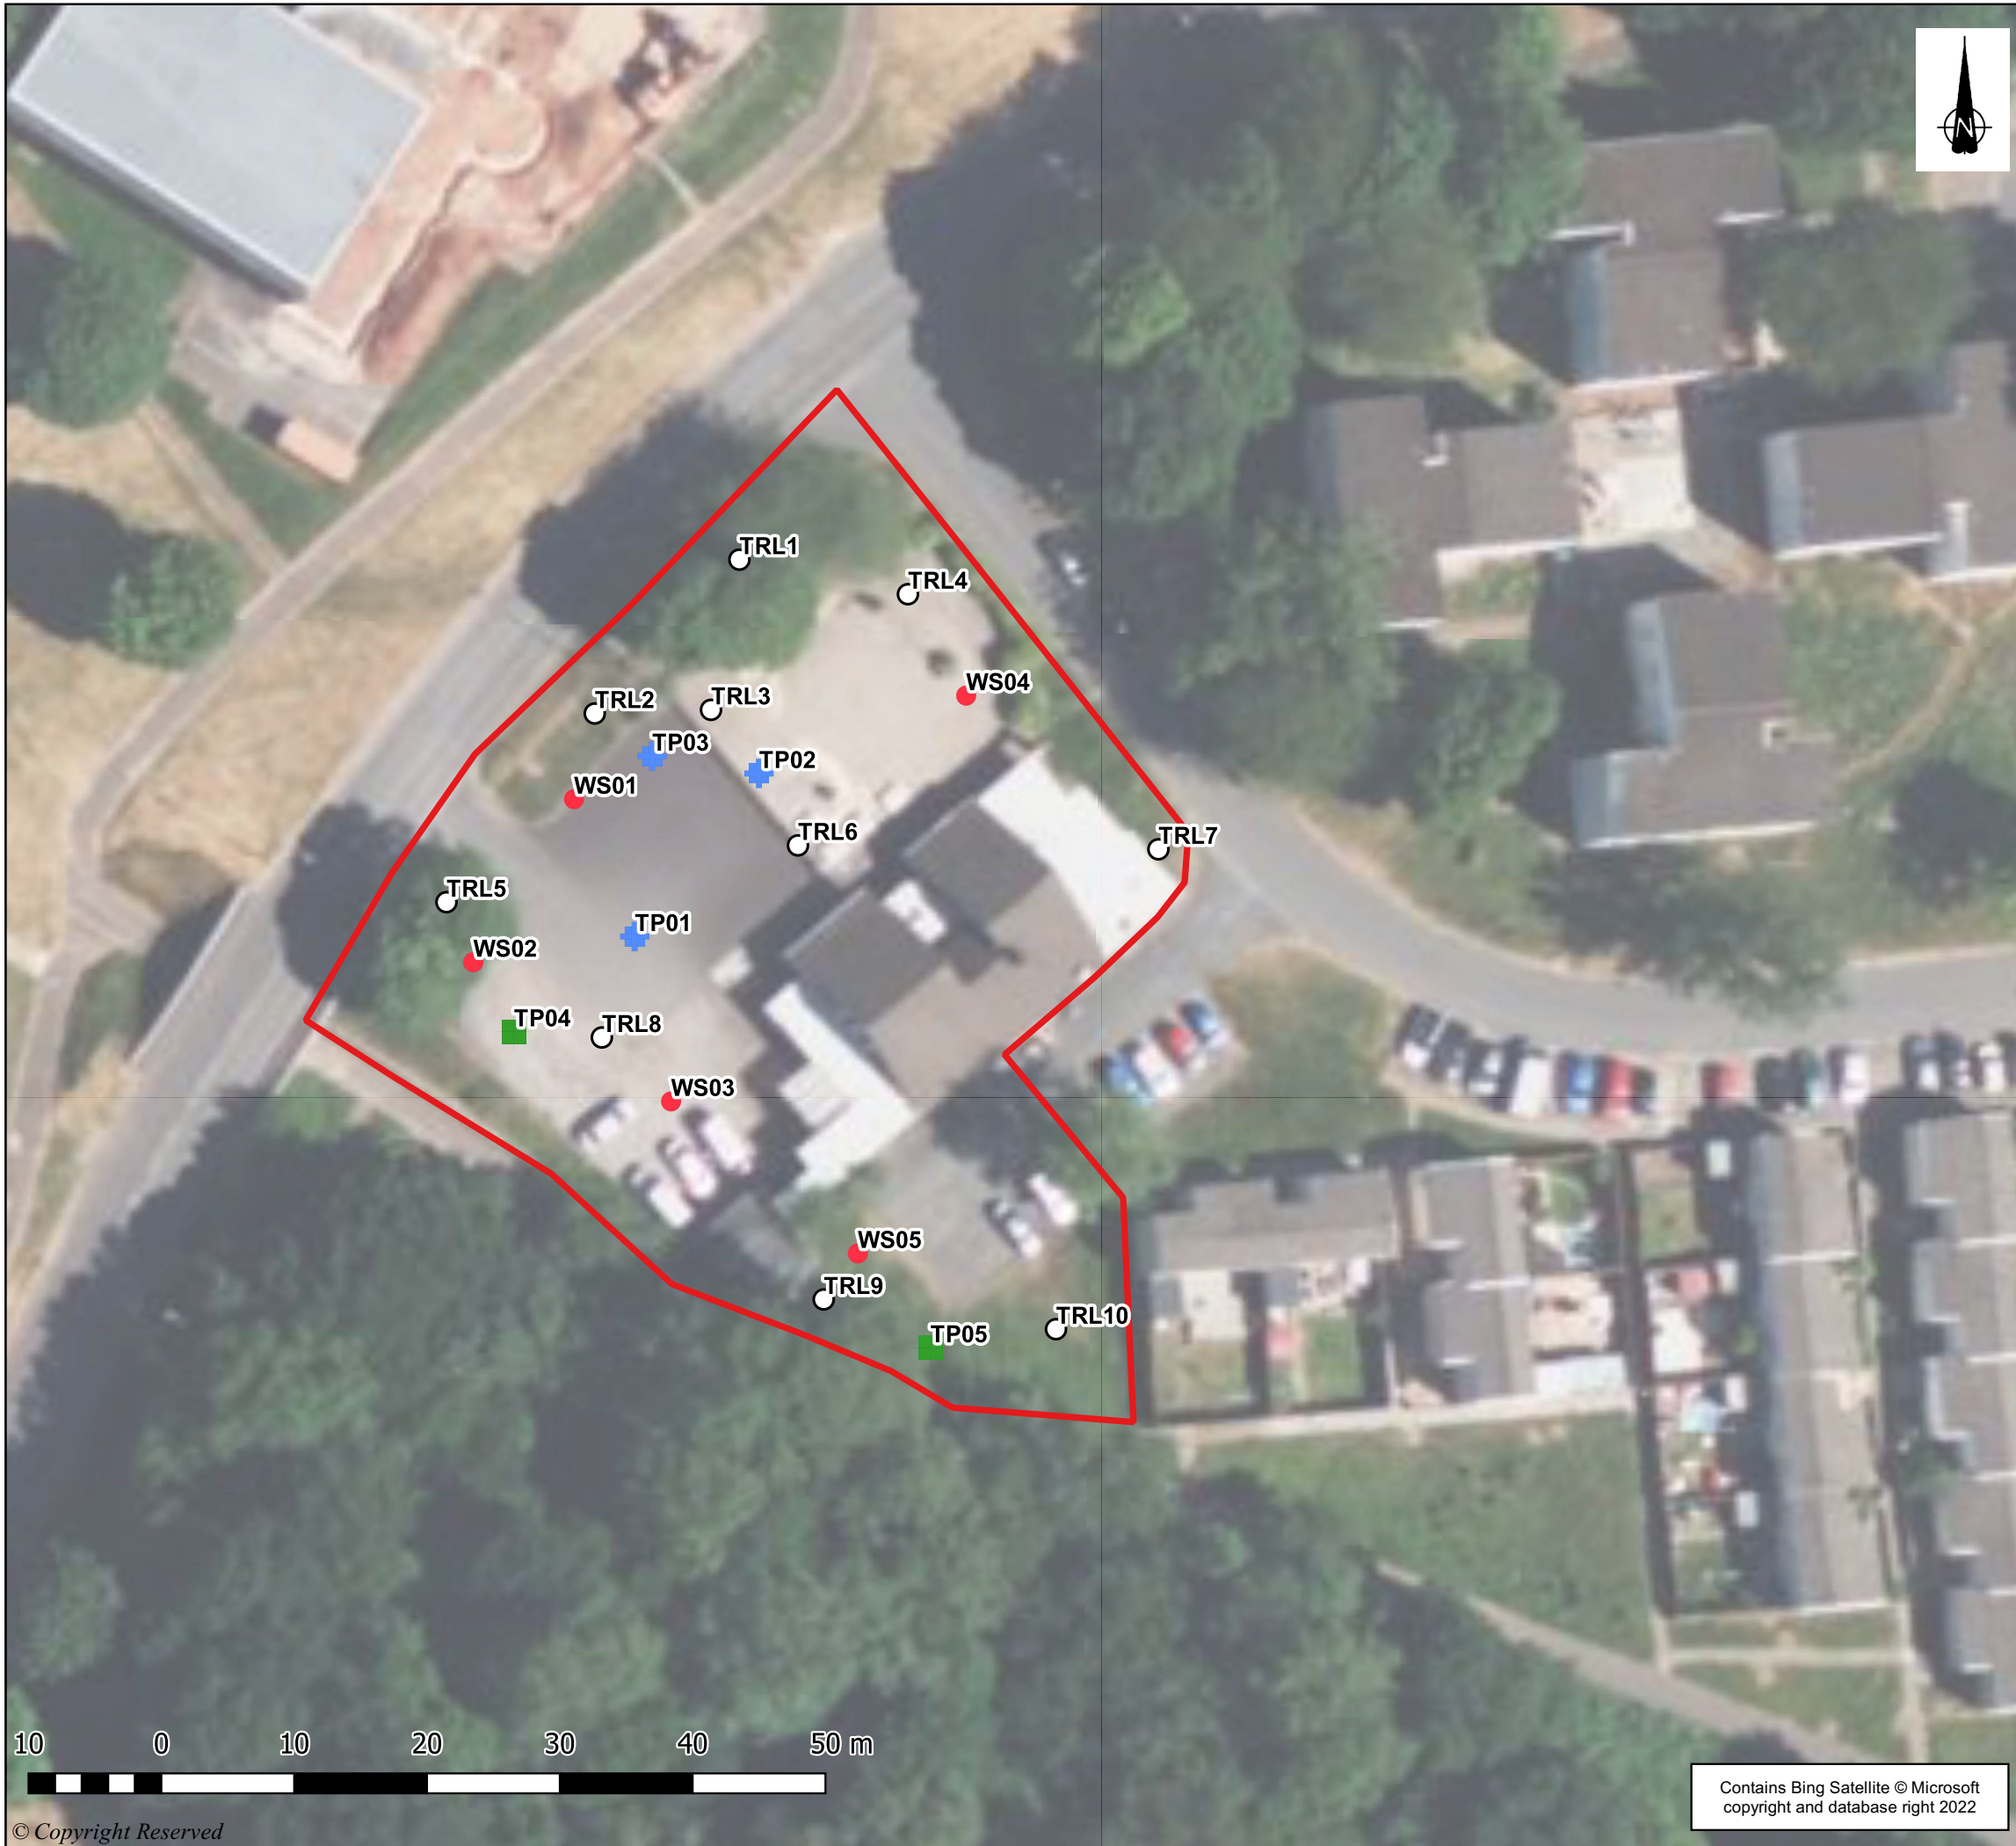
**Exploratory Hole Location Plan**

- KEY**
- Indicative Site Boundary
  - Windowless Sampler Borehole
  - Trial Pit Excavation
  - Trial Pit & Soakaway test
  - TRL-Dynamic Cone Penetration test
