## Bat Survey: Midway Lane, Abergavenny

Instructed by: Hopgrove Construction Ltd

Reported by: Ecological Services Ltd

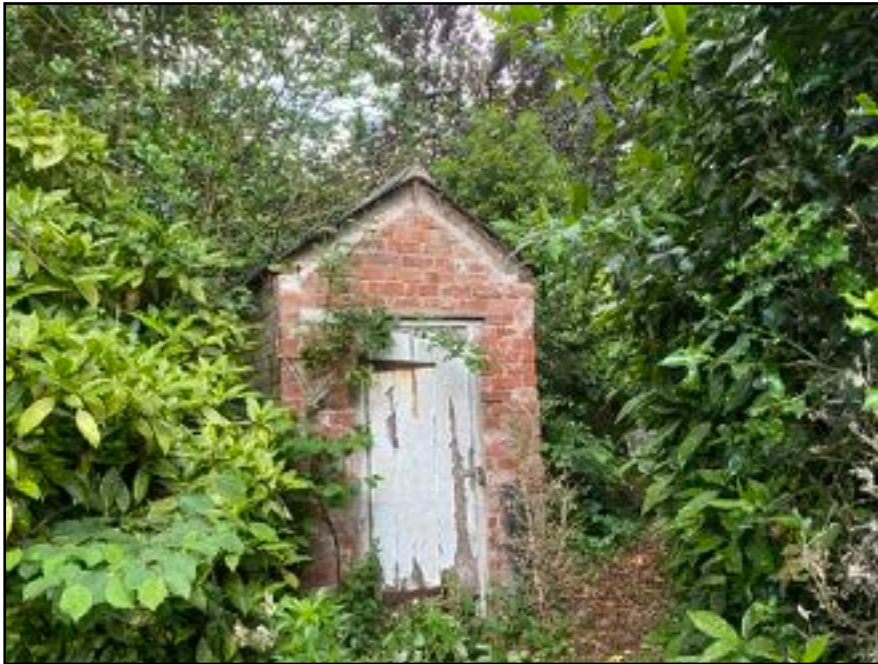
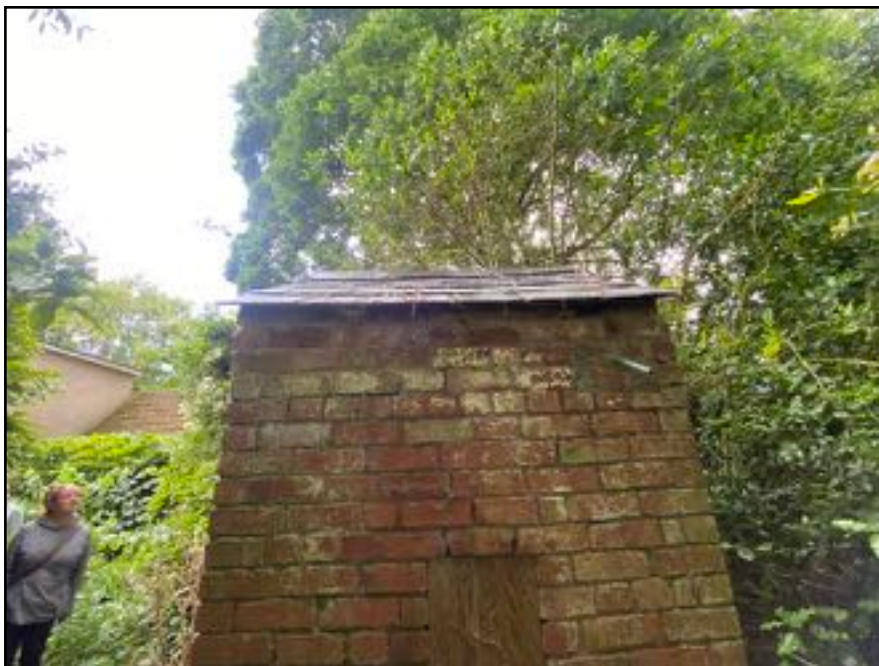
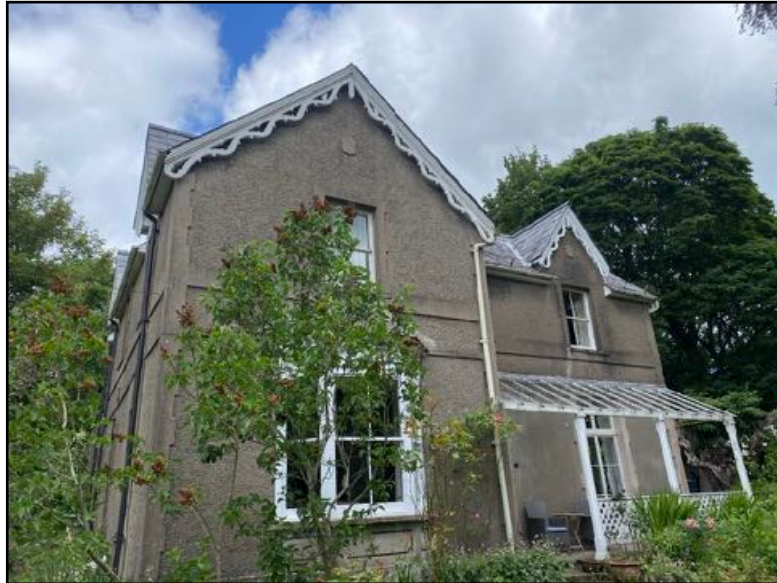
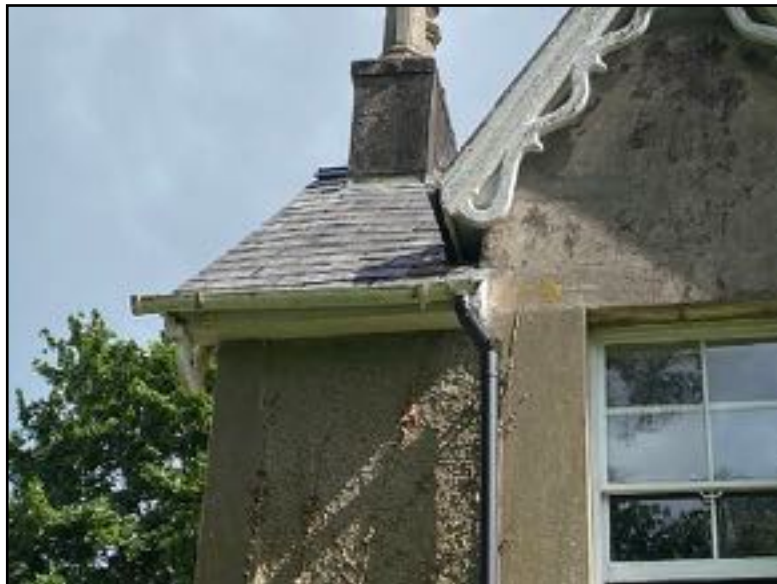
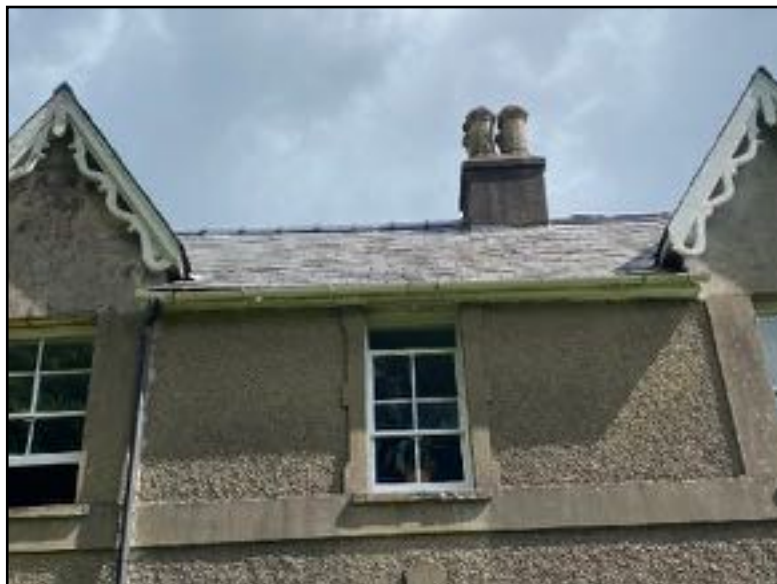
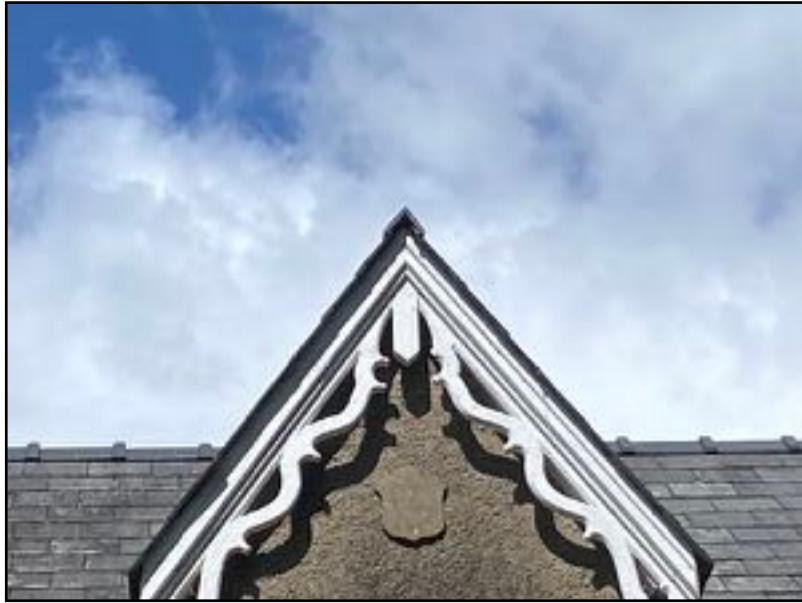
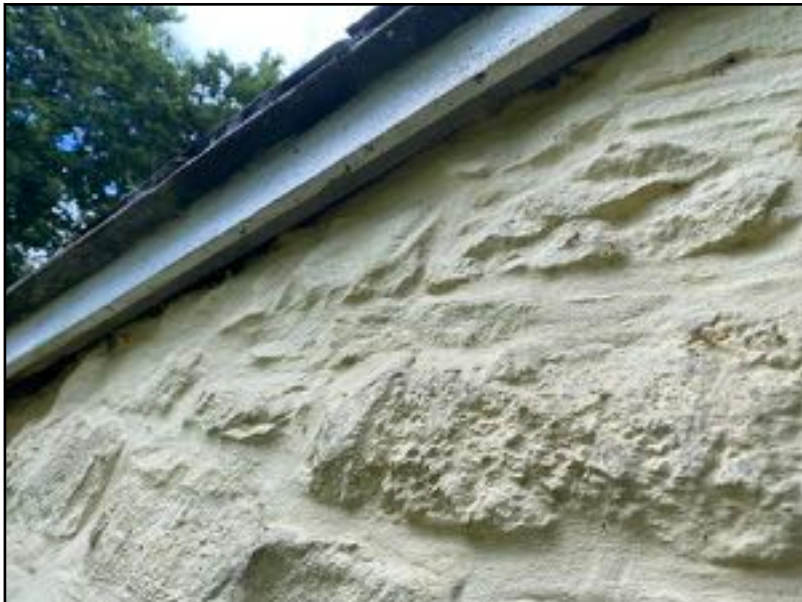
## 6.6 Examples of apertures allowing access to cavities in the buildings:

**6.3** Due to the age and condition of the dwelling, there were a number of opportunities present for bats to access and use the building and those that were available were classed as having high potential for roosting bats. There were raised slates and ridge tiles; apertures between the soffits and the walls; apertures at the corners and apexes of the dormers; areas of slightly raised lead flashing; raised tiles on the extensions and apertures between the soffits and the walls on the extensions. Due to the age and condition of the outbuilding, there were a limited number of opportunities present for bats to access and use the building and those that were available were classed as having low potential for roosting bats.

**6.4** No droppings or evidence of bats were discovered on any external features. However, this does not prove that bats are absent from the buildings.

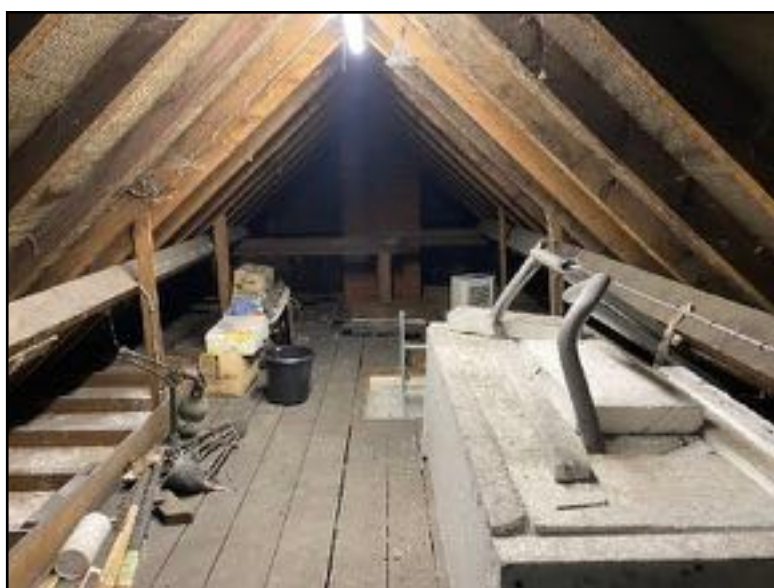
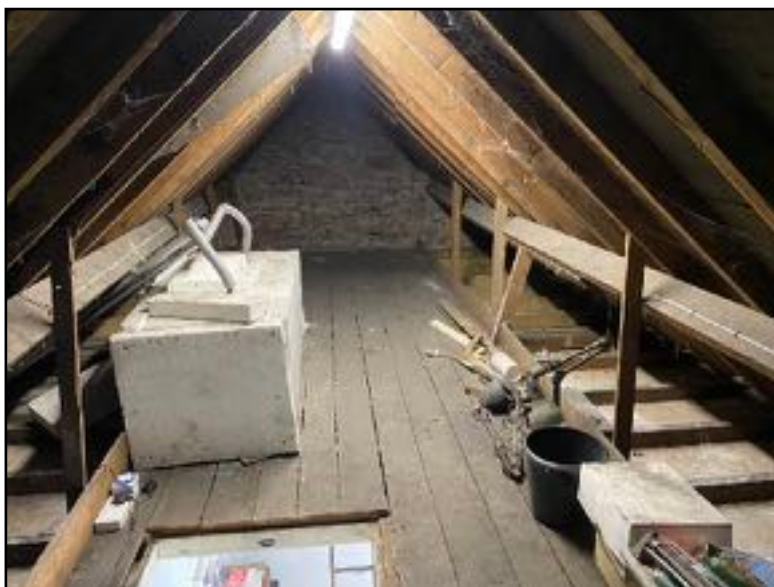
**7.3** There was an accessible attic space within the main dwelling. The space was lined; centrally boarded out and of a traditional cut design. There was also a small attic space within a single storey lean-to section to the western elevation of the dwelling which was lined.

**7.4** No droppings or evidence of bats were discovered on any internal features.

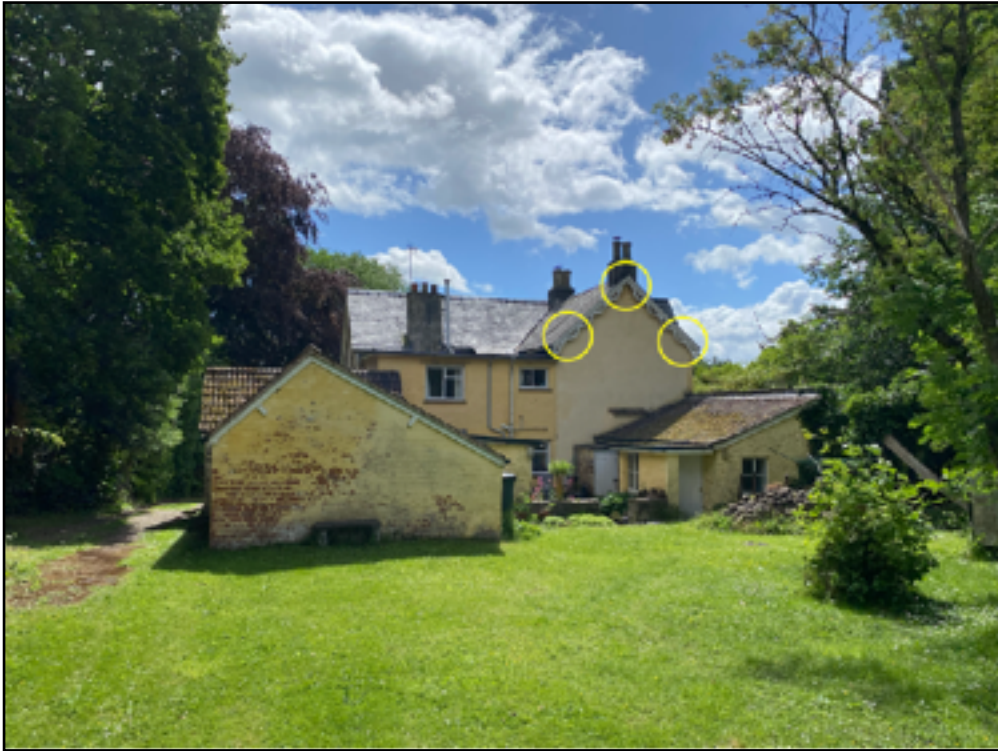
**5 Soprano Pipistrelles (*Pipistrellus pygmaeus*) were observed emerging from underneath the barge boards to the western gable end of the dwelling.**

**9.5 The emergence surveys did identify a small Soprano Pipistrelle maternity roost within the western gable end of the dwelling.** The remaining bats using the dwelling as day roosts are likely to be male or non-breeding females.

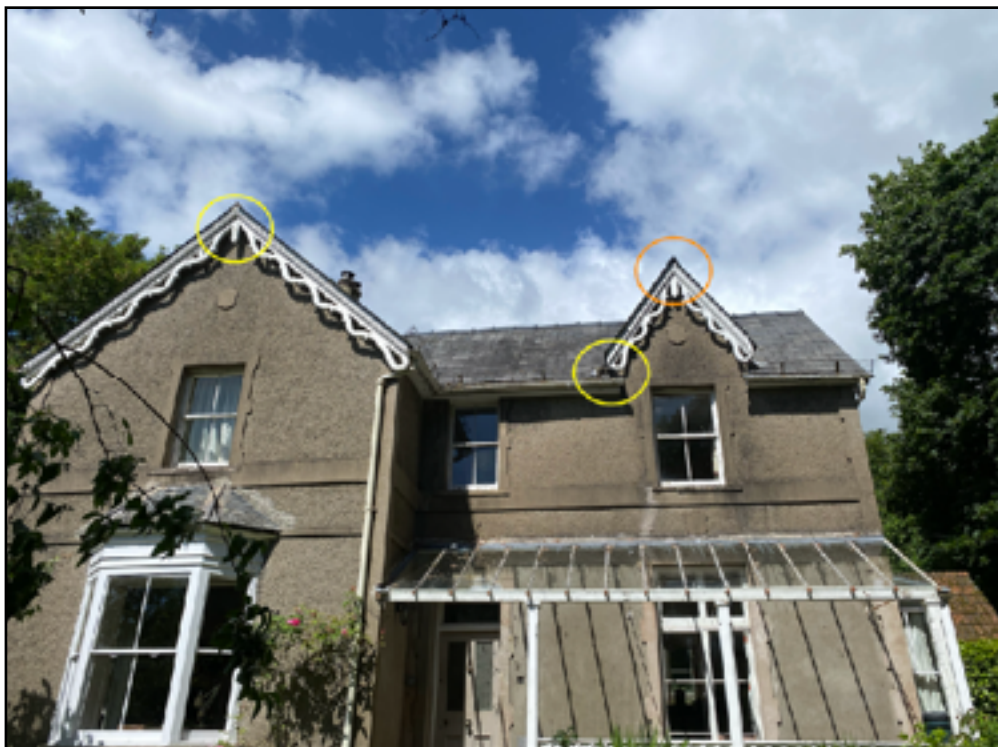
**2 Soprano Pipistrelles and 1 Whiskered Bat (*Myotis mystacinus*)** were observed emerging from apertures at the apexes and the corner of the dormer window to the eastern elevation of the dwelling.

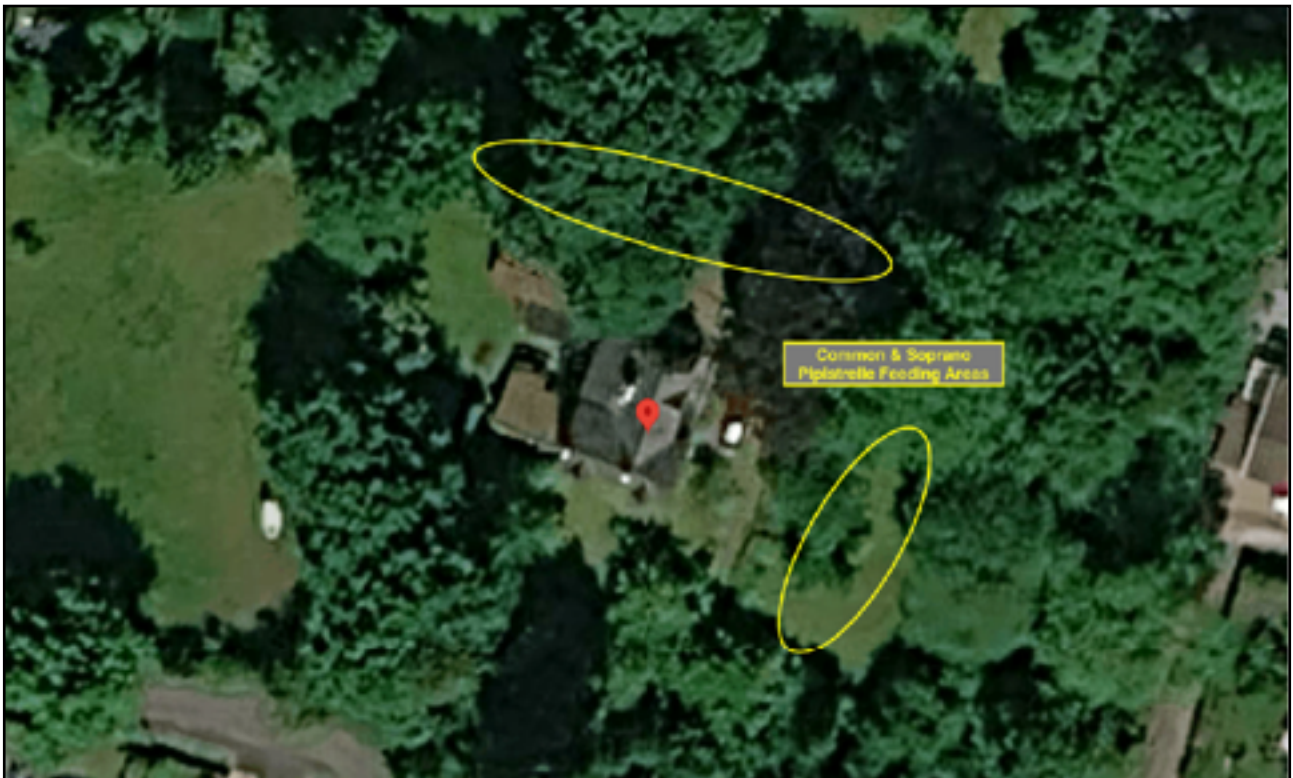
**8.9** During the first and second emergence surveys, a very low number of bat calls were recorded. No bats emerged from the buildings and a small number of Common and Soprano Pipistrelles were observed foraging to the north and east of the property.

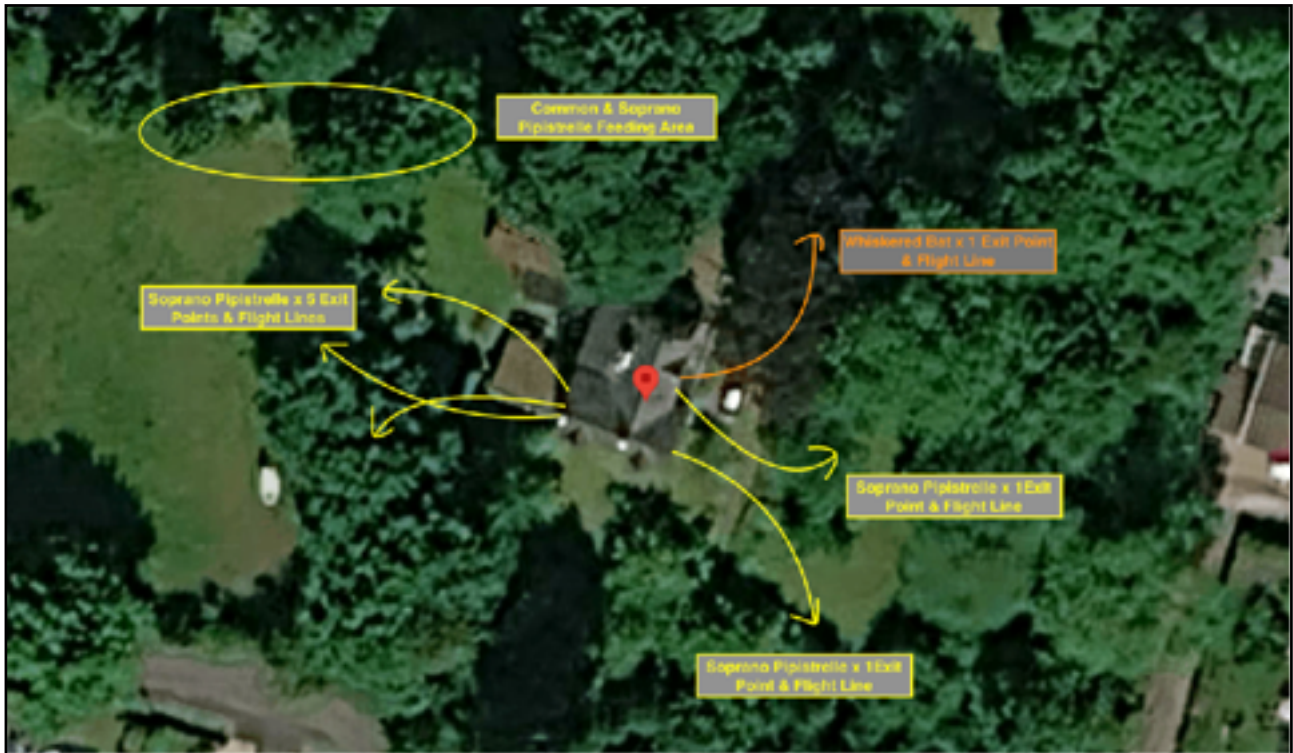
**8.10** During the third emergence survey, a very low number of bat calls were recorded. 7 Soprano Pipistrelles and 1 Whiskered Bat emerged from the dwelling. A small number of Common and Soprano Pipistrelles were observed foraging to the north west of the property.

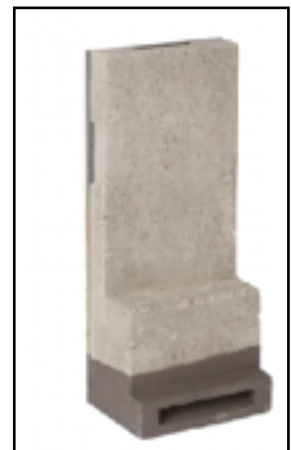
**10.2** It is proposed that new roosting for bats be created by building six Vivara Pro WoodStone Bat Boxes into the block work of the new builds; one on the eastern elevation of Plot 39; one on the eastern elevation of Plot 37; one on the southern elevation of Plot 32-35; one on the eastern elevation of Plot 24-27; one on the eastern elevation of Plot 22 and one on the western elevation of Plot 17-18. **Care must be taken not to obstruct the access slots.**

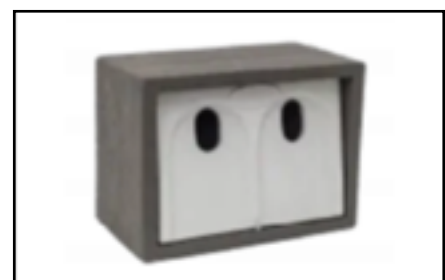
**10.4** Two Vivara Pro WoodStone House Sparrow Nest Boxes will be built into the block work of the new builds; one on the north eastern elevation of Plot 28-31 and one on the eastern elevation of Plot 1-12. **These will not be situated on south facing elevations. Care must be taken not to obstruct the entrance holes.**

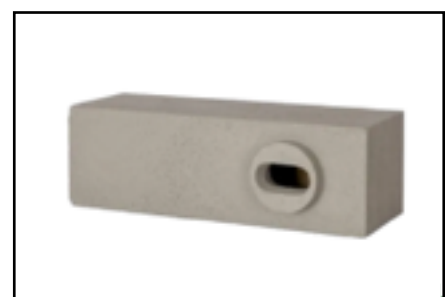
**10.5** Three PRO-UK Rendered Build-In Swift Boxes will be built into the block work of the new builds; one on the northern elevation of Plot 41; one on the northern elevation of Plot 32-35 and one on the eastern elevation of Plot 19-20. **These will not be situated on south facing elevations. Care must be taken not to obstruct the entrance holes.**

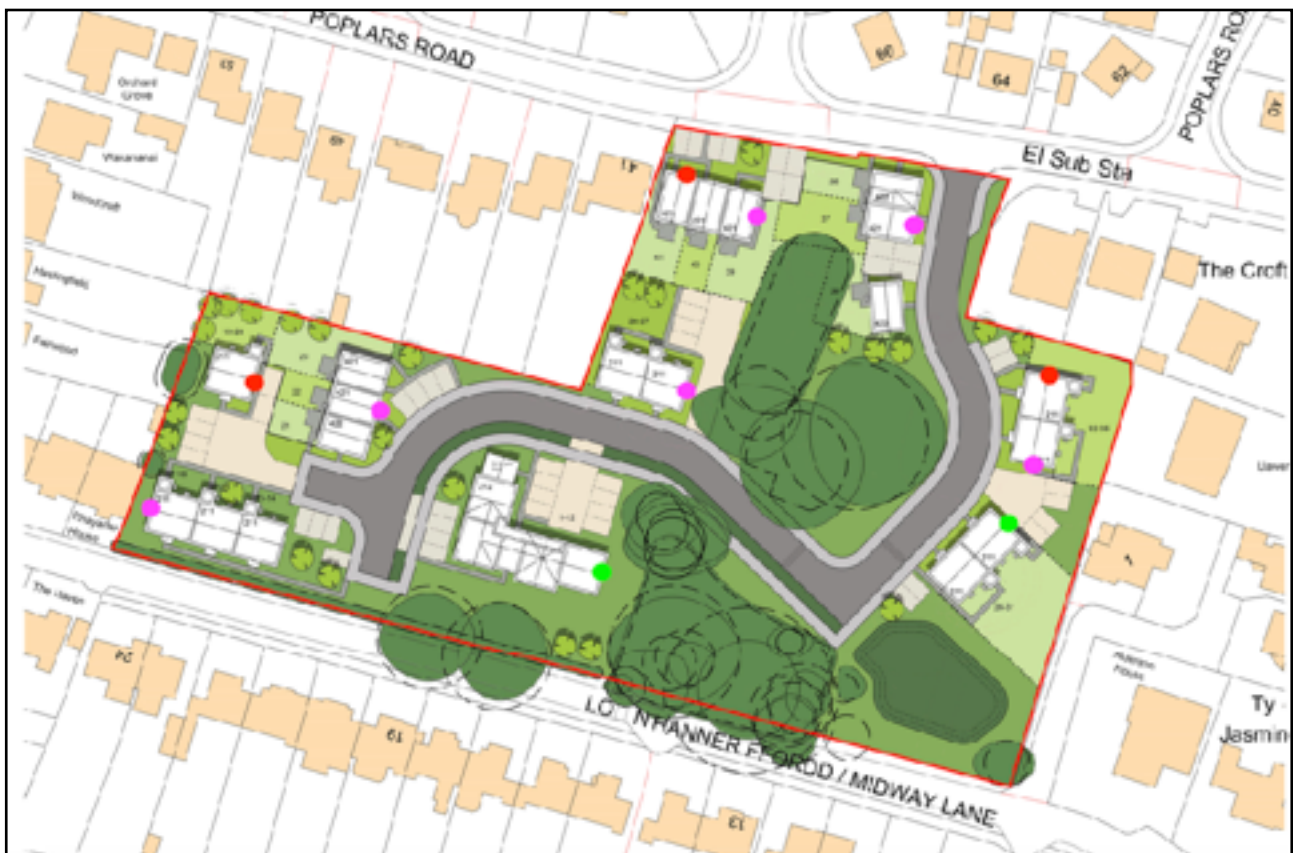
**10.10 Recommended Locations of Bat and Bird Mitigation:**

Location of Vivara Pro WoodStone House Sparrow Nest Box
-

Location of PRO-UK Rendered Build-In Swift Box
-

Location of Vivara Pro WoodStone Bat Box

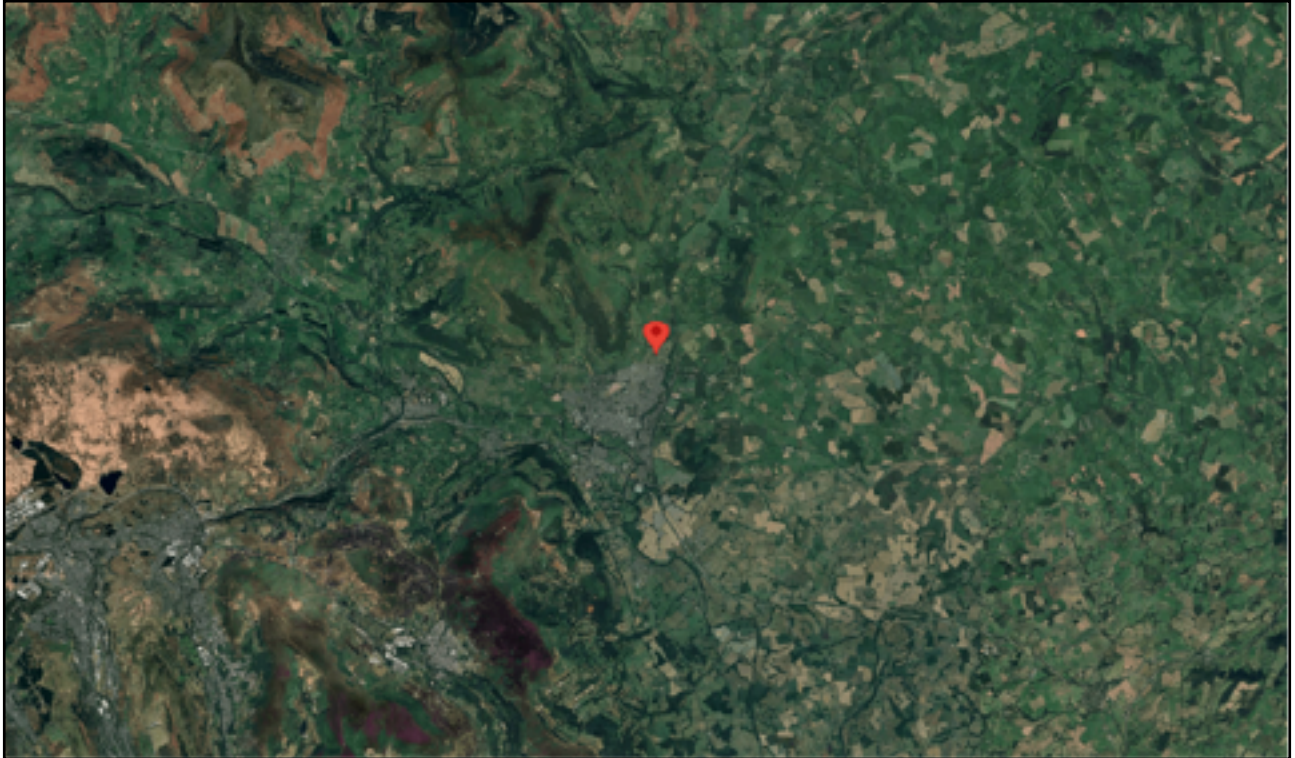
#### **Appendix 1 Aerial Site Photograph**

**The site in its wider environment showing good ecological connectivity to the surrounding habitat.**
