**WOLF'S CASTLE**

**PRELIMINARY ECOLOGICAL APPRAISAL REPORT**

**JANUARY 2025**

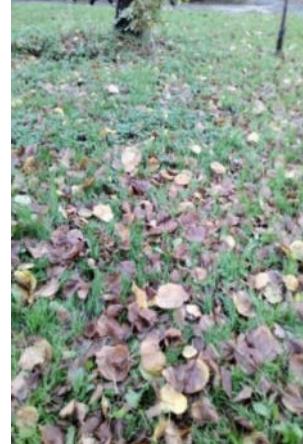
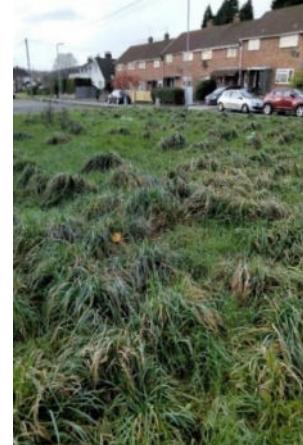
Habitat Description	UK Hab Classification	Photograph	Local BAP/S.7	Potential Constraints
<u>Modified grassland</u>  Modified grassland is present in all three areas. Areas 2 and 3 comprises mostly modified grassland, which is also present on Area 1. The modified grassland is species poor, heavily managed, and mostly mown short. There is some sward height variation in the grassland in the northeast of Area 1. Species present include annual meadow grass <i>Poa annua</i> (D), creeping buttercup <i>Ranunculus repens</i> (A), ribwort plantain <i>Plantago lanceolata</i> (O), perennial rye-grass <i>Lolium perenne</i> (O), dandelion <i>Taraxacum officinale</i> agg. (O), common cat's-ear <i>Hypochaeris radicata</i> (O), daisy <i>Bellis perennis</i> (O), clover <i>Trifolium</i> sp. (O), cock's-foot <i>Dactylis glomerata</i> (O), yarrow <i>Achillea millefolium</i> (O) oak saplings <i>Quercus</i> sp. (R), teasel <i>Dipsacus fullonum</i> .	<u>Primary code</u> g4 - Modified grassland <u>Secondary codes</u> 32 – scattered trees

X	<p>No – Modified grassland is a common and widespread habitat, and is not considered to be of conservation value, however the trees provide ecological benefits including foraging and commuting habitat for bats, and refuge habitat for a variety of fauna species (see Table 3).</p> <p><b>It will be necessary to undertake a BS5837 Tree Survey in the event that their removal, damage, or incursion into root zone is unavoidable.</b></p>

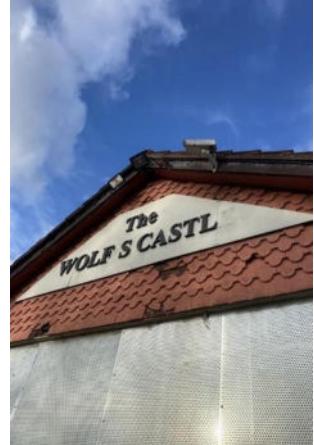
Habitat Description	UK Hab Classification	Photograph		Local BAP/S.7	Potential Constraints
<u>Buildings</u> Buildings B1 and B2 are located in Area 1. Both buildings are in a state of disrepair.  Further detail of features of the building pertaining to bats are detailed in Appendix 4 – Preliminary Roost Assessment (PRA) Survey Results.	<u>Primary code</u> u1b5 – Buildings

- 4.4.14 B1 and B2 were assessed as having high potential to support roosting bats. The buildings are suitable to support crevice dwelling bats in features such as raised roof and ridge tiles, lead flashing, bargeboards and fascias. Furthermore, there are numerous potential access points for void-dwelling species to gain entry to the interior including underneath raised and broken roof tiles, soffits, bargeboards. The open door on the northern aspect of the building could potentially provide access to the interior

4.4.16 As both B1 and B2 have the potential to support hibernating bats, **it is recommended that a hibernation survey is undertaken on both B1 and B2**. This survey should be undertaken during December-March.

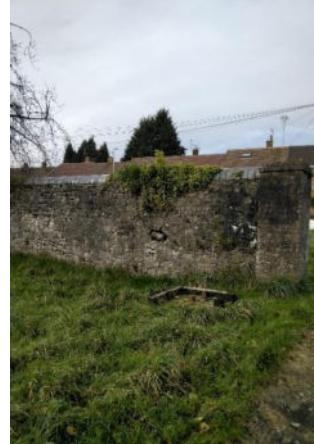
x	No – this habitat is not considered to be of any conservation concern. However, please see Table 3 re roosting bats.
Within Area 1 there is a stone and mortar wall connecting to B1.  In Area 1, a wooden fence connects the east extension of B1 to the mortared wall, blocking access to this area.  A steel security fence connects the north extension of B1 to B2, and the west gable end of B2 to the westernmost extension of B1, blocking access to this area.	<u>Primary code</u> U1e – built linear features  <u>Secondary codes</u> 853 – Mortared wall 612 – Fence 82 – Vacant or derelict land

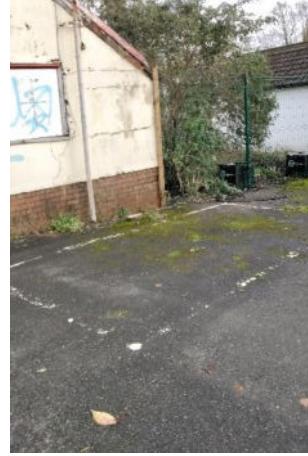
Habitat Description	UK Hab Classification	Photograph	Local BAP/S.7	Potential Constraints
<p><u>U1b – developed land; sealed surface</u> Areas of hard standing are present in all three areas, including pavements, car park, and a bus stop. Hard standing around the buildings of Area 1 have been colonised by vegetation due to its disuse. Vegetation is mainly growing around building edges. Species present include annual meadow grass (F), buddleja <i>Buddleja sp.</i> (O), dandelion (O), mosses, hedge mustard <i>Sisymbrium officinale</i> (O), daisy (O), willowherb <i>Epilobium sp.</i> (O), teasel (O), fleabane <i>Erigeron sp.</i> (O).</p>	<p><u>Primary code</u> u1b - developed land; sealed surface <u>Secondary code</u> 804 – car park</p>

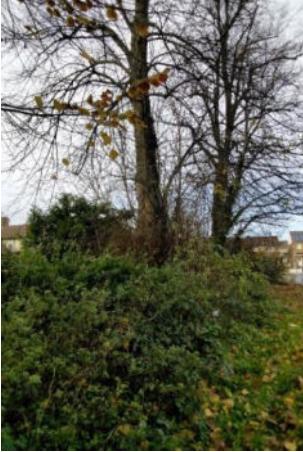
Habitat Description	UK Hab Classification	Photograph	Local BAP/S.7	Potential Constraints
<p><u>Mixed scrub/Line of Trees</u></p> <p>Mixed scrub was present in Area 1. Species in this habitat include bramble (D), nettle <i>Urtica sp.</i> (A), ivy <i>Hedera sp.</i> (F), broadleaf dock <i>Rumex obtusifolius</i> (F), Himalayan honeysuckle <i>Leycesteria Formosa</i> (O), oak saplings (O), ground ivy <i>Glechoma hederacea</i> (O), elder (O), sedge sp. <i>Cyperaceae sp.</i> (R).</p> <p>A line of trees is present within this habitat, some of which have been coppiced. Many trees within this line are host to ivy, and multiple trees have a number of basal shoots growing from the trunk.</p> <p>The line of trees was subject to a GLTA. Further details can be found in Appendix 3.</p>	<p><u>Primary code</u> h3h – mixed scrub</p> <p><u>Secondary codes</u> 33 – line of trees</p>

X	<p>Possibly - Further, it would be necessary to undertake a BS5837 Tree Survey in the event that their removal, damage, or incursion into root zone is unavoidable.</p> <p>Scrub habitat is usually considered common and widespread, see Table 3 re bats, breeding birds, and common reptiles.</p> <p>Himalayan honeysuckle is planted within gardens. It is recommended this is removed as it is invasive, outcompeting native species but not listed as an Invasive Non-Native Species listed on Schedule 9 of the Wildlife and Countryside Act 1981 (as amended).</p>

4.3.1 It is recommended that the mixed scrub and line of trees present to the east of area 1 is retained and protected in accordance with BS 5837:2012 Trees in Relation to Design, Demolition and Construction and in accordance with any Tree Protection Plans approved by the Local Authority. If this is not possible, any losses of mixed scrub should be compensated for in the landscape design. See sections 4.2.2 and 4.3 for recommendations regarding trees and bats respectively.

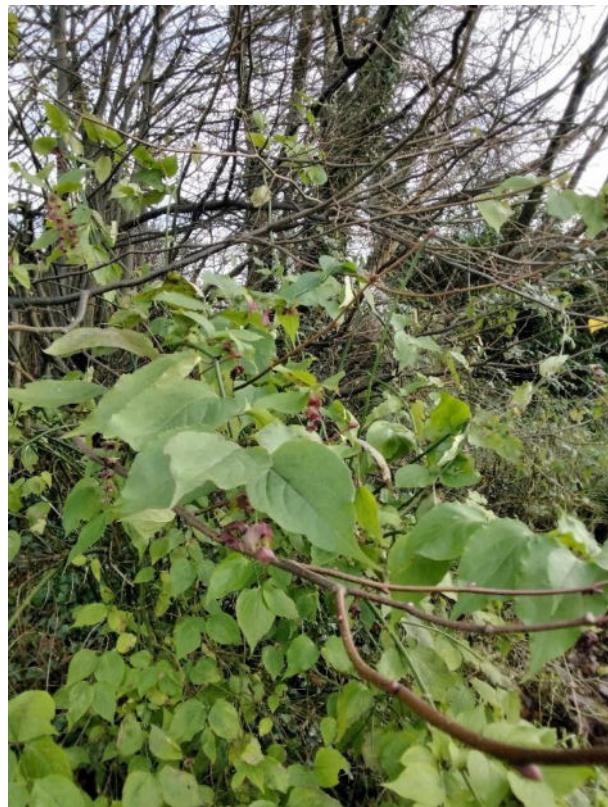
Ornamental shrub present in the mixed scrub within the main site.

- a. Himalayan honeysuckle *Leycesteria formosa* present.

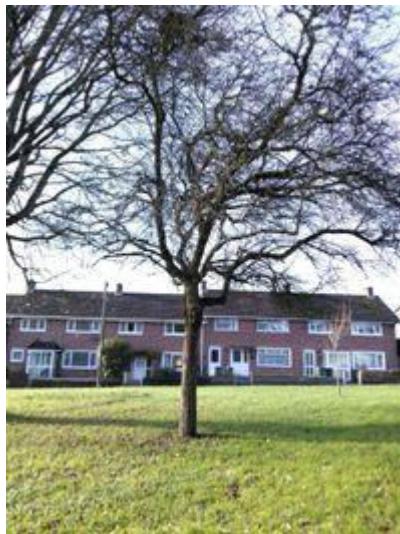
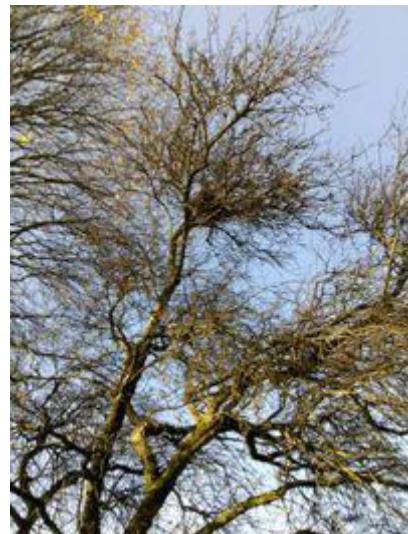
<u>Survey Responses</u>			
<b>Tree type / tree tag:</b>	T23	<b>Inspected by:</b>	Gm
<b>Approximate tree height (m):</b>	5	<b>Diameter at Breast Height (cm):</b>	30
<b>Age of tree:</b>	Semi-mature	<b>Safe to climb:</b>	Yes
<b>Tree suitability:</b>	None		
<b>Additional notes:</b>	Nest in tree - survey in late November. Loose bark on north facing branch but not enough to support a bat.		
<b>Photograph(s)</b>	3 photograph(s) taken, which are provided below.

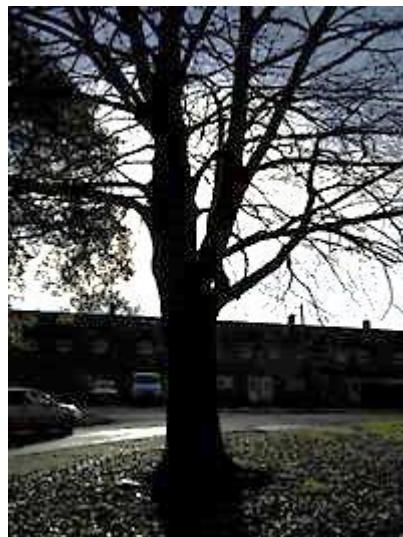
<u>Survey Responses</u>			
<b>Tree type / tree tag:</b>	T20	<b>Inspected by:</b>	Gm
<b>Approximate tree height (m):</b>	8	<b>Diameter at Breast Height (cm):</b>	50
<b>Age of tree:</b>	Mature	<b>Safe to climb:</b>	Yes
<b>Tree suitability:</b>	None		
<b>Additional notes:</b>	One knot hole facing north but backed		
<b>Photograph(s)</b>	2 photograph(s) taken, which are provided below.

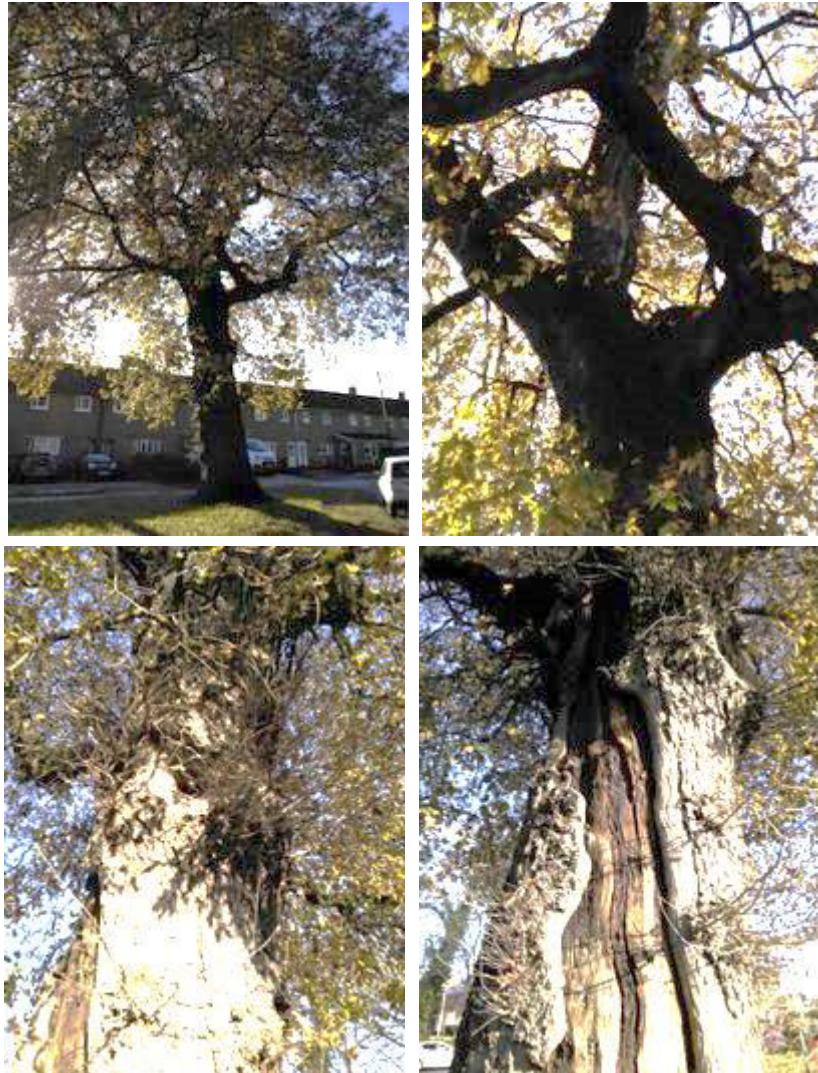
<u>Survey Responses</u>			
<b>Tree type / tree tag:</b>	T19 - oal	<b>Inspected by:</b>	Gm
<b>Approximate tree height (m):</b>	10	<b>Diameter at Breast Height (cm):</b>	70
<b>Age of tree:</b>	Mature	<b>Safe to climb:</b>	Yes
<b>Tree suitability:</b>	PRF-M	<b>Number of PRFs:</b>	2
<b>Any evidence of bats:</b>	None		
<b>Any evidence of other animals:</b>	None		
<b>Additional notes:</b>	PRF 1 – Knot hole, 3m high, 20cm diameter, 15cm height, clean dry internal.  PRF 2 – Fissure facing north, starting approx 5m up until 7m. Approx 2m tall, approx 10cm gap at widest places		
<b>Photograph(s)</b>	4 photograph(s) taken, which are provided below.

4.4.6 There are six trees (tree reference T9, T10, T11, T19 and T18 in total that have been assessed as PRF-M. It is recommended that PRF inspection surveys are carried out on these trees that will be impacted by the proposed development, with the aim of reassessing PRFs and determining likely presence/absence of bats at the time of survey and the requirement for further survey and/or mitigation.

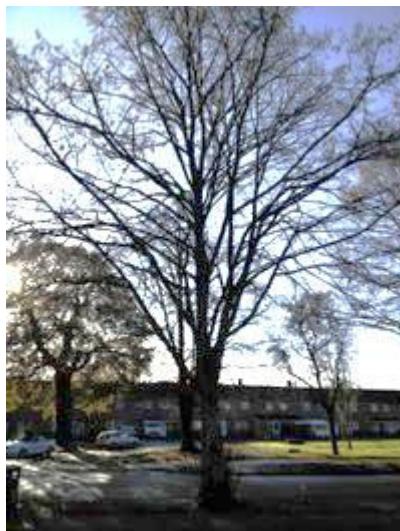
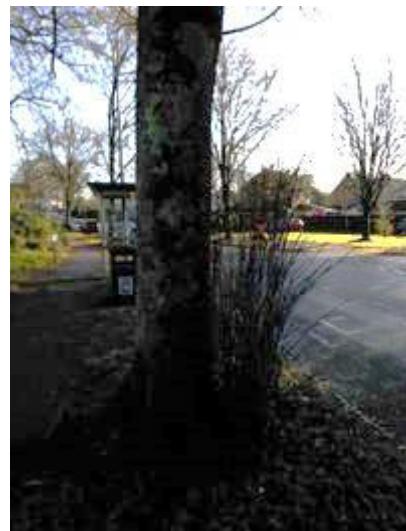
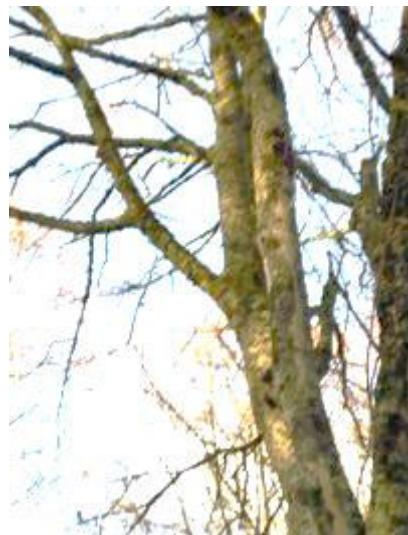
<u>Survey Responses</u>			
<b>Tree type / tree tag:</b>	T7	<b>Inspected by:</b>	Gm
<b>Approximate tree height (m):</b>	8	<b>Diameter at Breast Height (cm):</b>	40
<b>Age of tree:</b>	Semi-mature	<b>Safe to climb:</b>	Yes
<b>Tree suitability:</b>	FAR	<b>Number of PRFs:</b>	0
<b>Any evidence of bats:</b>	No		
<b>Any evidence of other animals:</b>	Starlings in tree		
<b>Additional notes:</b>	Open tear out facing south at approx 3m but too open to elements on some branch approx 1m lower		
<b>Photograph(s)</b>	3 photograph(s) taken, which are provided below.

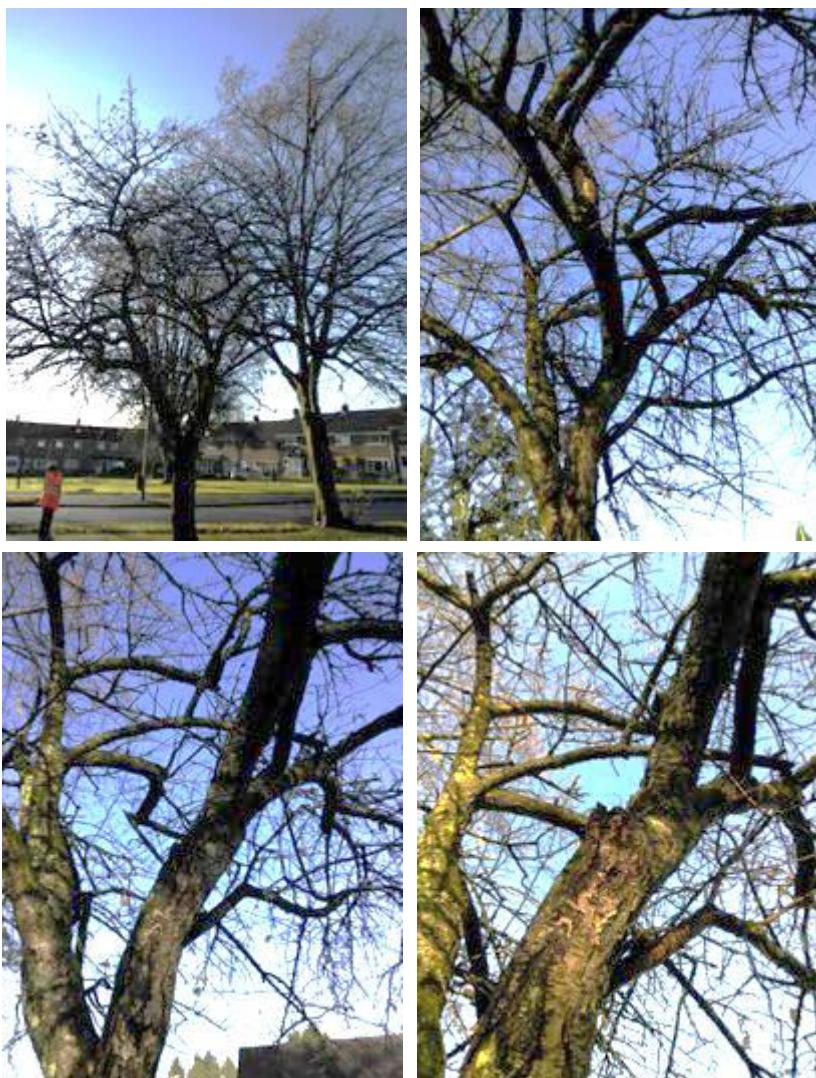
<u>Survey Responses</u>			
<b>Tree type / tree tag:</b>	T5	<b>Inspected by:</b>	Gm
<b>Approximate tree height (m):</b>	5	<b>Diameter at Breast Height (cm):</b>	40
<b>Age of tree:</b>	Semi-mature	<b>Safe to climb:</b>	Yes
<b>Tree suitability:</b>	None		
<b>Photograph(s)</b>	4 photograph(s) taken, which are provided below.

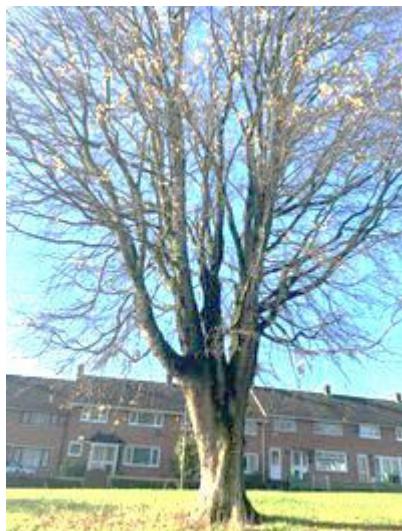
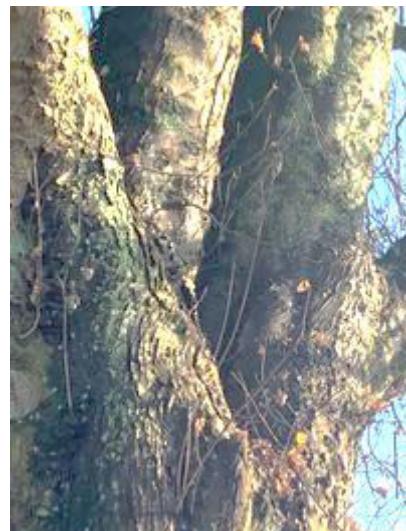
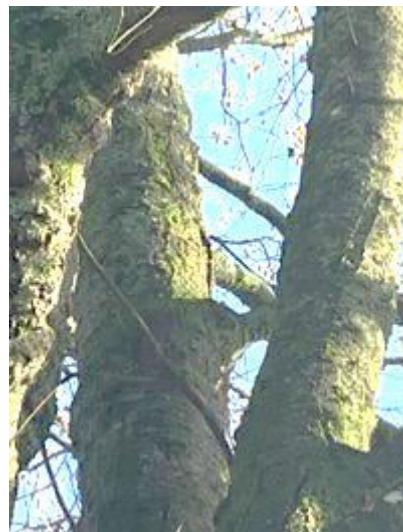
<u>Survey Responses</u>			
<b>Tree type / tree tag:</b>	T24	<b>Inspected by:</b>	Daisy Smith
<b>Approximate tree height (m):</b>	14	<b>Diameter at Breast Height (cm):</b>	120
<b>Age of tree:</b>	Mature	<b>Safe to climb:</b>	Yes
<b>Tree suitability:</b>	PRF-I	<b>Number of PRFs:</b>	2
<b>Any evidence of bats:</b>	None		
<b>Any evidence of other animals:</b>	None		
<b>Additional notes:</b>	2 PRF-I identified, 1 is an area of lifted bark on the trunk 2-3m high and south facing. 2 is lifted bark 6m high and on a branch south west facing.		
<b>Photograph(s)</b>	3 photograph(s) taken, which are provided below.

4.4.2 There are seven trees that have been assessed as PRF-I. These do not require further surveys, but it is recommended that soft felling is used to perform any works on these trees, under the supervision of a suitably qualified bat licensed ecologist.

4.4.3 It is recommended these trees are soft felled when bats are considered not to be hibernating i.e., between the months of April to September. The sections of the trees with PRFs will be removed, cutting above/below the feature being careful not to damage the feature itself, and left on the ground for a period of 24 hours to allow, in the unlikely event, any missed animals the opportunity to escape. If bats are found, work will stop immediately, and advice sought from the Ecological Clerk of Works or Natural Resources Wales (NRW).

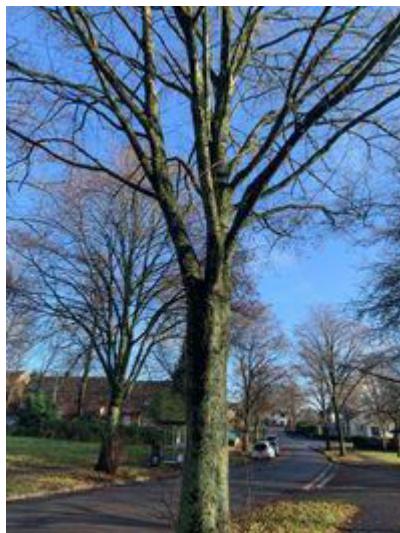
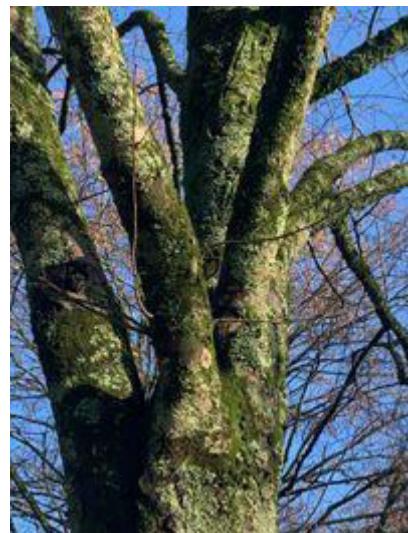
<u>Survey Responses</u>			
<b>Tree type / tree tag:</b>	T22	<b>Inspected by:</b>	Daisy Smith
<b>Approximate tree height (m):</b>	10	<b>Diameter at Breast Height (cm):</b>	50
<b>Age of tree:</b>	Semi-mature	<b>Safe to climb:</b>	Yes
<b>Tree suitability:</b>	FAR	<b>Number of PRFs:</b>	2
<b>Any evidence of bats:</b>	None		
<b>Any evidence of other animals:</b>	None		
<b>Additional notes:</b>	Two potential PRFs, FAR as can't fully inspect from ground. On main trunk, 3.5m west facing		
<b>Photograph(s)</b>	2 photograph(s) taken, which are provided below.

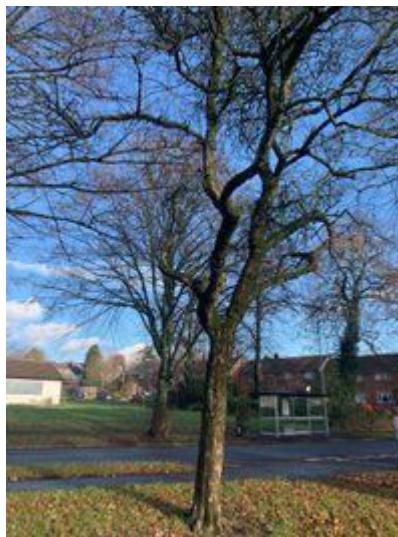
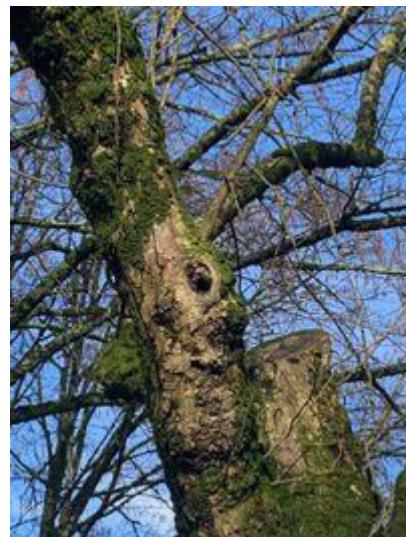
<u>Survey Responses</u>			
<b>Tree type / tree tag:</b>	T21	<b>Inspected by:</b>	Daisy Smith
<b>Approximate tree height (m):</b>	6	<b>Diameter at Breast Height (cm):</b>	25
<b>Age of tree:</b>	Semi-mature	<b>Safe to climb:</b>	Yes
<b>Tree suitability:</b>	PRF-I	<b>Number of PRFs:</b>	1
<b>PRF number:</b>	1	<b>PRF type:</b>	Woodpecker hole
<b>PRF height (m):</b>	3	<b>PRF suitability:</b>	PRF-I
<b>Direction of PRF:</b>	South		
<b>Location of PRF:</b>	On branch coming off main trunk		
<b>PRF entrance description:</b>	Approx 4cm		
<b>PRF internal description:</b>	Dark and dry		
<b>Any evidence of bats:</b>	None		
<b>Any evidence of other animals:</b>	None		
<b>Photograph(s)</b>	2 photograph(s) taken, which are provided below.

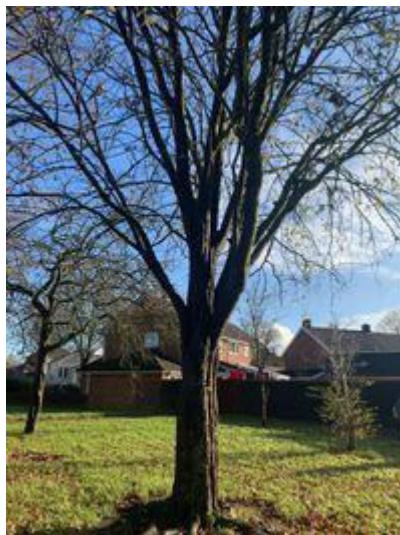
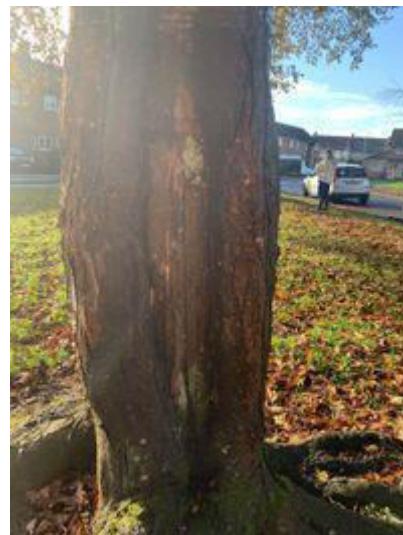
<u>Survey Responses</u>			
<b>Tree type / tree tag:</b>	T18	<b>Inspected by:</b>	Daisy Smith
<b>Approximate tree height (m):</b>	8	<b>Diameter at Breast Height (cm):</b>	50
<b>Age of tree:</b>	Semi-mature	<b>Safe to climb:</b>	Yes
<b>Tree suitability:</b>	PRF-M	<b>Number of PRFs:</b>	1
<b>PRF number:</b>	1	<b>PRF type:</b>	Tear out
<b>PRF height (m):</b>	1	<b>PRF suitability:</b>	PRF-M
<b>Direction of PRF:</b>	North		
<b>Location of PRF:</b>	Trunk		
<b>PRF entrance description:</b>	Dry cavity		
<b>PRF internal description:</b>	Dry		
<b>Any evidence of bats:</b>	None		
<b>Any evidence of other animals:</b>	None		
<b>Photograph(s)</b>	3 photograph(s) taken, which are provided below.

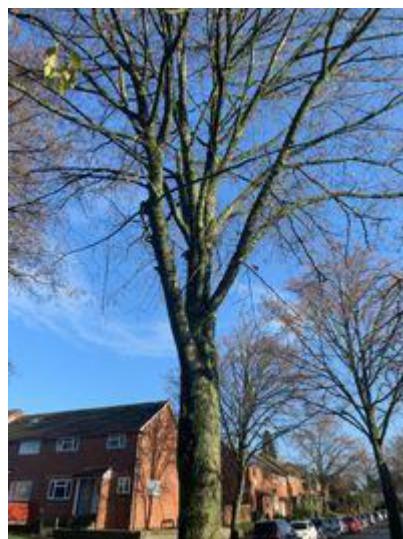
<u>Survey Responses</u>			
<b>Tree type / tree tag:</b>	T17	<b>Inspected by:</b>	Daisy Smith
<b>Approximate tree height (m):</b>	9	<b>Diameter at Breast Height (cm):</b>	40
<b>Age of tree:</b>	Semi-mature	<b>Safe to climb:</b>	Yes
<b>Tree suitability:</b>	None		
<b>Photograph(s)</b>	1 photograph(s) taken, which are provided below.

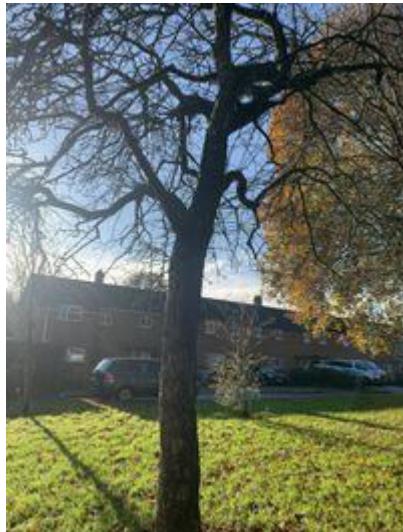
<u>Survey Responses</u>			
<b>Tree type / tree tag:</b>	T16	<b>Inspected by:</b>	Daisy Smith
<b>Approximate tree height (m):</b>	5	<b>Diameter at Breast Height (cm):</b>	20
<b>Age of tree:</b>	Semi-mature	<b>Safe to climb:</b>	No
<b>Tree suitability:</b>	FAR	<b>Number of PRFs:</b>	1
<b>Additional notes:</b>	1 PRF. Wound at 3.5m high. South facing. Looks dry, upward facing so can't see the full extent of it.		
<b>Photograph(s)</b>	2 photograph(s) taken, which are provided below.

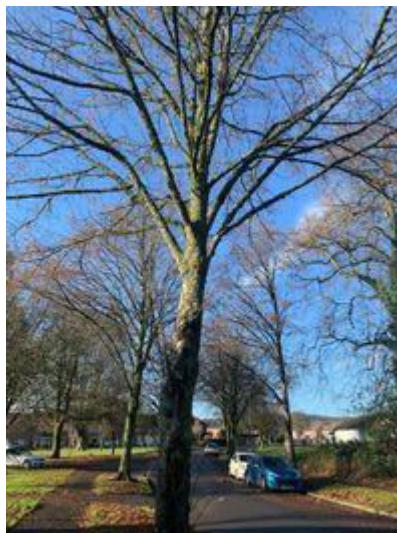
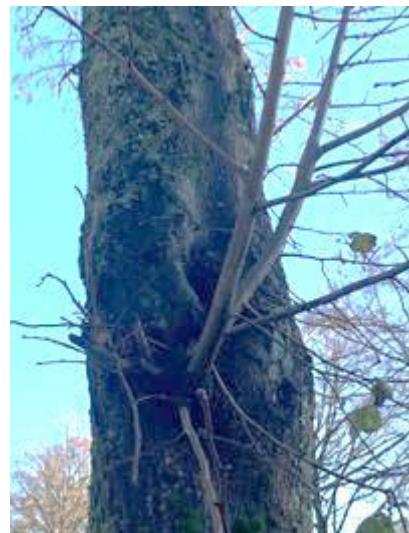
<u>Survey Responses</u>			
<b>Tree type / tree tag:</b>	T15	<b>Inspected by:</b>	Daisy Smith
<b>Approximate tree height (m):</b>	9	<b>Diameter at Breast Height (cm):</b>	40
<b>Age of tree:</b>	Semi-mature	<b>Safe to climb:</b>	Yes
<b>Tree suitability:</b>	PRF-I	<b>Number of PRFs:</b>	1
<b>Any evidence of bats:</b>	None		
<b>Any evidence of other animals:</b>	None		
<b>Additional notes:</b>	One PRF, 2m high. Facing west. Looks quite backed but some small gaps. On main tree trunk.		
<b>Photograph(s)</b>	2 photograph(s) taken, which are provided below.

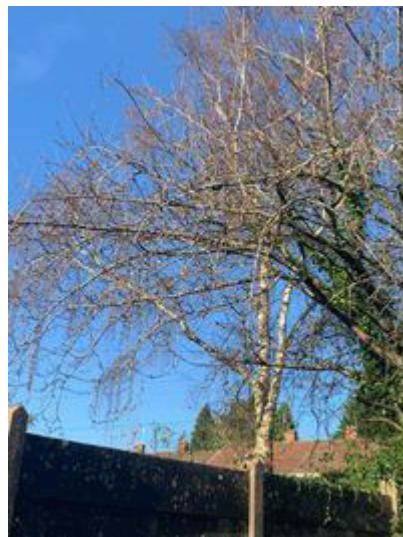
<u>Survey Responses</u>			
<b>Tree type / tree tag:</b>	T14	<b>Inspected by:</b>	Daisy Smith
<b>Approximate tree height (m):</b>	8	<b>Diameter at Breast Height (cm):</b>	25
<b>Age of tree:</b>	Semi-mature	<b>Safe to climb:</b>	No
<b>Tree suitability:</b>	None		
<b>Photograph(s)</b>	1 photograph(s) taken, which are provided below.

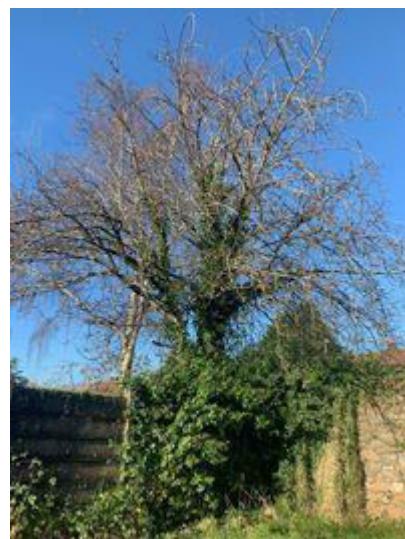
<u>Survey Responses</u>			
<b>Tree type / tree tag:</b>	T13?	<b>Inspected by:</b>	Daisy Smith
<b>Approximate tree height (m):</b>	7	<b>Diameter at Breast Height (cm):</b>	30
<b>Age of tree:</b>	Semi-mature	<b>Safe to climb:</b>	No
<b>Tree suitability:</b>	None		
<b>Photograph(s)</b>	1 photograph(s) taken, which are provided below.

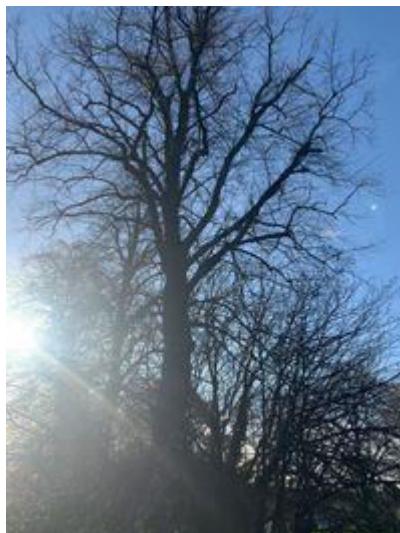
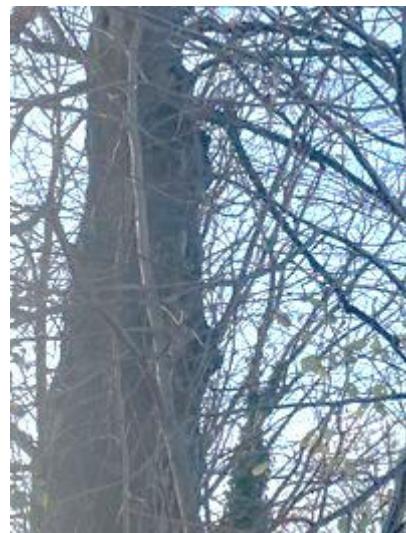
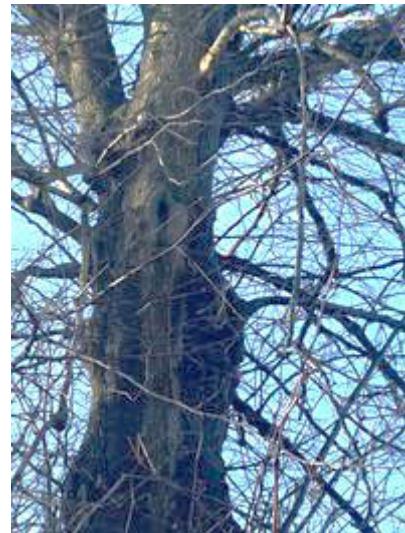
<u>Survey Responses</u>			
<b>Tree type / tree tag:</b>	T12	<b>Inspected by:</b>	Daisy Smith
<b>Approximate tree height (m):</b>	14	<b>Diameter at Breast Height (cm):</b>	100
<b>Age of tree:</b>	Mature	<b>Safe to climb:</b>	Yes
<b>Tree suitability:</b>	PRF-M	<b>Number of PRFs:</b>	3
<b>Any evidence of bats:</b>	None		
<b>Any evidence of other animals:</b>	None		
<b>Additional notes:</b>	Three knot holes, approximately 4-7m high. Facing north and east. Large dry dark openings. FAR required higher up if impacts.		
<b>Photograph(s)</b>	3 photograph(s) taken, which are provided below.

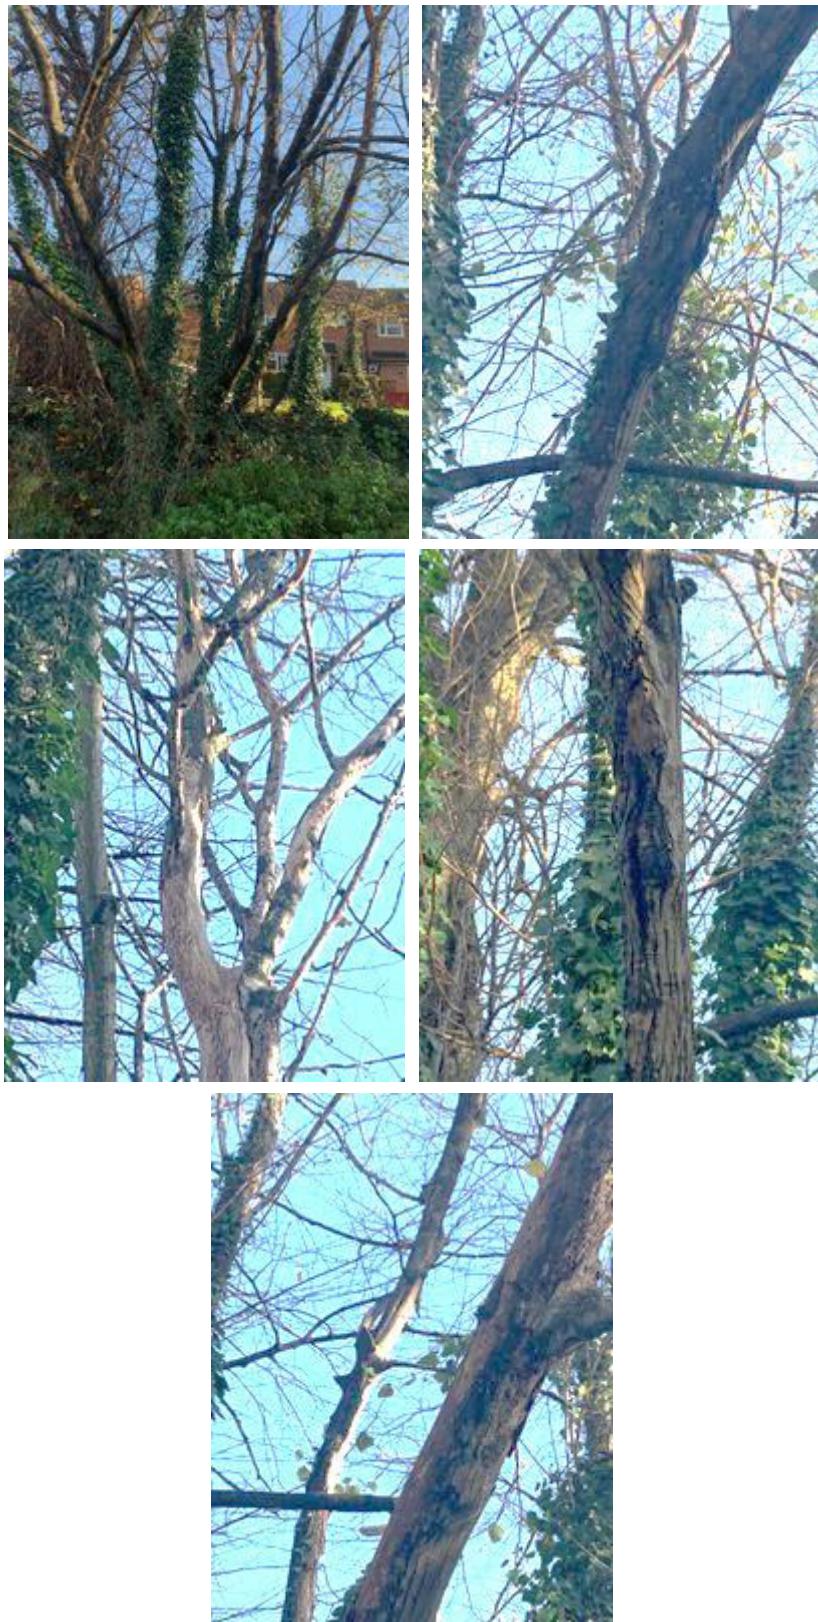
<u>Survey Responses</u>			
<b>Tree type / tree tag:</b>	T11	<b>Inspected by:</b>	Daisy Smith
<b>Approximate tree height (m):</b>	8	<b>Diameter at Breast Height (cm):</b>	20
<b>Age of tree:</b>	Semi-mature	<b>Safe to climb:</b>	Yes
<b>Tree suitability:</b>	PRF-M	<b>Number of PRFs:</b>	4
<b>Any evidence of bats:</b>	None		
<b>Any evidence of other animals:</b>	None		
<b>Additional notes:</b>	Multiple areas of lifted bark. At all heights on the tree. PRFs face all directions. The extent of lifted bark varies for each PRF but bark lifted covers the majority of the tree.		
<b>Photograph(s)</b>	5 photograph(s) taken, which are provided below.

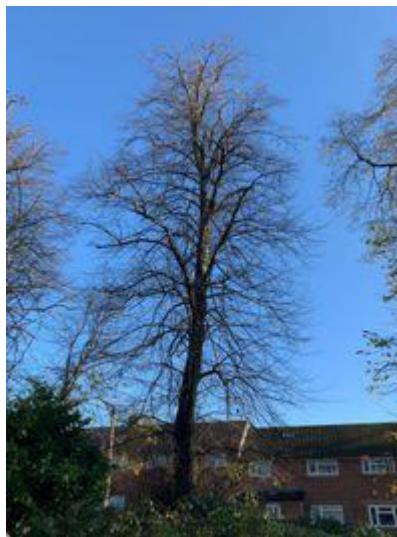
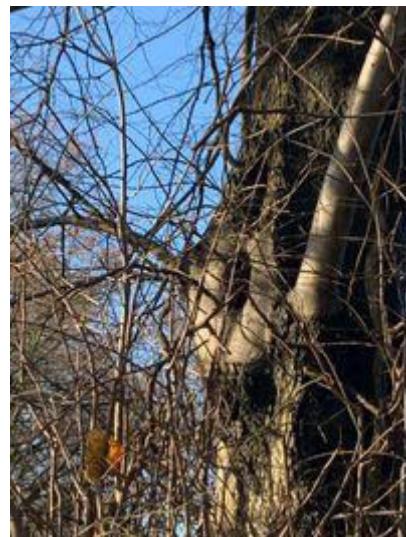
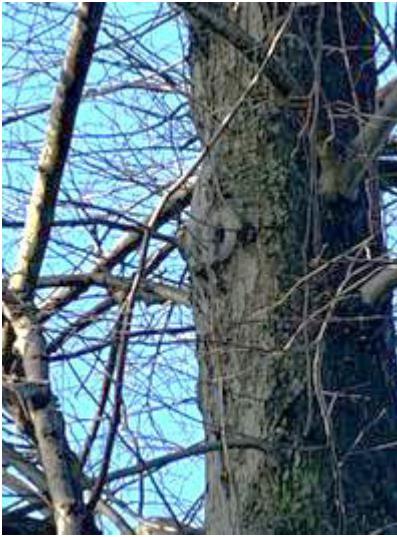
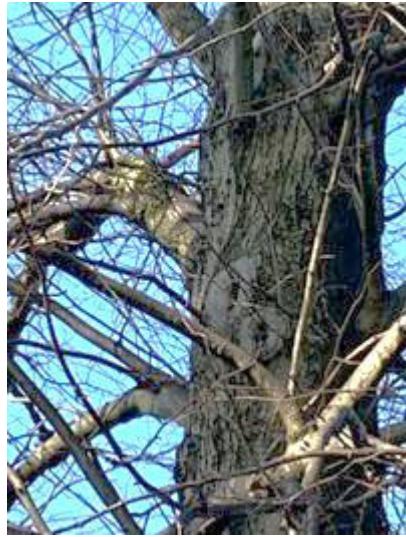
<u>Survey Responses</u>			
<b>Tree type / tree tag:</b>	T10	<b>Inspected by:</b>	Daisy Smith
<b>Approximate tree height (m):</b>	14	<b>Diameter at Breast Height (cm):</b>	100
<b>Age of tree:</b>	Mature	<b>Safe to climb:</b>	Yes
<b>Tree suitability:</b>	PRF-M	<b>Number of PRFs:</b>	0
<b>Any evidence of bats:</b>	None		
<b>Any evidence of other animals:</b>	None		
<b>Additional notes:</b>	Multiple large knot holes. 4 PRFs identified from ground level. FAR if impacts to the tree. PRFs facing all directions.		
<b>Photograph(s)</b>	4 photograph(s) taken, which are provided below.

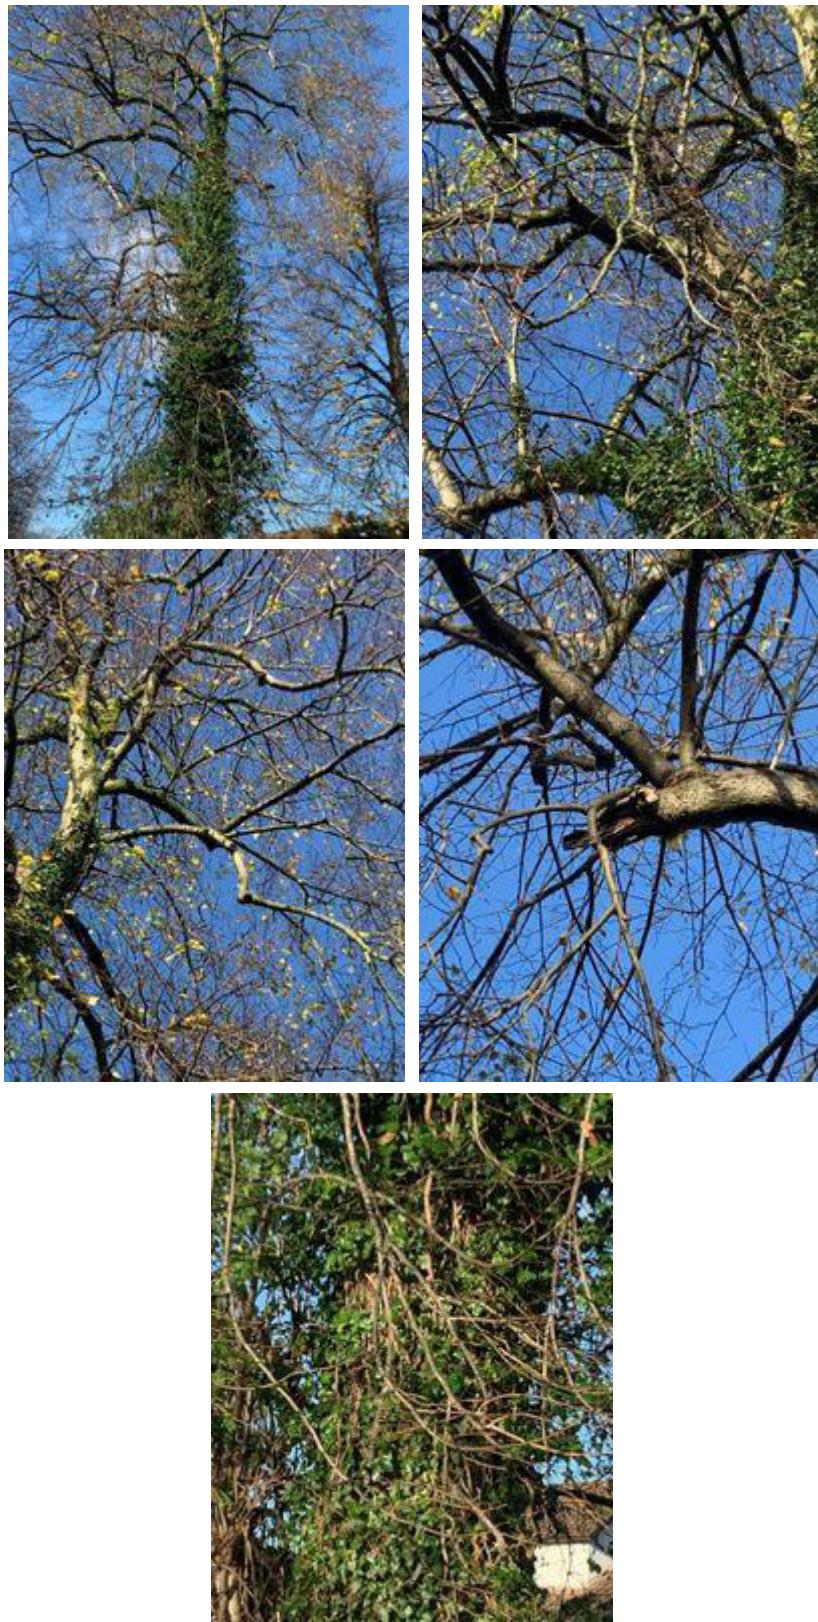
<u>Survey Responses</u>			
<b>Tree type / tree tag:</b>	T9	<b>Inspected by:</b>	Daisy Smith
<b>Approximate tree height (m):</b>	12	<b>Diameter at Breast Height (cm):</b>	90
<b>Age of tree:</b>	Mature	<b>Safe to climb:</b>	Yes
<b>Tree suitability:</b>	PRF-M	<b>Number of PRFs:</b>	0
<b>Any evidence of bats:</b>	None		
<b>Any evidence of other animals:</b>	None		
<b>Additional notes:</b>	>7 PRFs seen from ground level. FAR if impacted to assess full extent. Multiple knot holes, broken branches, lifted bark. PRFs facing all directions and varying height on the tree. Main stem is covered in thick Ivy, with overlapping stems.		
<b>Photograph(s)</b>	5 photograph(s) taken, which are provided below.

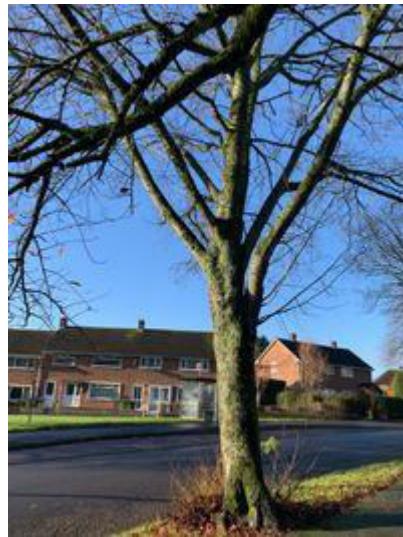
<u>Survey Responses</u>			
<b>Tree type / tree tag:</b>	T4	<b>Inspected by:</b>	Daisy Smith
<b>Approximate tree height (m):</b>	7	<b>Diameter at Breast Height (cm):</b>	50
<b>Age of tree:</b>	Semi-mature	<b>Safe to climb:</b>	Yes
<b>Tree suitability:</b>	None		
<b>Photograph(s)</b>	1 photograph(s) taken, which are provided below.

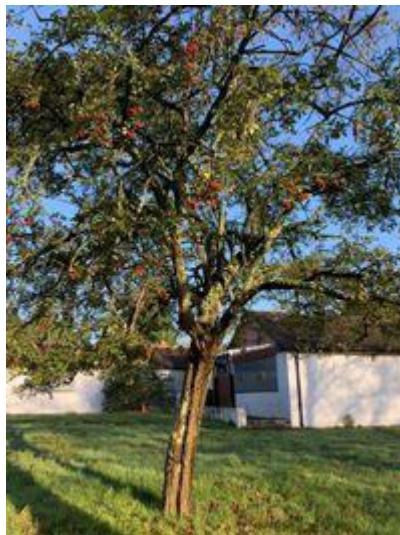
<u>Survey Responses</u>			
<b>Tree type / tree tag:</b>	T3	<b>Inspected by:</b>	Daisy Smith
<b>Approximate tree height (m):</b>	4	<b>Diameter at Breast Height (cm):</b>	30
<b>Age of tree:</b>	Semi-mature	<b>Safe to climb:</b>	No
<b>Tree suitability:</b>	PRF-I	<b>Number of PRFs:</b>	1
<b>PRF number:</b>	1	<b>PRF type:</b>	Compression forks
<b>PRF height (m):</b>	2	<b>PRF suitability:</b>	PRF-I
<b>Direction of PRF:</b>	South		
<b>Location of PRF:</b>	On main trunk		
<b>PRF entrance description:</b>	0		
<b>PRF internal description:</b>	0		
<b>Any evidence of bats:</b>	None		
<b>Any evidence of other animals:</b>	None		
<b>Additional notes:</b>	1 PRF, formed as a result of two stems joining. 10cm entrance, may lead further into stem. Entrance relatively wet. Could do FAR		
<b>Photograph(s)</b>	2 photograph(s) taken, which are provided below.

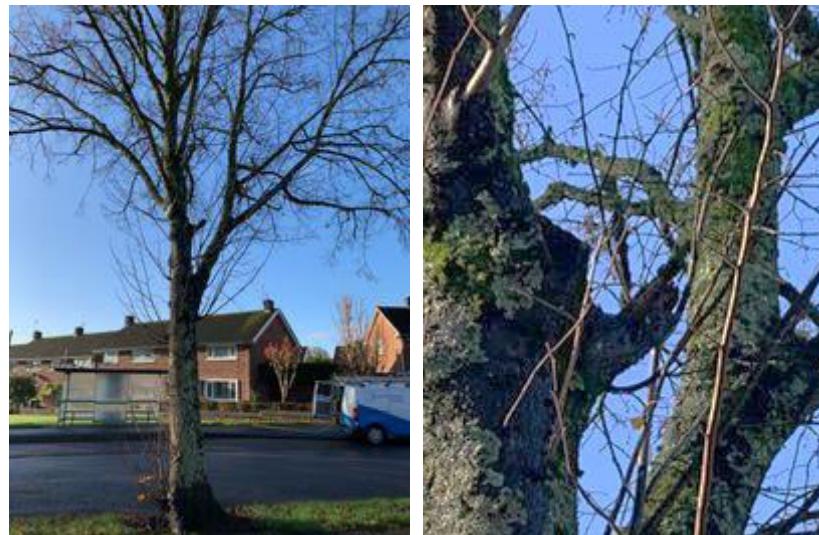
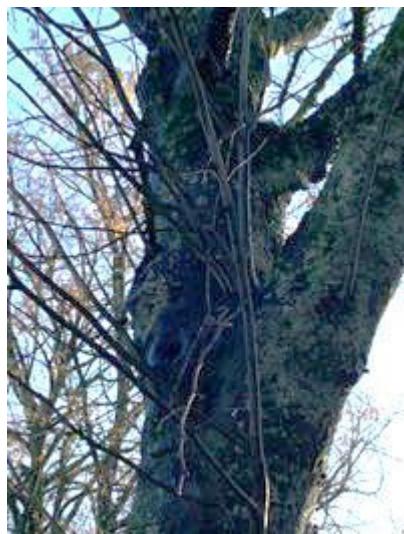
<u>Survey Responses</u>			
<b>Tree type / tree tag:</b>	T2	<b>Inspected by:</b>	Daisy Smith
<b>Approximate tree height (m):</b>	7	<b>Diameter at Breast Height (cm):</b>	40
<b>Age of tree:</b>	Semi-mature	<b>Safe to climb:</b>	Yes
<b>Tree suitability:</b>	PRF-I	<b>Number of PRFs:</b>	3
<b>Any evidence of bats:</b>	Not Inspected		
<b>Any evidence of other animals:</b>	None		
<b>Additional notes:</b>	Three PRFS. 1 and 2 are knotholes at 2.5m and 2.75m respectively. Entrances are wet at this time of the year. Unable to describe internally from ground level. PRF 3 is a broken limb, unable to determine suitability from ground level.		
<b>Photograph(s)</b>	3 photograph(s) taken, which are provided below.

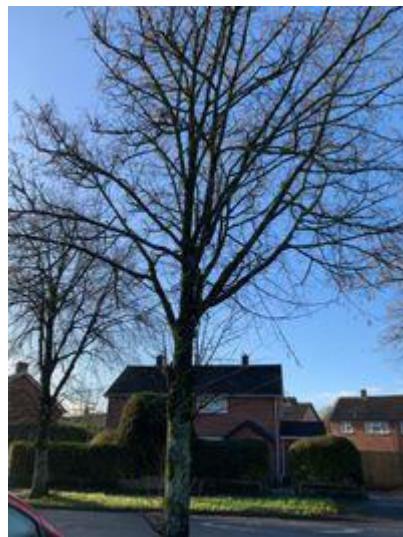
<u>Survey Responses</u>			
<b>Tree type / tree tag:</b>	T1	<b>Inspected by:</b>	Daisy Smith
<b>Approximate tree height (m):</b>	7	<b>Diameter at Breast Height (cm):</b>	40
<b>Age of tree:</b>	Semi-mature	<b>Safe to climb:</b>	Yes
<b>Tree suitability:</b>	None		
<b>Photograph(s)</b>	1 photograph(s) taken, which are provided below.

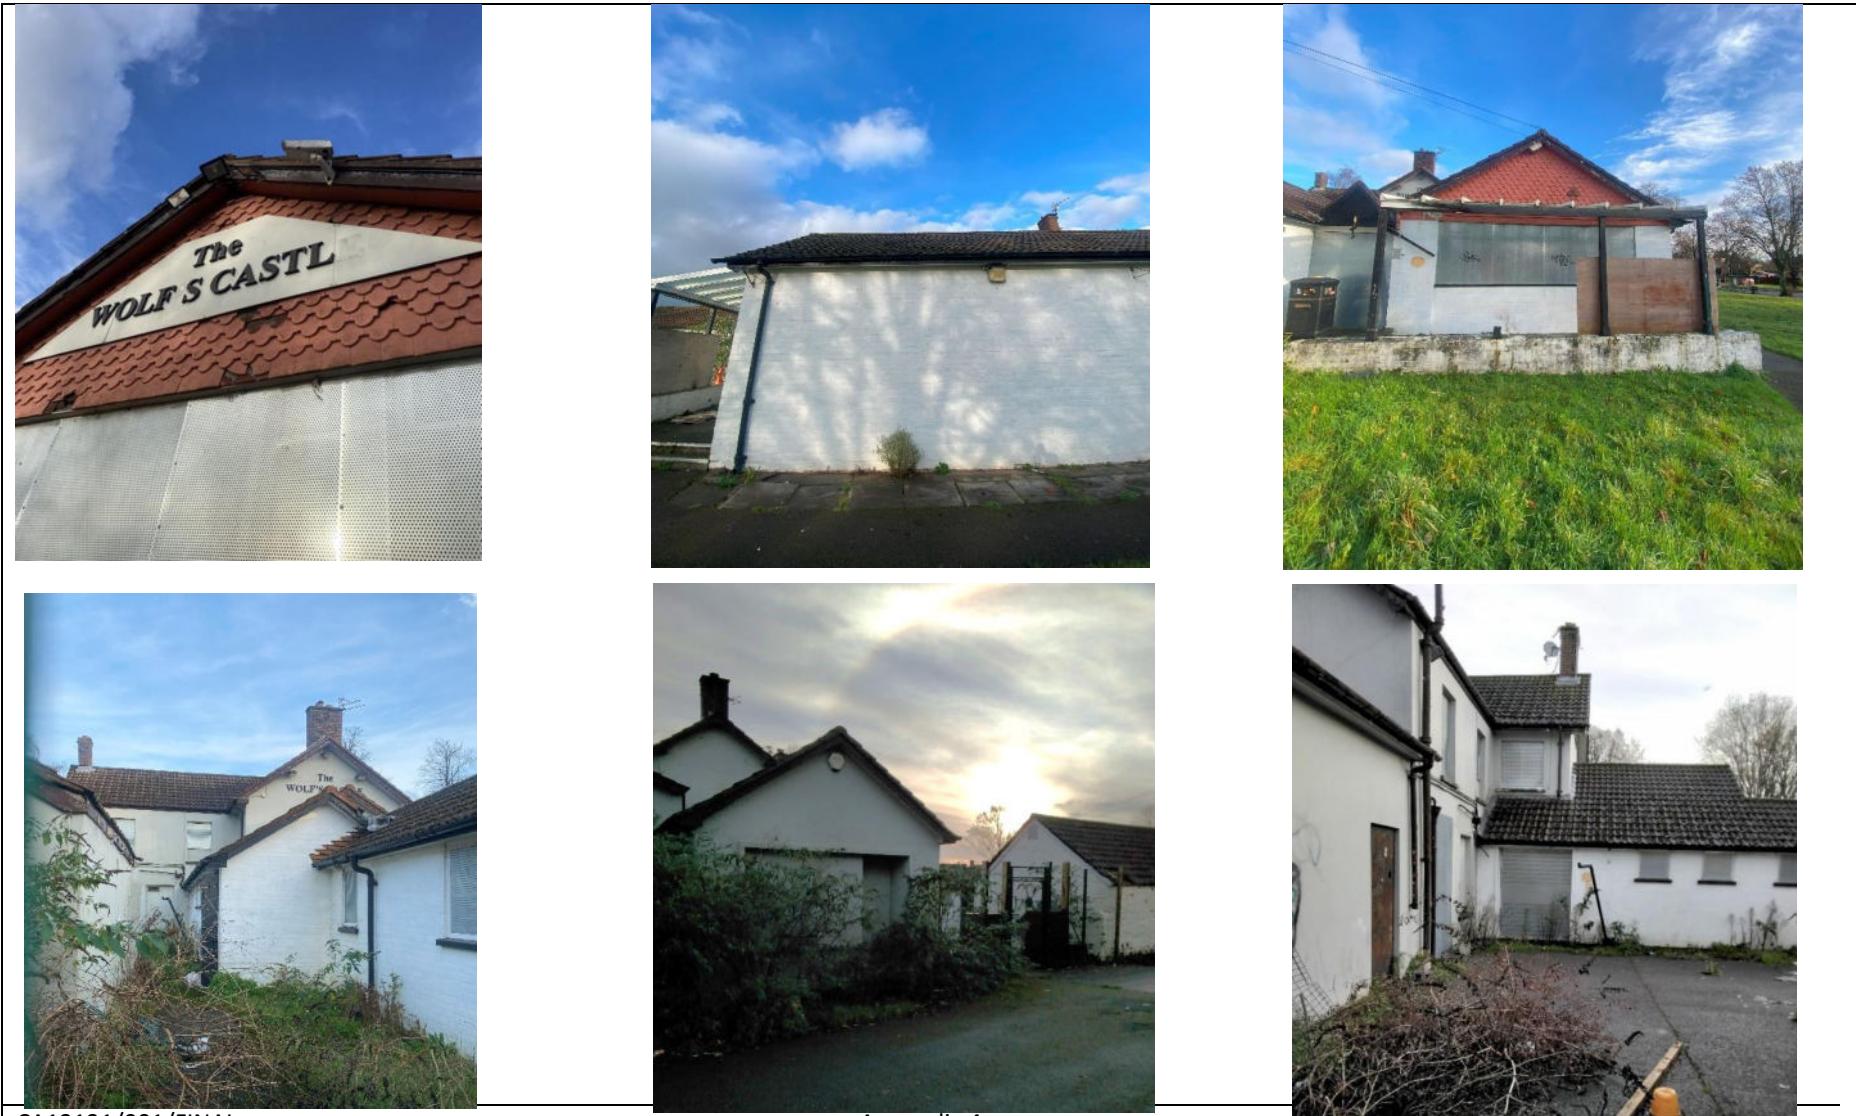
B1 is considered to have **high suitability** to support roosting bats. Due to the construction of the building, it has the potential to offer a constant cool temperature suitable to **support species of hibernating bats** including Leisler's *Nyctalus leisleri*, *Pipistrellus* sp. and brown long-eared bat *Plecotus euritus*, in features such as the roof void and broken window frames.

Feature	Feature description and suitability	Image
Broken soffit	There are numerous broken soffit boxes on all sides of the building, potentially providing bats with an access points interior the interior. Bats may also utilise the interior of the soffit to roost.

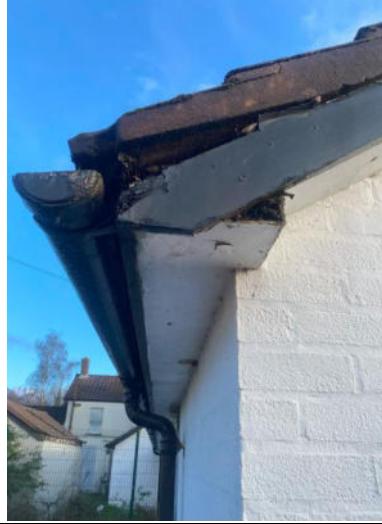
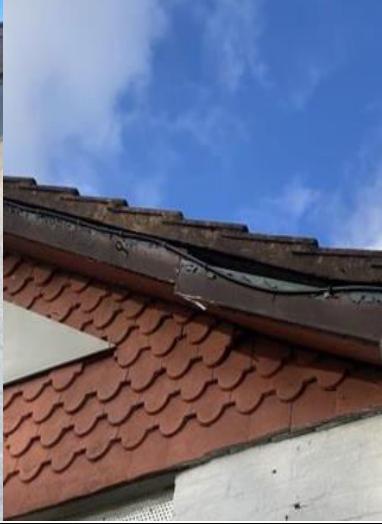
Broken bargeboard	This feature is present on most sides of the buildings and may provide bats with entry to the interior of the building or to roosting underneath.

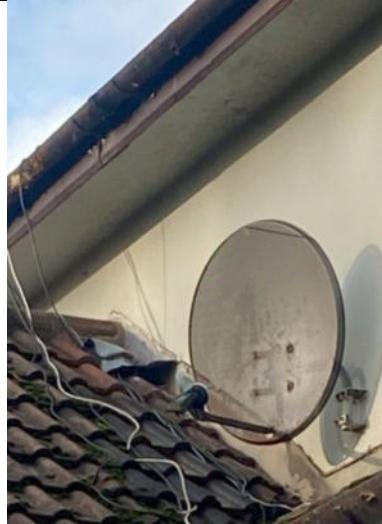
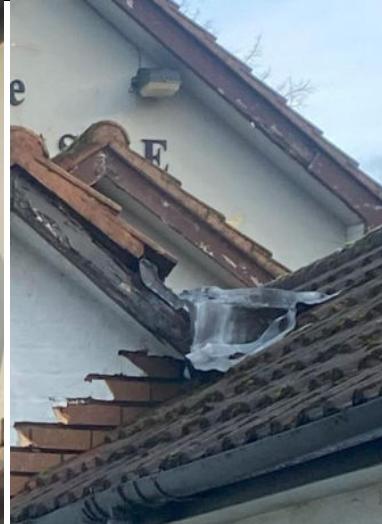
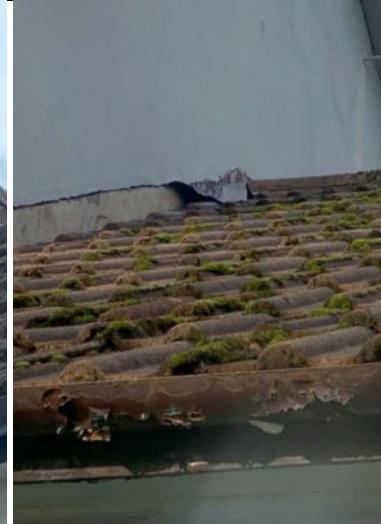
Raised and missing lead flashing	Missing lead flashing could provide bats with direct access into the interior of the building. Raised lead flashing could provide a suitable roosting place for crevice dwelling bats.

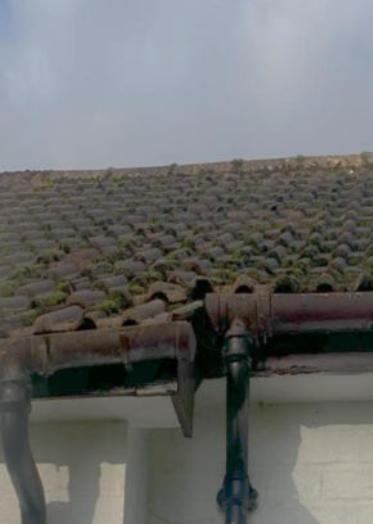
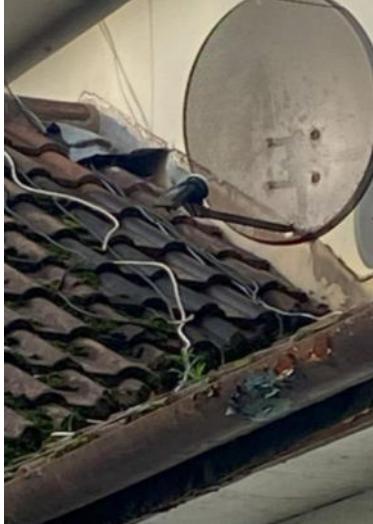
Broken/raised roof tiles	This feature could provide access to the interior for roof void dwelling bats, as well as suitable roosting places for crevice dwellers.

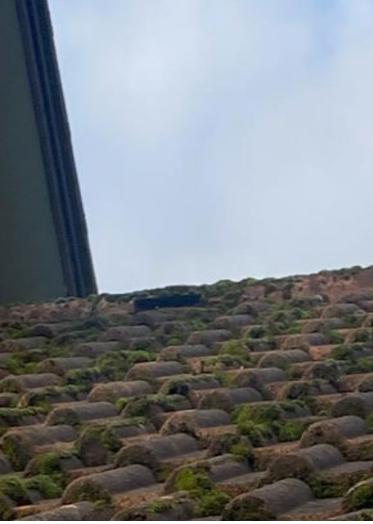
Broken/raised ridge tiles	This may allow bats to enter the building – suitable for roof void and crevice dwelling bats.
