**WOLF'S CASTLE**

**PRELIMINARY ECOLOGICAL APPRAISAL REPORT**

**JANUARY 2025**

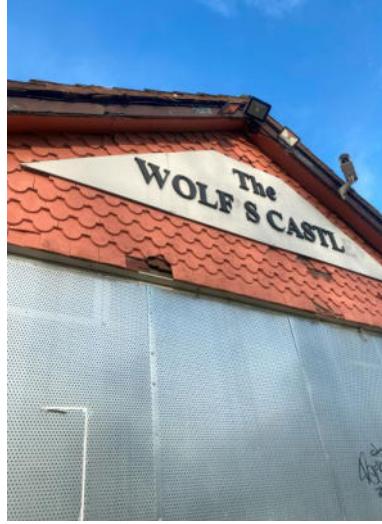
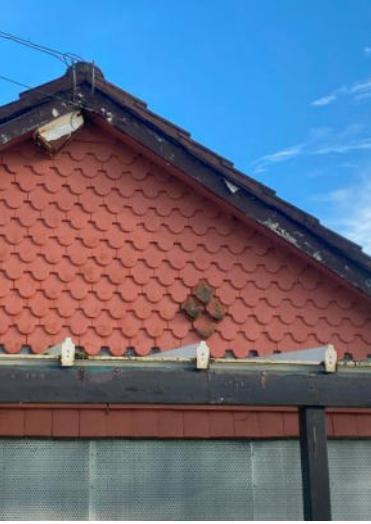
Raised, broken, and missing hanging tiles	Locations include the gable end of the south extension, and the gable end of the west extension with the glass porch. Some hanging tiles are missing and may allow roof void bats to enter the building. Where the hanging tiles are lifted and do not allow access to the building, it may still be suitable for crevice dwelling bats.

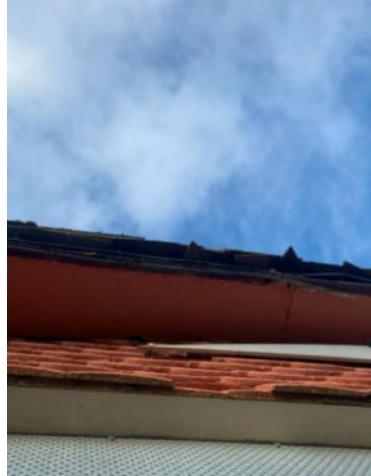
Raised Wolf's Castle sign	The sign reading 'The Wolf's Castle' is raised from the hanging tiles. The gap between the hanging tiles and sign may form a form of cavity wall - may be suitable for crevice dwelling bats.

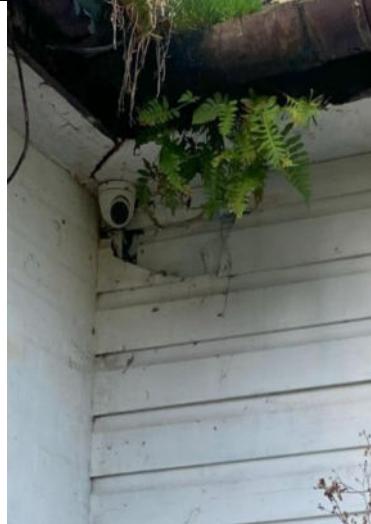
Broken Wooden Cladding	The broken cladding may be suitable roosting place for crevice dwelling bats.

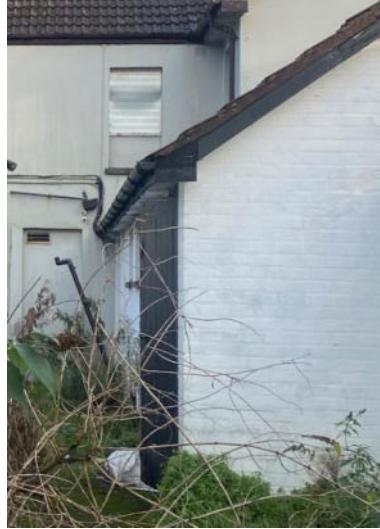
Door left open	Door on the north aspect of the building being held ajar by a bag. This may allow for bats that require flight access to their roosts to roost within B1. It may also be suitable for roof and crevice dwelling bats.

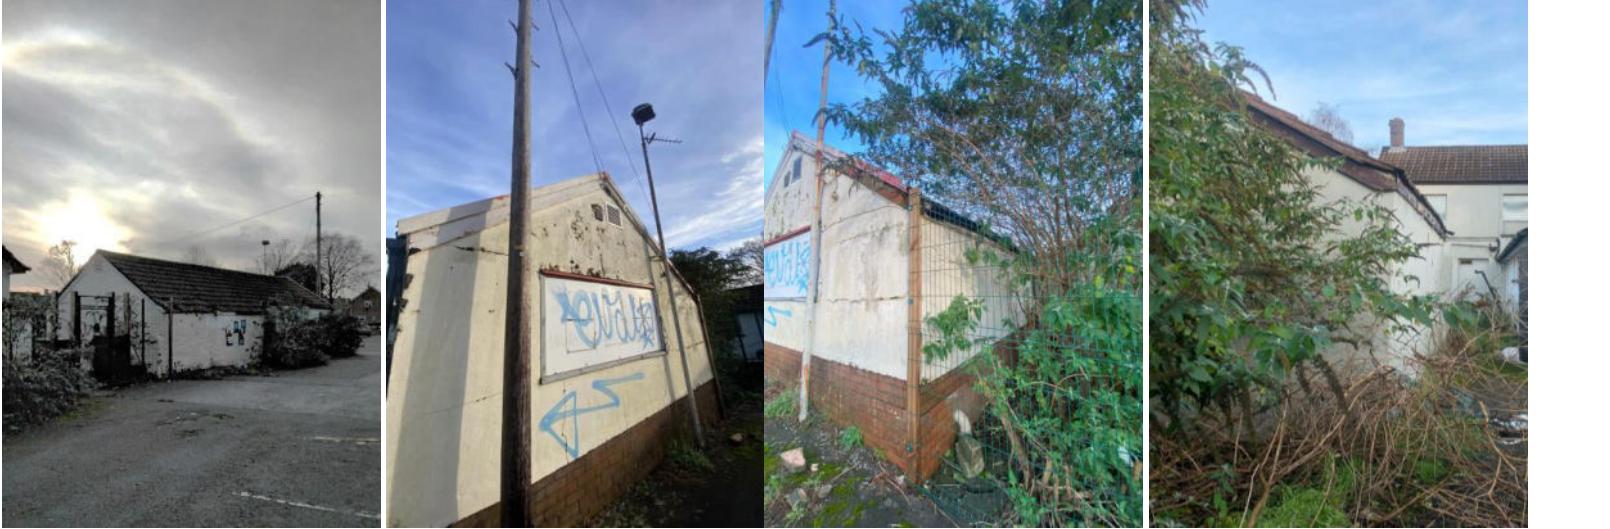
<b>Building 2 (B2)</b>			
<p>The smallest building on site, a former outbuilding known as B2, was surveyed. The building is a single storey structure, comprised of brick, stone, and mortar. There are two extensions, one to the north with a flat bitumen felt roof, and one to the south and has a dual pitched roof. The building is generally in poor condition. The bargeboards and fascias are wooden. The roof is dual pitched composed of interlocking clay roof and ridge tiles. The western end of the building and south extension is rendered, which is in good condition. There is a tall security light in the west gable end, although it is likely not in use.</p> <p>The fungus <i>Deconica horizontalis</i> is growing on the north extension's wooden fascia, indicating its deterioration.</p> <p>B2 is considered to have <b>high suitability</b> to support roosting bats. Due to the construction of the building, the interior has the potential to offer a constant cool temperature suitable to <b>support species of hibernating bats</b> including <i>Leisler's Nyctalus leisleri</i>, <i>Pipistrellus sp.</i> and brown long-eared bat <i>Plecotus euritus</i>.</p>

The image consists of four separate photographs arranged horizontally. The first photo on the left shows a wide view of a derelict industrial site with several small buildings and overgrown vegetation under a cloudy sky. The second photo shows a close-up of a weathered, light-colored wall with blue graffiti and a blue arrow. The third photo shows a wall with a red brick base and a white upper section, with a wire fence and dense green bushes in the foreground. The fourth photo on the right shows a view through overgrown bushes towards a white building with a chimney.

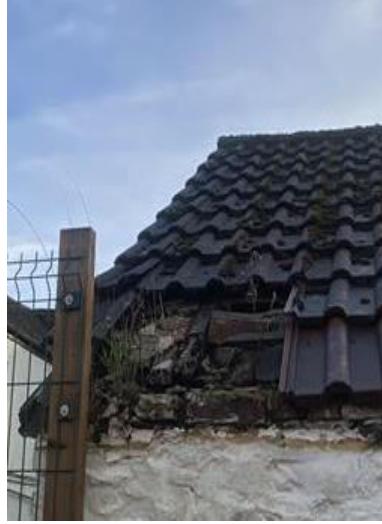
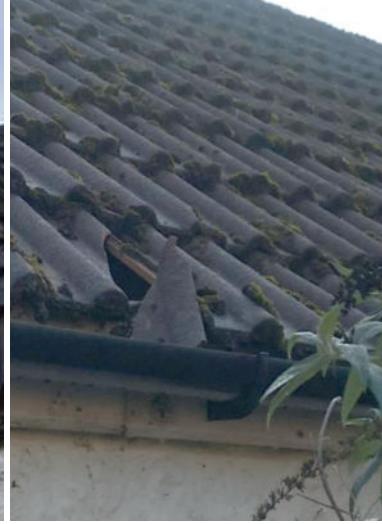
Missing/Broken roof tiles	<p>A large section of the roof on the north aspect is missing. This could provide bats with direct access into the interior.</p> <p>There are numerous roof tiles across the building which could provide bats with roosting opportunities.</p>

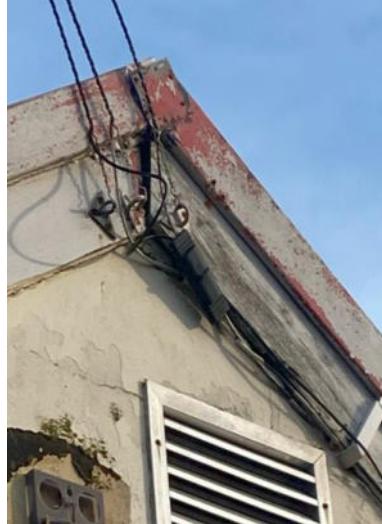
Broken bargeboards	<p>Located at the west gable end of B2. The metal bargeboard marking the building's apex is lifted, and the wooden bargeboard beneath is lifted. This may allow bats to access the building – suitable for roost void dwelling bats. If access cannot be</p>

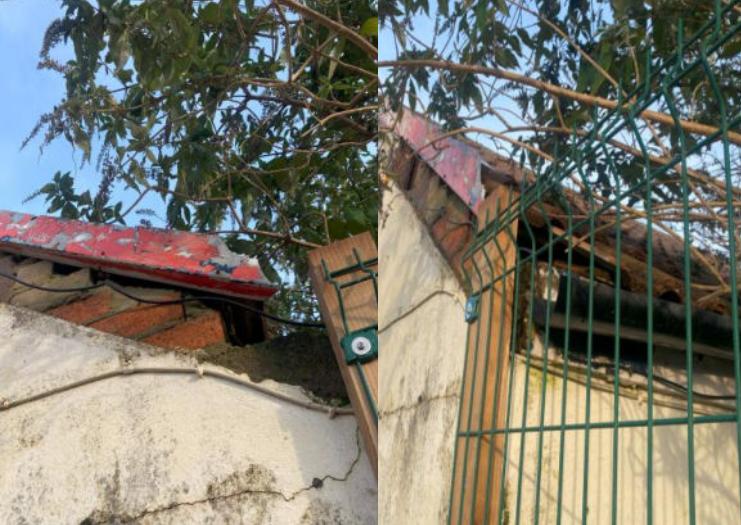
obtained - suitable for crevice dwelling bats.	
Missing bargeboard	<p>The bargeboard is missing from the west gable end, and tiles missing from the south aspect of the main building of B2, creating a large gap. There is clear access to the building – suitable for roof void and crevice dwelling bats.</p>

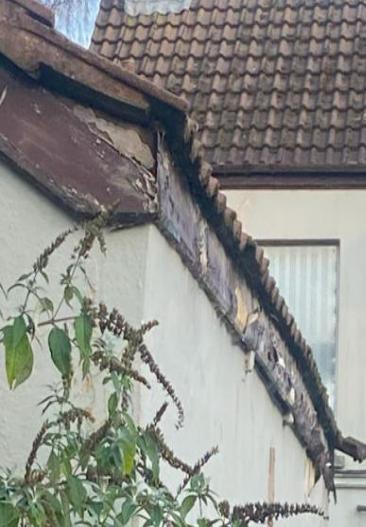
Raised fascia	Located on the south aspect extension, along the south aspect. The raised fascia may allow access to the building. If access cannot be obtained - suitable for crevice dwelling bats.
