Land at Craig Y Parcau Bridgend

Flood Consequence Assessments (FCA)

October 2025

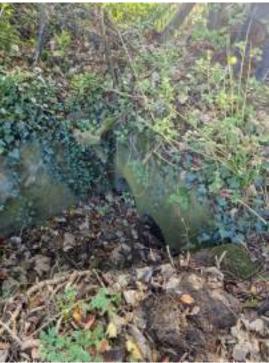
Debris within the existing twin culvert outfall – taken 27/10/2025

3.3.1 An existing watercourse flows north to south through the centre of the development within a SINC and Ancient Woodland designated area approximately 4-6m below the developable land areas. The unnamed watercourse outfall from the development area conveyed to the opposite side of 'New Inn Road', to the south of site, via a twin pipe culvert as shown overleaf:

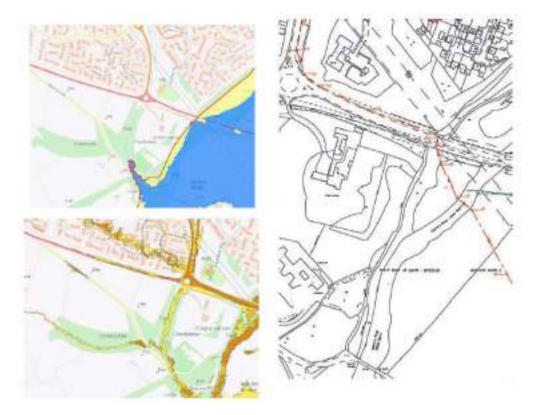
"The stream that runs through the site, it is believed to be the main means of stormwater discharge from the site given the site topography. The detailed flood risk maps maintained by Natural Resources Wales (excerpt opposite left bottom) show the area of stream running through the site to be an area of low surface water flood risk (shown in yellow). Environment Agency Wales have previously advised HD Ltd through their consultants Opus that the permitted (stormwater) discharge rate to the River Ogwr depended upon where on the River the development surface water was discharged. If the discharge to the River Ogwr was north of the A48 crossing then a maximum discharge rate of 28.2l/s/ha would be permitted. If however the discharge was south of the A48 then there would be no restriction of

discharge rate imposed by them provided SUDS features were incorporated within the proposed drainage scheme."

As this document was included within the Bridgend LDP under Supporting Evidence for Proposed Allocation COM1(1) – Craig Y Parcau document SD183 Drainage Strategy, can you confirm that should we provide a positive outfall for the Surface water to the river Ogwr this would be acceptable at free discharge as per the approved document attached as the development is South of the A48?

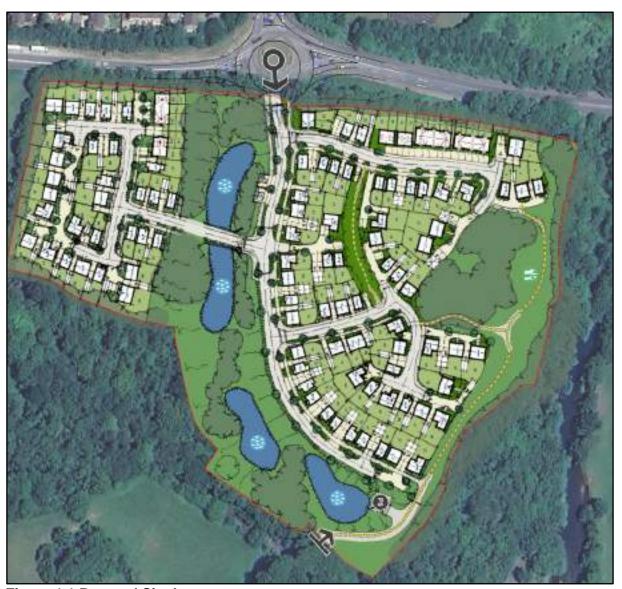
Figure 1.1 Proosed Site Layout

Bellway Homes (the Client) is proposing the construction of a new residential development at Craig-y-Parcau, Bridgend. The proposed site layout can be seen **Figure 1.1**.

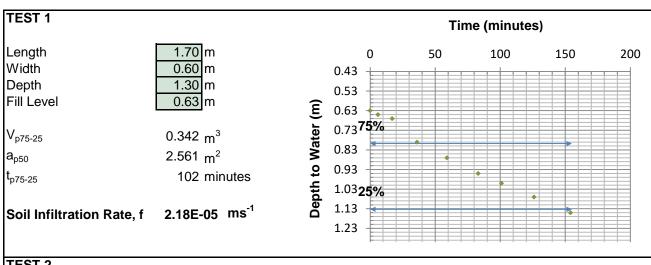
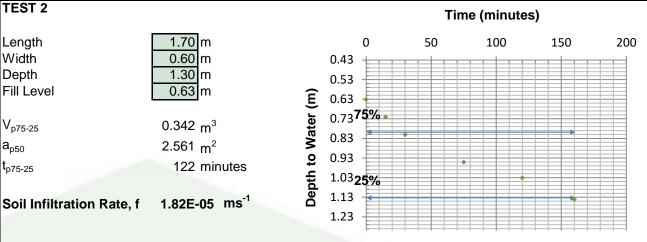
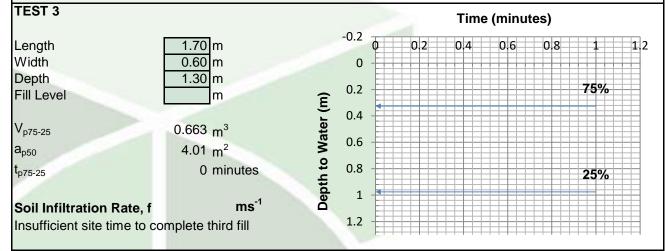
TP23 Trial Pit:

Test carried out in accordance with BRE Digest 365 (2016)

Trial Pit	Depth Range of Test (m)	Geology Description	Infiltration Rate (ms ⁻¹)
TP23	0.4-1.15		1.82 x10 ⁻⁰⁵
TP25	1-1.5	Oli ala tha a sa a la a sana a lla a sitta	No infiltration
TP26	0.5-1.0	Slightly sandy gravelly silty CLAY with low cobble and	6.53x10 ⁻⁰⁵
TP27	0.5-1.2	boulder content	No infiltration
TP28	0.7-1.2	bodider content	2.21x10 ⁻⁰⁵
TP29	1.1-1.6		No infiltration

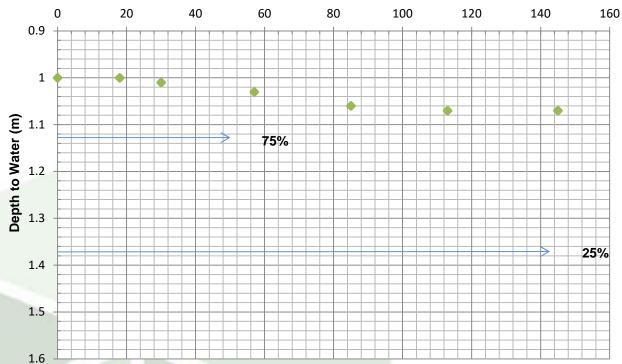
insufficient flow to calculate infiltration rate

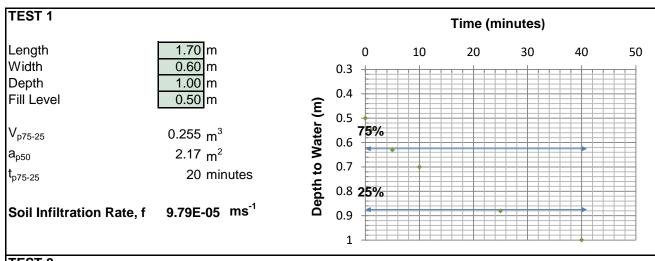
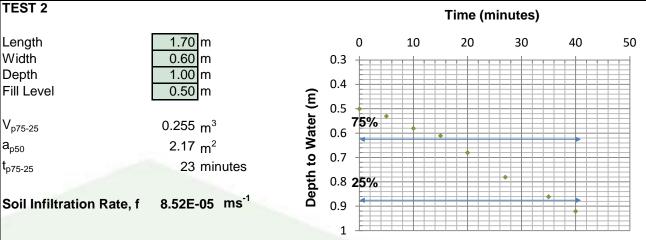
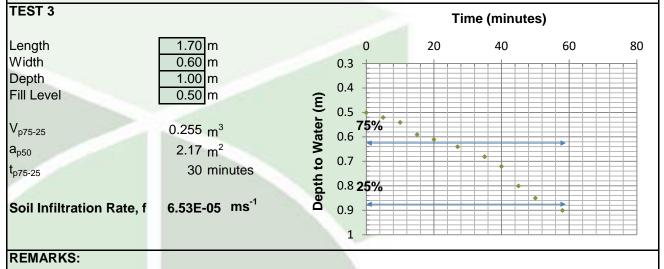
TP26 Trial Pit:

Test carried out in accordance with BRE Digest 365 (2016)

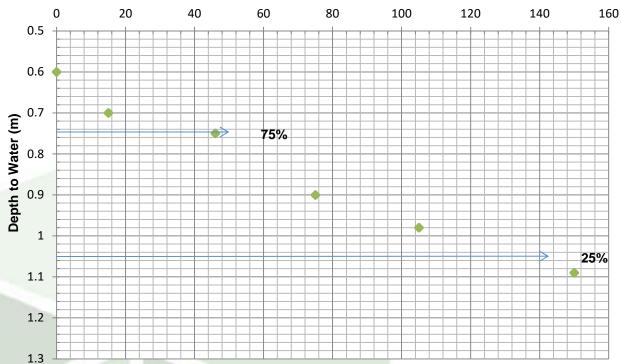
Soil Infiltration Rate, f 2.08E-05

Test carried out in accordance with BRE Digest 365 (2016). Insufficient site time to complete additional fills

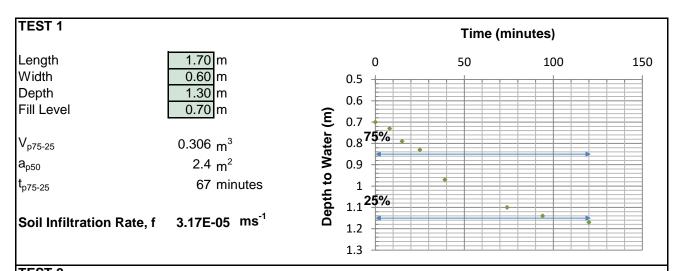
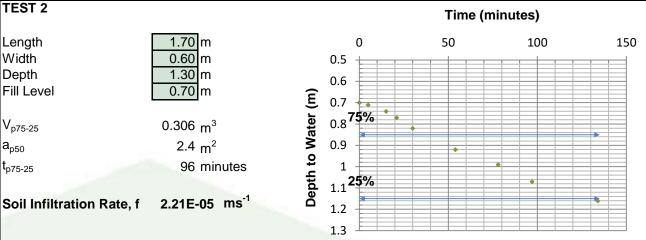
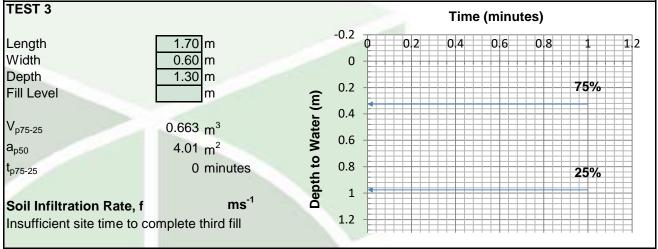
Date: 08-Nov Engineer: Elliot Trial Pit: TP28

Test carried out in accordance with BRE Digest 365 (2016)

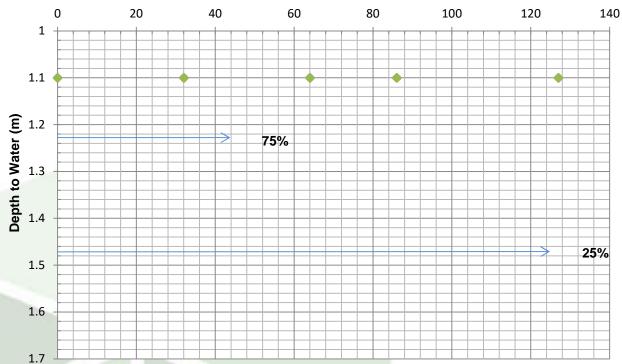
insufficient flow to calculate infiltration rate

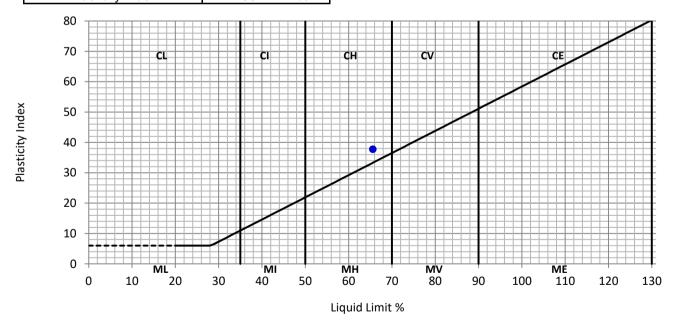
Liquid Limit	66	%
Plastic Limit	28	%
Plasticity Index	38	%

Preparation:	4.2.3 Natural Spe	cimen	
Proportion retained on 425µm sieve: 2 %

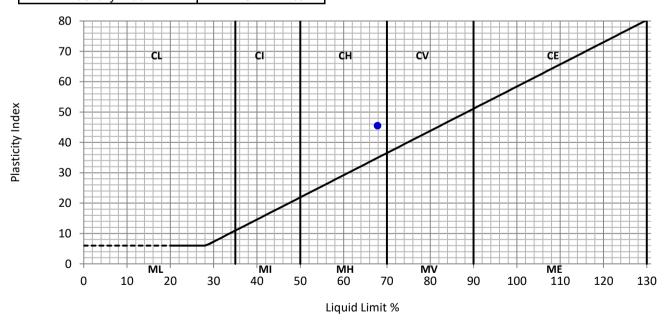
Liquid Limit	68	%
Plastic Limit	22	%
Plasticity Index	46	%

Preparation:	4.2.3 Natural Spe	cimen	
Proportion retained on 425µm sieve: 0 %
