Forensic engineering

a professional approach to investigation

Proceedings of the international conference organized by the
Institution of Civil Engineers and held in London, UK,
on 28–29 September 1998

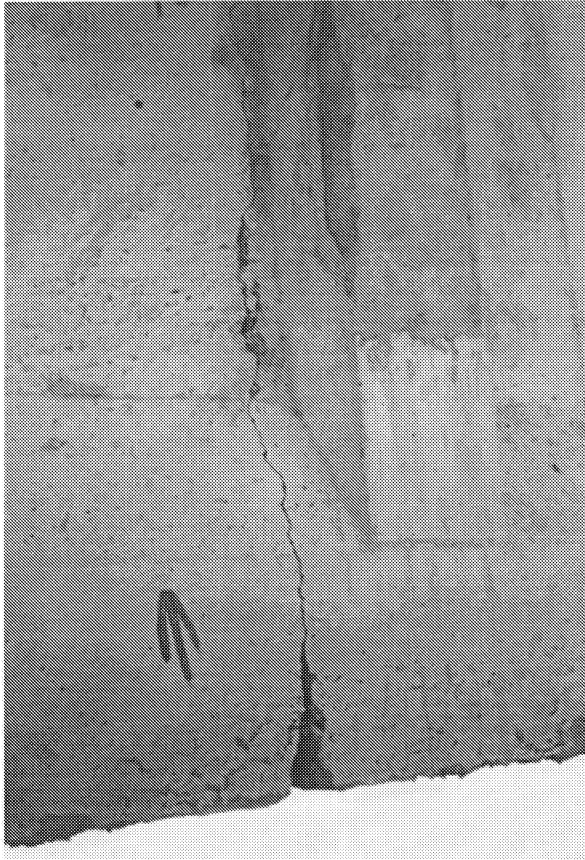
Figure 2. Flexural shear crack in bottom flange and web.

transverse diaphragms. A major crack adjacent to a diaphragm is illustrated in Figure 2. A review of the original design calculations, drawings and construction records highlighted a series of important factors which could have contributed to a significant loss of pre-compression in the bottom flanges. The design was based upon the first UK Code of Practice for prestressed concrete, CP115⁽¹⁾, which has now been superseded by BS 5400⁽²⁾.

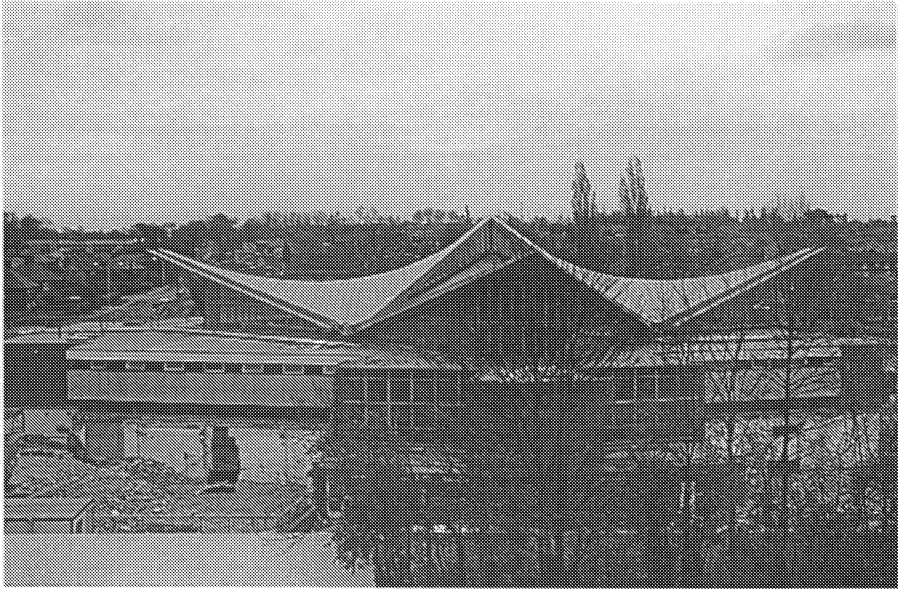
Figure 3. Hyperbolic-paraboloid shell roof.

The thin shell roof structure was made from 75mm thick lightweight reinforced concrete cast in situ onto asbestos sprayed wood wool tiles. The first phase of the refurbishment required that these tiles were removed. However, once the insulation layer was removed, it was found that leaching of water and fines had occurred at the interface with the concrete and large voids had formed. In a large number of positions the reinforcement was visible and corroded. This added a further dimension to the cable removal, since the behaviour of the roof during removal of the tendons could not be accurately predicted. However, some estimate of the behaviour had to be made prior to dismantling.

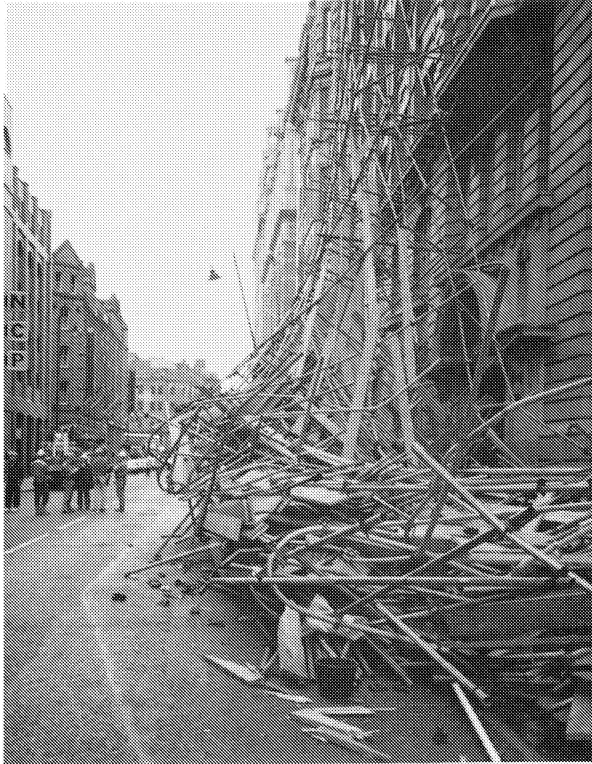
figure 1- *the debris was localised*

- (1) the collapse was in a 20m section of a scaffold 60m long;
- (2) the debris occupied an area not much beyond the footprint of the scaffold.

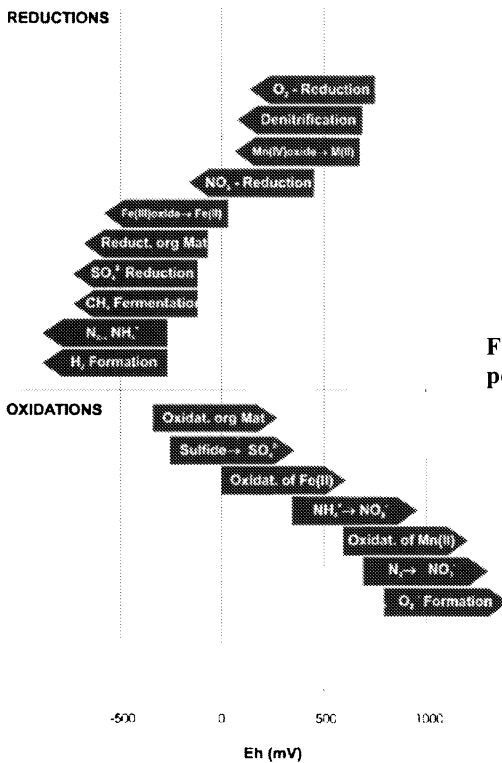
Figure 4. Order of oxidation potentials in soils and sediments^[9]

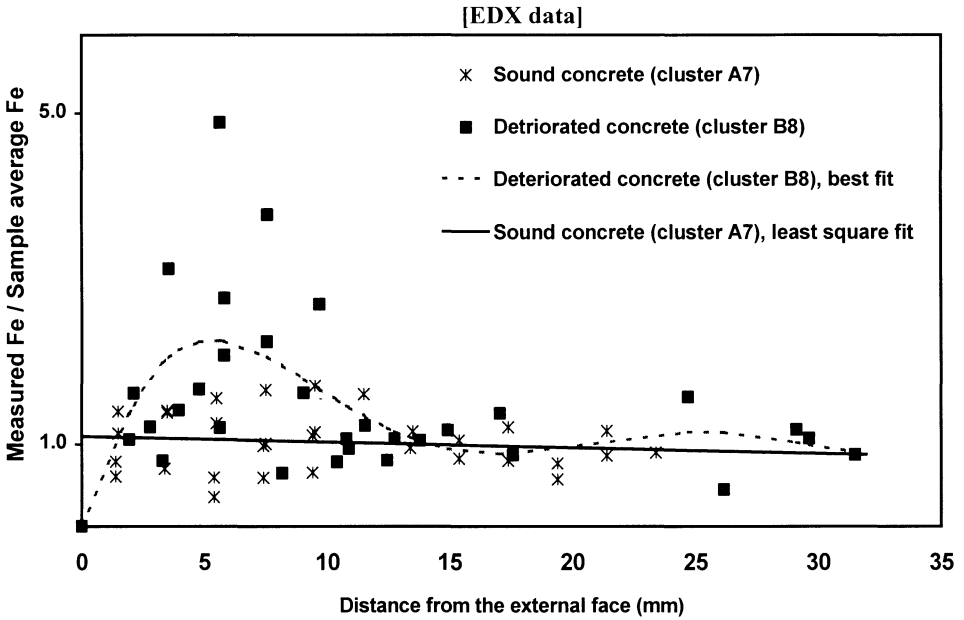
Figure 5. Variation of iron content in samples taken from deteriorated piles (cluster B8) and sound pile segments (cluster A7, within the skirt and below the mudline)

Bio-corrosion of concrete results in a series of changes in the microstructure of concrete, which can be identified by microscopic studies. In hardened concrete, a reduction of pH at the surface and possibly the successive layers by neutralizing effects such as carbonation, creates migration of iron ions (cations, i.e. positive ion charge) from an inside to outward direction. During microbial corrosion, migrating iron ions gradually accumulate and concentrate locally between the corroded and sound concrete. These ions eventually form a very thin iron layer dividing concrete between corroded and sound.^[16] Thus, the iron layer can be an indicator of the rate of microbial corrosion of concrete. The SEM-EDX data of the samples from the concrete cores taken from the deteriorated piles showed a high concentration of iron at about 6-7mm away from the surface of the pile, Figure 5. On the other hand, the iron-rich layer could not be identified in the concrete samples taken from the pile within the skirt and below the mudline, Figure 5. The segments of piles within the skirt and below the mudline did not exhibit signs of deterioration.

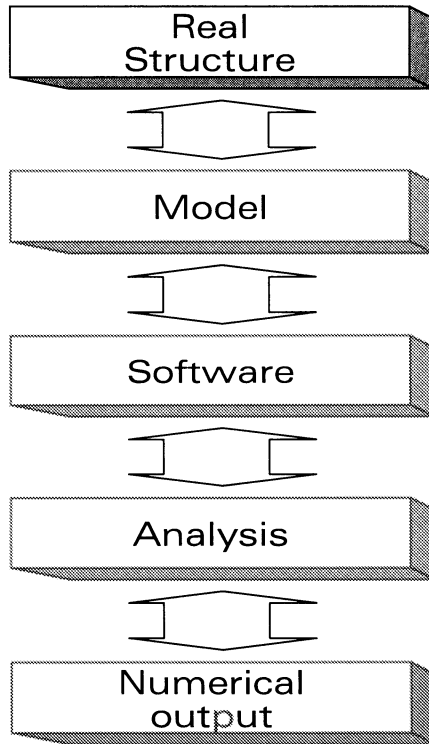
Figure 1. Diagrammatic representation of design process

The modelling process as applied to computer assisted design is shown diagrammatically in figure one. The real world structure is converted into a conceptual model. Software is selected that is used to analyse the model. The result of this analysis is taken to predict the behaviour of the real world structure.
