Introduction to Earthquake Engineering

Durgesh C. Rai

Department of Civil Engineering Indian Institute of Technology Kanpur Kanpur 208 016

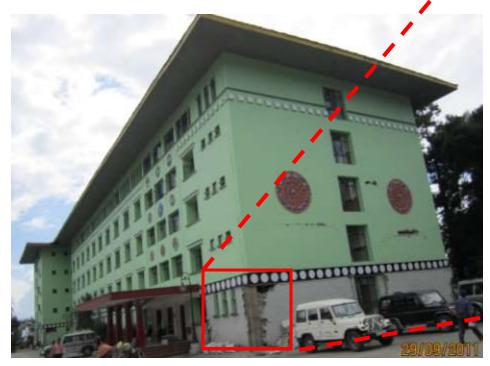
Failure of concrete block masonry cladding

Damage to state secretariat building at Tashiling, Gangtok

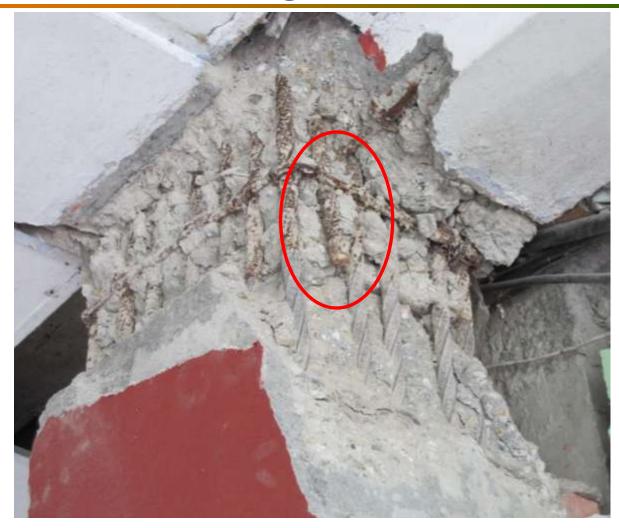
Splicing Near Beam-Column Joint

Damage to state secretariat building at Tashiling, Gangtok

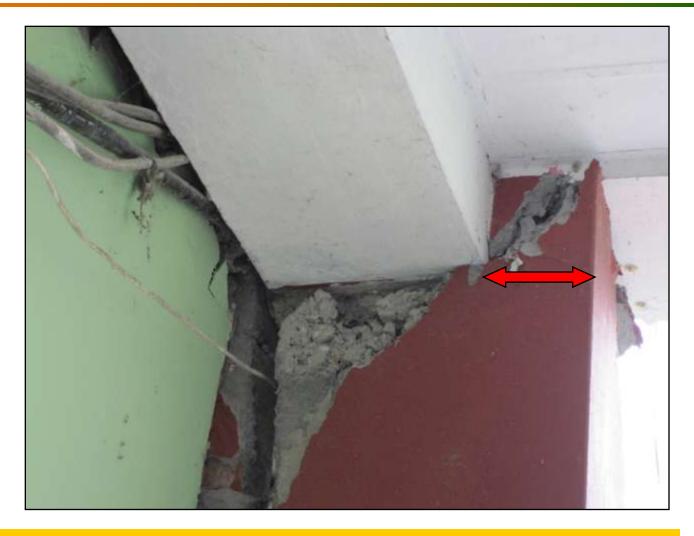
Offset in Beam

Damage to state secretariat building at Tashiling, Gangtok

- Mild steel bar as main reinforcement
- Poor quality of concrete

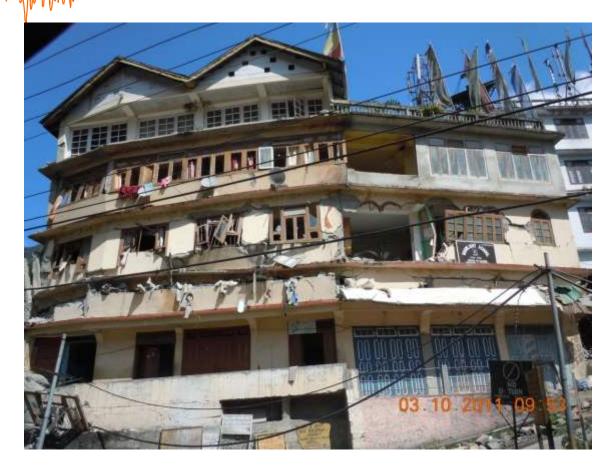
Pan-caking failure of school cum residential building at Chungthang

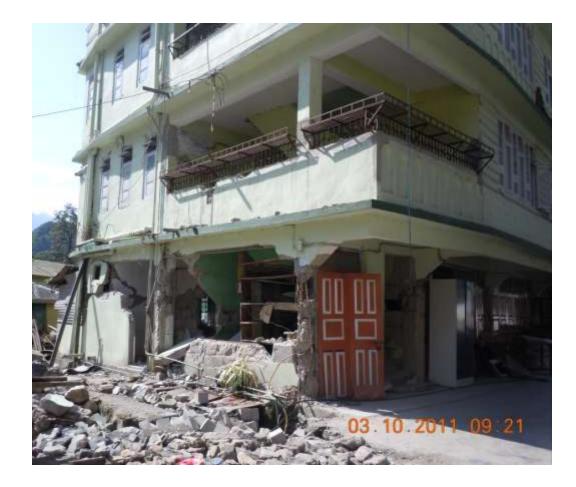
Severe damage in a 5 storey building at Chungthang

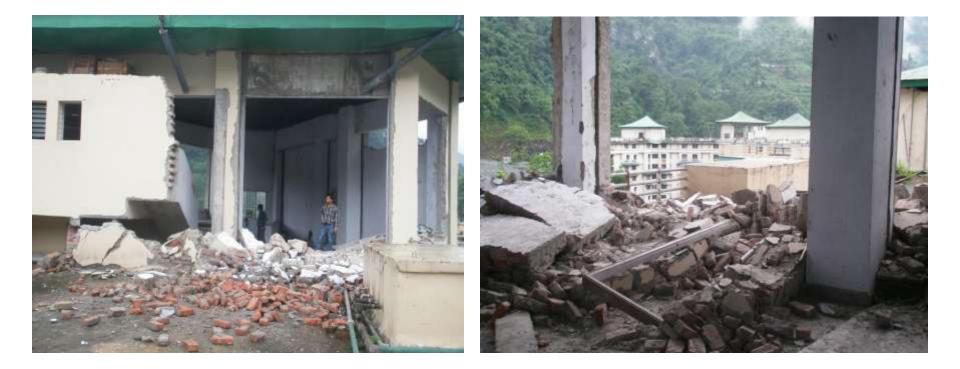
Out-of-Plane Failure of Infill in SMIT buildings

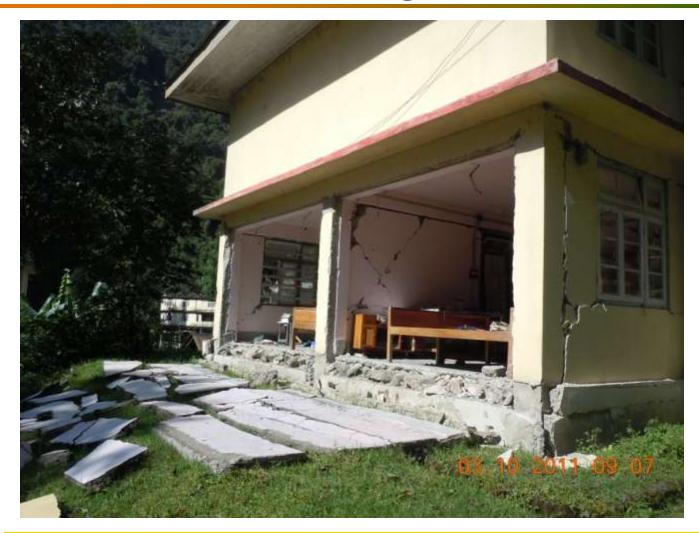
Out-of-Plane Failure of Infill of SDM Quarter at Chungthang

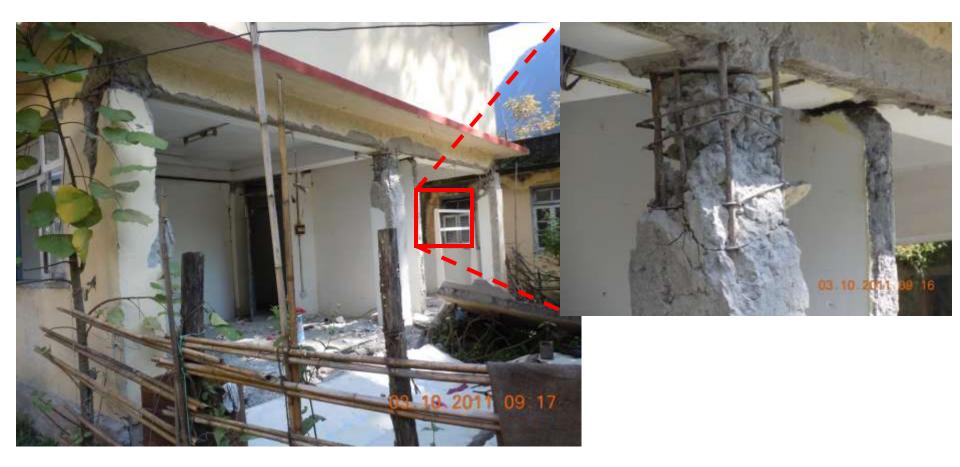
Column failure due to poor detailing in government quarter at Chungthang

- Inadequate confining reinforcement
- Cold Joint Topi Construction

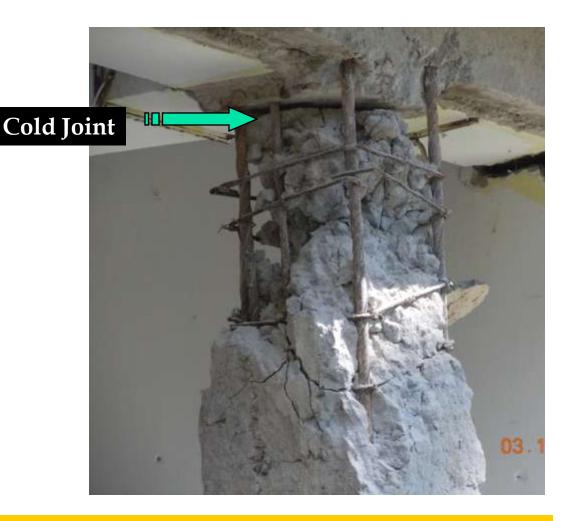
Column failure at government quarter building at Chungthang

Large Spacing b/w Stirrups > 250 mm

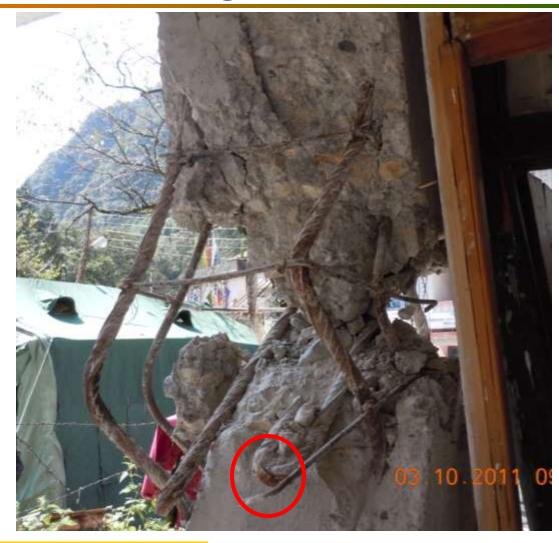
Failed column of a building in Chungthang

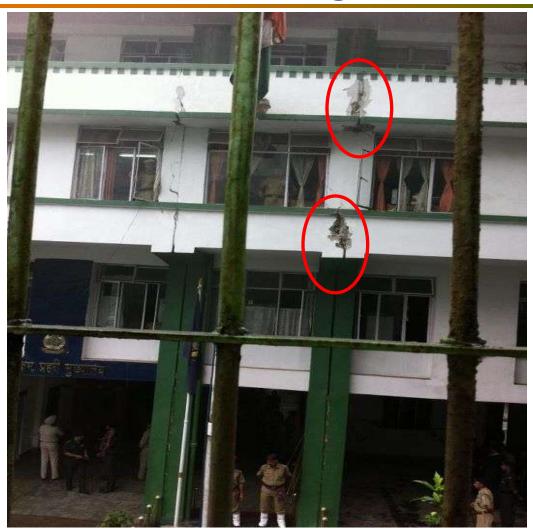
Minor damages in Police headquarter building at Gangtok

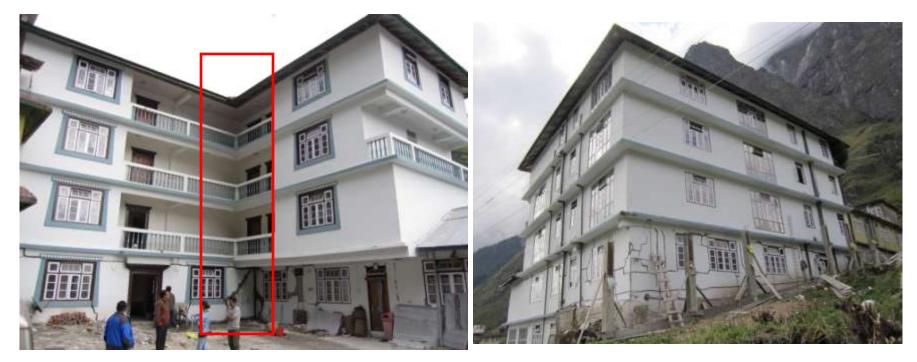
- •Out of plane failure of inner walls
- Shear cracks in exterior walls

L Shaped Hotel building, suffered considerable damage at Lachung

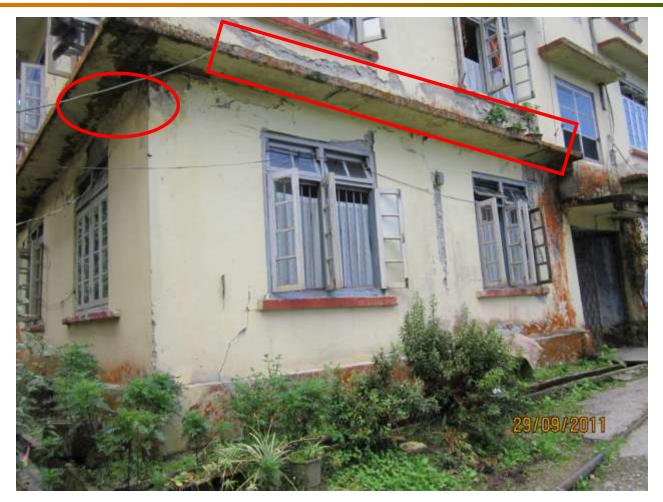
Minor cracks and delamination of plaster in staff quarters of TNA at Gangtok

- Older Block (60 year old)
 - Ikra infill
 - RC frame
 - Negligible damage

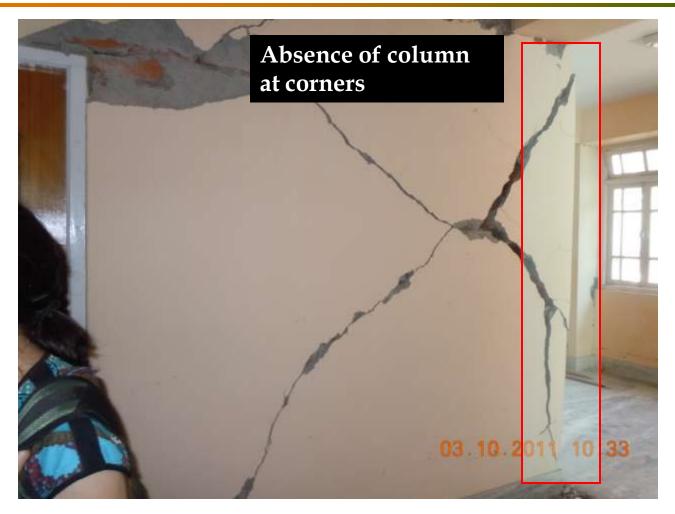
Shear failure and detachment of wall at corner in a building, Chungthang

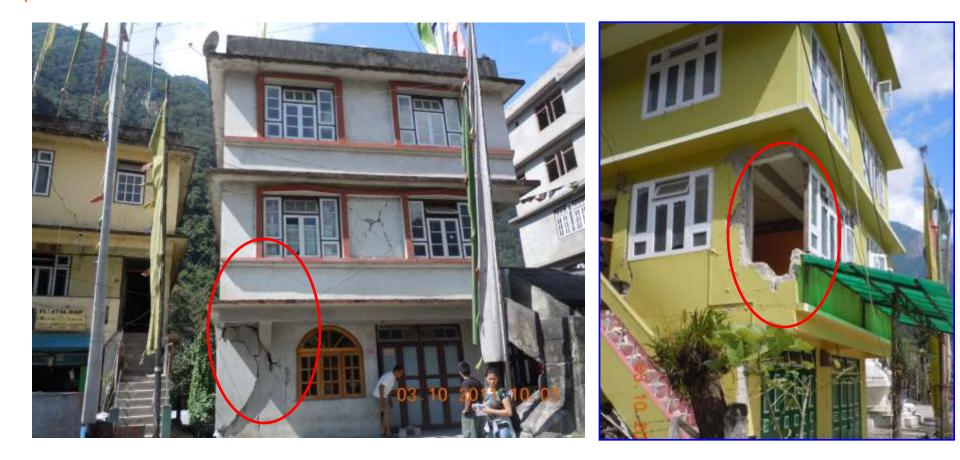
Damage to exterior unsupported wall on the cantilever projections in two of the buildings at Chungthang

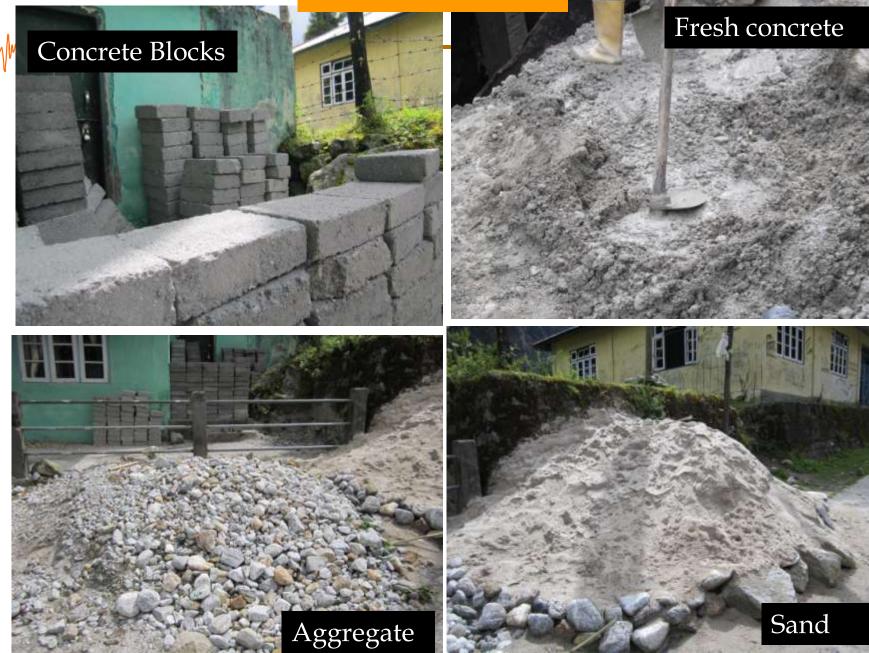
Quality control of materials

- Thin concrete blocks
- Poorly graded aggregate
- Rounded aggregate
- Poor quality of sand
- No control on w/c ratio in concrete
- No control over mixing of concrete

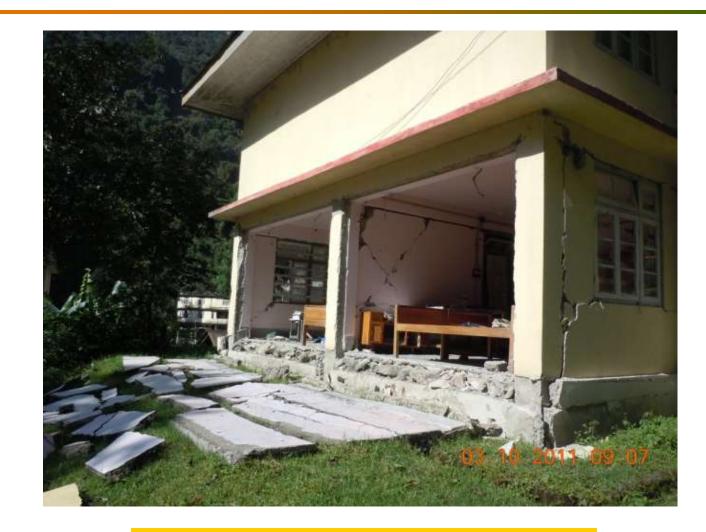
Out-of-plane failure of infill wall

Brittle masonry walls are weak in direction perpendicular to its plane

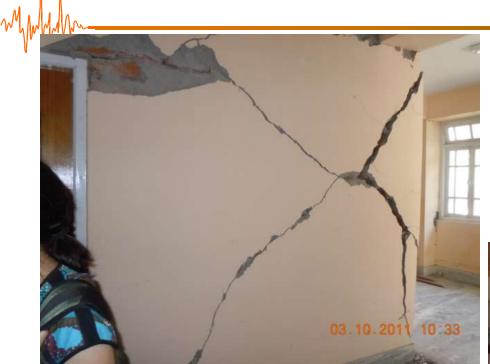
In-plane failure of infill wall

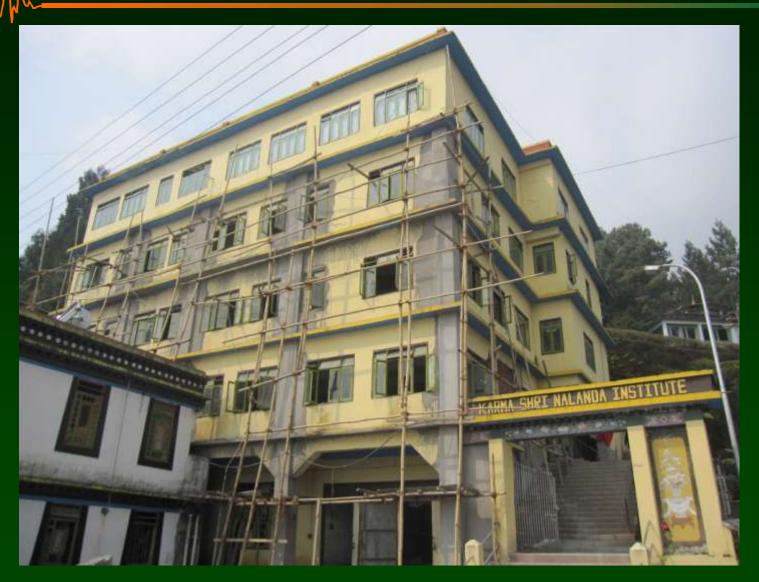
Retrofitting of Damaged RC Columns, Rumtek

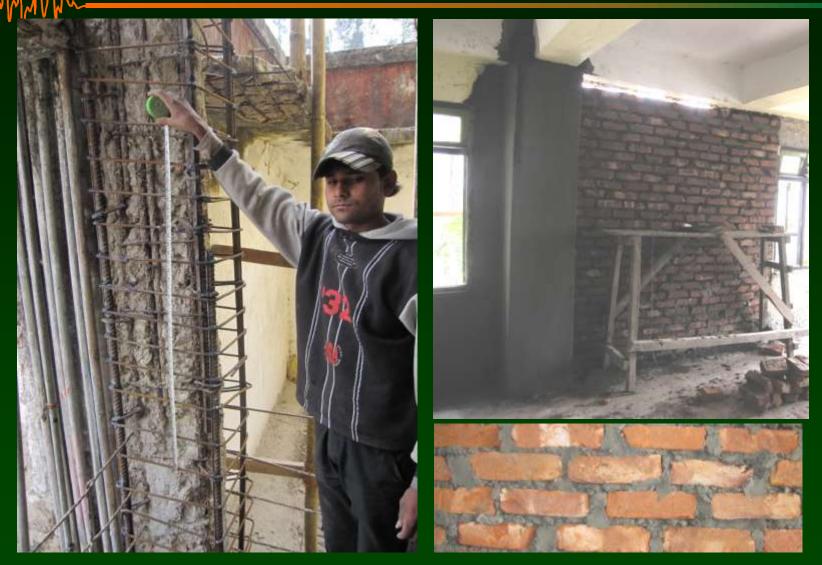
Retrofitting of Damaged RC Columns, Rumtek

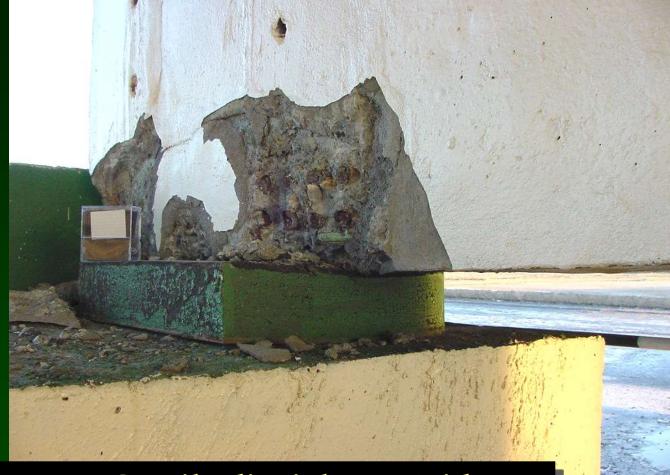
The New Surajbadi Highway Bridge *Jumping of Girders and damage*
