John Veisz Vs Giovanni Esposito Et Al

: **COMPLAINT AND JURY DEMAND**

615 FIRST STREET, OCEAN CITY, NJ 08226

ROOF—SIDING PUNCH LIST FOR IMPERIAL SIDING AND HOME IMPROVEMENTS, INC.

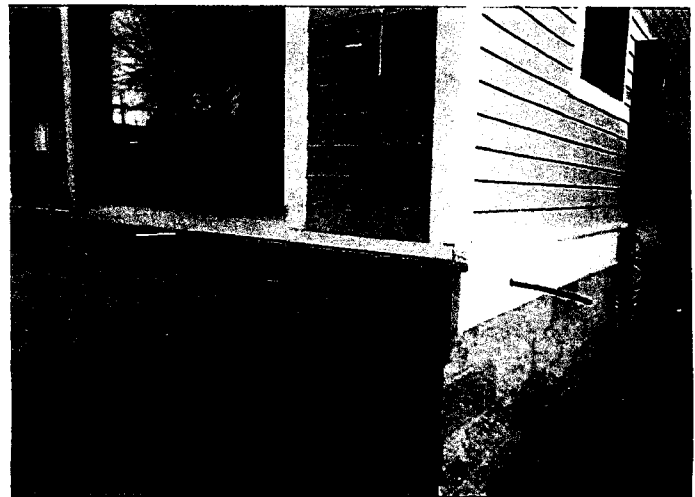
Photo #6

Condition: Northeast corner of east deck. Installation of siding and PVC base at deck is acceptable. The installers started the installation on the north side of the north side of the house, along the rear towards the west. The General Contractor noticed the installers did not set-up/survey level corner marks and had offered to assist with same but was advised that it was not needed. The siding drops as it moves to the west. Installation is poor. Note siding under the window.

Action Required: To be determined

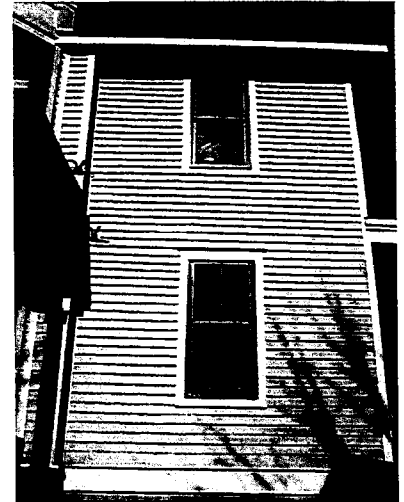
Photo #1

Condition: James Hardi plank siding on the southeast corner of the house (closest to corner of First St. and Ocean Ave.) Installation is level and relatively neat. The position of the water table and drip cap allowed for the required installation of a PVC base on the deck to the right below the siding as designed and contracted.

Note siding installation below and above windows.

Action Required: Clean and touch up construction marks, scrapes, nail holes and all other defects with paint; typical over entire house.

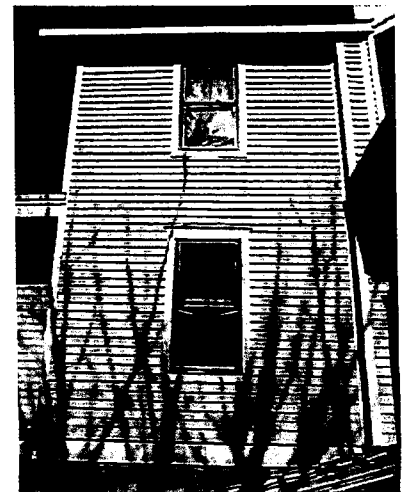
Photo #3

Condition: James Hardi plank siding on the southwest corner of the house (closest to garage). The installers did not install the siding level and in variance with printed installation instructions of manufacturer. The siding begins to slope starting at the front door. The position of the water table and drip cap drops 1-1/2" from south east corner of the house and is unacceptable. The drop in siding only allowed for a sliver of pvc trim to be installed under the siding on the west deck, in variance with the design.

Note siding installation below and above windows.

Action Required: Remove and reinstall siding level as contracted.

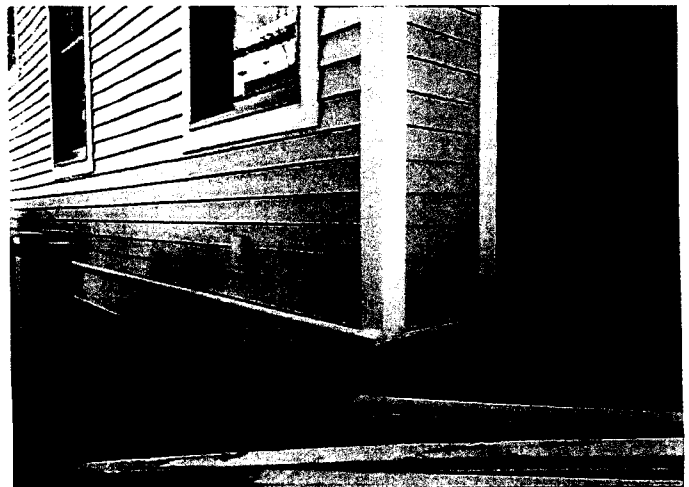
Photo #9

Condition: Siding installation at northwest corner is not level and drops. Note restricted dimension between deck and bottom of siding allowing sliver of PVC trim. Bottom course of siding projects out past the corner trim.

Action Required: To be determined

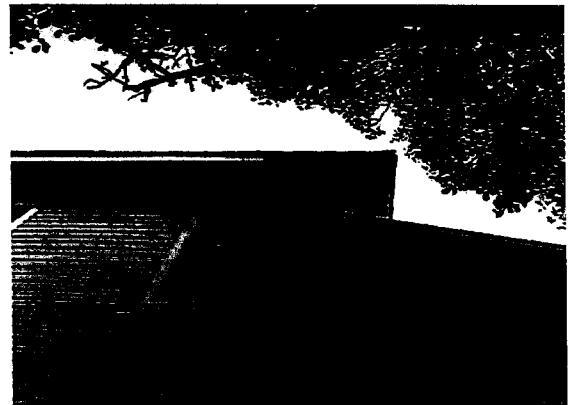
Photo #12

Condition: Irregular siding installation at north side of house.

Installers used 1 x 3 grey batten trim in lieu of 1 x 2 Azek batten called for on drawings sent to Ed W. on (2) occasions and discussed. Horizontal bottom trim is only 1 x 3; 1 x 6 shown on drawing.

Action Required: Remove and replace with materials called for on contract drawings Notes [AD], North Elevation #2 on Drawing A-3. Note: 3/4/17—Noted grey stock was removed and 1/2" x 4 white pvc was installed. Condition is acceptable on North side. On South side, complete installation of pvc sheathing and trim near eave edge at step in wall.

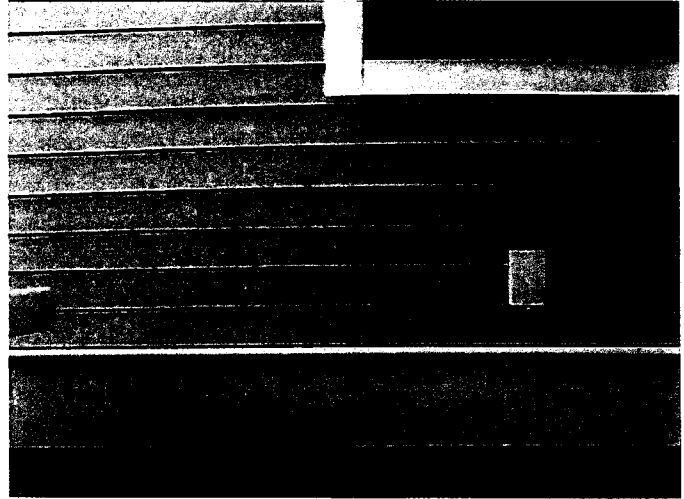
Condition: Typical damaged surfaces are unacceptable. Previously discussed with installers and Ed W. when work was in progress. Nothing was done. Note position of siding under window sill is lower at northwest end of house compared to northeast end of house. Siding is not level.

Action Required: Clean, fill all nail holes with matching sealant and repaint in accordance with manufacturer's printed instructions.

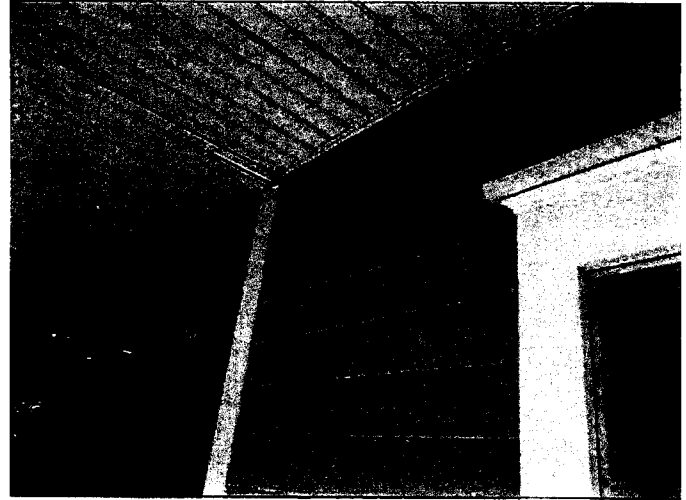
Condition: Joint in soffit was not installed as discussed with Ed W. and Installers on site. Condition was to be moved to column Center line to disguise break between sloping and level soffit

Action Required: Remove and reinstall.

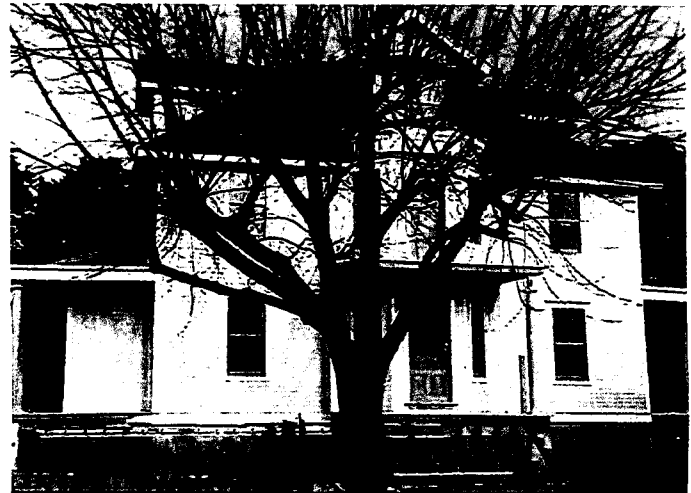
Photo #18

Condition: Siding to the right of the front door was cracked during the process of installing pvc trim under the siding above the decl.

Action Required: Remove and replace all damaged siding, typical.

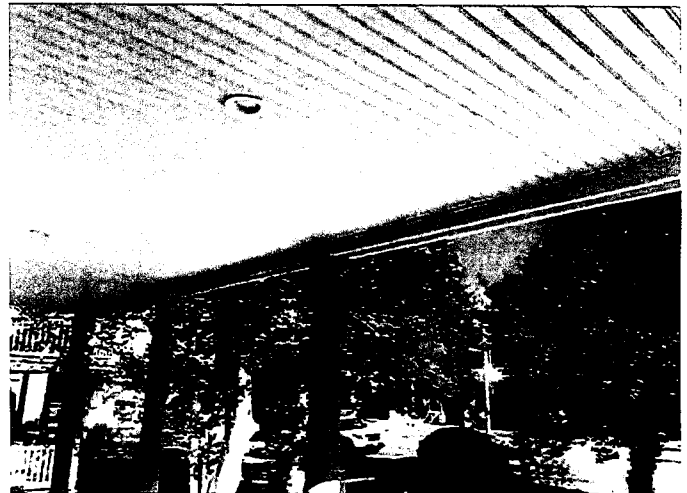
Photo #20

Condition: Soffit was not installed with receiver channel. Irregular gap is unacceptable.

Action Required: Remove and reinstall to correct condition. Typical at all decks.

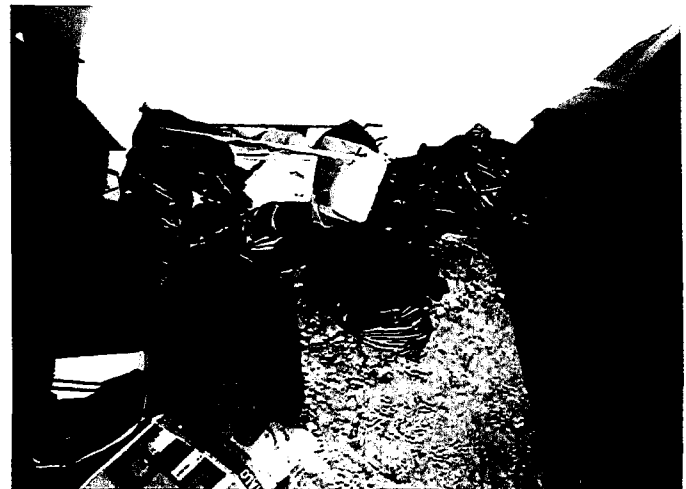
Photo #24

Condition: Debris from siding installation remains all over the project site. Materials are thrown all over the yard.

Action Required: All debris related to siding, soffit and roof construction is to be removed from the project site pursuant to our contract.

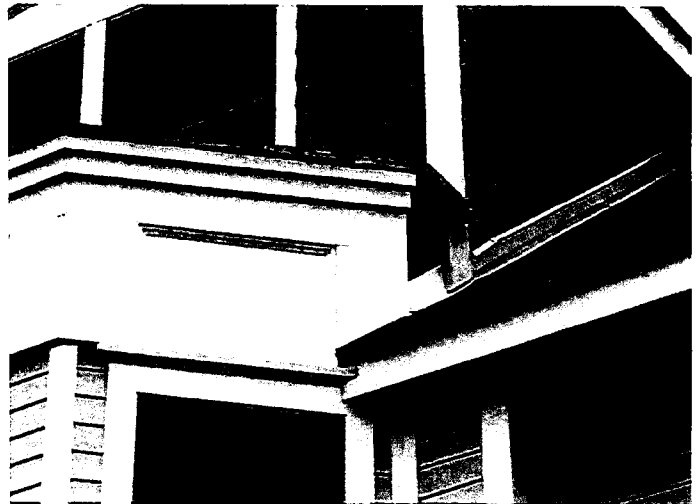
Photo #26

Condition: Failed to install sheathing and underlayment behind pvc trim and sheathing previously reported on numerous occasions. Wood Shakes were not installed in accordance with Malbec printed installation instruction. Exposure is not 5-1/2". Net result is raw edge of shakes were not touched up as specified and extends beyond outer face of pvc corner trim; typical

Action Required: Touch up paint all raw shakes

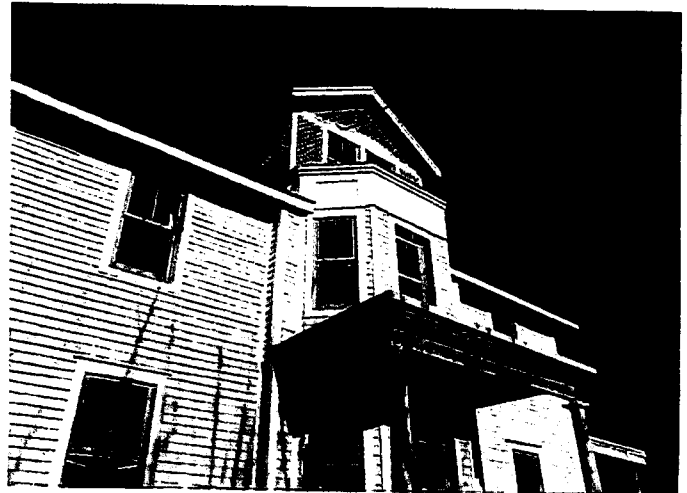
Photo #30

Condition: PVC fascia trim on upper and lower decks are incomplete.

Action Required: Complete installation of all outstanding pvc fascia trim on upper and lower decks; typical as contracted.
