A Look at the White House Kitchens

LYDIA BARKER TEDERICK

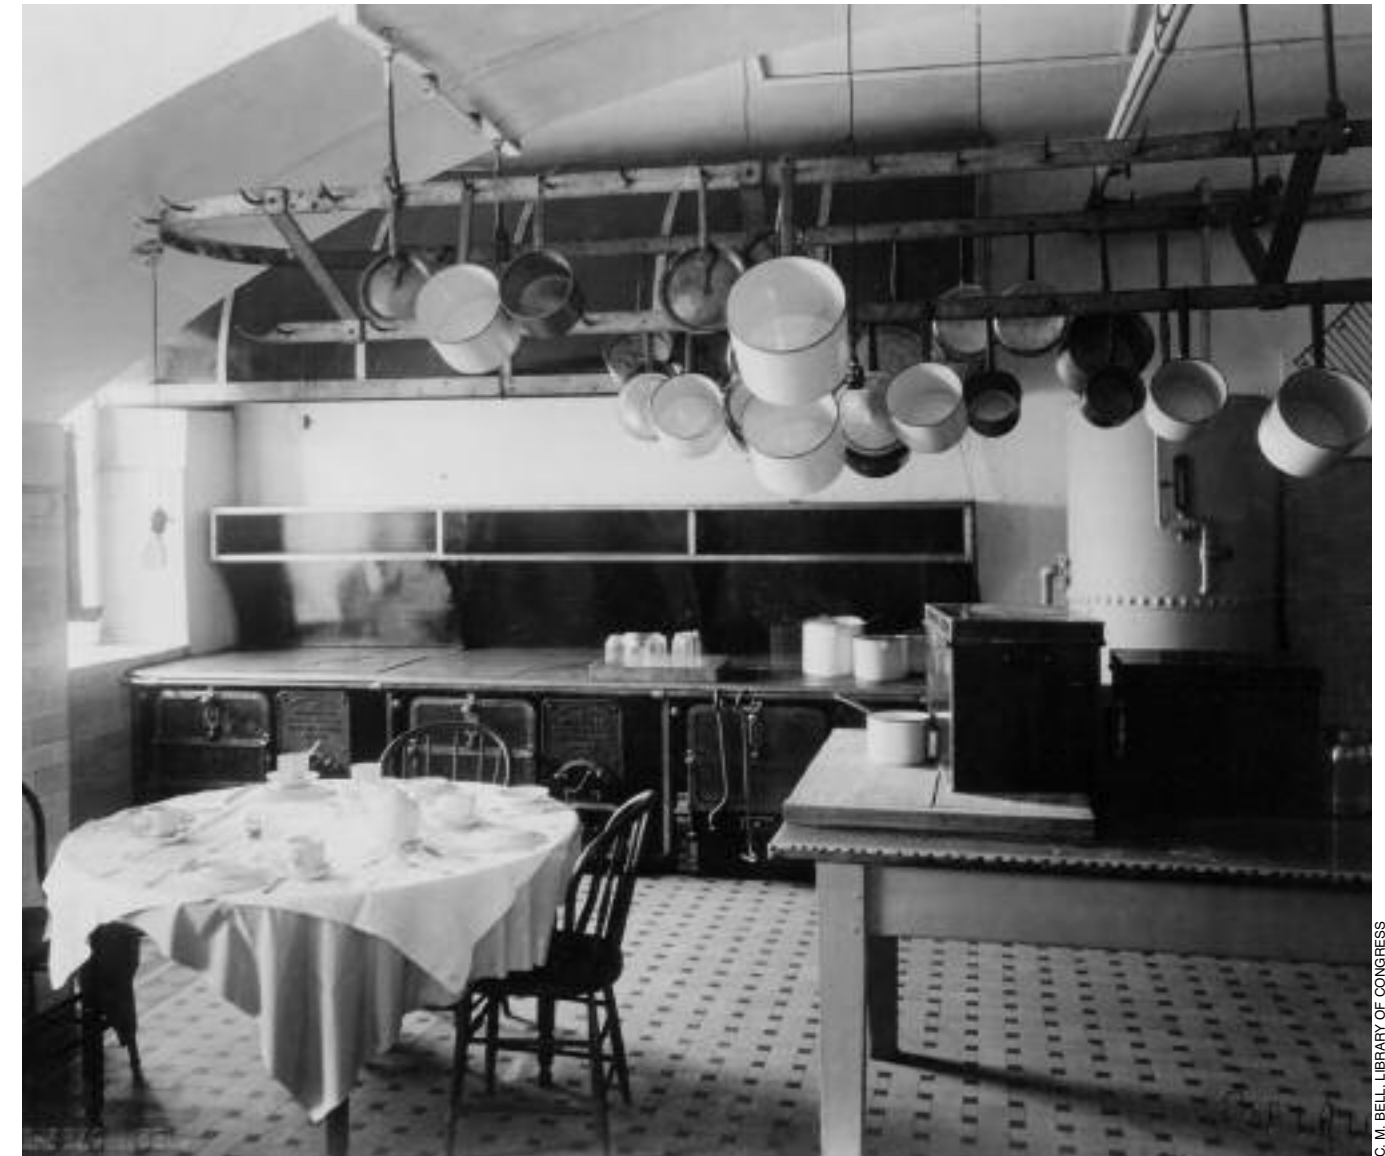
A view of the kitchen in 1901. The large kitchen was used for main events and more formal entertaining. The round table at left is set for a staff meal. The presence of electricity, introduced to the White House in 1891, can be seen by the surface-mounted electrical wiring placed along the ceiling. Single light bulbs hang from the ceiling to illuminate the room; one appears over the round table.

The neighboring larger kitchen, today's main kitchen, was utilized only for major occasions when more workspace was required. Because it was used less frequently, it also served as a dining area for the domestic staff. In 1889, *Frank Leslie's Illustrated Newspaper* published a wood engraving of this room that is one of the earliest images. A similar view was photographed by C. M. Bell in 1901, showing a large gas range and a table set for a staff meal.

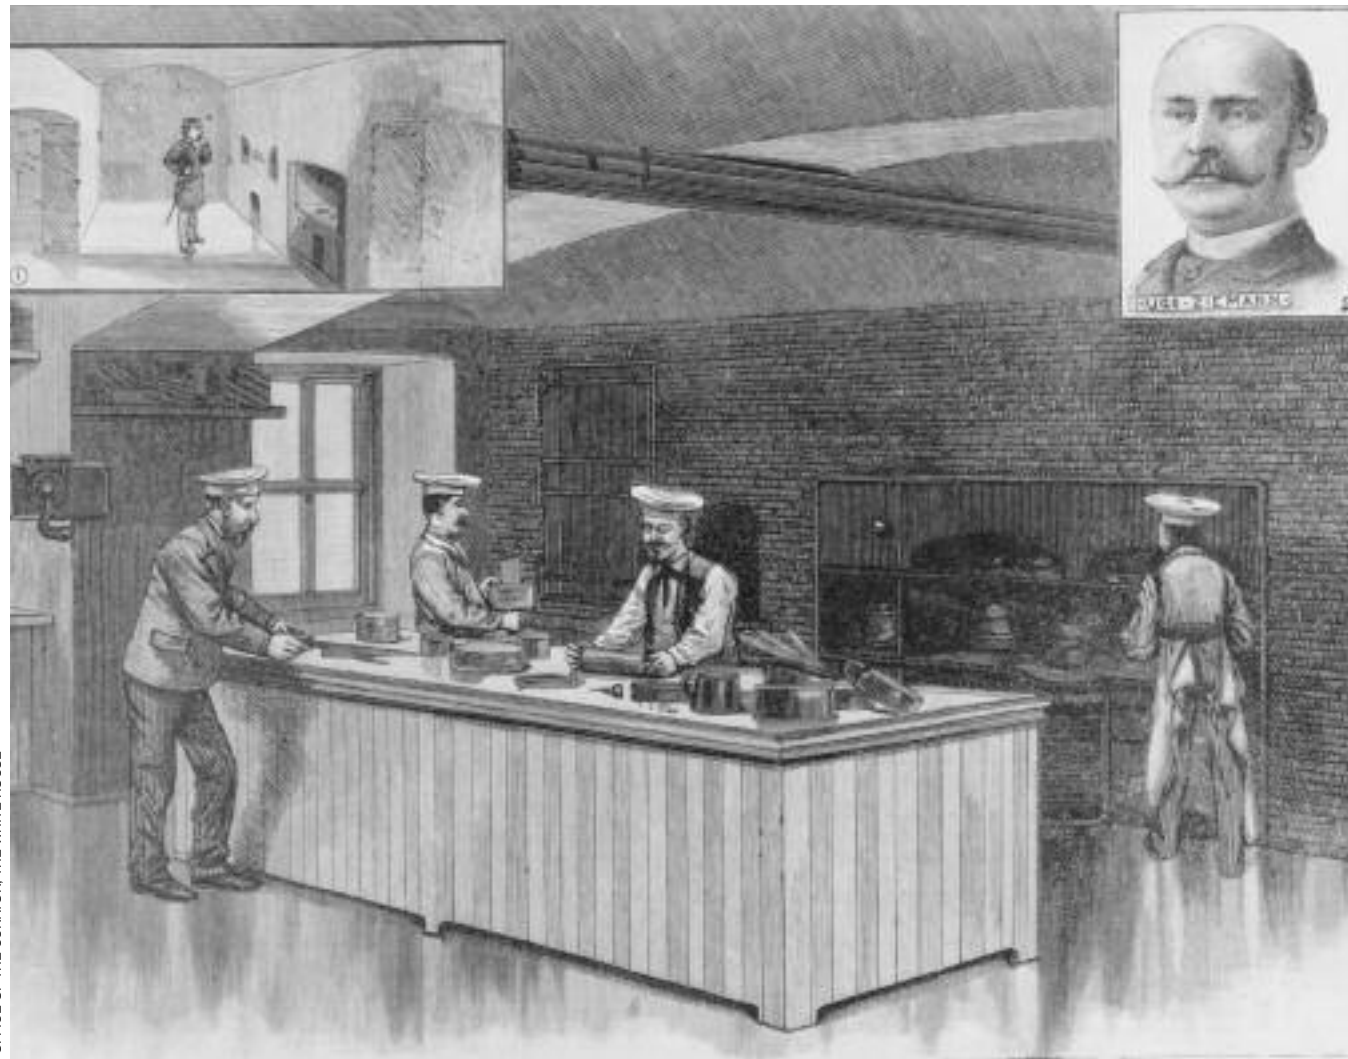
Washington, D.C.— The White House Kitchen— Preparing Dinner, after C. Bunnell (dates unknown), from Frank Leslie's Illustrated Newspaper, April 6, 1889. This wood engraving, published not long after Benjamin Harrison became president, includes an early image of the main kitchen, located in the northwest corner of the Ground Floor since the mid-nineteenth century; a view of the original kitchen in Andrew Jackson's time (inset above left), which was located at the center of the Ground Floor beneath the Entrance Hall; and a portrait of Hugo Ziemann, a chef for President Chester Arthur (inset above right).

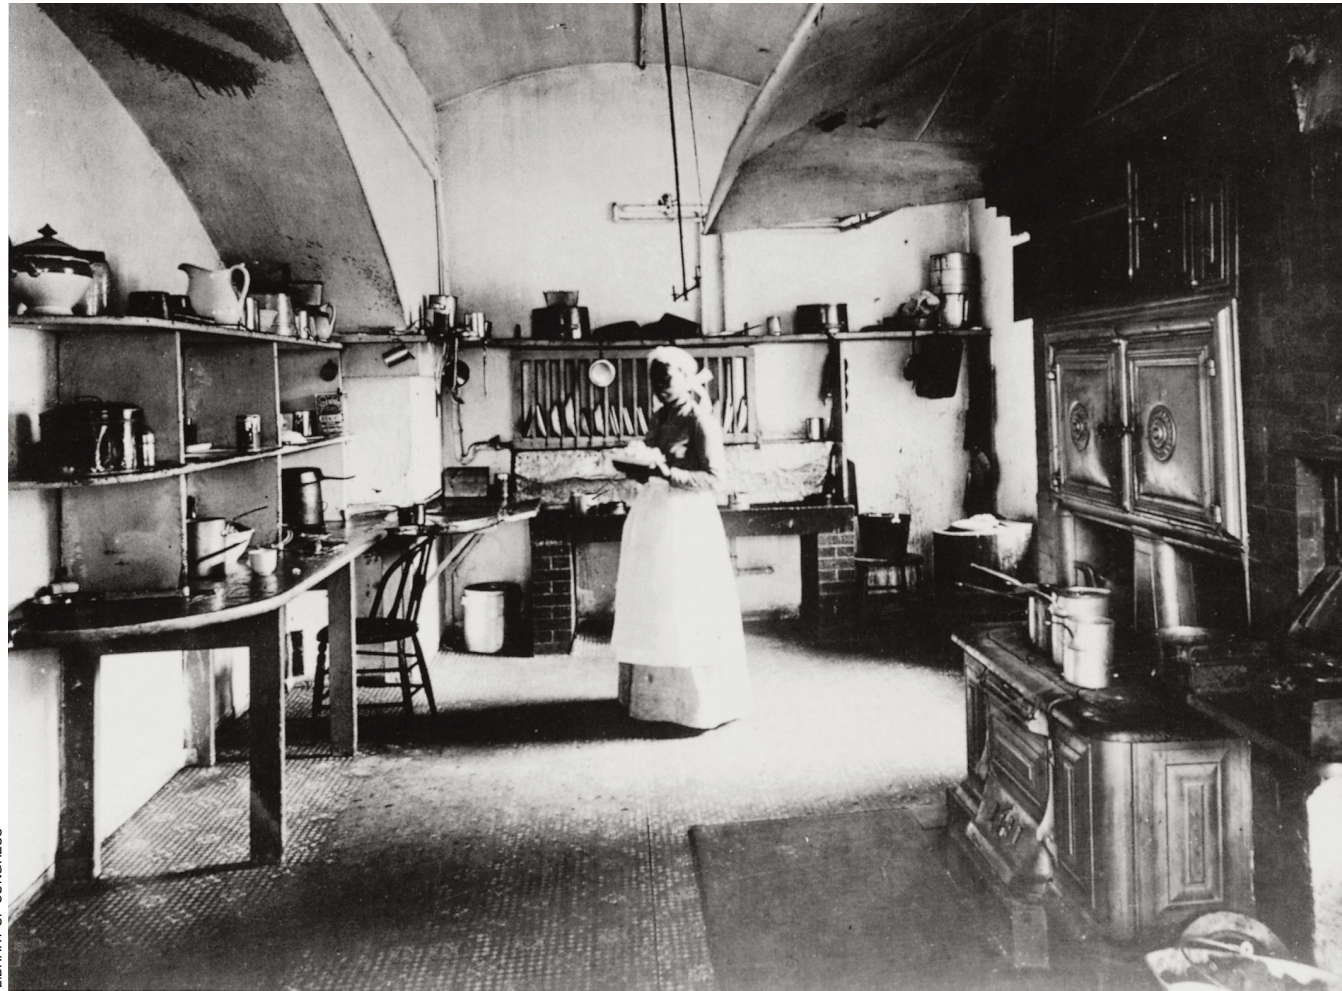
Dolly Johnson, the family cook for President Benjamin Harrison, was photographed in the small, or everyday kitchen in the northwest corner of what was then called the basement, by Frances Benjamin Johnston, c. 1890. In addition to a dish rack, visible in the background, and various everyday utensils and pans, a soup tureen (on exhibit today in the China Room) from the Ulysses S. Grant rose-band service can be seen at left on the top shelf. Ordered in 1870 from Haviland & Co., this porcelain dinner service was utilized for less formal occasions.

Located directly below the State Floor Butler's Pantry, the so-called small kitchen was used to prepare everyday meals for family and staff. The earliest photograph of this room may have been taken by photojournalist Frances Benjamin Johnston. The revealing image, dated c. 1890, shows a coal range and shelves laden with pans, various cooking utensils, and tableware. Also featured is the Benjamin Harrison family cook, Dolly Johnson.

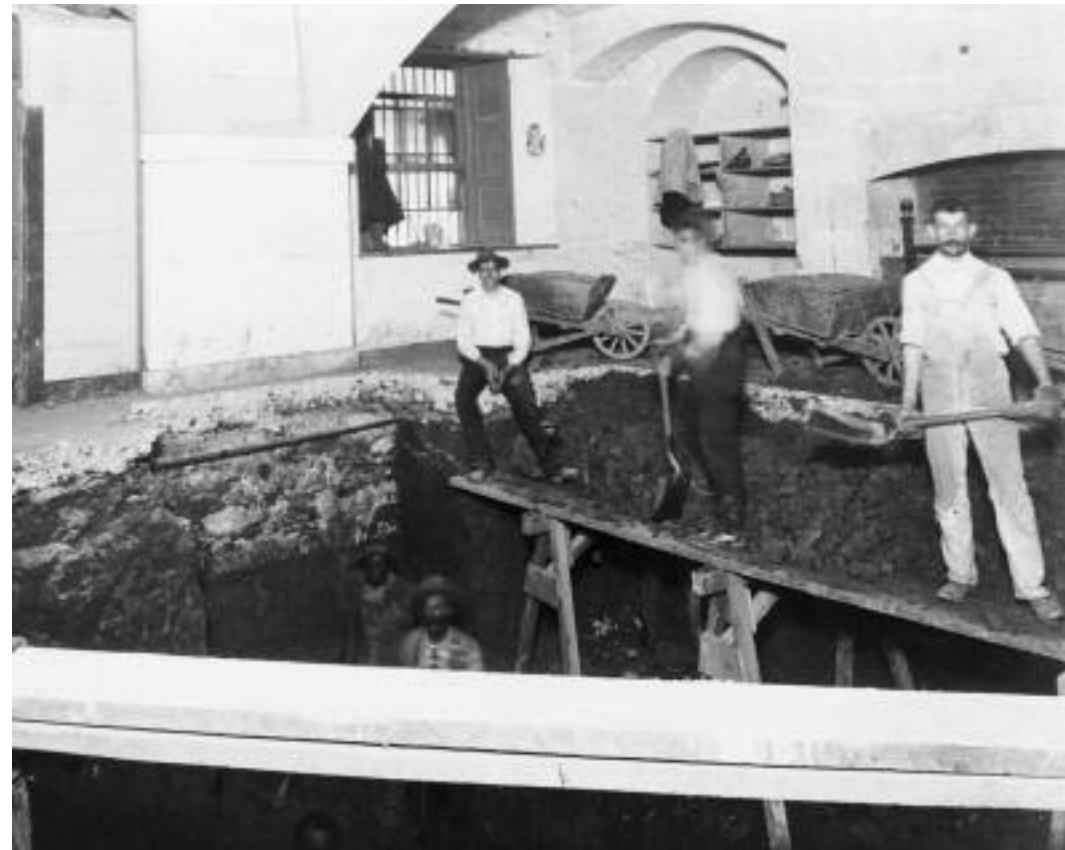
July 20, 1902.
 During the 1902 renovation, the space that had been the original kitchen, under the Entrance Hall, was excavated for a boiler pit. One of the early kitchen fireplaces is visible at right, still with fragments of an early turning spit.

The central room that had been the original kitchen, located under the Entrance Hall, was turned into a furnace room in 1902 and was used for that purpose until the Truman renovation, 1948–52. In 1935, the machinery was repositioned within the space to partition rooms for use as a staff dining room and a store pantry. During the Truman renovation, the furnace was placed underground and the old kitchen became the Broadcast Room. Since the Kennedy administration, the room has again been partitioned into smaller spaces, one of which is now occupied by the Office of the Curator.

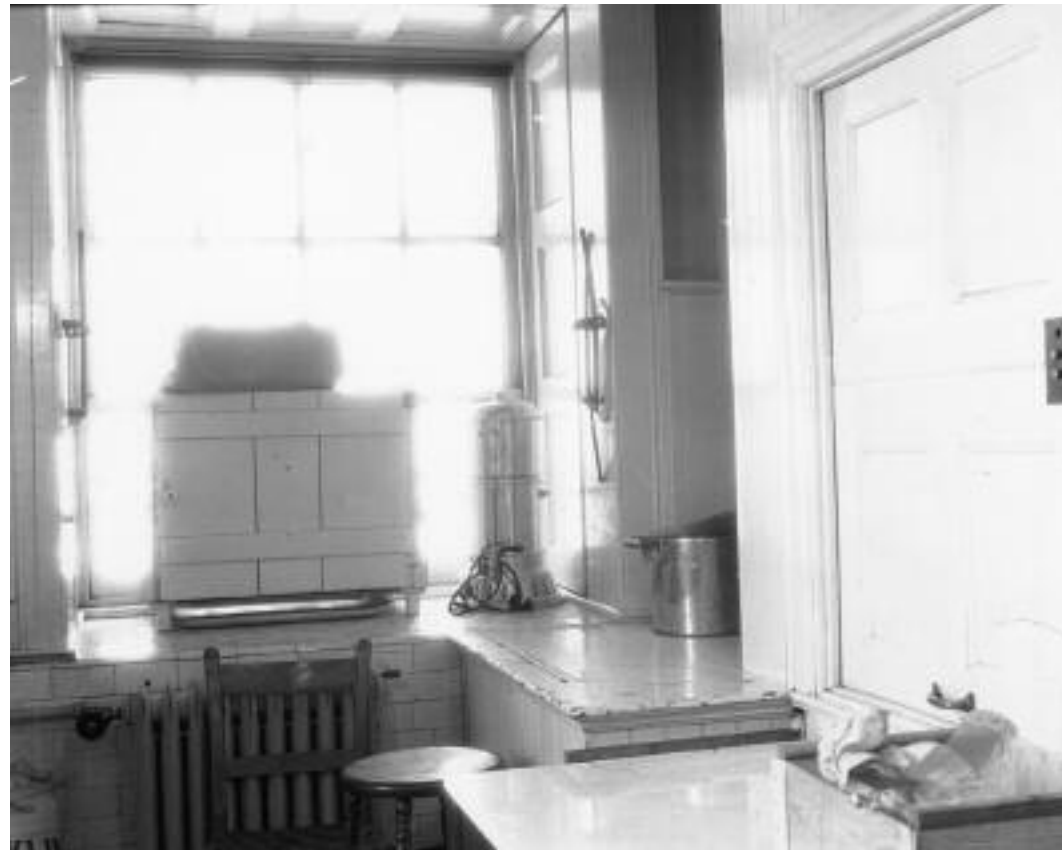
The smaller family kitchen was equipped with a dumbwaiter. The 1902 device, seen on the right, was electrically operated, where its predecessor had been hand operated with pulleys, rope and counter-weights. The box with the drip pan centered in the window well appears to be an ice chest. In the corner next to the chest is an electric coffee percolator.

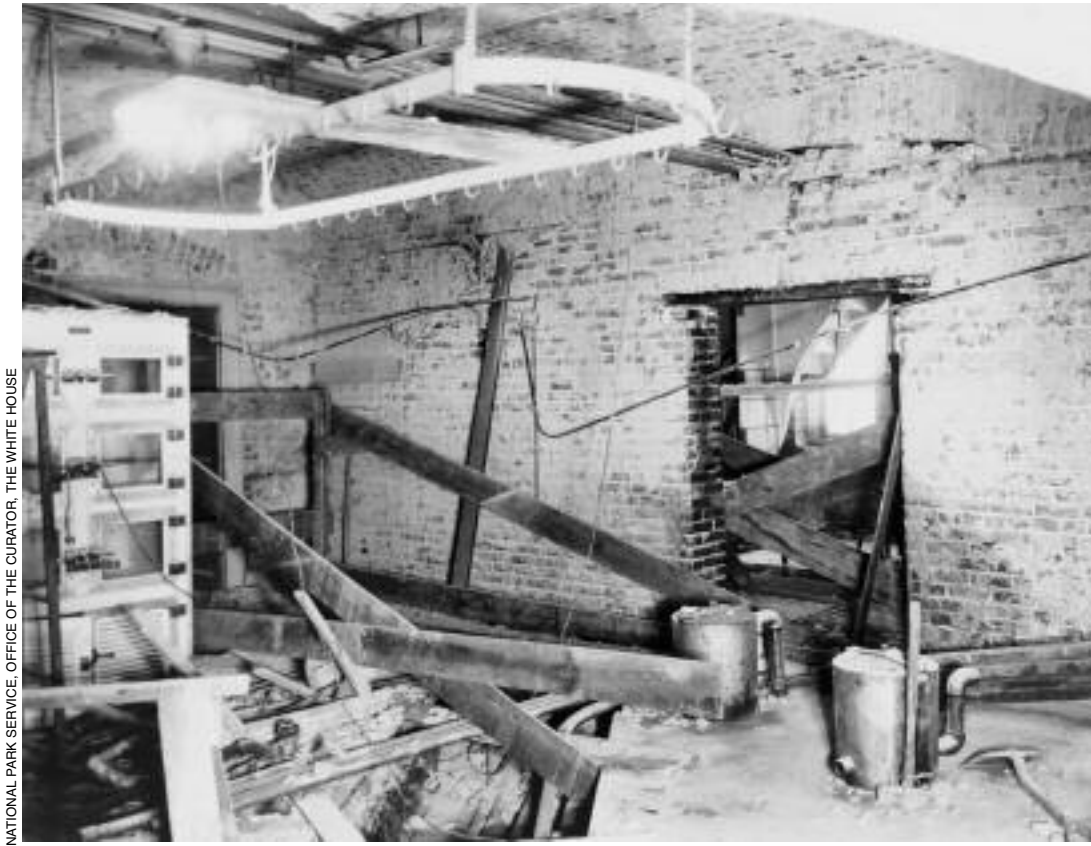
The southwest corner of the kitchen, photographed during construction. Through the doorway at right is a glimpse of the staircase added to the adjoining pantry in 1902. Note the pot rack still hanging overhead and in the walls, evidence of the old arching system that supported the house. Today this structural work is replaced by steel.

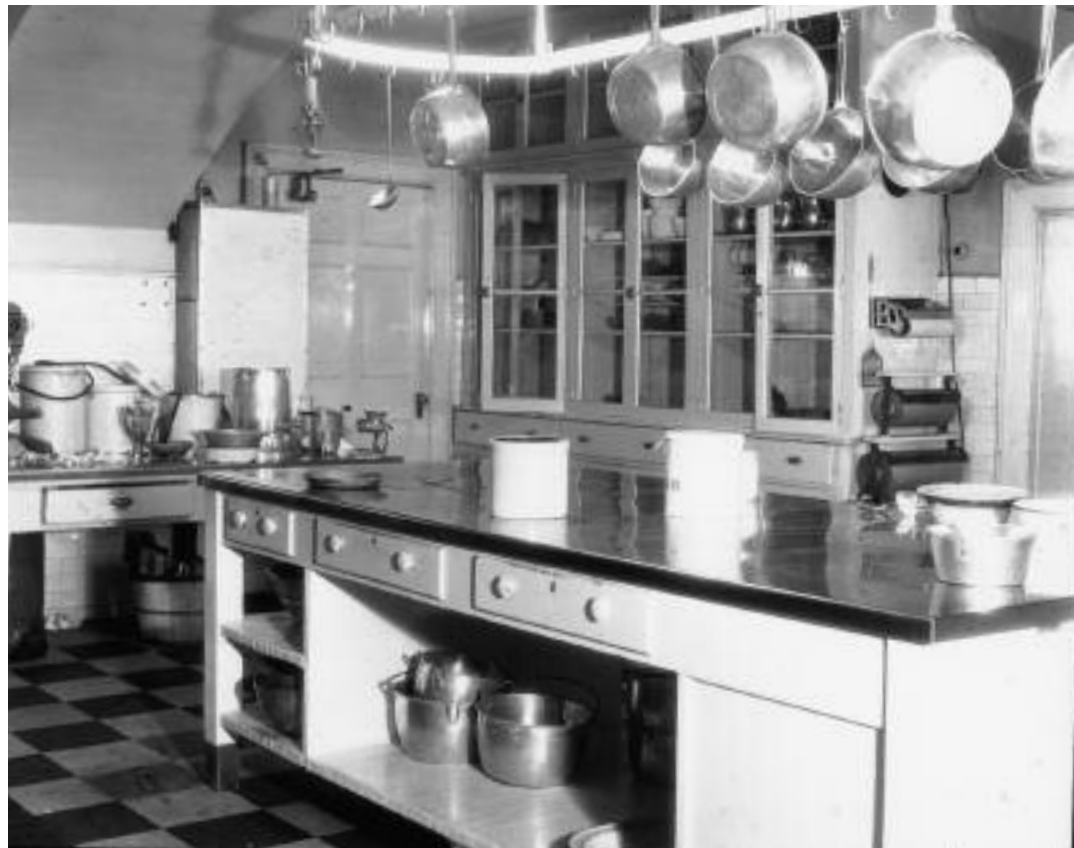
This photograph shows the southwest corner of the kitchen of 1902 as it appeared almost unchanged before remodeling. The door at left leads into the Ground Floor Corridor. The doorway at right opens into a pantry. This kitchen was not all of one design but was an accumulation of improvements beginning in 1902. The linoleum floor for example may not have been especially old.

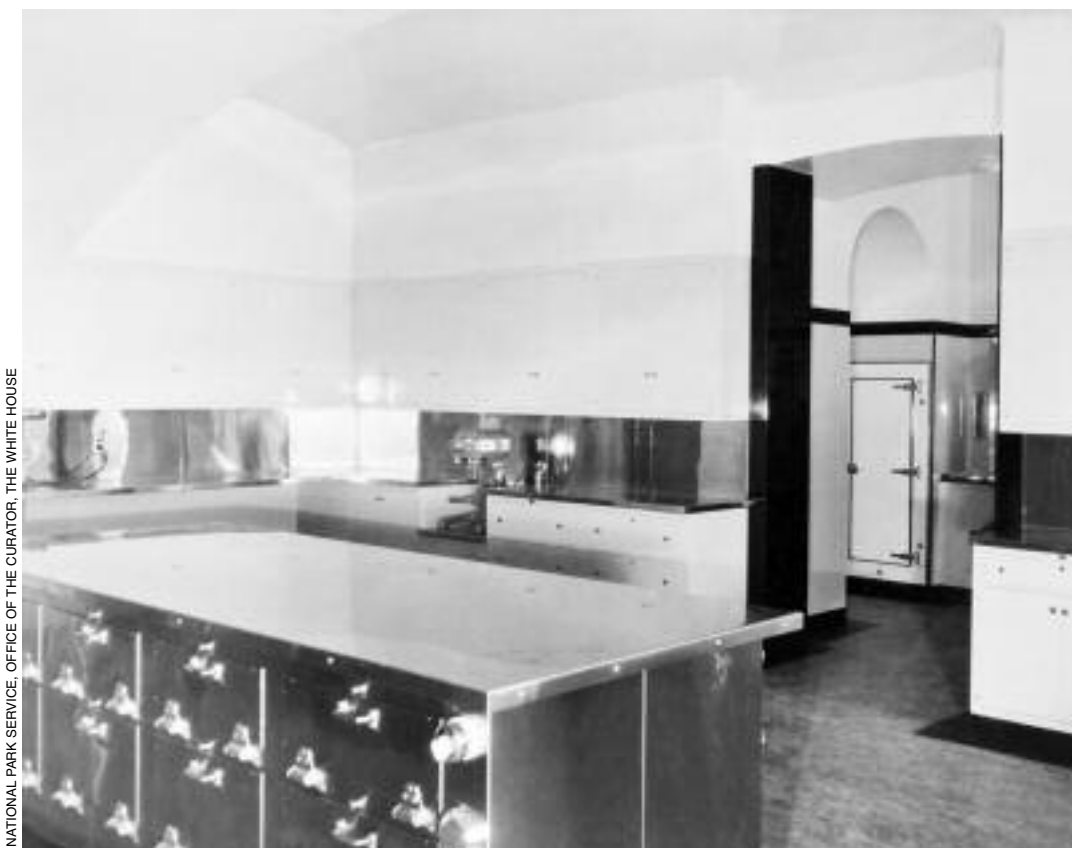
After the renovation project was completed, the southwest view was again photographed showing the revised streamlined kitchen. The door that led into the Ground Floor Corridor was removed and replaced with cabinets. One of several new refrigerators can be seen in the service pantry, through the doorway at right.

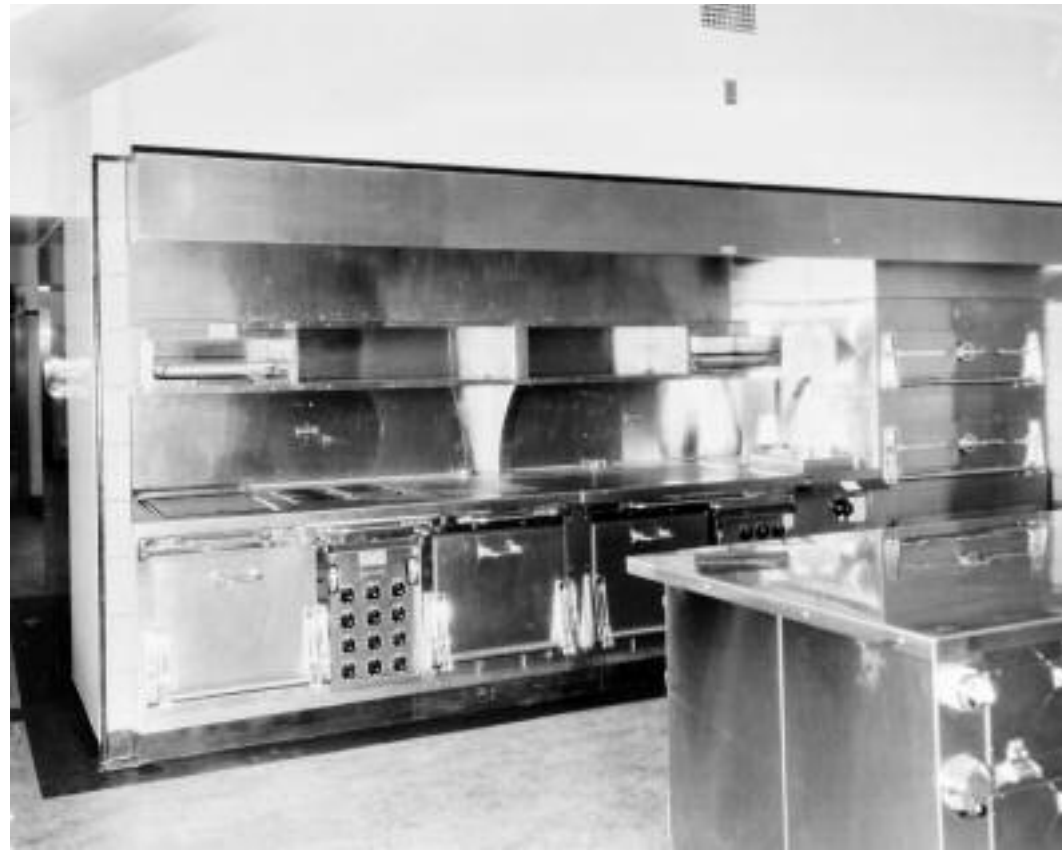
FDR's "New Deal" kitchen had the up-to-date appointments of America's best hotels—except the space, which always at the White House is limited. The renovated space contained new stainless electric appliances including ranges, ovens, and food warmers. A new doorway was added at left, which led to the preparation pantry, the store pantry, and access to various storerooms, a wine cellar, and refrigerated areas that were also built under the north driveway in 1935.

Photographs taken by the National Park Service documented the appearance of the kitchen prior to construction and the dramatic end result. The “New Deal Kitchen,” as it was nicknamed by the staff, now had the latest equipment in stainless steel and was capable of providing a full-course meal for more than one thousand people. Electric appliances included a 16 foot long stove, six roasting ovens, warming ovens, eight refrigerators, new dumbwaiters, a meat grinder, all sorts of mixers, five dishwashers, waffle irons, a soup kettle, a 30 gallon ice cream storage box, and a deep fry pan that could hold 5 gallons of fat. Aluminum utensils, so shiny and new “they looked like a display window in Tiffany’s,” were also purchased.¹⁸ New fixtures provided indirect lighting to the room. Walls of Carrara glass bordered with strips of black glass, floors of green and cream linoleum, and sinks and work surfaces of stainless steel also added to a clean, modern look. Special attention was given to selecting equipment with rounded corners to help prevent dust from accumulating and surfaces that would be easy to clean. Mrs. Nesbitt recalled:

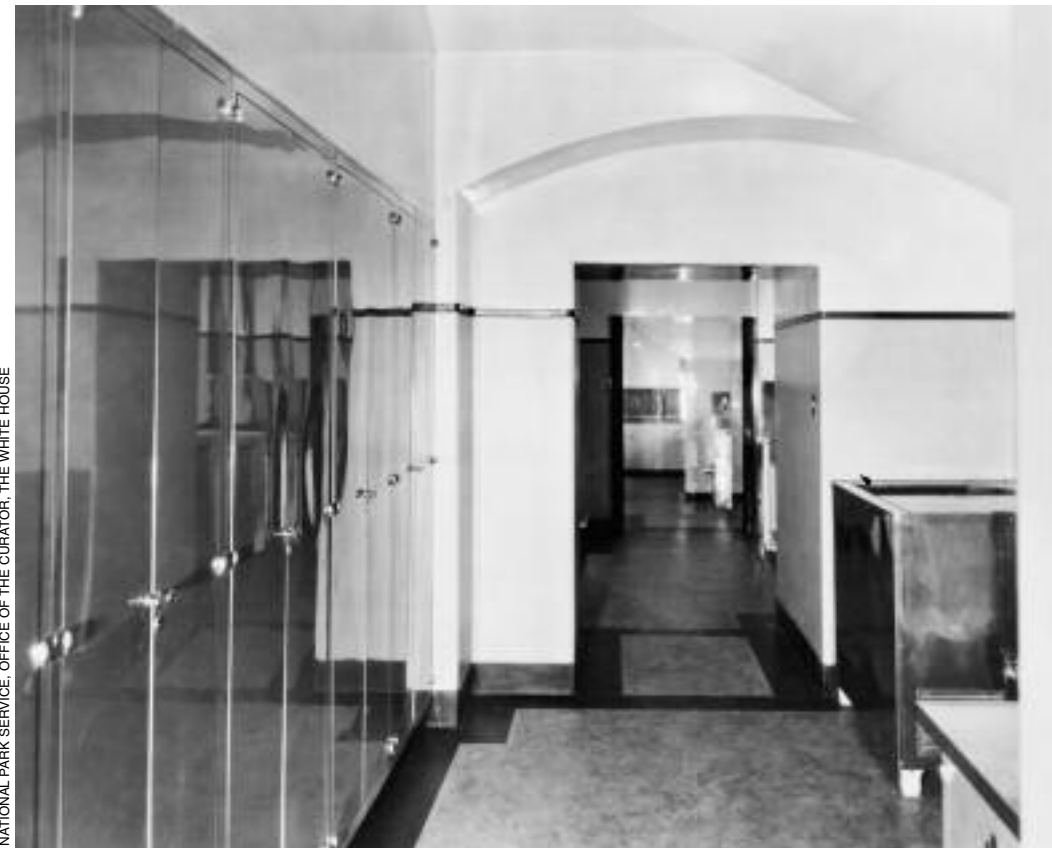
In the central room that had been the original kitchen and, after 1902, a furnace room, space was partitioned off for a staff dining room and the store pantry, seen in this photograph. Stainless steel food cabinets appear at left, and, at right, is a stainless steel fish box. The main kitchen can be seen in the background through the doorway.

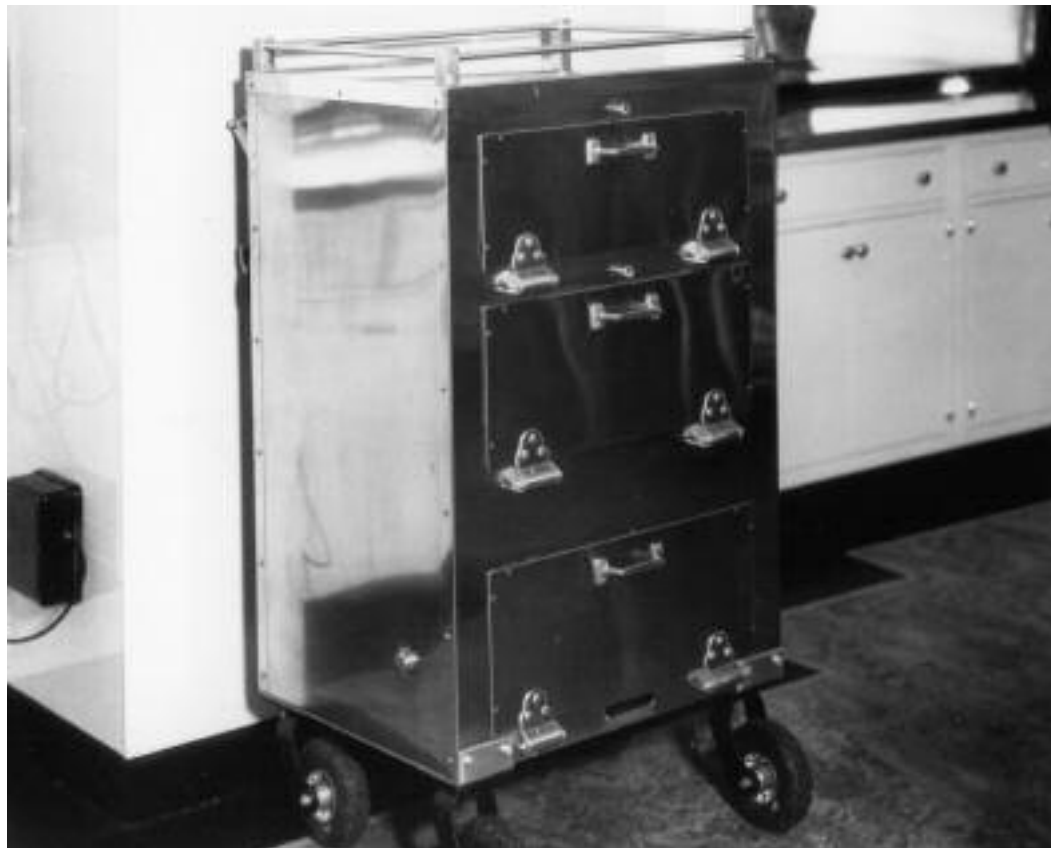
A special warming and delivery cart was acquired for food prepared for President Franklin Roosevelt. It had two drawers for hot dishes and one drawer for cold and enabled the president's meals to be transported from the residence kitchen to the West Wing at an ideal temperature.

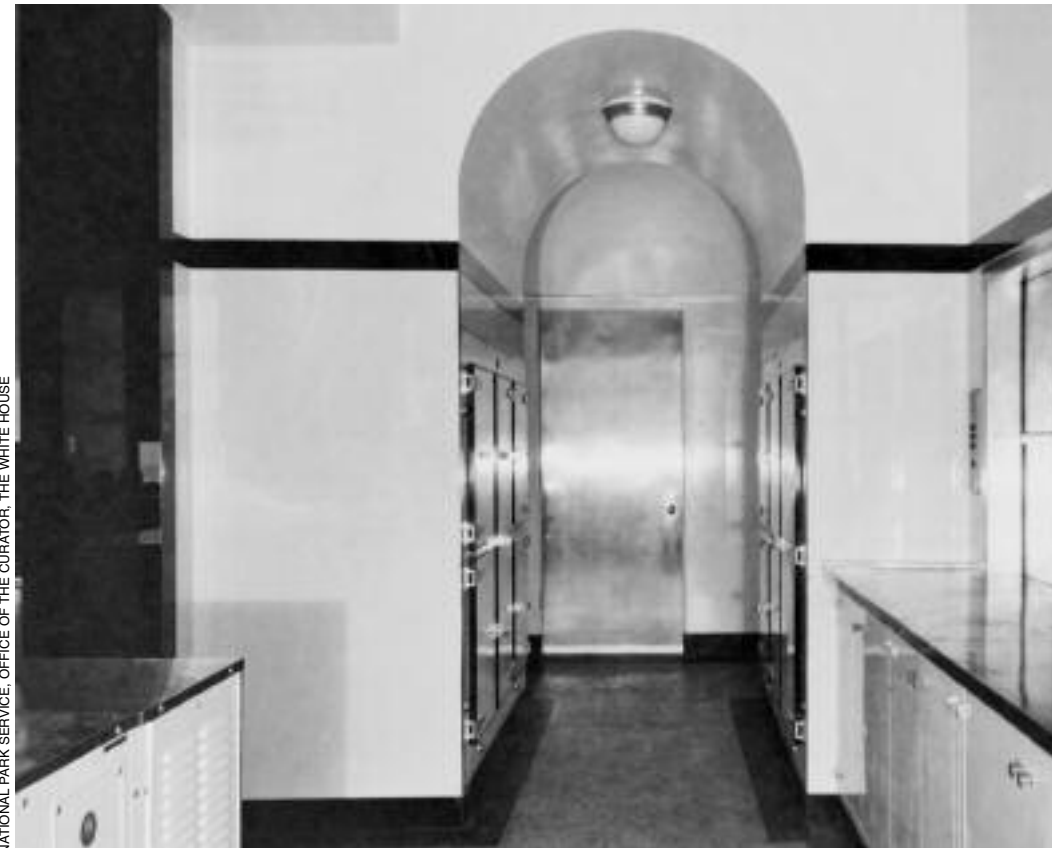
The service pantry, the room that had been the everyday kitchen, was reconfigured in 1935 to include built-in refrigerators, under the arch, and two new dumbwaiters. The ice cream storage box appears at left.

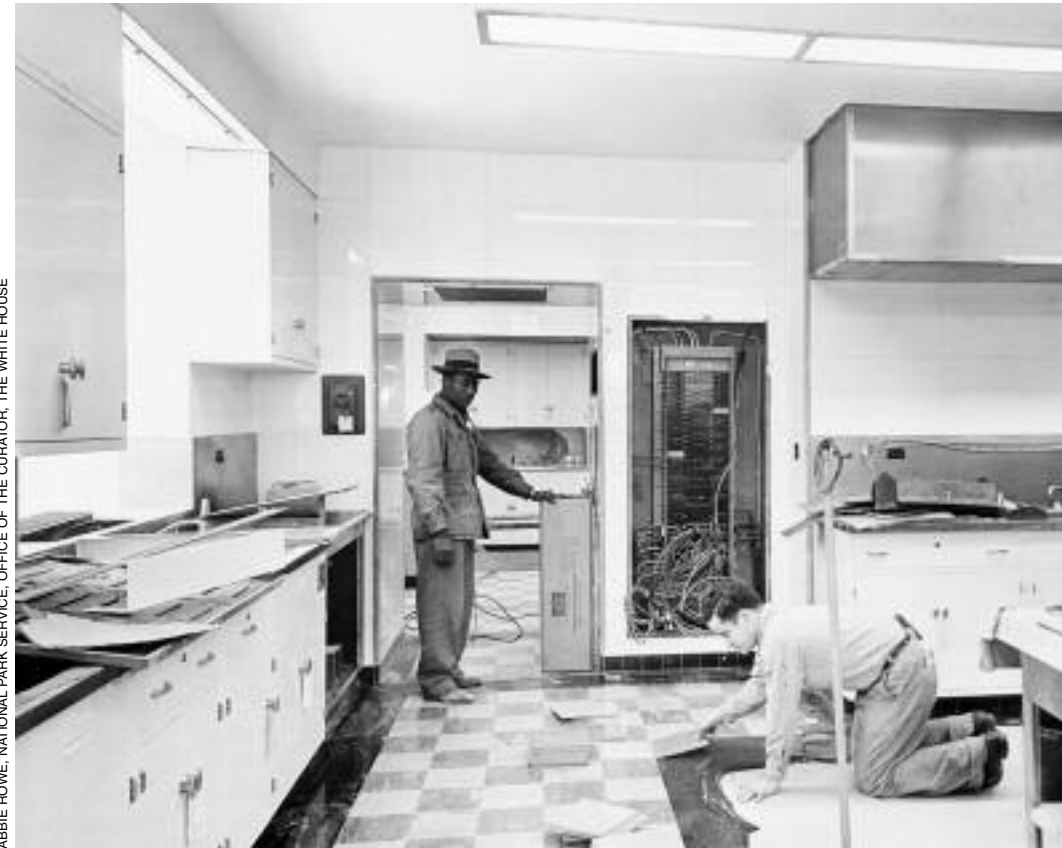
February 14, 1952.
In addition to document-
ing the demolition of the
building's interior, Abbie
Rowe also photographed
rooms while they were
being reassembled. In
February 1952, appli-
ances and other fixtures
were installed in the
main kitchen.

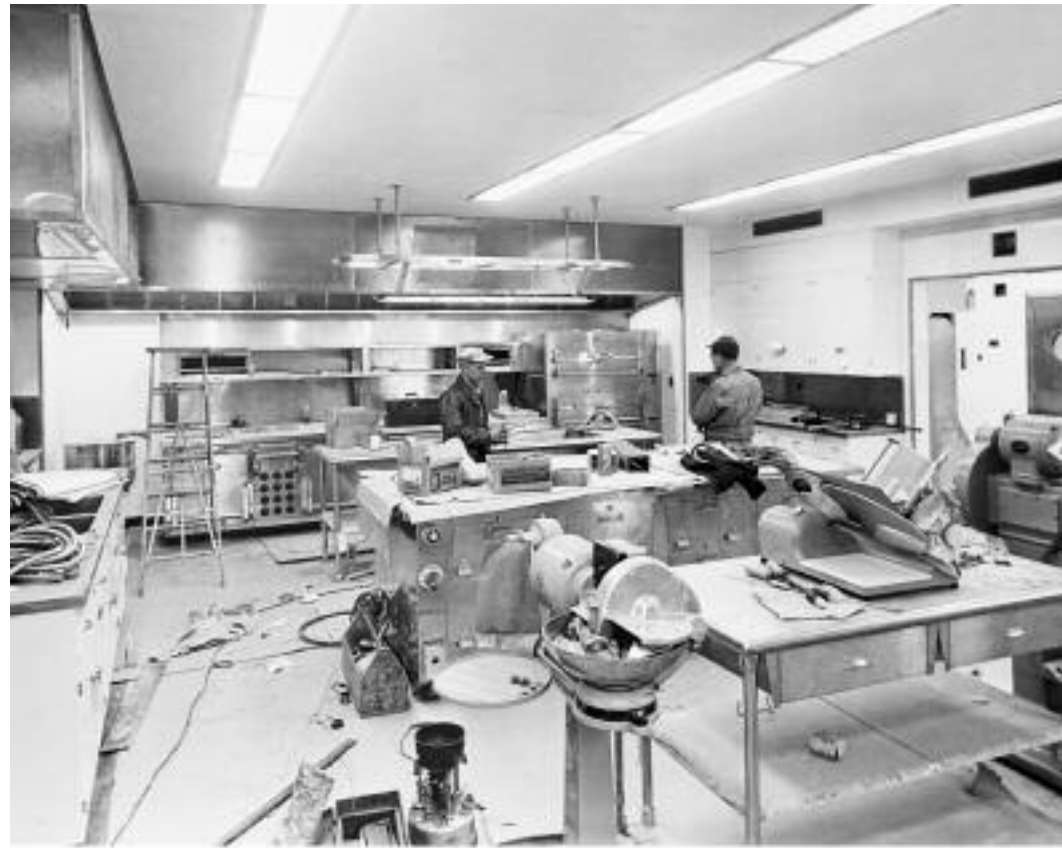
February 21, 1952.
The new Truman kitchen shown here being installed was tailored precisely to White House needs, with every modern culinary convenience. The ovens and ranges that had been against the east wall were now positioned along the south wall of the room.

During the Truman renovation, the interior of the White House was gutted, with the exception of the Third Floor, and rebuilt to include basement levels that provided additional space for staff, storage, and machinery. Along with the replacement of some of the appliances, the kitchen area was reconstructed with a few noticeable changes. No longer needed structurally in a house newly framed in steel, the great ceiling arch was removed and replaced with a flat ceiling. Ranges and ovens were moved to the south wall, and stainless steel sinks and draining racks were placed along the east wall. New metal cabinets also lined the room. In addition to dumbwaiters and a spiral staircase in the neighboring pantry area, a staff elevator was added that has proved invaluable with the movement of staff, food items, and equipment to other floors of the house. Several photographs taken by National Park Service photographer Abbie Rowe captured views of the kitchen before, during, and after the renovation.

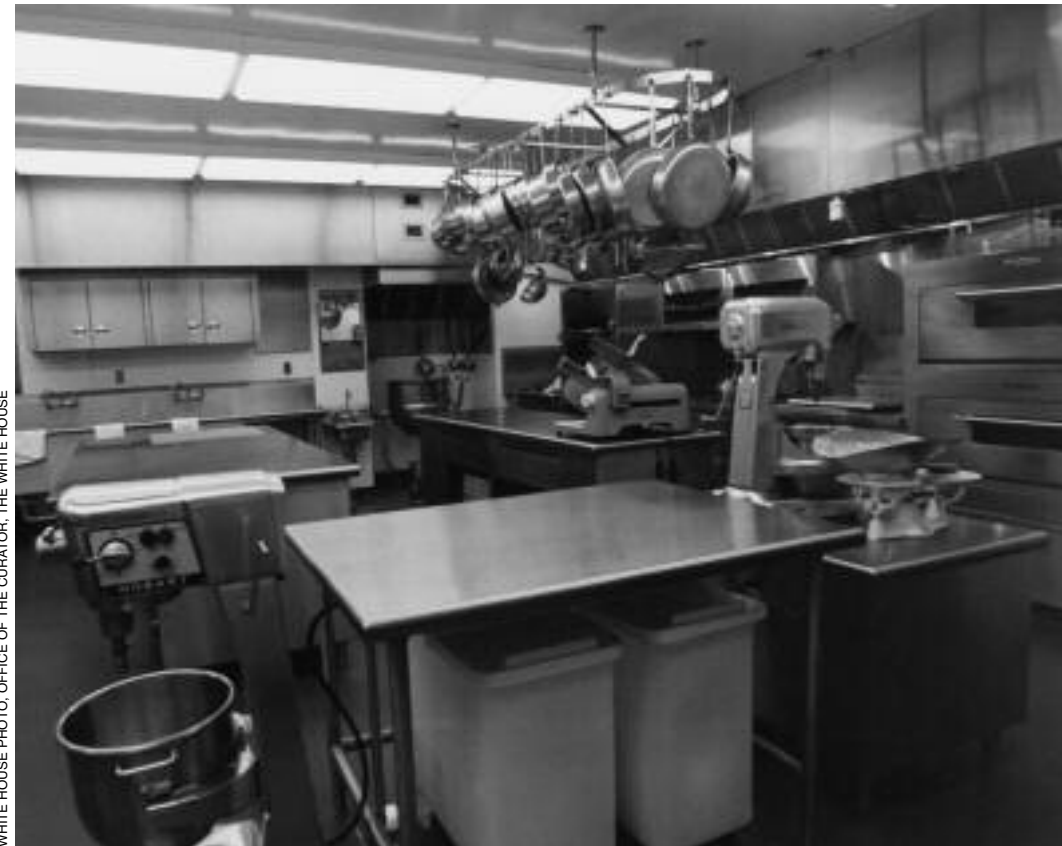
September 22, 1971.
This southeast view of the kitchen was taken after the project was completed. Much of the equipment installed nearly twenty years earlier during the Truman renovation, including two ranges and a food warmer from 1935, had become obsolete and was replaced. Work areas were rearranged to make better use of limited space.

The main kitchen was again renovated during August 1971, while President Richard M. Nixon and his family were away for a summer vacation. The project was undertaken primarily to make more efficient use of the limited available space and improve the ventilation and fire prevention systems. In addition, most of the equipment that dated to the Truman renovation, as well as two ranges and a food warmer from 1935, was obsolete and needed to be replaced.²¹ The renovation also eliminated foot traffic through the food preparation area by sacrificing a small part of the north end of the kitchen for a narrow hallway, created by the addition of a partial wall covered with tile, that led around the kitchen, into the pantry, and to the staff elevator. The White House Photo Office was on hand to photograph various stages of the work.

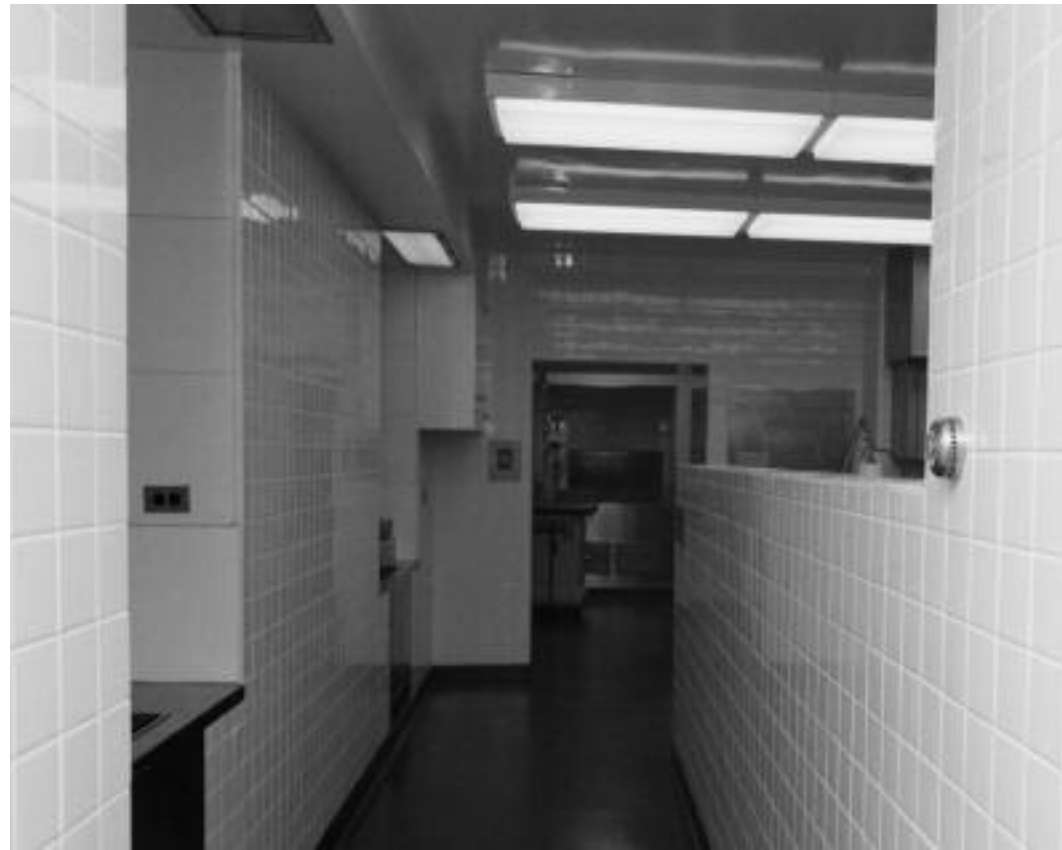
September 22, 1971.
In 1971, a partial wall, seen at right, was installed along the north end of the kitchen to help restrict foot traffic through the food preparation area.

the kitchen area, to show the changes that had occurred since the Truman renovation. Since 1971, few alterations have been made to the main kitchen. The general layout of equipment and workstations has remained the same, and appliances have been replaced only when necessary. Work space for the main kitchen staff increased slightly in 1993 when the pastry department was moved to the new pastry kitchen installed in the mezzanine level of the Butler's Pantry. In 1997, the kitchen was completely enclosed with the addition of glass and stainless steel doors and a floor-to-ceiling partition, replacing the partial wall along the north end of the room, to further remove outside distractions.

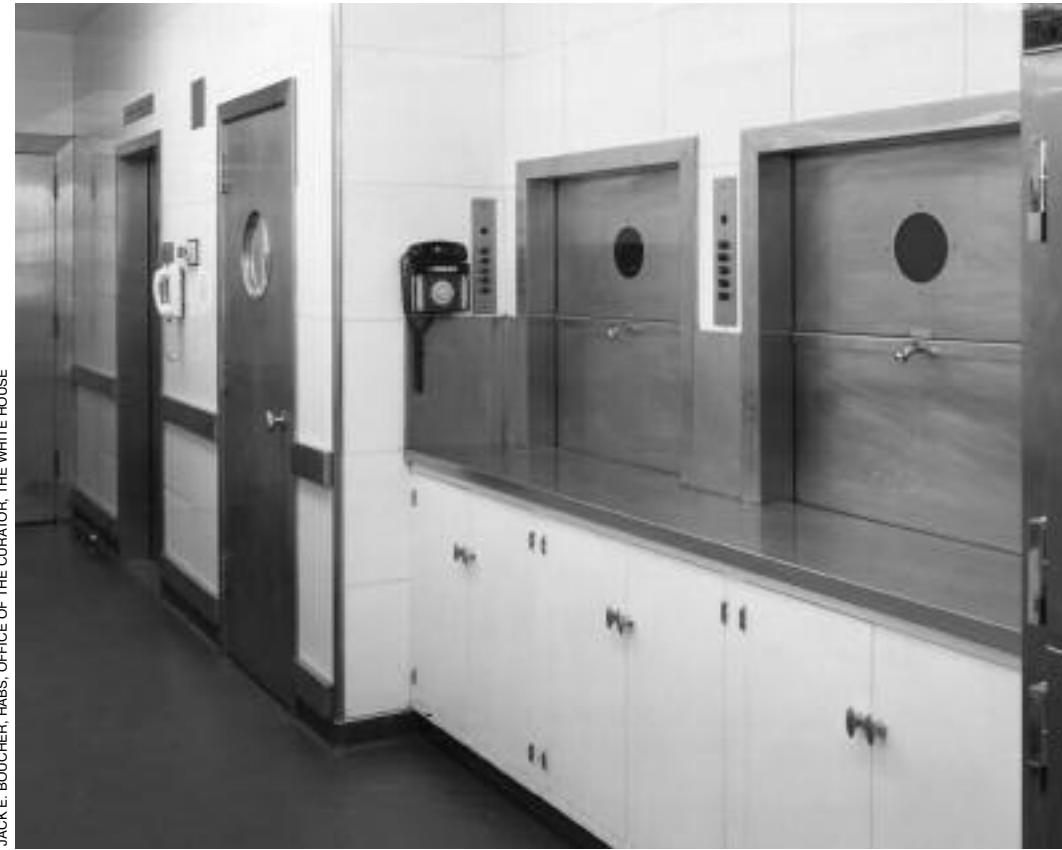
c. 1990–92.
During the Truman renovation, a spiral staircase and a staff elevator were placed next to the dumbwaiters in the pantry area to enable easier movement of food from the kitchen to the State Floor dining rooms. This arrangement remains to the present day.

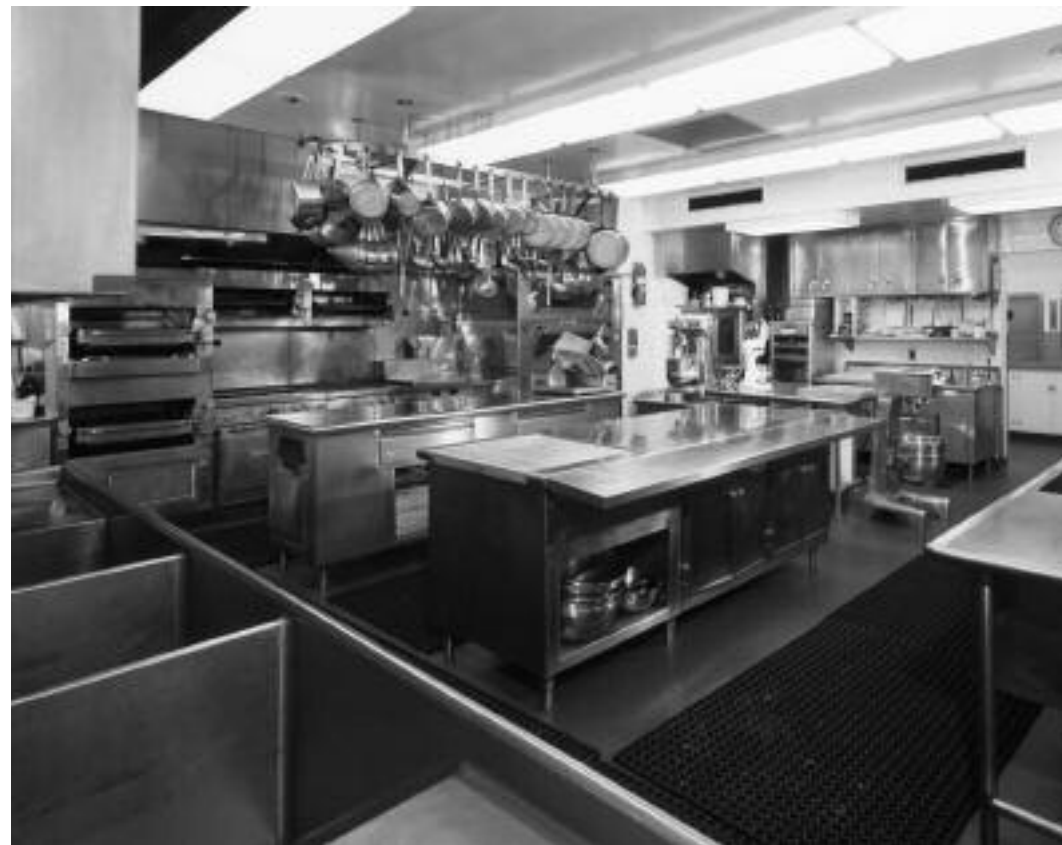
c. 1990–92.
The Historic American Building Survey (HABS) produced measured drawings, field notes, and photographs of the White House, 1988–92, to show the changes that had occurred since the Truman renovation. This image reflects the appearance of the main kitchen as it is today. The placement of the sinks, ranges, ovens, and work spaces has not changed since the Nixon administration. Equipment installed in 1971 has been replaced when necessary.

From 1988 to 1992, the Historic American Building Survey (HABS) produced measured drawings, field notes, and photographs of the White House, including
