# ANALYSIS OF BROWNFIELDS CLEANUP ALTERNATIVES (ABCA)

**Former Newport School**  
7456 East Street  
Newport, New York

HRP PROJECT# HER1512.BA

Issued On: November 14, 2024

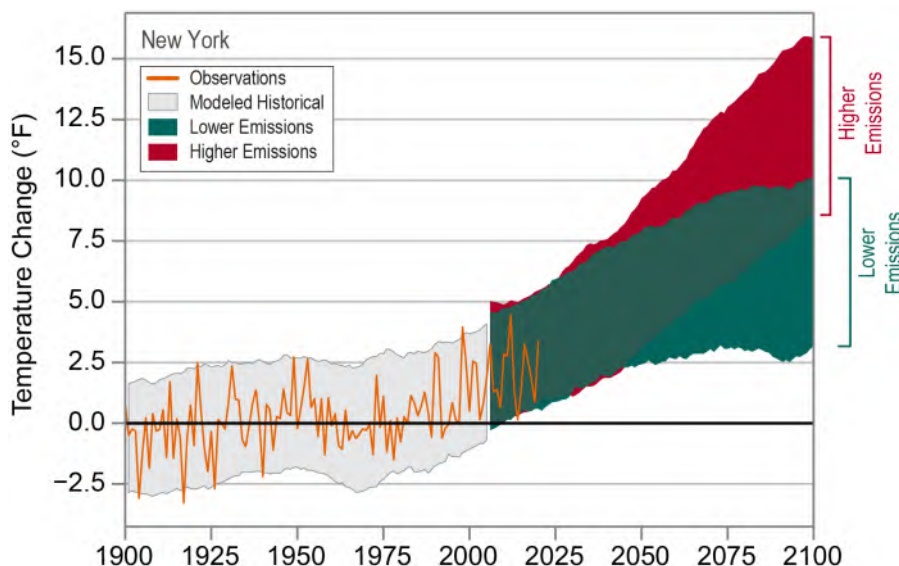
**Figure 1:** Observed and projected changes (compared to the 1901–1960 average) in near-surface air temperature for New York. Observed data are for 1900–2020. Projected changes for 2006–2100 are from global climate models for two possible futures: one in which greenhouse gas emissions continue to increase (higher emissions) and another in which greenhouse gas emissions increase at a slower rate (lower emissions). Temperatures in New York (orange line) have risen almost 2.5°F since the beginning of the 20th century. Shading indicates the range of annual temperatures from the set of models. Observed temperatures are generally within the envelope of model simulations of the historical period (gray shading). Historically unprecedented warming is projected during this century. Less warming is expected under a lower emissions future (the coldest end-of-century projections being about 3°F warmer than the historical average; green shading) and more

warming under a higher emissions future (the hottest end-of-century projections being about 11°F warmer than the hottest year in the historical record; red shading). Sources: CISESS and NOAA NCEI.

**Under a higher emissions pathway, historically unprecedented warming is projected during this century** (Figure 1). Even under a lower emissions pathway, annual average temperatures are projected to most likely exceed historical record levels by the middle of this century. However, a large range of temperature increases is projected under both pathways, and under the lower pathway, a few projections are only slightly warmer than

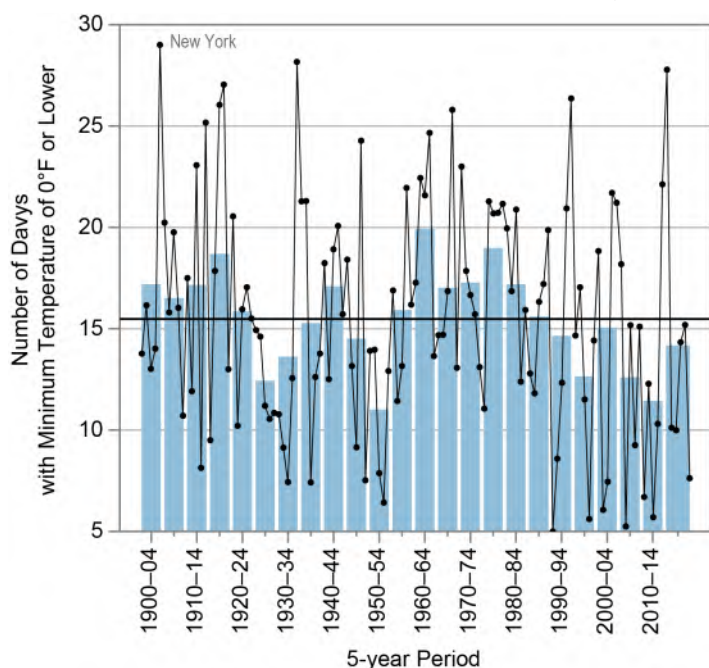
Observed Number of Very Cold Nights

**Figure 3:** Observed annual number of very cold nights (minimum temperature of 0°F or lower) for New York from 1900 to 2020. Dots show annual values. Bars show averages over 5-year periods (last bar is a 6-year average). The horizontal black line shows the long-term (entire period) average of 16 nights. The number of very cold nights has been below average since 1990, reflecting a long-term winter warming trend. Sources: CISESS and NOAA NCEI. Data: GHCN-Daily from 12 long-term stations.

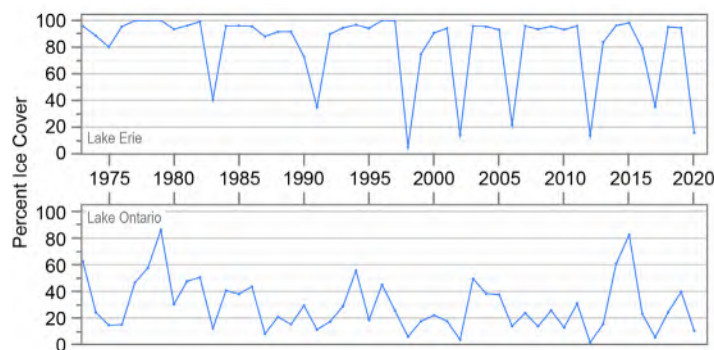
Annual Maximum Ice Cover for Lake Erie and Lake Ontario

**Figure 4:** Annual maximum ice cover extent (%) for Lake Erie (top) and Lake Ontario (bottom) from 1973 to 2020. During most years, Lake Erie was nearly frozen over, while Lake Ontario was mostly ice-free. There were 6 years when Lake Erie was mostly ice-free, and all of those occurred since 1998. Since 2006, Lake Ontario's ice cover extent has remained below 40%, except for higher values during the cold 2013–14 and 2014–15 winters. Source: NOAA GLERL.

Since the beginning of the 20th century, temperatures in New York have risen almost 2.5°F, and temperatures in the 2000s have been higher than in any other historical period (Figure 1). As of 2020, the hottest year on record for New York was 2012, with a statewide average temperature of 48.8°F, more than 4°F above the long-term average (44.5°F). This warming has been concentrated in the winter and spring, while summers have not warmed as much (Figures 2a and 2b). Summer warming is more influenced by the number of warm nights than by the occurrence of very hot days (Figures 2c and 2d). The state has experienced an increase in the number of warm nights and a decrease in the number of very cold nights (Figure 3). The increase in winter temperatures has had an identifiable effect on Great Lakes ice cover. Since 1998, there have been several years when Lakes Erie and Ontario were mostly ice-free (Figure 4).

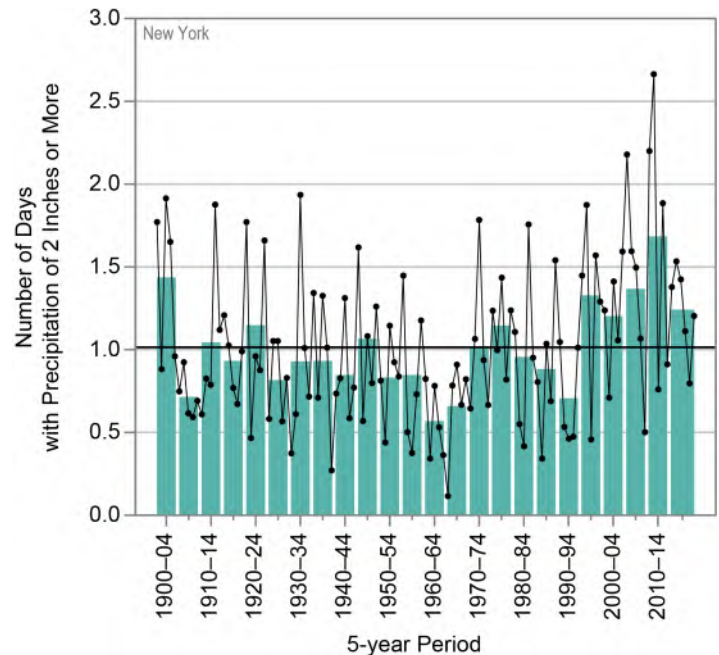
### Observed Number of 2-Inch Extreme Precipitation Events

**Figure 5:** Observed annual number of 2-inch extreme precipitation events (days with precipitation of 2 inches or more) for New York from 1900 to 2020. Dots show annual values. Bars show averages over 5-year periods (last bar is a 6-year average). The horizontal black line shows the long-term (entire period) average of 1.0 days. A typical station experiences 1 event each year. Since 1995, New York has experienced an above average number of 2-inch extreme precipitation events, with the highest frequency occurring during the 2010–2014 period. Sources: CISESS and NOAA NCEI. Data: GHCN-Daily from 16 long-term stations.

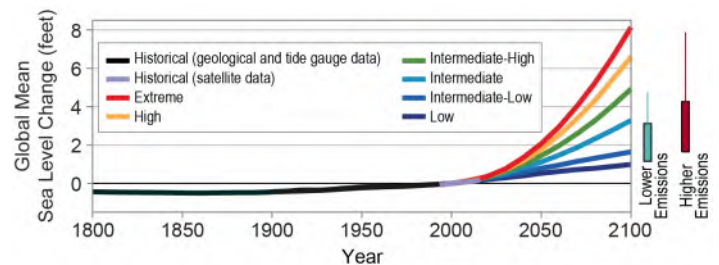
### Observed and Projected Change in Global Sea Level

**Figure 6:** Global mean sea level (GMSL) change from 1800 to 2100. Projections include the six U.S. Interagency Sea Level Rise Task Force GMSL scenarios (Low, navy blue; Intermediate-Low, royal blue; Intermediate, cyan; Intermediate-High, green; High, orange; and Extreme, red curves) relative to historical geological, tide gauge, and satellite altimeter GMSL reconstructions from 1800–2015 (black and magenta lines) and the very likely ranges in 2100 under both lower and higher emissions futures (teal and dark red boxes). Global sea level rise projections range from 1 to 8 feet by 2100, with a likely range of 1 to 4 feet. Source: adapted from Sweet et al. 2017.

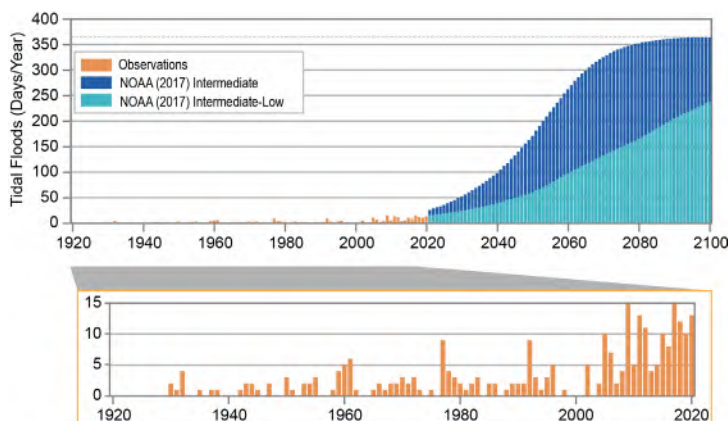
Observed and Projected Annual Number of Tidal Floods for The Battery, NY

**Figure 7:** Number of tidal flood days per year at The Battery, NY, for the observed record (1920–2020; orange bars) and projections for two NOAA (2017) sea level rise scenarios (2021–2100): Intermediate (dark blue bars) and Intermediate-Low (light blue bars). The NOAA (2017) scenarios are based on local projections of the GMSL scenarios shown in Figure 6. Sea level rise has caused a gradual increase in tidal floods associated with nuisance-level impacts. The greatest number of tidal flood days (all days exceeding the nuisance-level threshold) occurred in 2009 and 2017 at The Battery. Projected increases are large even under the Intermediate-Low scenario. Under the Intermediate scenario, tidal flooding is projected to occur nearly every day of the year by the end of the century. Additional information on tidal flooding observations and scenarios is available at <https://statesummaries.ncics.org/technicaldetails>. Sources: CISESS and NOAA NOS.

These events can damage infrastructure, cause road closures, and overwhelm storm drains. As sea level has risen along the New York coastline, the number of tidal flood days (all days exceeding the nuisance-level threshold) has also increased, with the greatest number occurring in 2009 and 2017 (Figure 7). This is a particular concern for New York because of dense, high-value development along the coastline.
