DeRuyter Reservoir Dam Rehabilitation Project

February 1, 2019

NYS Canal Corporation

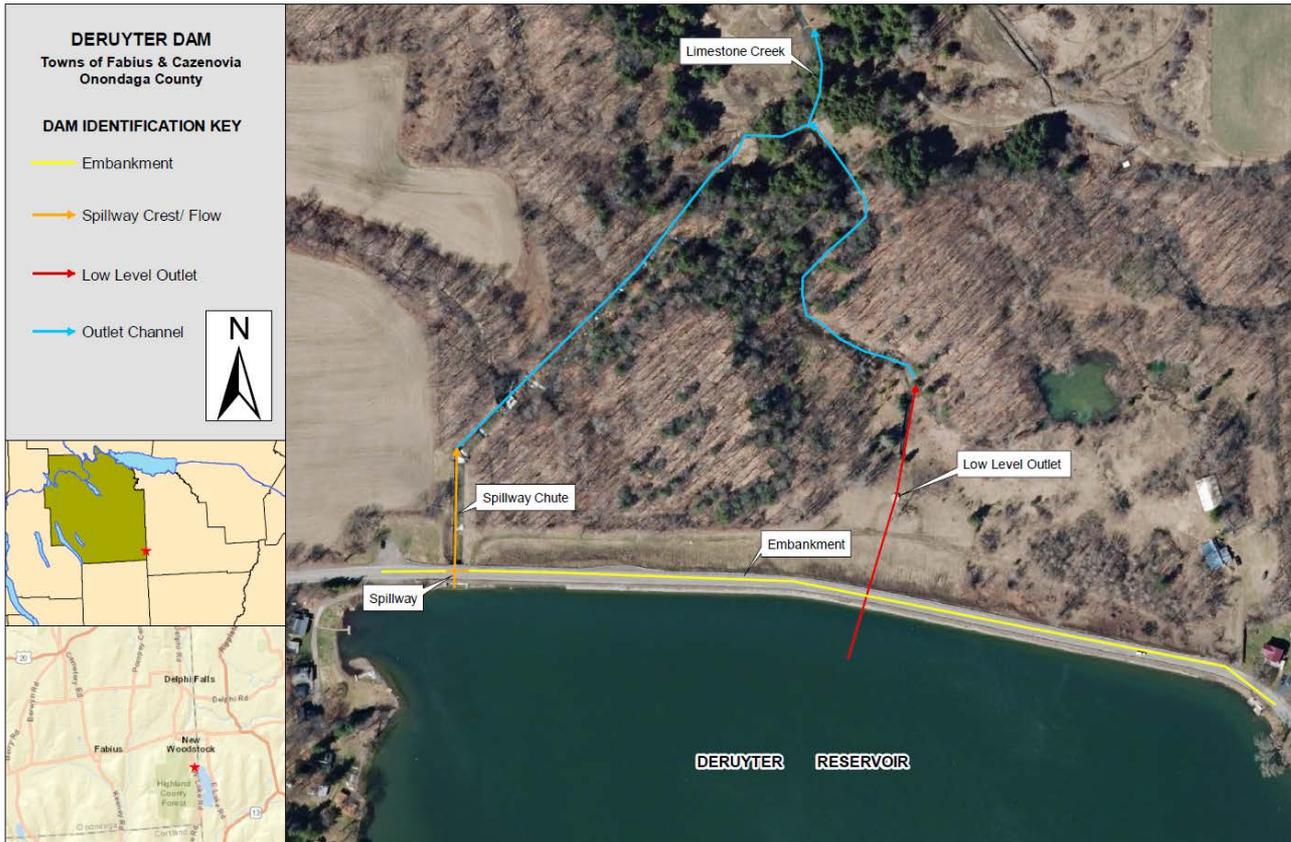
DeRuyter Dam Infrastructure Overview

- Dam consists of:
 - 1600 ft long earthen embankment
 - Overflow spillway crest, spillway chute and energy dissipater
 - Low Level Outlet (LLO) works and an LLO sluice channel.

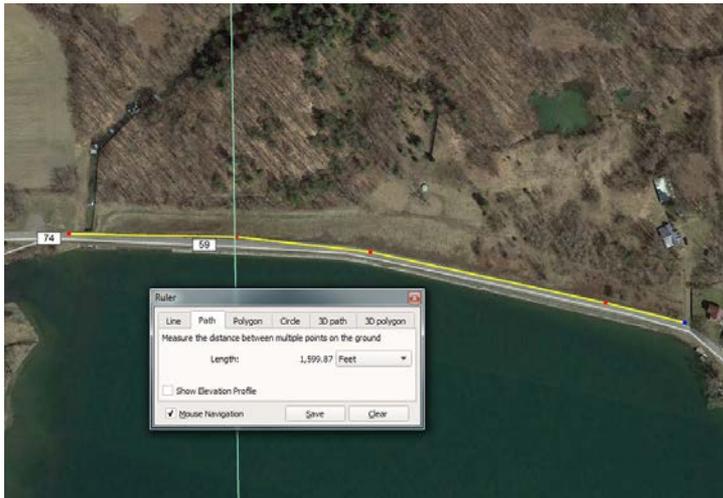
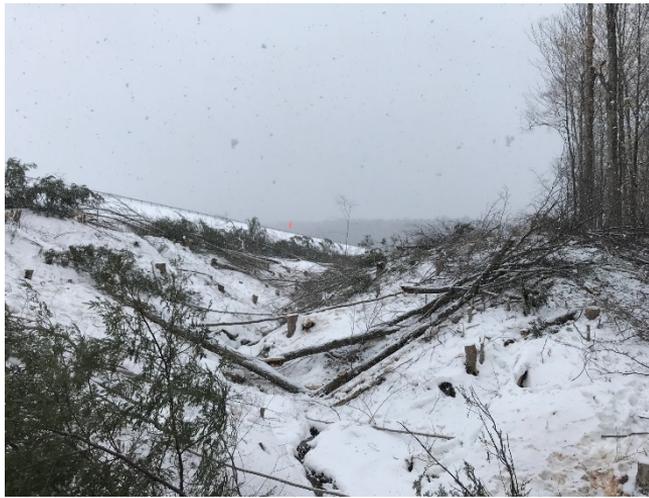
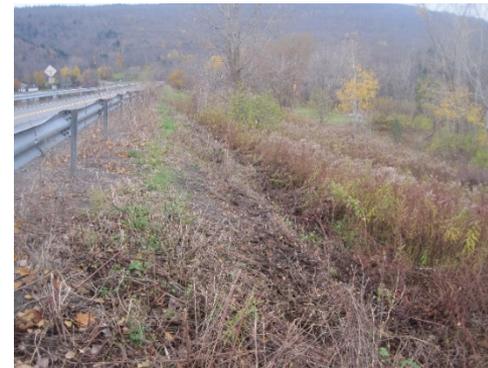
Why the Project Is Needed – Embankment

- Stumps remaining from 2018 tree removal must be removed and backfilled with appropriate materials.
- The dam embankment has calculated stability deficiencies based on the design, geometry, and known material properties.
- Dam embankment exhibits ongoing seepage and wet areas exist throughout the embankment with variable rates of seepage.

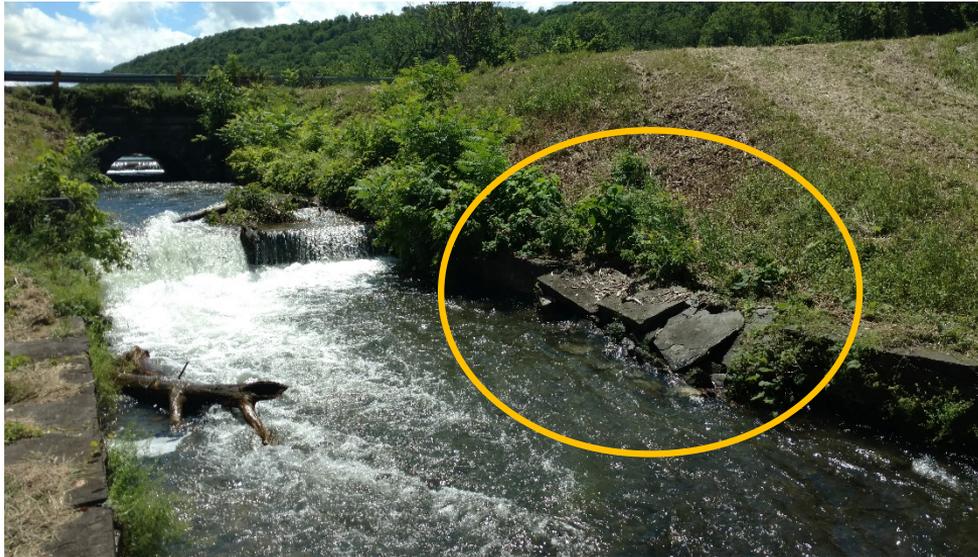
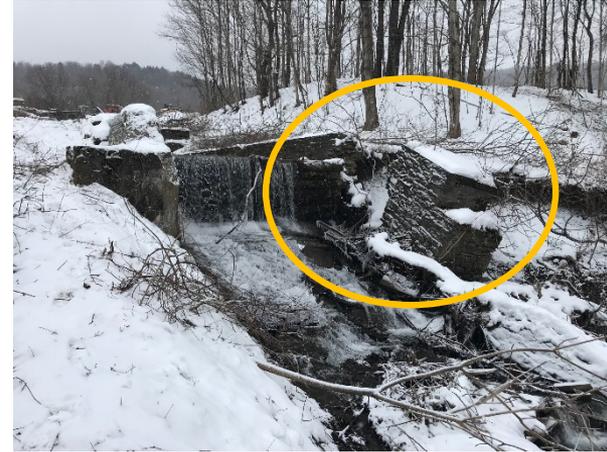
Why the Project Is Needed – Spillway

- On-going erosion and deterioration of the masonry spillway chute and failure of spillway terminus.
- Spillway chute is unable to contain high flows within the spillway training walls during high flow/flood events.
- Spillway chute construction is susceptible to damage during high flow events.

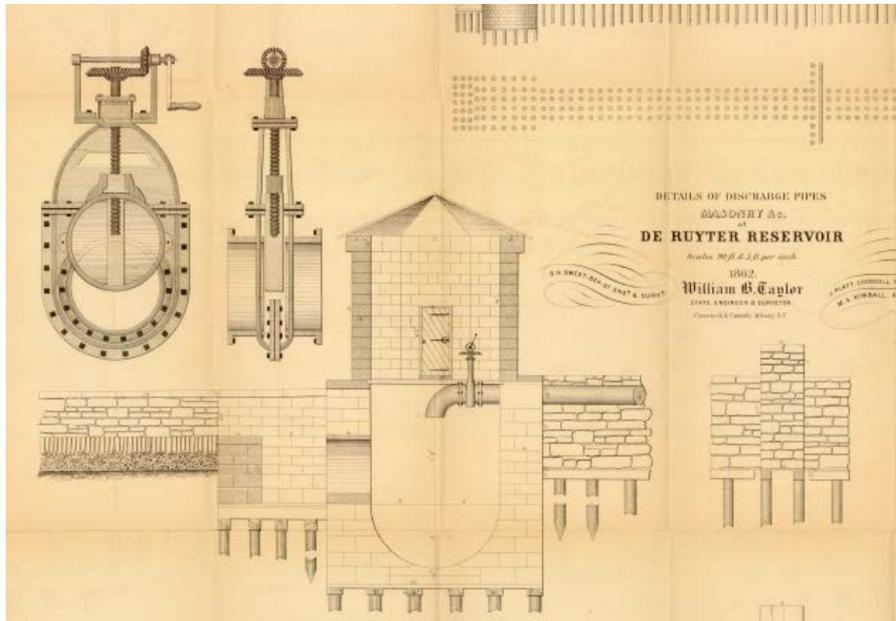
Why the Project Is Needed – Low Level Outlet

- At 155 years, existing Low Level Outlets have exceeded their useful life and are planned to be sealed in place and replaced with a shallow pipe/ siphon system.

- The Low Level Outlets are used to regulate water levels below the spillway crest and provide the yearly winter reservoir drawdown.
- The valves have been replaced in prior rehabilitations.

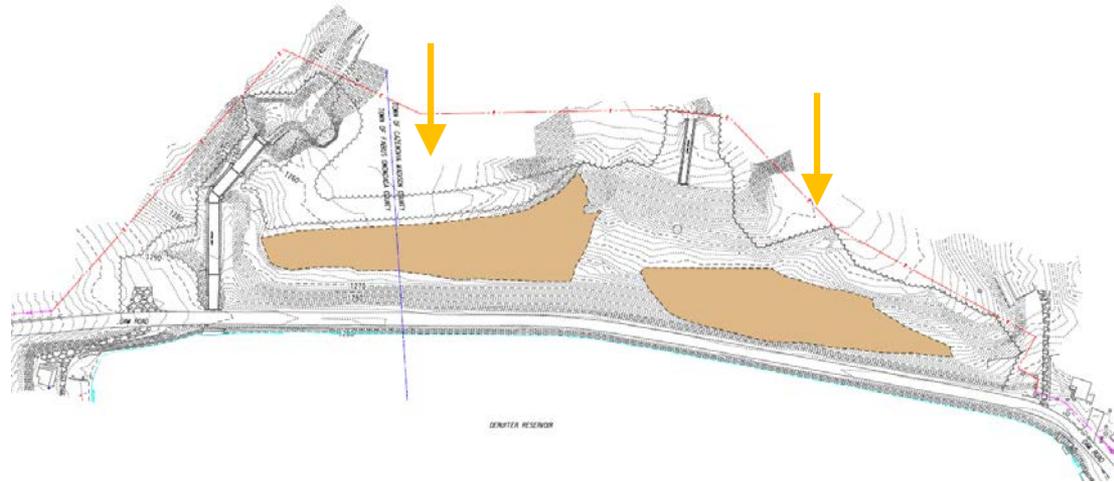
Embankment Buttress: Placing mass embankment fill on the East and West embankments to improve stability. The added soil mass resists the tendency for the slope to deform.

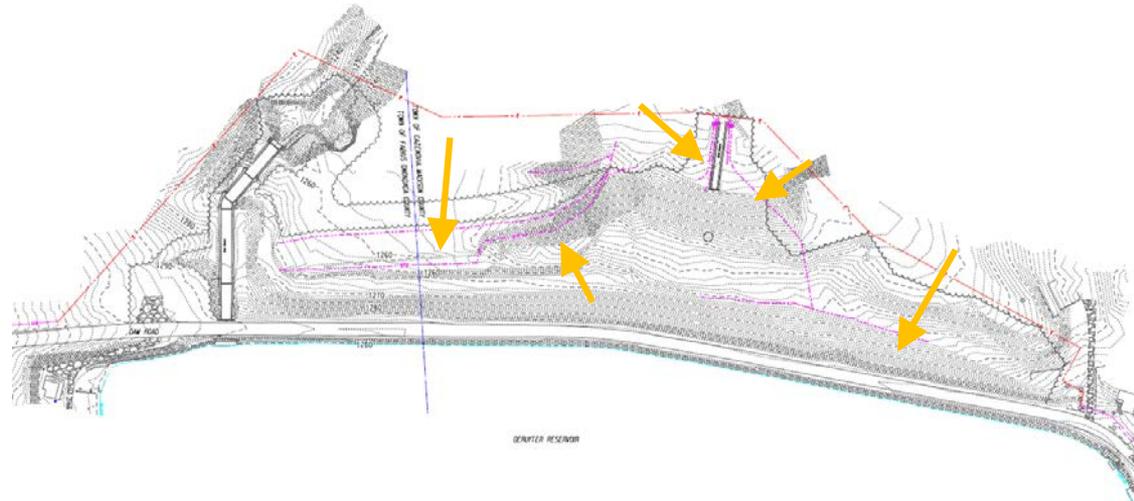
Drainage: Install drainage system in the existing seepage pathways to capture and direct seepage to monitoring weirs. Backfill these areas as part of embankment buttress work

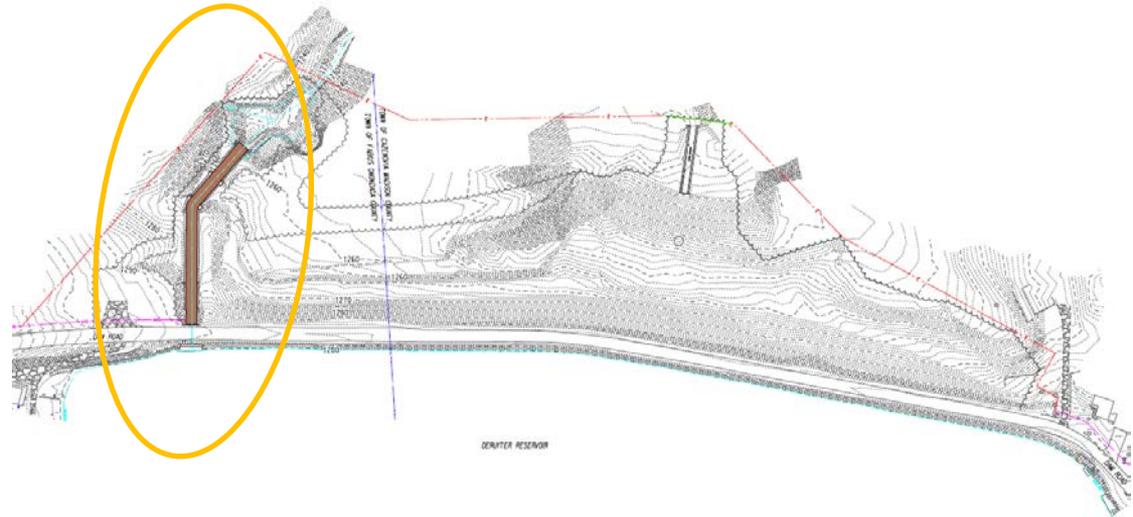
Spillway Chute Repairs: Cast in place concrete spillway liner cast within the existing masonry spillway. A form-liner will be incorporated to mimic the existing stone masonry. The new spillway wall will be higher than the existing walls in order to contain the required flow.

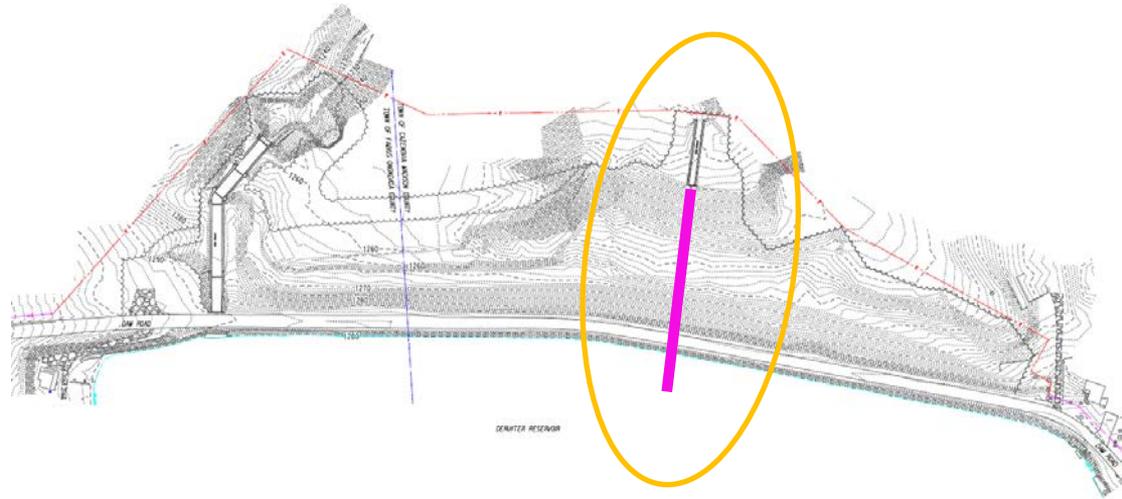
Low Level Outlets: Abandon existing pipes and outlet channel in place filling with materials to prevent future leakage. Construct new shallow pipe system to provide the same functionality.

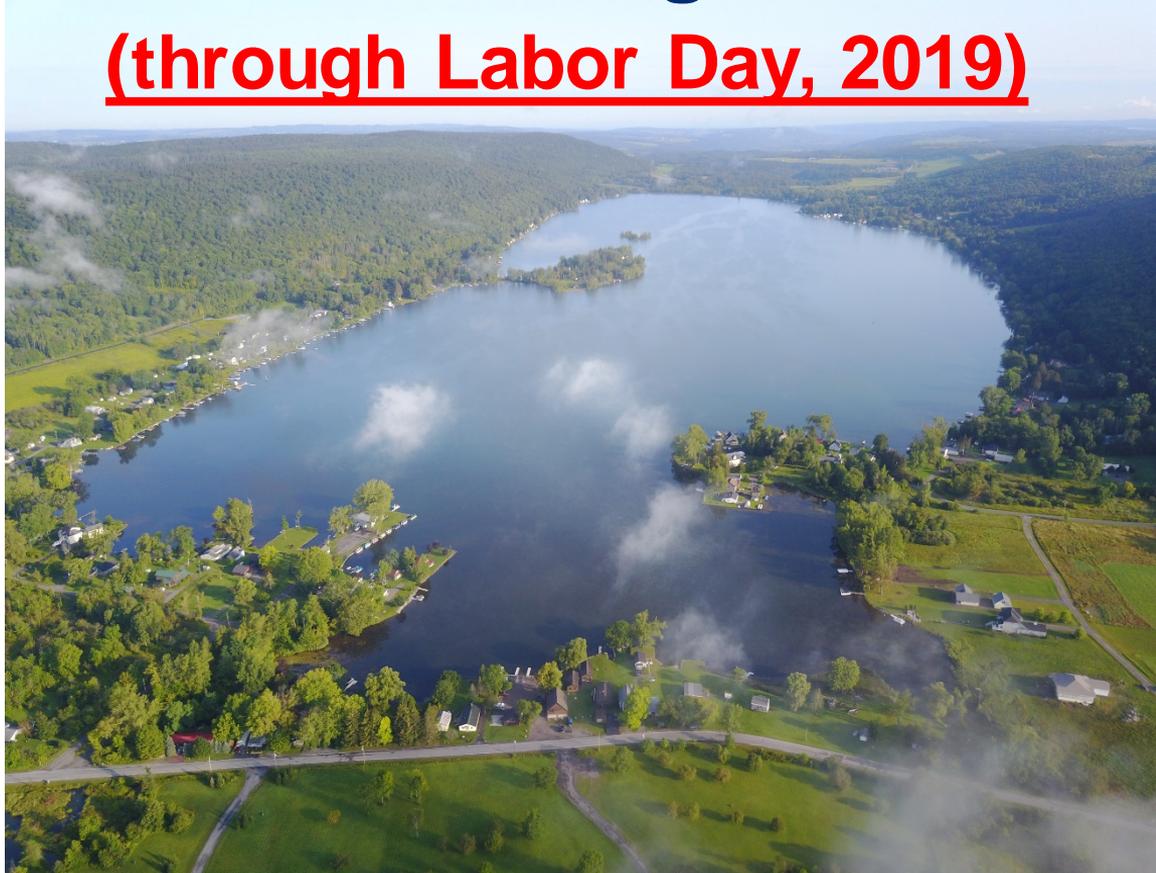
Reservoir Lowering – Reservoir Full

(through Labor Day, 2019)

Timing of reservoir lowering and refilling dependent on hydrologic and other weather factors. Also assumes rehabilitation and use of former inlet channel.

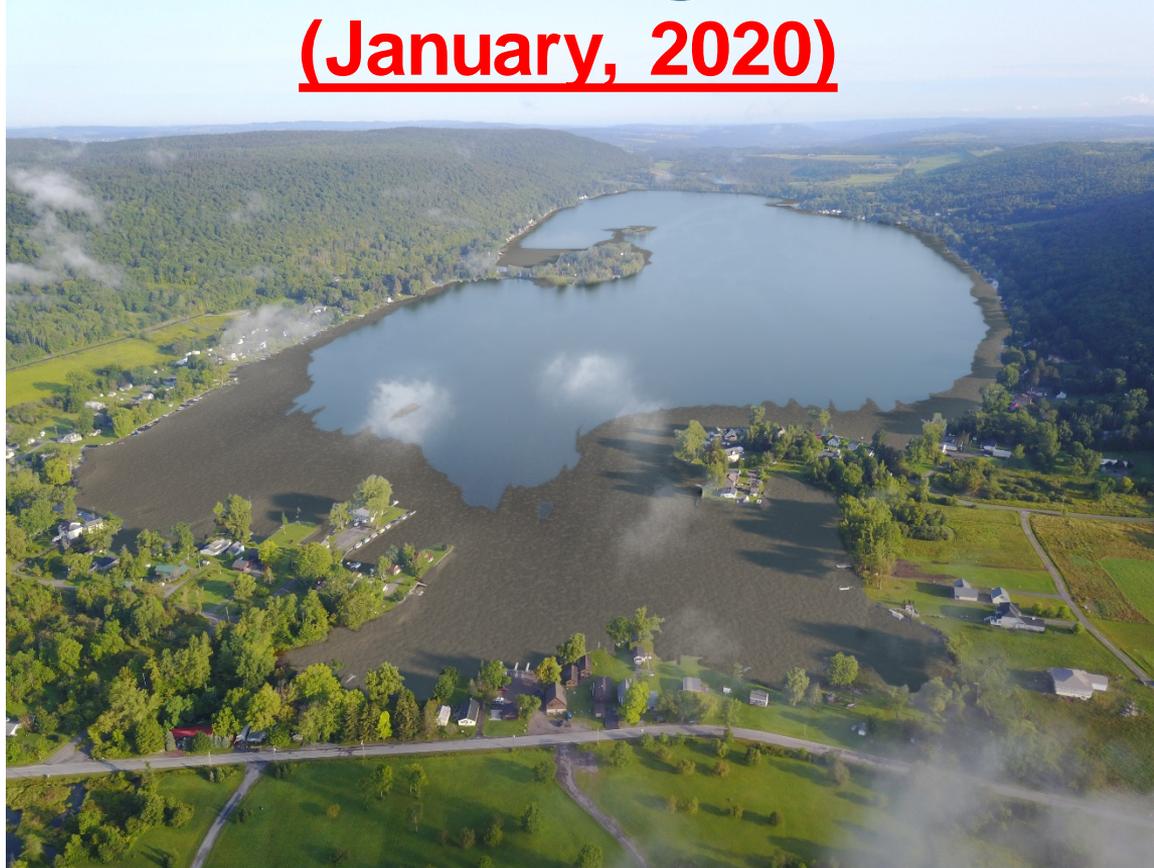
Reservoir Lowering – Reservoir -10 ft

(January, 2020)

Timing of reservoir lowering and refilling dependent on hydrologic and other weather factors. Also assumes rehabilitation and use of former inlet channel.

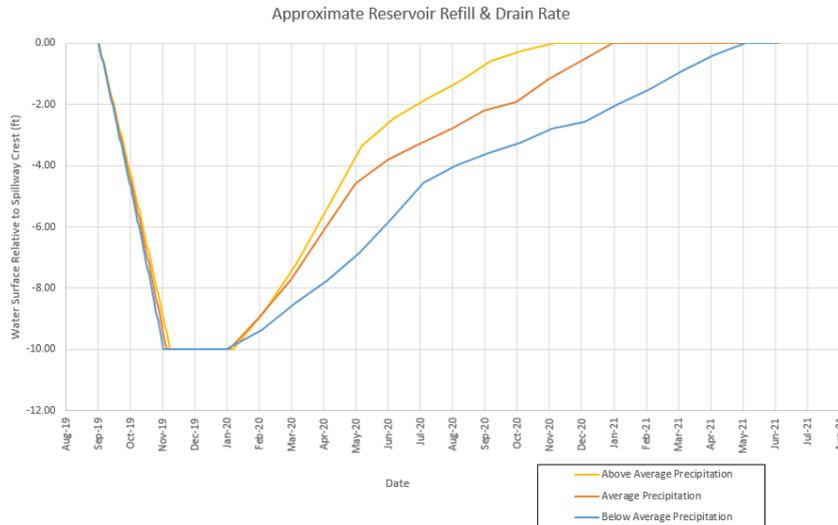
DeRuyter Drainage Basin Only

Why reactivate the inlet? Truncates time at reduced pool levels mitigating recreational, environmental and other impacts to the reservoir and surrounding community
