WARRIORS OFF ROAD

PROBLEMS WITH THE FRONT COUNTER SHAFT SPROCKET WASHER

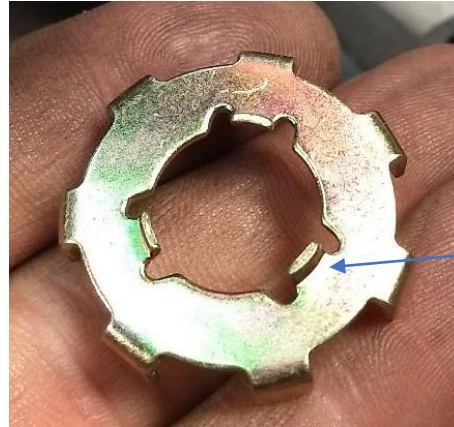
These three tabs are not bent correctly from the factory and do not fit inside the counter shaft splines

This small washer has a long history of allowing the nut to come loose during riding. As a result it can cause the chain to come off the sprocket and the small nut will be lost almost for sure. Another risk is to the engine case, in the event the sprocket comes loose and the chain binds, it might cause sever damage to the engine case.

Fix: open up the tabs to fit inside the countershaft sprocket splines.

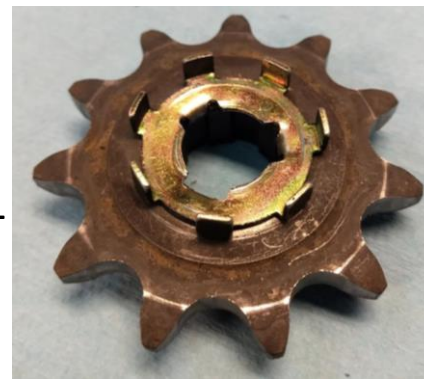
Pic 1

Problem: is that the three small tabs are not open enough to slide into the countershaft sprocket splines.
(Pic 1)

The nut has no way of locking down with this washer able to rotate

1. Using the front sprocket, place it on a sturdy surface, than place the washer on top like in (pic 1.)
2. Then using a small punch and hammer, tap the tabs inwards so they fit inside the splines on the sprocket. (Pic 2)
3. You should not be able to rotate the washer after this mod. It should fit easily into the sprocket splines.
4. Mount it back on the UTV, install the modified washer, add blue Loctite and tighten down the nut. Then bend the outer tabs into the nut to secure it down.
