68-72 Pontiac GTO Dixco Tachometer

Reverse Engineering Document R1.0

A customer sent me a Pontiac-branded hood-mounted Dixco-made tachometer that was supplied for 68-72 GTOs.

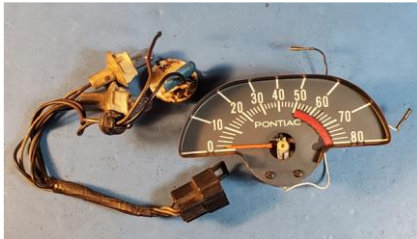
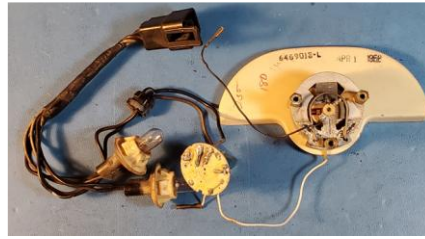
It appears to have been badly neglected for a lot of years and my customer had done a cosmetic restoration on it. It arrived with only 4 components on the original PCB. Here are photos of what I received:

The harness connector has 3 male pins, one for the 2 GRY wires to the two 158 T10 base illumination bulbs, one for the BRN wire from the coil negative terminal and one for the ground shared between the bulbs and the tachometer circuit. The BRN wire goes to a female pin that connects to the top male pin on the PCB. The BLK wire goes to a female pin that connects to the bottom male pin on the PCB and to both bulbs.

The meter has two wires coming from it with female pins on them, one WHT and one BLK. The BLK wire is the meter negative wire and goes to the male pin on the PCB that is just to the left of the center ground pin. The WHT wire is the meter positive wire and goes to the male pin on the PCB that is just to the right of the center ground pin. The meter has about 220 ohms of resistance.

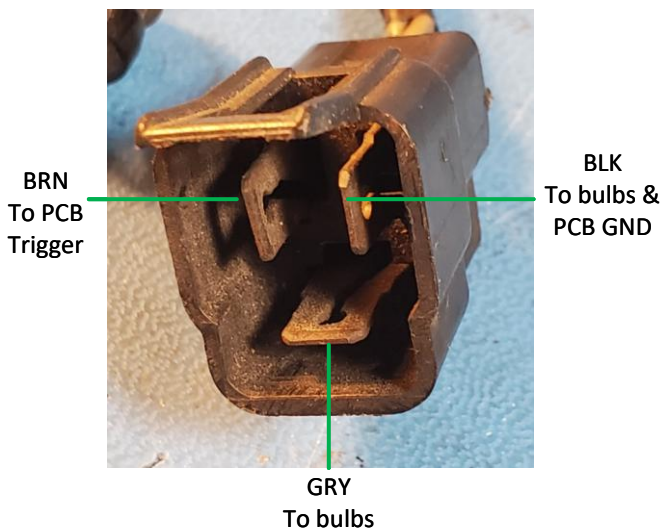
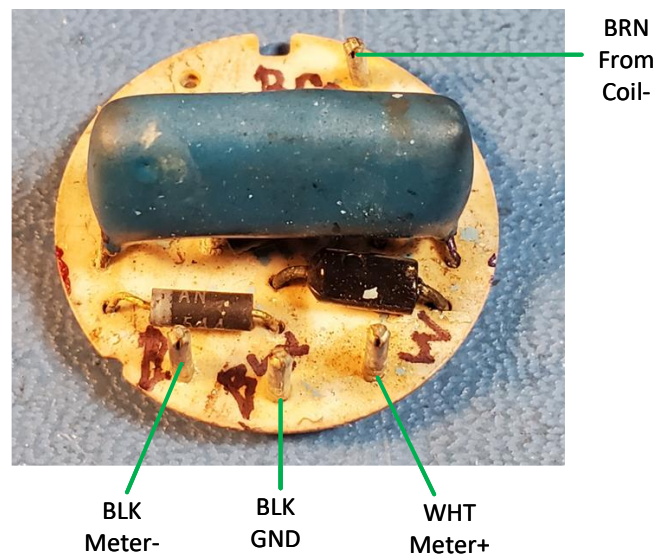
The 4 components on the PCB were 2 silicon diodes (one of which was functional), a 6.2V Zener diode (non-functional) and a 0.33uF, 200V capacitor (which measured 0.1uF). That, plus the traces and wiring on the back of the PCB confirmed that the circuit used was the no-transistor Dixco circuit. The input inductor and resistor were missing. It also made it clear which male pins on the PCB were which.

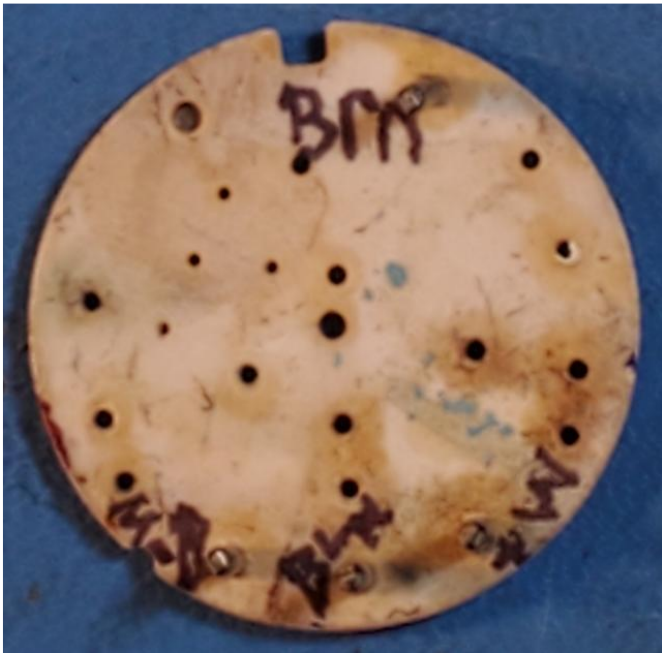
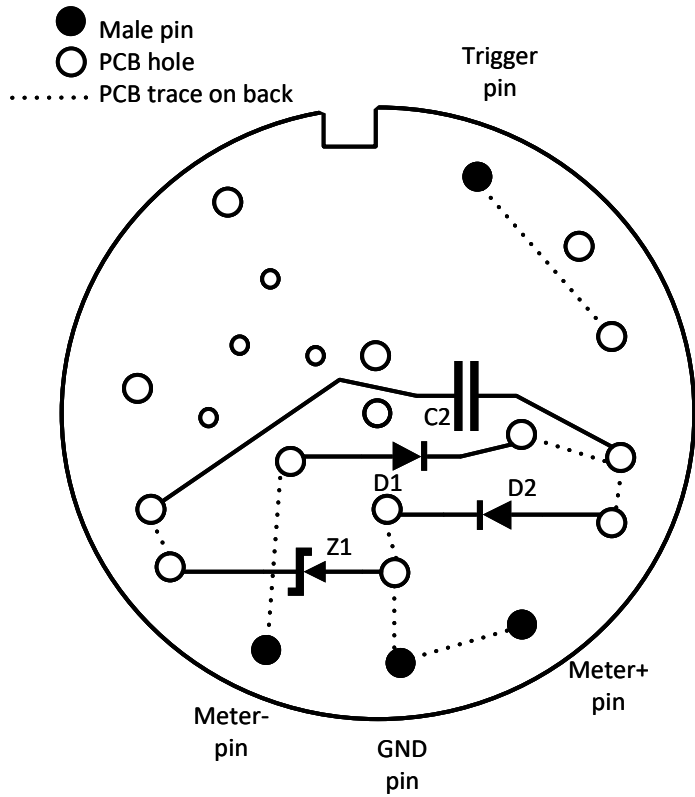
Here is a photo with the component holes along with a diagram that shows how the original components were installed.

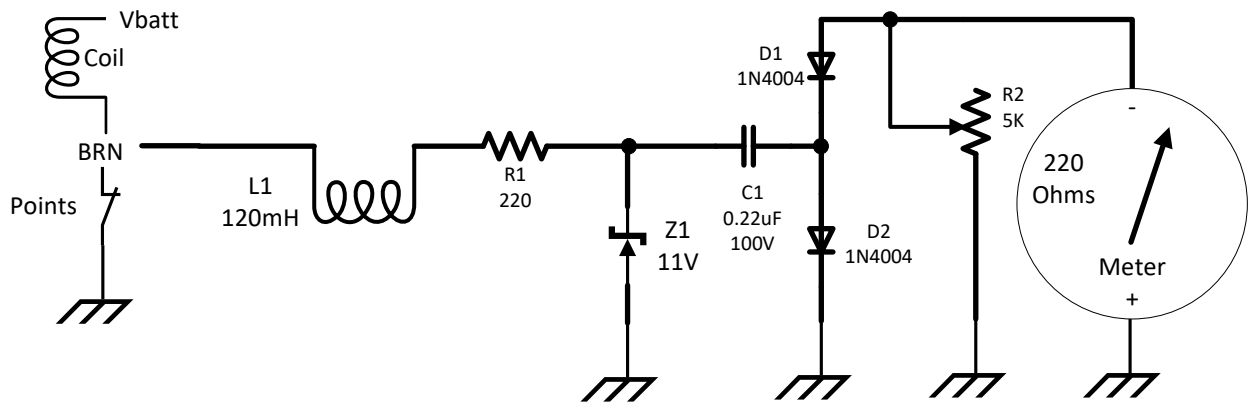
Here are the schematics of the replacement circuit:

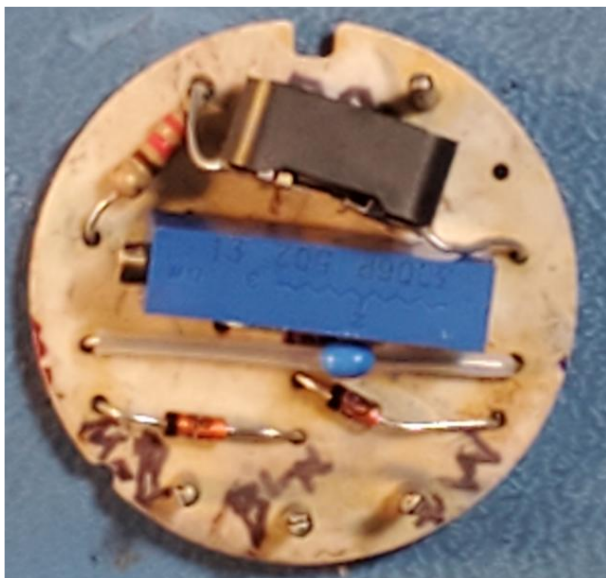
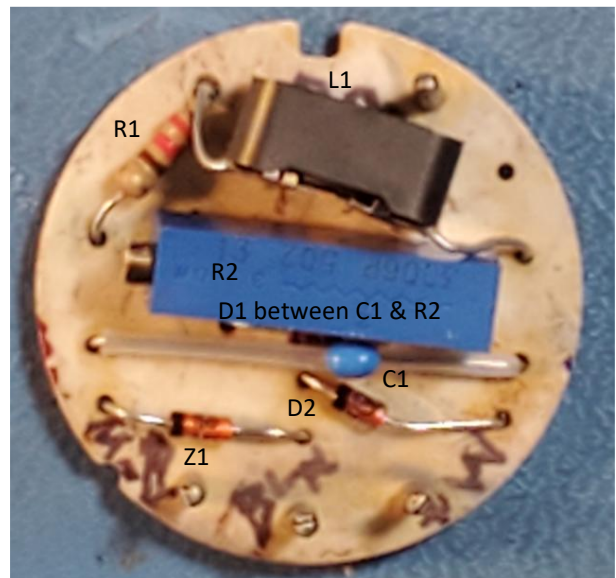
Here is the assembled PCB with the new components. The diodes and cap occupy the original positions:

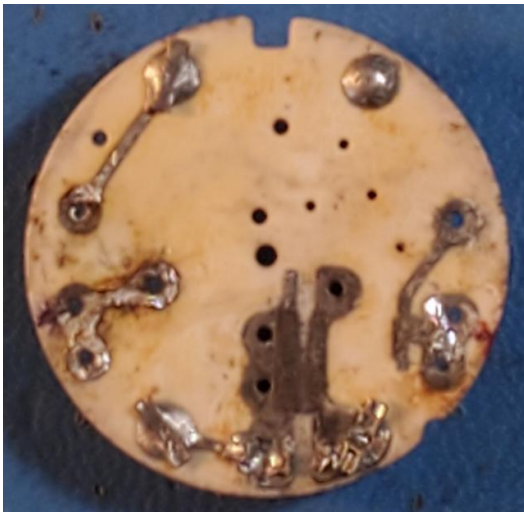
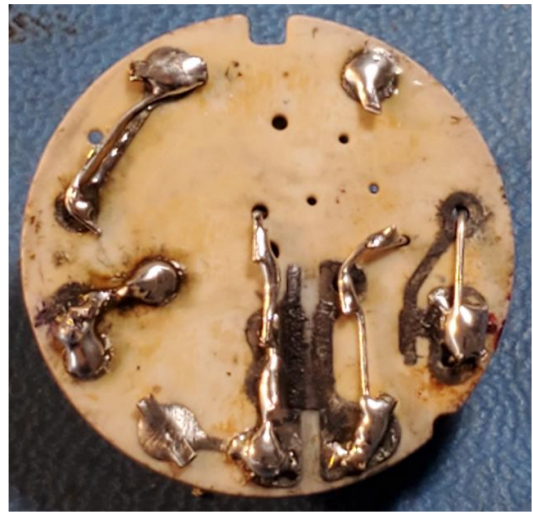
Here is a photo of the back of the PCB without anything installed. It shows many missing traces. The photo on the right shows the back of the PCB with the new components installed.

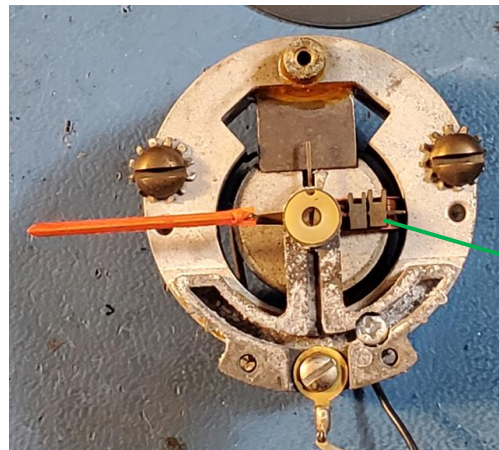
Counterweights

Testing with the new circuit showed that the tachometer could not be calibrated across the scale. I calibrated it at 4000 RPM and it read about 1000 RPM too high at the high end of the scale and about 1000 RPM too low at the low end of the scale.

Most Dixco meters are sealed in plastic, but this one is not. I finally asked the customer if he had repainted the needle. He said he had. The additional weight of the new paint on the needle was the culprit. I removed the face to see if there was an adjustable counterweight and there were 2.

Adjusting the 2 counterweights was a little tricky, but it was finally calibrated across the scale.
