# 67 Saab Sonnet II VDO Tachometer Schematics

## Rev 1.2

Mark Olson  
Accutach Co.

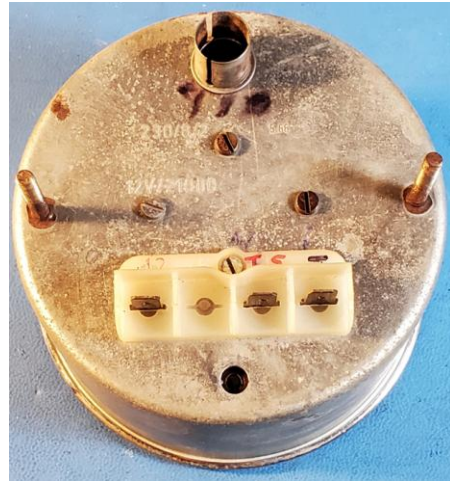
I received a non-functional rare VDO tachometer from a customer who asked me to see if I could fix it. It was from a 1967 Saab Sonnet II with a 3-cylinder, 2-stroke engine.

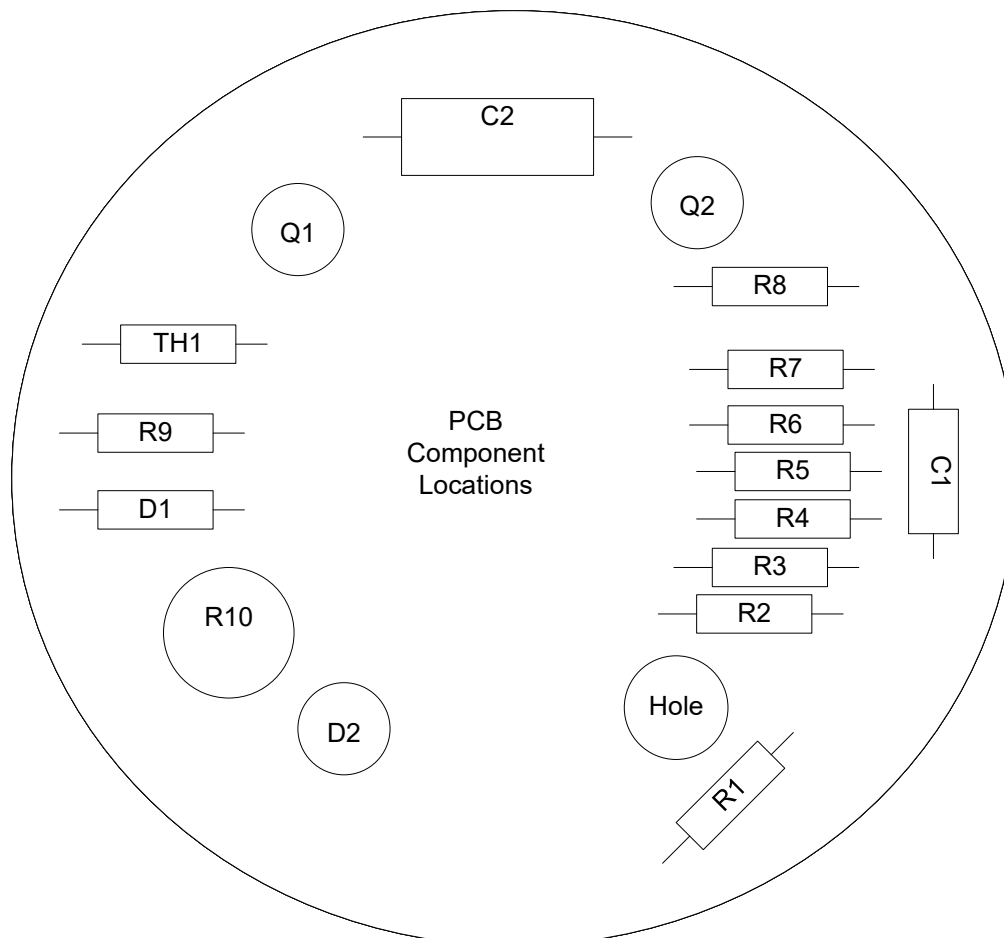
The schematics and component layout diagrams are on the last page.

There are two transistors configured in what appears to be a one-shot configuration. It was impossible to see the part numbers on the transistors. Based on the circuit, I surmise that they are PNP transistors, but I may be wrong. In-circuit, the diode tester reported a 0.2V diode drop across what I guessed is the EB junction, although it could be a CB junction of an NPN transistor. With a 0.2V drop, I am guessing that these are germanium transistors.

D1 is clearly a diode, but I could not see the polarity band on it, so I am just guessing as to its orientation. I may have gotten it backwards.

I am guessing that D2 is a diode since it is in a 2-wire case very similar to that of the transistors. However, it failed the diode tester, so if it is a diode, it had failed.

C1 is marked 1000, although no units, so I have no idea what it should be. C2 is marked 33uF. But both caps measured in the single digit nF range when measured in-circuit, which may not be accurate.

- Q1 and Q2 are Ge PNP transistors with 0.2V DB drop
- R10 not on PCB
- D1 direction is uncertain
- D2 is assumed to be a diode. It is in a metal transistor can with only 2 leads. Marked with "92" and Z7". Failed diode test
- Thermistor value unknown as colors are gone
