RV Inspection Report

2024 Brinkley G3500

Buyer: Pre-Purchase RV Inspection

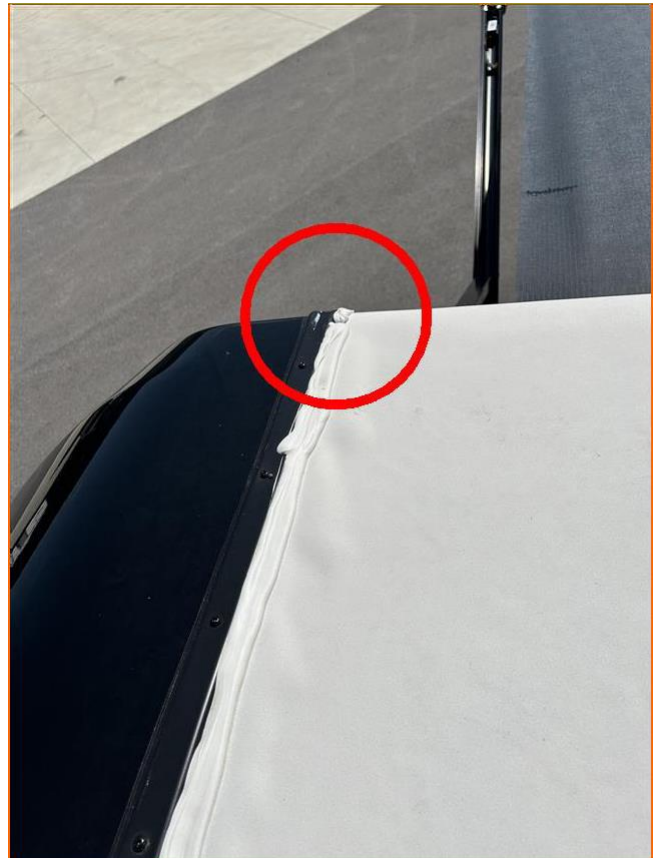
Front Cap, Joints, Seals, and Gutters

Two spots on the front cap seal have gaps in the sealant. Recommend repair to prevent water intrusion.

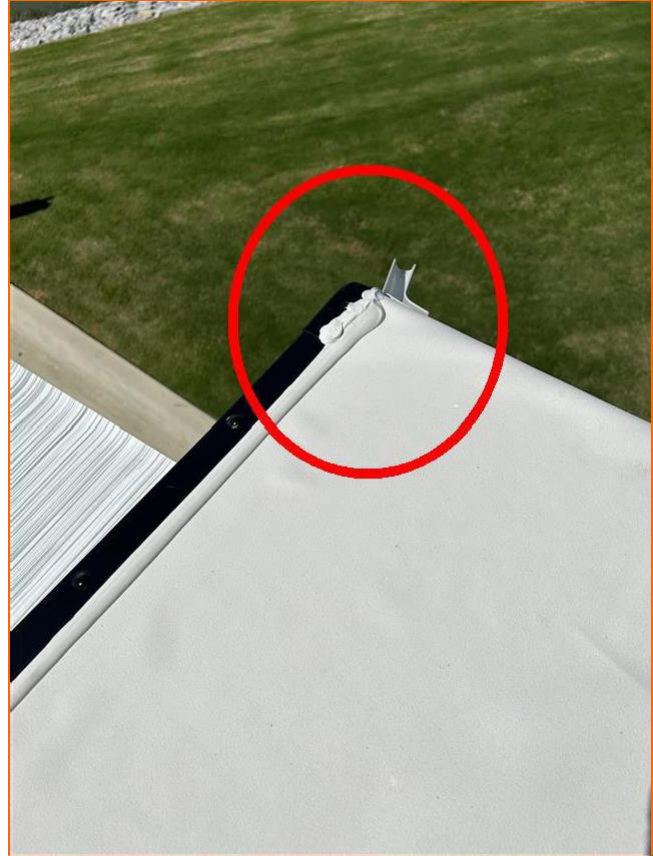
Rear Cap, Joints, Seals, and Gutters

Two spots on the rear cap seal have gaps in the sealant. Recommend repair to prevent water intrusion.

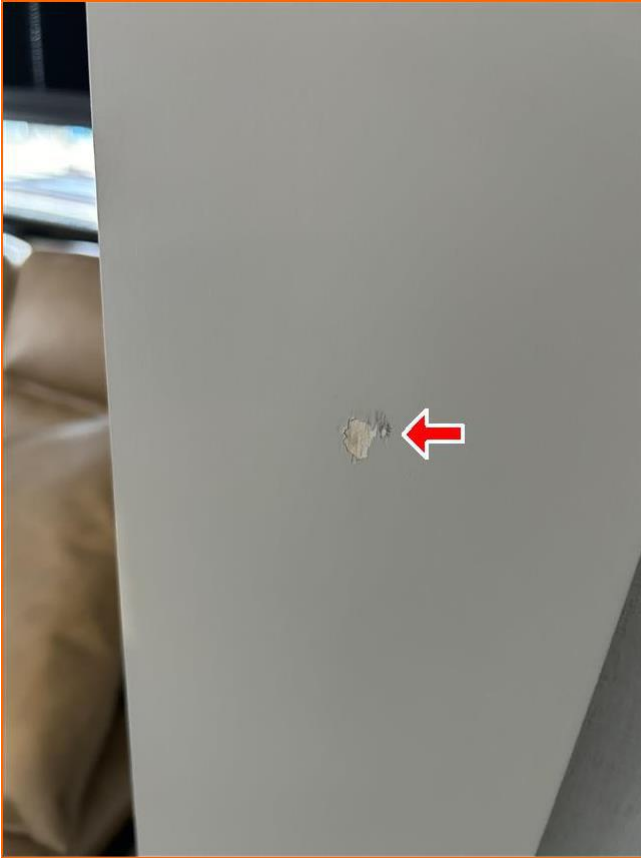
Walls

There is a paint chip on the door frame going from the kitchen to the garage. Recommend touch-up.

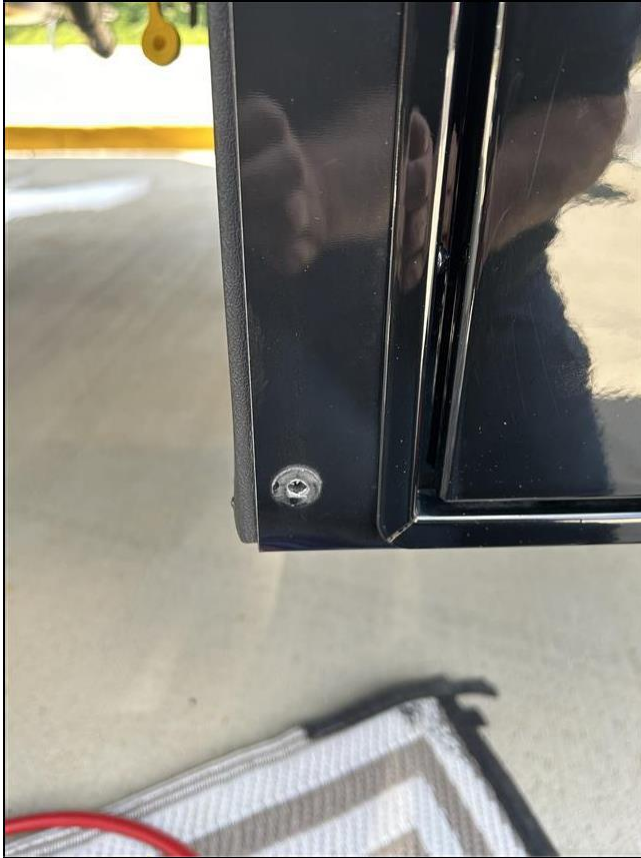
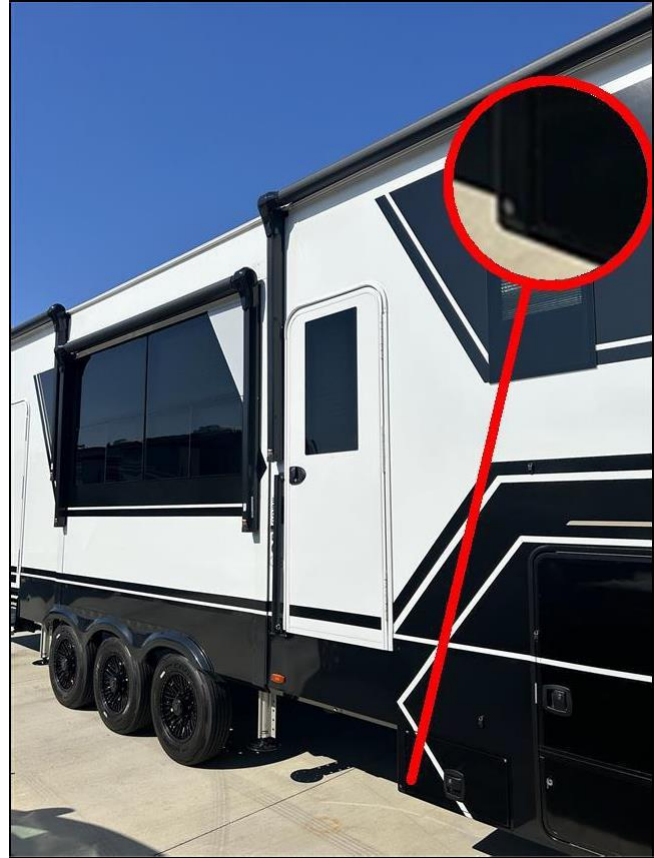
3.7 Joints and Trim

The head of a rivet is missing. Location - next to the front steps.

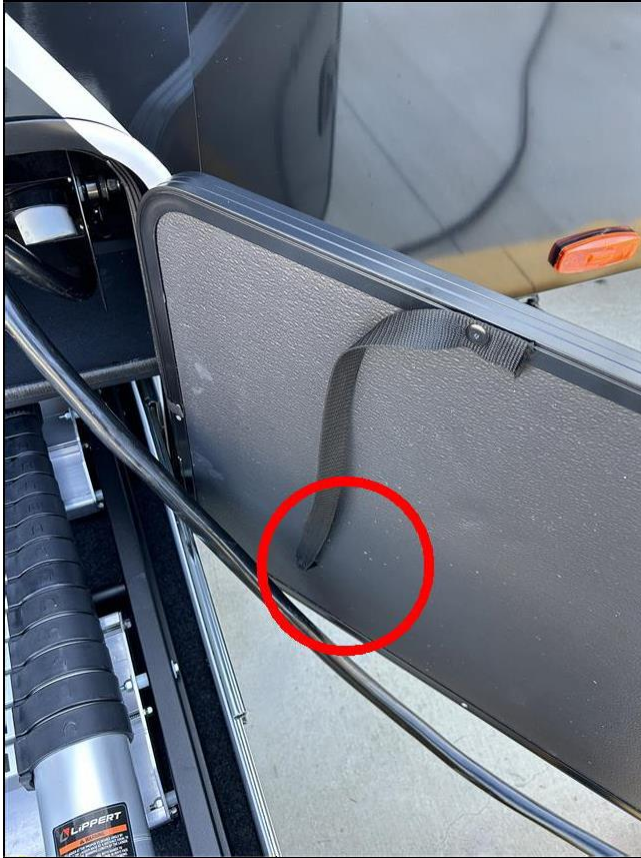
4.8 Cargo/Access Doors

Power cord compartment.

The door strap is detached. Recommend repair.

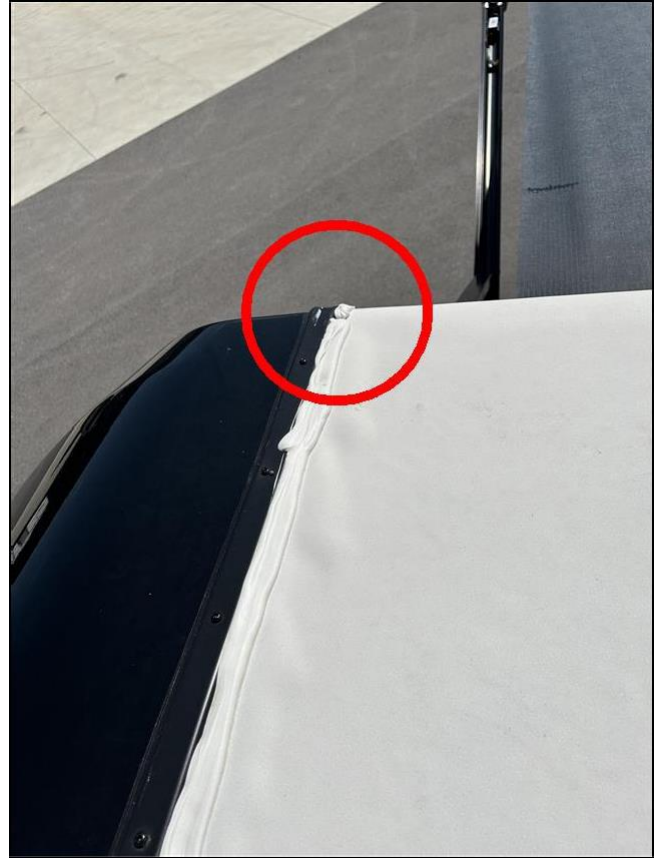
6.1 Front Cap, Joints, Seals, and Gutters

Comments: Fair

Two spots on the front cap seal have gaps in the sealant. Recommend repair to prevent water intrusion.

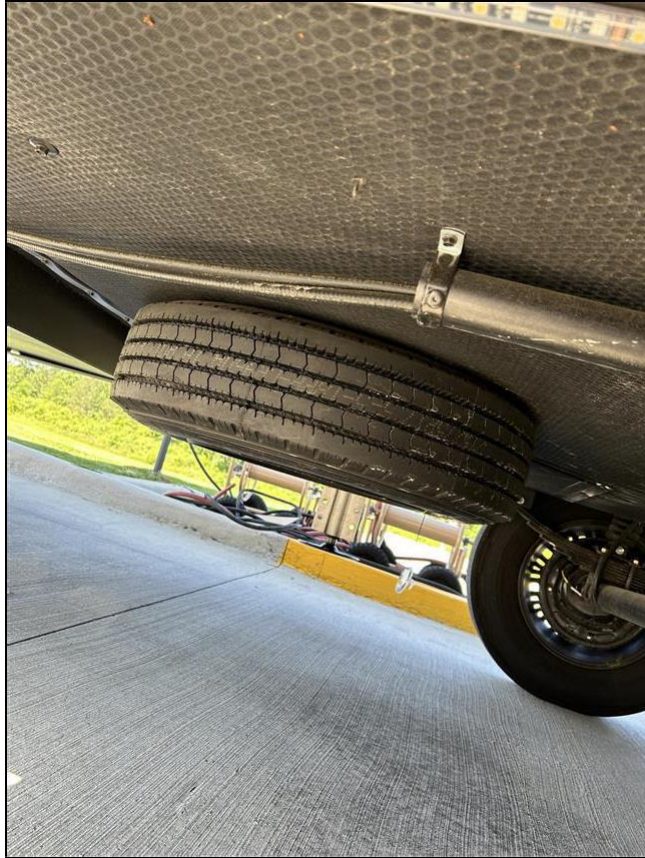
11.11.GTire and Wheel General Condition

Comments: Acceptable

Air pressure in this tire is 117.6
Recommended pressure is 123

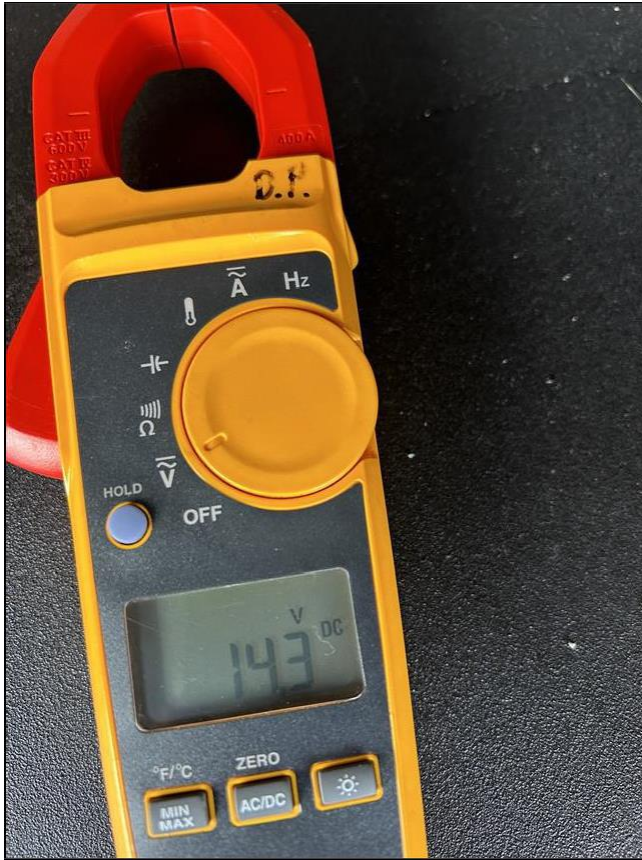
17.16 Converter / Charger Operation and Condition

Comments: Acceptable

Inspector verified the converter is operational by checking battery output while plugged into shore power, and then checking again while unplugged from shore power.

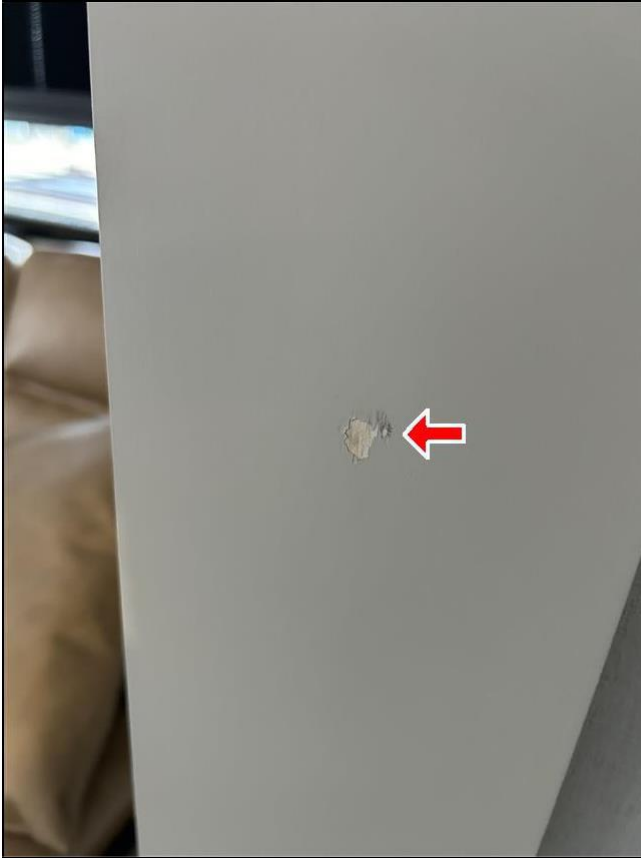
20.8 Walls

There is a paint chip on the door frame going from the kitchen to the garage. Recommend touch-up.

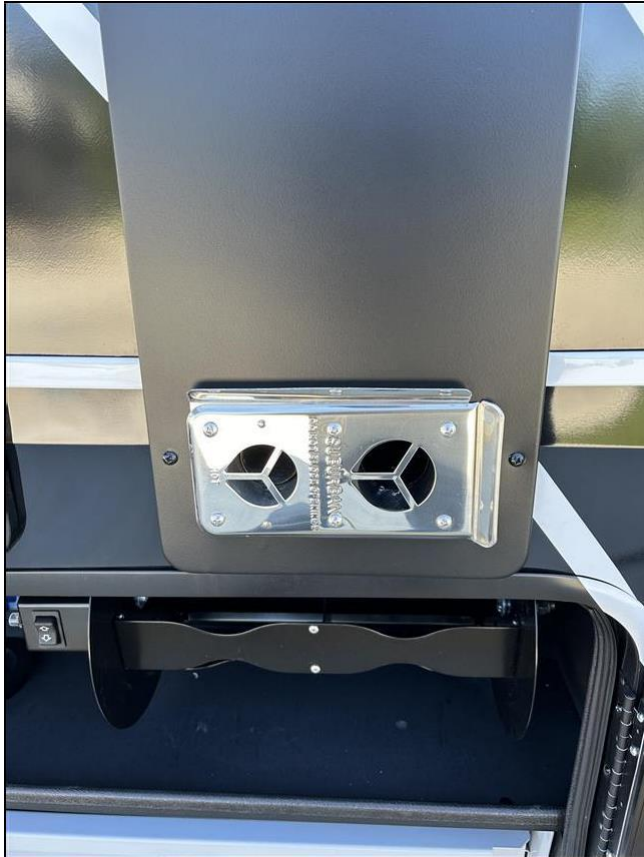
28.2 Furnace Air Intake / Exhaust Area Condition

Comments: Acceptable

It is recommended that dauber screens be installed, especially if living in the South.

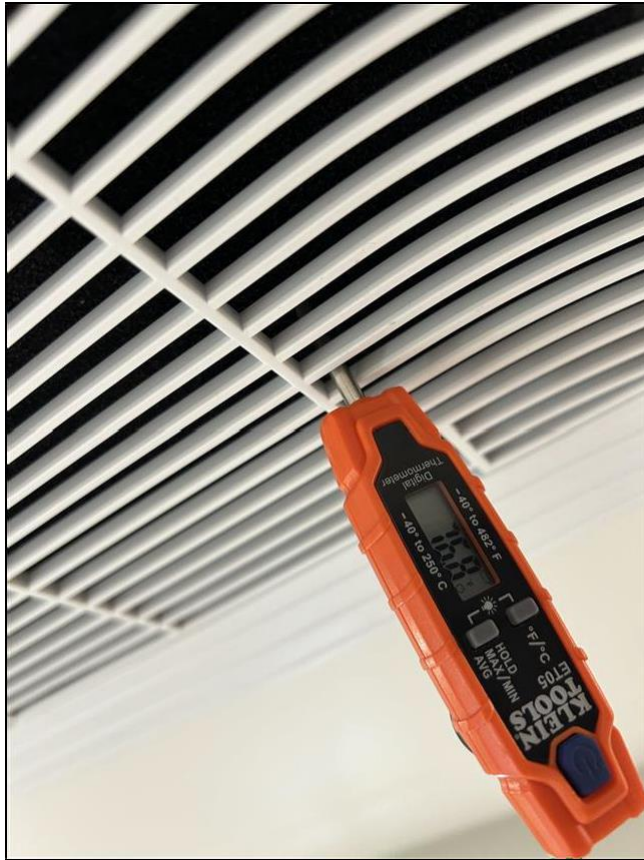
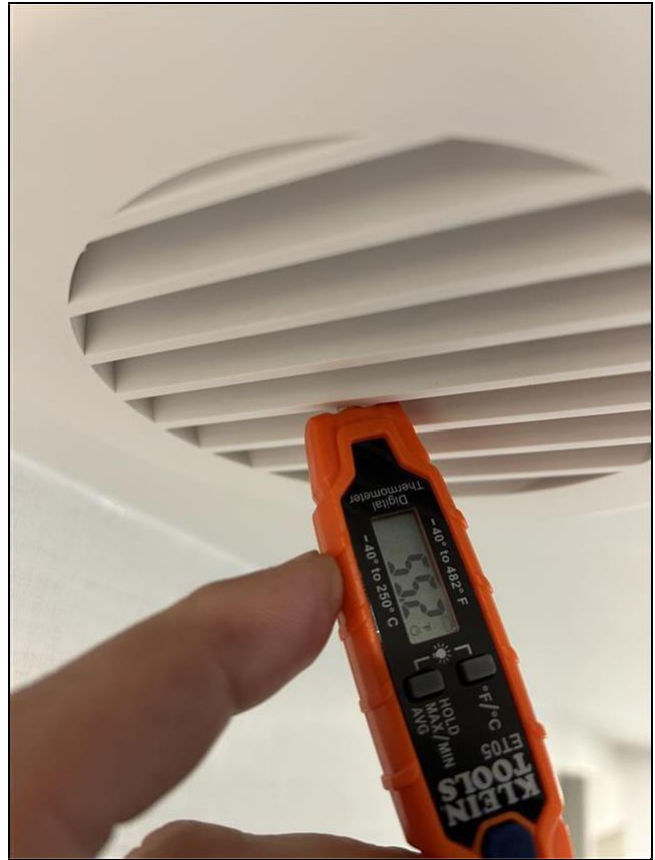
29.0.A Air Conditioner Condition

Comments: Acceptable

Intake air temperature: 76.8
Output air temperature: 55.2
Delta-T = 21.6

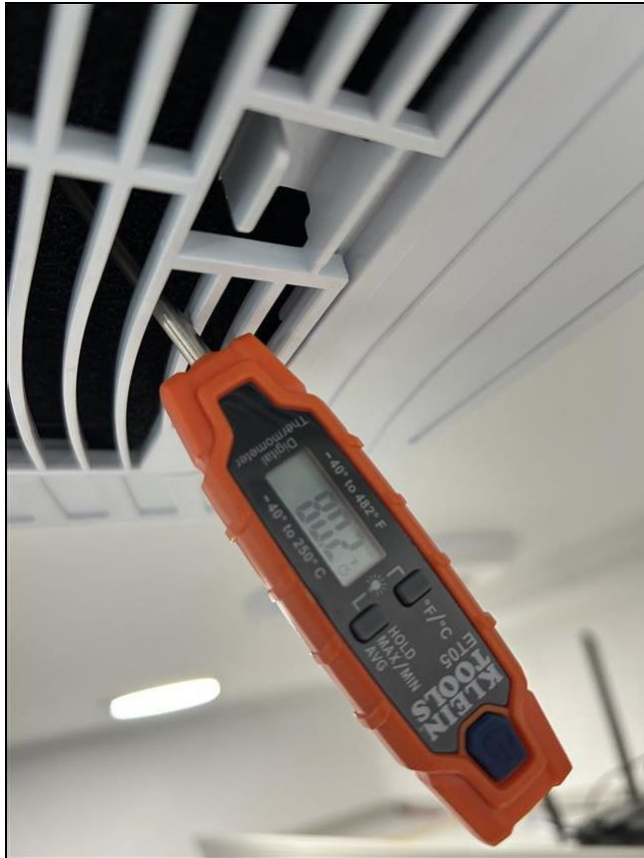
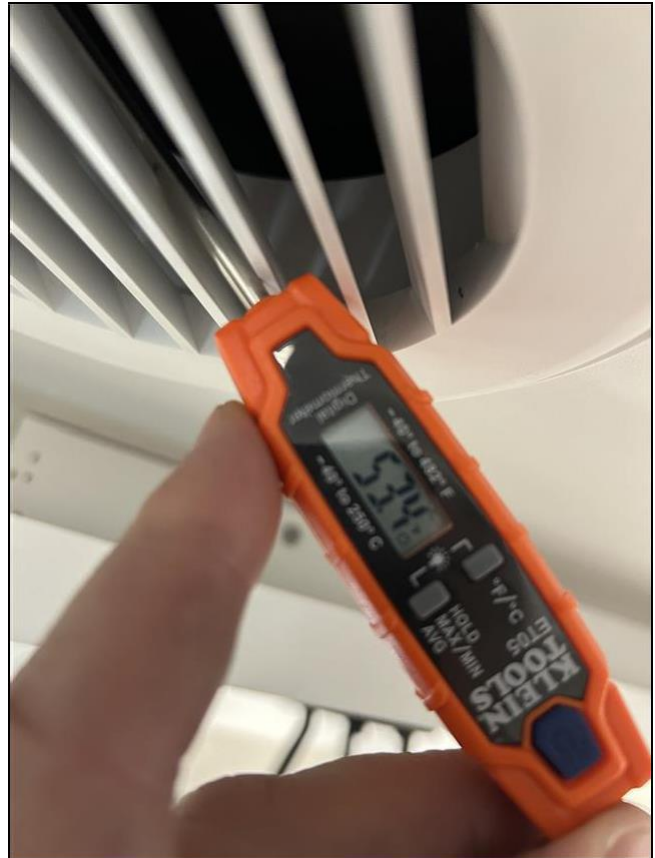
29.0.B Air Conditioner Condition

Comments: Acceptable

Intake air temperature: 80.2
Output air temperature: 53.4
Delta-T = 26.8

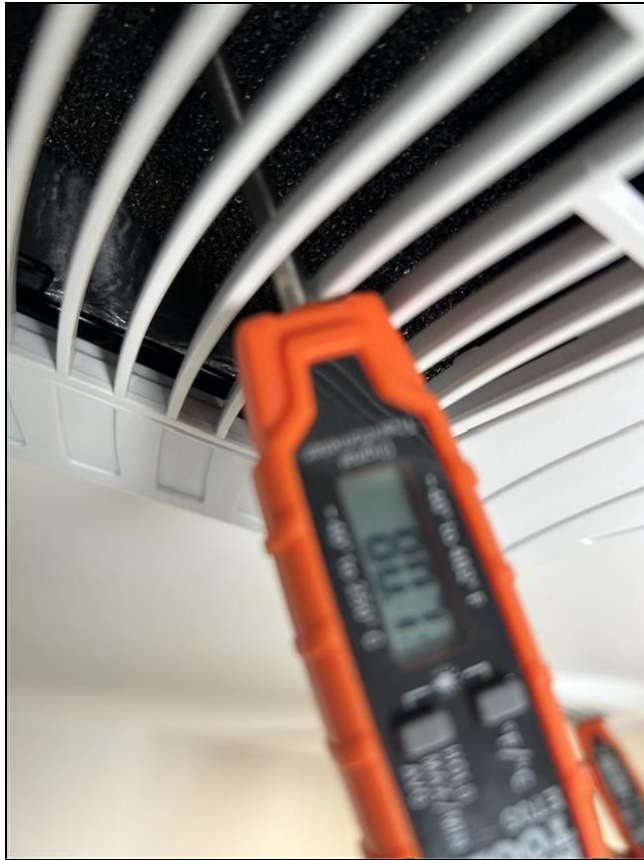
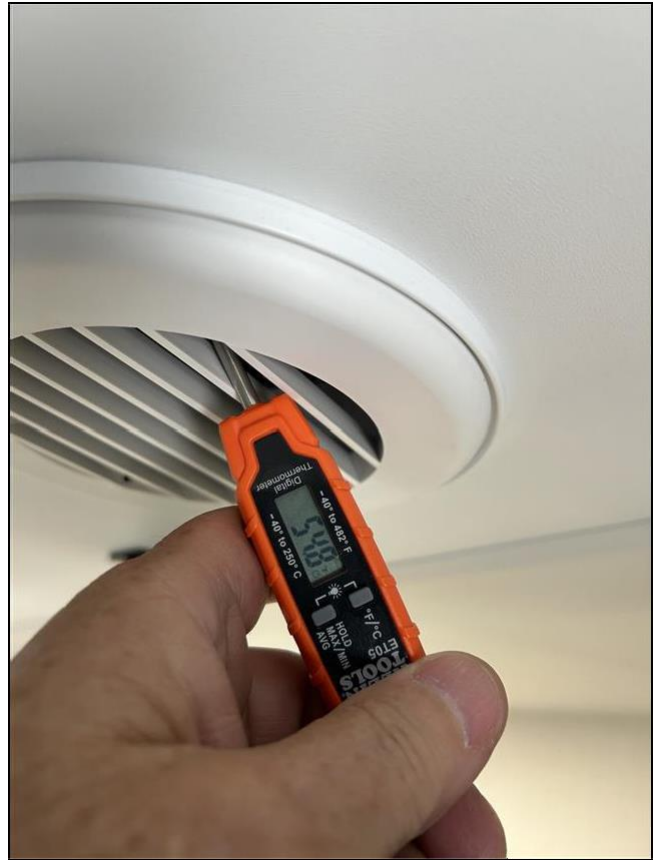
29.0.C Air Conditioner Condition

Comments: Acceptable

Intake air temperature: 80.7
Output air temperature: 54.8
Delta-T = 25.9
