RV Inspection Report

2024 Georgetown 5 Series 31L5
VIN Number: [REDACTED]

Buyer: Pre-Purchase RV Inspection

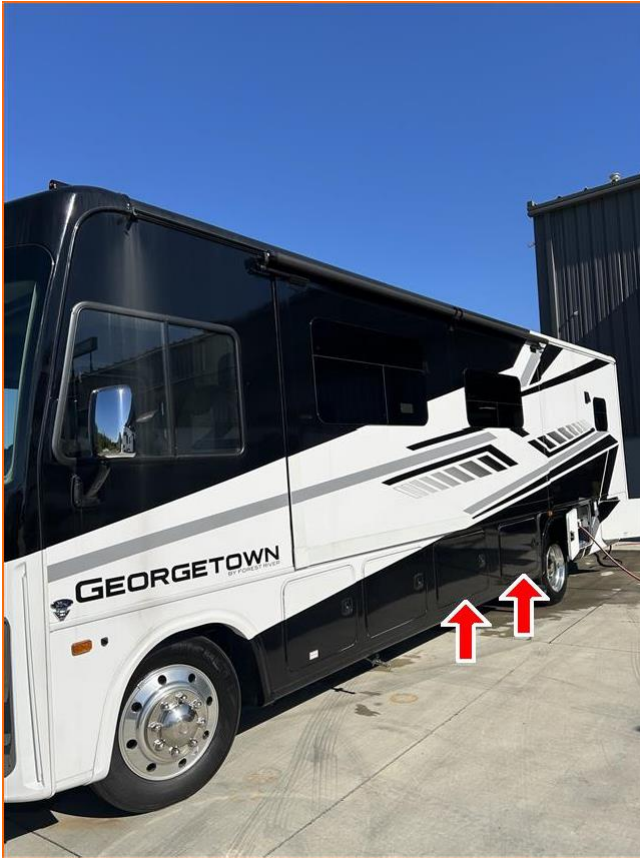
Cargo/Access Doors

Bay doors 3 and 4 scrape at the bottom. Recommend adjustment/alignment.

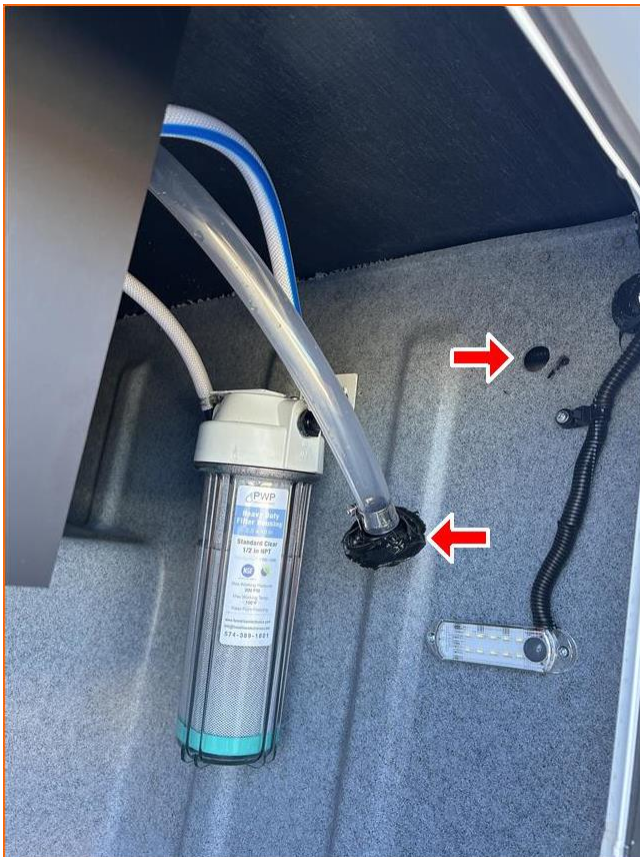
Fresh Water Tank

The fresh water overfill hose is disconnected. Recommend repair.

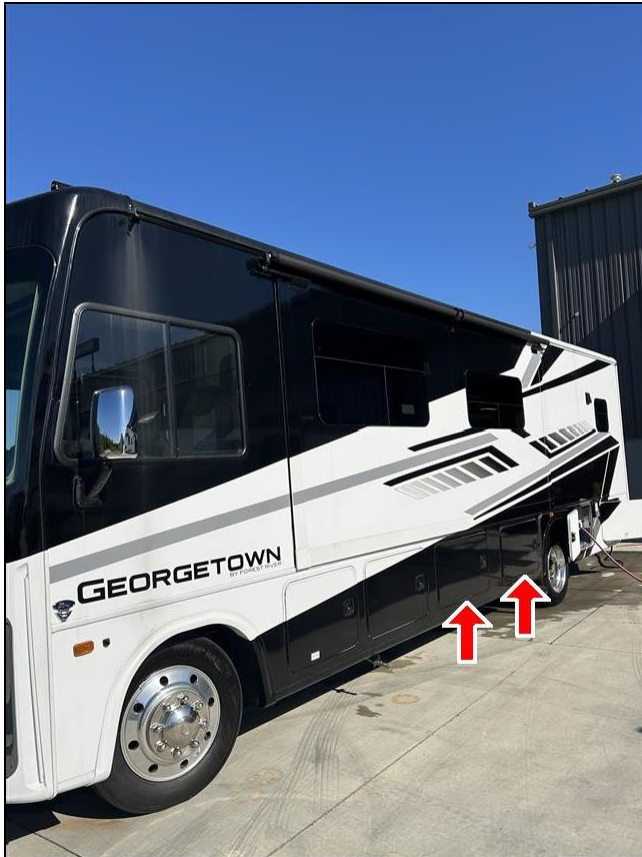
4.5 Cargo/Access Doors

Comments: Fair

Bay doors 3 and 4 scrape at the bottom. Recommend adjustment/alignment.

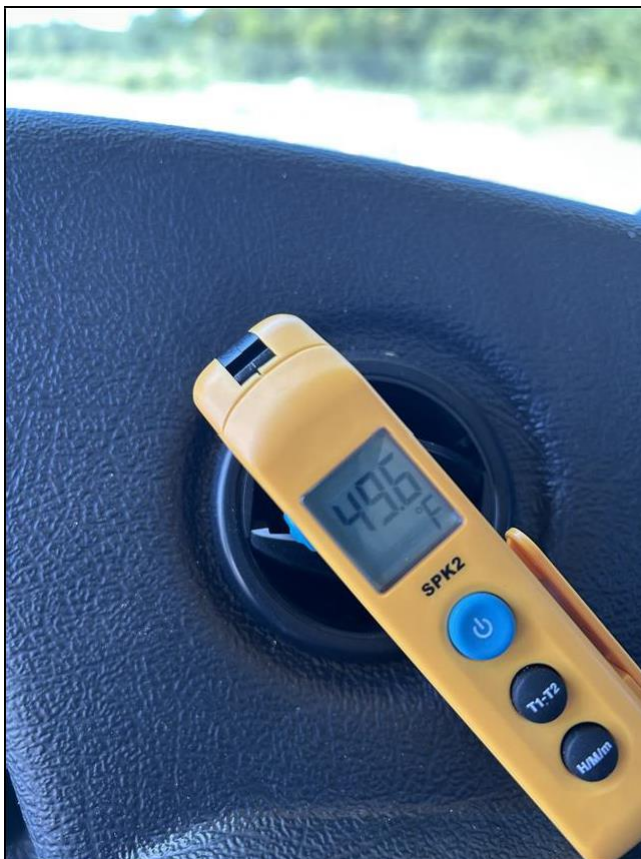
13.10 Dash Air Conditioner operation

Dash air temp on max = 49.6

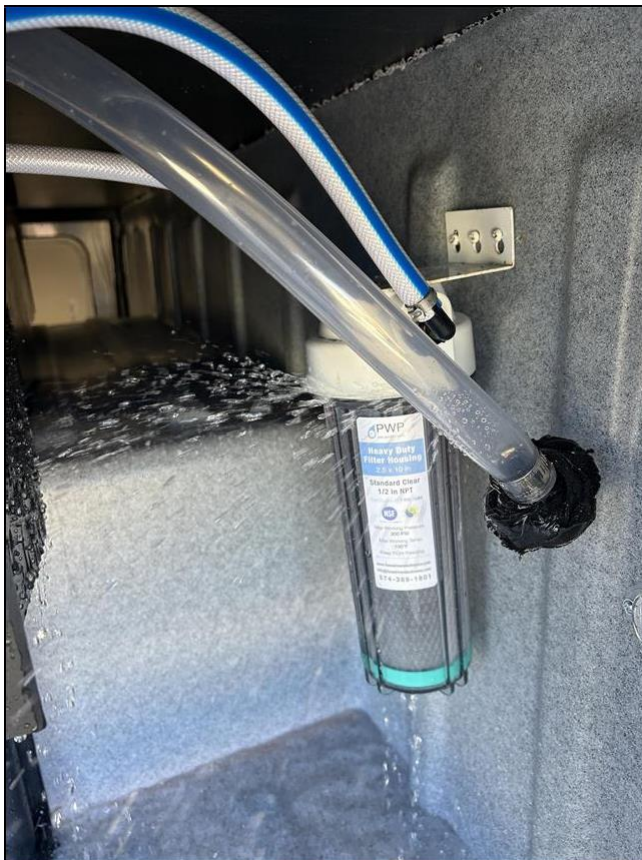
16.10 Onboard Water Filtration System

Comments: Poor

Lots of water spraying.

The water filter is leaking. Recommend repair.

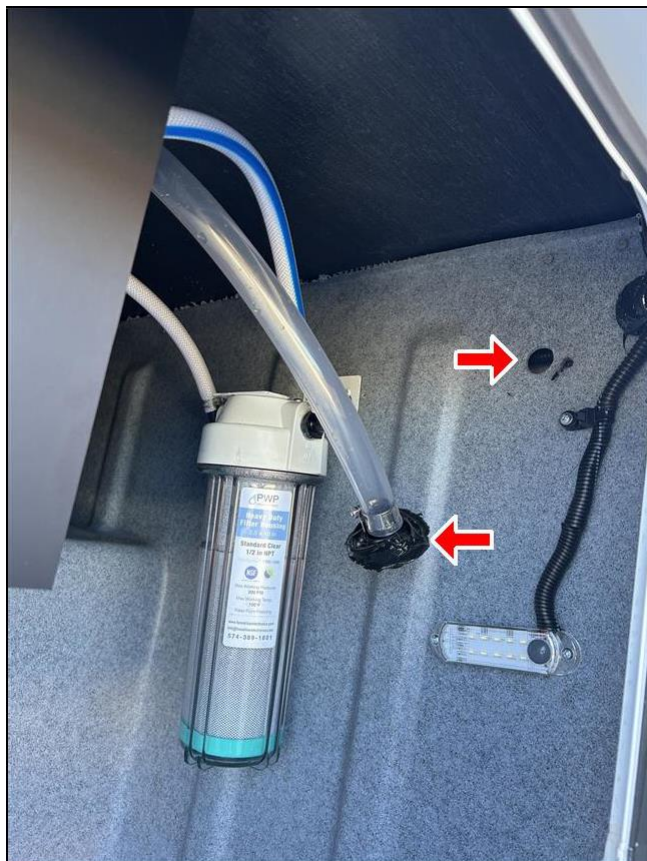
16.12 Fresh Water Tank
Comments: Fair

The fresh water overfill hose is disconnected. Recommend repair.

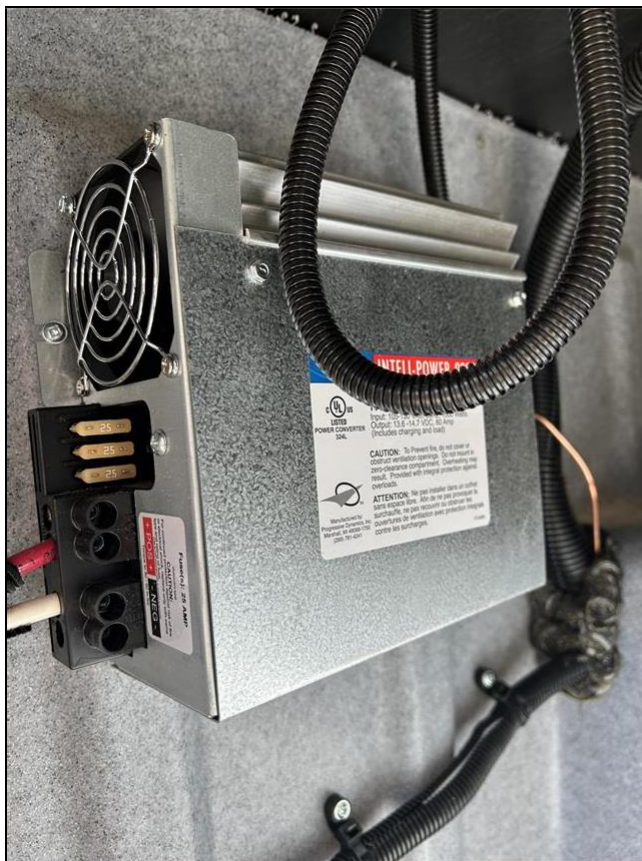
17.12 Converter/Charger - Operation and Condition

The converter was verified as operational by checking battery output while plugged into shore power, and then checking again while unplugged from shore power.

DC voltage with shore power (or generator) on: 13.7

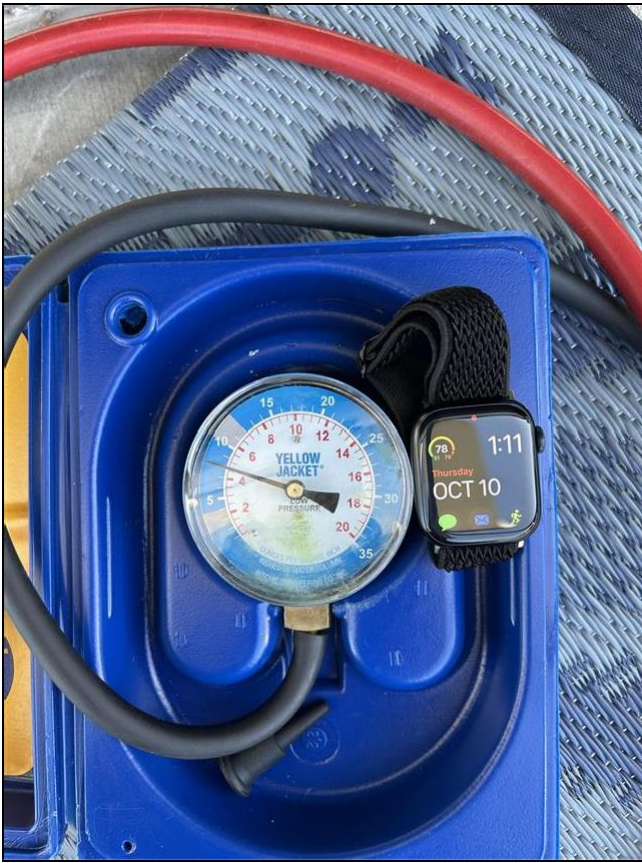
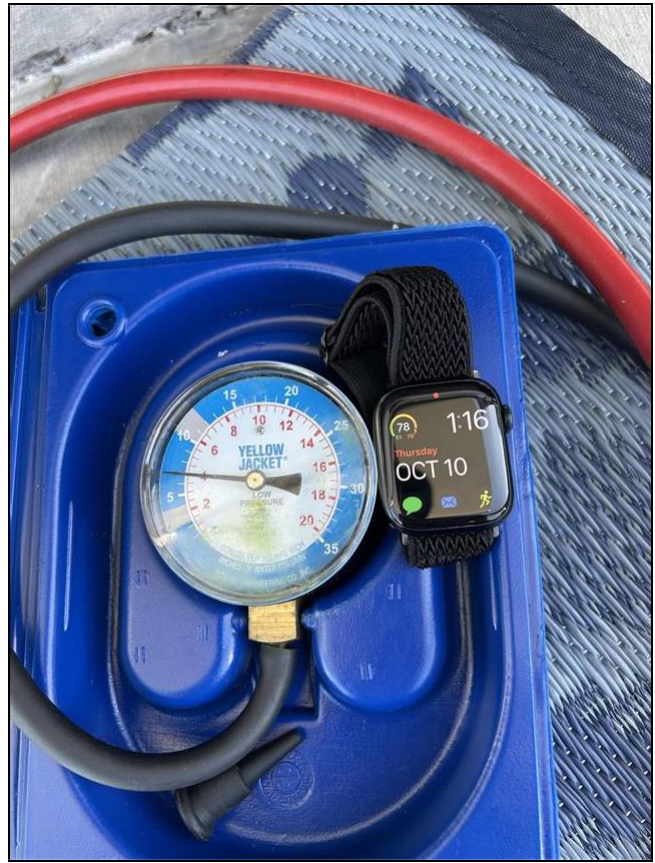
18.0 LP System Timed Leak Test

Begin Test

End Test

LP leak test is performed by attaching manometer to a LP access point - an outside grill port or under the stove top. LP tank is then turned off and pressure is bled down to 8 w.c. and timed for five minutes to verify there is no drop in pressure.

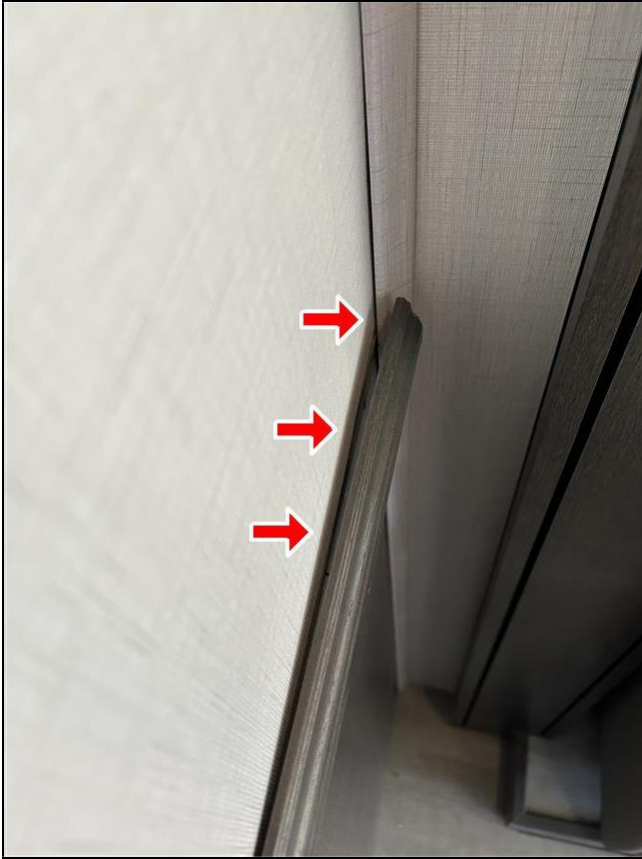
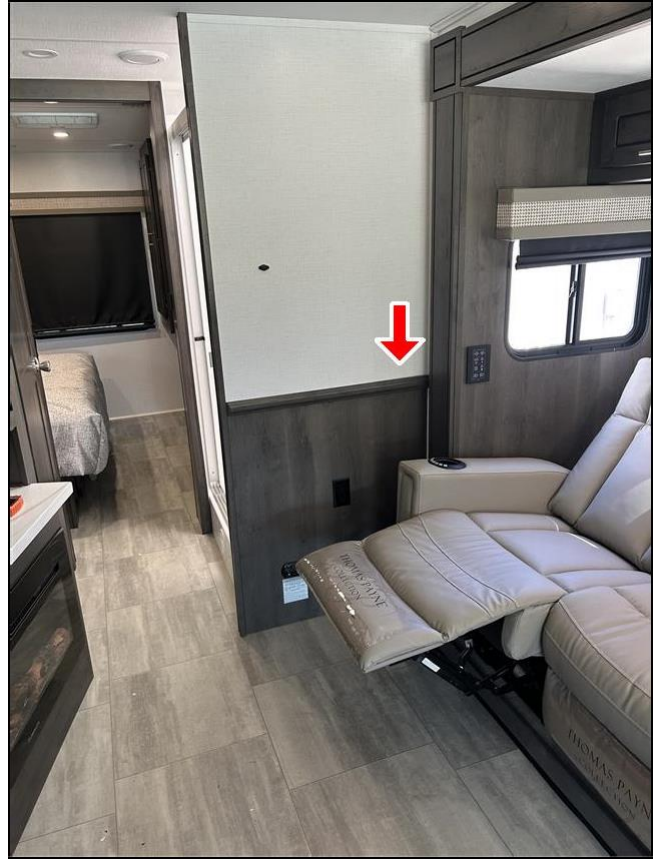
20.7 Walls

Comments: Fair

This piece of molding is detached from the wall. Location - in the living area, on the wall behind the shower.
Recommend repair.

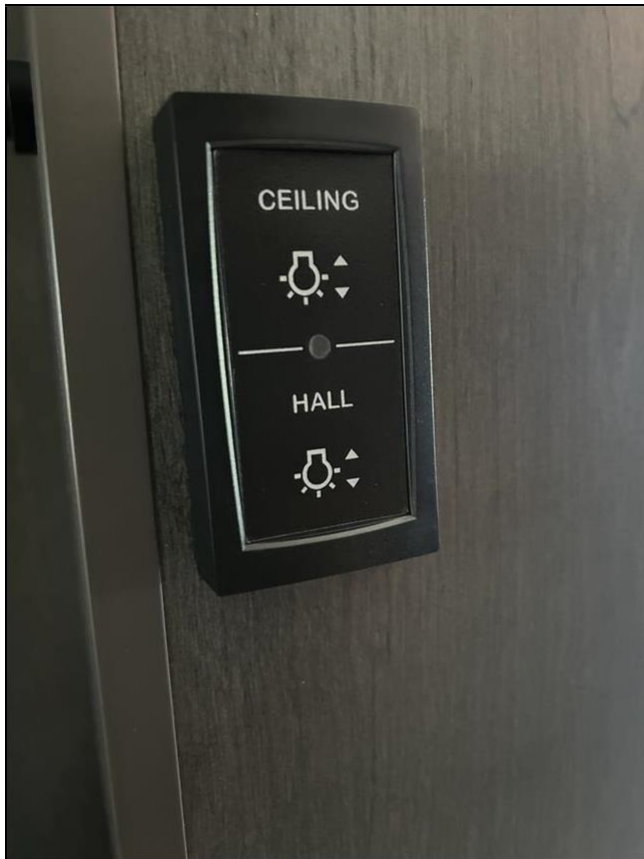
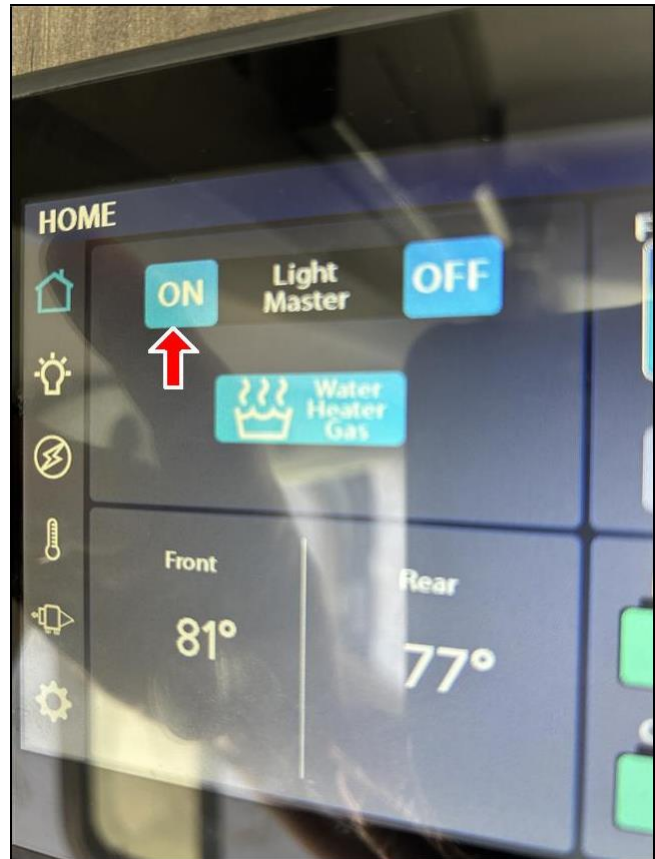
21.7 Lights and Light Fixtures

Comments: Poor

This switch is in the bedroom. The "Ceiling" button controls the bedroom lights, as it should. When all lights are on in the coach (by activating the master switch), the "Hall" button turns off not only the hall lights, but all lights. And they won't turn back on without activating the master again. Recommend repair.

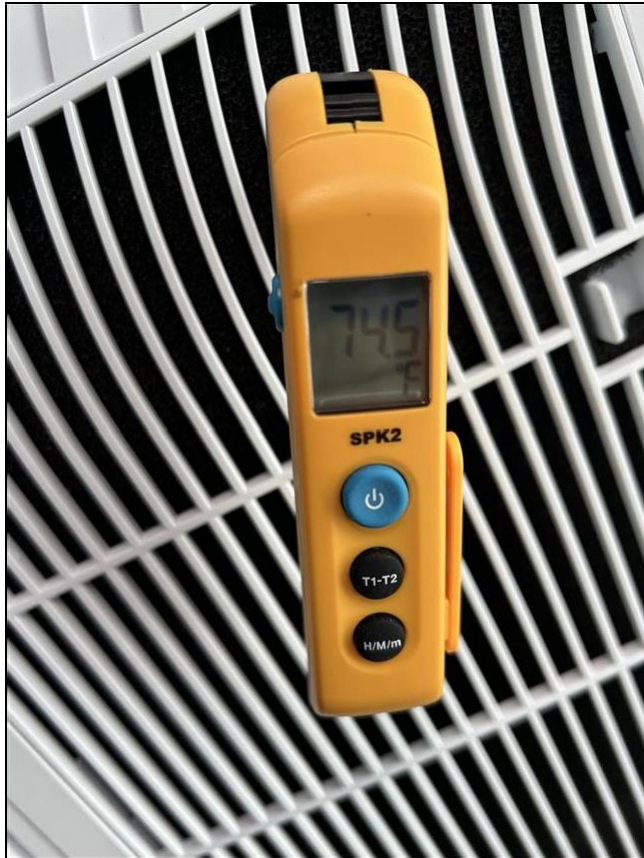
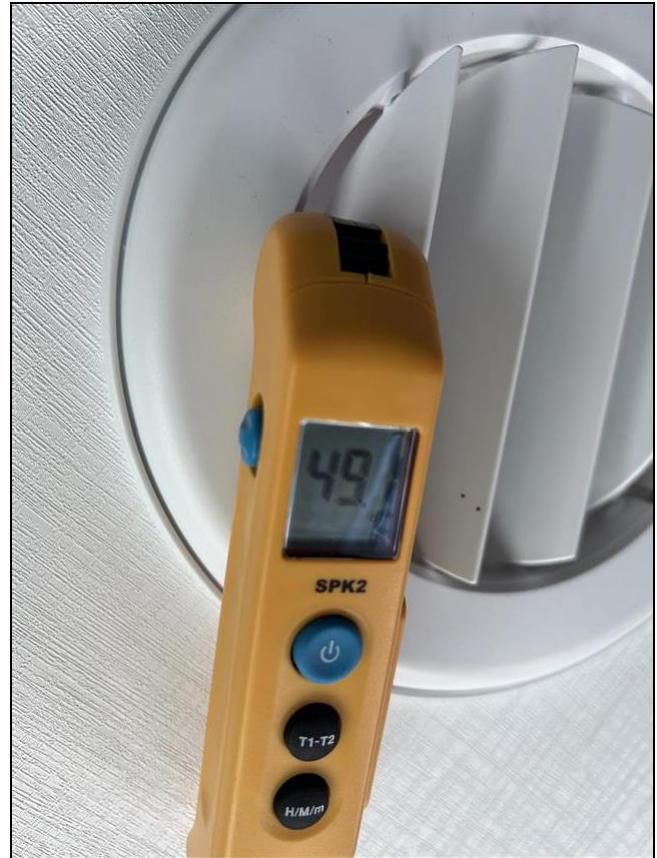
26.0.A Air Conditioner Operation and Condition

Intake air temperature: 74.5
Output air temperature: 49.1
Delta-T = 25.4

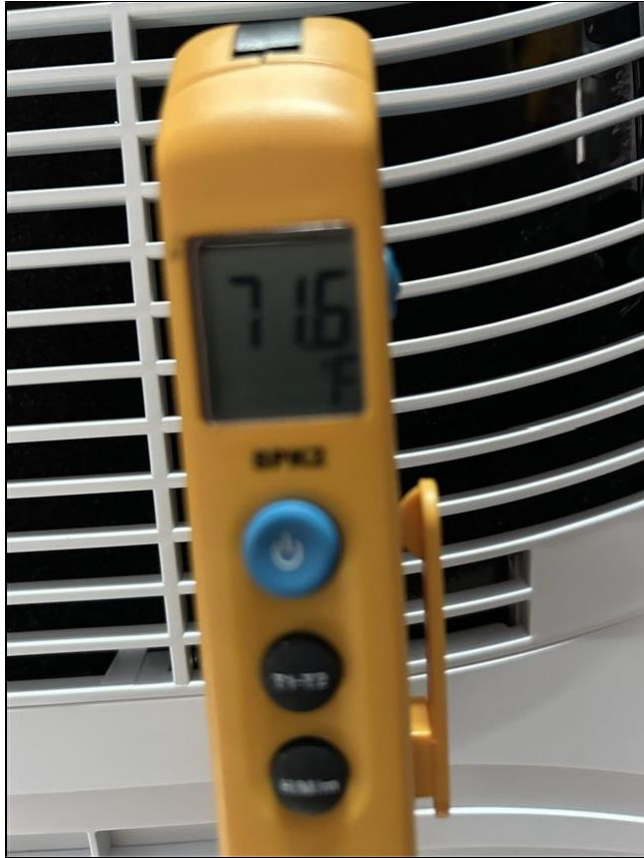
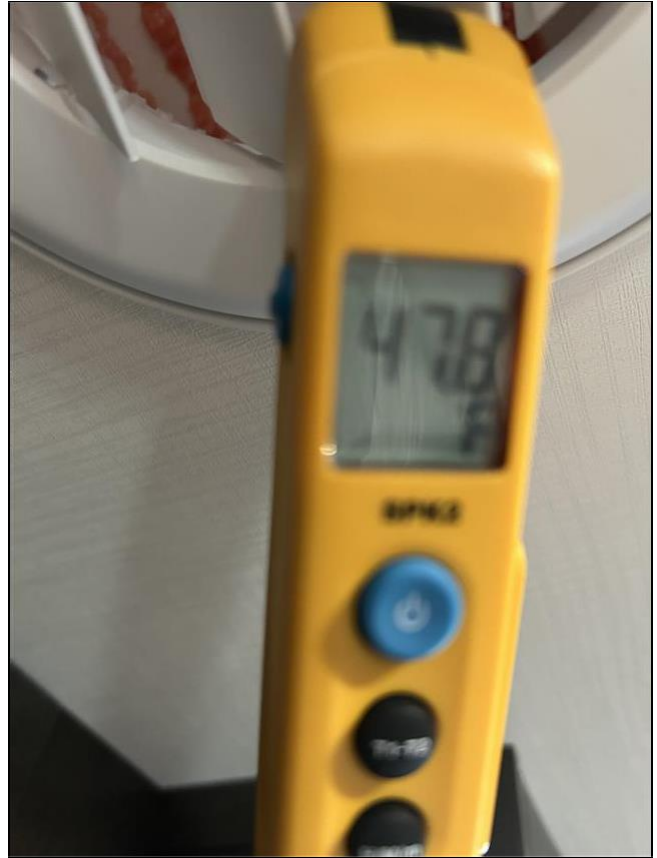
26.0.B Air Conditioner Operation and Condition

Intake air temperature: 71.6
Output air temperature: 47.8
Delta-T = 23.8
