# RV Inspection Report

**2020 Gulf Stream Conquest 6238**

## Summary of Issues Found: pages 2-13

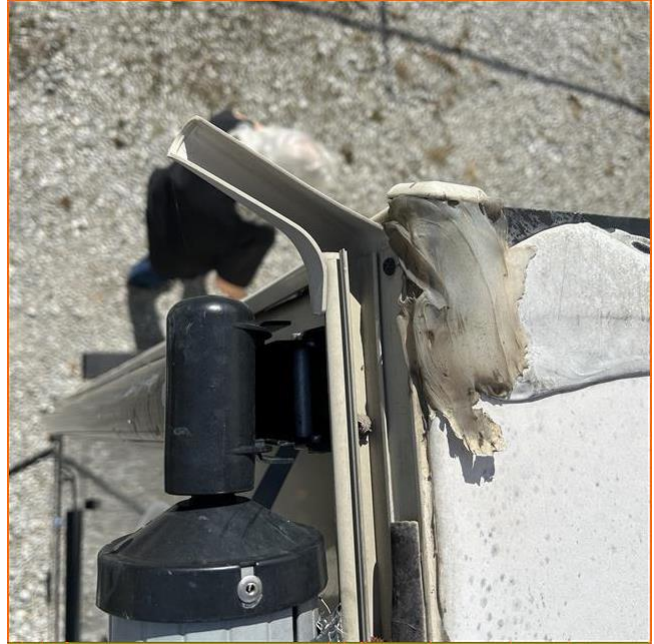
#### Rear Cap, Joints and Seals

Both rear cap corners have been repaired, but the wrong kind of sealant was used. Recommend evaluation by a qualified service technician.

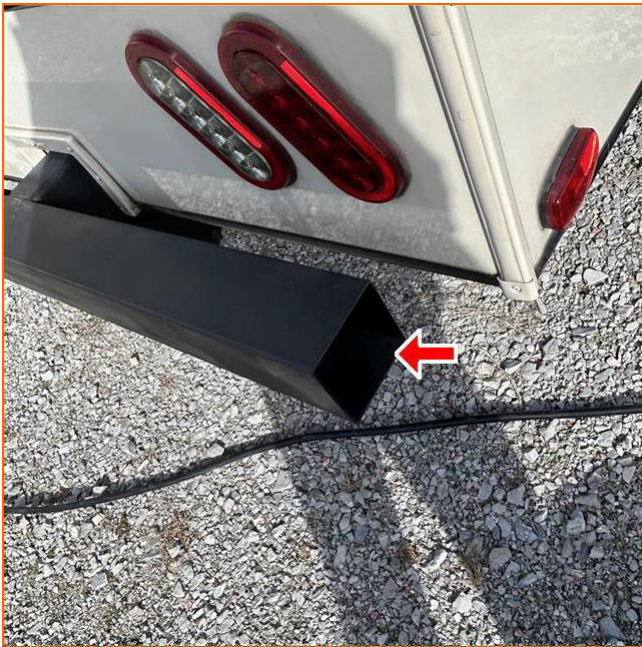
## Rear Bumper Condition

One end cap is missing from the rear bumper. Recommend replacement.

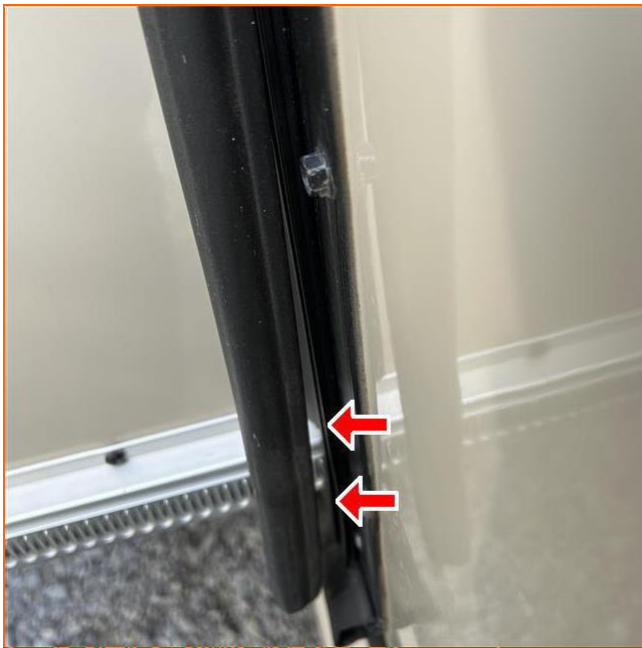
## Slideout T-Molding Trim

A portion of the bulb seal is detached. Recommend repair.

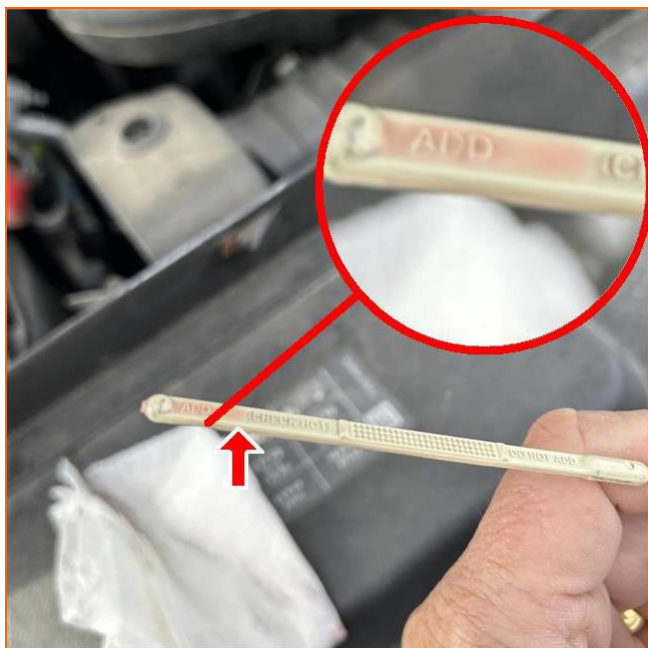
### Engine Transmission Fluid level

The transmission fluid is at the "ADD" level. Recommend filling to appropriate level.

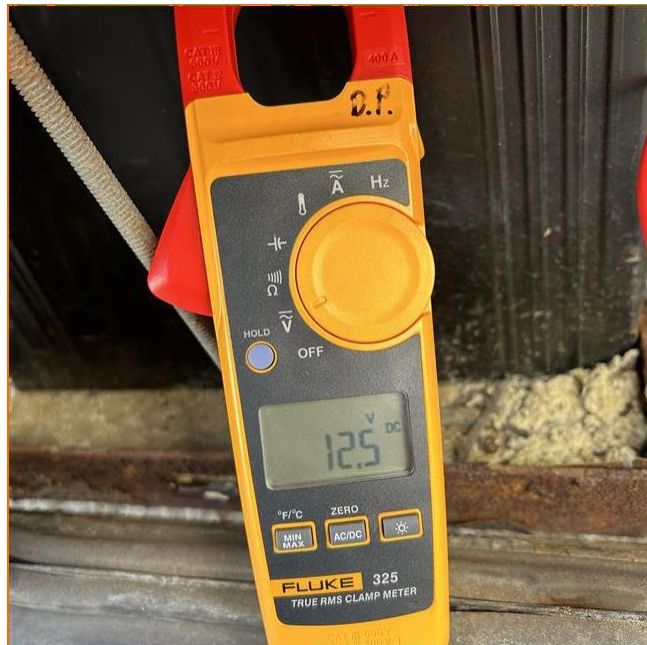
### 12-Volt DC House (Coach) Batteries - Condition

Battery voltage was 13.6 while plugged into shore power, and was 12.5 when unplugged from shore power. There should be a voltage drop when unplugged from shore power and the converter kicks in. However, a drop of this amount indicates the battery may be weakening. Recommend evaluation of the battery.

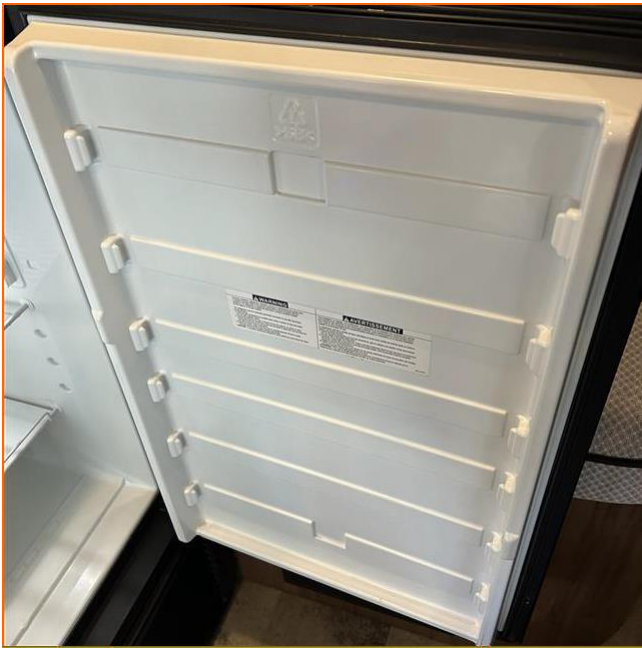
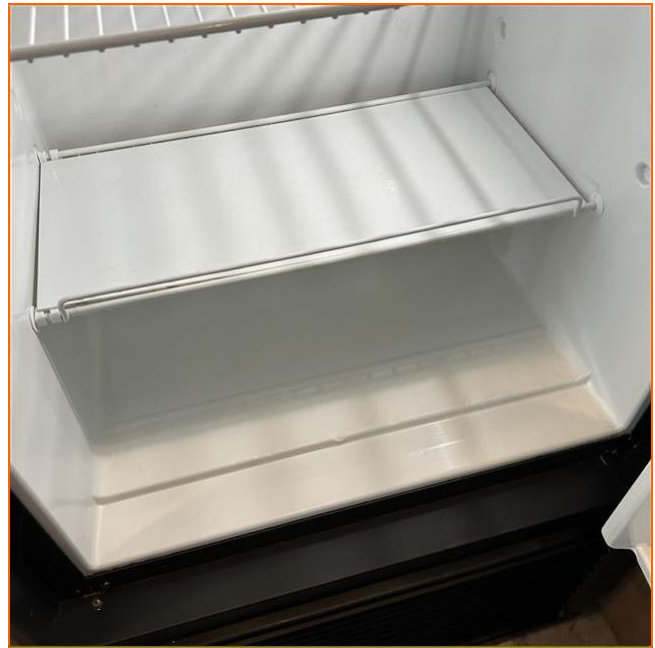
## Refrigerator - Shelves, Racks, Trays, Drawers

The drawer and door bins are missing from the refrigerator.

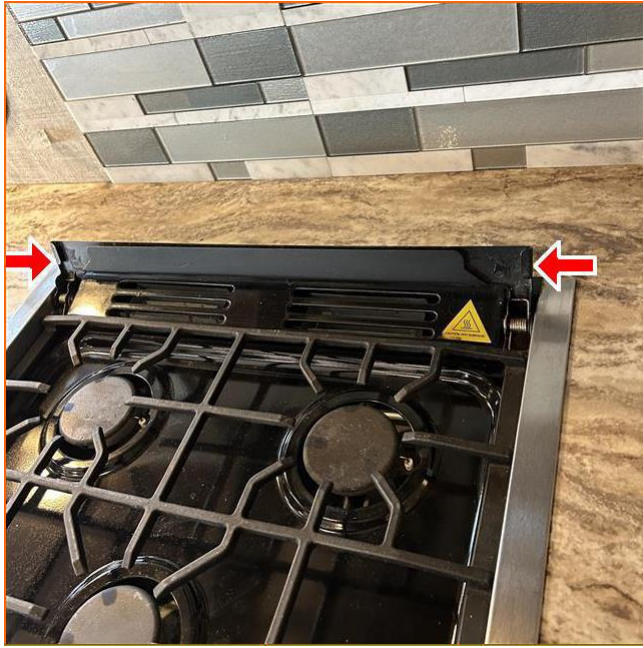
## Cooktop - Burner Grate/Cover Condition

The cooktop cover is missing. Recommend replacement.

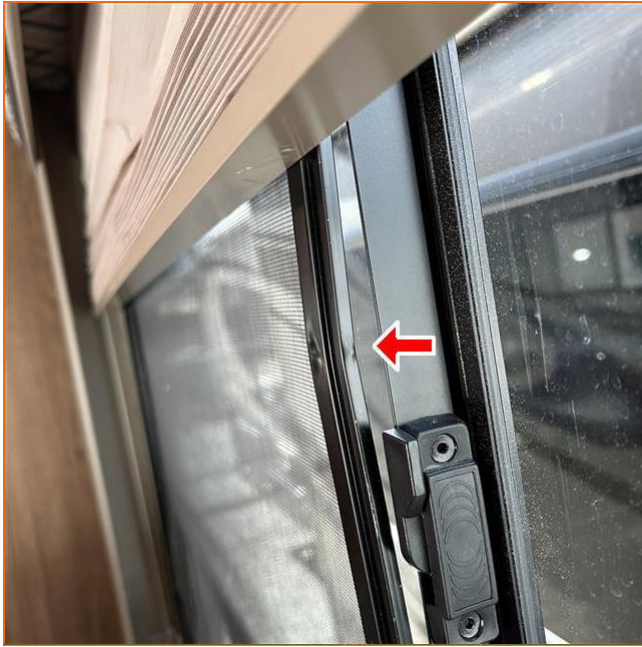
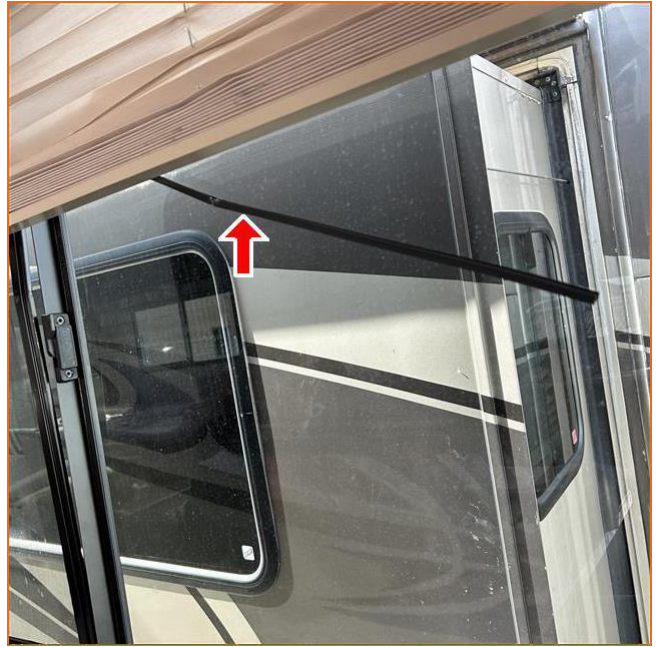
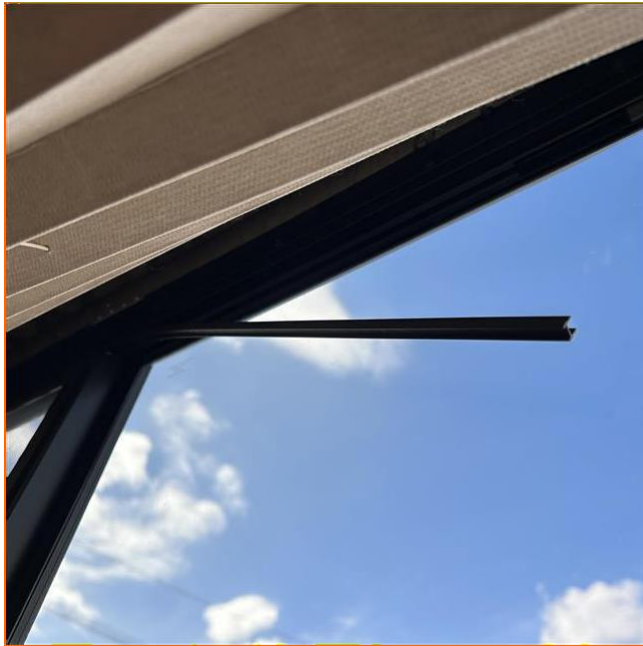
## Windows, Screens

This one is in the loft area

The screen at the dinette area is bent. Recommend straightening or replacement. Also, a piece of the interior window trim is detached and hanging down. Recommend repair.

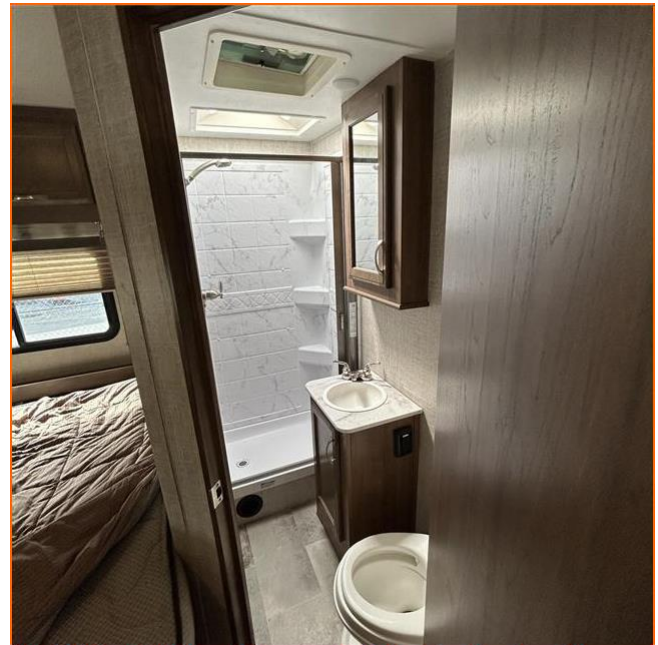
### Shower / Tub - Operation and Condition

The shower head handle is cracked and spraying water. Recommend replacement.

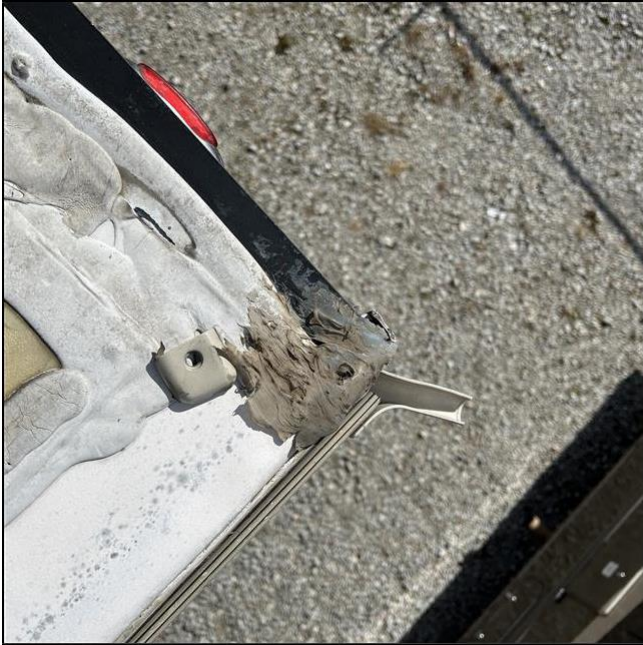
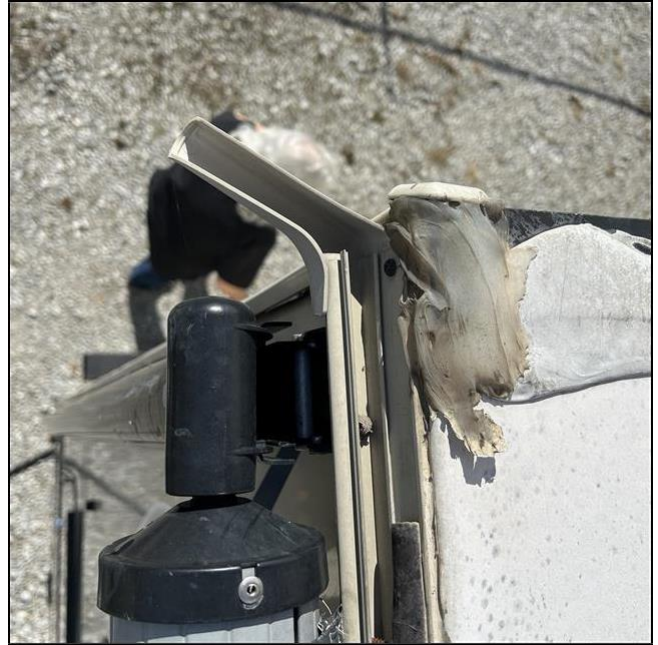
## 2.3 Rear Cap, Joints and Seals

Both rear cap corners have been repaired, but the wrong kind of sealant was used. Recommend evaluation by a qualified service technician.

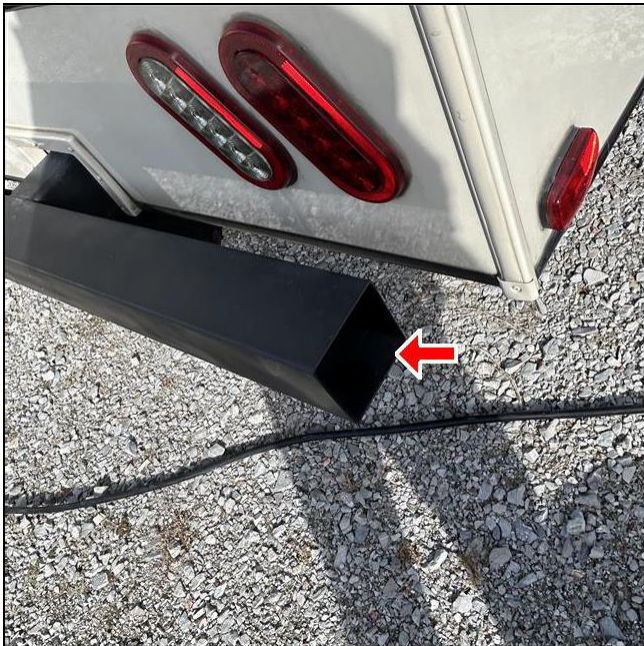
### 5.3 Rear Bumper Condition

One end cap is missing from the rear bumper. Recommend replacement.

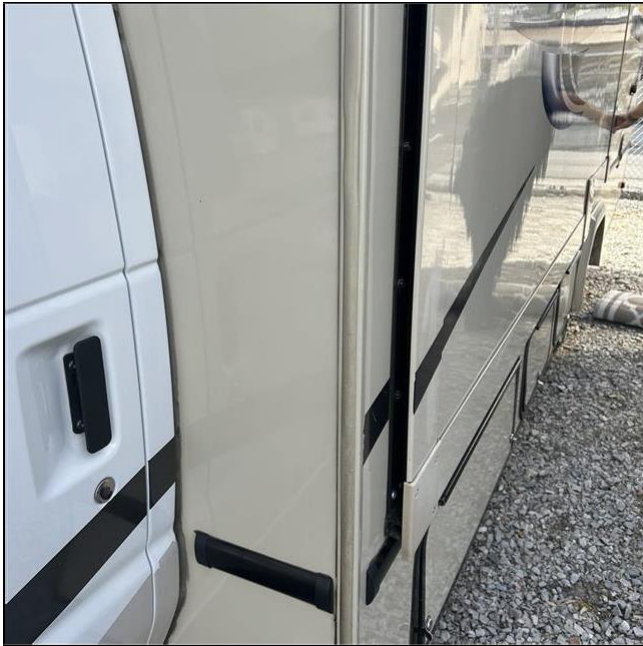
#### 6.1.B Slideout Operation and Alignment

The bottom of the slideout is not pulled in tight. Recommend evaluation by a qualified service technician to determine whether or not it needs adjusted.

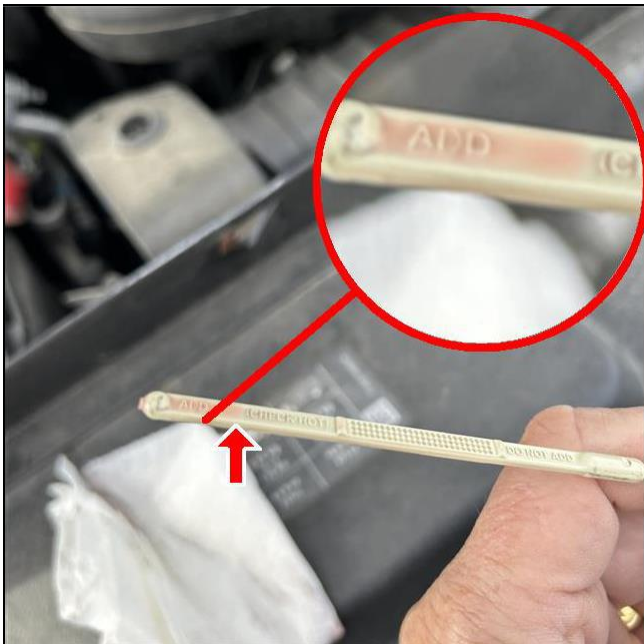
#### 9.3 Engine Transmission Fluid level

The transmission fluid is at the "ADD" level. Recommend filling to appropriate level.

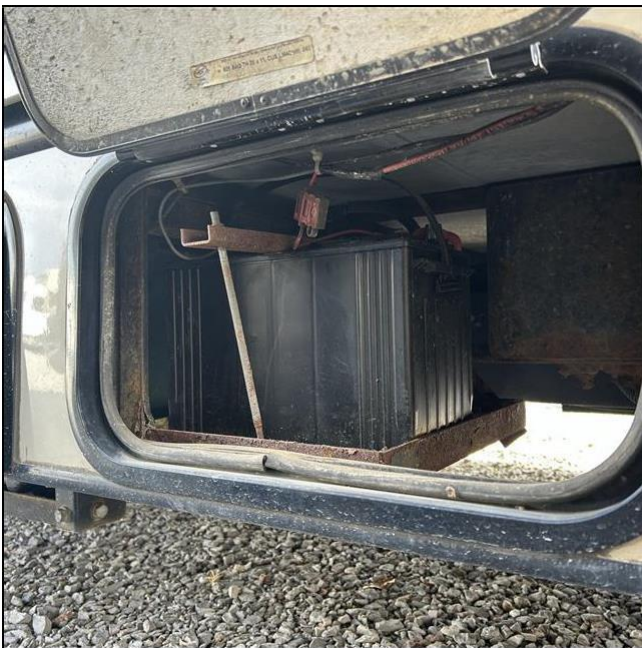
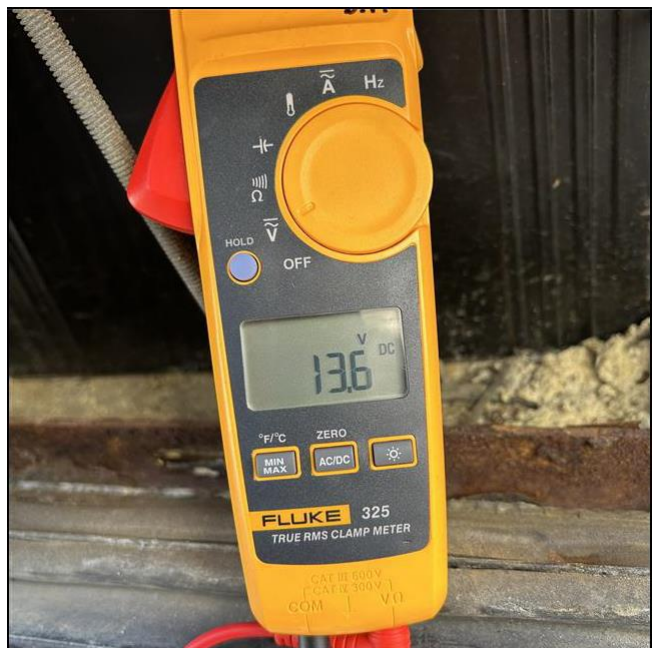
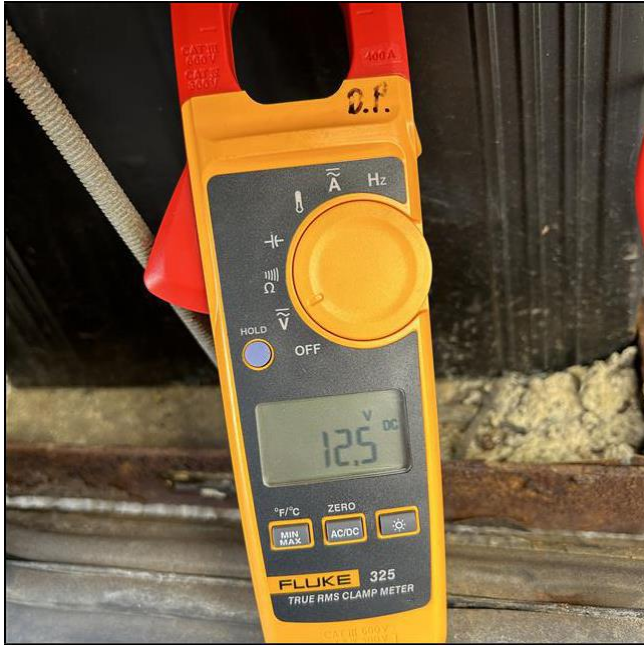
## 12.30 12-Volt DC House (Coach) Batteries - Condition

Battery voltage was 13.6 while plugged into shore power, and was 12.5 when unplugged from shore power. There should a voltage drop when unplugged from shore power and the converter kicks in. However, a drop of this amount indicates the battery may be weakening. Recommend evaluation of the battery.

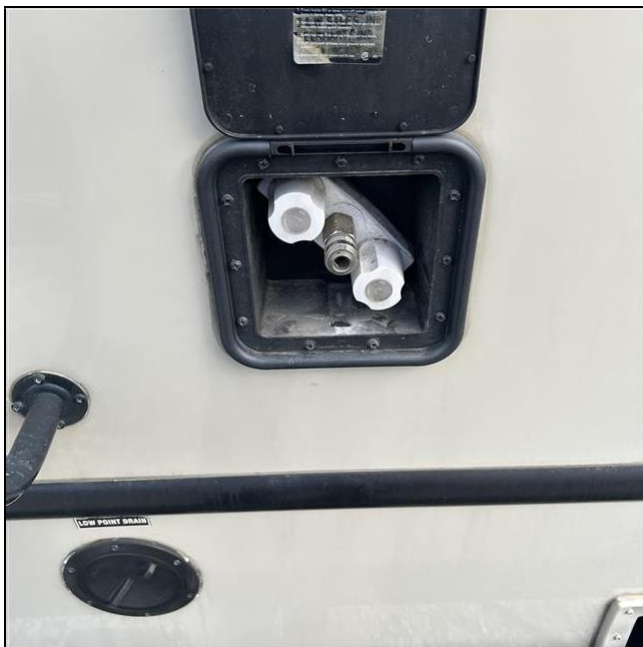
### 13.2 Outside Shower - Condition and Operation

The outside shower hose is missing.

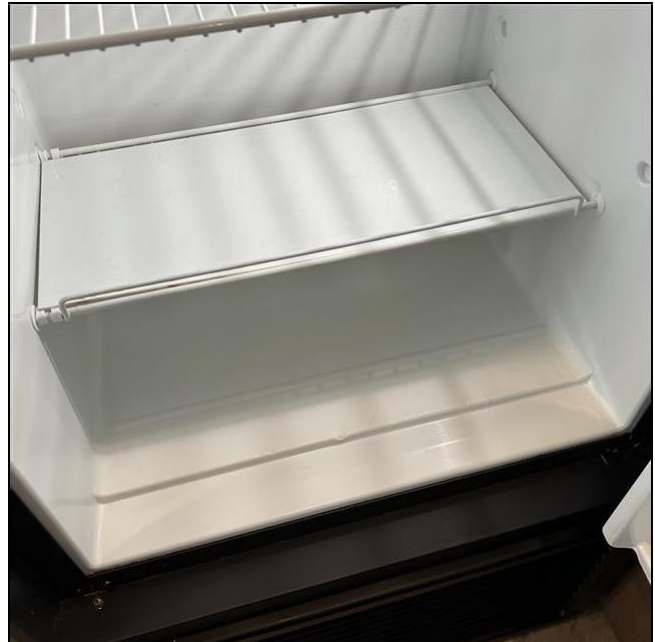
#### 15.7 Refrigerator - Shelves, Racks, Trays, Drawers

The drawer and door bins are missing from the refrigerator.

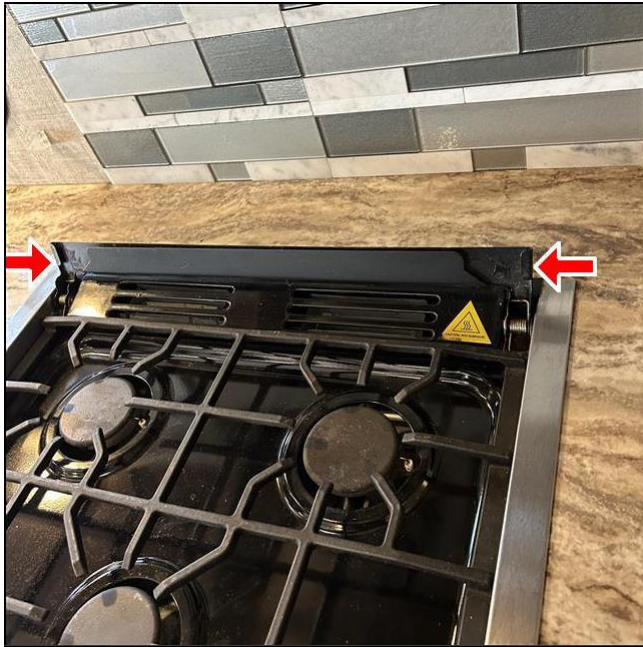
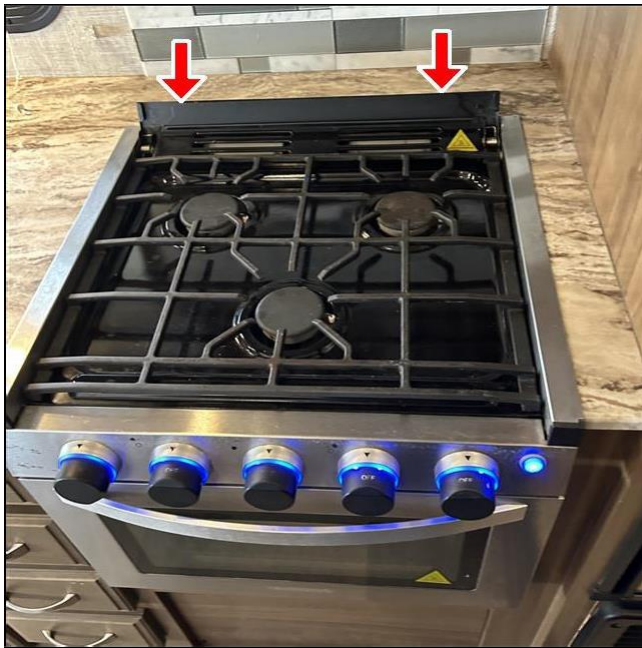
**15.13 Cooktop - Burner Grate/Cover Condition**

The cooktop cover is missing. Recommend replacement.

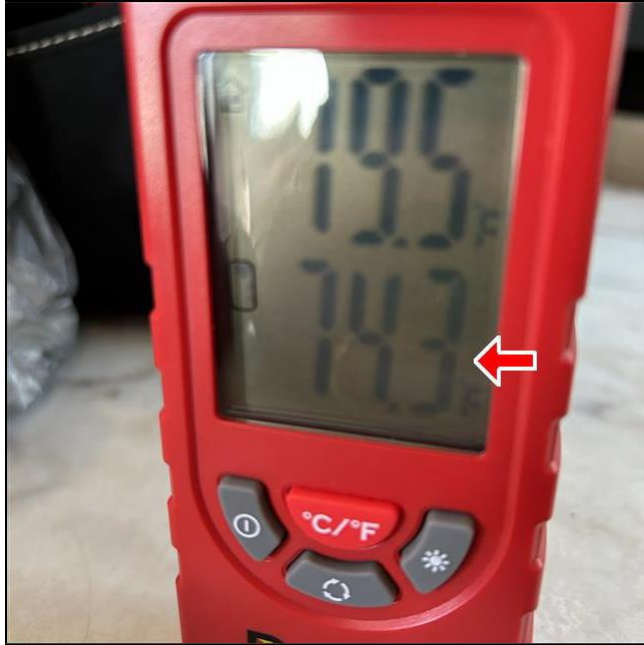
Intake air temp 74.3

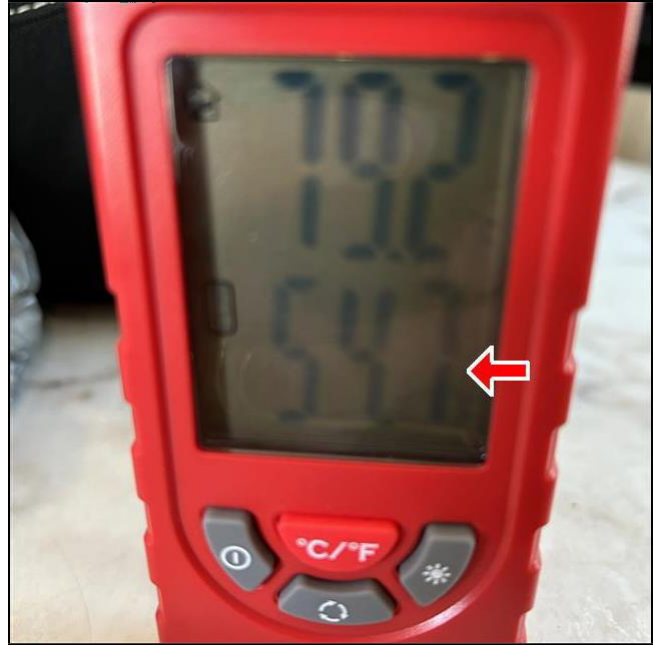
Output air temp 54.7

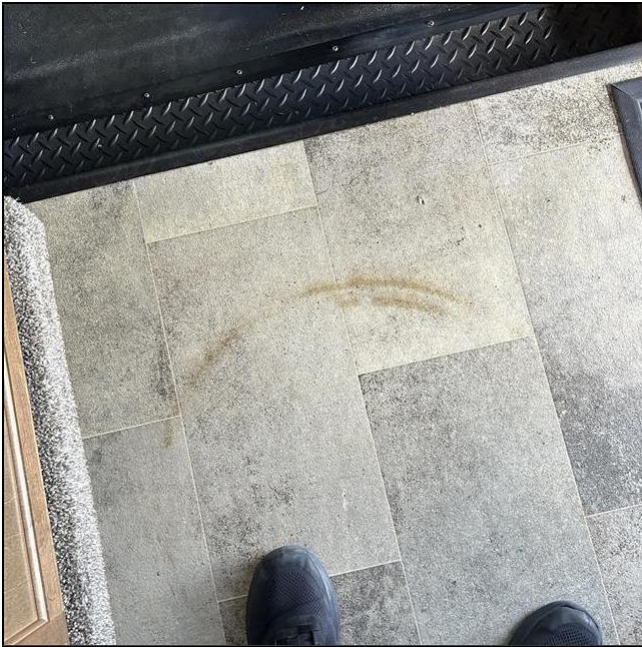
**18.9 Flooring**

There is a stained spot on the kitchen floor. Recommend cleaning.

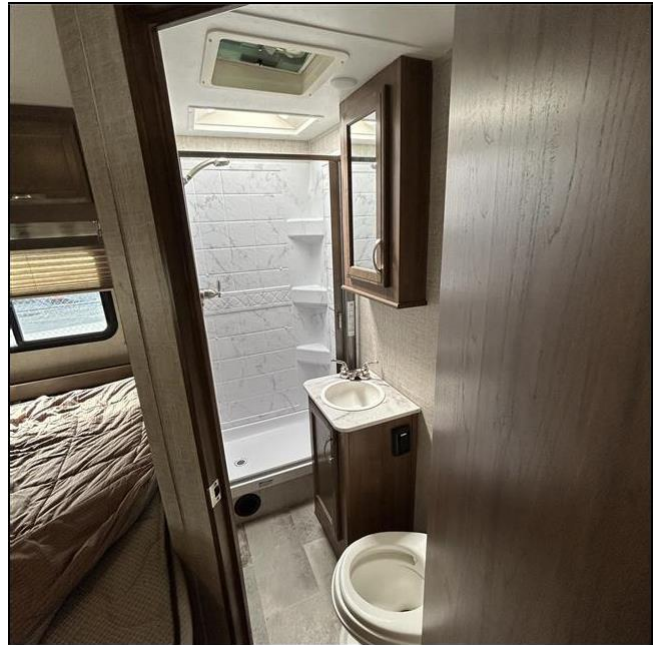
**19.6 Shower / Tub - Operation and Condition**

The shower head handle is cracked and spraying water. Recommend replacement.
