# RV Inspection Report

**2026 Venture Sport Trek 353VRK**  
**VIN:** [REDACTED]

WE RV Services, LLC  
David Patty  
256-605-2225  
david@wervservices.com

Buyer: Pre-Purchase RV Inspection

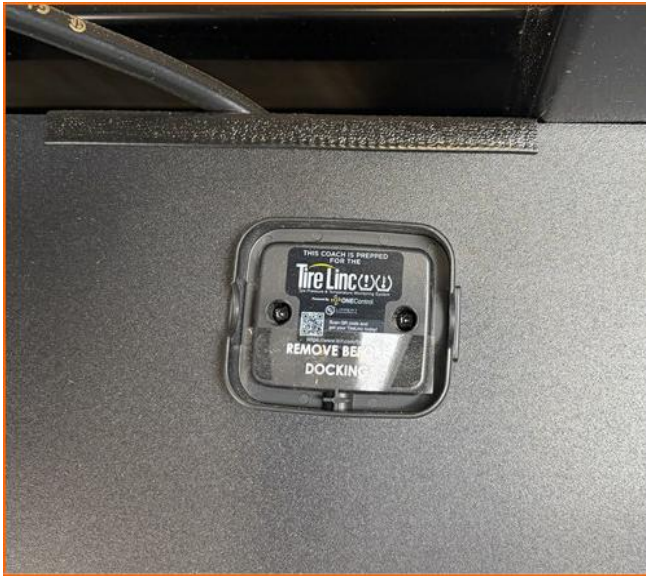
##### Tire and Wheel General Condition

RV is prepped for TPMS, but a monitor and components were not located. Recommend determining if this RV comes with the TPMS.

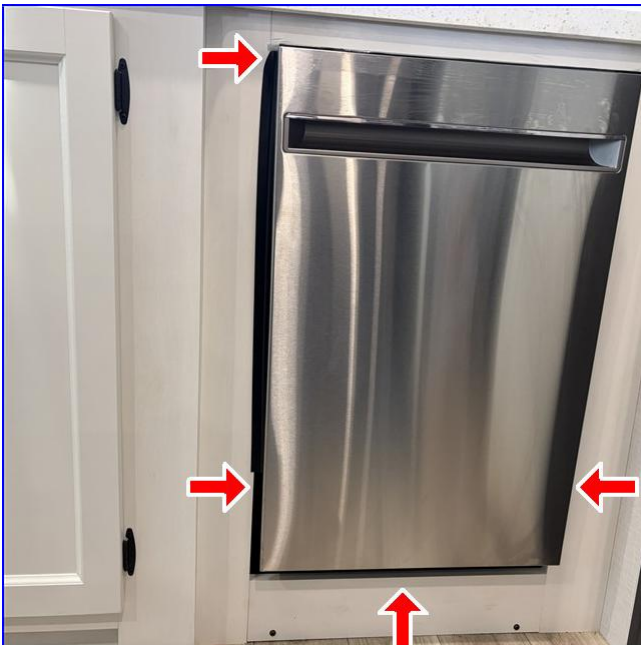
##### Dishwasher - Condition and Operation

It appears some trim is missing from around the dishwasher.

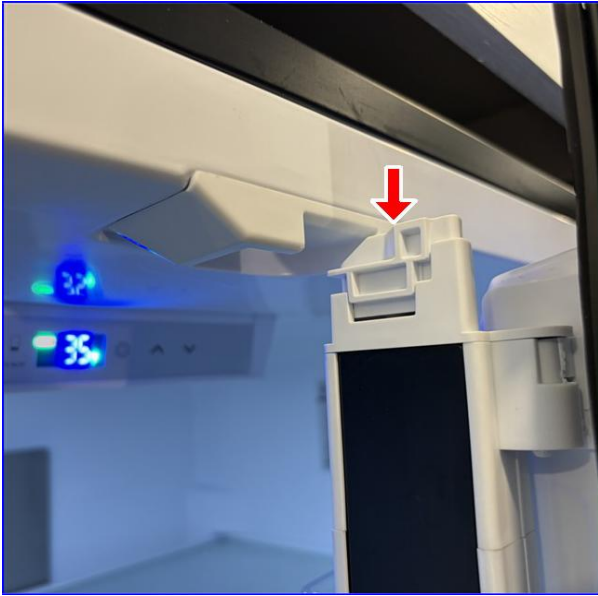
### Refrigerator - Doors, Latch, Seals, Panels

The right side door snags at this spot, when closing. Recommend adjustments.

View from the top

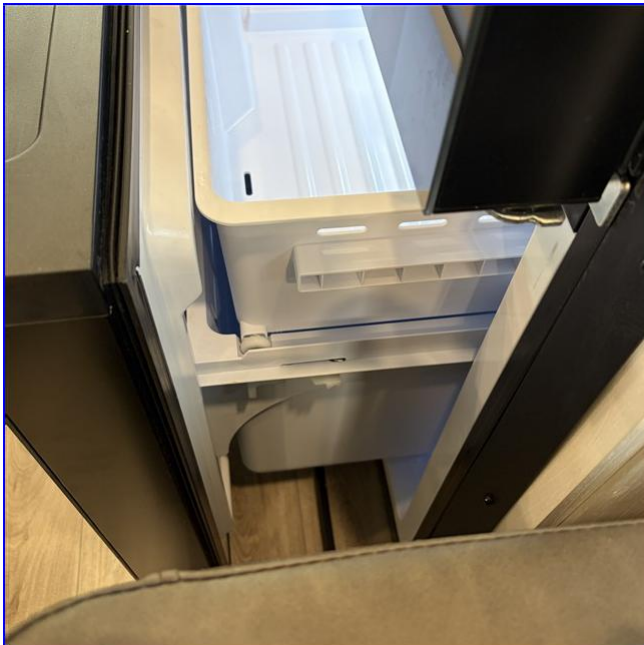
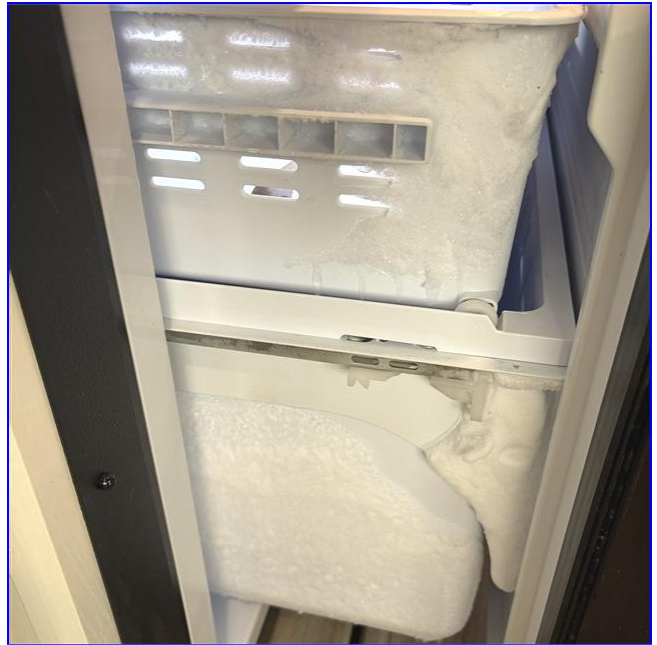
### Freezer - Doors, Latch, Seals, Panels

The right side of the freezer drawer is fine, but the left side is covered in frost, some of it is thick. This is usually an indication of the door not sealing properly on that side. Recommend evaluation and repairs as needed.

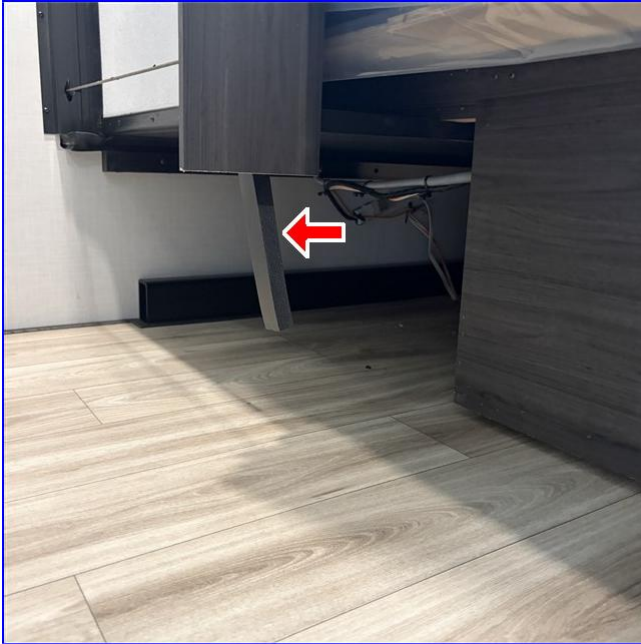
#### Walls, Flooring, Ceiling

There is a piece of molding detached from the slideout trim, at the front of the bed. Recommend repair.

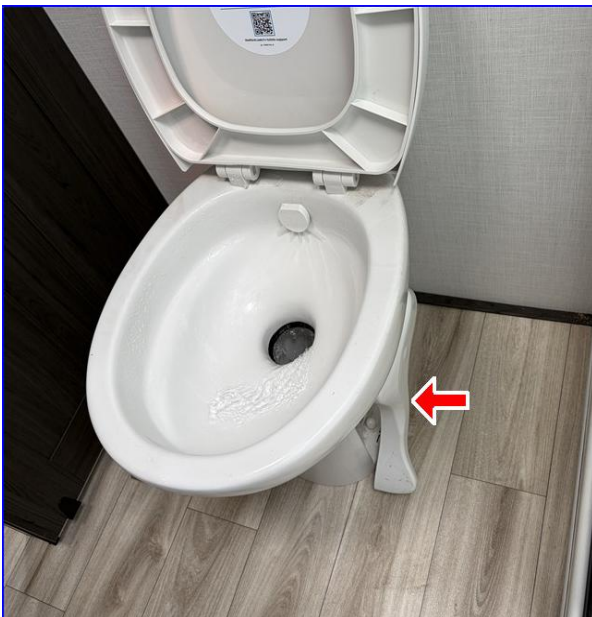
#### Toilet - Operation and Condition

The foot pedal sticks in the down position and will not spring back up. It must be manually pulled back up. Recommend repair.

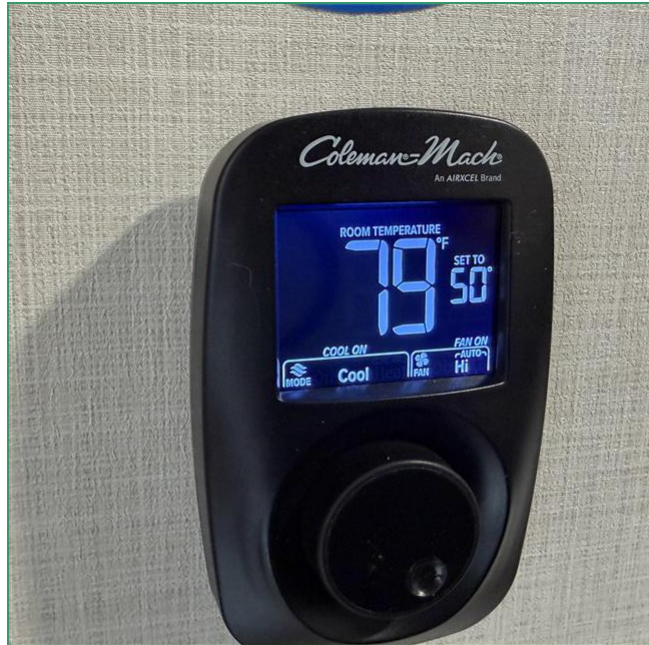
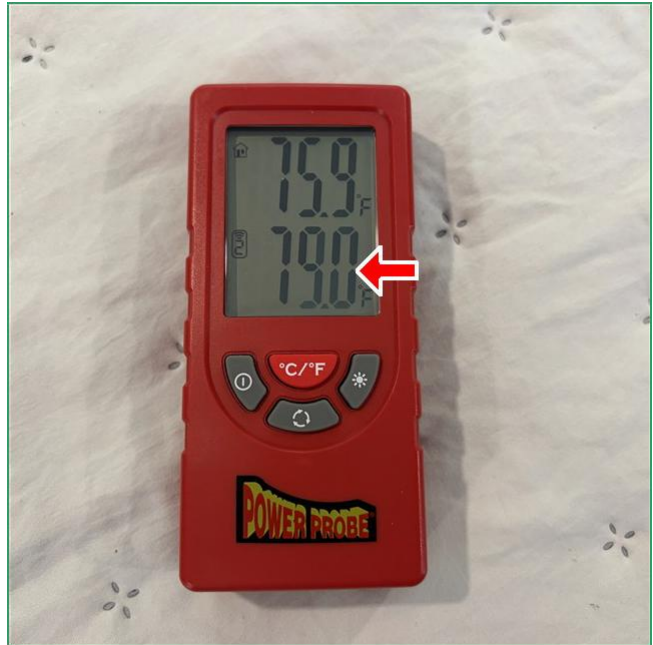
#### Air Conditioner Operation

The Bedroom AC was not cooling. It was run for 15 minutes, set at 50 deg, and output air did not get below 79 deg. Recommend repair.

Output air temp

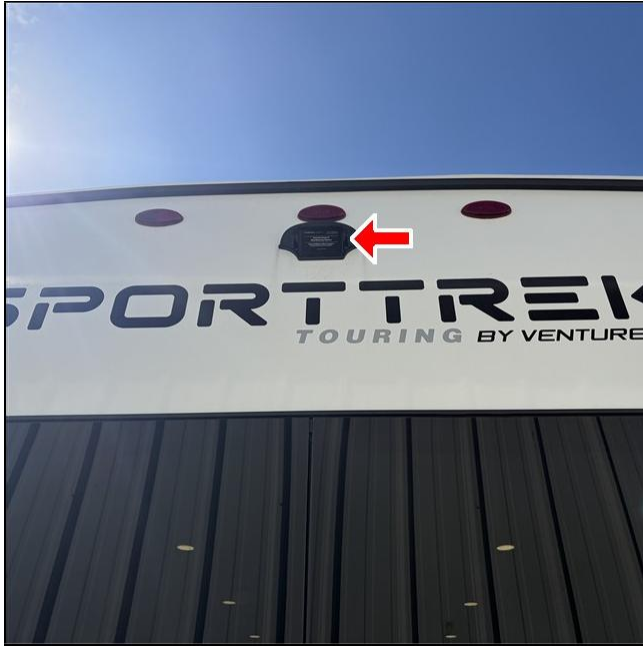
### 5.7 Rear Camera

Prepped for camera

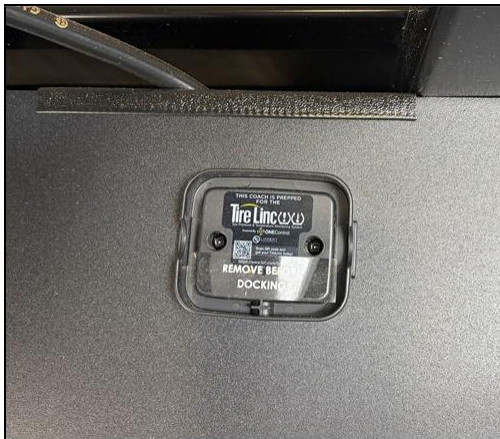
### 12.12.A Tire and Wheel General

A TPMS repeater is installed, but a monitor and components were not located. Recommend determine if this RV comes with the TPMS.

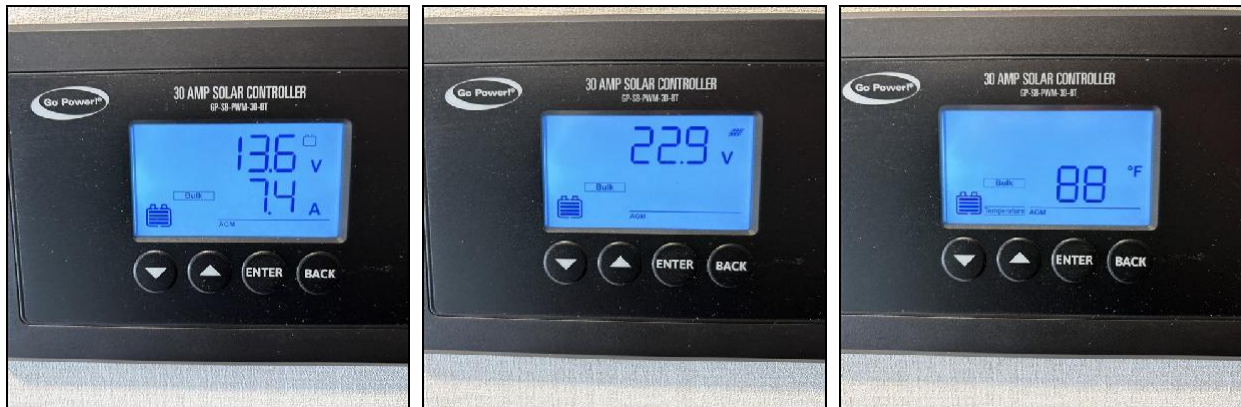
### 17.15 Solar System - Condition and Operation

Batteries were not installed at the time of the inspection. The solar panels and monitors were observed, but the system could not be verified that it will charge the batteries. Recommend verifying after batteries are installed.

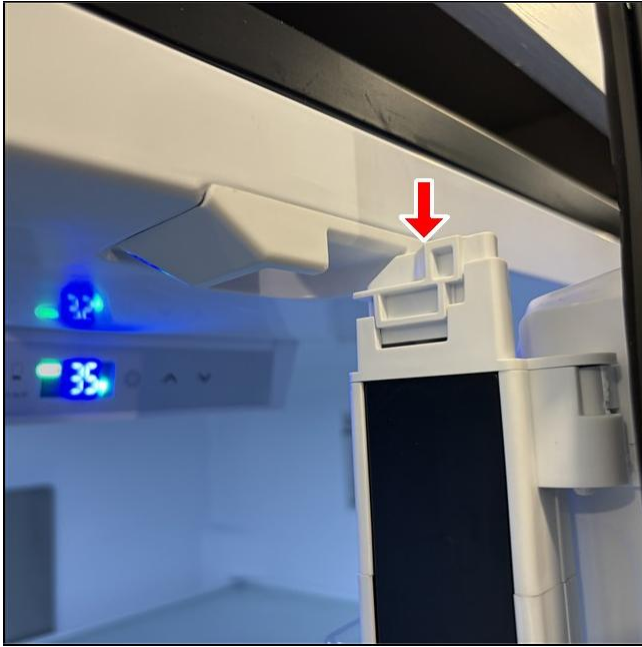
Comments: Fair

The right side door snags at this spot, when closing. Recommend adjustments.

View from the top

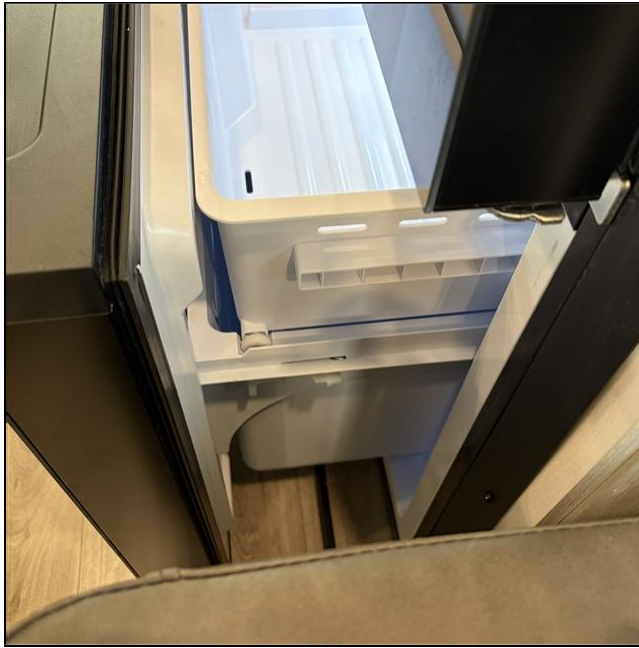
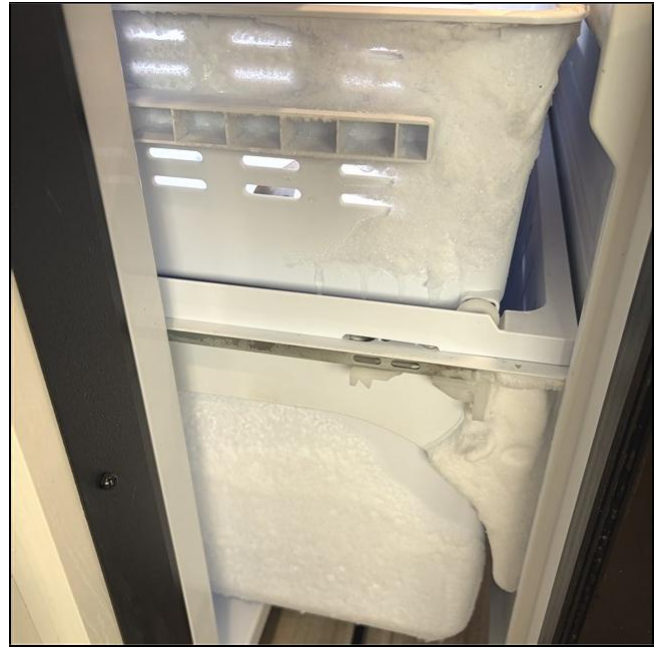
Comments: Fair

The right side of the freezer drawer is fine, but the left side is covered in frost, some of it is thick. This is usually an indication of the door not sealing properly on that side. Recommend evaluation and repairs as needed.

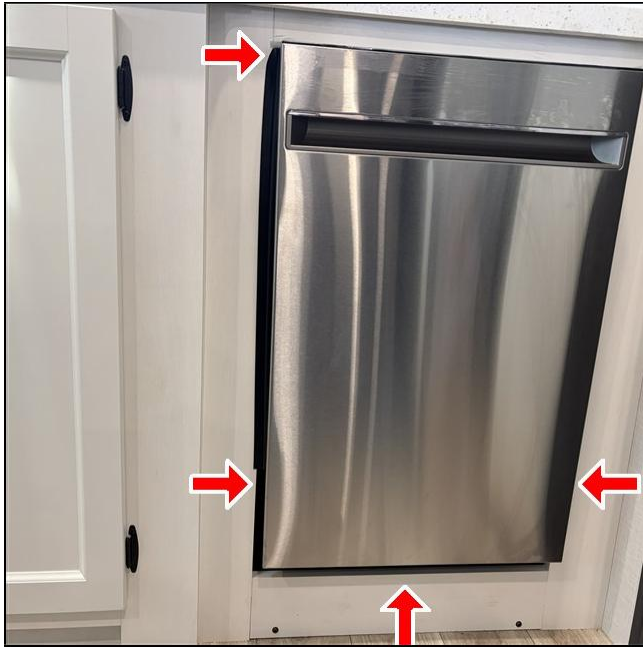
## 20.26 Dishwasher - Condition and Operation

It appears some trim is missing from around the dishwasher.

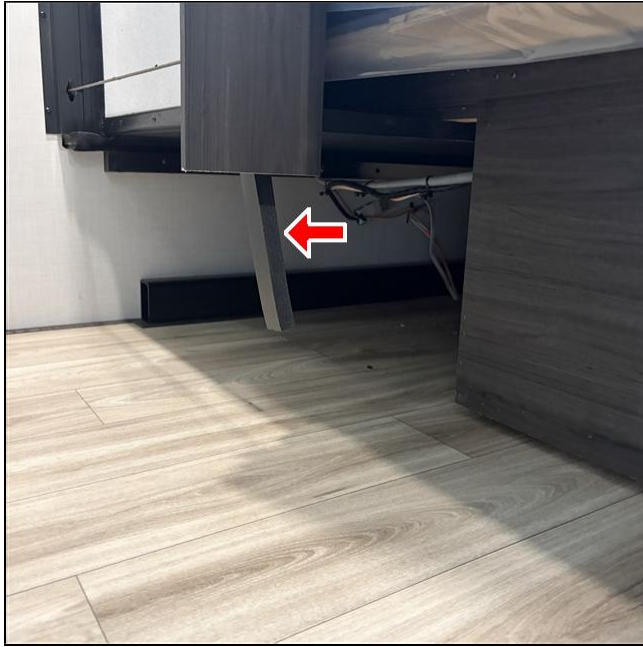
Comments: Fair

There is a piece of molding detached from the slideout trim, at the front of the bed. Recommend repair.

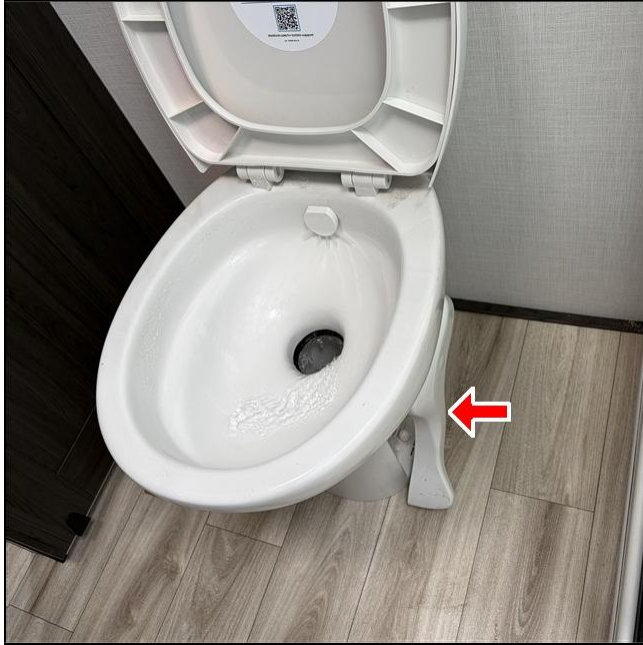
### 24.9 Toilet - Operation and Condition

Comments: Fair

The foot pedal sticks in the down position and will not spring back up. It must be manually pulled back up.  
Recommend repair.

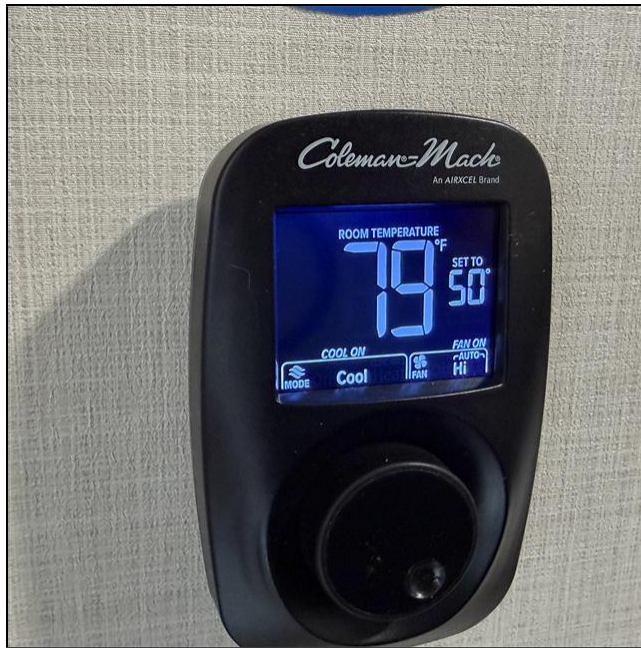
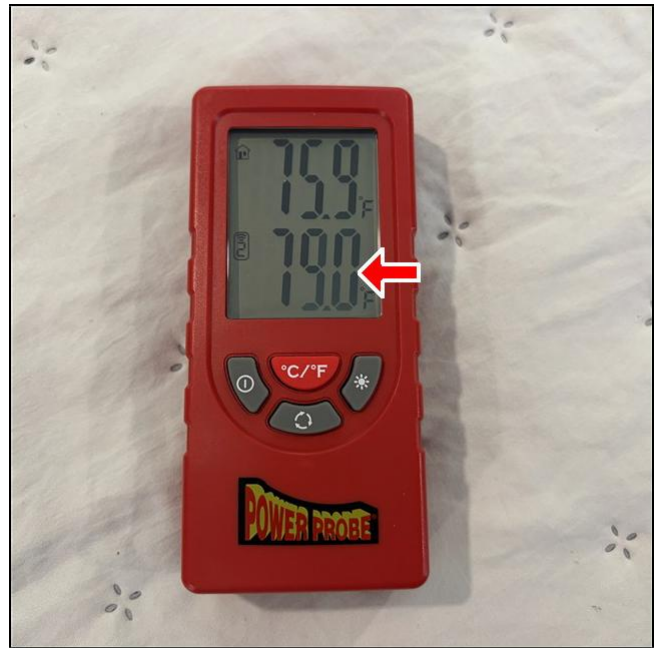
### 30.0.A Air Conditioner Operation

Comments: Poor

The Bedroom AC was not cooling. It was run for 15 minutes, set at 50 deg, and output air did not get below 79 deg. Recommend repair.

Output air temp

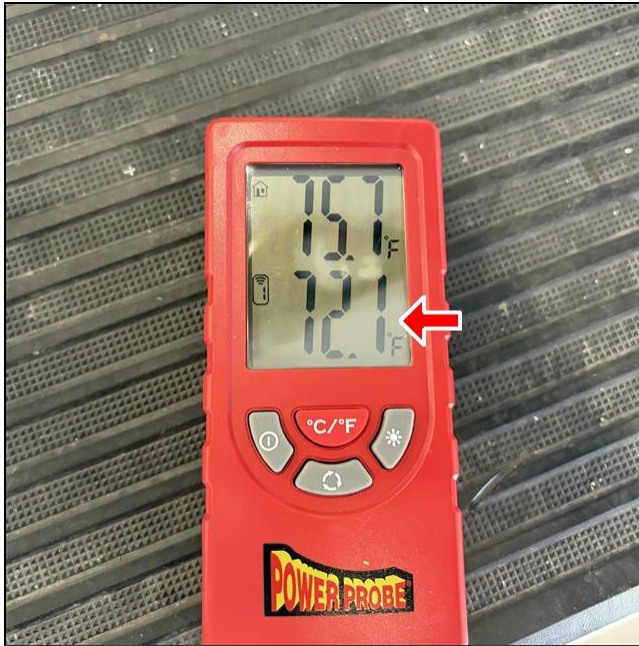
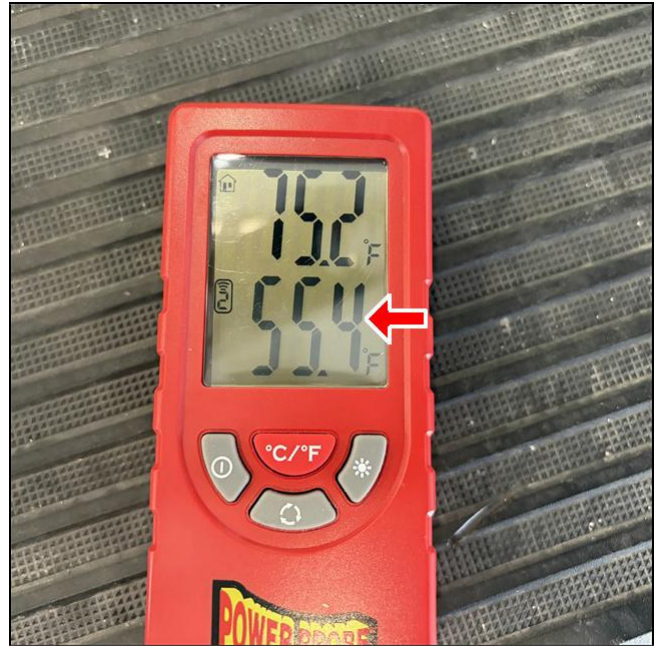
### 30.0.B Air Conditioner Operation

Output air temperature: 55.4

Delta-T = 16.7

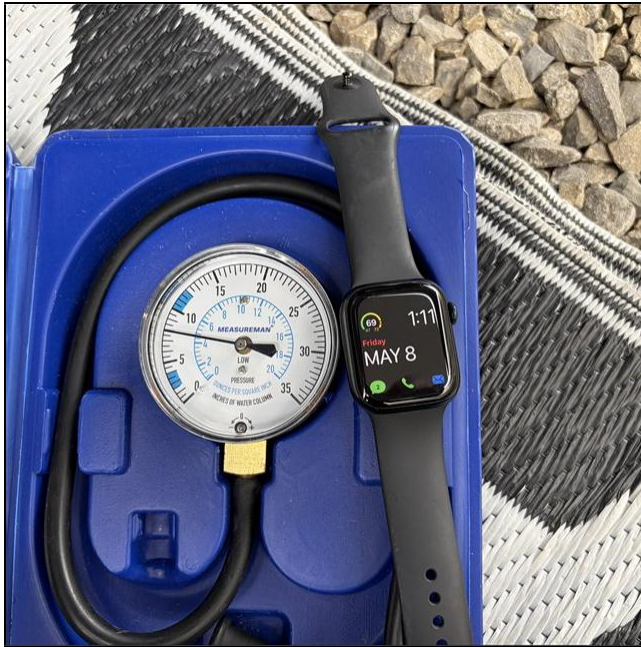
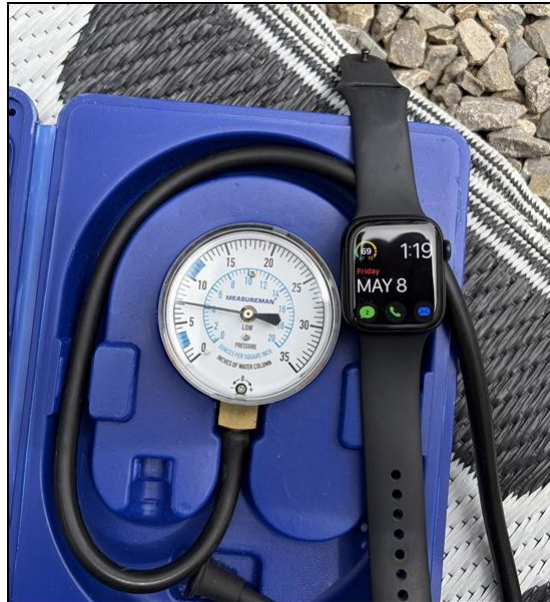
### 32.0 LP System Timed Leak Test

LP leak test was performed by attaching a manometer to the outside grill port. LP tank was then turned off and pressure was bled down to 8 w.c. and timed for five minutes to verify there is no drop in pressure. **The test was run 2 times, and both times there was a slight drop in pressure.** Recommend further evaluation and repairs as needed.
