# RV Inspection Report

**2026 Jayco Redhawk 24B**  
**VIN:** [REDACTED]

*WE RV Services, LLC*  
*David Patty*  
*256-605-2225*  
*david@wervservices.com*

Buyer: Pre-Purchase RV Inspection

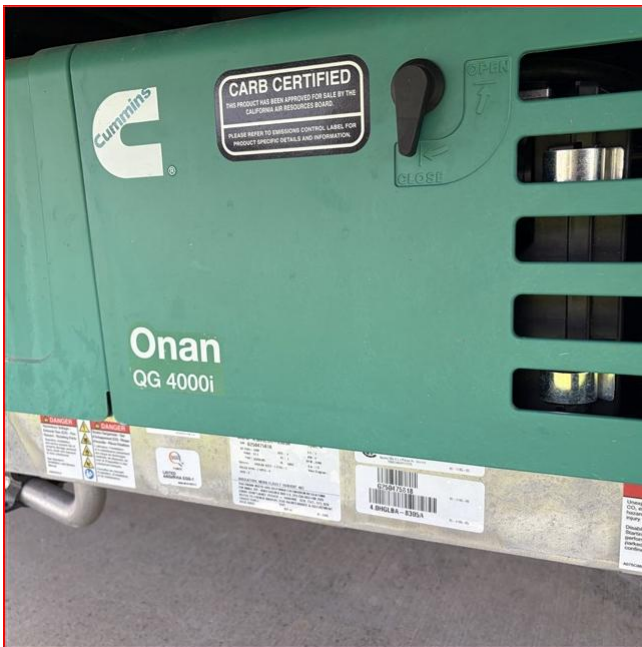
##### Generator - Operation and Condition

LP generator failed to start and produce power. Inspector pressed primer button until the primer light came on and it would not start, and also tried holding it an extra 10 seconds several times. (Perhaps it wasn't held long enough to purge the lines?) LP appliances (cooktop and furnace) operated normally, indicating propane was available to the coach. Recommend evaluation and repair as needed.

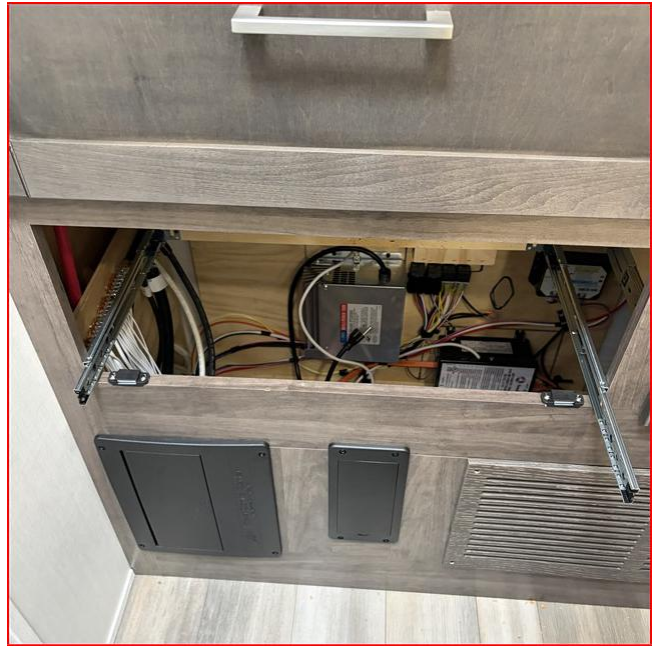
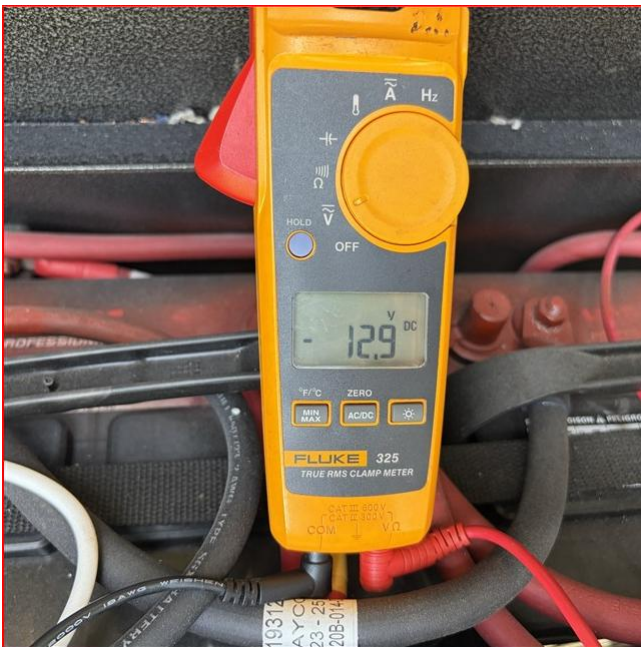
## Converter / Charger Operation and Condition

DC voltage with shore power off: 12.9

DC voltage with shore power on: 12.9

These findings indicate the converter/charger is not charging the house batteries while connected to shore power. Inspector accessed the converter and noticed its 120-volt power cord was disconnected with no accessible receptacle observed in the converter compartment. Recommend inspect, correct, and verify proper converter operation.

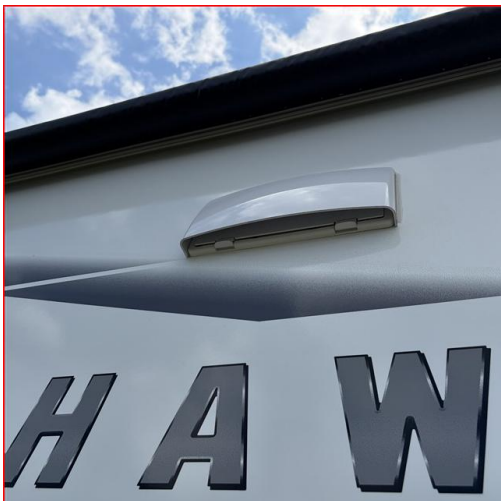
#### Cooktop Exhaust Vent, Light, Fan

The vent is usually latched shut from the factory. Recommend opening before first use.

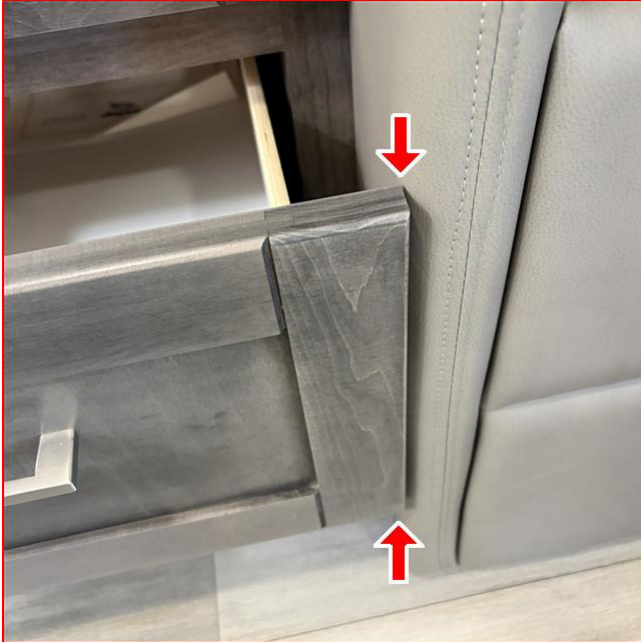
#### Closets and Pantries

This pantry drawer scrubs the dinette when opening and closing. Recommend making adjustments as necessary.

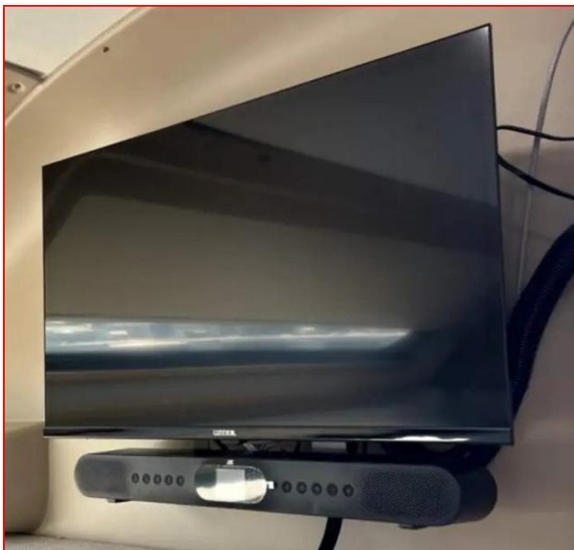
#### Operation and Condition

The TV would not turn on. Perhaps remote needs new batteries? Recommend evaluate and repair as needed.

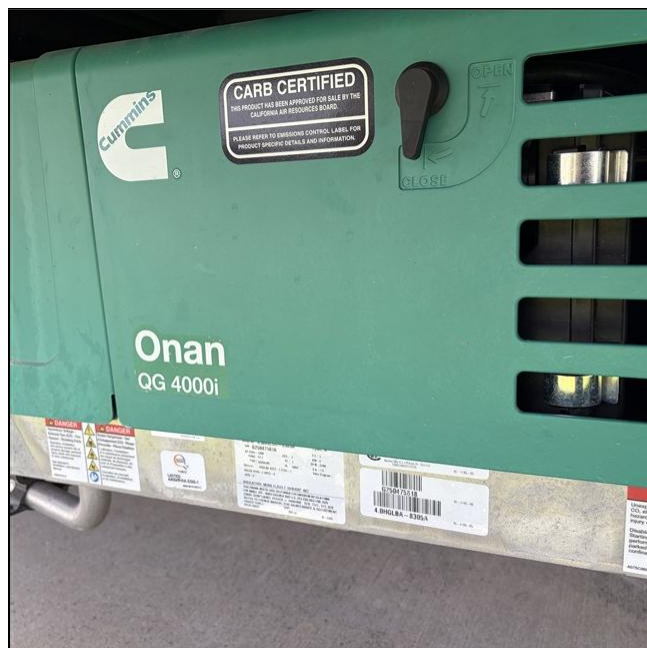
## 16.6 Generator - Operation and Condition

LP generator failed to start and produce power. Inspector pressed primer button until the primer light came on and it would not start, and also tried holding it an extra 10 seconds several times. (Perhaps it wasn't held long enough to purge the lines?) LP appliances (cooktop and furnace) operated normally, indicating propane was available to the coach. Recommend evaluation and repair as needed.

Generator brand: Onan QG 4000i

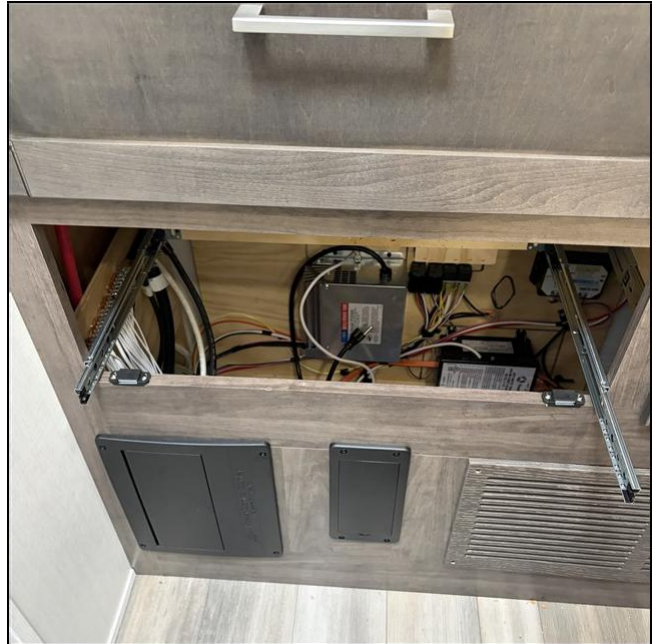
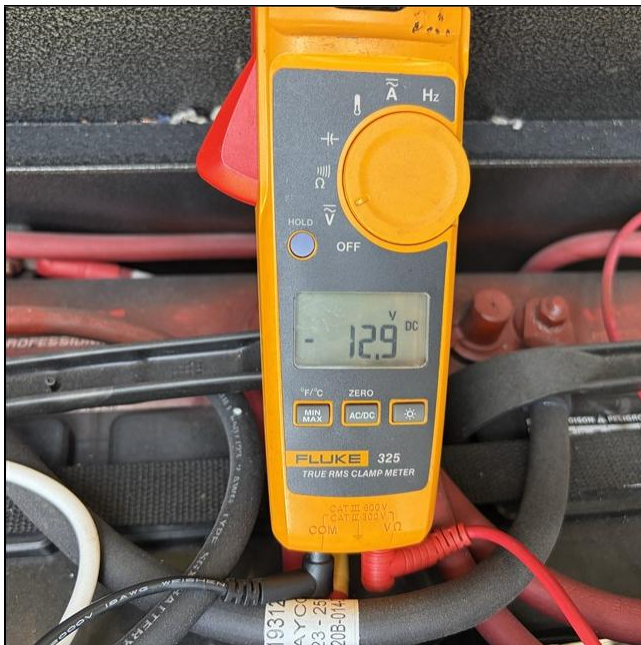
## 16.9 Converter / Charger Operation and Condition

Comments: Poor

DC voltage with shore power on: 12.9

These findings indicate the converter/charger is not charging the house batteries while connected to shore power. Inspector accessed the converter and noticed its 120-volt power cord was disconnected with no accessible receptacle observed in the converter compartment. Recommend inspect, correct, and verify proper converter operation.

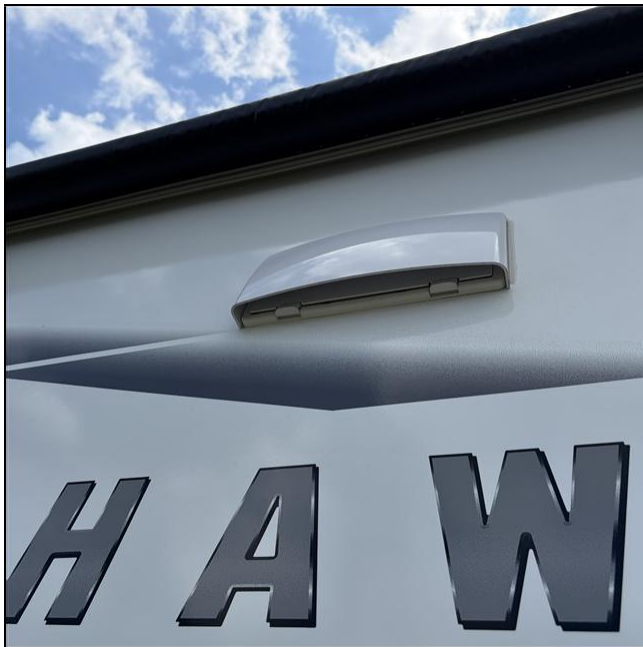
#### 19.15 Cooktop Exhaust Vent, Light, Fan

The vent is usually latched shut from the factory. Recommend opening before first use.

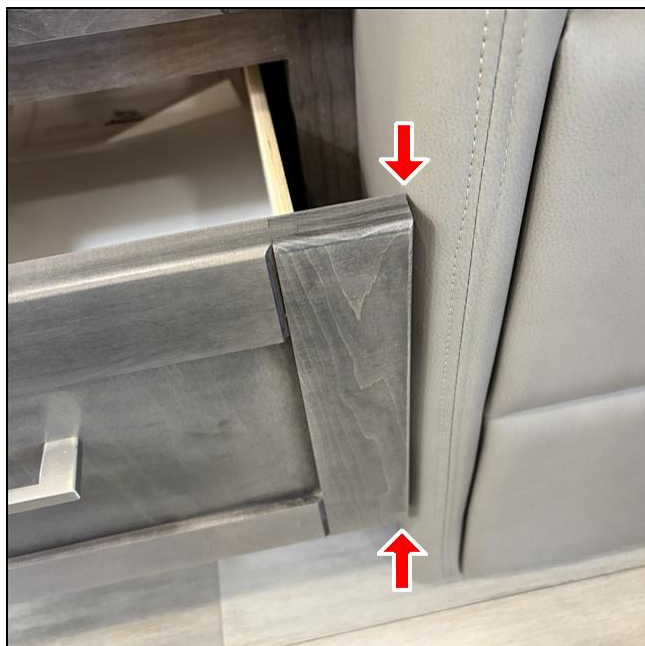
Comments: Fair

This pantry drawer scrubs the dinette when opening and closing. Recommend making adjustments as necessary.

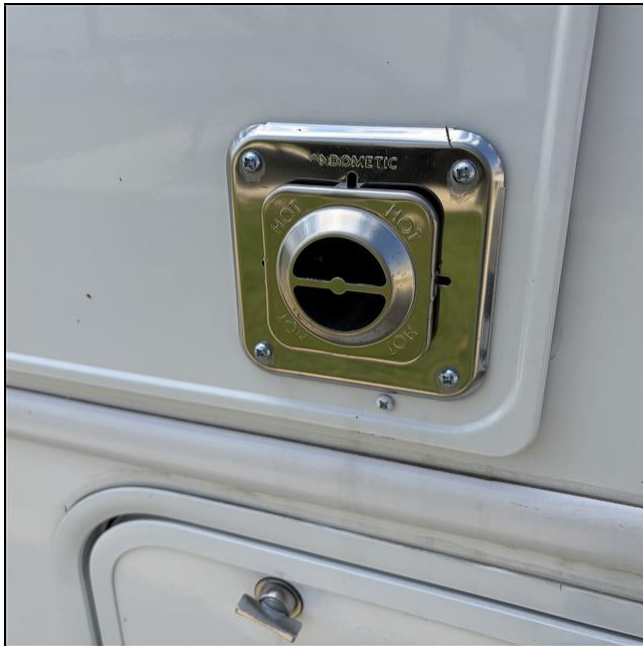
### 24.2 Furnace Air Intake / Exhaust Area Condition

Dauber screens? no

Dauber Screens are recommended, especially in the South.

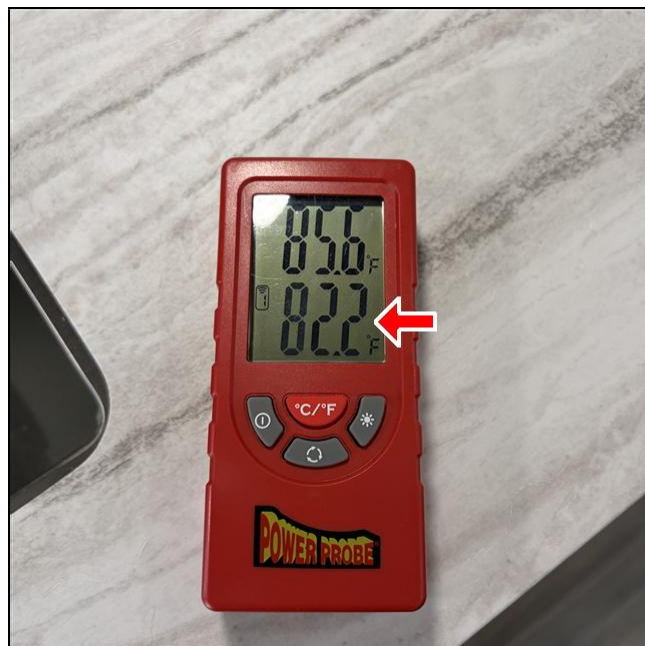
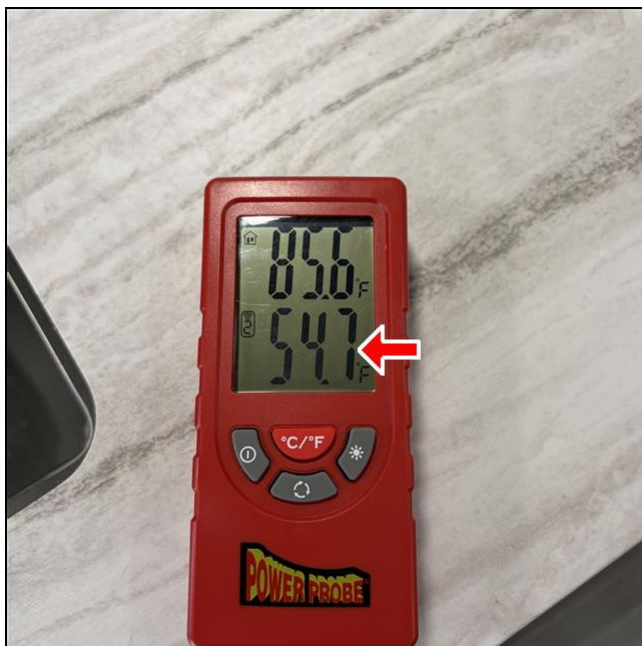
### 25.0 Air Conditioner Operation

Output air temperature: 54.7

Delta-T = 27.5

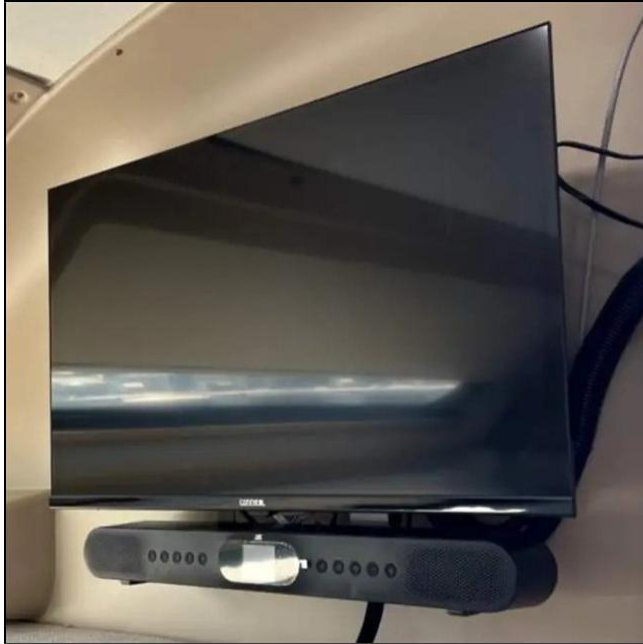
### 26.0.A Operation and Condition

Comments: Fair

The TV would not turn on. Perhaps remote needs new batteries? Recommend evaluate and repair as needed.
