# RV Inspection Report

2022 Thor Miramar 37.1

WE RV Services, LLC  
David Patty  
256-605-2225  
david@wervservices.com

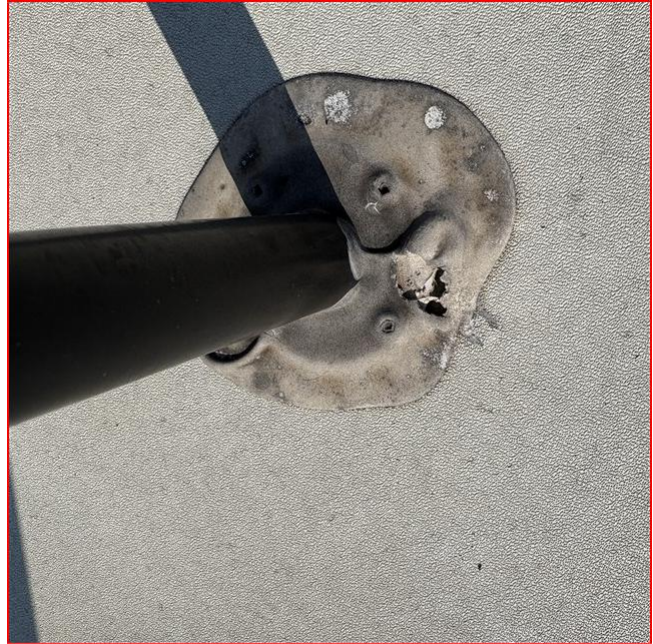
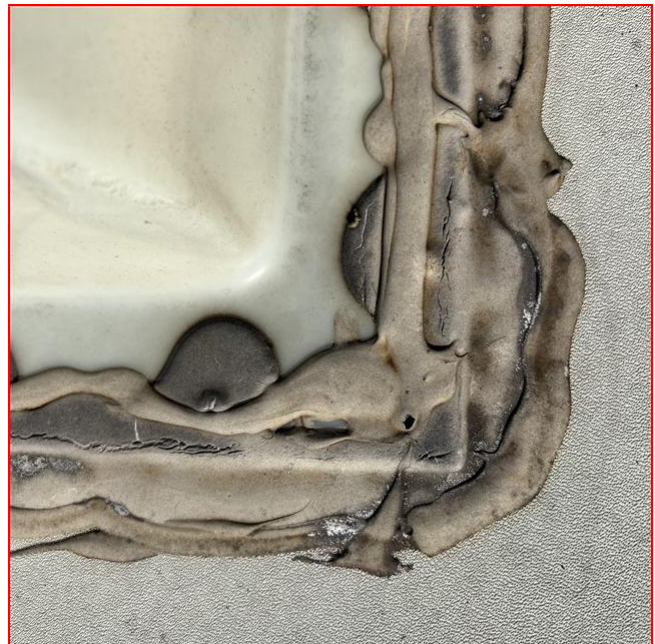
##### General Roof Condition

There are several areas of sealant that are beginning to deteriorate. No signs of water intrusion yet, but recommend evaluation by a service technician and resealing as needed to prevent any future water intrusion.

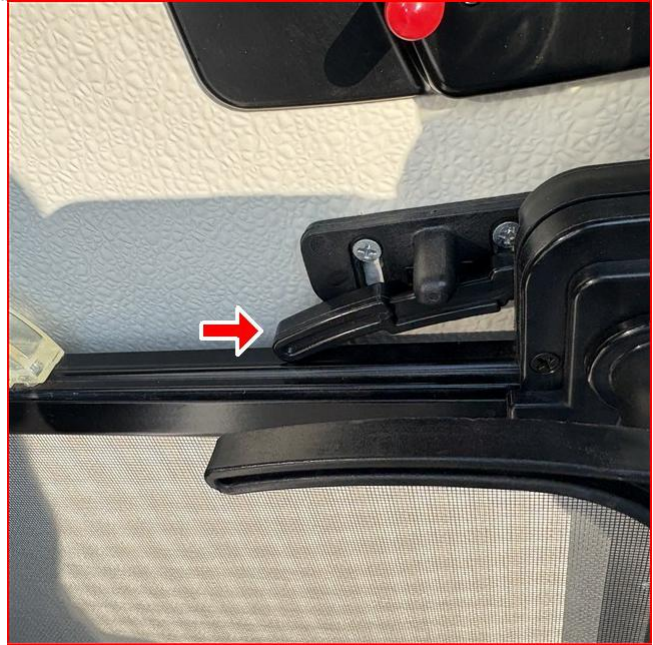
#### Screen - Operation and Condition

The screen latch is not operating properly. If the inside plastic slide is closed, the screen can't be opened from the outside - pushing down on the handle will not disengage the lock. Also the latch will not catch on the door as it should. Recommend adjusting or repair.

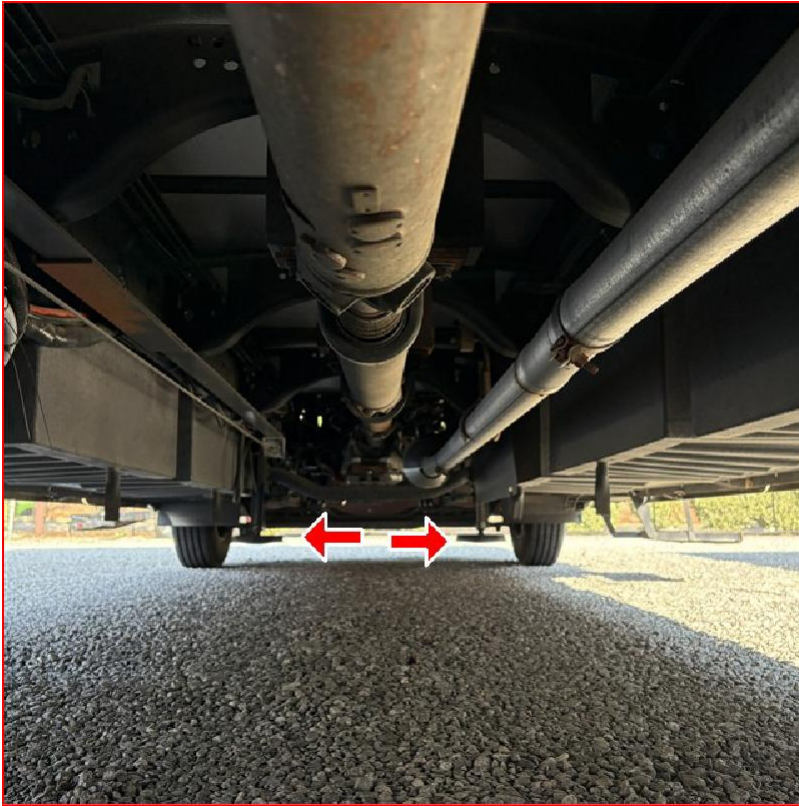
#### Leveling System Operation and Condition

The back levelers extend and retract as they should, but **the front ones do not**. Recommend repair.

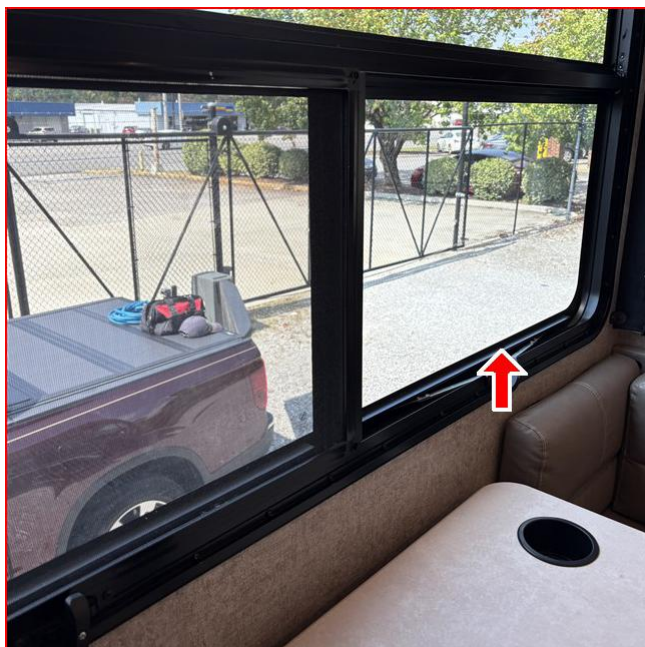
## Windows, Screens

One of the screens is missing at the dinette. Recommend replace.

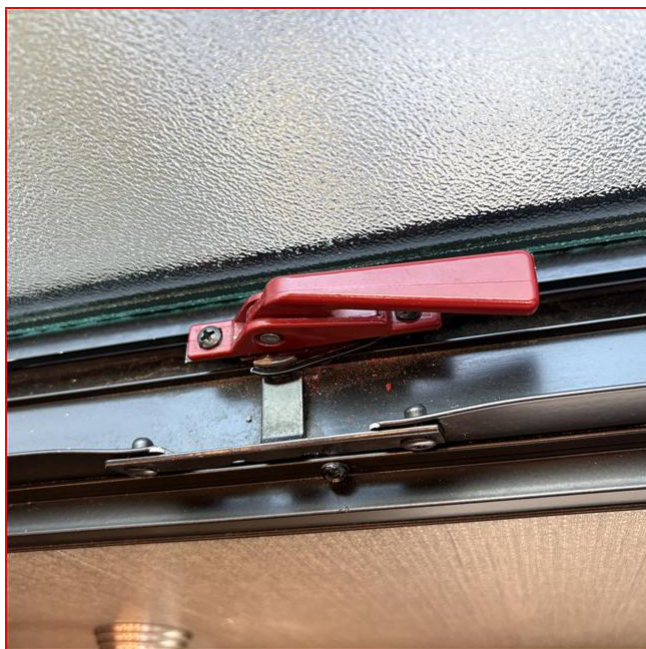
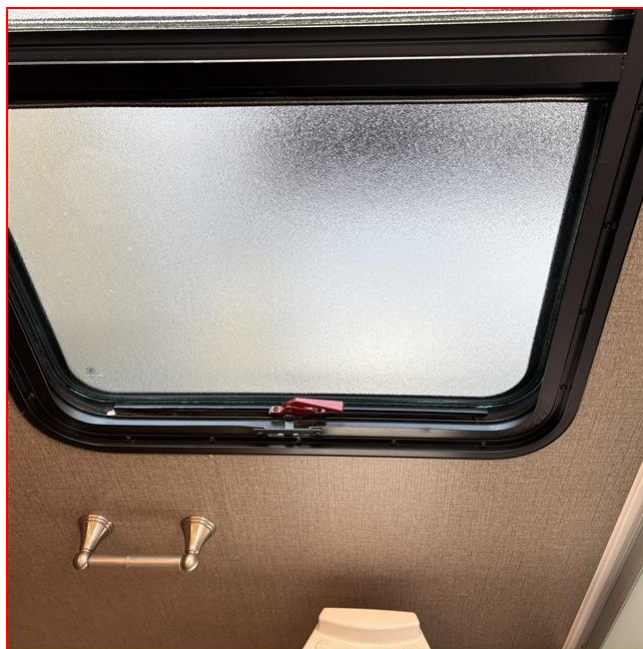
## Windows and Screens

The window in the rear bath will not latch or fully shut. Recommend repair.

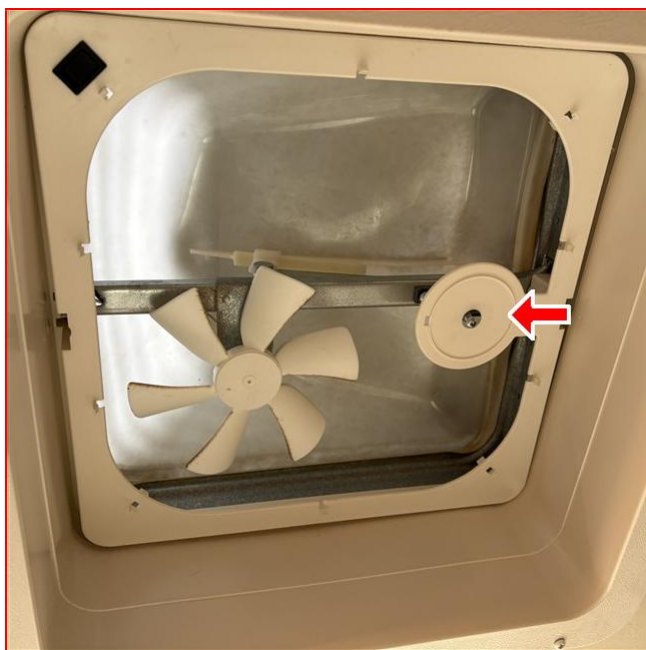
## Vent

The twist handle to raise the lid of the vent fan is missing. Recommend repair.

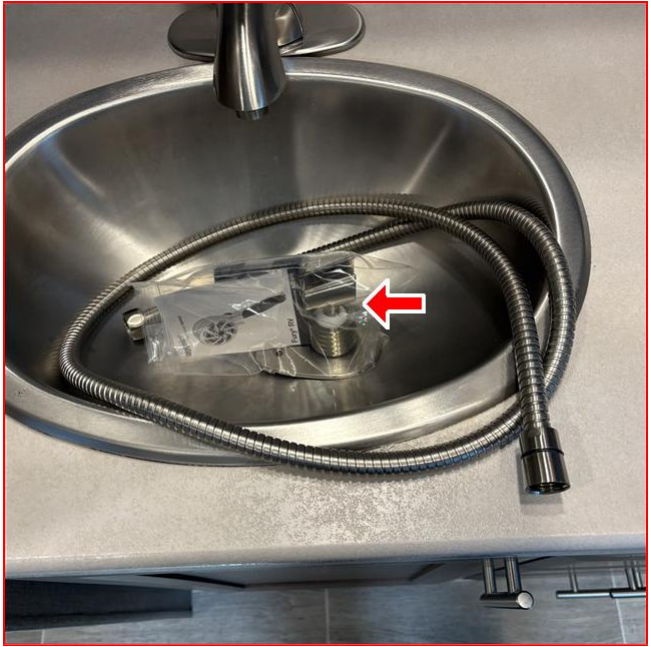
### Shower / Tub - Operation and Condition

The shower head holder is detached from the wall. It appears this is already in the process of being repaired - there are some parts in the sink.

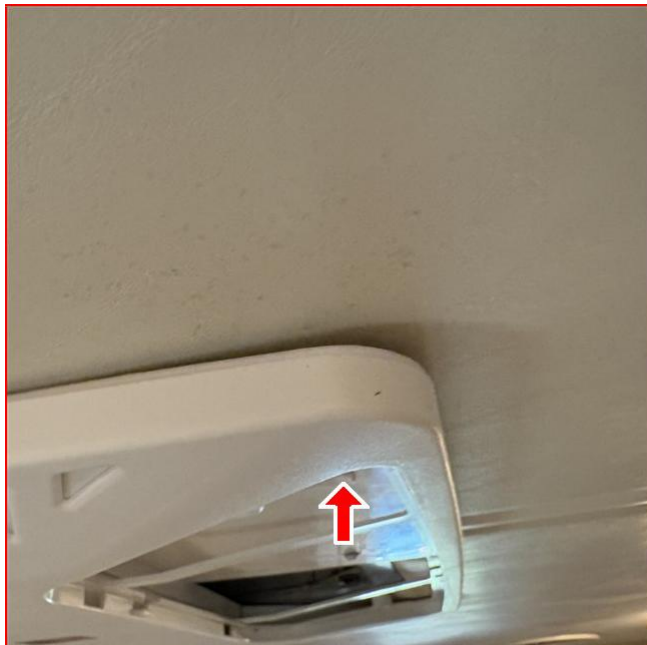
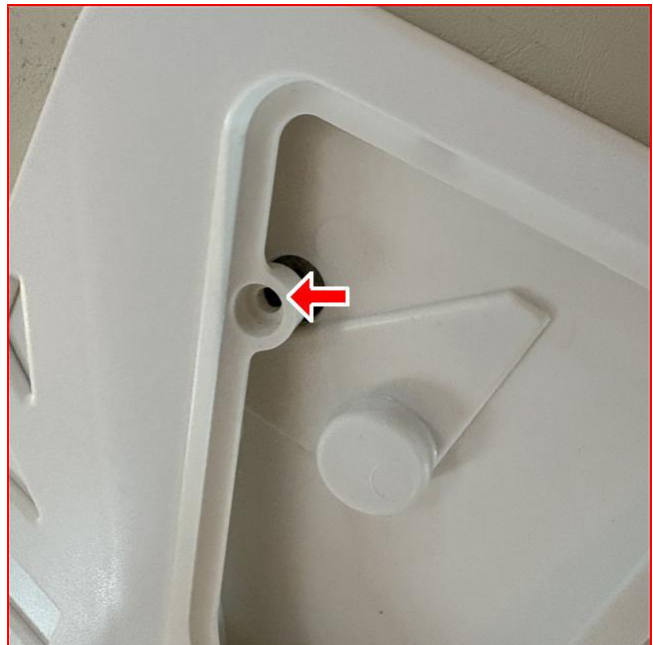
#### Air Conditioner Operation

A screw is missing that attaches the AC shroud to the ceiling. Recommend repair.

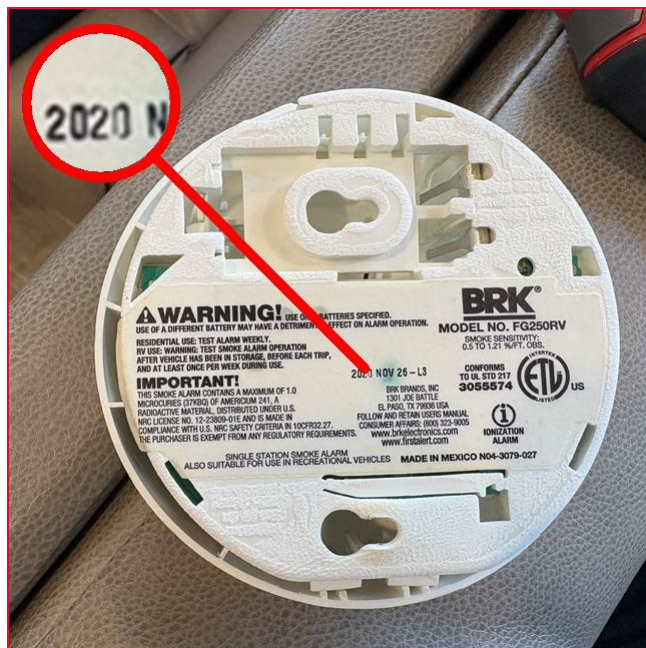
#### Smoke Detector Tested

The smoke detector operates but it is past its expiration date. Recommend replacement before the coach is occupied.

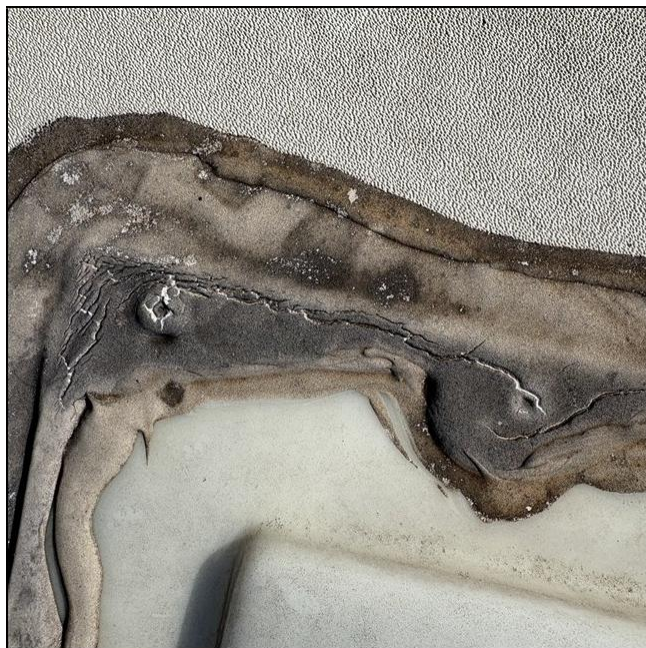
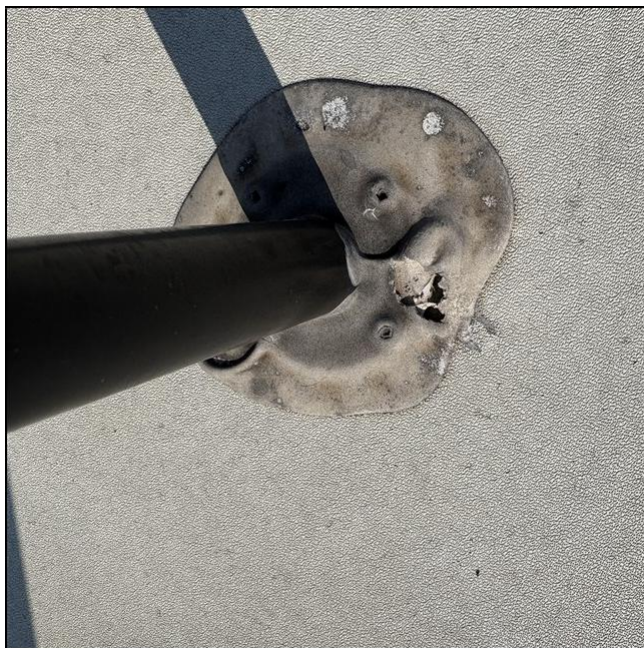
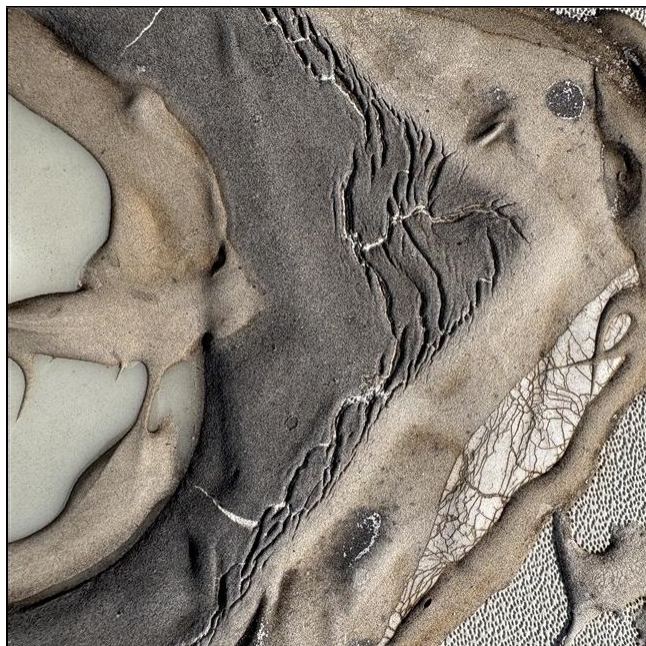
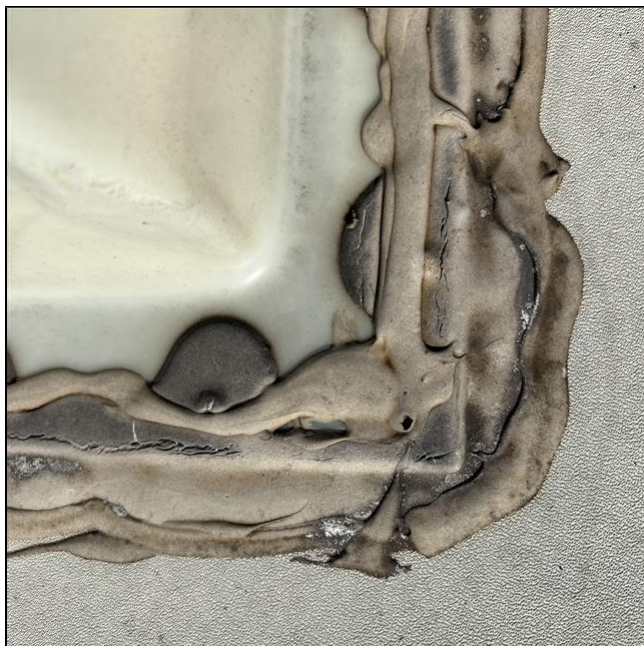
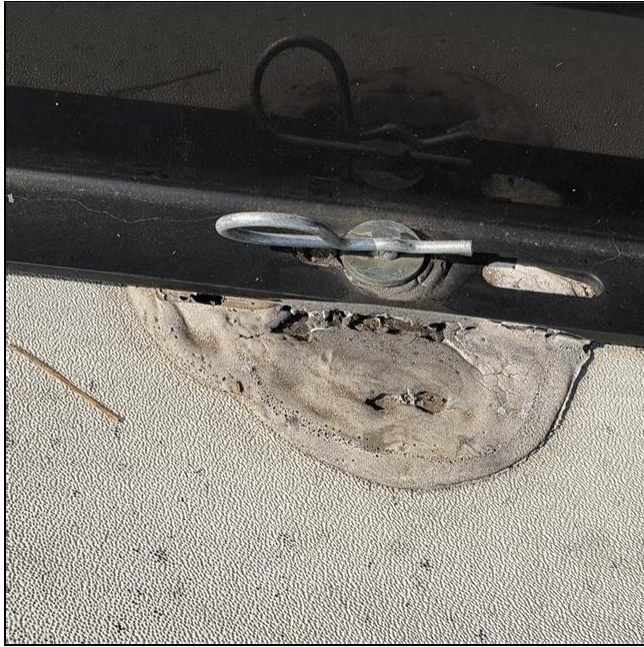
### 6.0 General Roof Condition

Comments: Fair

There are several areas of sealant that are beginning to deteriorate. No signs of water intrusion yet, but recommend evaluation by a service technician and resealing as needed to prevent any future water intrusion.

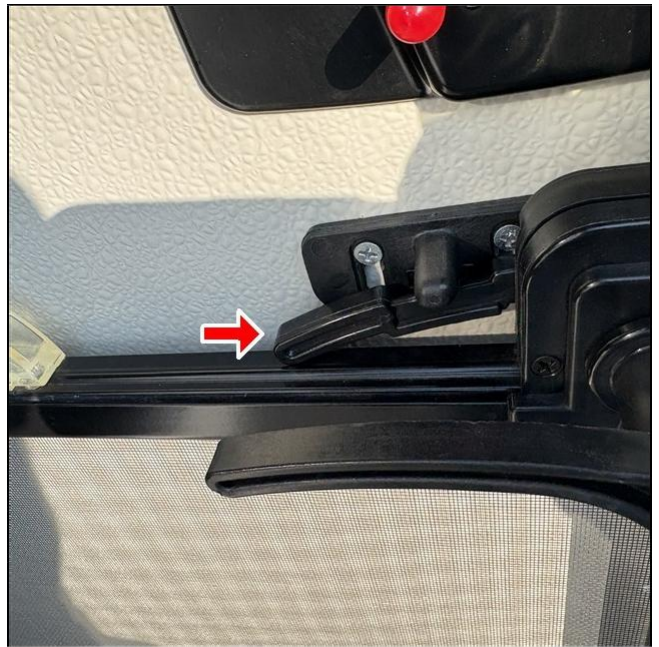
### 7.1 Screen - Operation and Condition

Comments: Poor

The screen latch is not operating properly. If the inside plastic slide is closed, the screen can't be opened from the outside - pushing down on the handle will not disengage the lock. Also the latch will not catch on the door as it should. Recommend adjusting or repair.

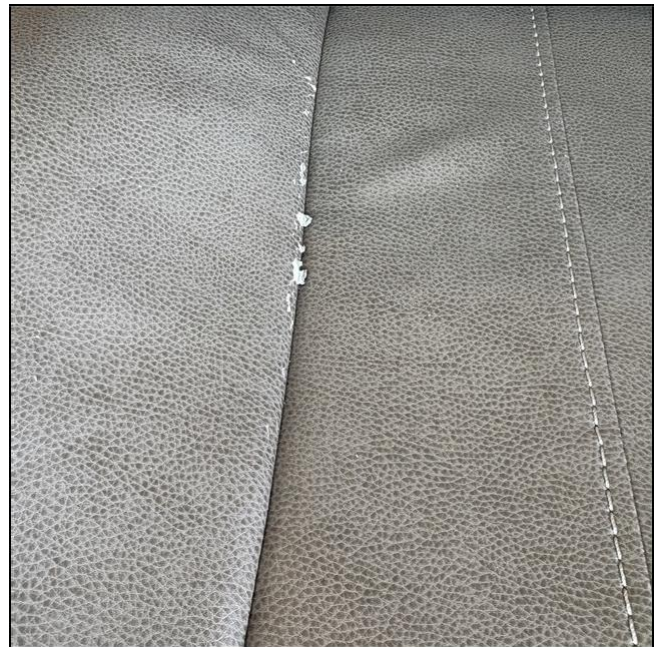
### 13.8 Seats - Condition and Operation

Comments: Acceptable

There are some minor worn areas on the seats

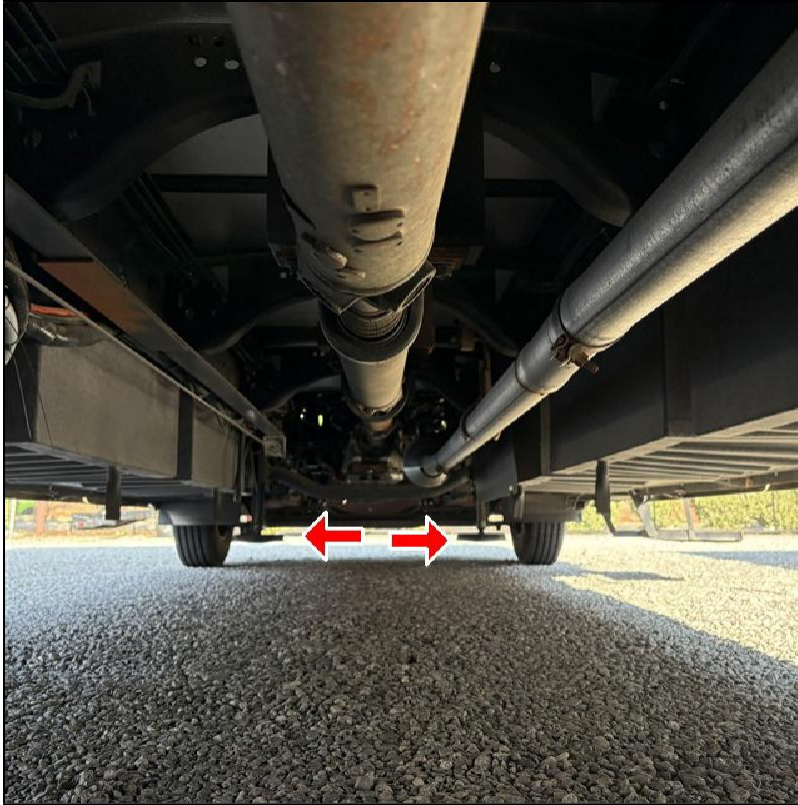
### 14.0 Leveling System Operation and Condition

Comments: Poor

The back levelers extend and retract as they should, but the front ones do not. Recommend repair.

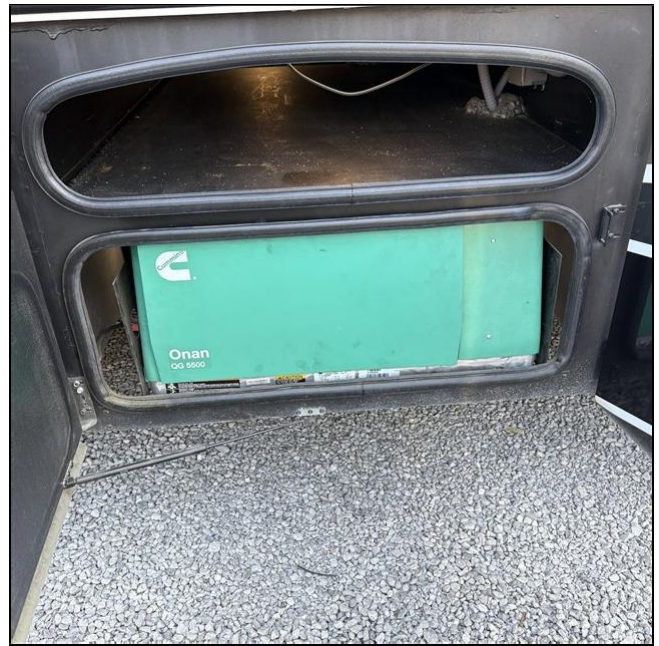
## 16.10 Generator - Operation and Condition

Comments: Poor

The gen will prime and start while plugged into shore power, but will not prime nor start when unplugged. Recommend repair.

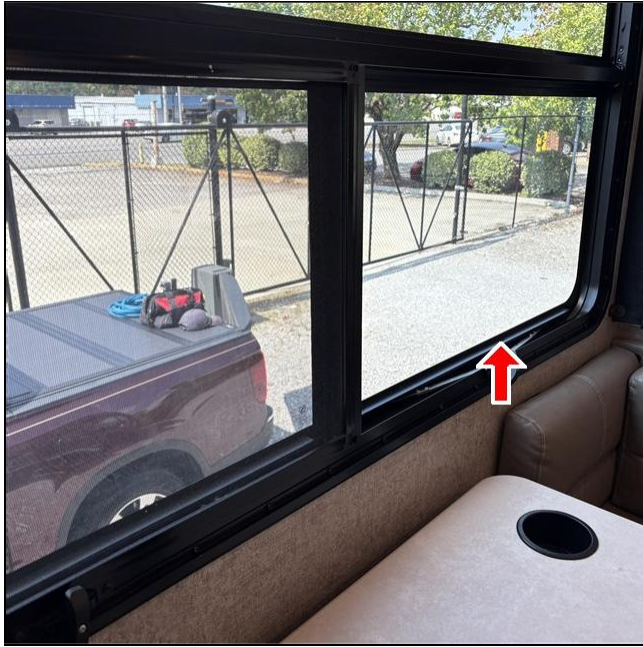
**Comments:** Fair

One of the screens is missing at the dinette. Recommend replace.

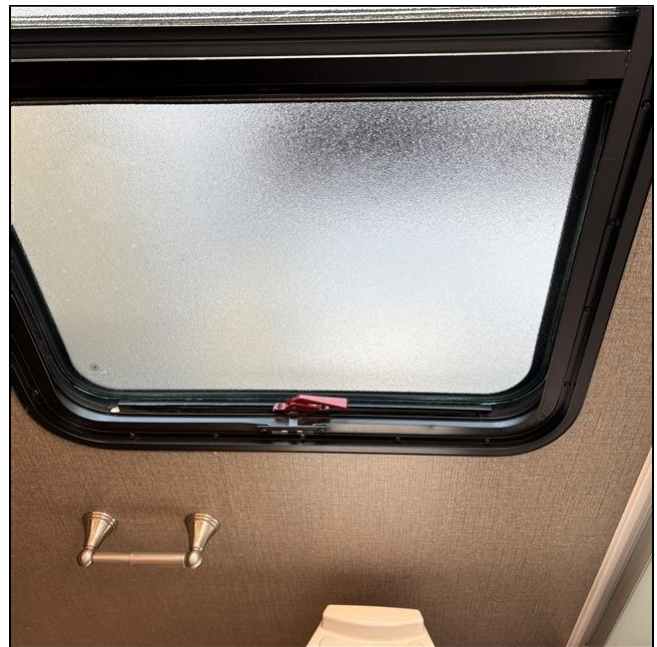
Comments: Poor

The window in the rear bath will not latch or fully shut. Recommend repair.

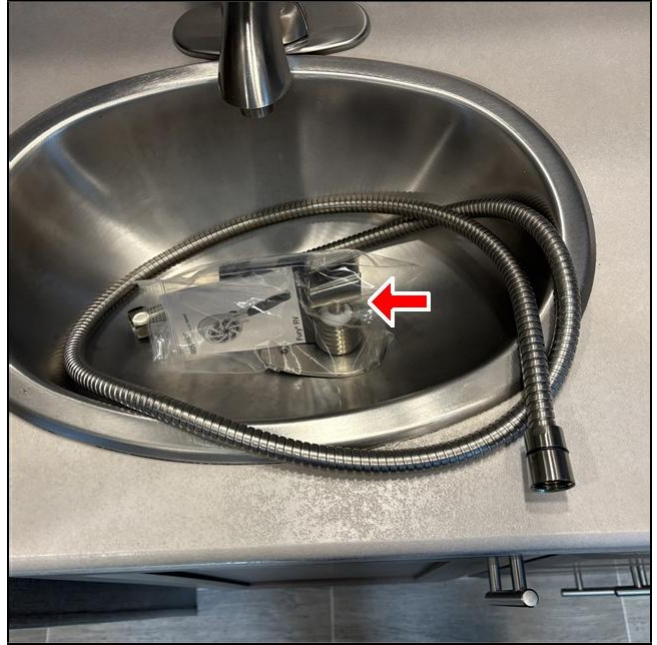
### 23.13 Shower / Tub - Operation and Condition

Comments: Fair

The shower head holder is detached from the wall. It appears this is already in the process of being repaired - there are some parts in the sink.

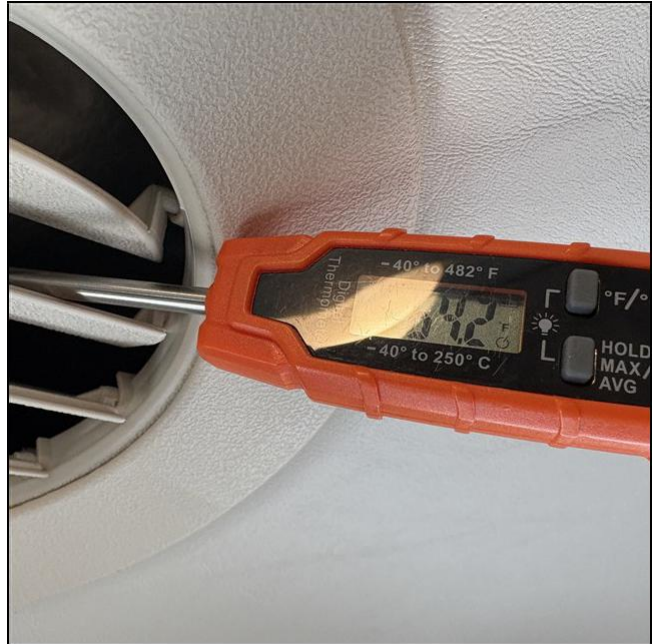
### 27.0.A Air Conditioner Operation

Output air temperature: 64.2

Delta-T = 17.4

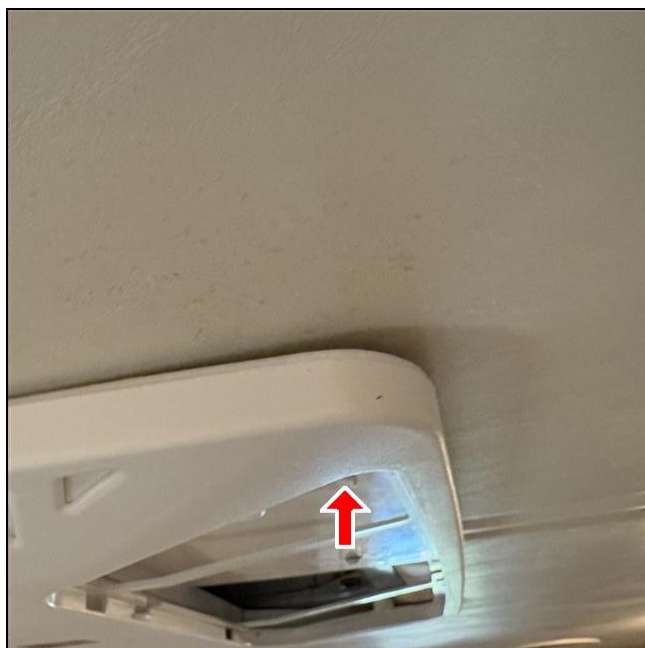
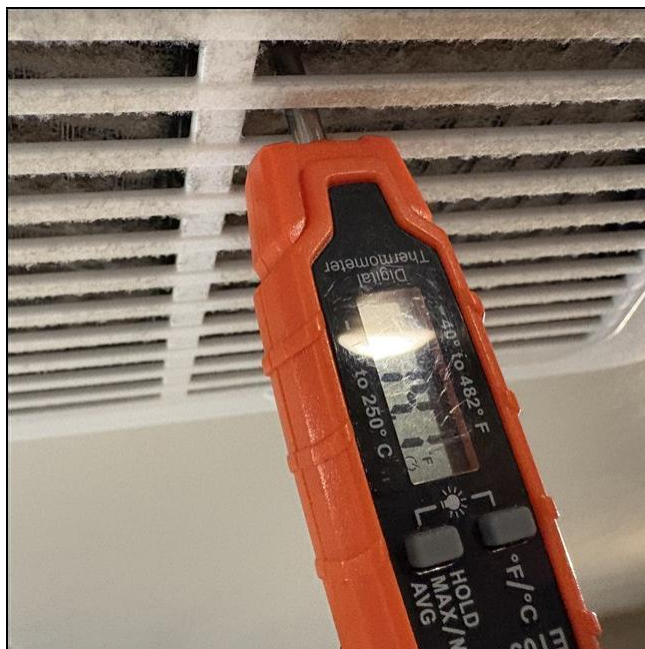
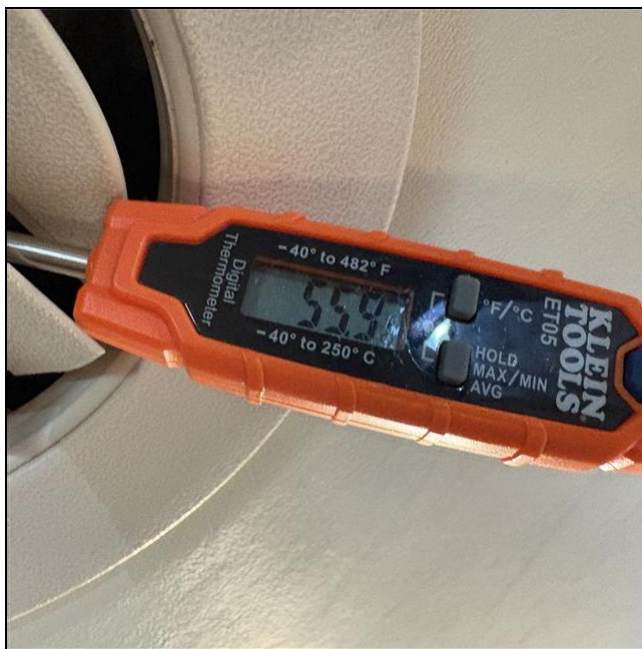
### 27.0.B Air Conditioner Operation

A screw is missing that attaches the AC shroud to the ceiling. Recommend repair.

Output air temperature: 55.9

Delta-T = 19.2
