Sierra Ranches Wetland Preserve

Davie, Broward County, Florida, USA

How does the Preserve Physically look?

What's the Problem?

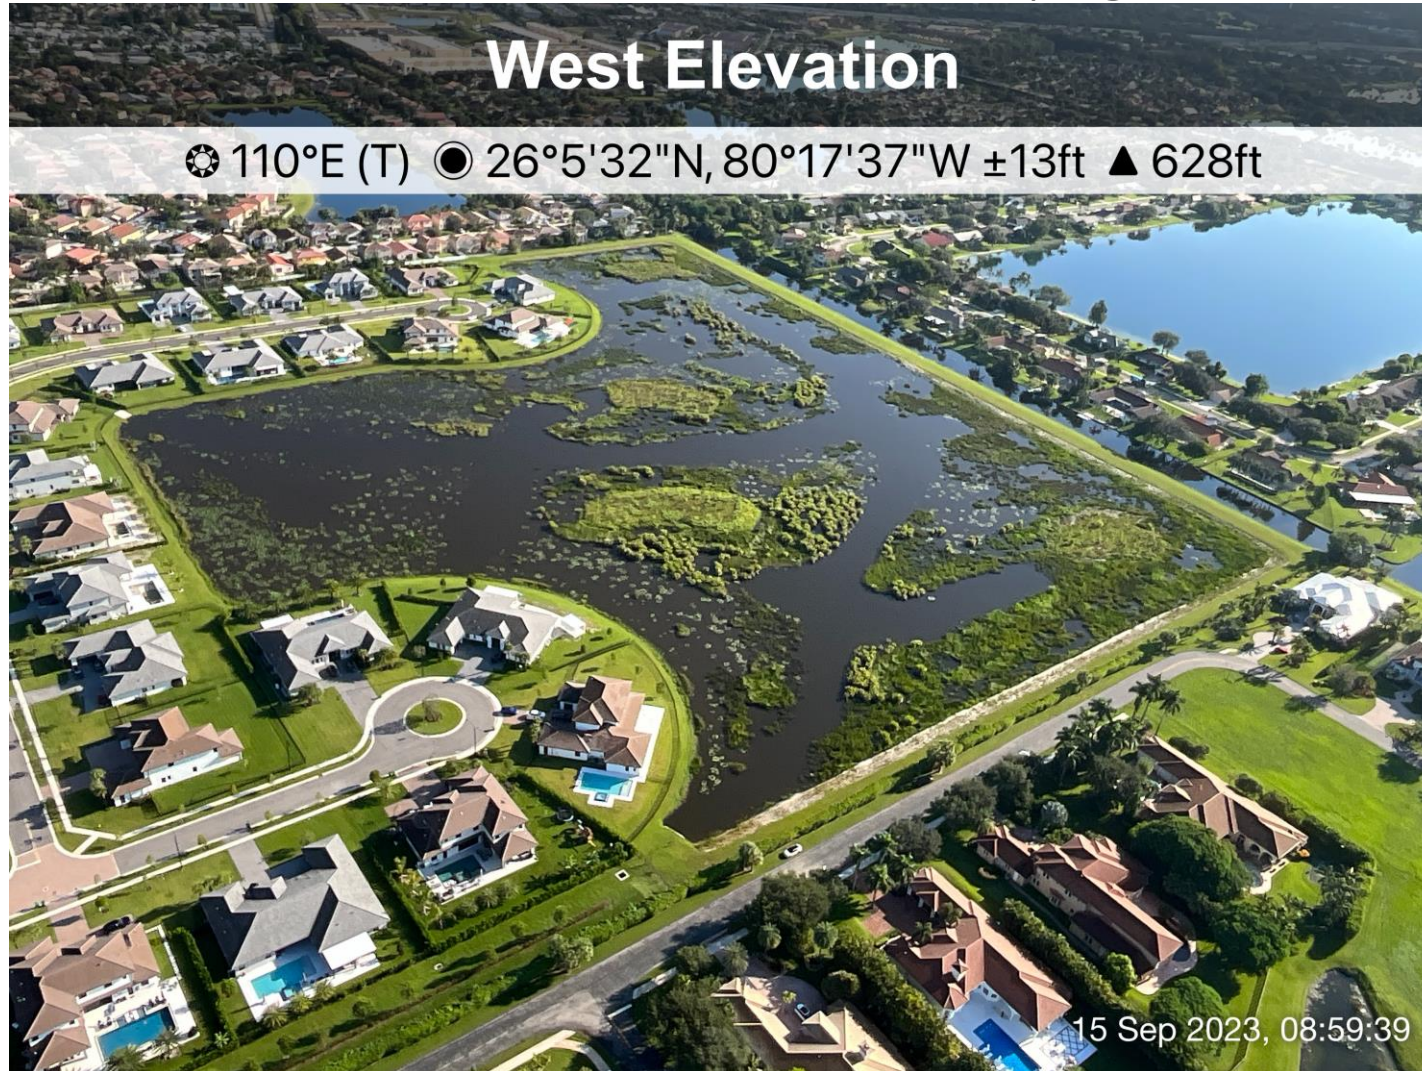
Inspection photo from South Florida Water Management District (SFWMD), Sep 15, 2023

Sierra Ranches Preserve is an engineered body

It has an water channels cut into it around residential lots that are also connected to deep water channels that lead to the outfall at the east end. Controlled discharge takes place into canal N17 over a weir, inverted baffle and through a 48" pipe via gravity

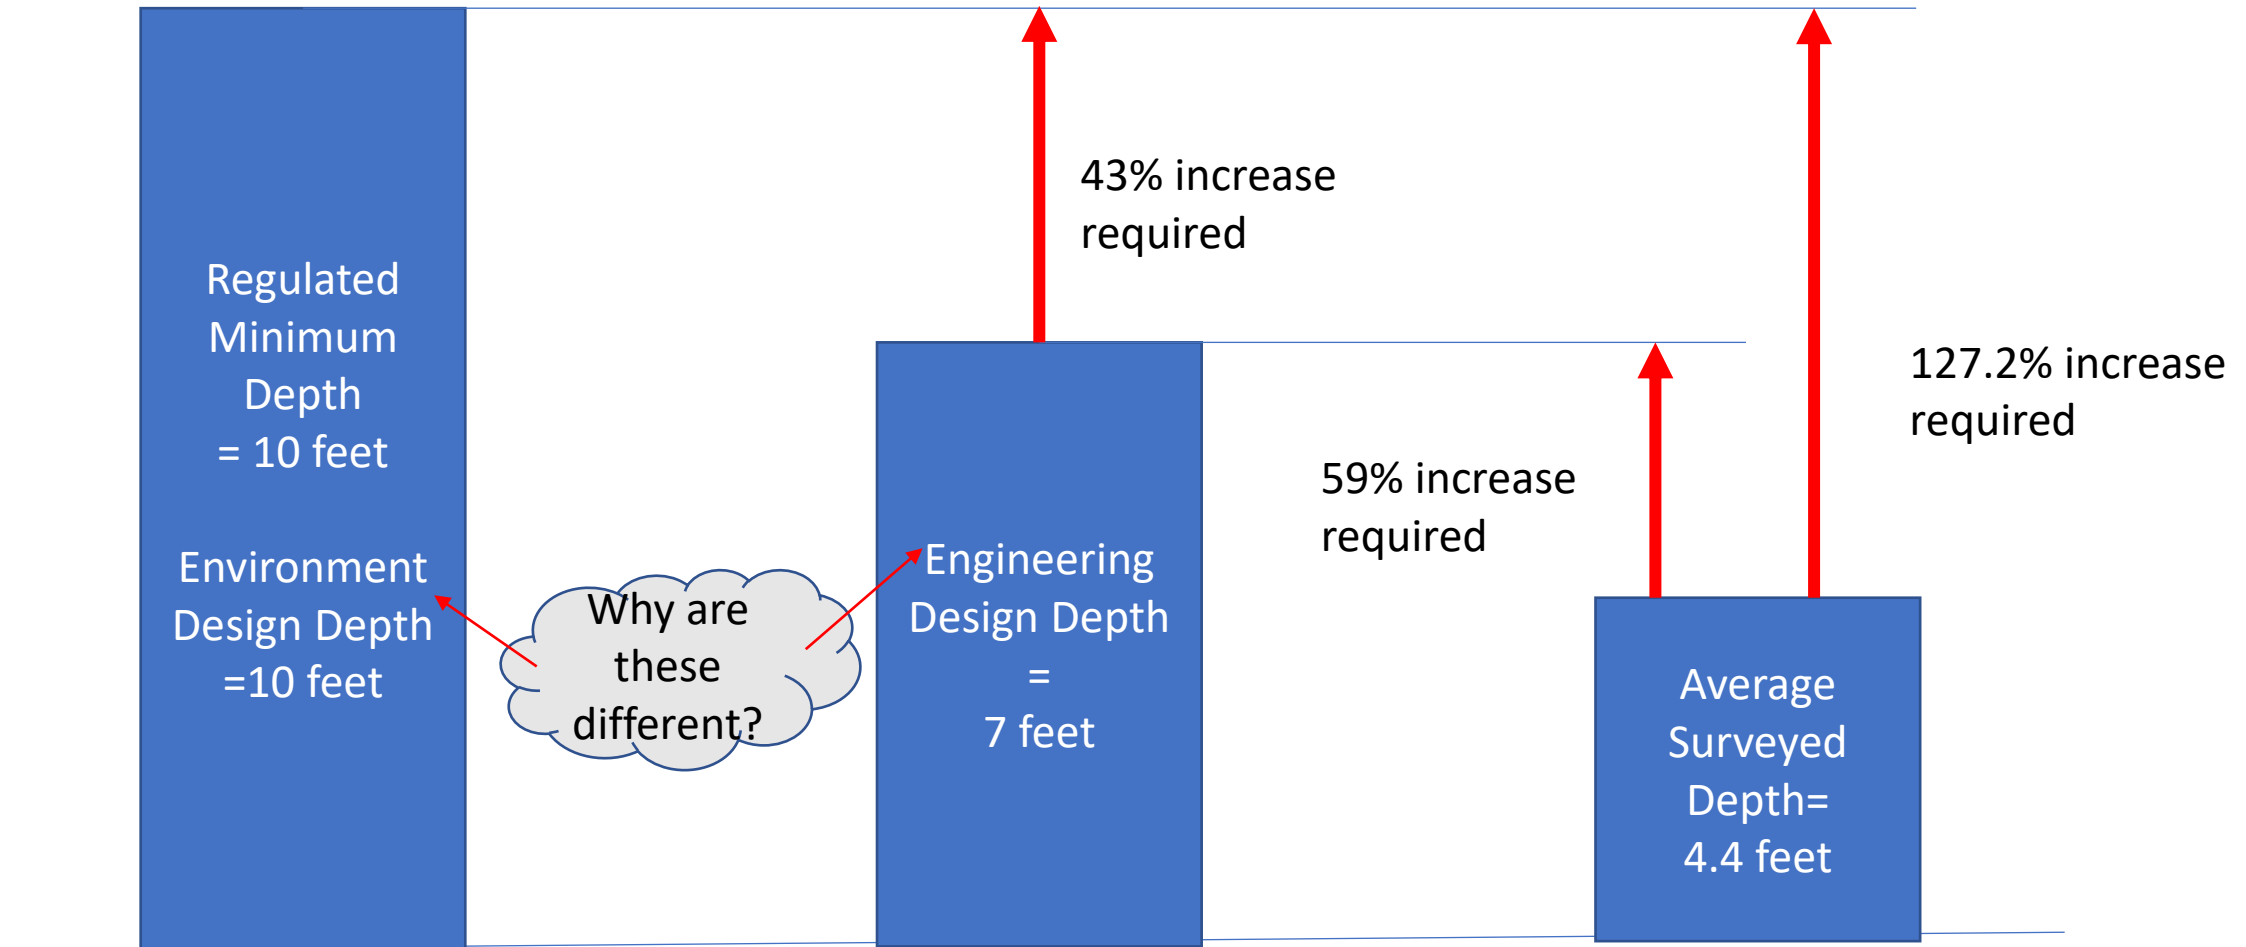
Regulated Depth vs. Design Depth vs. Actual Sep '23 Depth

- The consequences of these sub-optimal design choices and poor engineering have manifested in a catastrophic failure of water channels around residential lots as confirmed by measurements taken just two years after build

- Average depth reduction of 37% and as much as 48% at the most catastrophic failure section
 - This has led to nuisance native and non-native wetland species proliferating through the open water channels around residential lots. They have not also been controlled via maintenance activities.

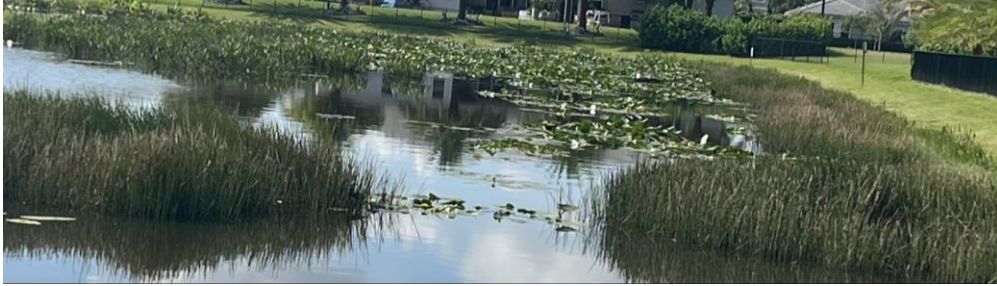
Proliferation of native and non-native nuisance species in the residential shorelines and open water buffer

Water Buffer being completely taken over by spatterdocks, pickerelweed and spikerush – View south from boatramp

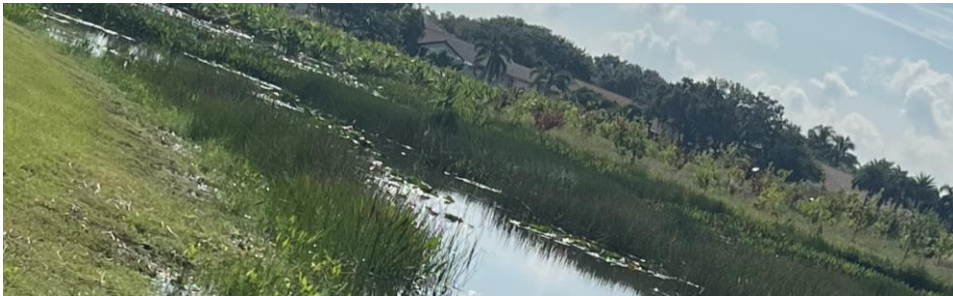
At Lot 20 there is no open water channel anymore at some points

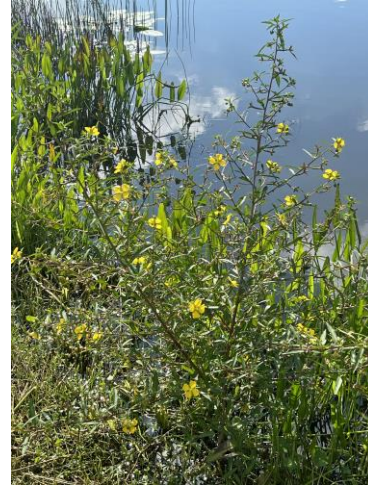
An exotic species will never grow this big if regularly maintained

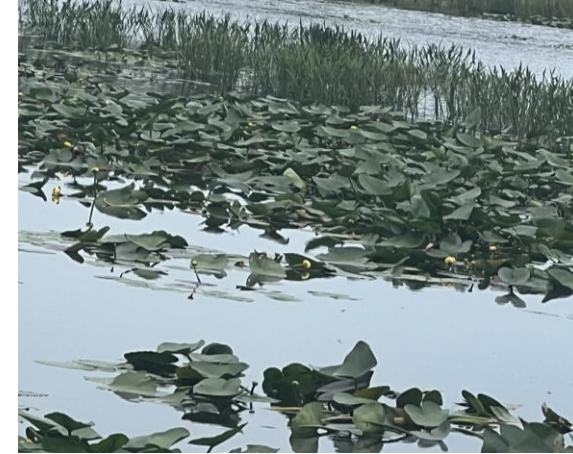
Spatterdocks dominating the open water buffer and the planted marsh beyond the 34 foot water buffer in front of Lots 26 and 27. Spatterdocks are native flow attenuating nuisance species that should not exist in a flowage channel and should be eliminated by early intervention.

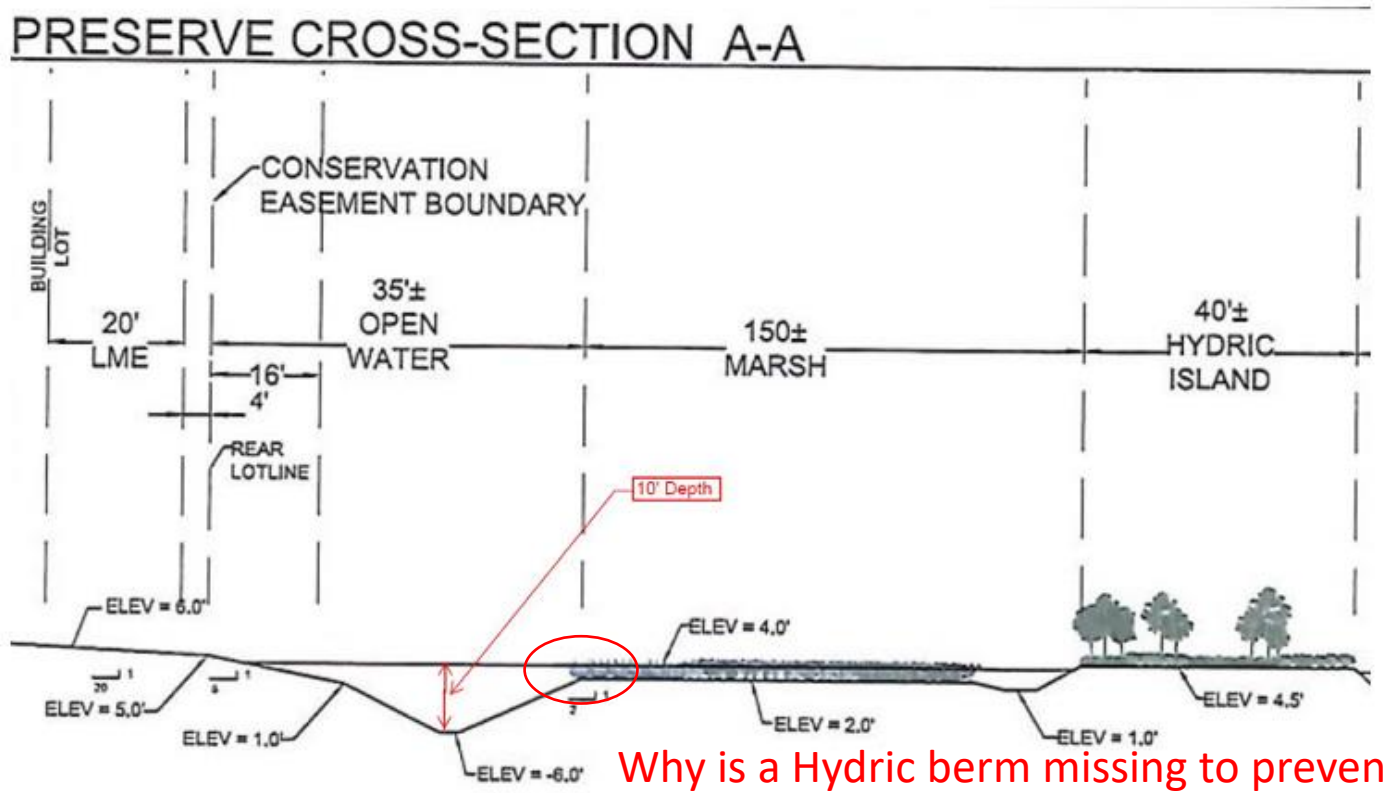
2018 Executed Environmental Plan showing 10 feet depth. CBWCD rules on grading will prevent this depth from being achieved if the Open water is artificially limited to 35 feet

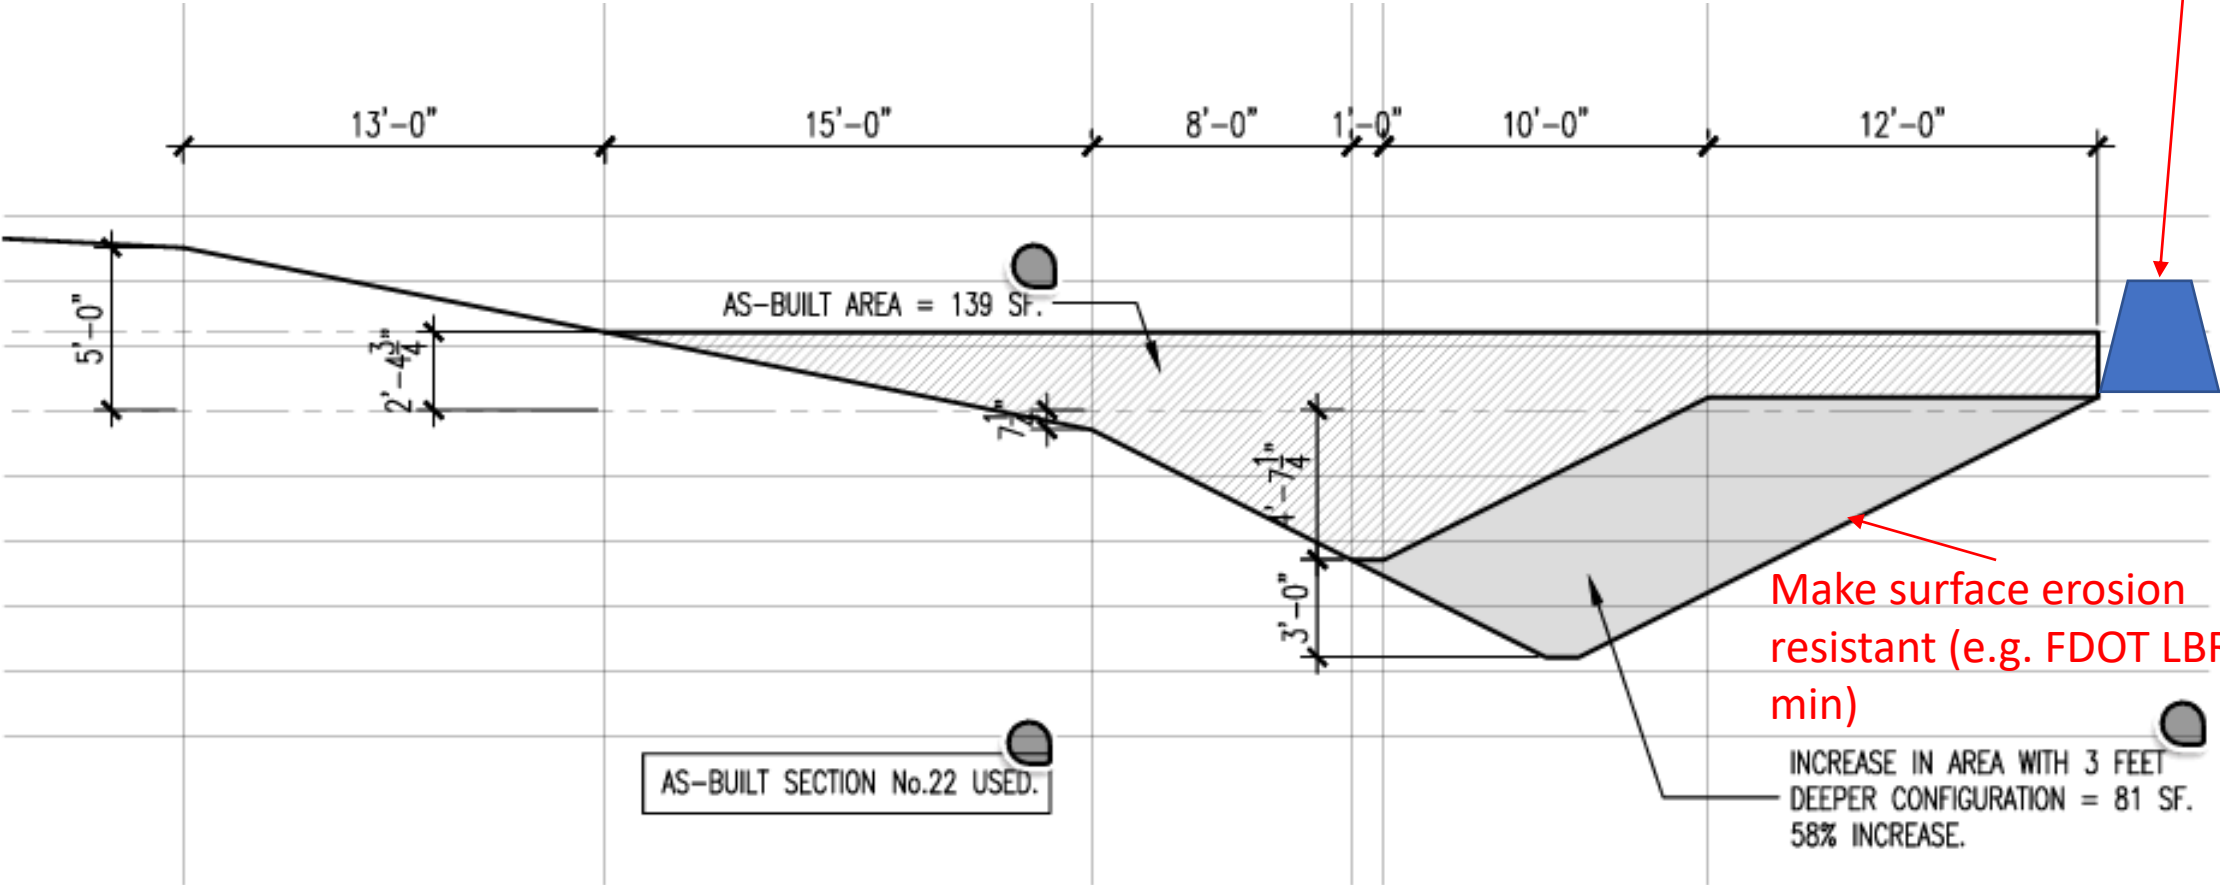
Current Cross-Section from Wetland design plans (showing 10' Channel)

Why is a Hydric berm missing to prevent sloughing of open marsh muck into the open water flow channel?

Impact of making channel deeper by 3 feet i.e. total 10 feet deep and maintaining V-section

Add hydric berm to prevent sloughing of muck from marsh into the water channel

Make surface erosion resistant (e.g. FDOT LBR 40 min)

INCREASE IN AREA WITH 3 FEET DEEPER CONFIGURATION = 81 SF. 58% INCREASE.

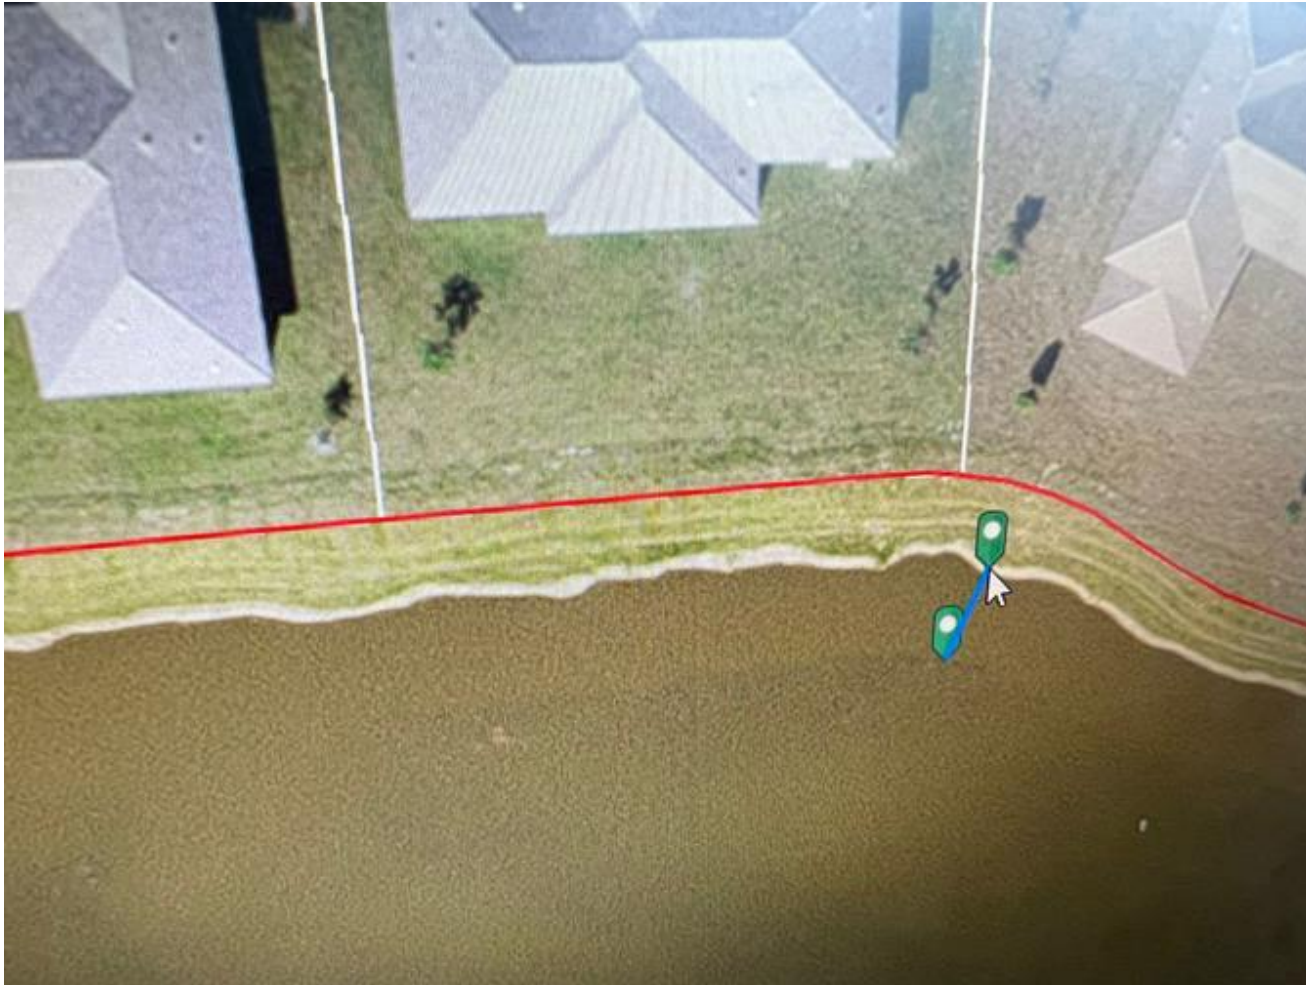
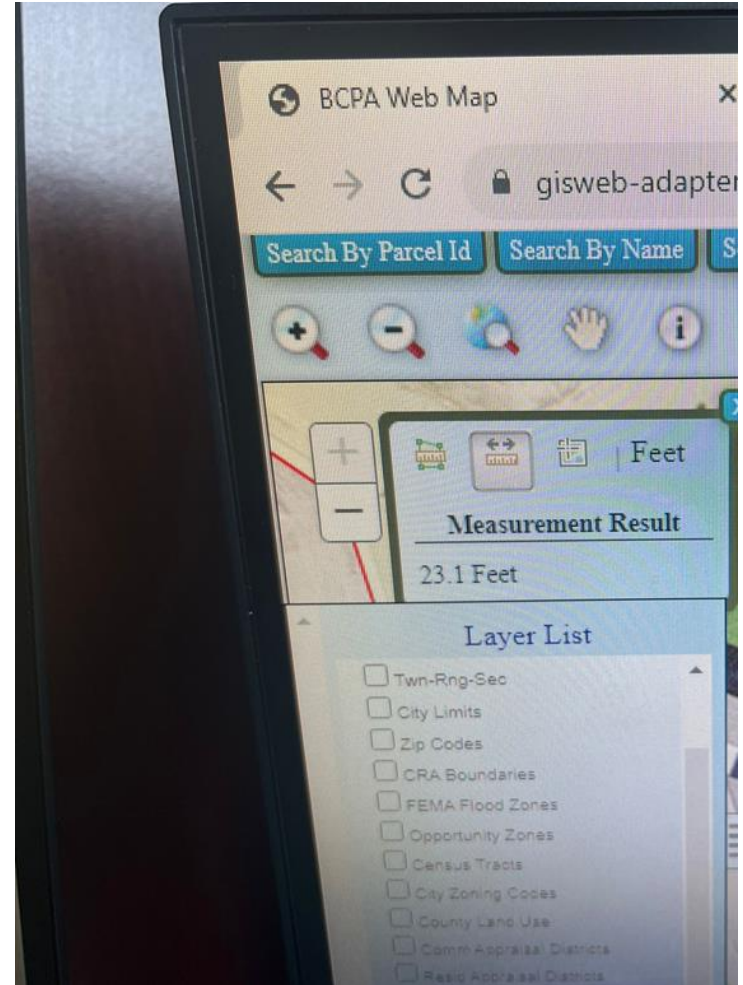
The Curious case of Lot #20

Satellite Image apparently suggests 23 feet open water channel width which is over 10 feet shorter span of open water vs the as builts that show 34 feet the same year (how is that possible?)

Shallow marsh portion is identified with dark shade in satellite image of water

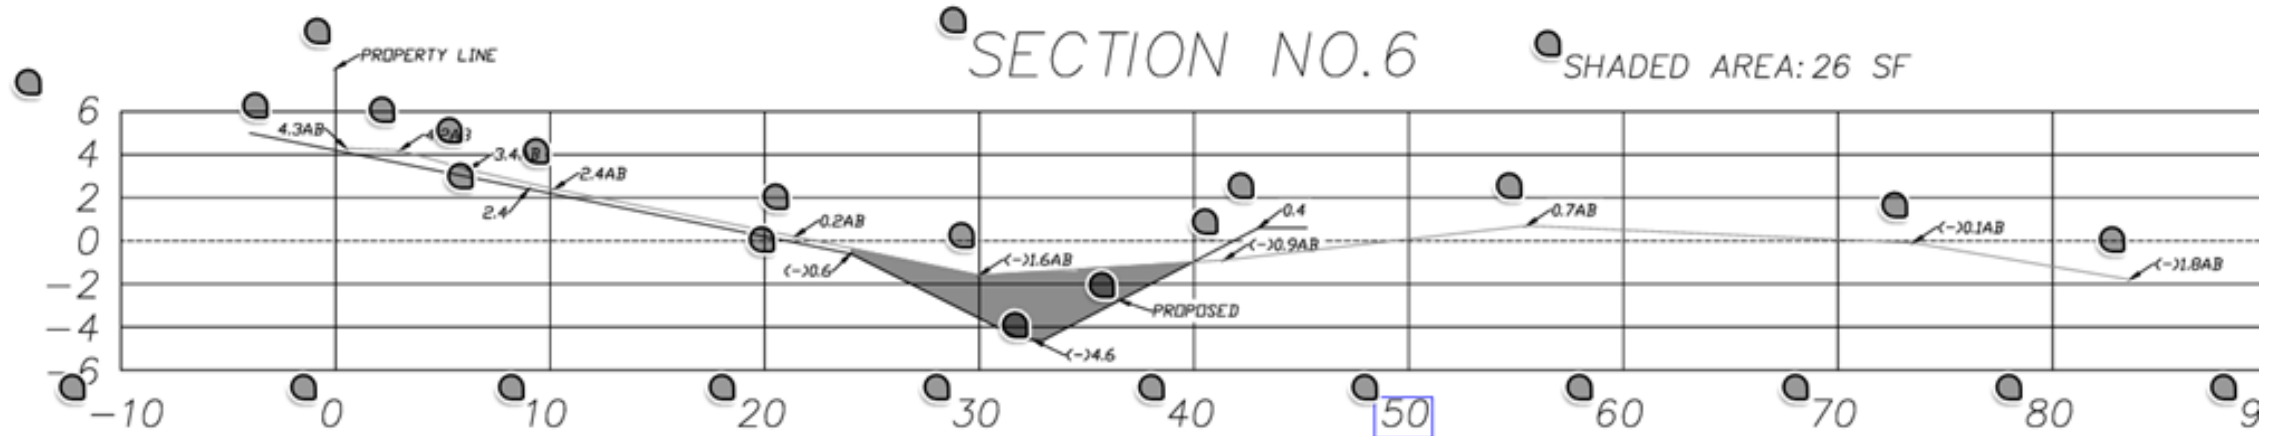
The Curious case of Lot #20

Data from September 2023 shows the deepest point is 4 feet vs. 7 feet, an almost 43% decrease
