The Basic Soldering Guide Photo Gallery

The Basic De-soldering Guide Photo Gallery (and Black Museum of Bad Soldering)

The Black Museum of Bad Soldering

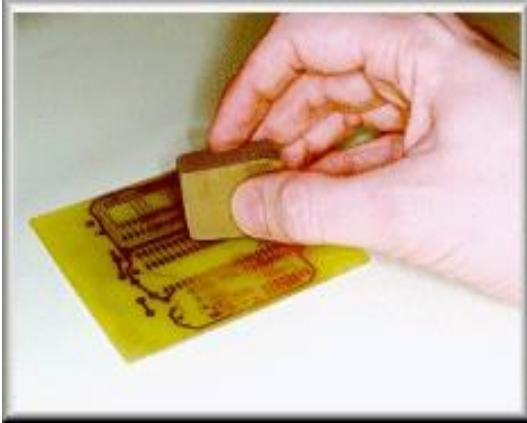
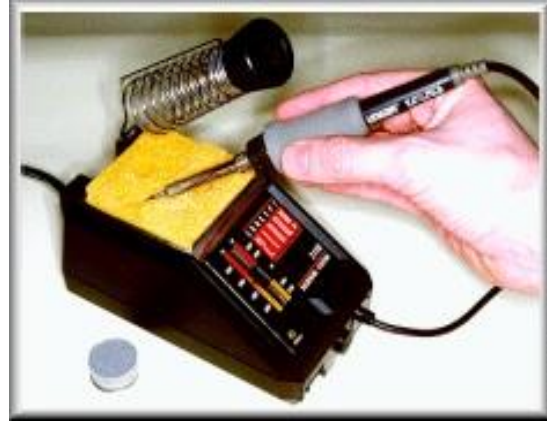
(Left) Printed circuit board copper tracks must be clean to begin with, especially if they're not previously "tinned" with solder. Clean any raw p.c.b. copper tracks gently with e.g. an abrasive rubber block available from electronics suppliers. **(Right)** Clean the iron "bit" (soldering iron tip) using a damp sponge. The soldering iron featured is an Ungar Concept 2100 Soldering Station. Other popular brands of soldering equipment include [Weller](#) and [Antex](#).

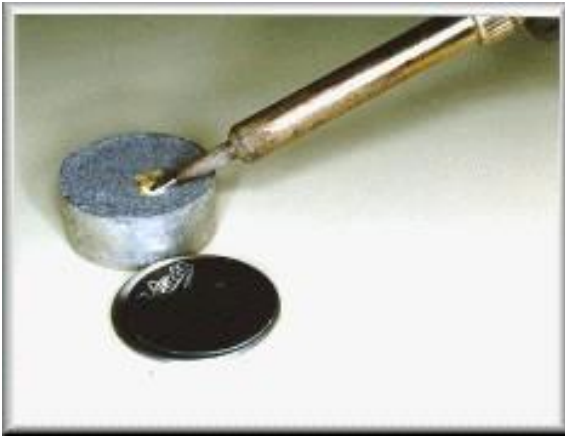
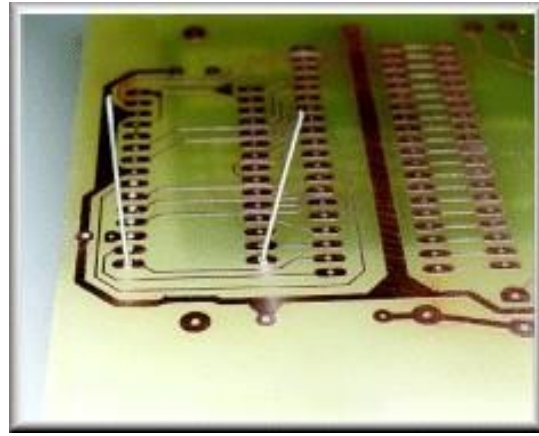
(Left) A useful product is Multicore's Tip Tinner Cleaner (TTC) - a 15 gramme tin of special paste which cleans and "tins" the soldering iron iron, in one go. New tips must be tinned **immediately** when used for the first time. **(Right)** Insert components and splay the leads so that the part is held in place.

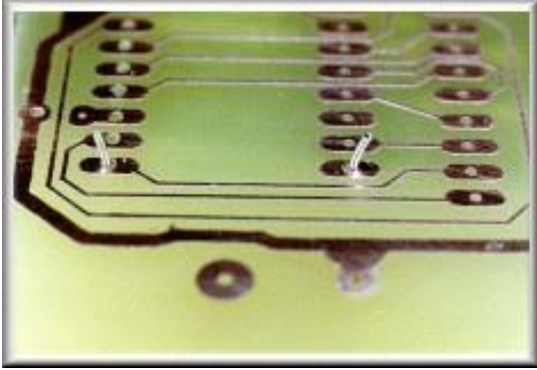
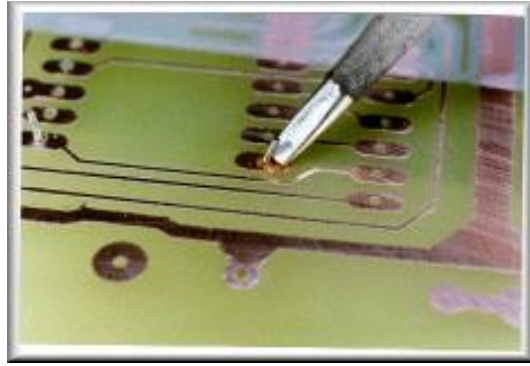
(Left) It's usually best to snip the electronic component wires to length prior to soldering. This helps prevent transmitting mechanical shocks to the copper foil. **(Right)** Apply a clean soldering iron tip to the copper solder pad and the component lead, in order to heat *both* items at the same time.

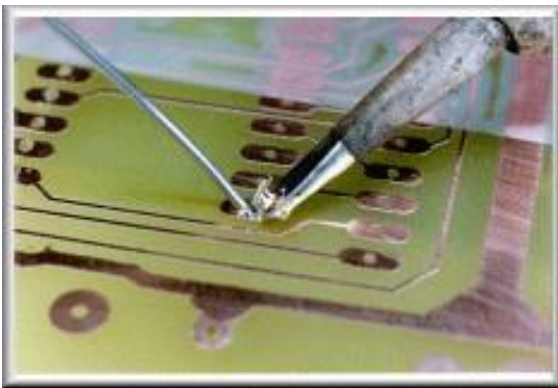
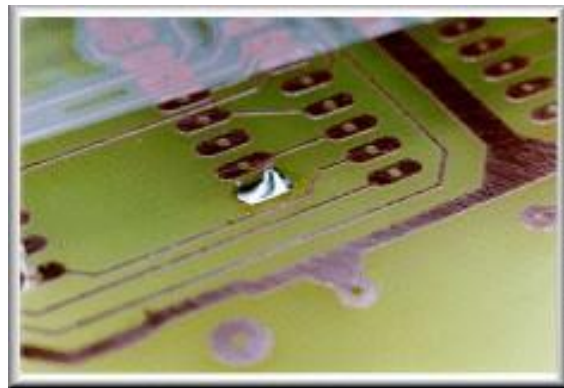
(Left) Continue heating and apply a few millimetres of solder. Remove the iron and allow the solder joint to cool naturally. **(Right)** It only takes a second or two, to make the perfect joint, which should be nice and shiny. Check the Guide for troubleshooting help.

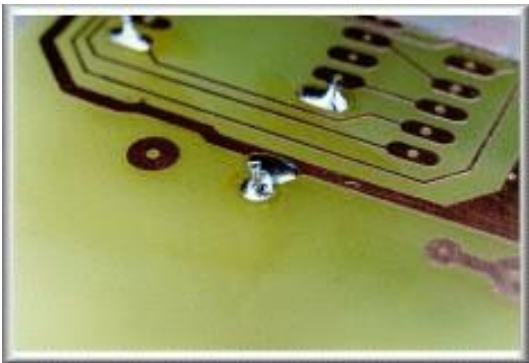
An example of a "dry" or "gray" solder joint - the solder failed to flow, and instead beaded to form globules around the wire.

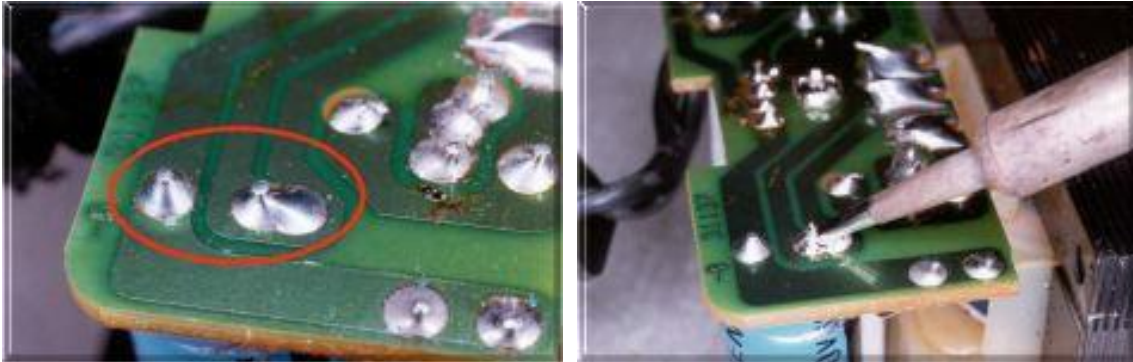
(Left) The two solder joints to be desoldered, to enable a faulty electrolytic capacitor to be removed from the printed circuit board.

(Right) If using a suction---type [desoldering pump](#), apply the soldering iron tip first to melt the solder joint (say for 1---2 seconds). Ensure the spring---loaded desoldering pump is 'primed' and ready to go...

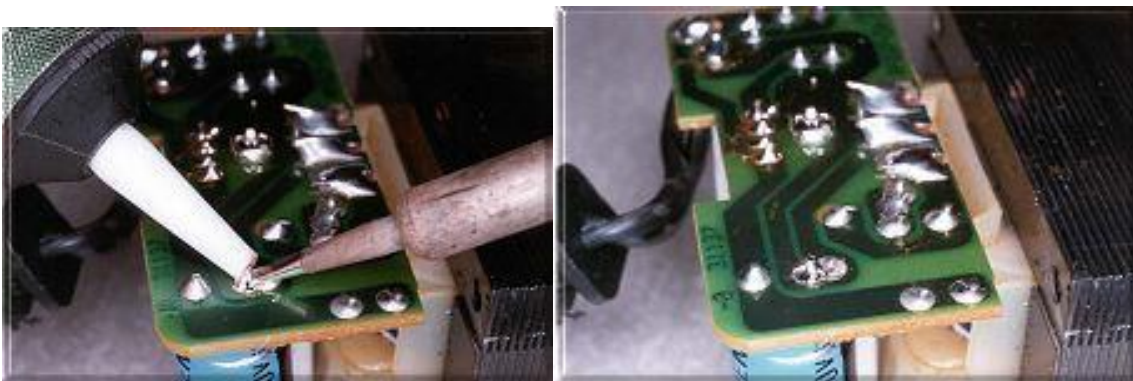
(Left) The PTFE nozzle of the desoldering pump is applied to the molten solder and the spring---loaded plunger is then immediately released, drawing the molten solder up into the pump. Remove the soldering iron tip. Repeat the process if needed.
Handy tip: sometimes it helps to add some fresh solder and then desolder the whole joint.

(Right) The first p.c.b. joint, now desoldered. The second joint will be desoldered using traditional desoldering braid.

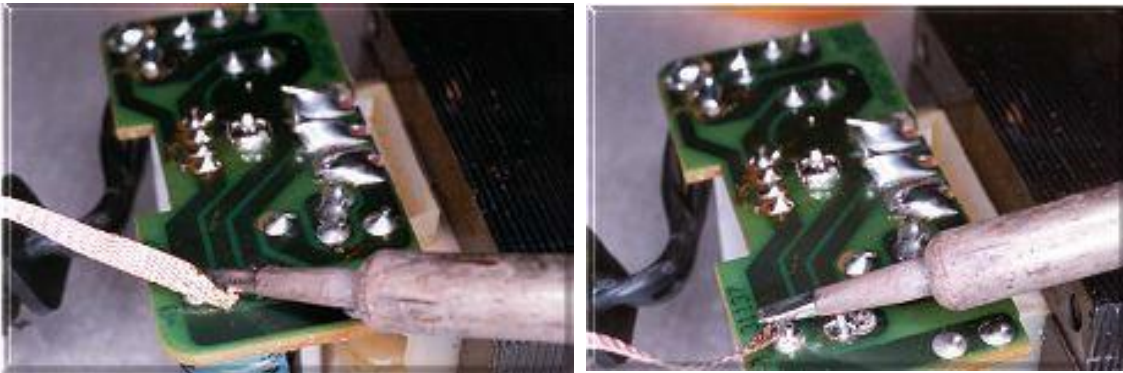
(Left) Select a suitable width of desoldering braid, and **press it down** onto the **COLD** joint using the hot tip of the iron. A flat soldering iron bit is preferable.

(Right) The molten solder is drawn up by capillary action into the desoldering braid. Take care not to overheat the board (the p.c.b. copper track may lift off), nor 'drag whiskers' of solder over the board, nor let the braid solidify onto the joint! Remove the braid while the joint is still molten.

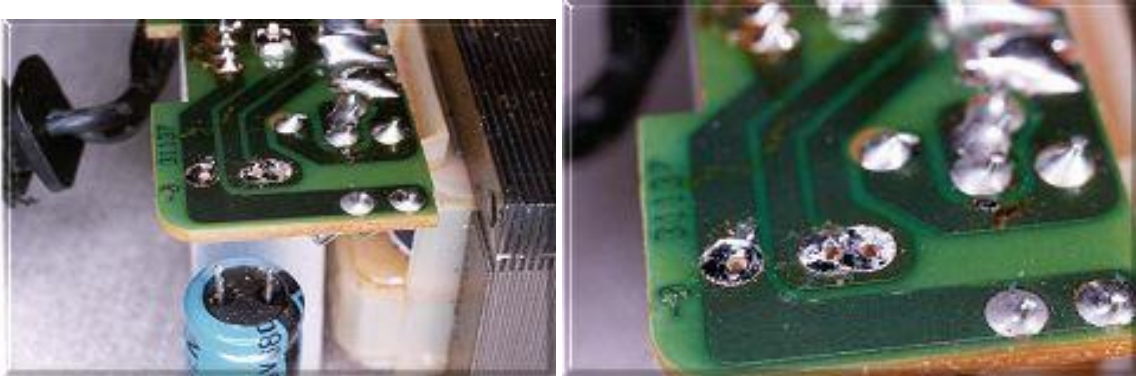
(Left) The faulty electrolytic capacitor dropped out of the board after desoldering. Sometimes, it may need persuading with pliers.... but don't overdo this or you risk damaging the copper tracks on the p.c.b.

(Right) Close---up photograph of both joints, now desoldered and ready for the replacement component to be fitted.

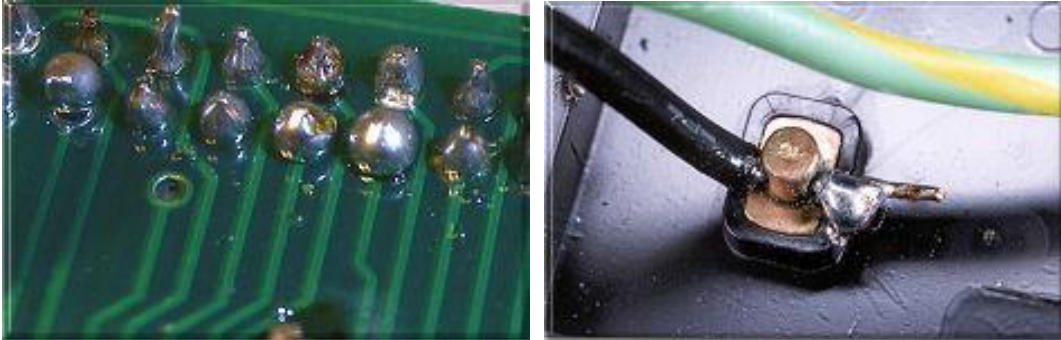
(Left) A tenfold excess of solder on this hand---soldered printed circuit board, and (extreme left) an incomplete solder joint with poor coverage. There is no need to add more solder "for luck".

(Right) An example of a dry (or gray) solder joint found inside a commercial PSU for a computer peripheral. The wire had been fed through the hole in the brass terminal, and merely tacked on with a blob of solder. This is a fire hazard (risk of arcing and overheating).

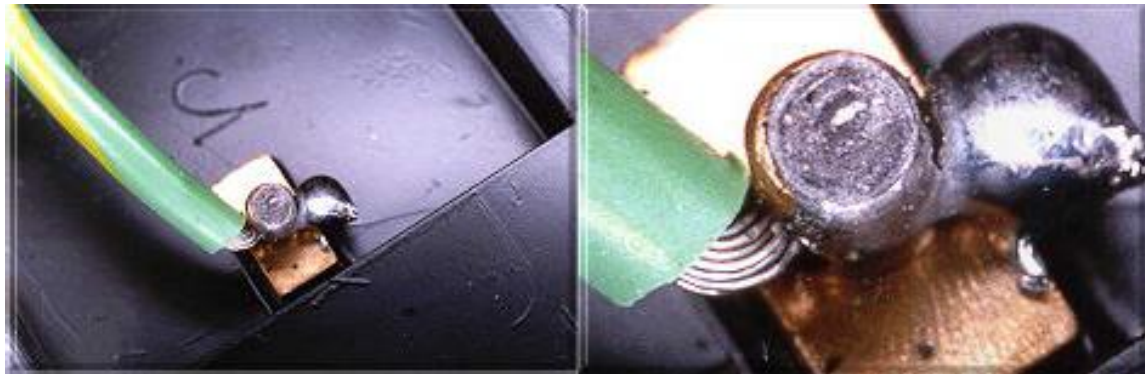
(Left) Hmmmm... this joint looks somewhat suspect as well... it's the earth (ground) wire in the same PSU

(Right) A close---up reveals the terrible standard of soldering (and quality control), with a fracture visible on this ground/ earth joint.

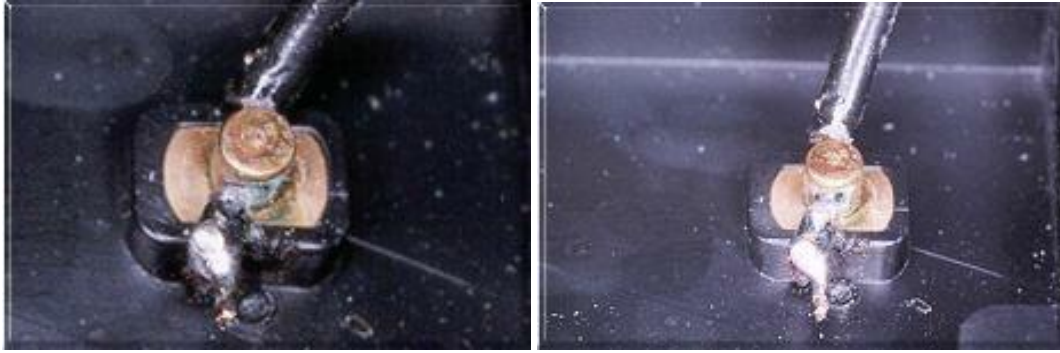
(Left) How **not** to make a mains voltage soldered joint. This solder joint went "dry" and starting arcing, nearly destroying the attached equipment. It is also a fire hazard.

(Right) The same mains connection, the wire merely being 'tacked on' with a blob of solder.
