Evaluation of Lead Service Line Lining and Coating Technologies

Project #4351

Stephen J. Randtke, Edward F. Peltier, Craig D. Adams, Rachael F. Lane, Zachary A. Breault, and Ray E. Carter, Jr.
University of Kansas, Lawrence, KS 66045

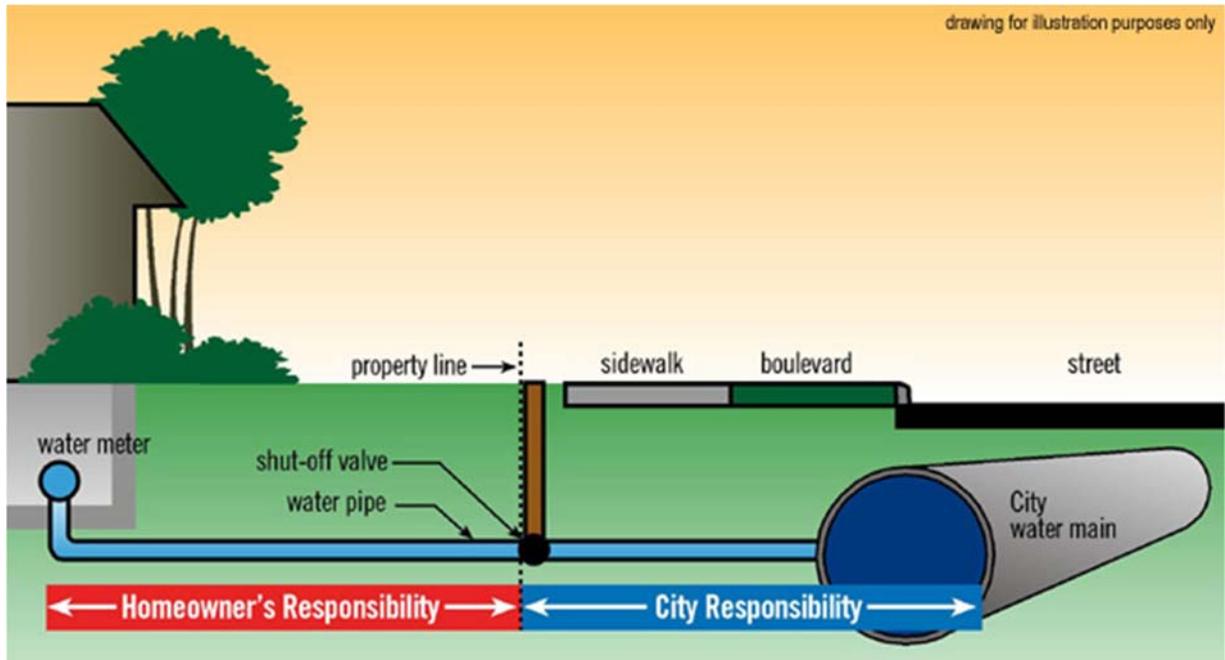
Figure 1.1 Typical financial responsibility for a water service line extending from a water main to a home or building

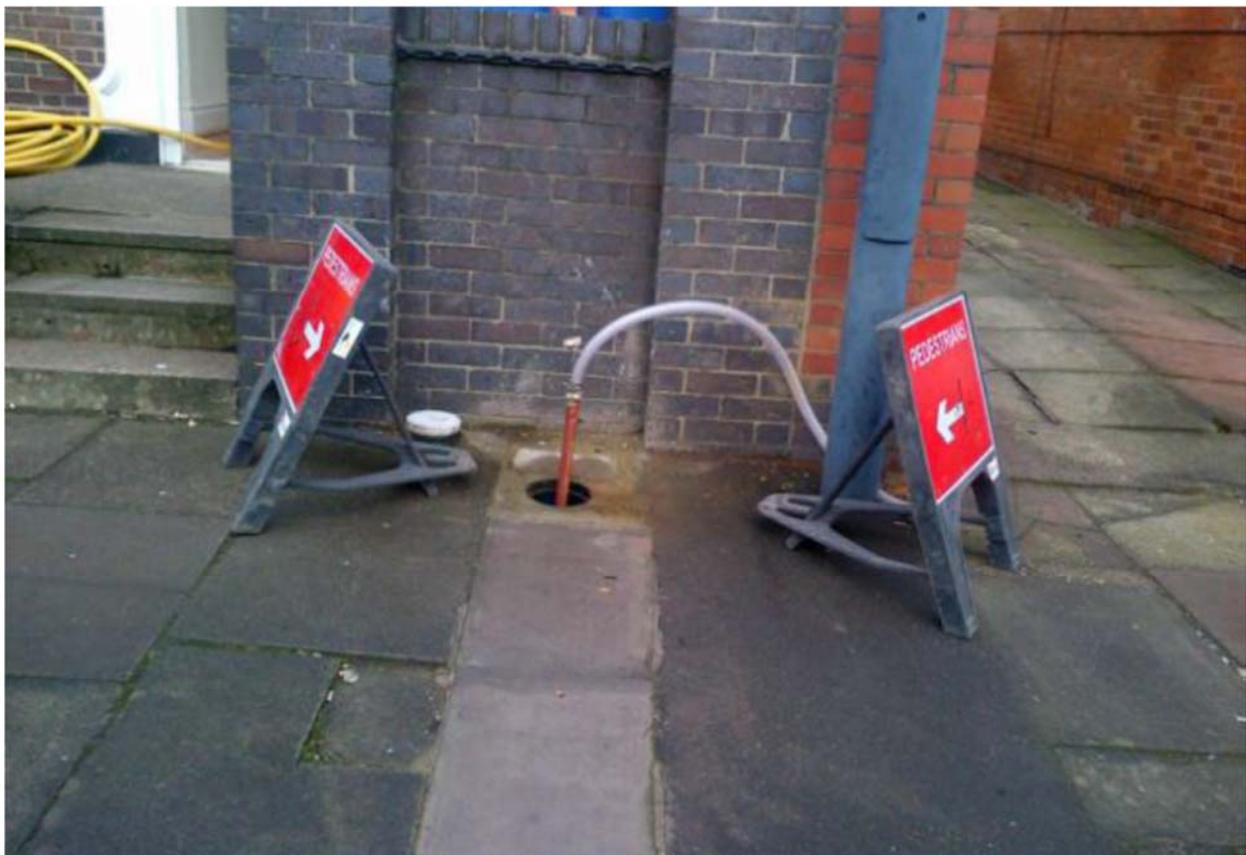
Figure 2.2 Applying an epoxy coating through a stop tap

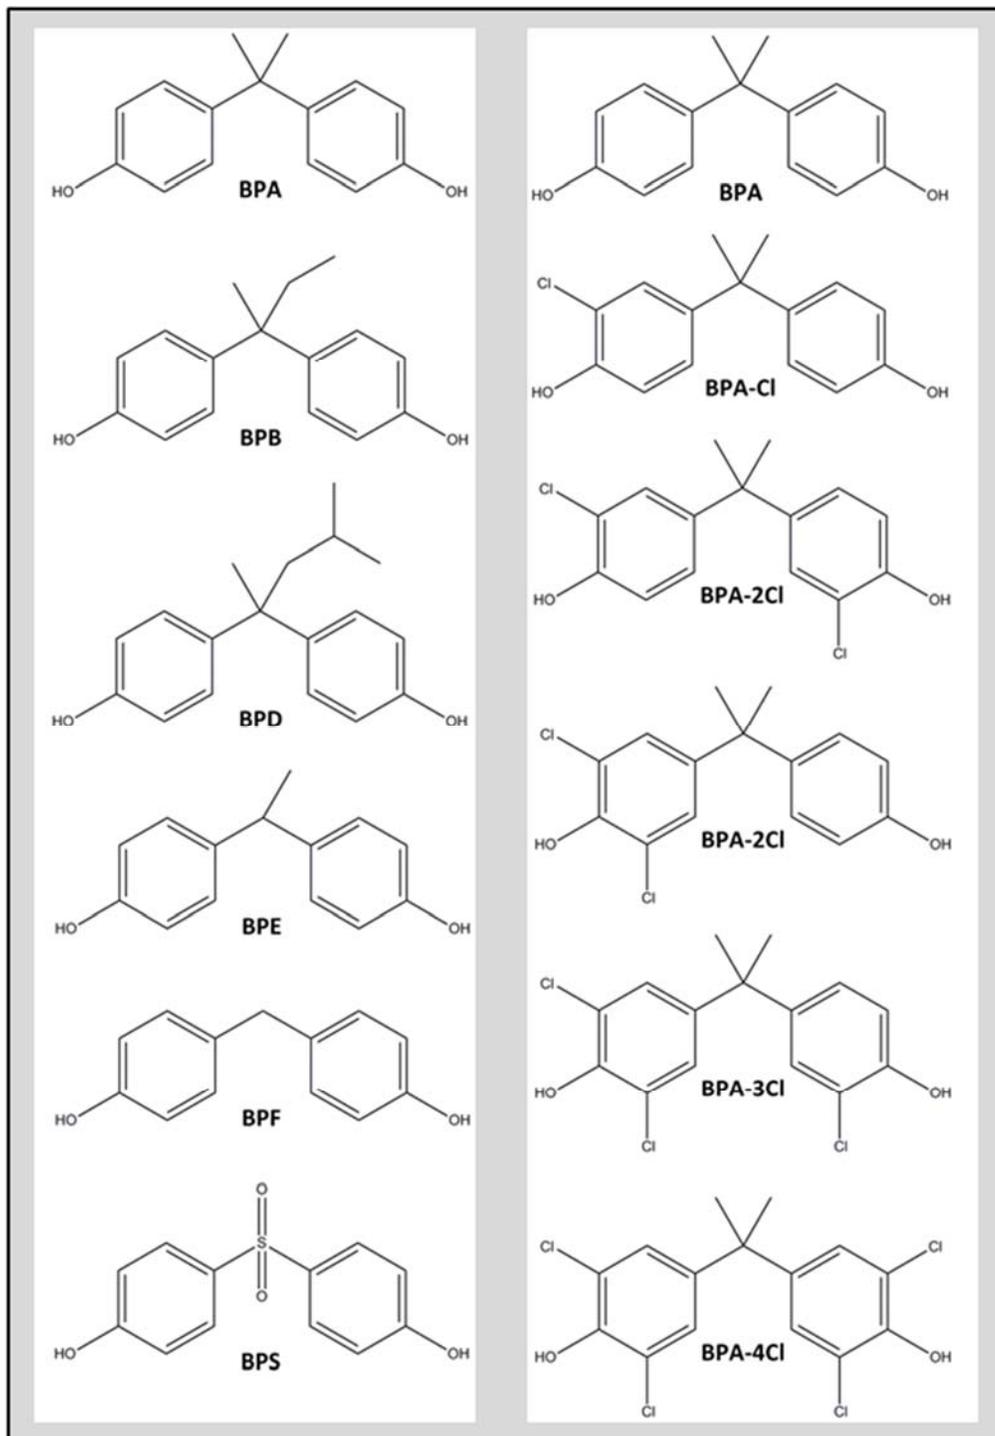
Figure 2.3 Structures of selected bisphenols and chlorinated BPA by-products

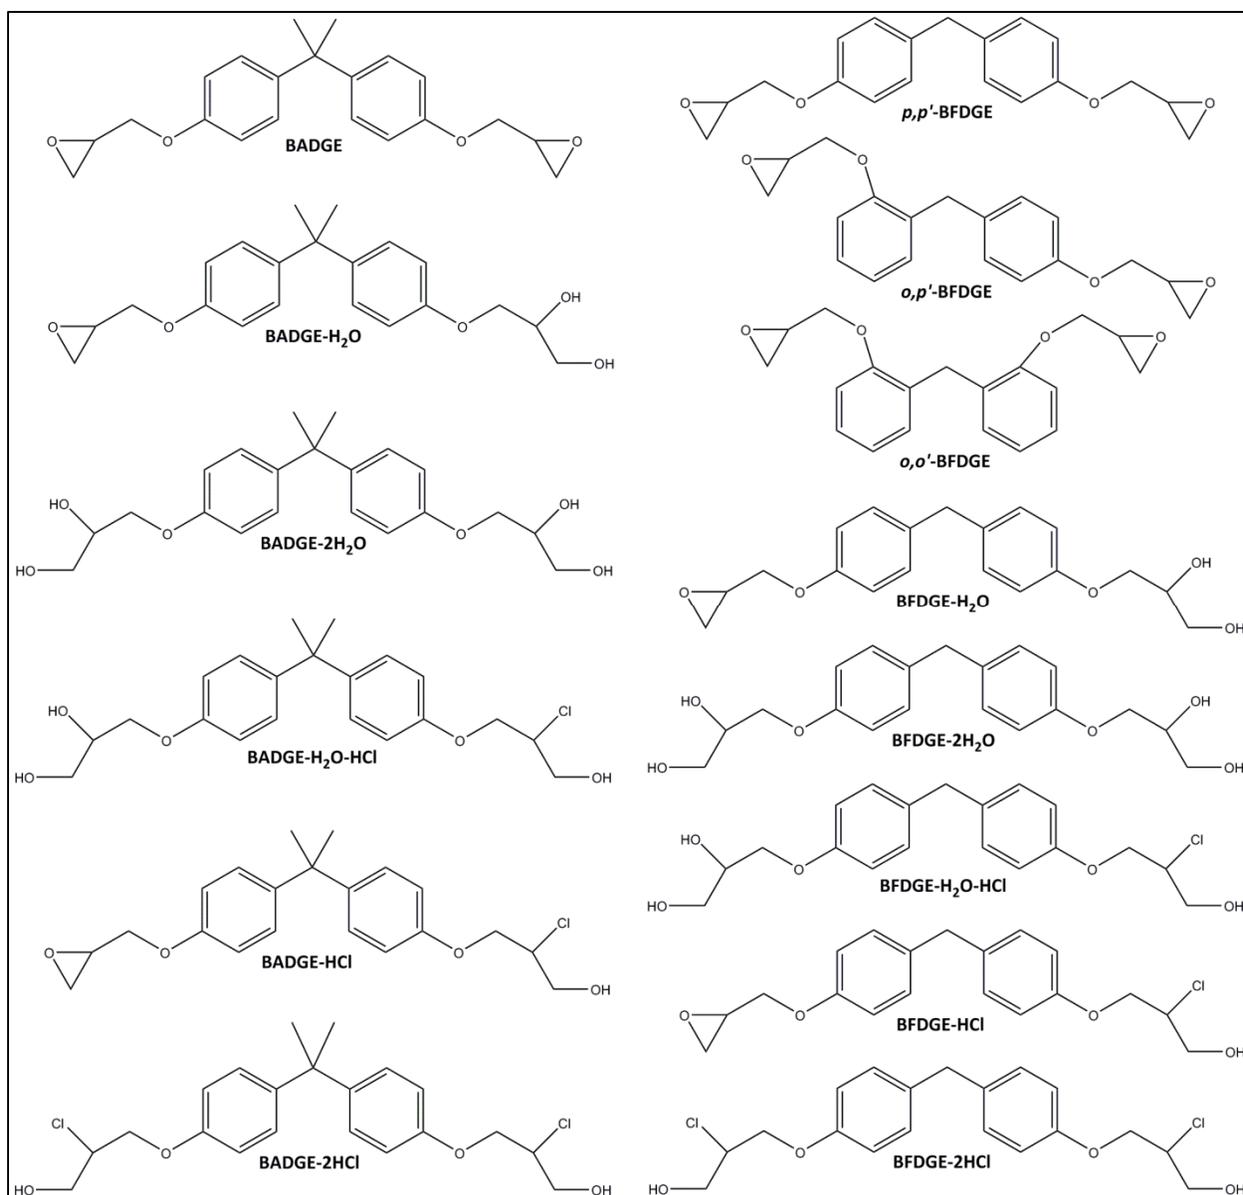
Figure 2.4 Structures of selected bisphenol diglycidyl ethers and related by-products

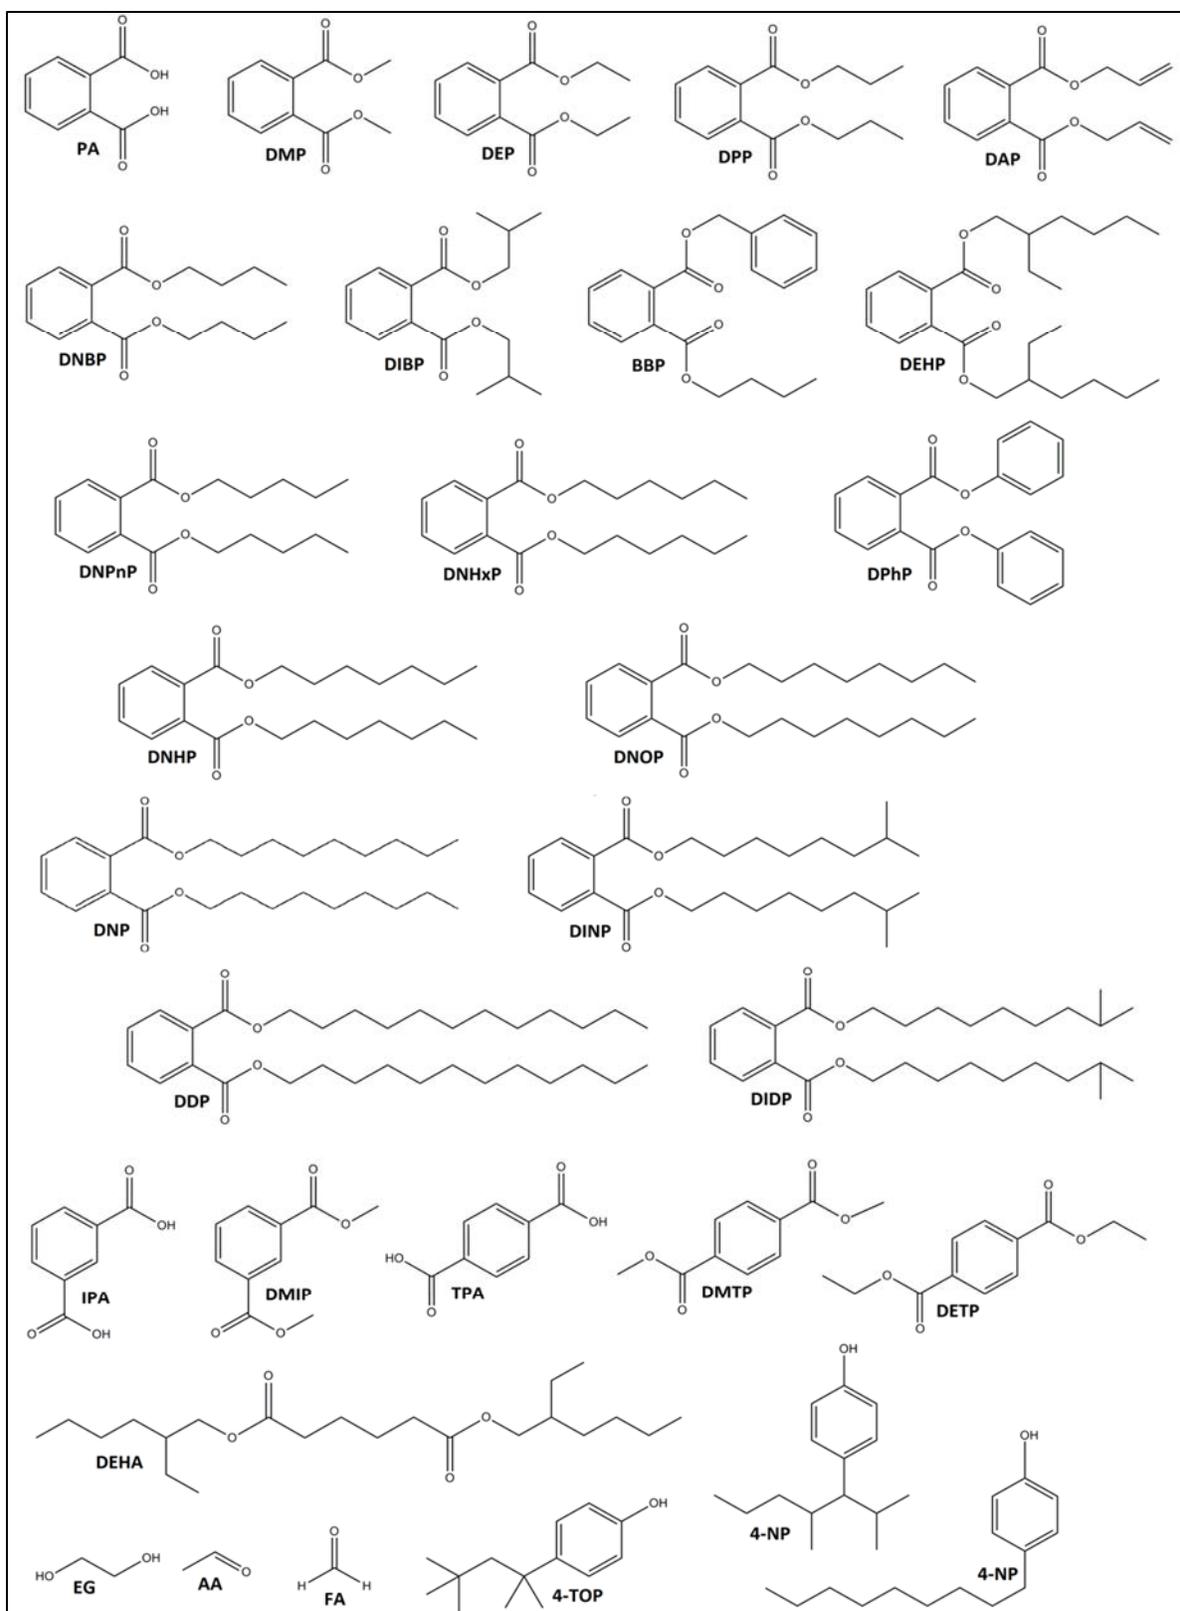
Figure 2.5 Structures of potential leachates from PET plastics

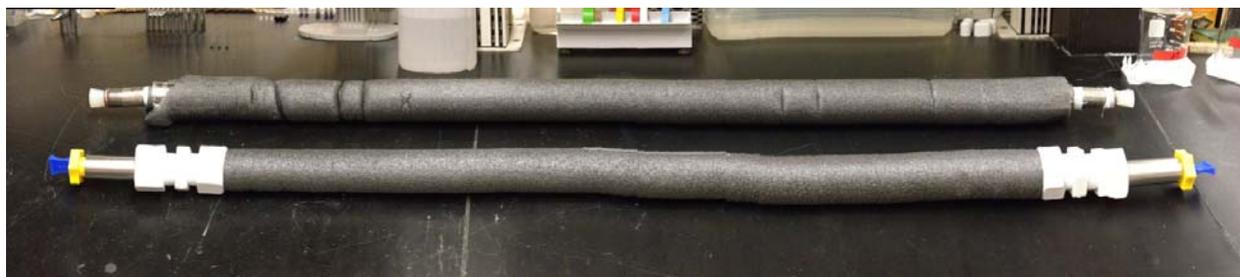
Note: Top: LSL with threaded SS nipples and silicone stoppers. Bottom: CSL with unthreaded SS pipe nipples connected with polypropylene compression fittings and fitted with HDPE stoppers.

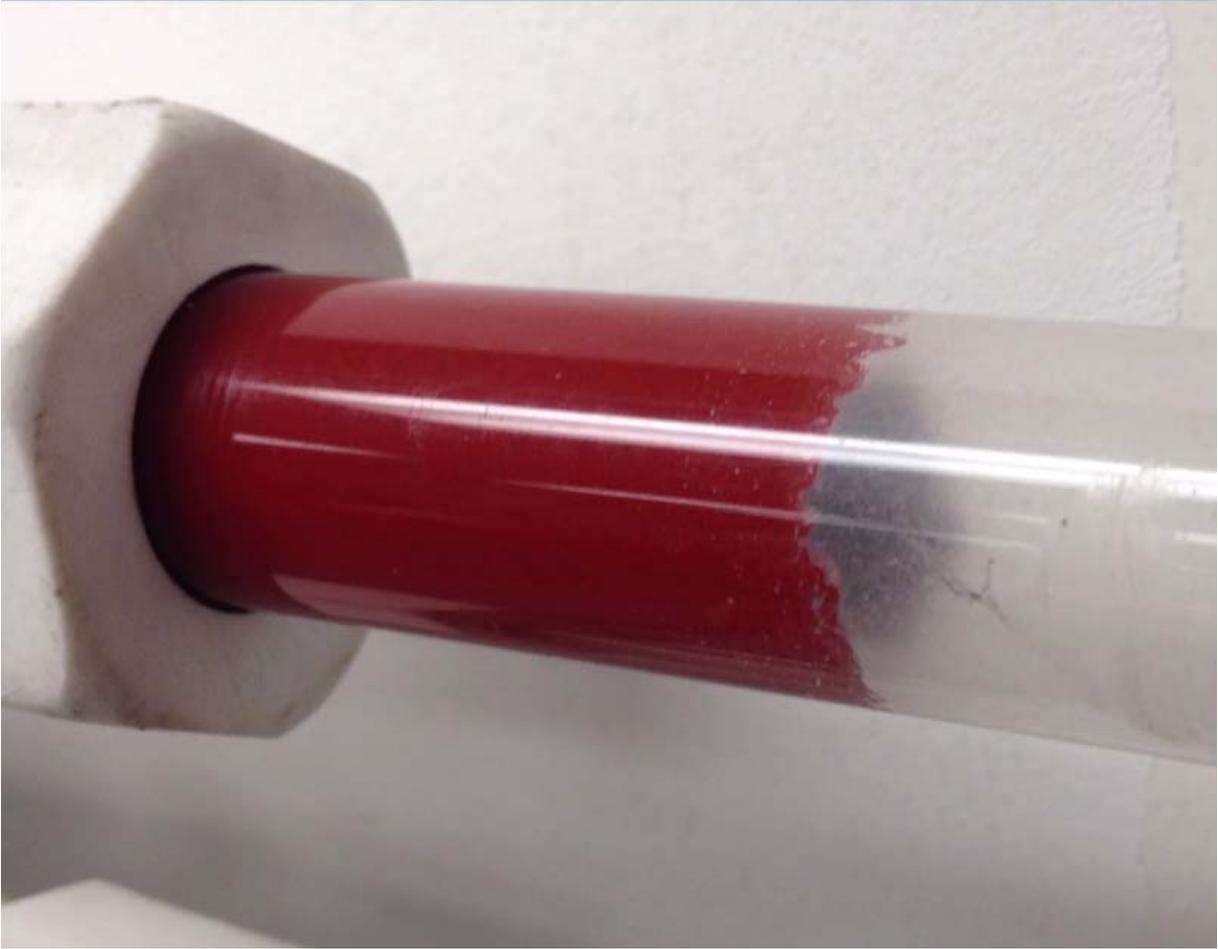
Figure 3.2 Image of epoxy coating as it is being installed through transparent acrylic pipe

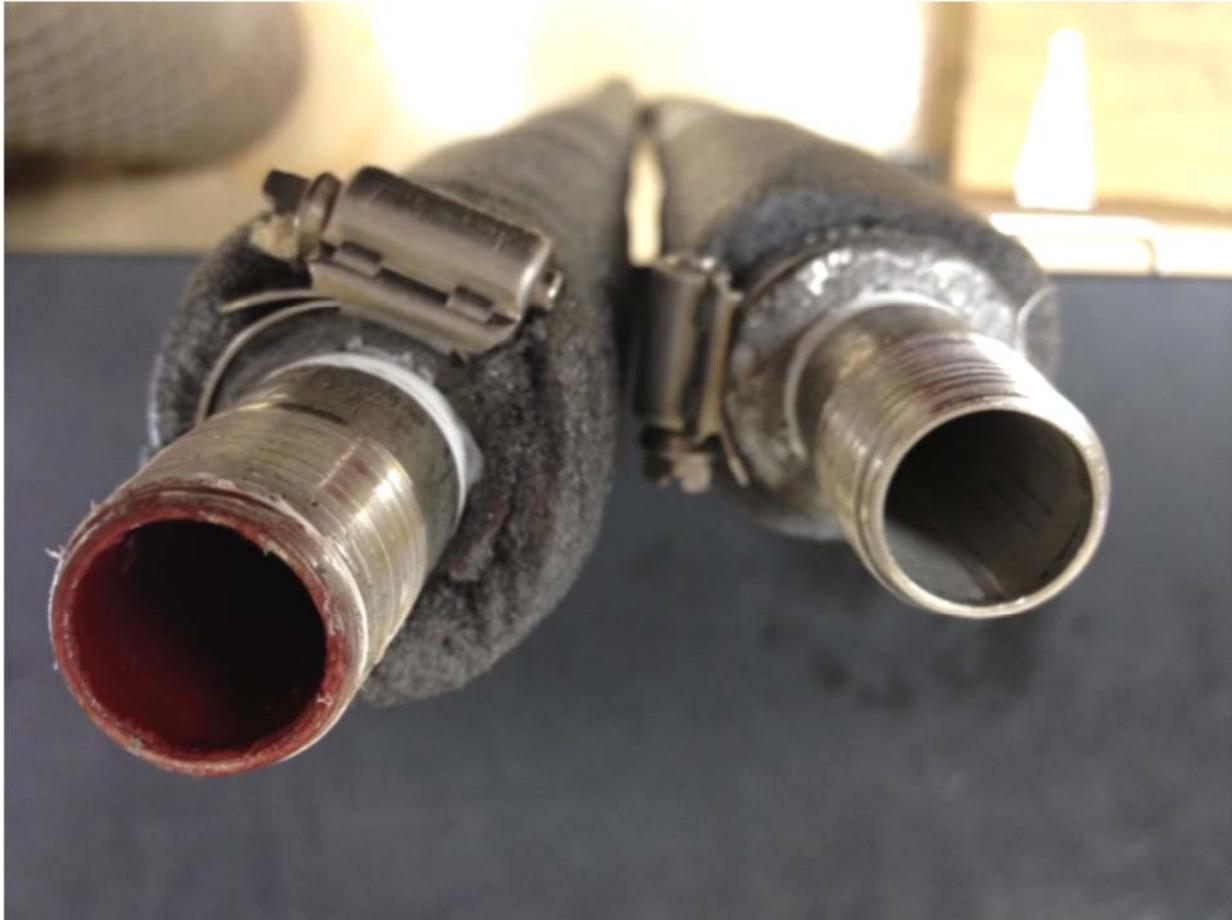
Figure 3.3 Image comparing an epoxy-coated LSL (left) to an uncoated LSL (right)

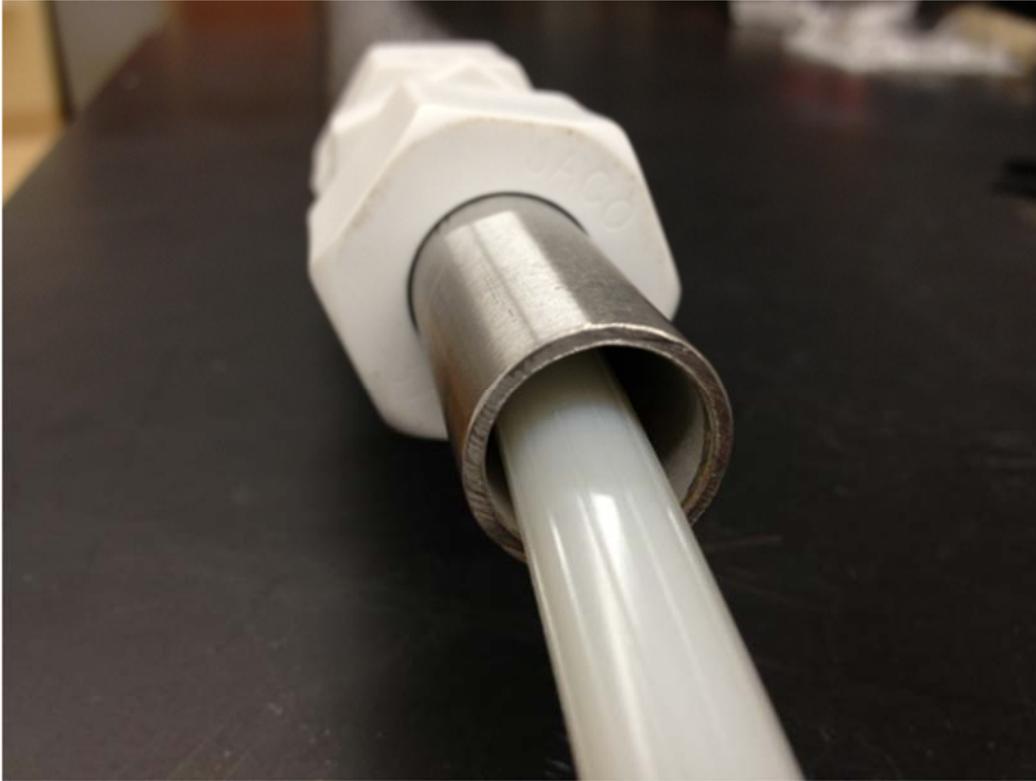
Figure 3.4 Unexpanded PET liner inserted into an unthreaded SS pipe nipple

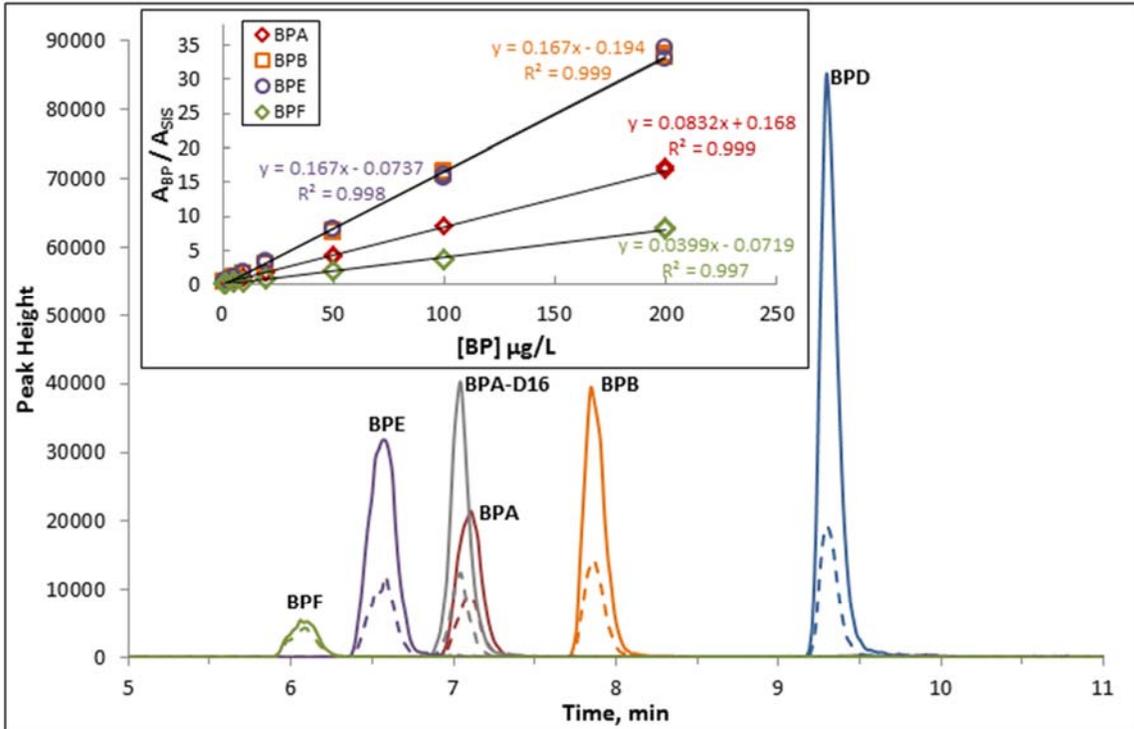
Figure 3.6 LC/MS/MS chromatogram of a 20 $\mu\text{g/L}$ mixed bisphenols standard and calibration curves (top); LC/MS/MS chromatogram of an 80 $\mu\text{g/L}$ mixed chlorinated bisphenol A standard and calibration curves (bottom)

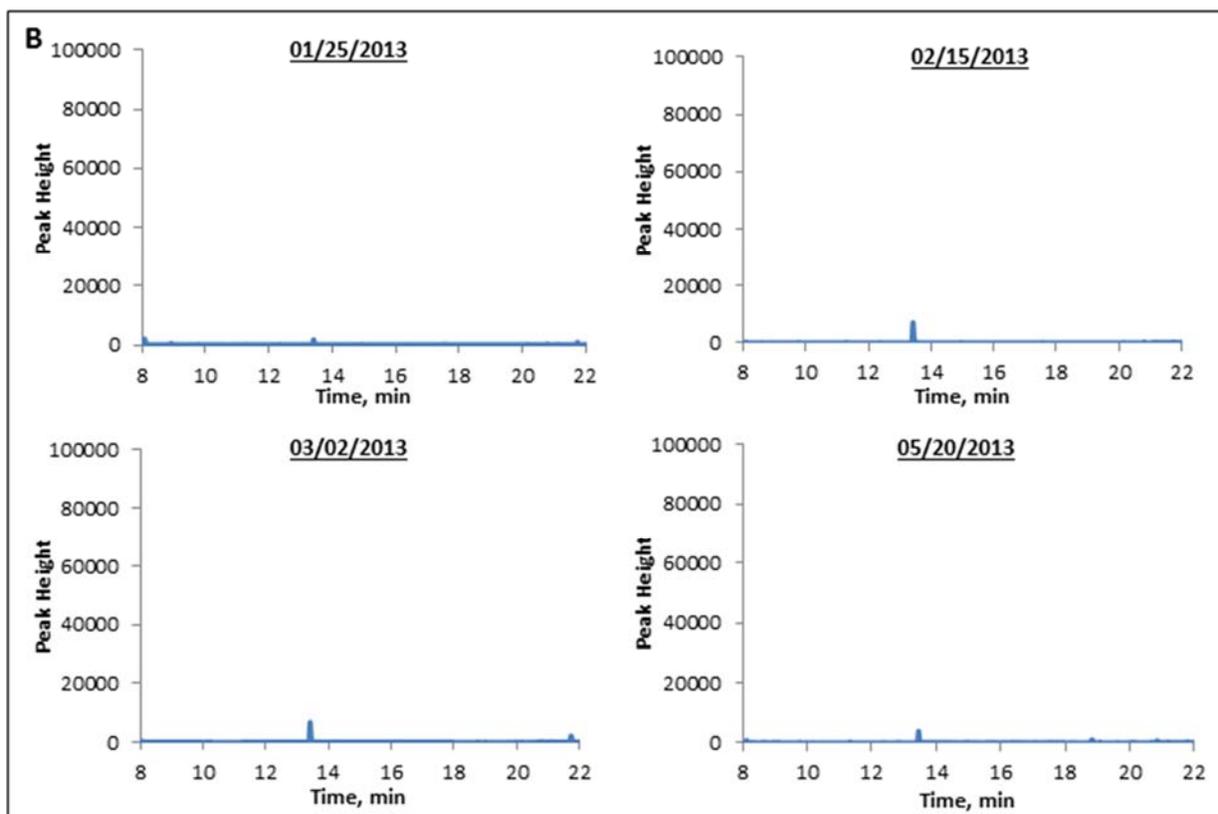
Figure 3.9 GC/MS chromatograms of control blanks for analysis of phthalate esters: (A) control blank used during method optimization, with inlay zoomed in to show low-level phthalates in the background; (B) control blanks from different dates illustrating the variable low-level phthalate background.

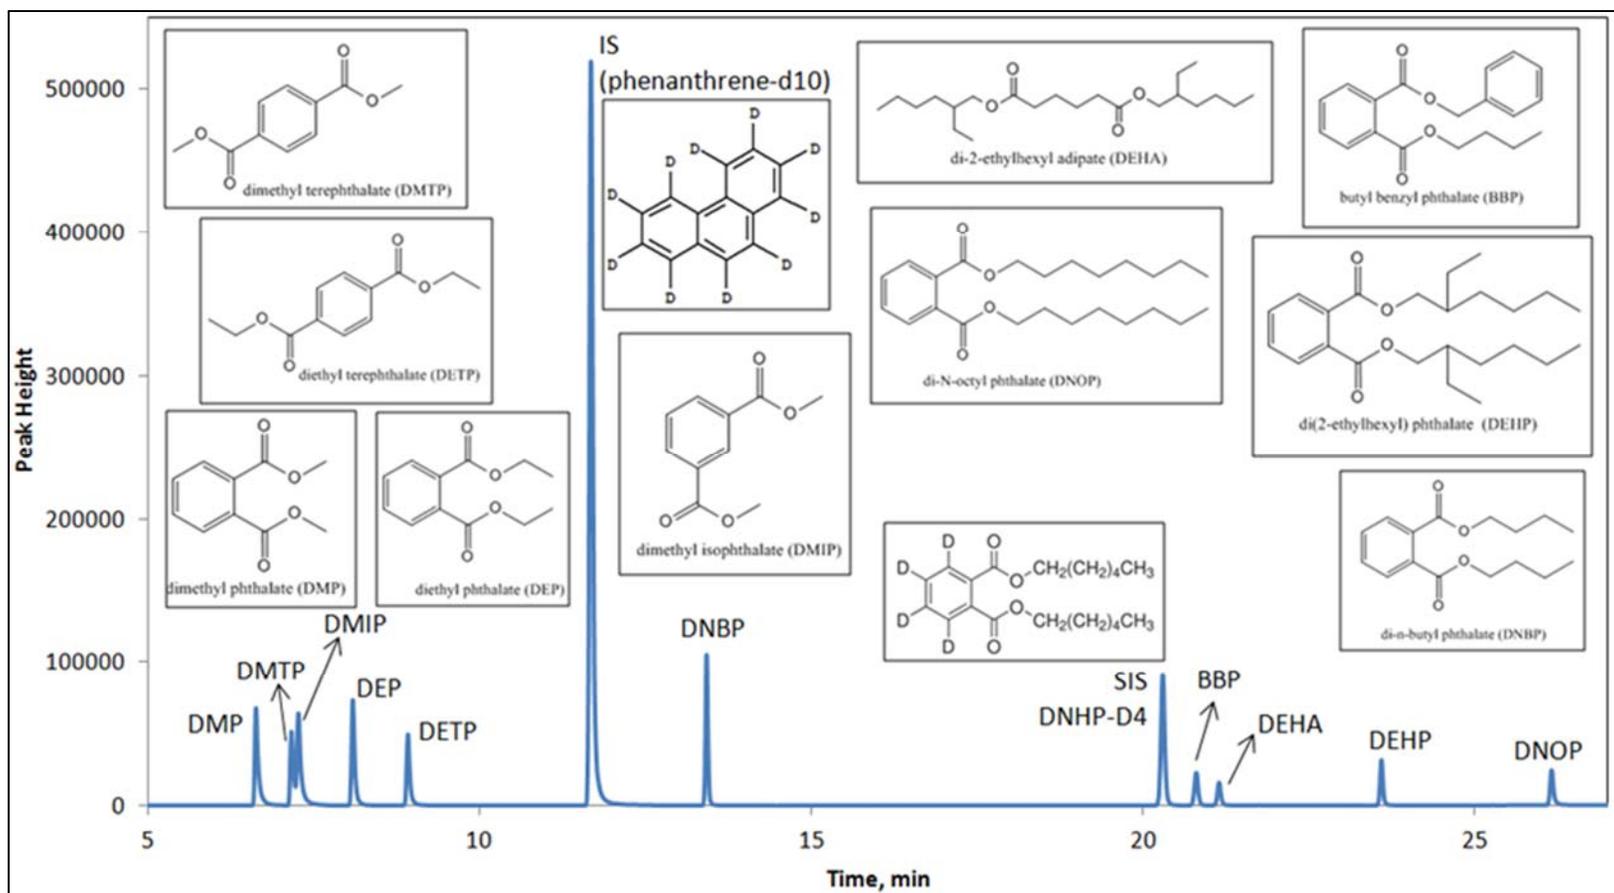
Figure 3.10 GC/MS with LLE extraction of an 800 µg/L mixed phthalate ester standard

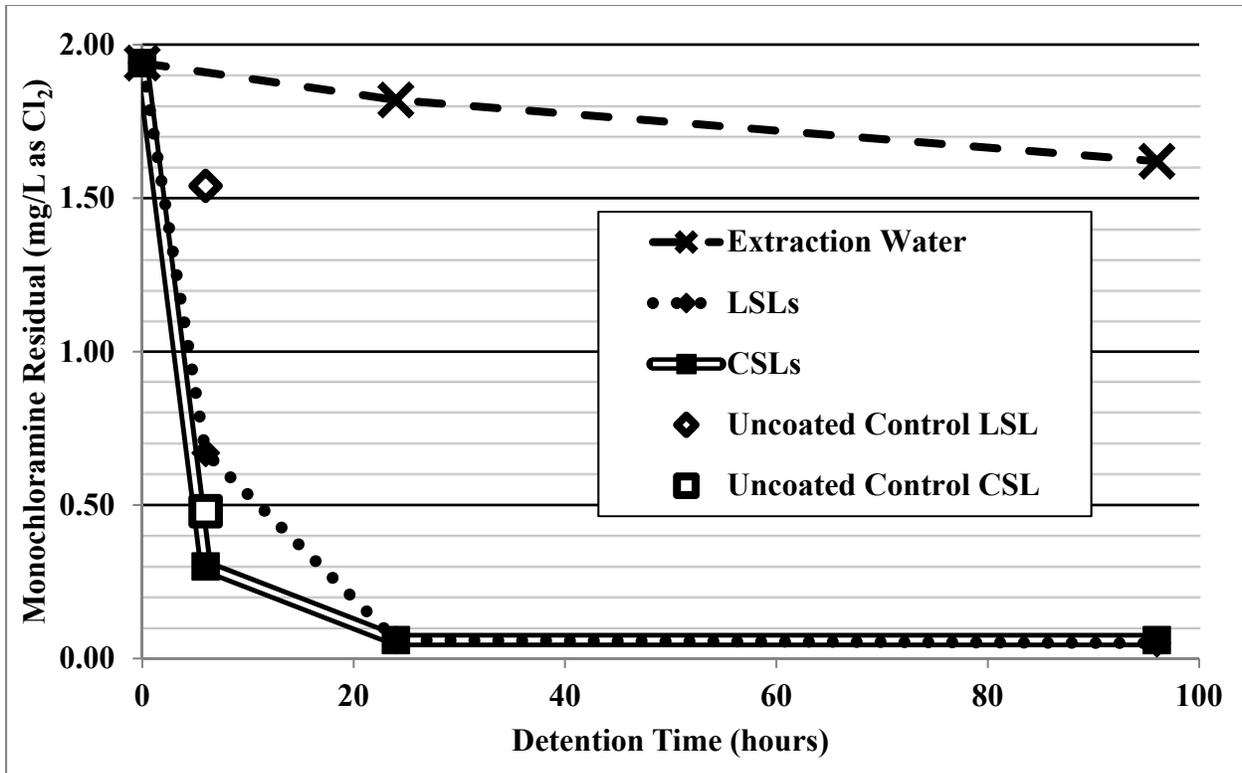
Figure 4.5 Monochloramine versus time in samples from epoxy-coated pipe sections

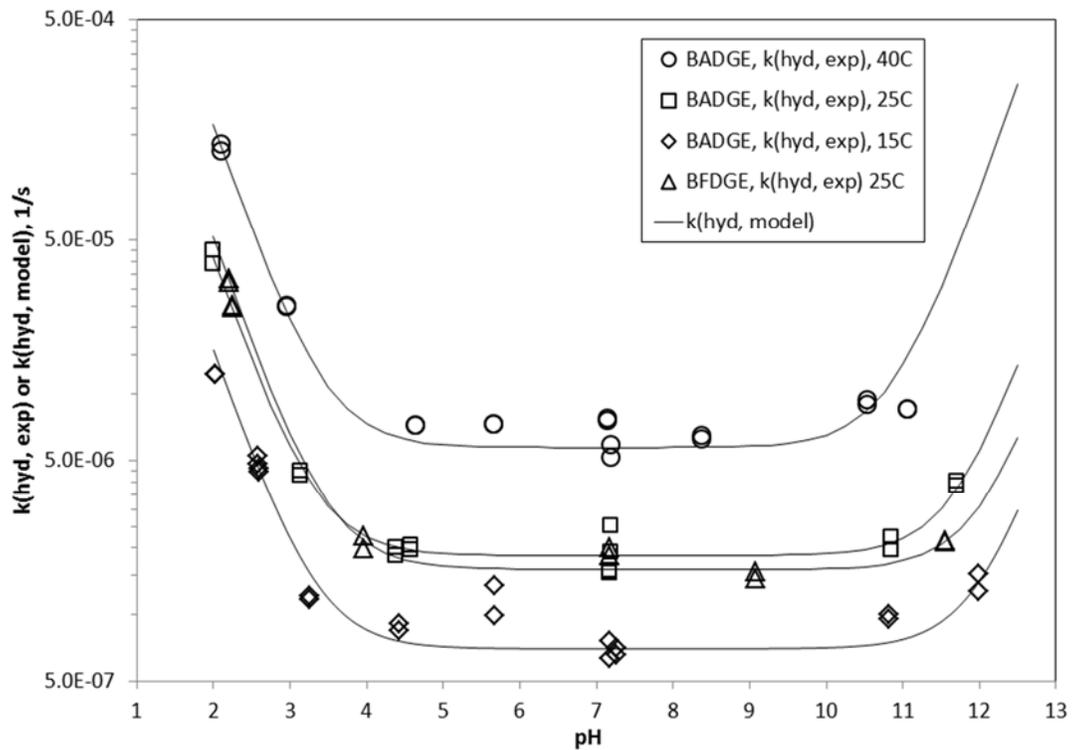
Figure 4.14 Plot comparing the experimental kinetic rates (data points) and model results (black lines) for hydrolysis of BADGE and BFDGE

BADGE hydrolysis was studied as a function of pH (2–12) and temperature (15–40 °C). BADGE hydrolyzed to BADGE-H₂O and then to BADGE-2H₂O, the major end product under these conditions. Experimentally measured BADGE hydrolysis rates agreed well with modeled rates; thus, the model can be used to estimate BADGE concentrations remaining in water over time, facilitating exposure assessments. The half-lives of BADGE at pH 7 and 15, 25, 35, and 40 °C were found to be 11, 4.6, 2.0, and 1.4 days, respectively. At 25 °C and pH 2–12, BFDGE hydrolyzed at a rate very similar to that of BADGE, with a half-life of 5 days at pH 7 and 25 °C. No hydrolysis or decay of BPA was observed for reaction times up to 30 days for pH values of 2–12 at 25–40 °C.

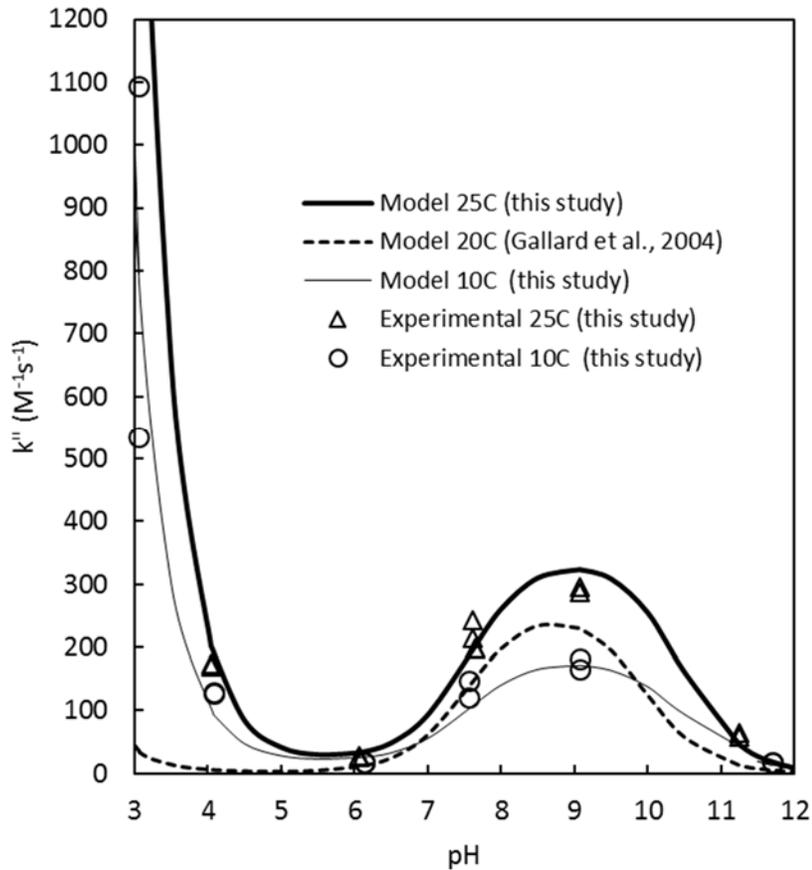
Figure 4.16 Experimental, modeled, and previously published second-order rate constants for BPA oxidation by free chlorine

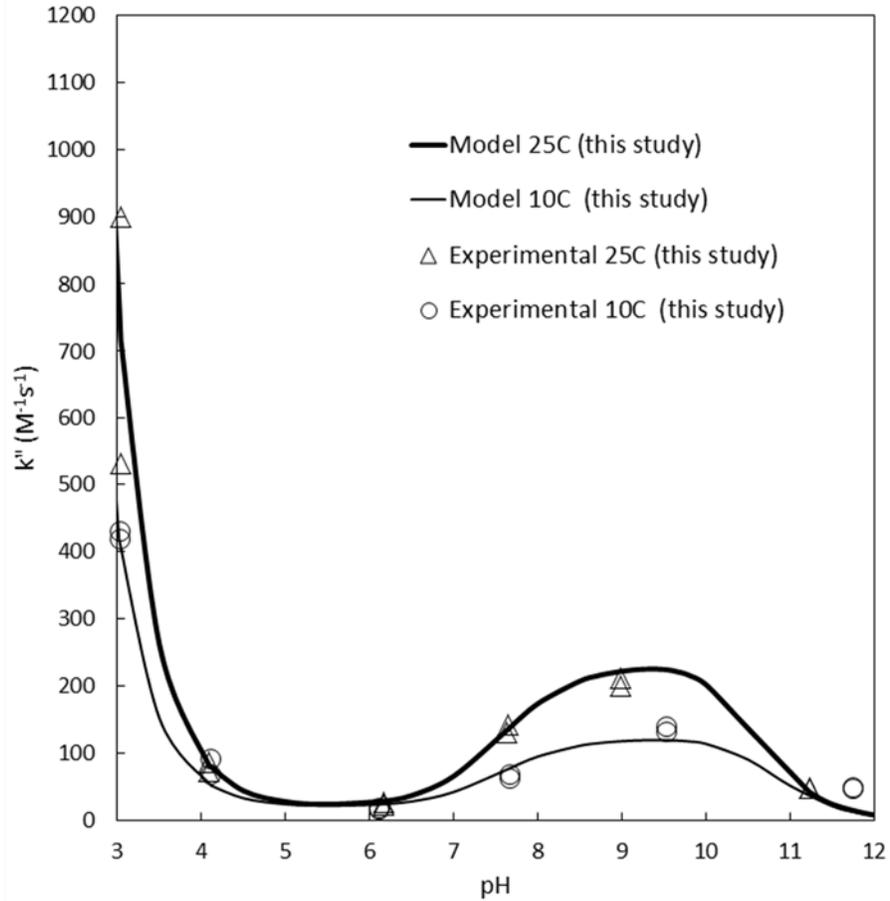
Figure 4.17 Experimental and modeled second-order rate constants for oxidation of BPF with free chlorine

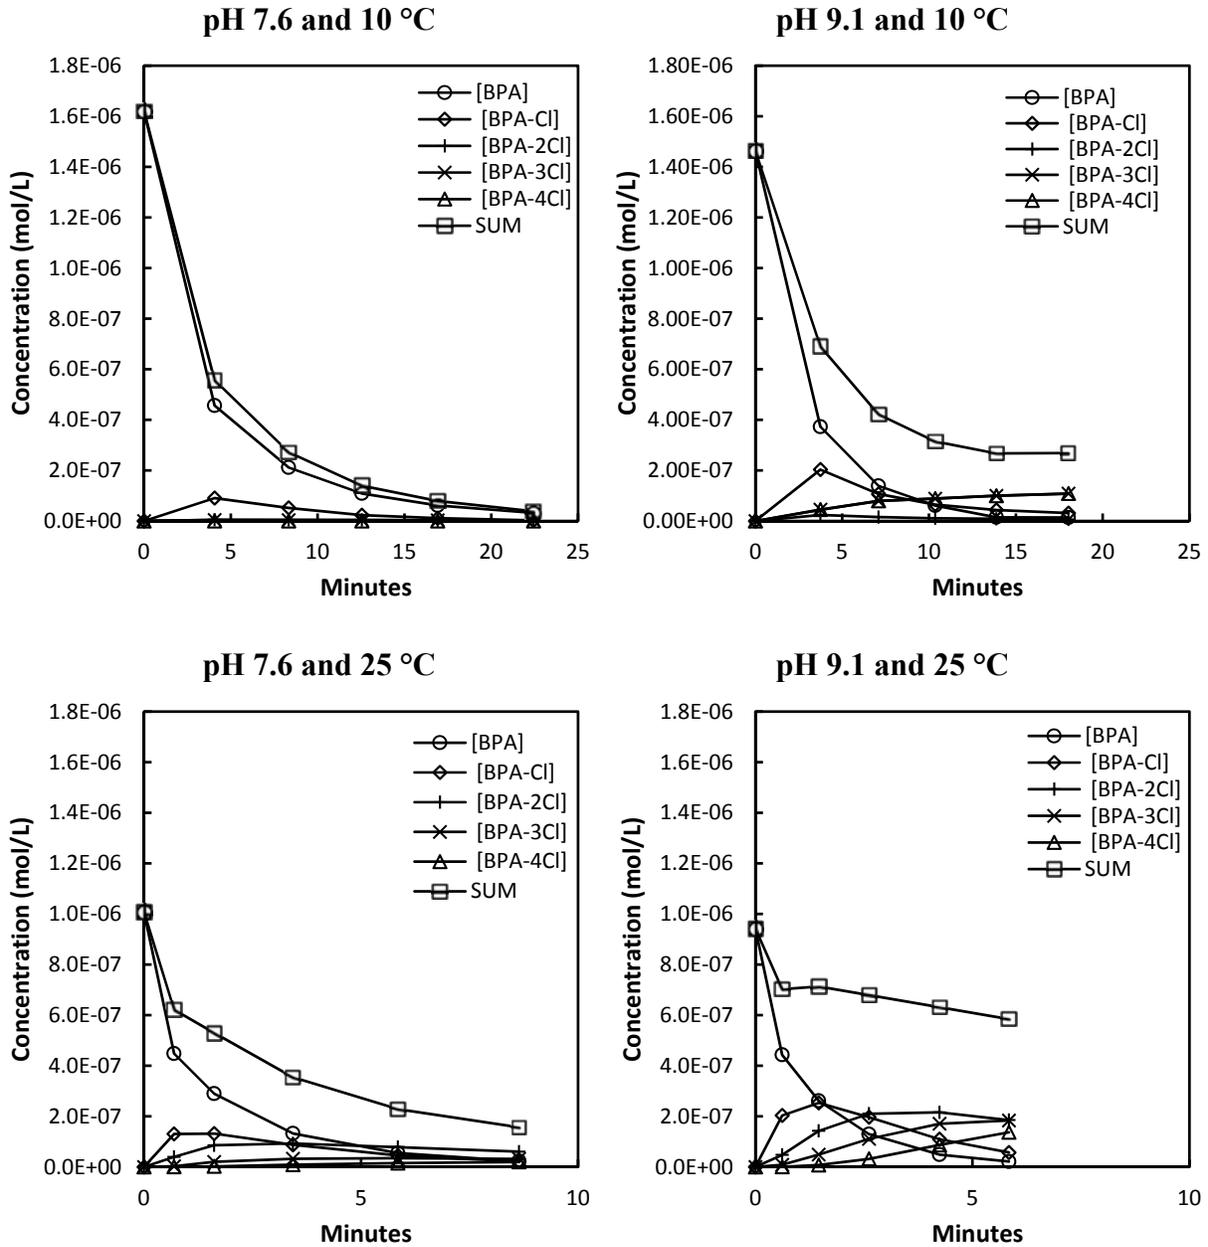
Figure 4.19 BPA decay and formation of chlorinated by-products during oxidation of BPA with free chlorine at pH 7.6 and 9.1 at 10 °C and 25 °C

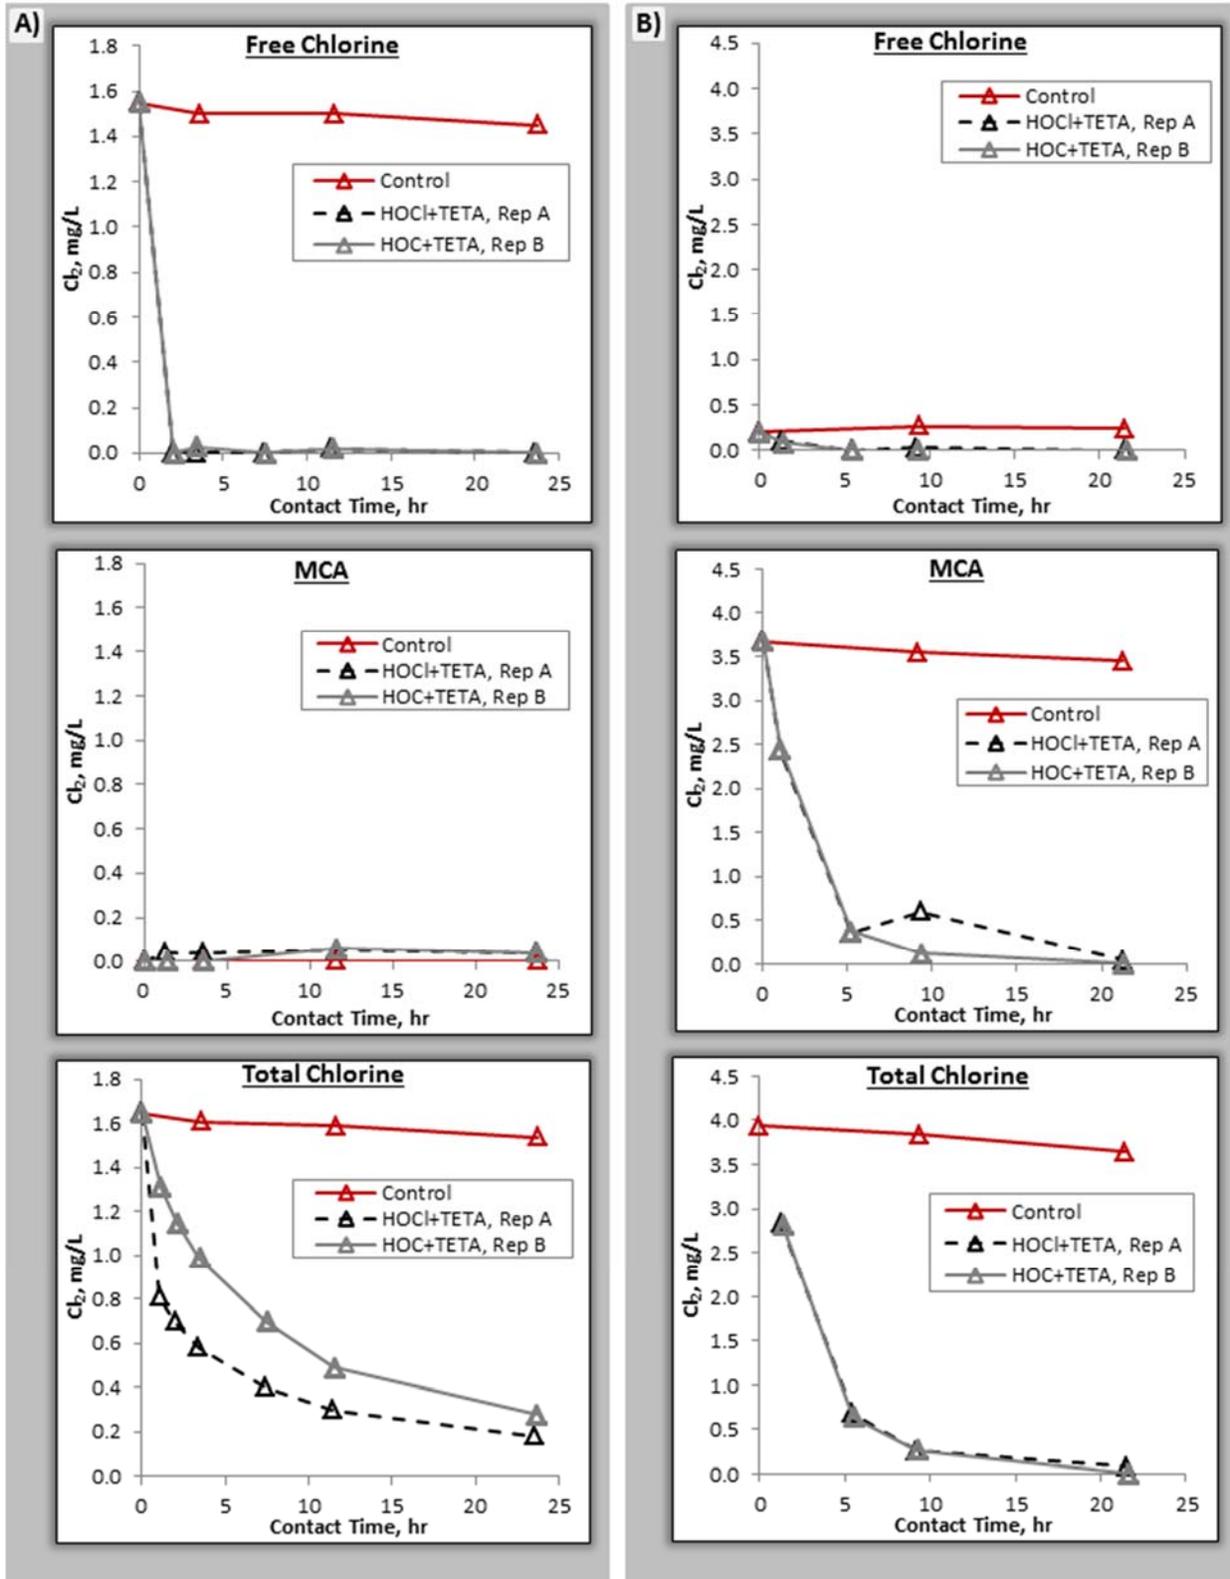
Figure 4.22 Concentrations of free chlorine, monochloramine (MCA), and total chlorine (all in mg/L as Cl₂) over time in solutions containing: A) TETA and free chlorine; and B) TETA and MCA

What does merit attention in comparing the results of [Figure 4.23](#) to those in [Figure 4.22](#) is that in both cases: 1) free chlorine decayed much more rapidly than MCA; and 2) total chlorine decayed less rapidly than free chlorine or MCA, although the difference was very small on average, and variable, for the epoxy-coated pipe sections ([Figure 4.23](#)). The latter result is as expected since, if organic chloramines formed as free or combined chlorine reacted with the epoxy coating, most of them would be expected to be associated with the solid phase (whether bound or trapped in the epoxy) and not with the aqueous phase from which the samples were drawn for analysis.
