Evaluation of Lead Service Line Lining and Coating Technologies

Project #4351

Stephen J. Randtke, Edward F. Peltier, Craig D. Adams, Rachael F. Lane, Zachary A. Breault, and Ray E. Carter, Jr.
University of Kansas, Lawrence, KS 66045

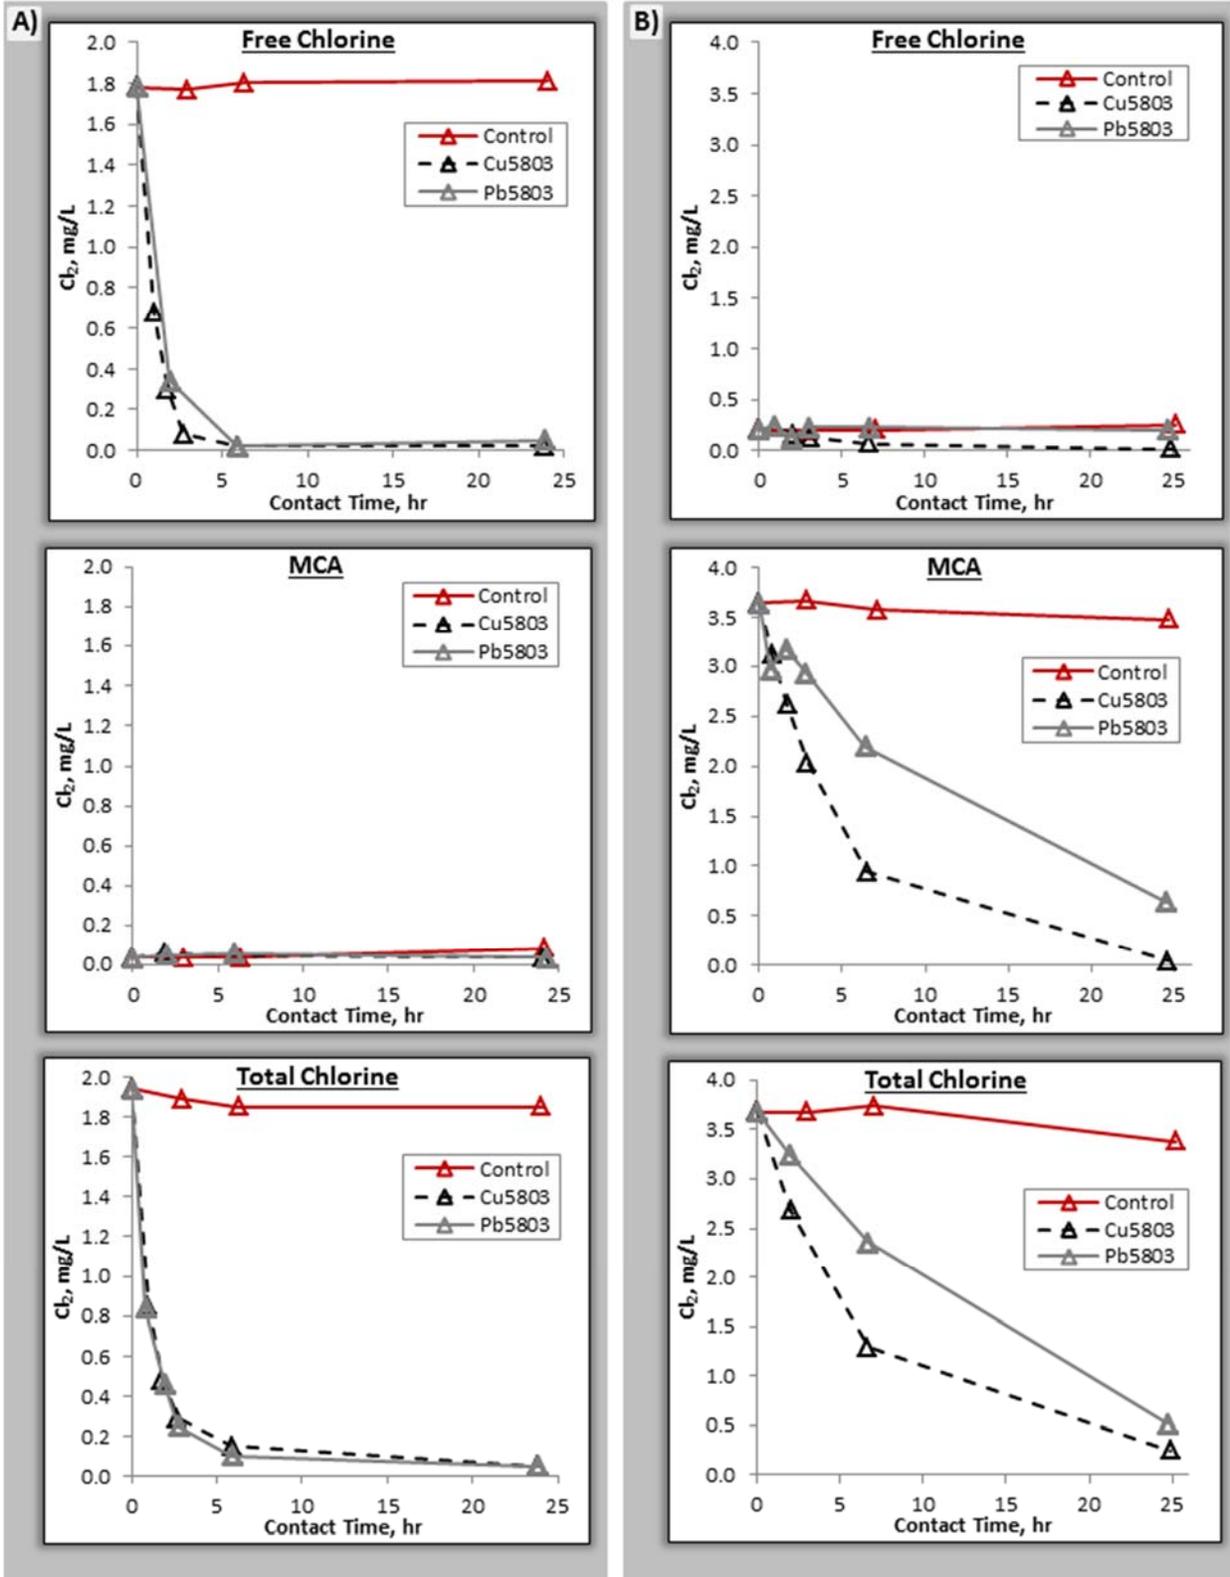
Figure 4.23 Concentrations of free chlorine, monochloramine (MCA), and total chlorine (all in mg/L as Cl₂) over time in epoxy-coated lead and copper pipe sections filled with extraction water initially containing: A) free chlorine; and B) monochloramine (MCA)

What does merit attention in comparing the results of [Figure 4.23](#) to those in [Figure 4.22](#) is that in both cases: 1) free chlorine decayed much more rapidly than MCA; and 2) total chlorine decayed less rapidly than free chlorine or MCA, although the difference was very small on average, and variable, for the epoxy-coated pipe sections ([Figure 4.23](#)). The latter result is as expected since, if organic chloramines formed as free or combined chlorine reacted with the epoxy coating, most of them would be expected to be associated with the solid phase (whether bound or trapped in the epoxy) and not with the aqueous phase from which the samples were drawn for analysis.

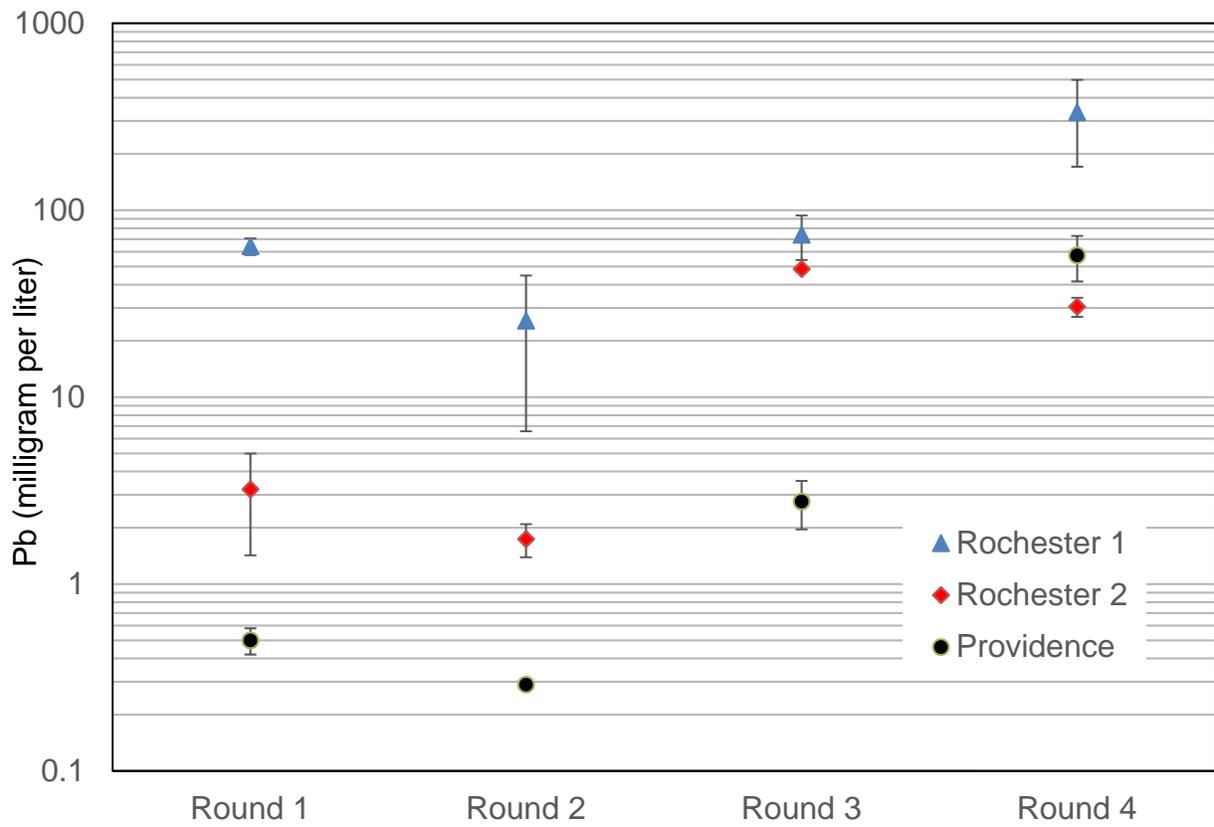
Note: Error bars indicate 1 SD.

Figure 4.24 Pb in extraction waters from unlined LSL pipe sections

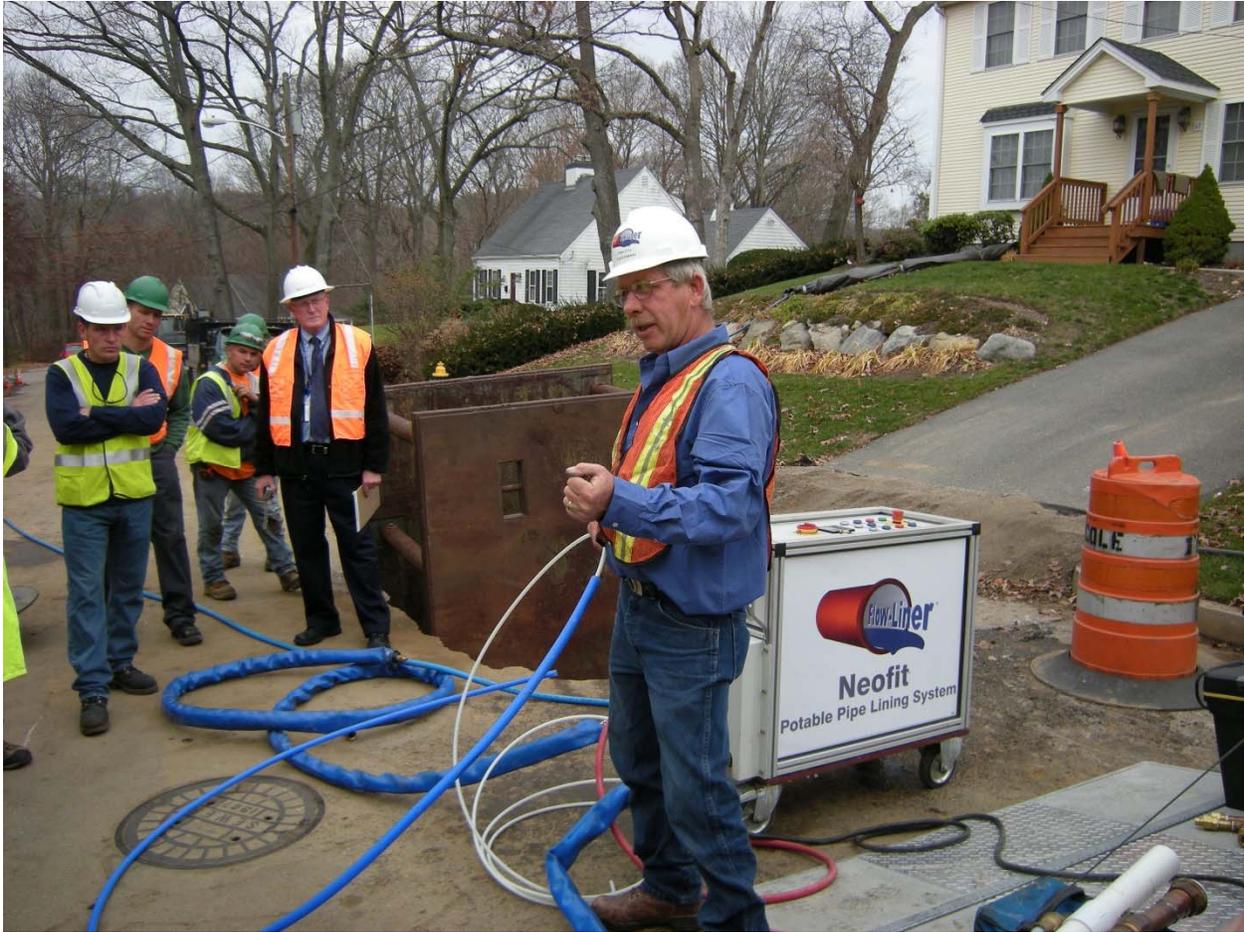
Figure 5.2 Demonstration of PET liner installation for Providence Water

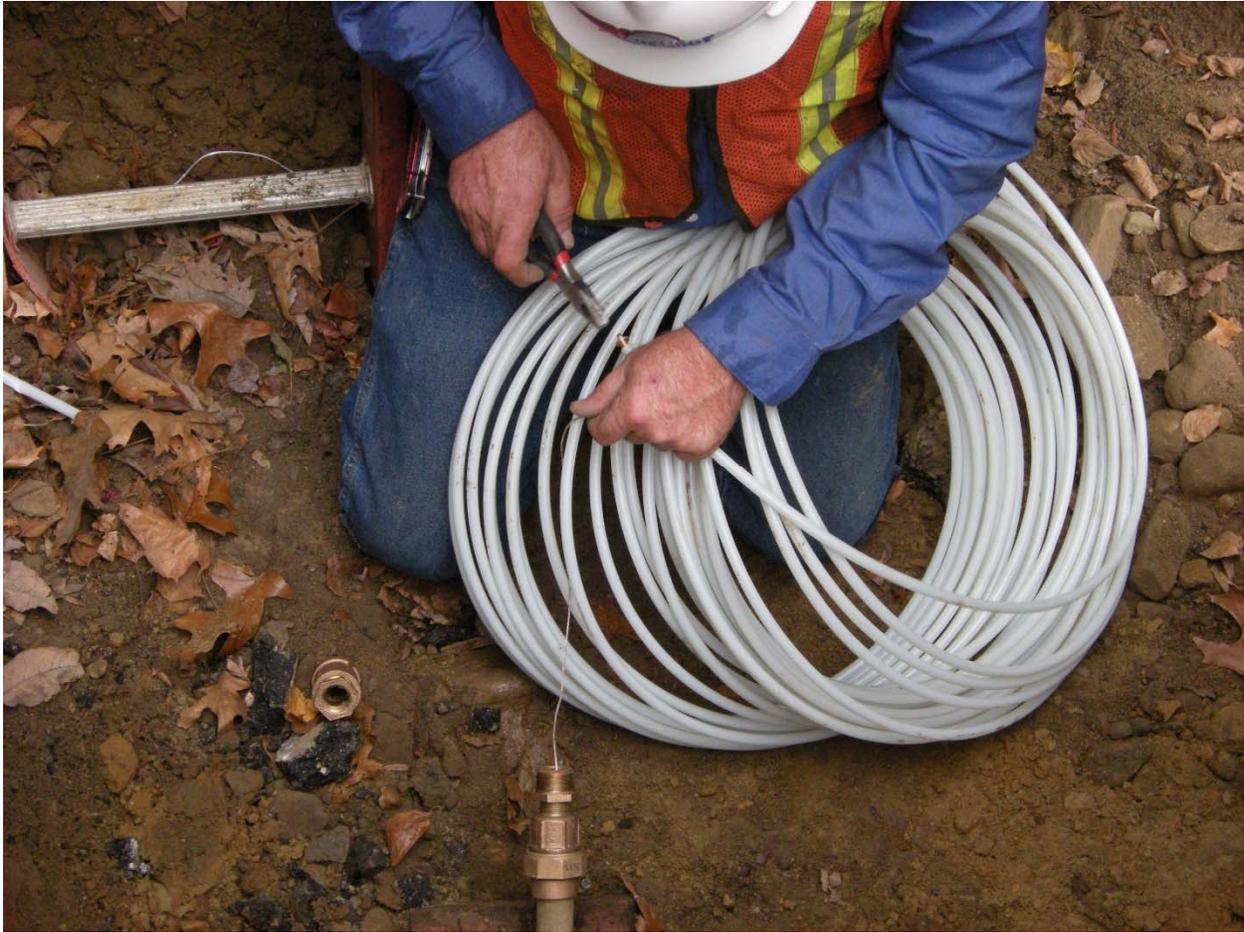
Figure 5.3 A PET liner being prepared for installation

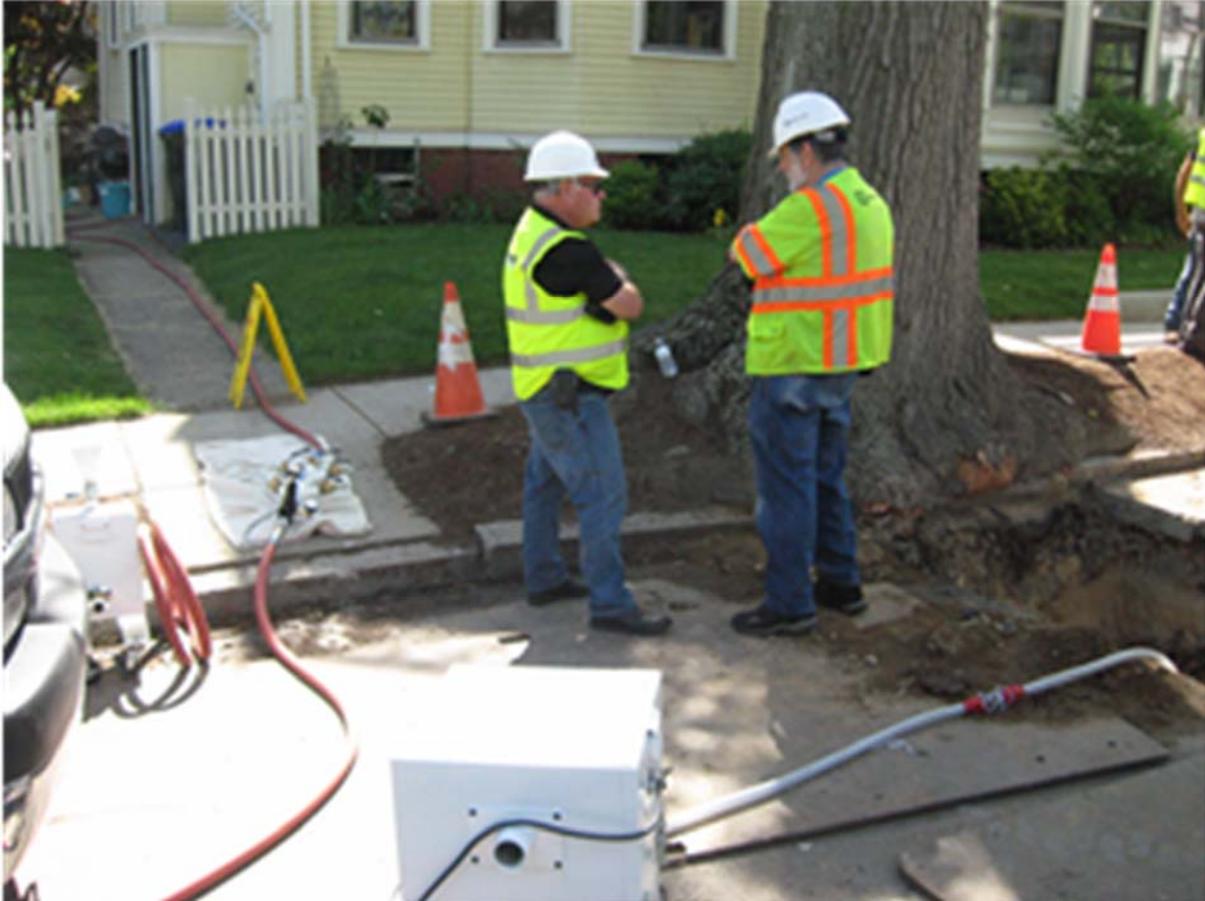
Figure 5.4 Demonstration of an epoxy-coating system for Providence Water
