# **APPENDIX L      SITE AUDIT STATEMENTS**

**Site Audit Report  
Stage 1 & 2, Little Bay Cove  
Development, Anzac Parade,  
Little Bay**

**Site Audit Report  
Stage 3 & 4, Little Bay Cove  
Development, Anzac Parade,  
Little Bay**

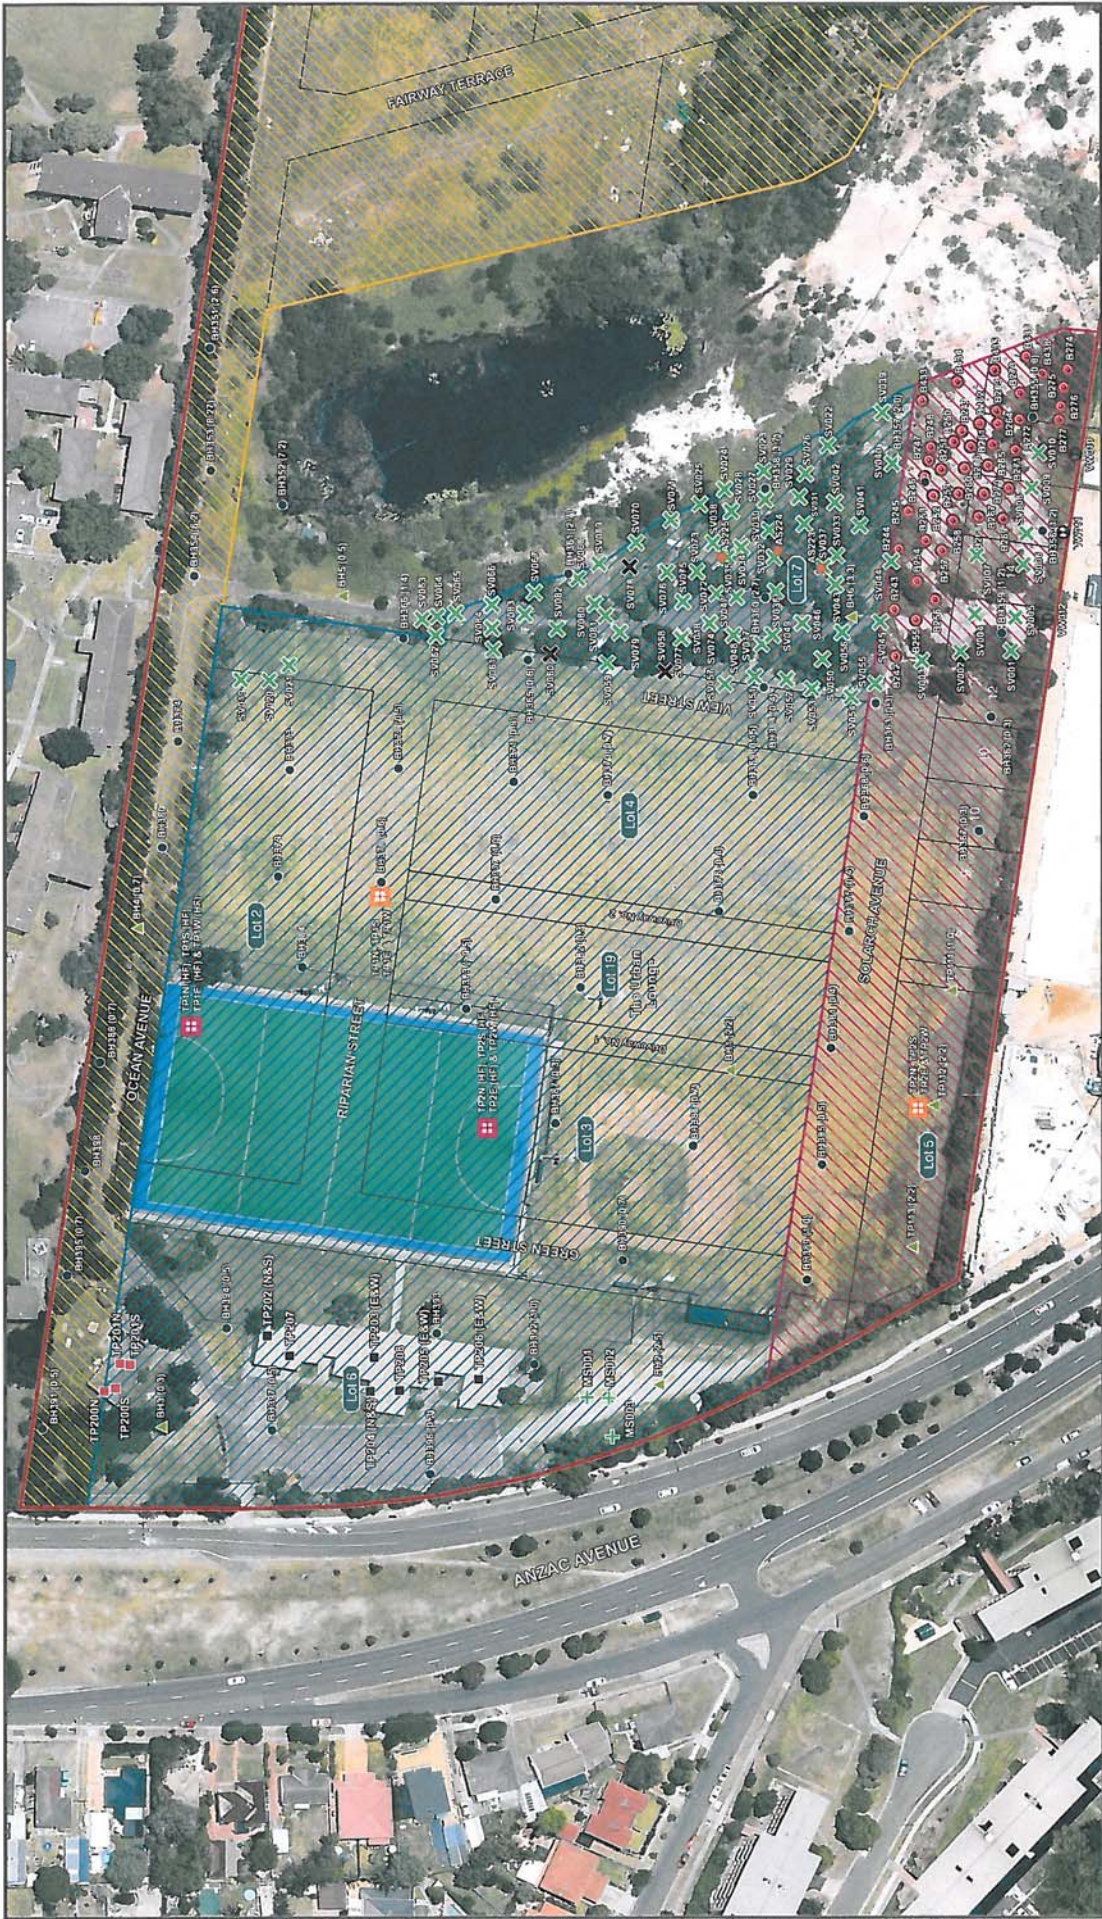
**Figure F1**

**Stage 1 and 2 Sample Location Plan**  
**Commercial & Industrial Property Pty Ltd (CIP)**  
**Remediation and Validation**  
**1406 - 1408 Anzac Parade,**  
**Little Bay NSW**

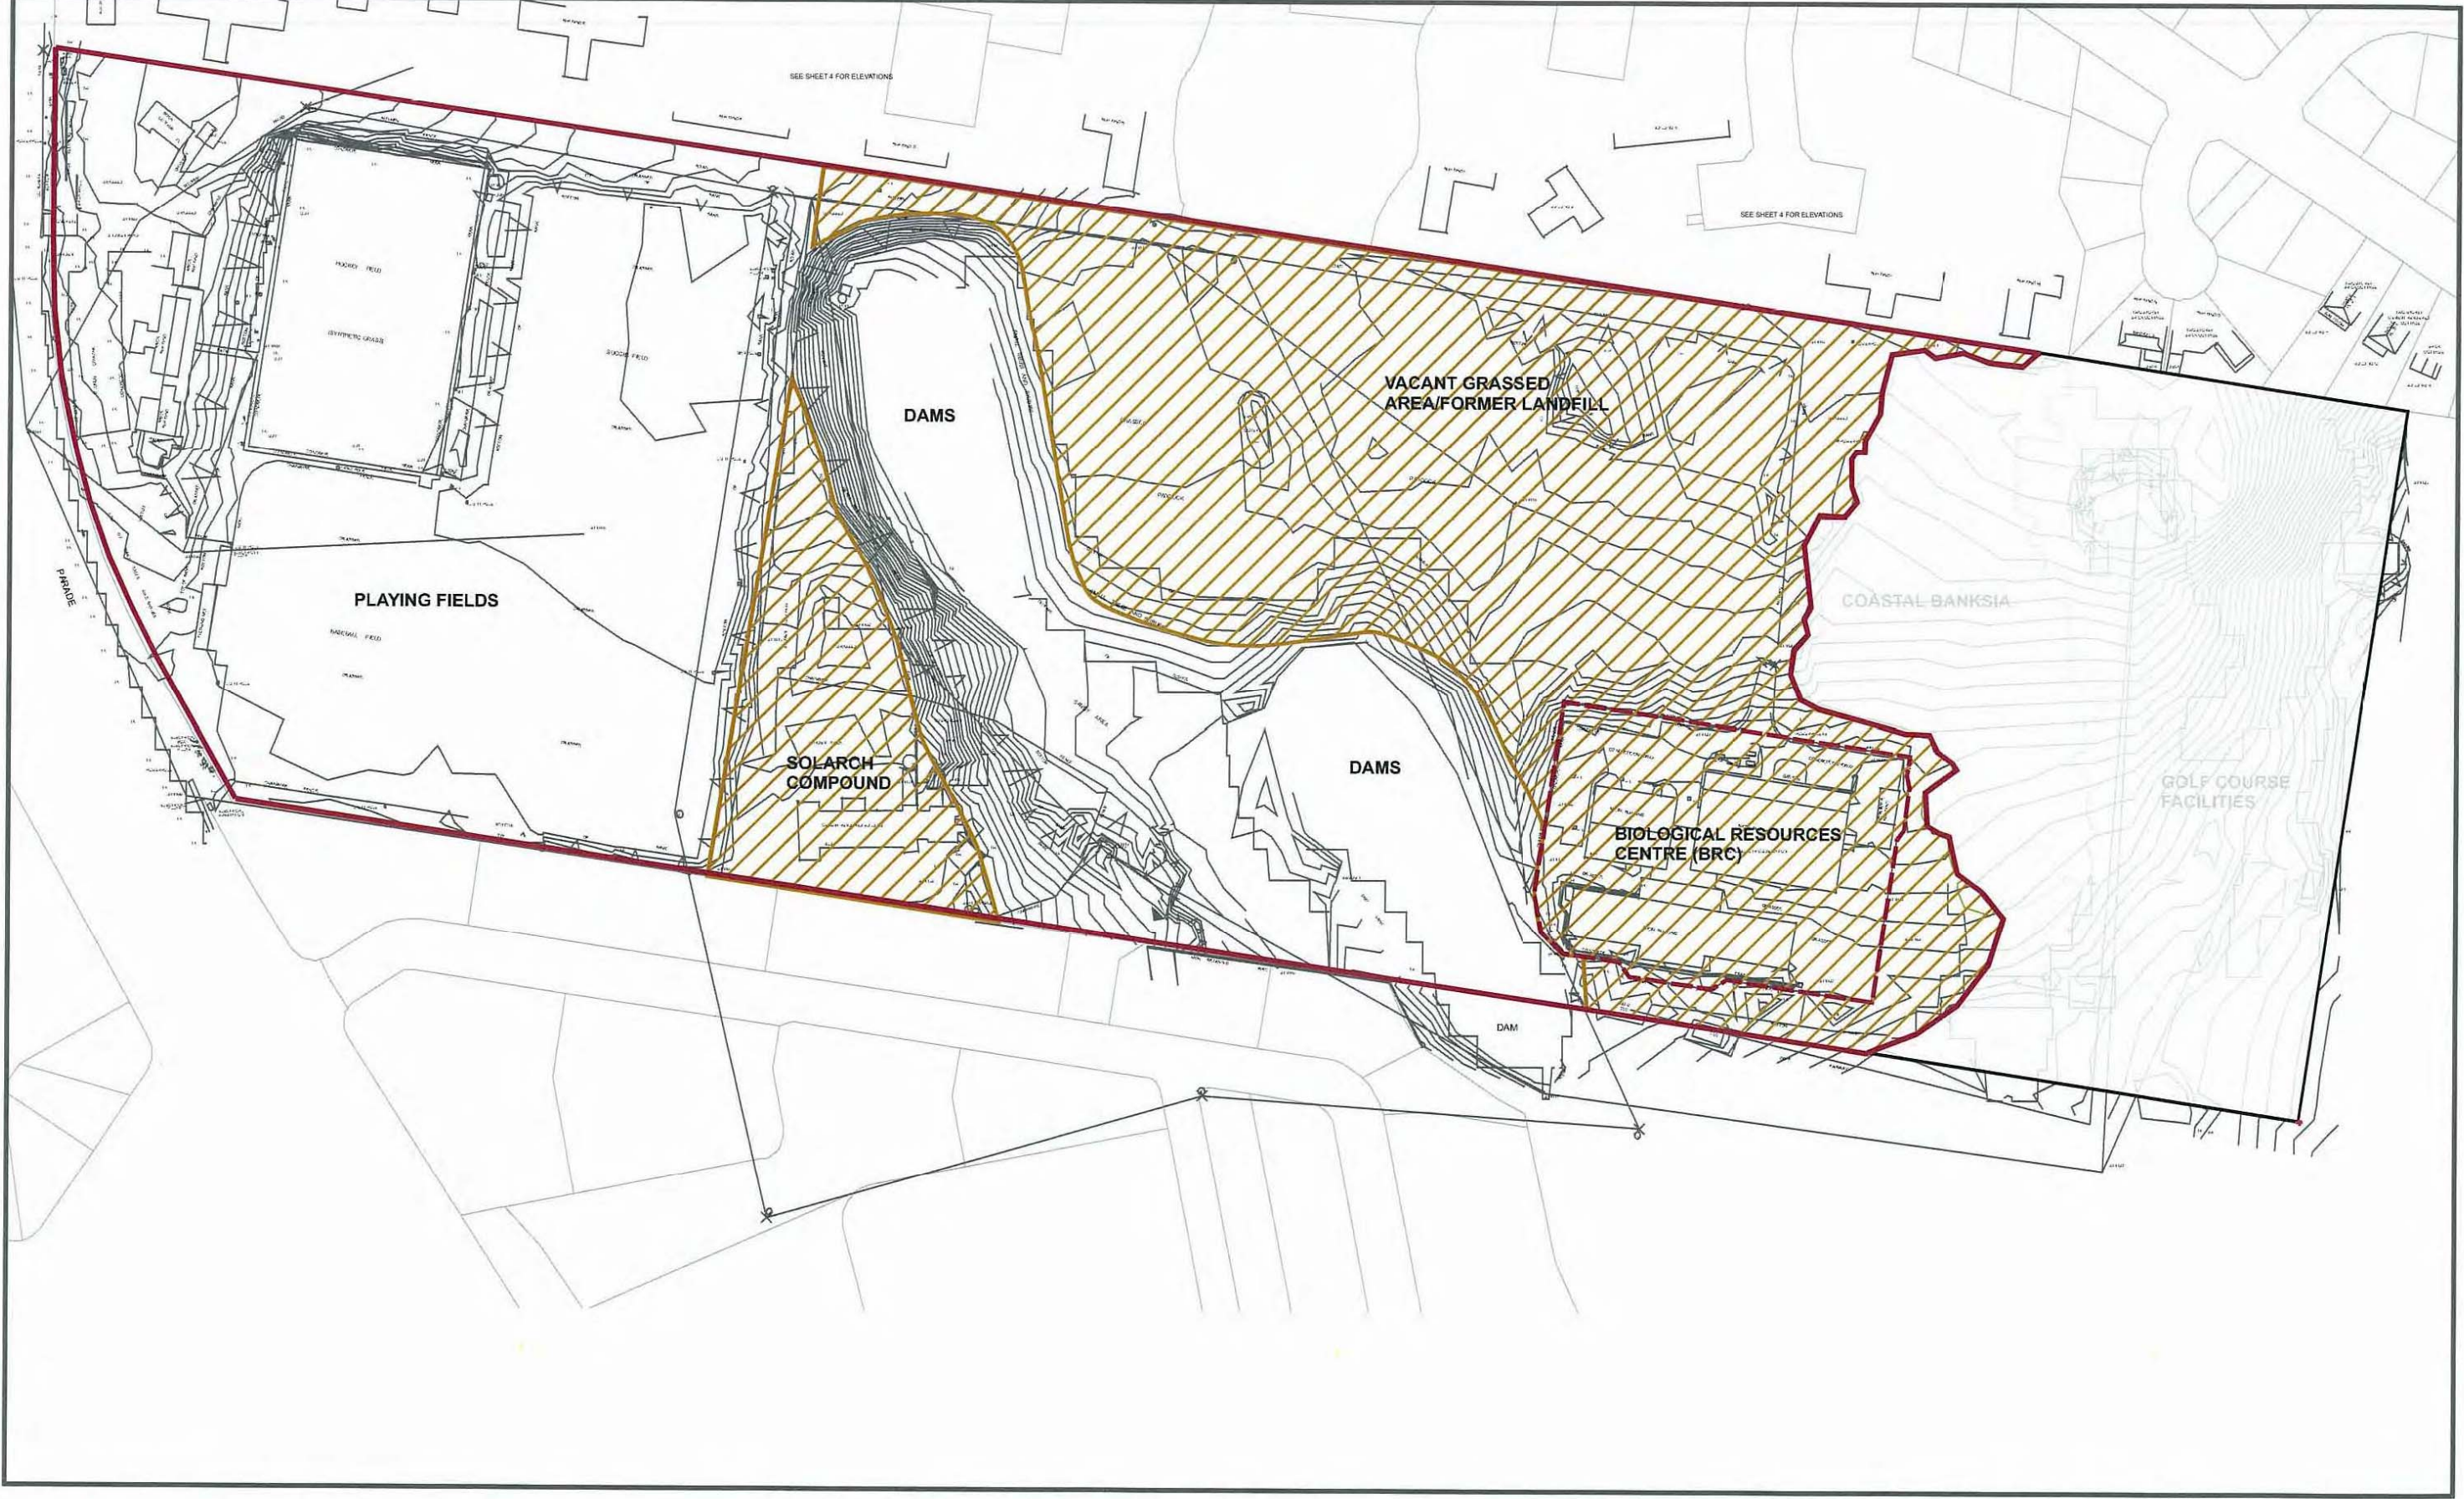
**Figure 5 | Remediation Area**  
**Charter Hall Pty Ltd**  
 1406 - 1408 Anzac Parade,  
 Little Bay NSW

- Little Bay Campus Boundary
- - - Biological Resources Centre Boundary (BRC)
- Remediation area

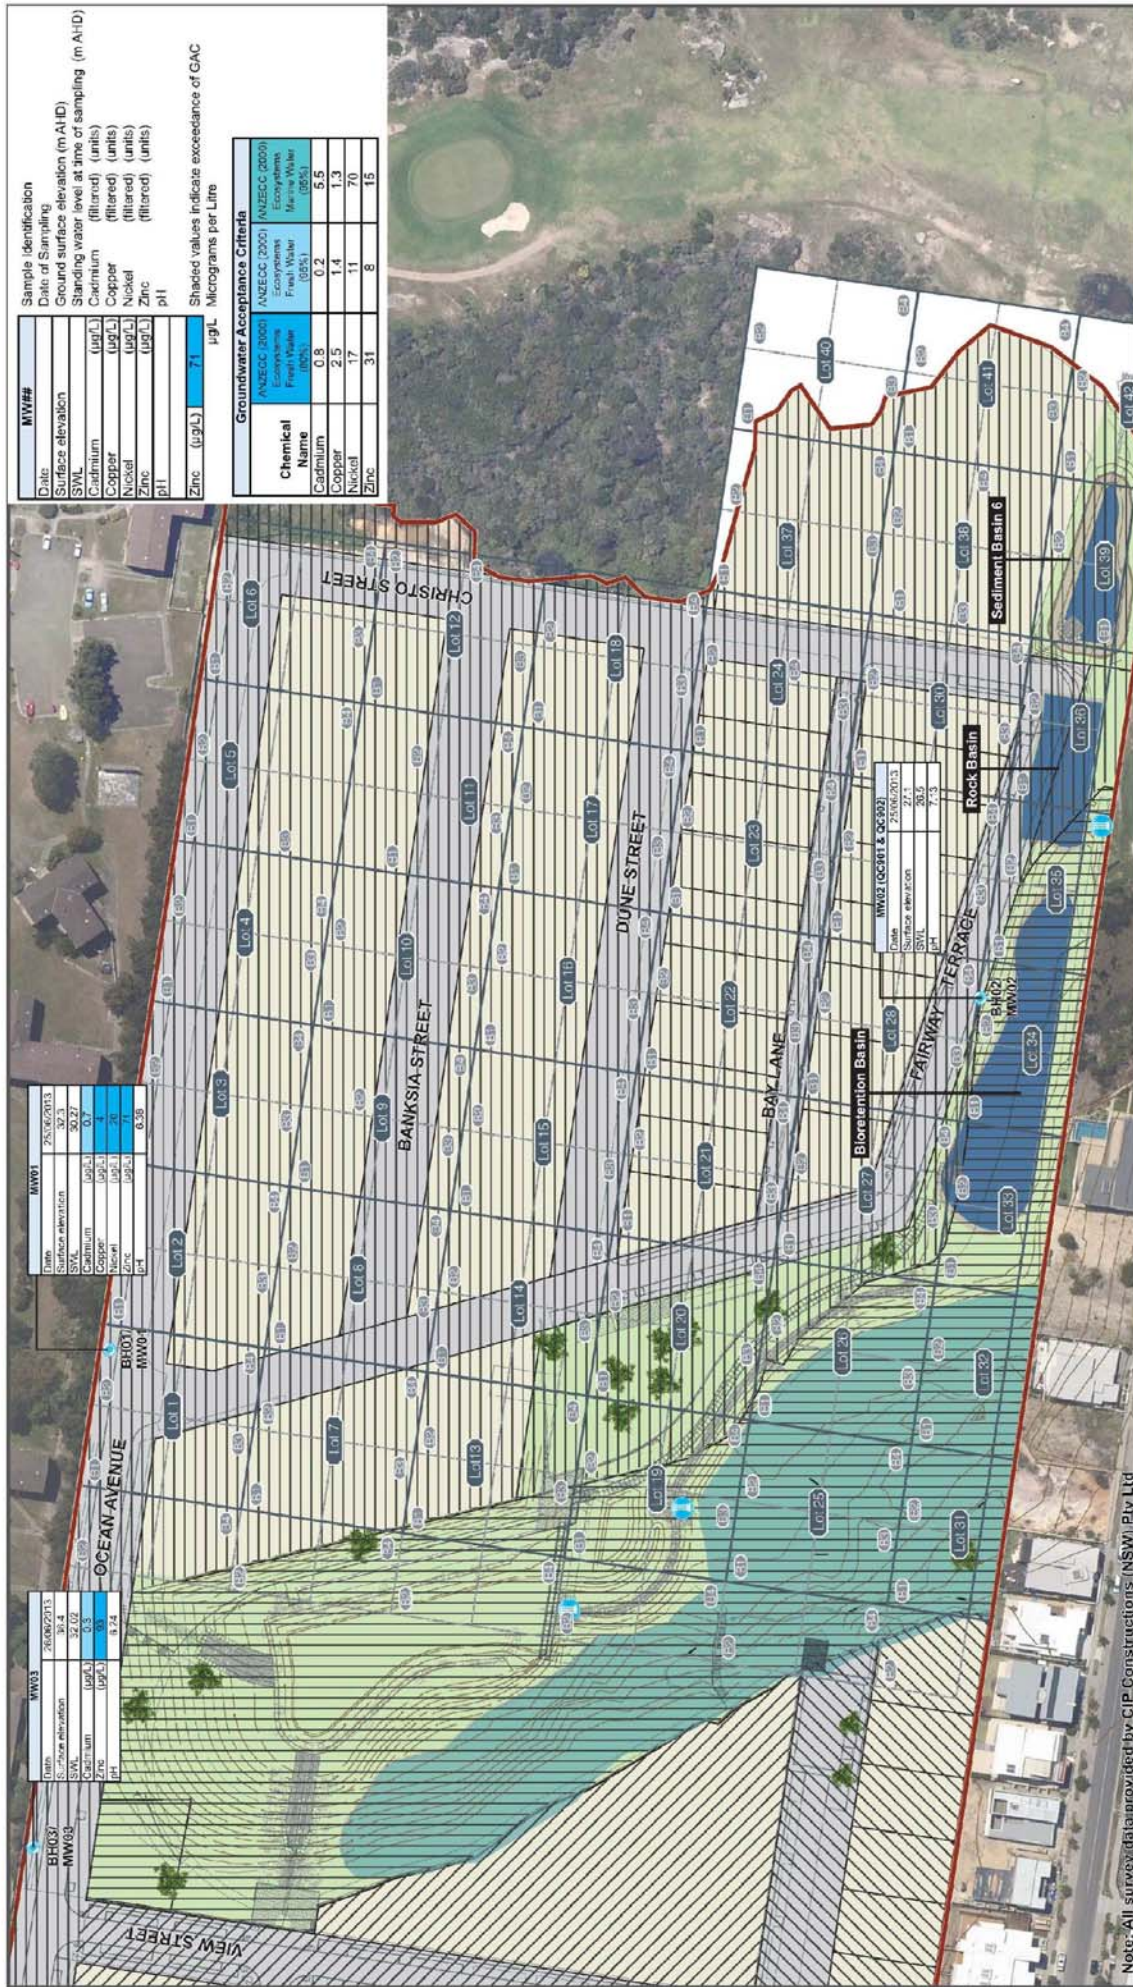
Item	MW01	26/06/2013
Date	26/06/2013	
Surface elevation	30.27	
SYWL	0.7	
Cadmium (µg/L)	4	
Copper (µg/L)	20	
Nickel (µg/L)	0.38	
Zinc (µg/L)	0.38	
pH	7.4

Item	MW03	26/06/2013
Date	26/06/2013	
Surface elevation	32.02	
SYWL	0.3	
Cadmium (µg/L)	0.3	
Copper (µg/L)	0.3	
Nickel (µg/L)	1.74	
Zinc (µg/L)	1.74	
pH	7.4

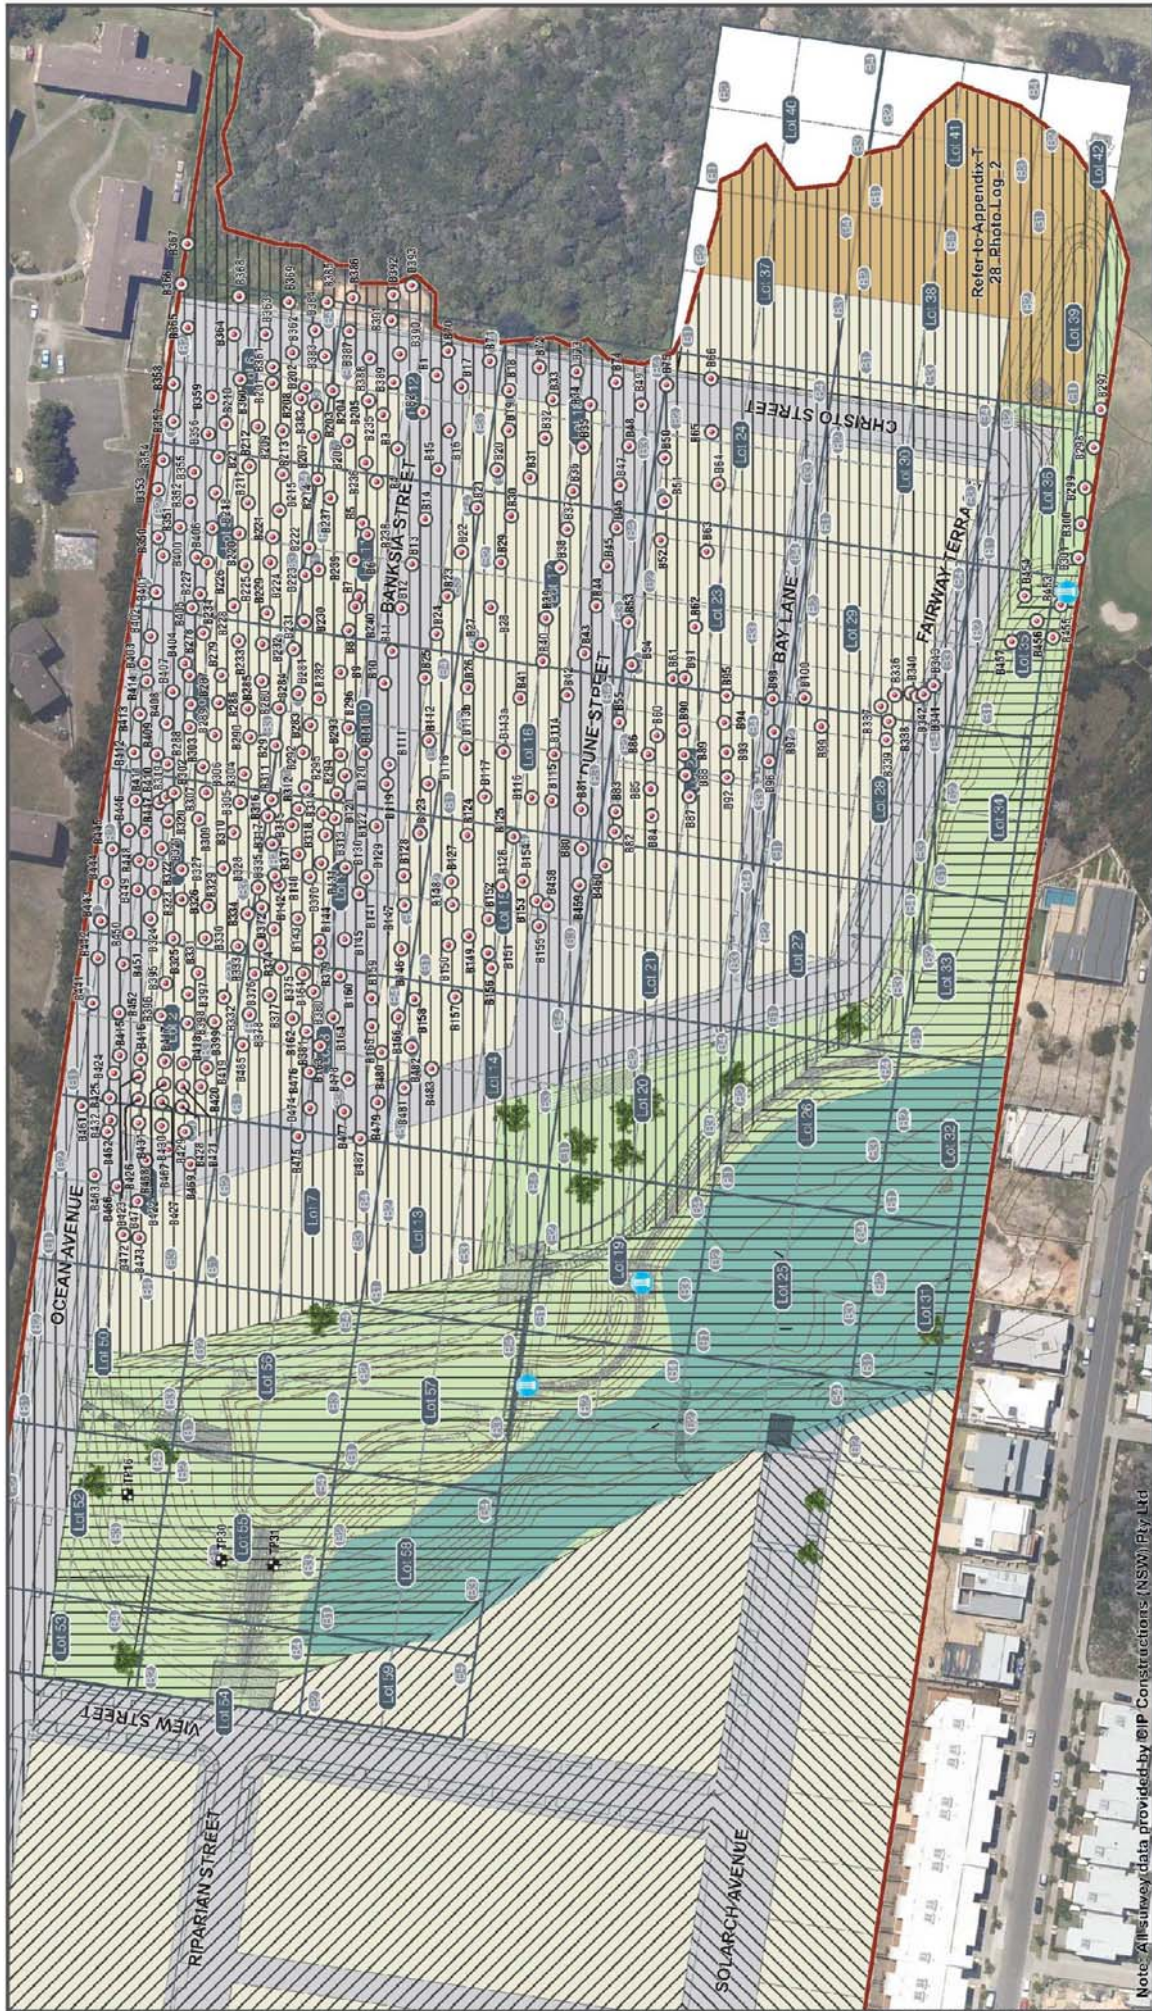
**MONITORING WELL LOCATION PLAN**  
UNSW Campus, 1408 Anzac Parade, Little Bay

Note: All survey data provided by CIP Constructors (NSW) Pty Ltd

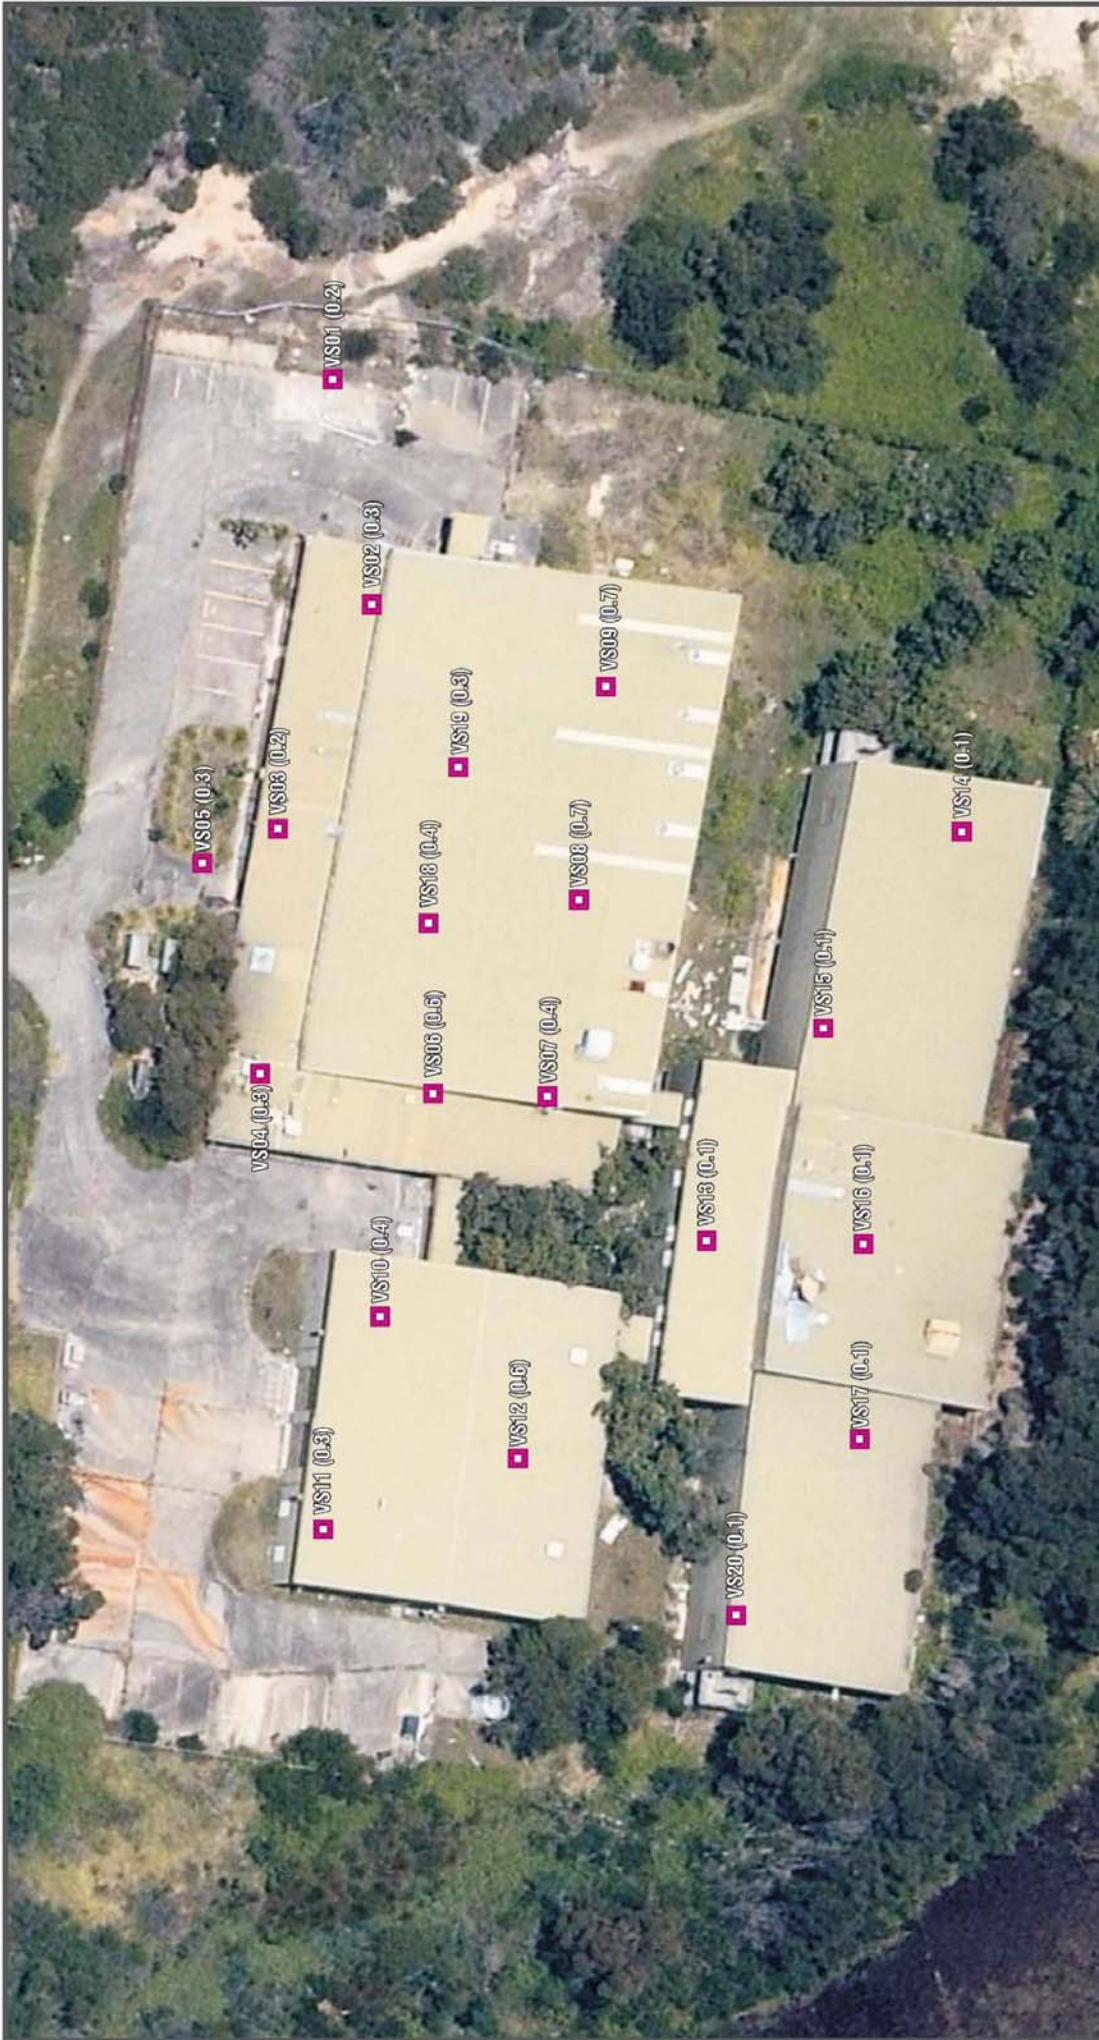
<p><b>Validation Sample Locations</b></p>	<p><b>Figure F3</b></p>
<p><b>Charter Hall Pty Ltd</b>                  Biological Resource Centre Post-Demolition                  1406 - 1408 Anzac Parade,                  Little Bay NSW</p>	
<p><b>LEGEND</b></p> <ul style="list-style-type: none"> <li>■ Indicative soil sample location</li> <li>(0.1) Depths to sandstone bedrock m bgs</li> </ul>	<p><b>AECOM</b>                  www.aecom.com</p> <p>PROJECT ID: 6012024                  CREATED BY: TD                  LAST MODIFIED: TO 12 07 2011</p> <p>0 20m</p>
