PROPERTY INSPECTION REPORT

Concerning: 526 Westminster Court, Midlothian, TX 76065
(Address or Other Identification of Inspected Property)

By: Dave Dudziak, Lic #21182 12/17/2015
(Name and License Number of Inspector) (Date)

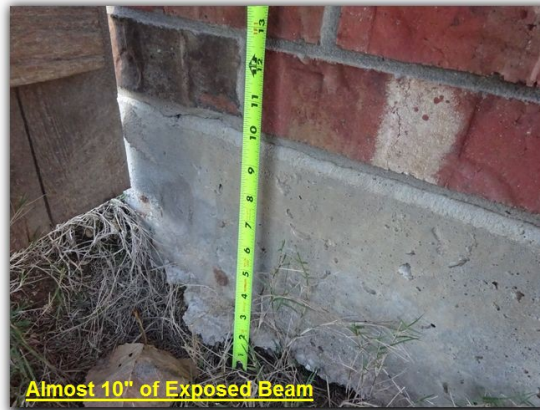
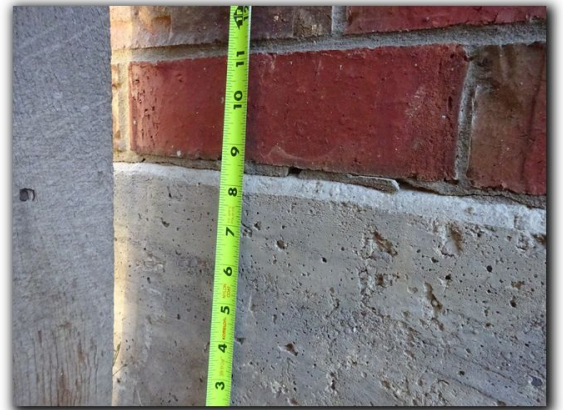
Soil levels against the exterior grade beam appeared to be too low. Proper soil levels against the foundation promote better stability of the foundation. This item should be corrected so there is less exposure of the foundation face. It is generally accepted that brick veneer house should have about 4-6 inches of clearance. This condition is found mainly on the eastern side of the home, but occurs at other locations.

High soil on western front corner of house.

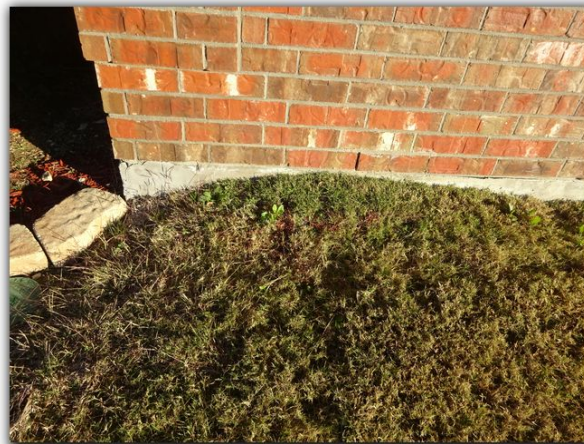
SUGGESTED FOUNDATION MAINTENANCE & CARE - Proper drainage and moisture maintenance to all types of foundations due to the expansive nature of the area load bearing soils. Drainage must be directed away from all sides of the foundation with grade slopes.

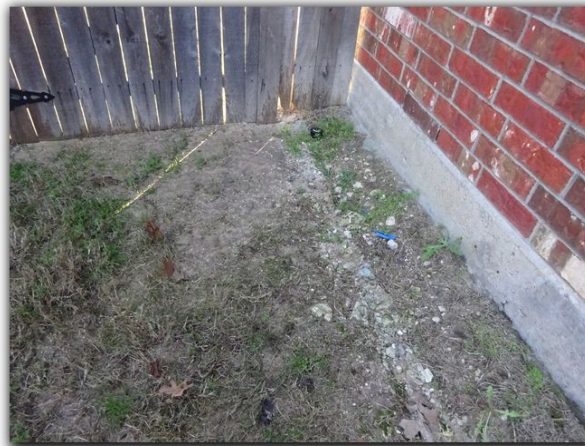
It is recommended that gutters be added to the remainder of the home, as soil erosion is apparent on the back and sides of the home.

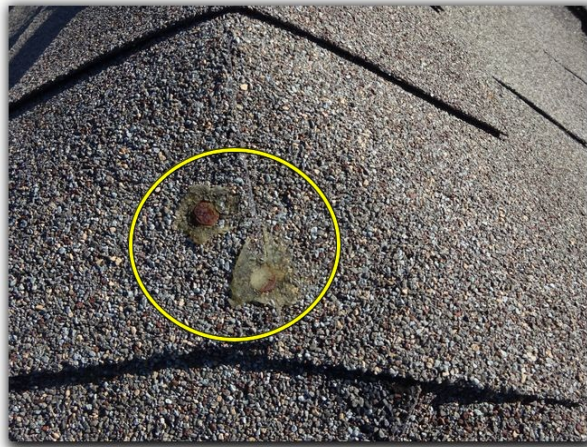
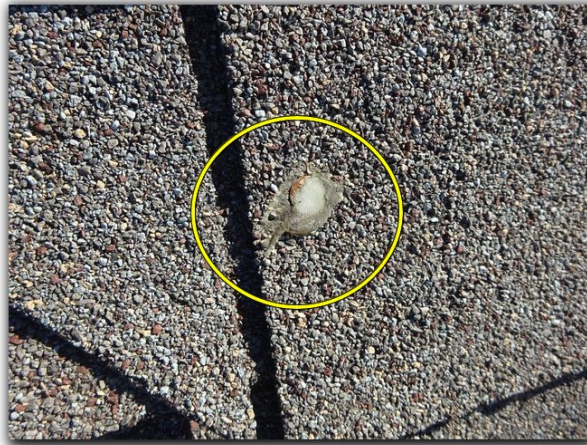
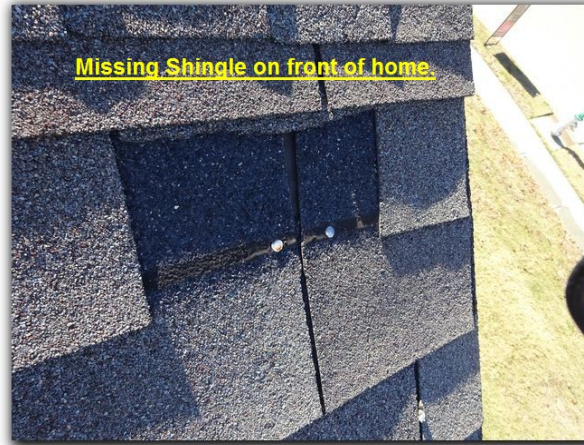
There are numerous nail heads that appear to have been sealed. The sealant is deteriorating. It is recommended that they be re-sealed to maintain the integrity of the roof.

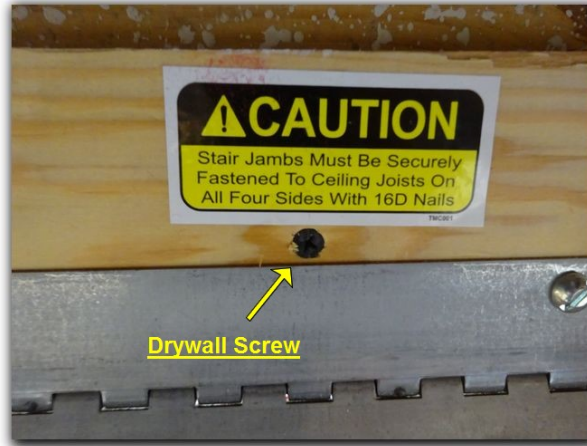
Attic access doorframe not properly secured to framing. It is installed with drywall screws. The manufacturer's recommendations clearly states for nails to be used.

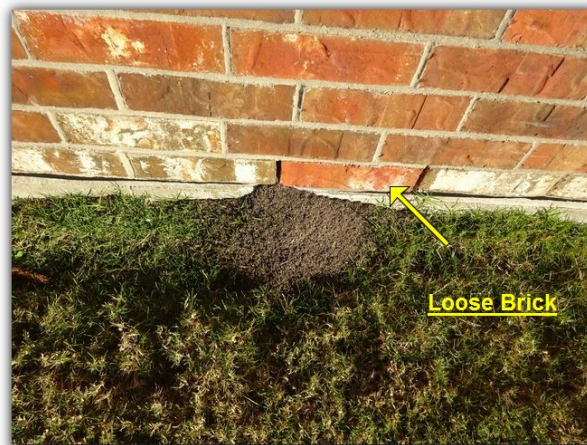
There are several bricks located on the west side of the home on the first course of brick. Note these bricks have weep holes on each side of the brick. This may have contributed to there being loose. This is only a cosmetic issue in that it does not compromise the integrity of the structure. Make repairS as needed.

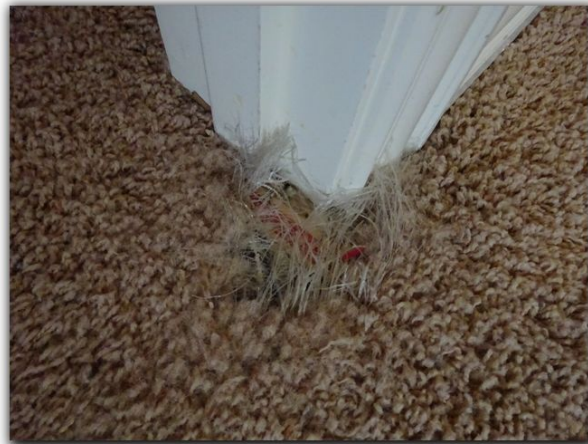
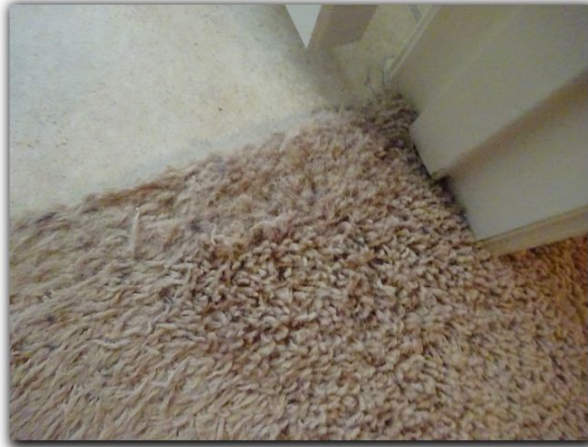
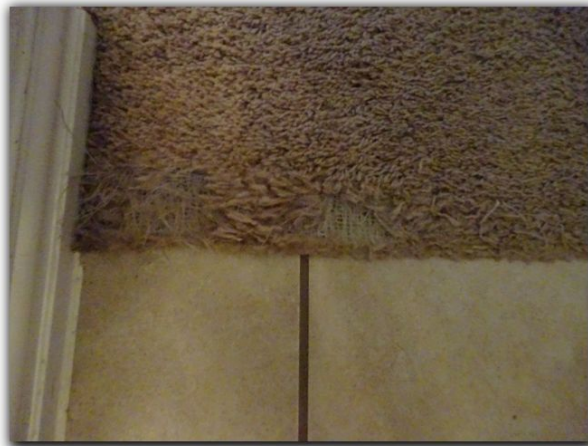
Observed the carpet worn and/or damaged in several areas of the home. Hallway to master bedroom, corner bedroom & kitchen to family room.

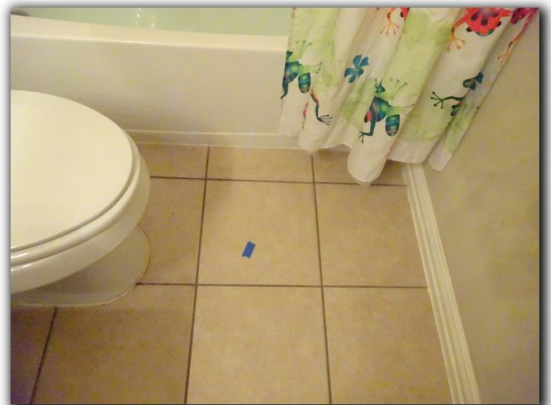
Cracked tile in hall bathroom

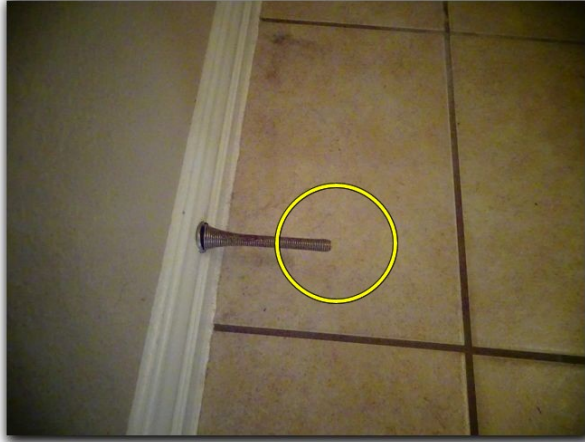
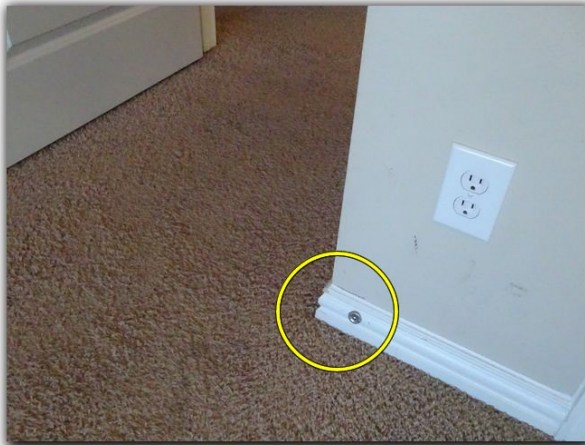
Many door have door stops that are missing parts, broken or missing.

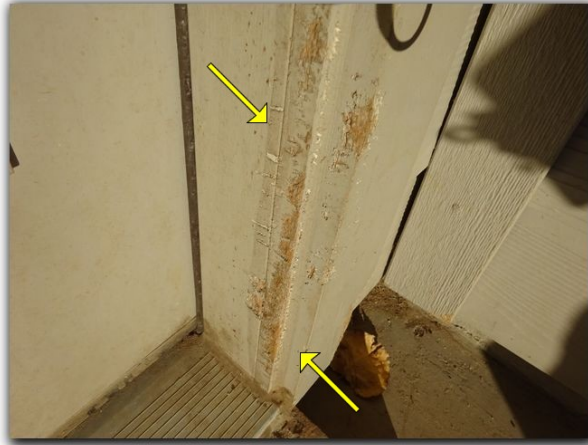
Rear Door has scratch marks & deteriorating paint.

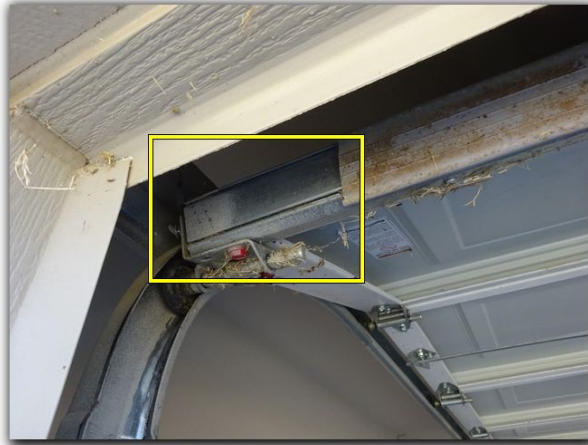
Bottom seal is a few inches short on the east side of door.

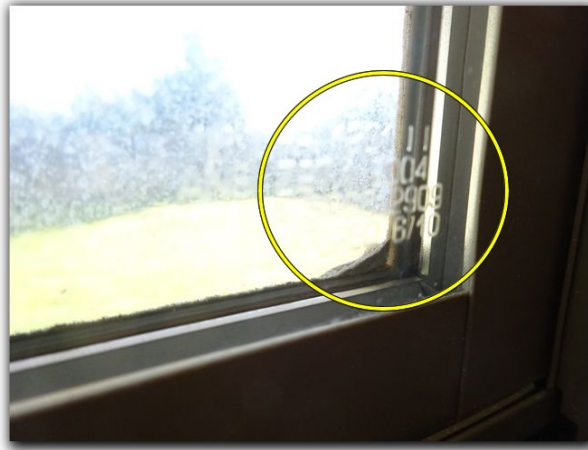
Observed Safety Glass in appropriate locations.

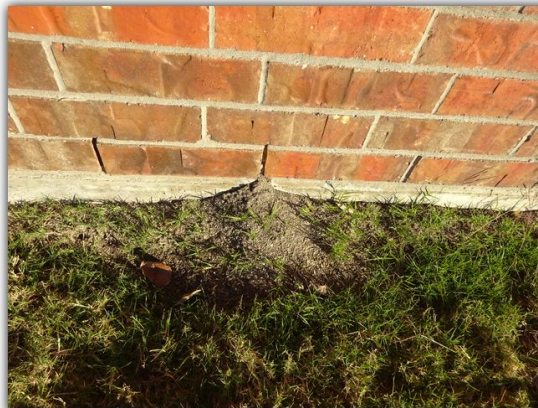
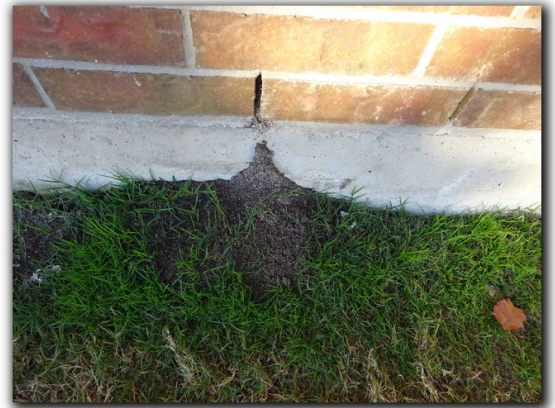
SPECIAL NOTE: Observed evidence of fire ant around the perimeter of the house.

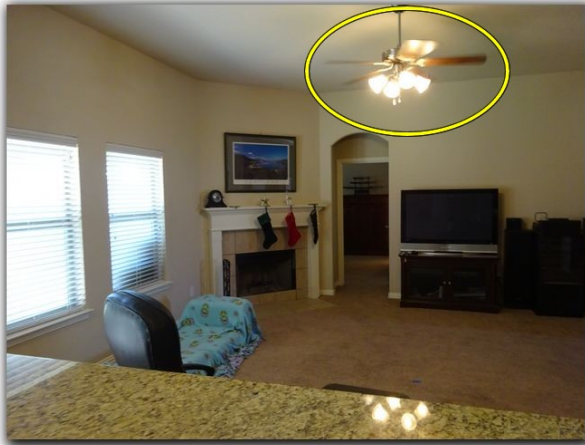
Family room ceiling fan was noisy.

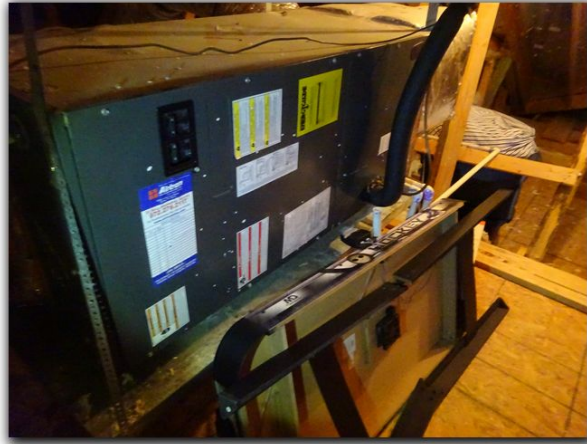
This component appears to be performing adequately at the time of this inspection. It is achieving an operation, function, or configuration consistent with accepted industry practices for its age.

It is good routine maintenance & safety practice to have this Heating unit checked & serviced by a Qualified/Licensed HVAC contractor.

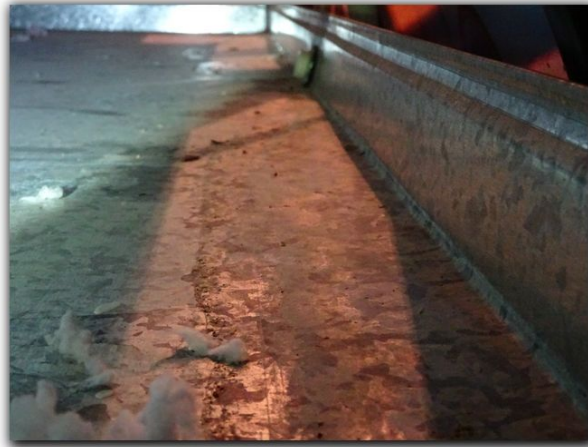
Note: The auxiliary/secondary drain pan under the coil housing has some water staining and/or a rust build-up. This would indicate that the pan has held water in the past and should be closely monitored. SEE NEXT PAGE

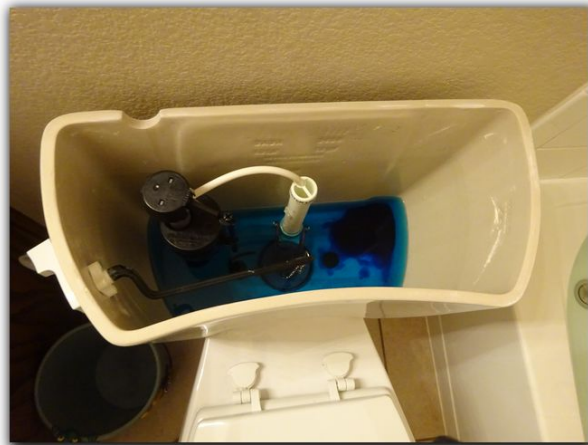
The commode tank valve (ball-cock assembly) is not functioning properly. The tank does not refill after flushing.

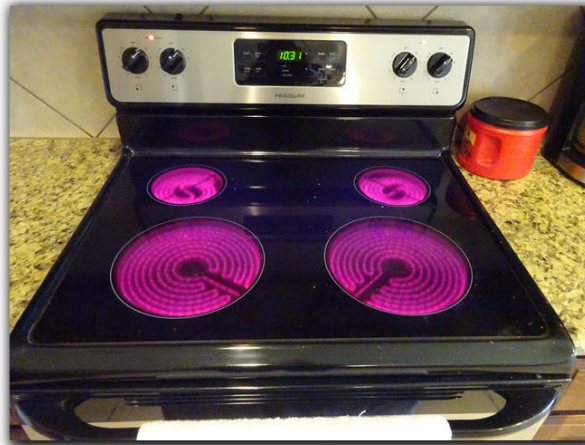
This component appears to be performing adequately at the time of this inspection. It is achieving an operation, function, or configuration consistent with accepted industry practices for its age.

Tested for: 350° F. Temperature Achieved: 350° Max variance is 25°

Observed anti-tip device

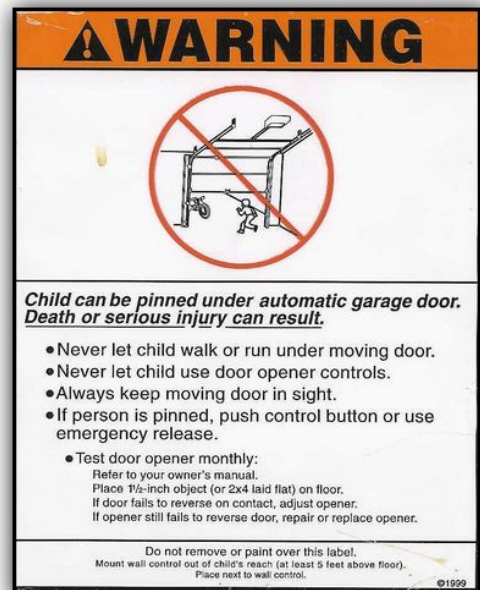
The garage door opener ***DID NOT*** automatically reverse under reasonable resistance when closing. Improvement may be as simple as adjusting the sensitivity control on the opener.

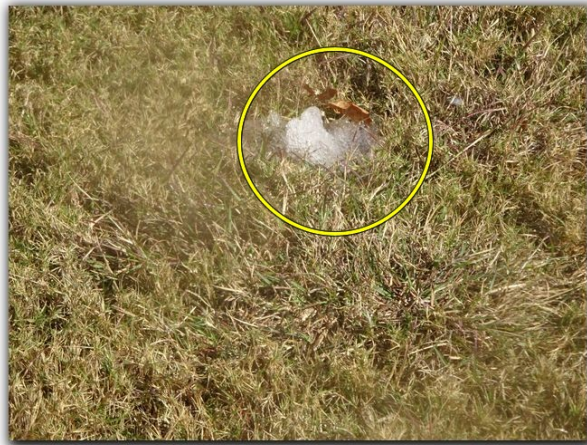
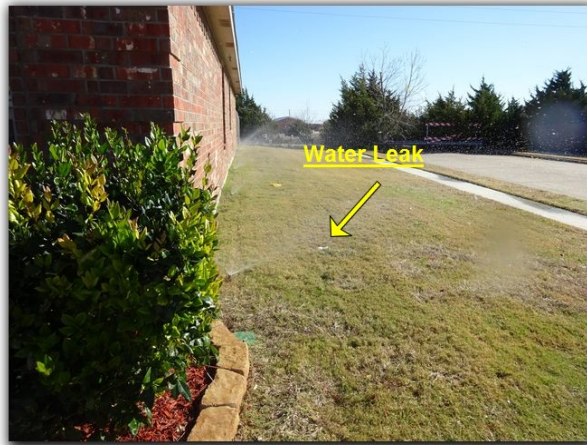
Observed water bubbling out of hole when Zone 6 was run. It is on the west side of the home a little over 40" front the side of the house.
