Testing that goes above and beyond code

Marcy Tyler

Director of Building Science

Air, Water & Fire: A Building Science Medley

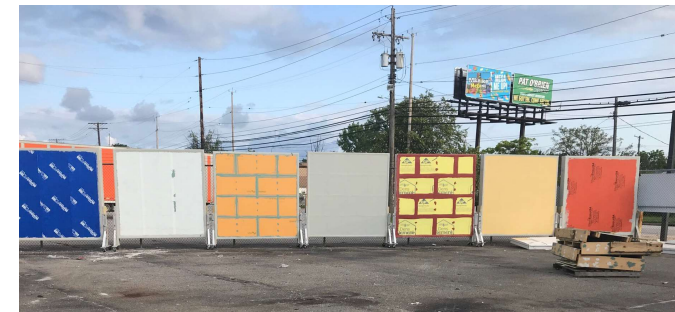
The Building Enclosure: A Jacket of Protection for your Building

Just like a jacket can protect you from the elements, the building façade is intended to do the same for the inner structure of your building.

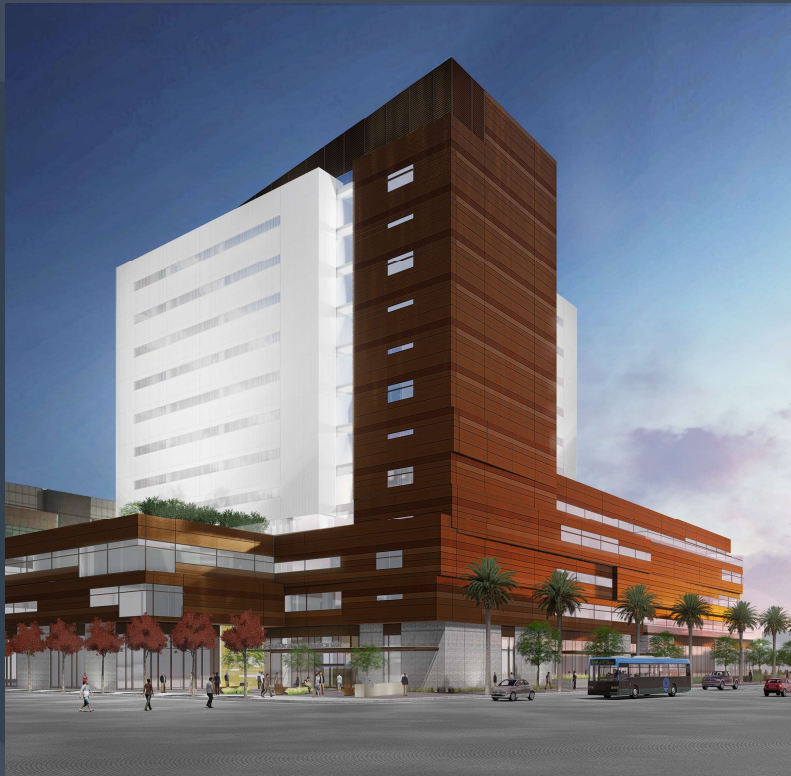
CONCEPT

Mission Bay Block 33, San Francisco, CA

- UCSF Wayne and Gladys Valley Center for Vision
- Consultant did not want to use Tremco Expansion Joint Materials.
- Designed project specific mock-up to validate performance during earthquake.

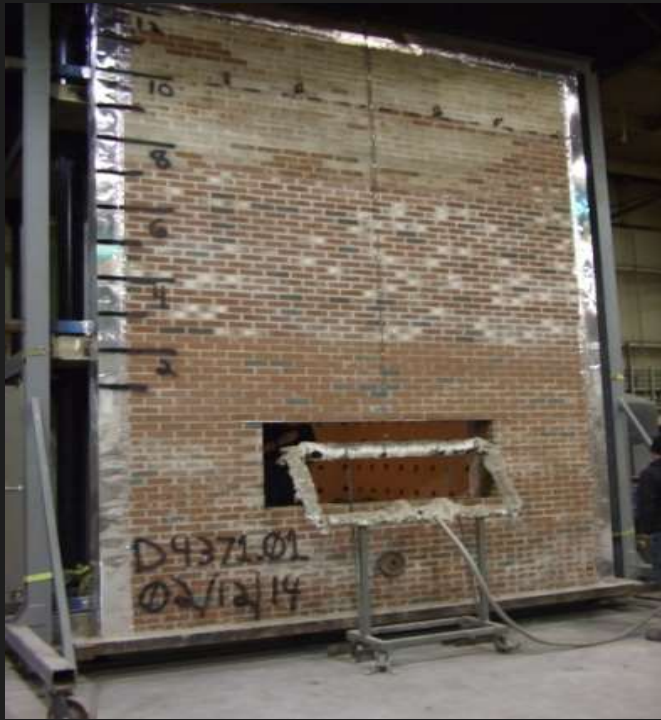
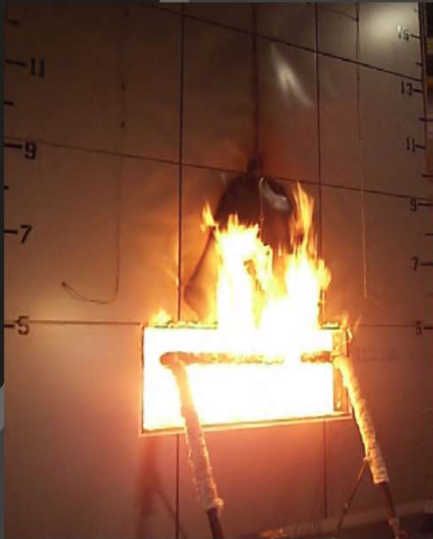
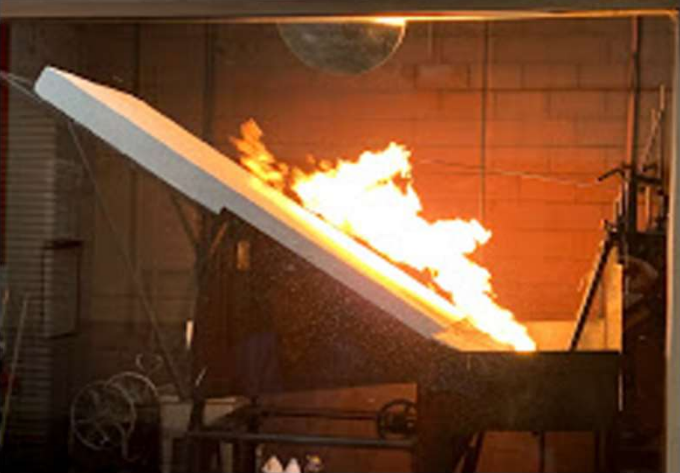
Fire Lab

UL790

Standard for Standard Test
Methods for Fire Tests of
Roof Coverings

CAN/ULC S107

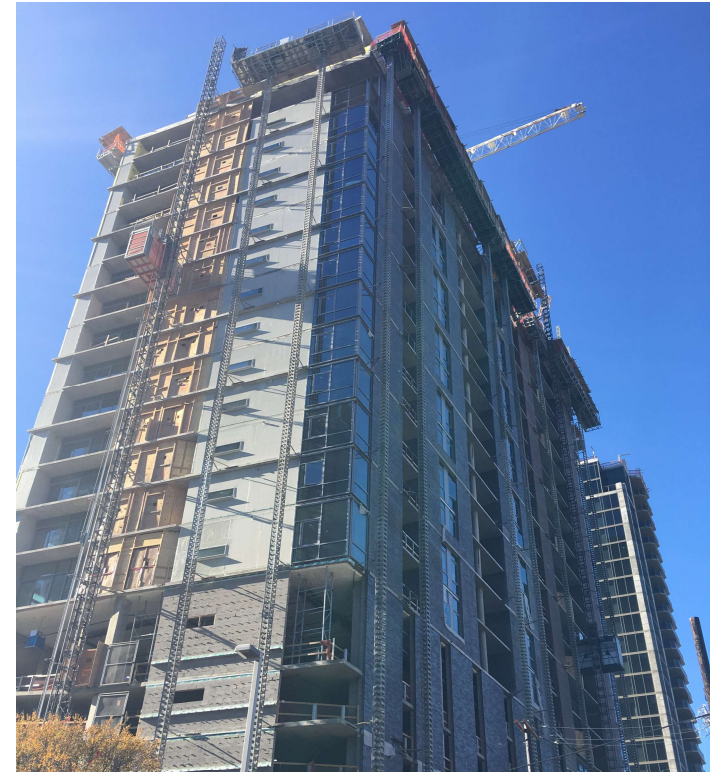
The Air Barrier System – Continuity

- Fluid-to-fluid system
 - Consistent thickness
 - Complete system, compatible accessories
-

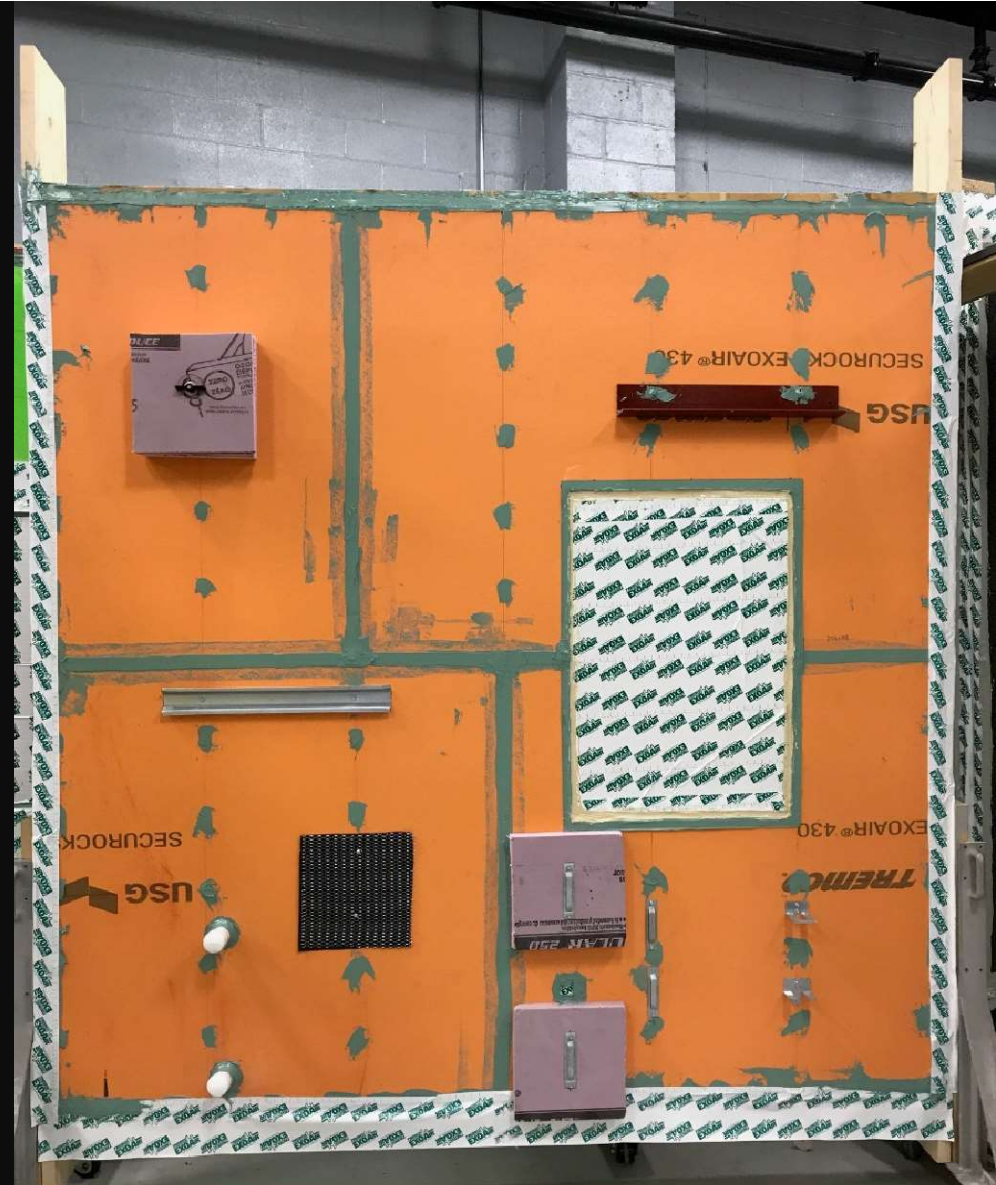
ASTM E 1186

- Standard Practices for Air Leakage Site Detection in Building Envelopes and Air Barrier Systems.
 - Only rate of pressurization is specified in standard, not maximum or minimum pressure.
 - Selective, qualitative test
 - “Gut Check”
-

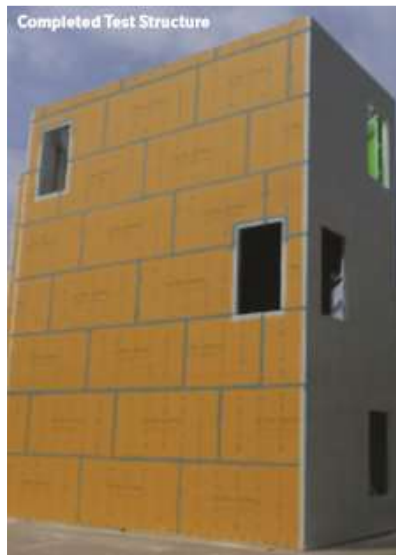
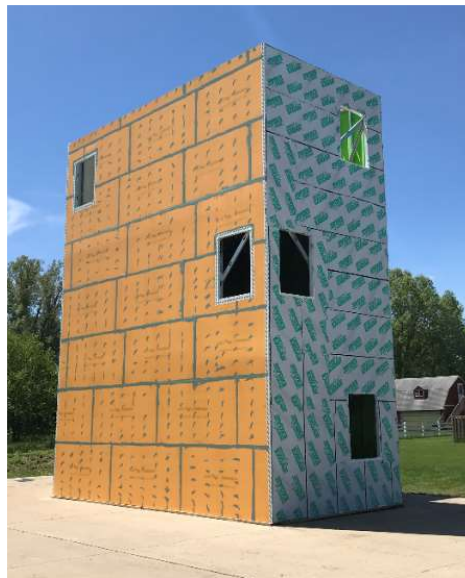
Factory-Applied Air Barriers – Time Study

Factory-Applied Air Barrier – 19:30
 Peel & Stick – 36:47
 Time Savings = 17 hours

Hours Saved	Panels	Sqft
1	3	100
10	31	1000
100	312	10000
200	625	20000
600	1875	60000

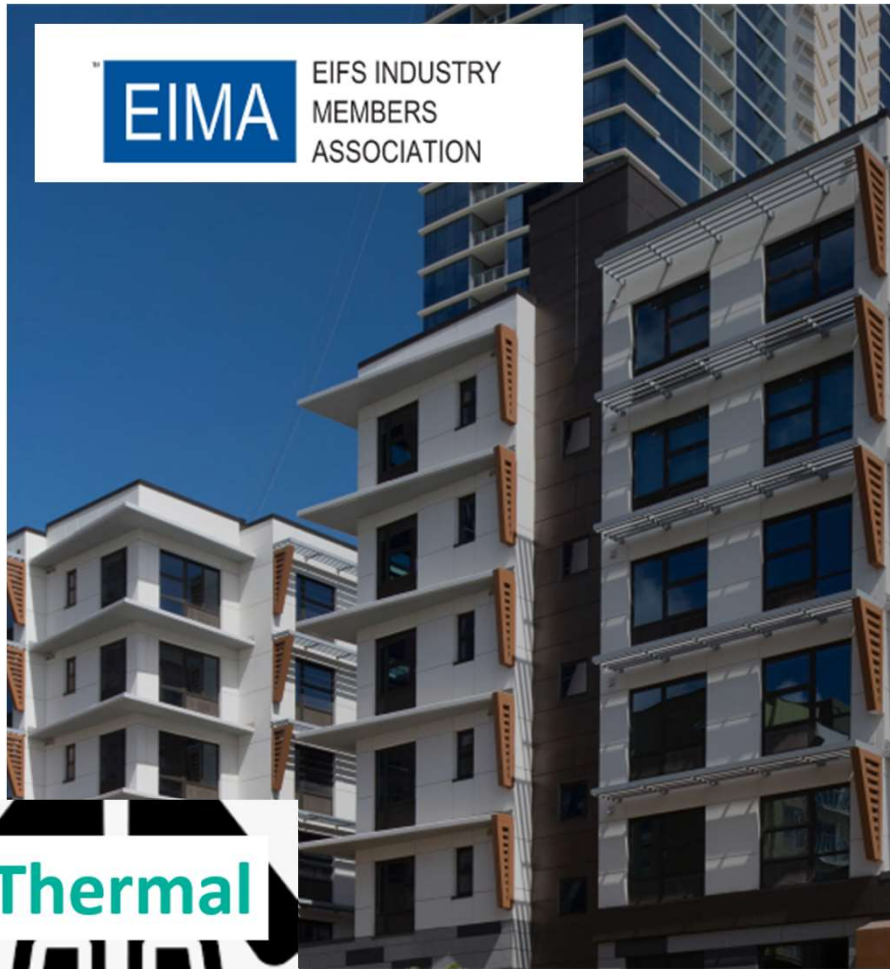
Thermal

Oak Ridge National Laboratory Study Determines: EIFS 84% More Thermally Efficient Than Any Other Wall System

A clear wall comparison was performed by ORNL scientists at the ORNL facility in Oak Ridge, Tennessee. Seven common cladding types:

opaque wall performance for a typical building is then measured using the "Whole Wall R-Value" concept, which additionally included effects from transition details at areas such as windows and doors, roof and floor lines, foundation and corners and others.

computer modeling were used to analyze steady state thermal performance of the clear wall area and wall interface details for the Dryvit wall system with 3 5/8-inch light gage steel framing.

Guarded hot box tests formed the basis for a finite difference computer model calibration. This computer model was then used to calculate local R-values for all typical wall interface details and the whole wall R-value. A re-

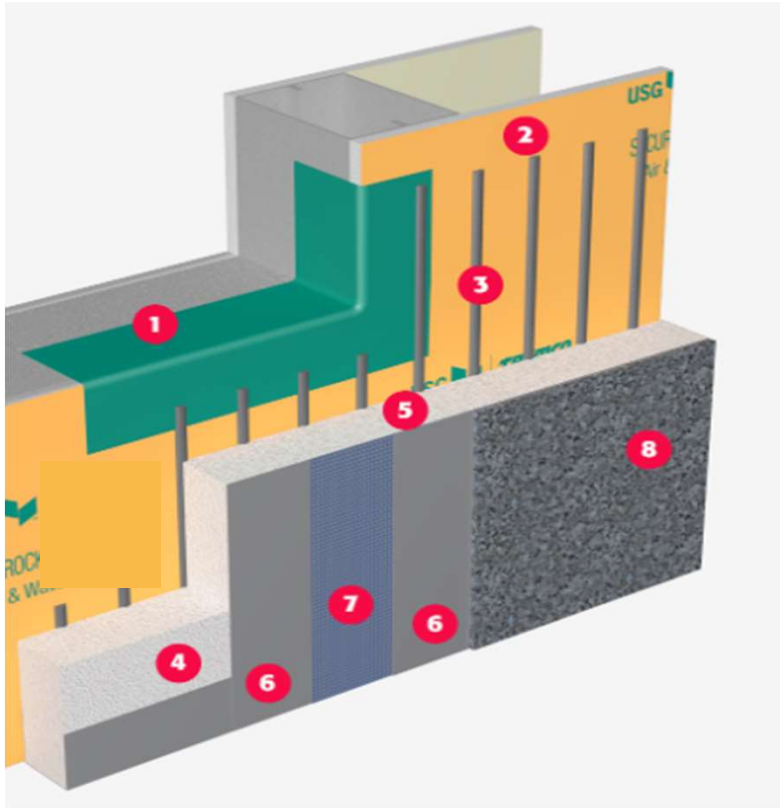
Pre-Applied Air Barrier with Continuous Insulation

1. Fluid applied flashing
2. Pre—applied air / water barrier on exterior sheathing
3. Adhesive / Drainage
4. Pre-based starter board
5. EPS continuous insulation
6. Base Coat
7. Reinforcing mesh
8. Finish

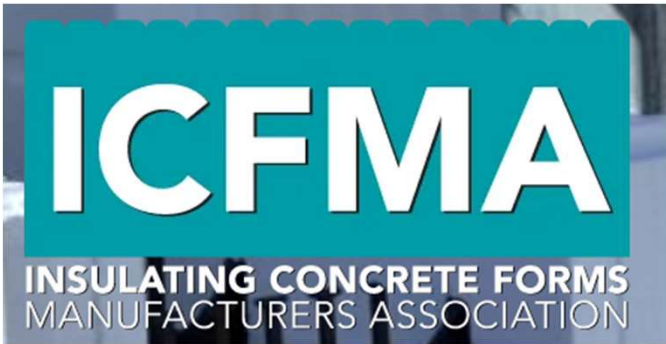
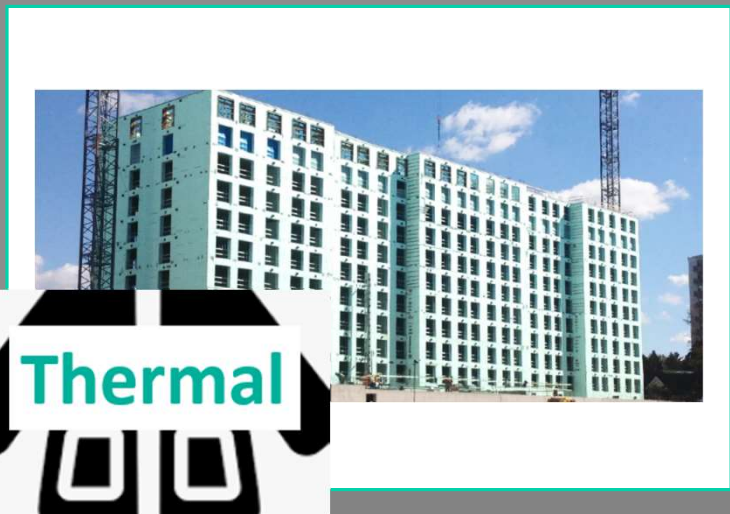
Owens Community
College
Perrysburg, OH

- Overclad of their administration building
- Condensation issue of the brick shelf penetrating thermal barrier
- Solution: NewBrick and continuous insulation

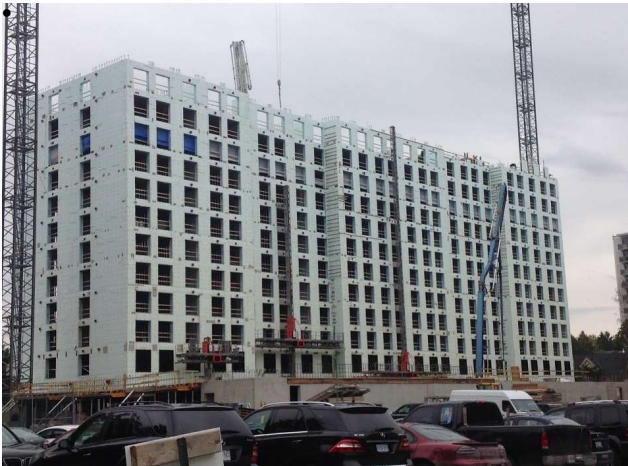
19 Story Luxe London – 1235 Richmond London, ON

- Type: 19 Story 311 Units - 250 Bed Facility
- Size: 337,000 SF
- ICF Wall Area: 150,000 SF
- ICF Install: 5 months
- Cost: 55M
- GC: *Reid & Deleye Contractors*
- Architect: *SRM Architects Inc*
- Completed: 2014 – 19 months

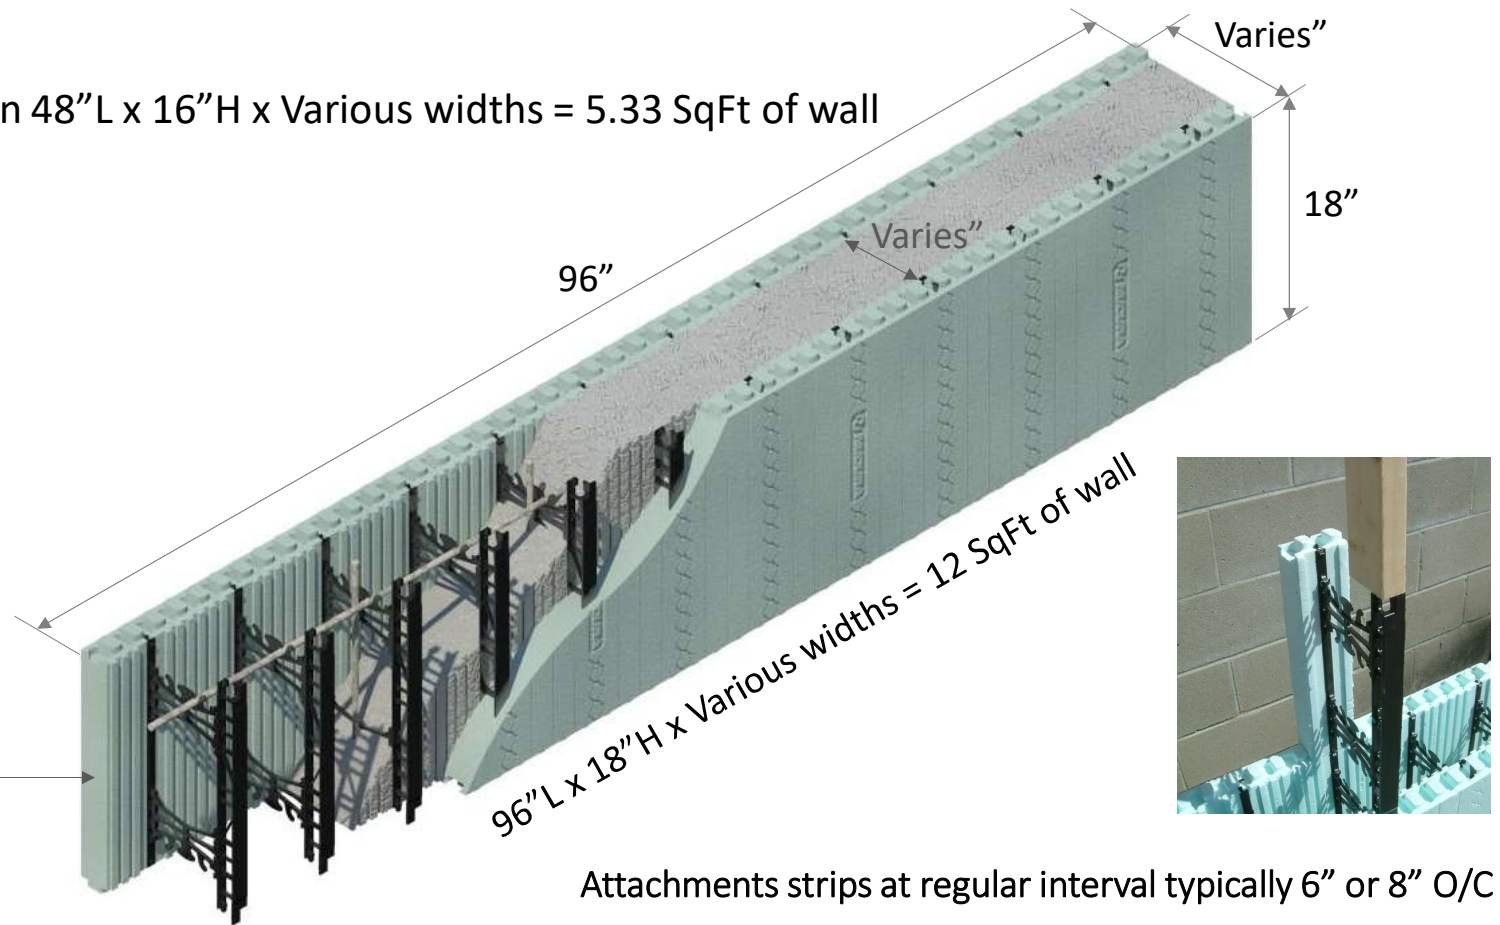
Nudura ICF Building Envelope Performance

ICFs combine 7 building elements within 1 product; installed by 1 sub-contractor, increasing construction speeds, reduced scheduling delays & mitigates performance risk of wall assembly:

1. Structurally Reinforced Concrete
2. Continuous Air Barrier (Concrete & Foam)
3. Continuous Insulation R-23+ up to R 48+
4. Vapor Barrier (EPS) 0.624 perm-inch or applied membrane
5. UL Fire Rating 2 – 4 hours
6. Interior & Exterior attachment studs/strips
7. Sound Attenuation STC 50 up to STC 72

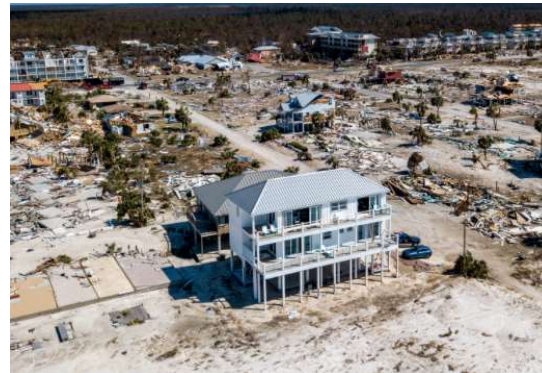
Nudura ICF House located at Mexico Beach after Hurricane Michael 2018 - CNN

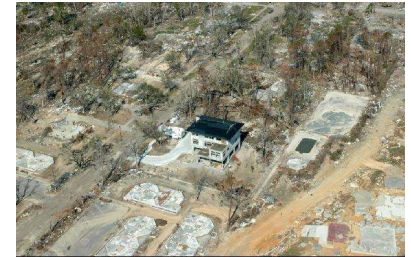
ICF House after Katrina 2005 - PCA

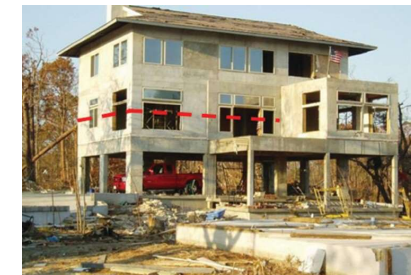
The water line was at 28 ft. as indicated by the red line in this photo.

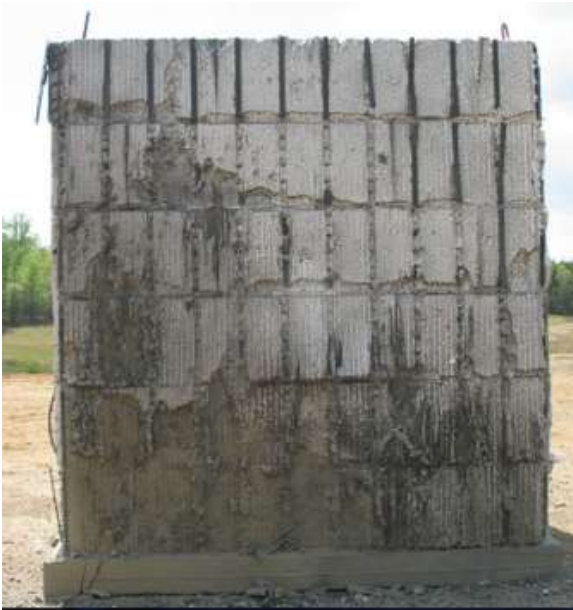
- 50 lb. of TNT
- 6" ICF, #4@16"oc
- Blast from 6' Away

US Military - Quantico Blast Testing on ICF Walls

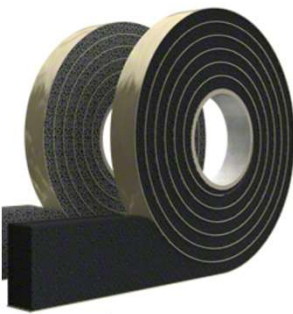
EXPANSION JOINTS & TRANSITION SEALANTS

*Pre-Compressed, Acrylic-Impregnated Foams | Preformed Extrusions
Closed-Cell Foams | Monolithic Polyurethane Methacrylate | Gun-Grade Foams*

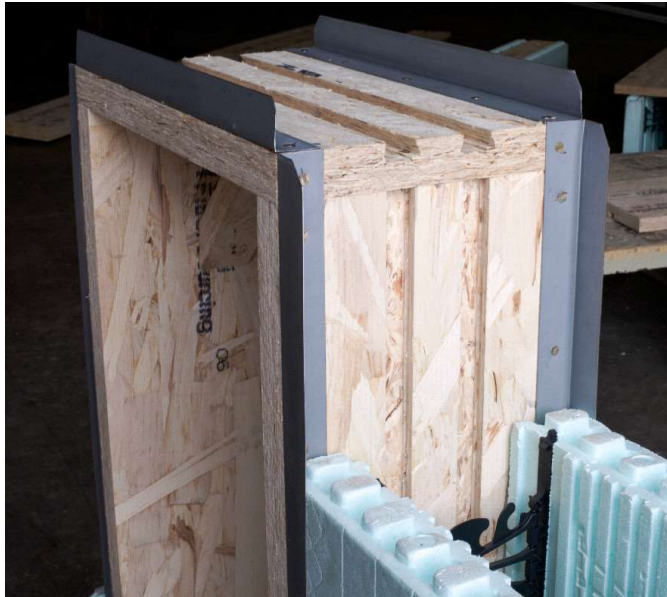
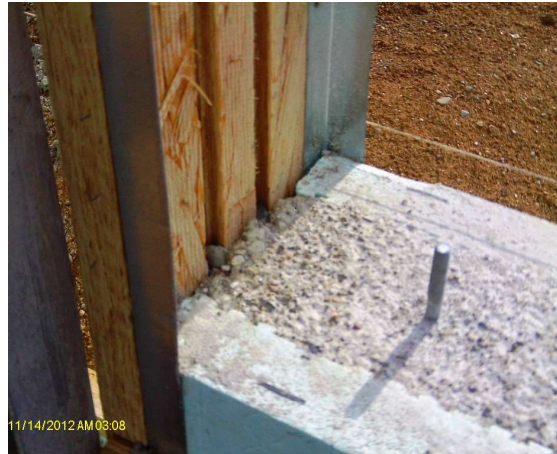
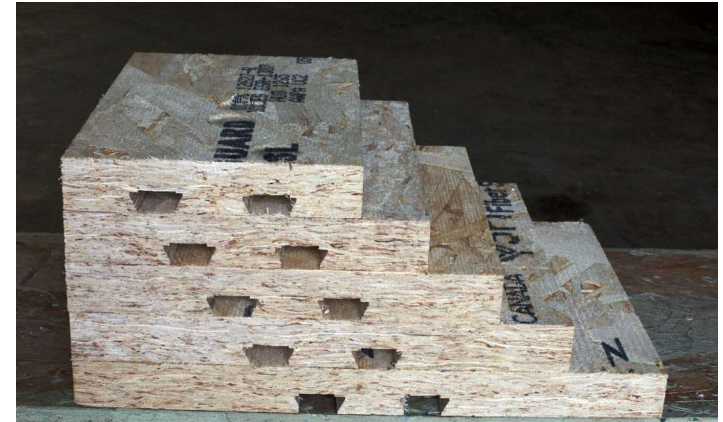
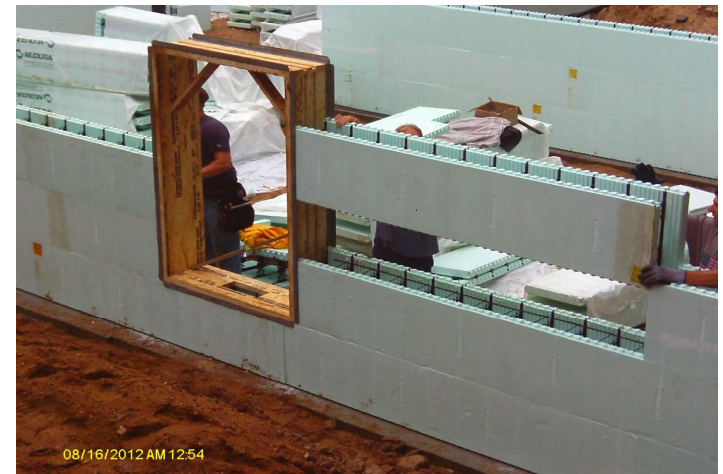
Engineered Wood Bucks

- Designed for direct contact with concrete
- Non-corrosive to metals
- Resistant to insects and decay
- Will not delaminate, become spongy or loose fastener holding strength when exposed in typical commercial construction
- Will not cup, warp or twist over time
- Engineered consistent, flat, stable framing material
- LSL bending strength reduces internal bracing before concrete pour

- Engineered wood buck using Laminated Strand Lumber (LSL)
- Exterior grade with termite resistant
- 1 ½" thickness and offered in various widths

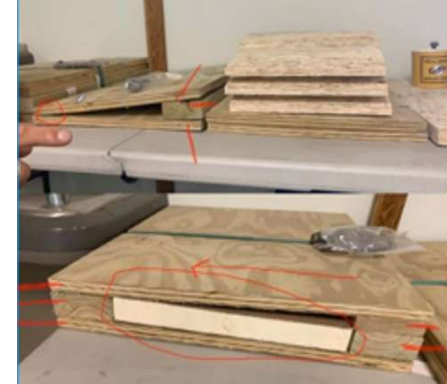
Parapet Caps

- How does it come together?
- How do you get the appropriate slope?
- Who is responsible?
- Are the materials being used weather resistant?
- Will sealants and flashing materials adhere?

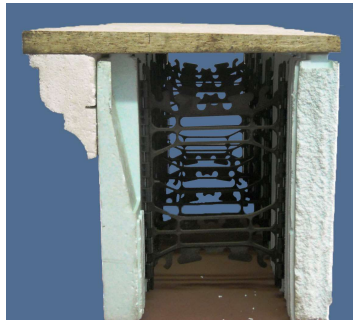
ALTERNATE CAP DETAIL

- Pre-engineered continuous parapet cap
- Pre-engineered with appropriate slope
- Can be easily installed
- Weather resistant construction
- Tenacious adhesion of Tremco sealants and membranes

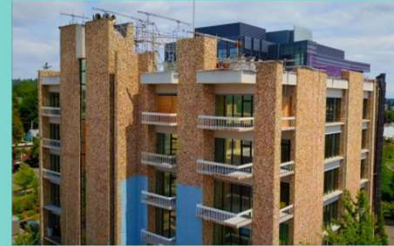
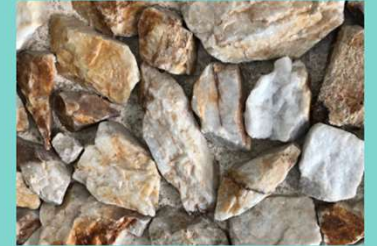
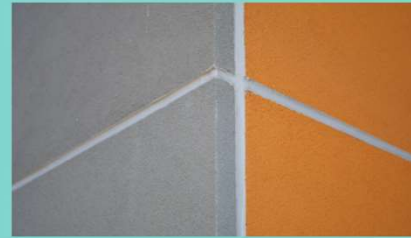
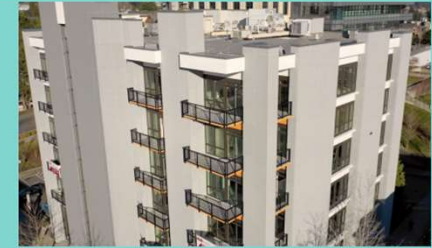
500 Pacific Avenue, Bremerton, Washington

After a baseball-sized stone fell to the sidewalk from an exterior wall of this Class A office building, the owners took immediate action to protect occupants and passersby.

Originally constructed in 1965, the façade of the 75-foot tall structure used concrete panels with embedded granite stones. Fast forward fifty years and the structure faced substantial weathering and water damage, which led to mold growth, corrosion of the balconies and failure of the decorative exterior.
