PEDCO BUILDING AIR LEAKAGE AND EFFECTS ON THE ENVELOPE A CASE STUDY

Tremco Roofing and Building Maintenance

Steve Tratt
October, 2015

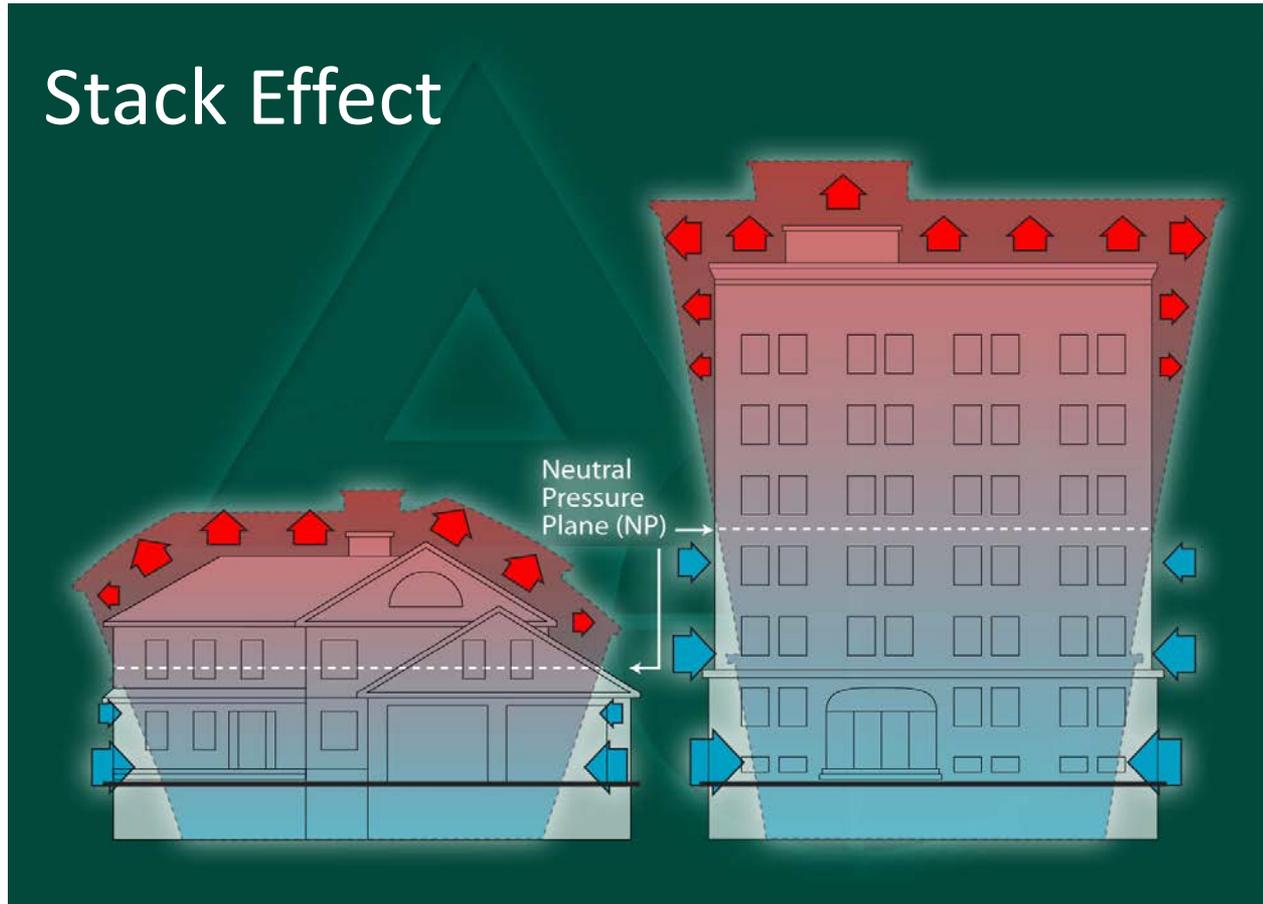
Stack effect is a temperature-driven phenomenon, which is especially noticeable in cold weather, when warmer indoor air, which is more buoyant than the colder outdoor air, tends to rise in the building.

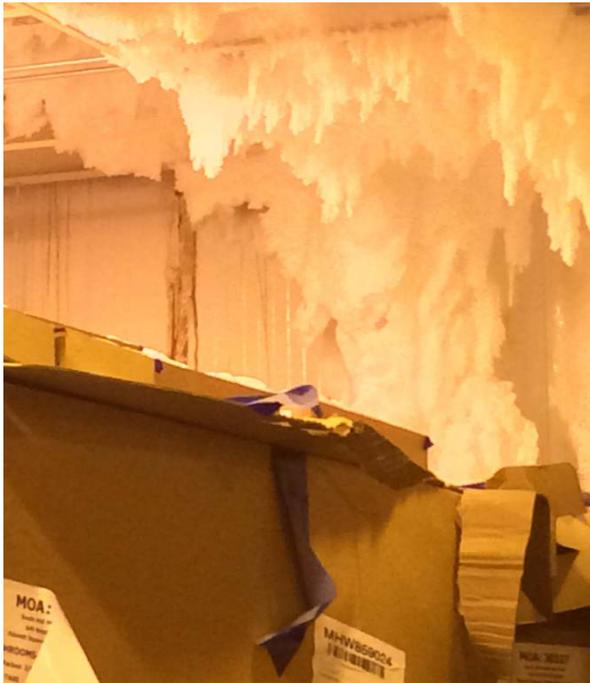
Cold storage issue in hot humid temperatures

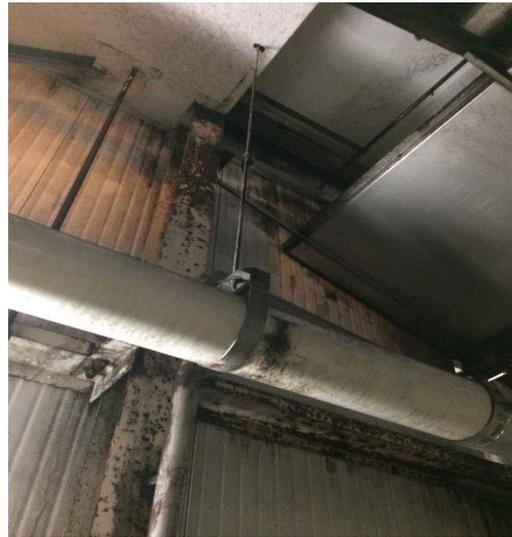
Mold / Mildew
Conditioned space Metal building in humid climate

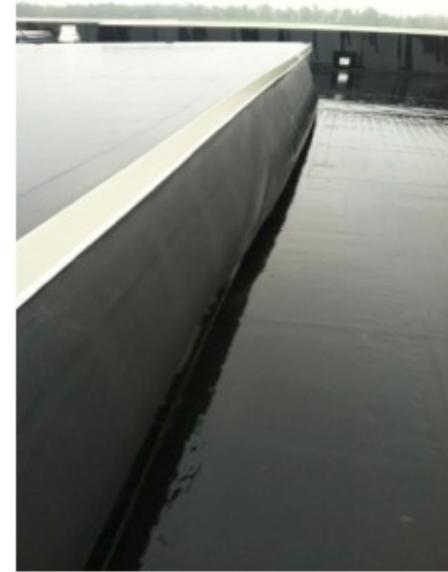
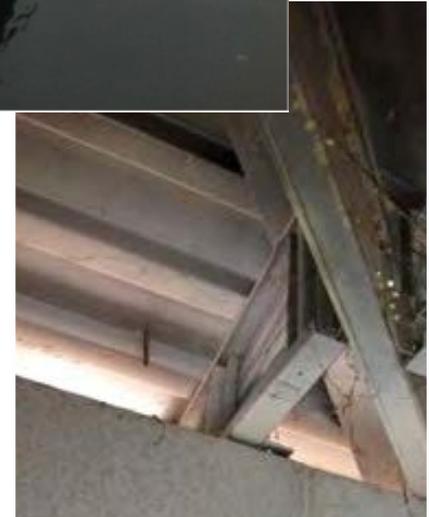
1 Problem in warmer climates .. Roof / Wall Connection

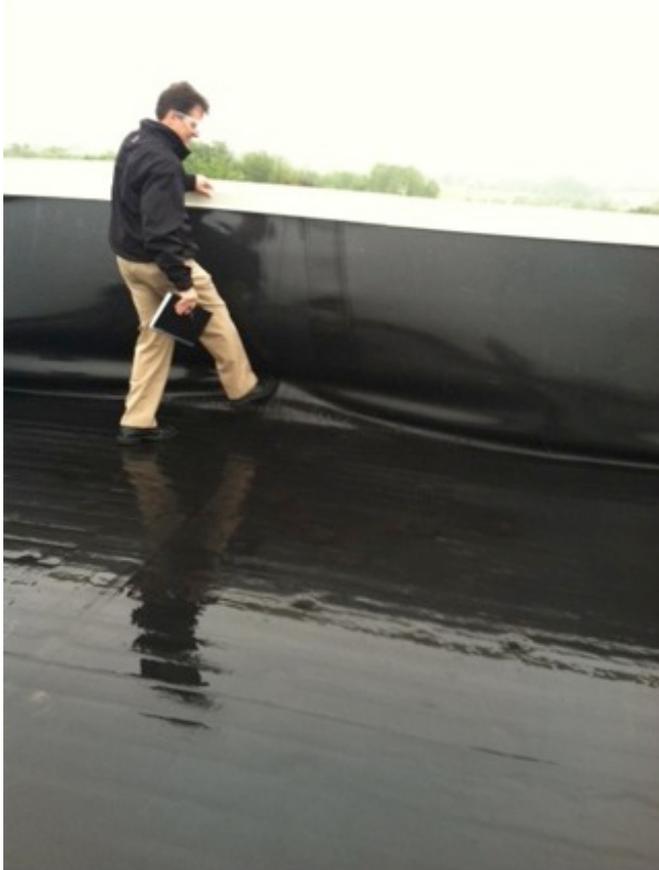
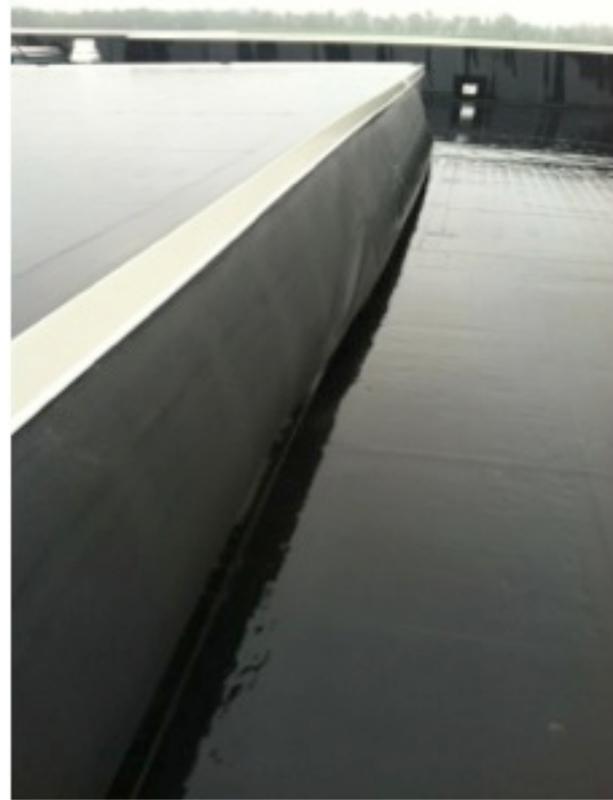
Case Study # 1

Issue: Manufacturing Company with pressure blowing roof into roof flashings causing failure

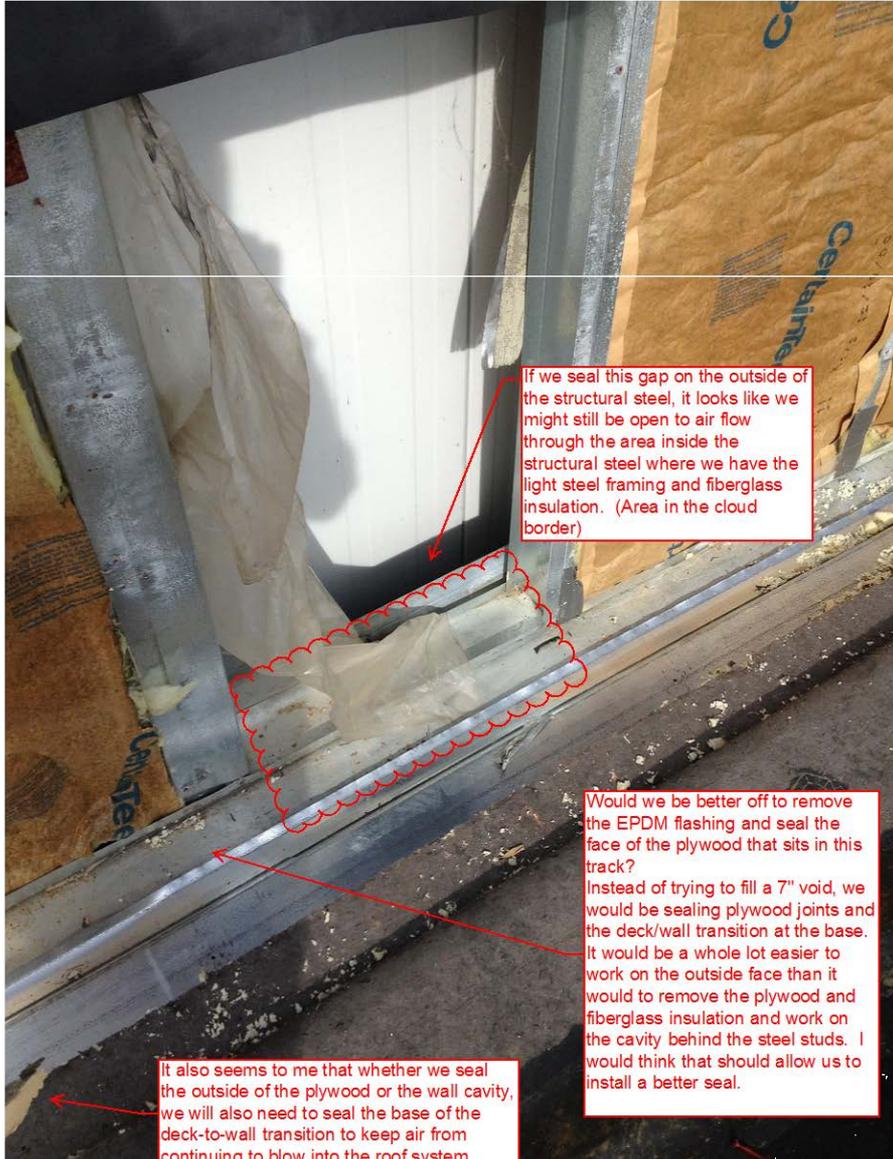
Case Study # 1

If we seal this gap on the outside of the structural steel, it looks like we might still be open to air flow through the area inside the structural steel where we have the light steel framing and fiberglass insulation. (Area in the cloud border)

Would we be better off to remove the EPDM flashing and seal the face of the plywood that sits in this track?
 Instead of trying to fill a 7" void, we would be sealing plywood joints and the deck/wall transition at the base. It would be a whole lot easier to work on the outside face than it would to remove the plywood and fiberglass insulation and work on the cavity behind the steel studs. I would think that should allow us to install a better seal.

It also seems to me that whether we seal the outside of the plywood or the wall cavity, we will also need to seal the base of the deck-to-wall transition to keep air from continuing to blow into the roof system.

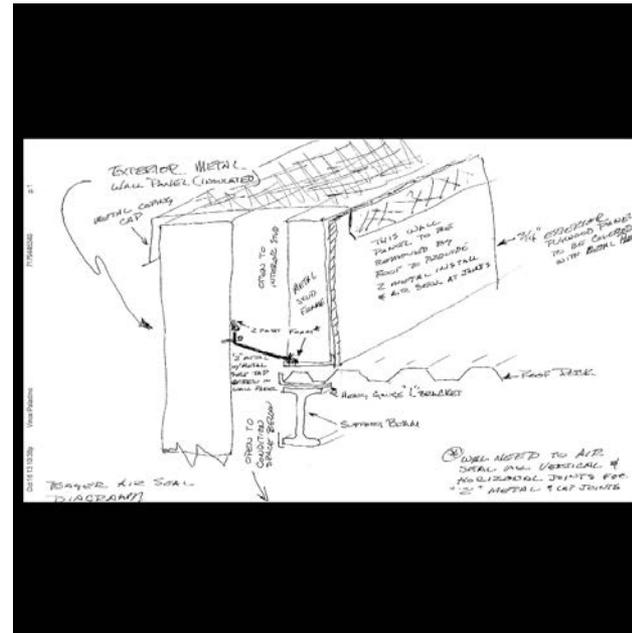
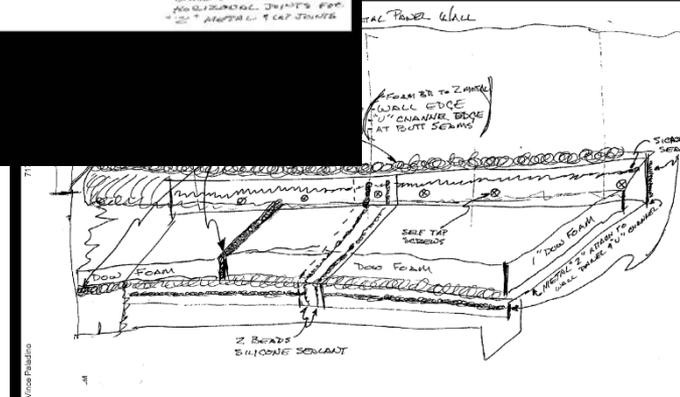
Construction: Exterior Insulated metal wall panel with Steel structural framing with no regard to conditioned & non conditioned space with significant Air leakage and pressure.

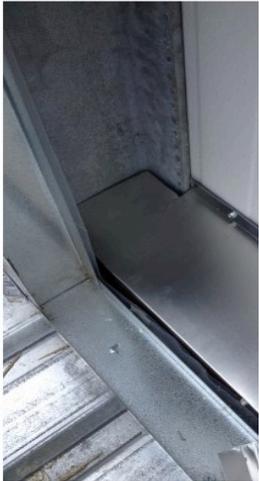
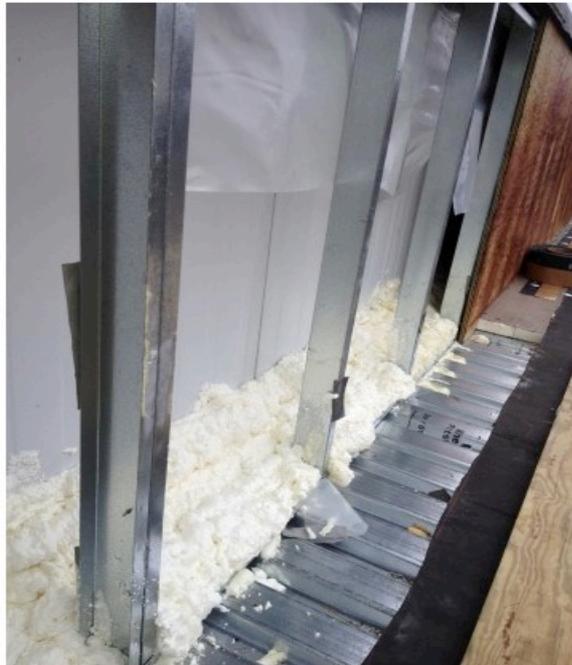
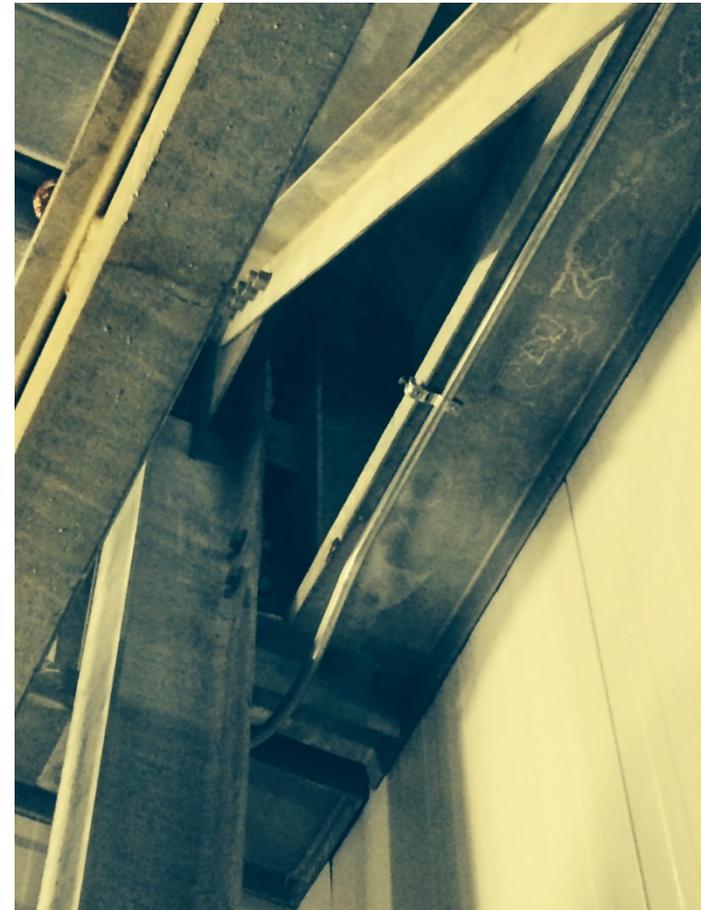
Case Study # 1

Results: Project coordinated with Roofing contractor to install metal wall panels and remediate air leakage at Roof Wall connection.

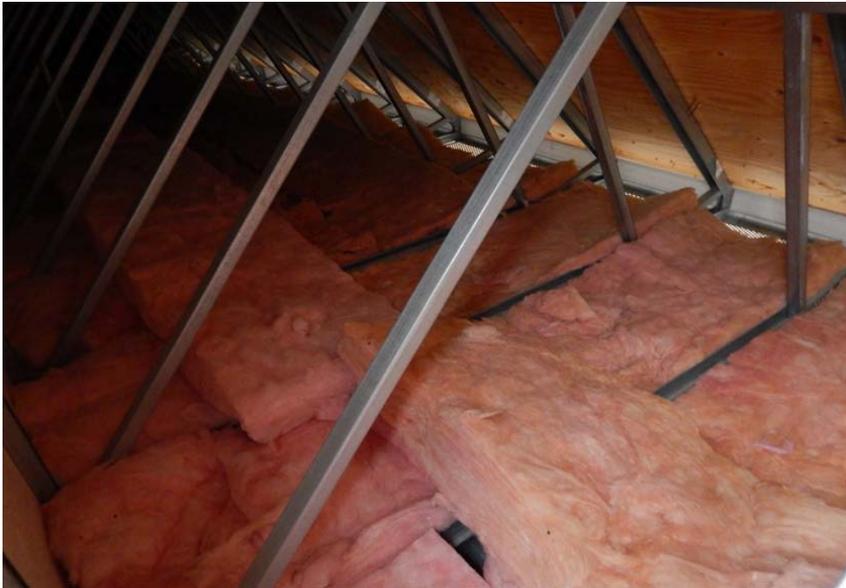
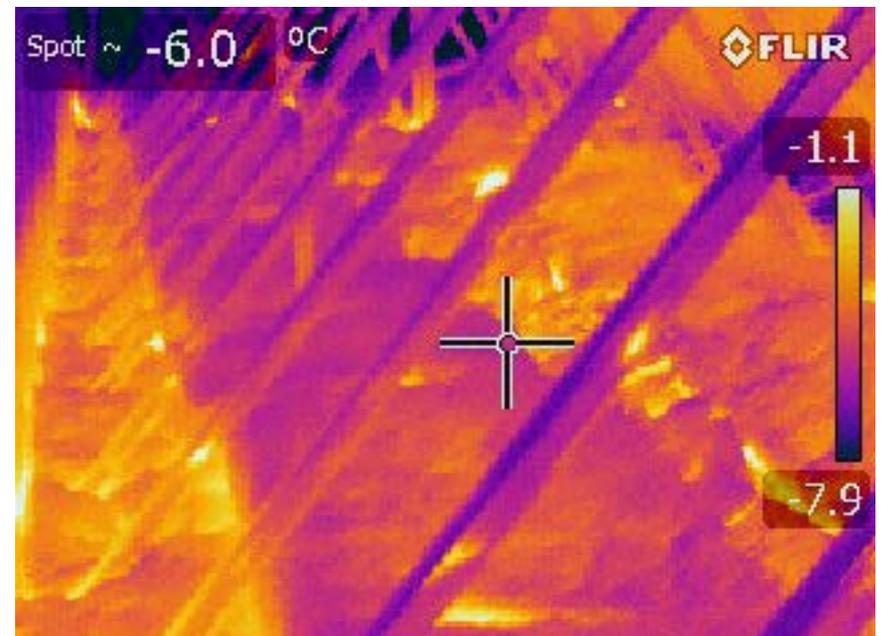
Case Study #2

Knee wall attic

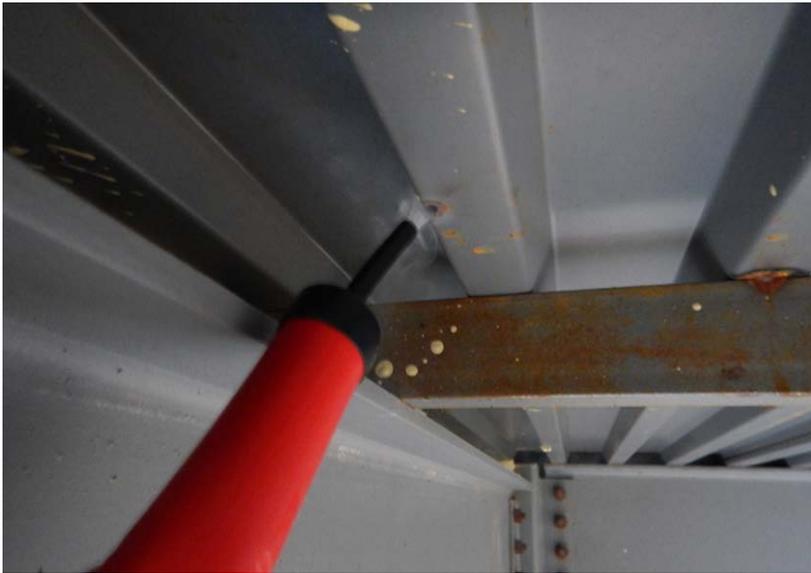
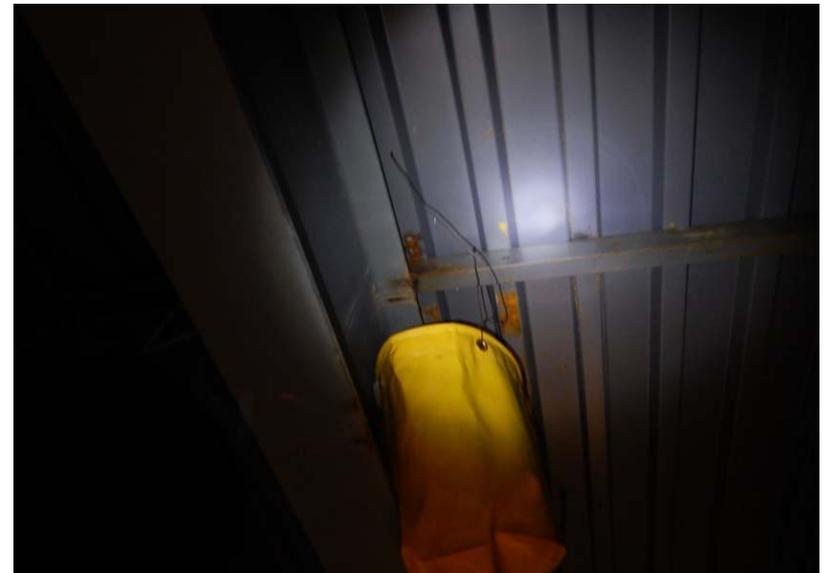
Case Study #2

Knee wall attic, many holes in roof deck below attic space. Condensation issues

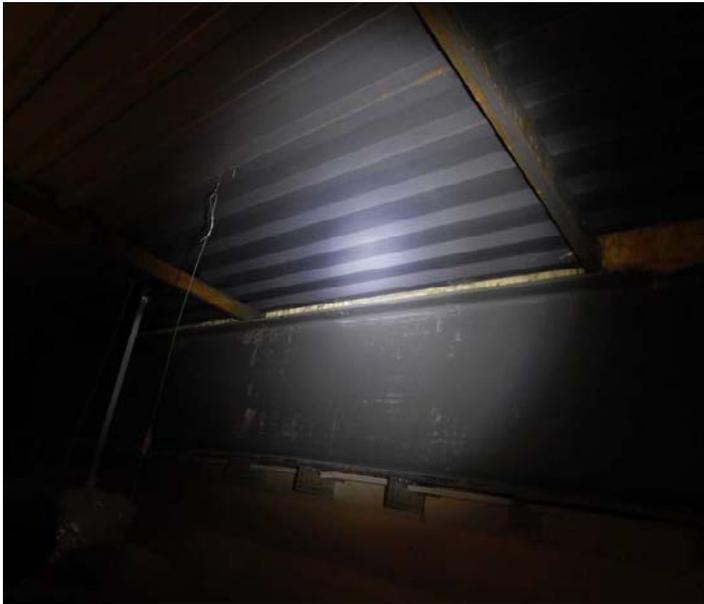
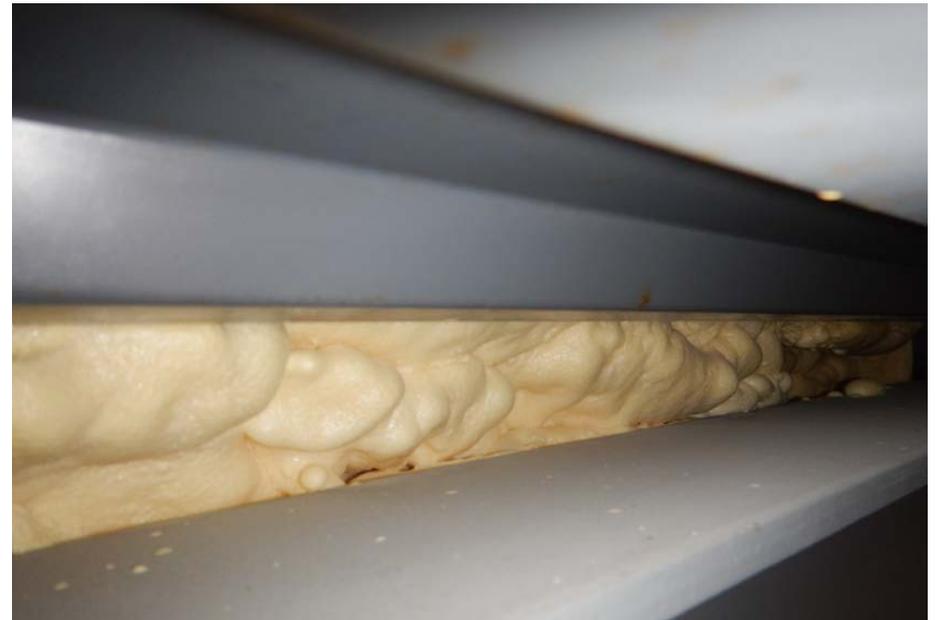
Case Study #2

Roof to Wall Intersection- Good condition

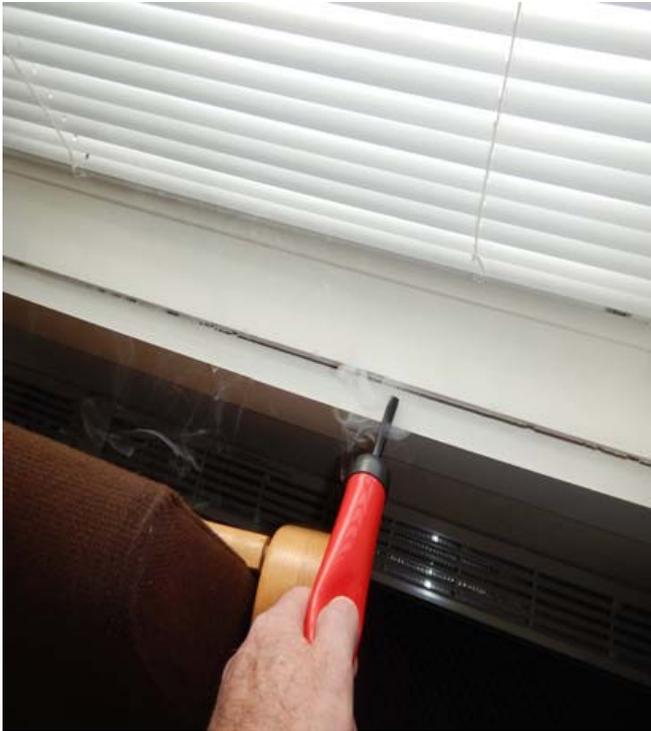
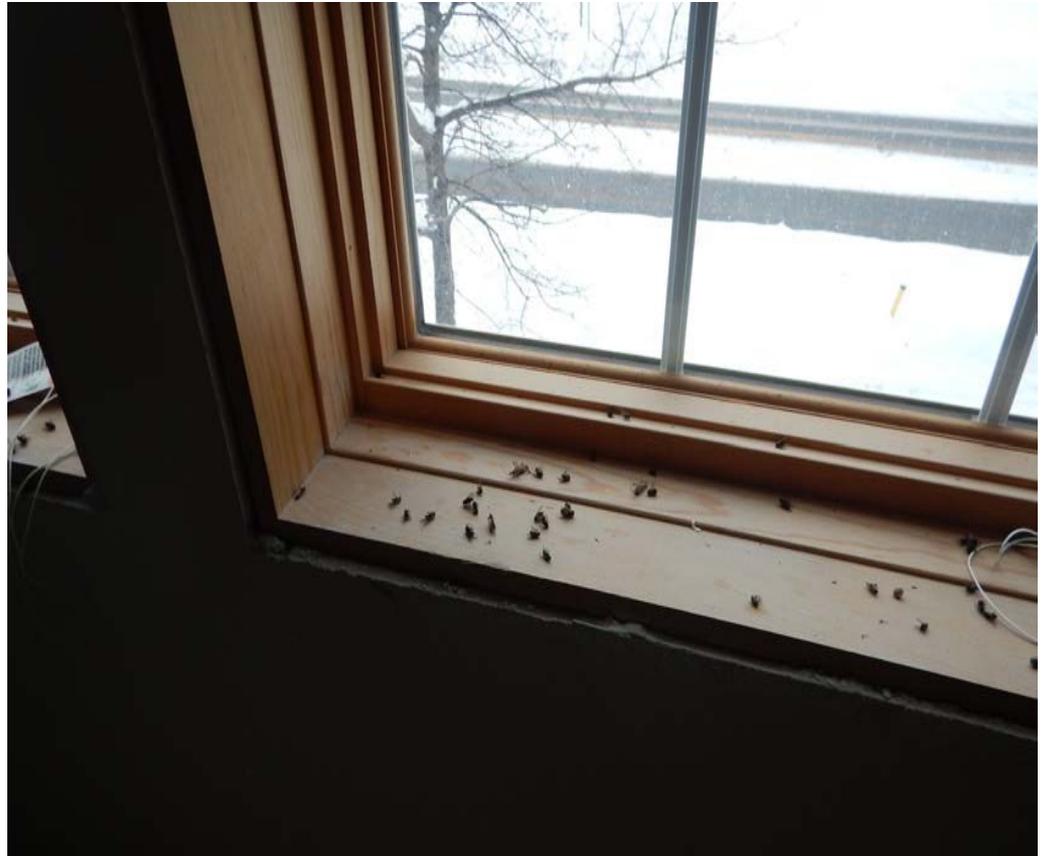
Case Study #2

Window Trim- signs of insect migration

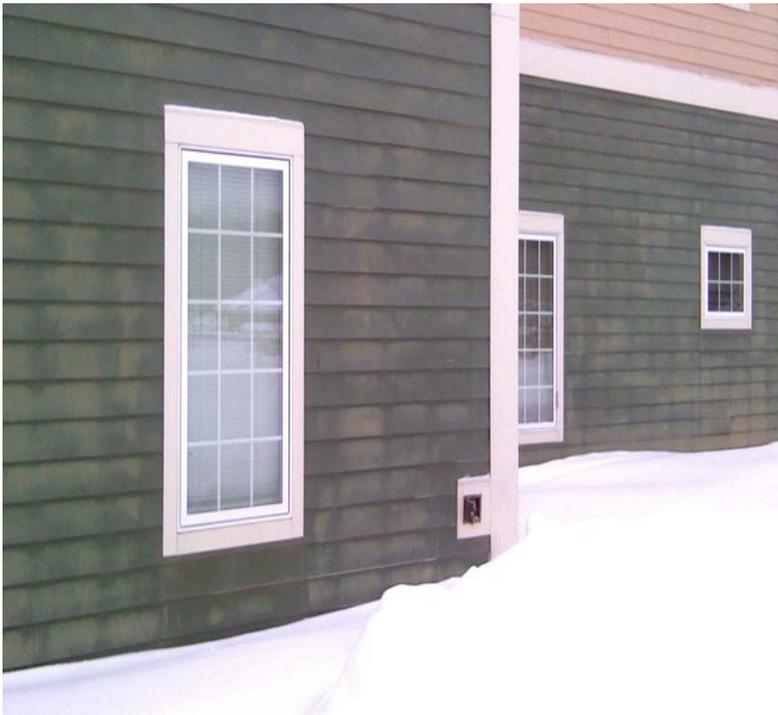
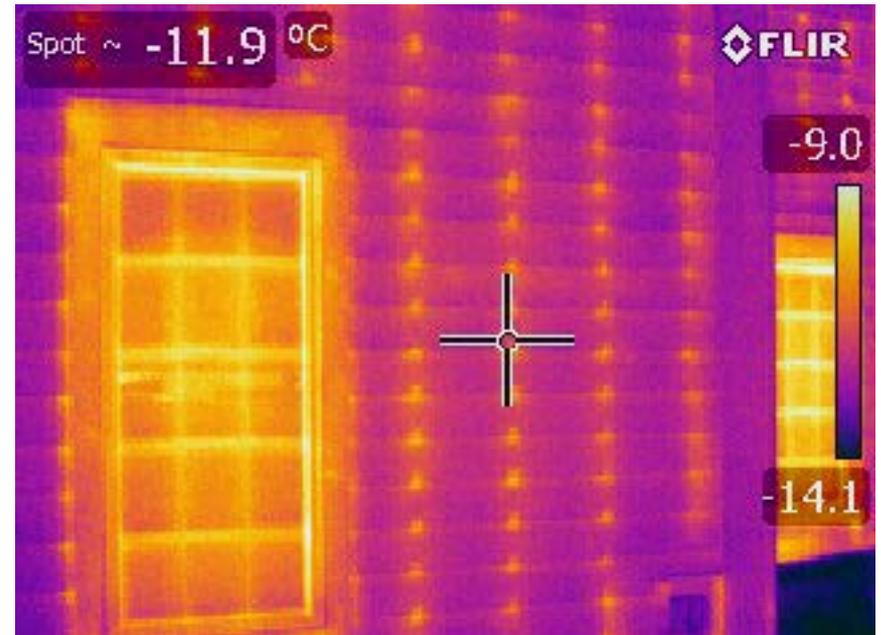
Case Study #2

Exterior Façade Issues-Thermal bridging

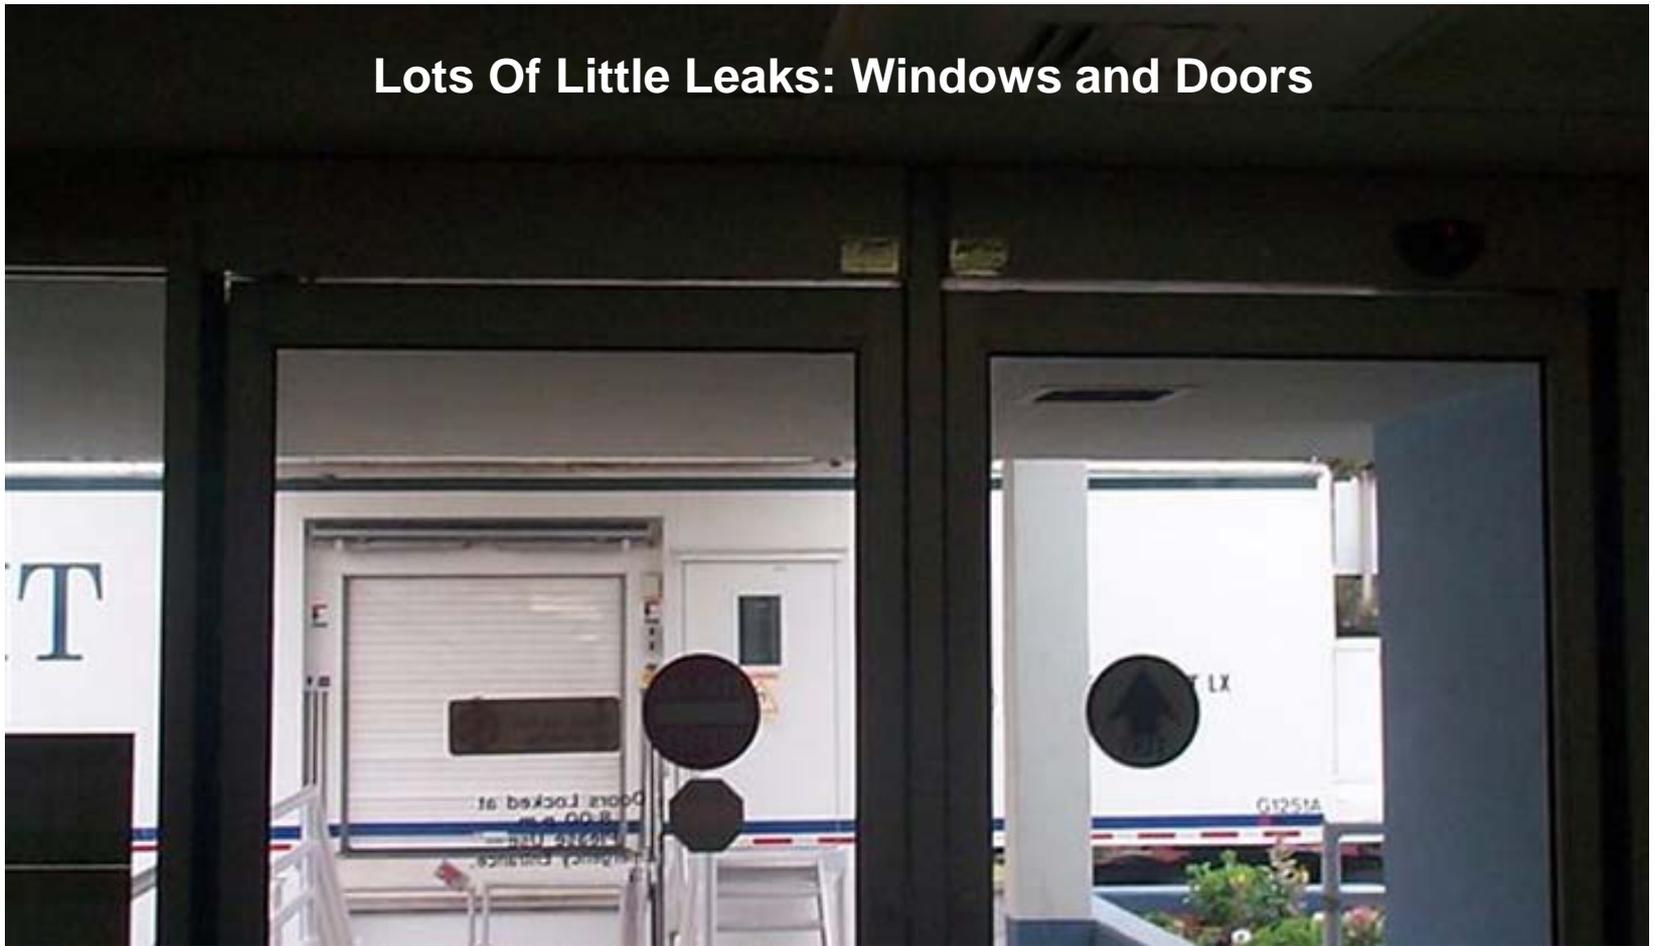
Case Study # 3

Lots Of Little Leaks: Windows and Doors

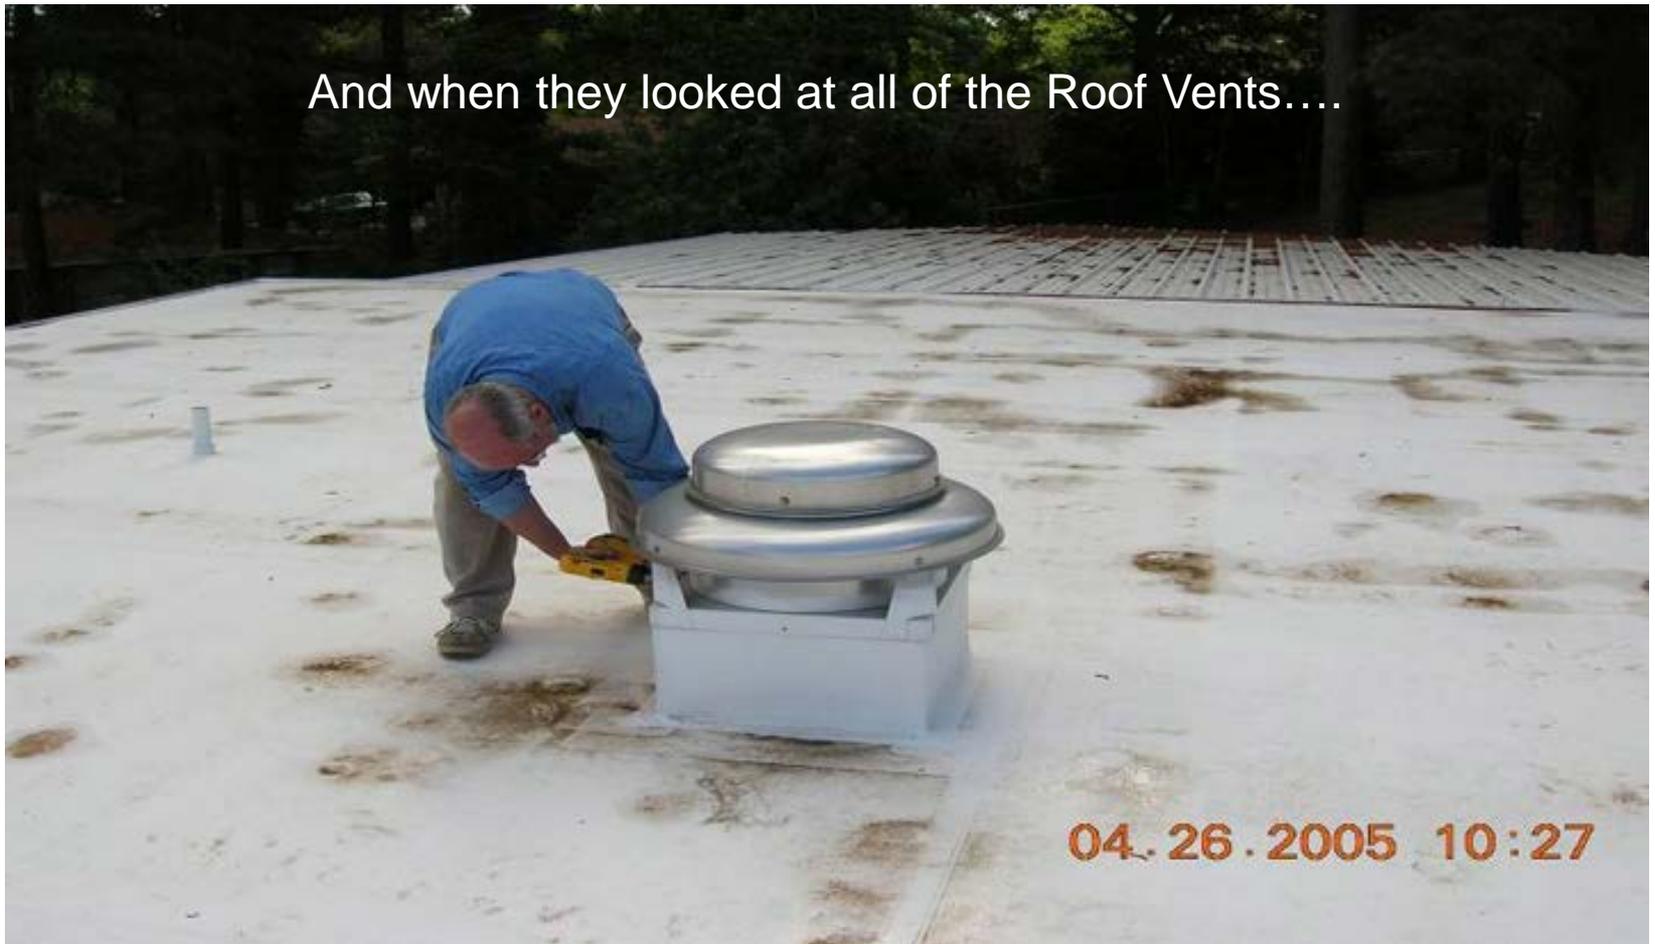
Case Study # 3

And when they looked at all of the Roof Vents....

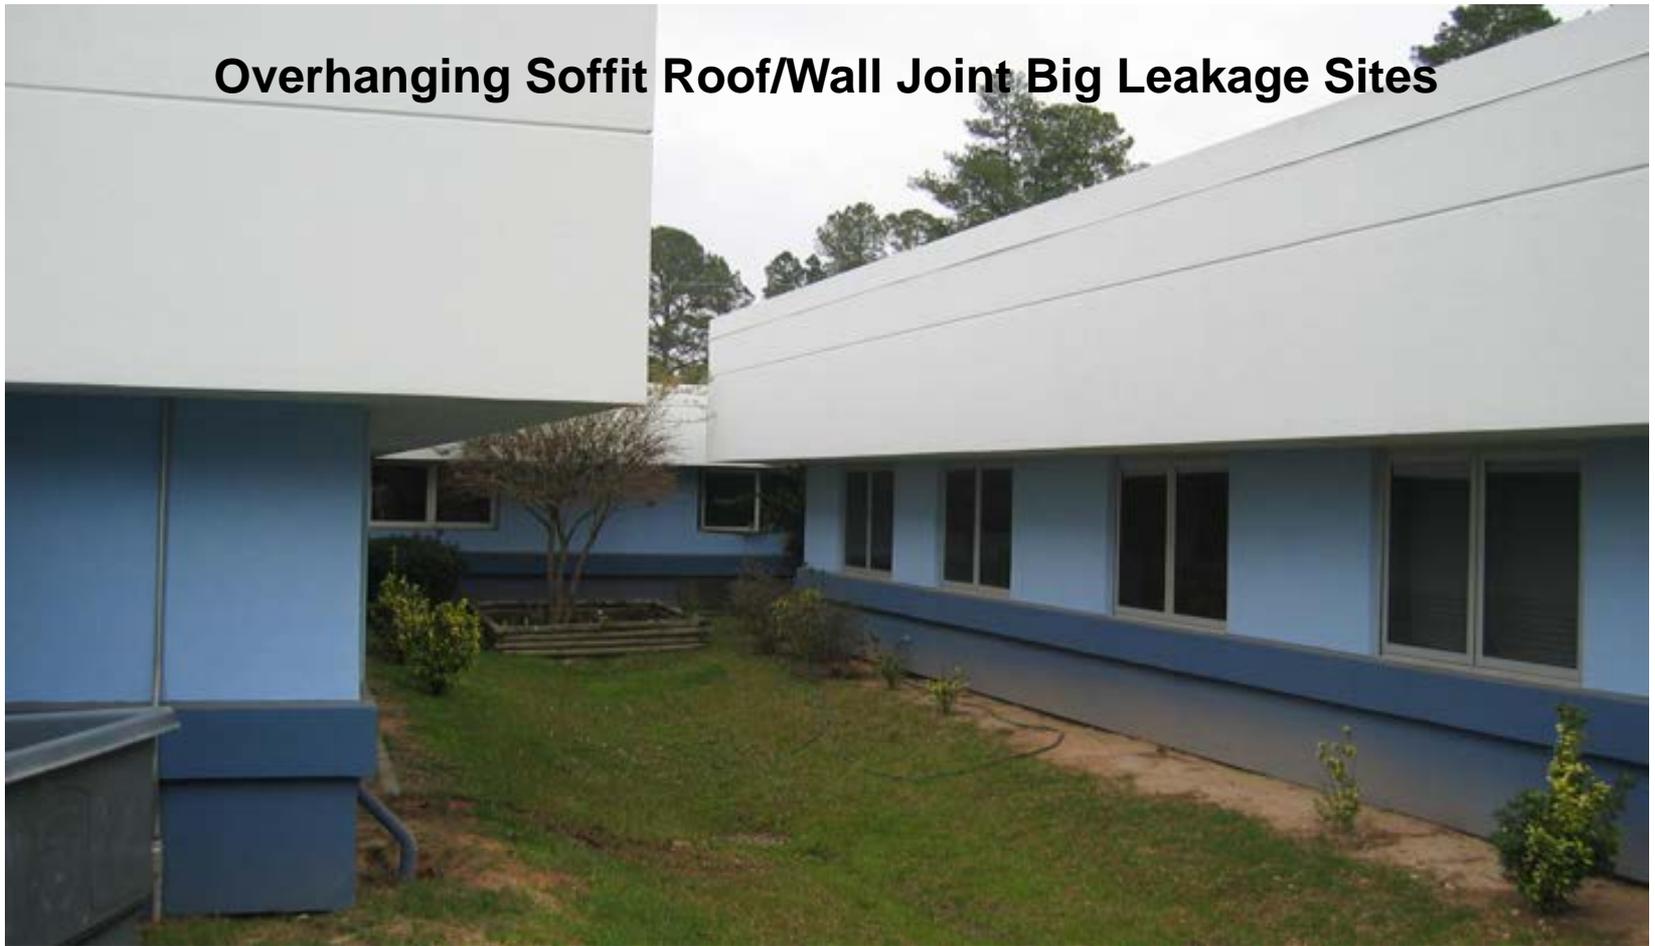
Case Study # 3

Overhanging Soffit Roof/Wall Joint Big Leakage Sites

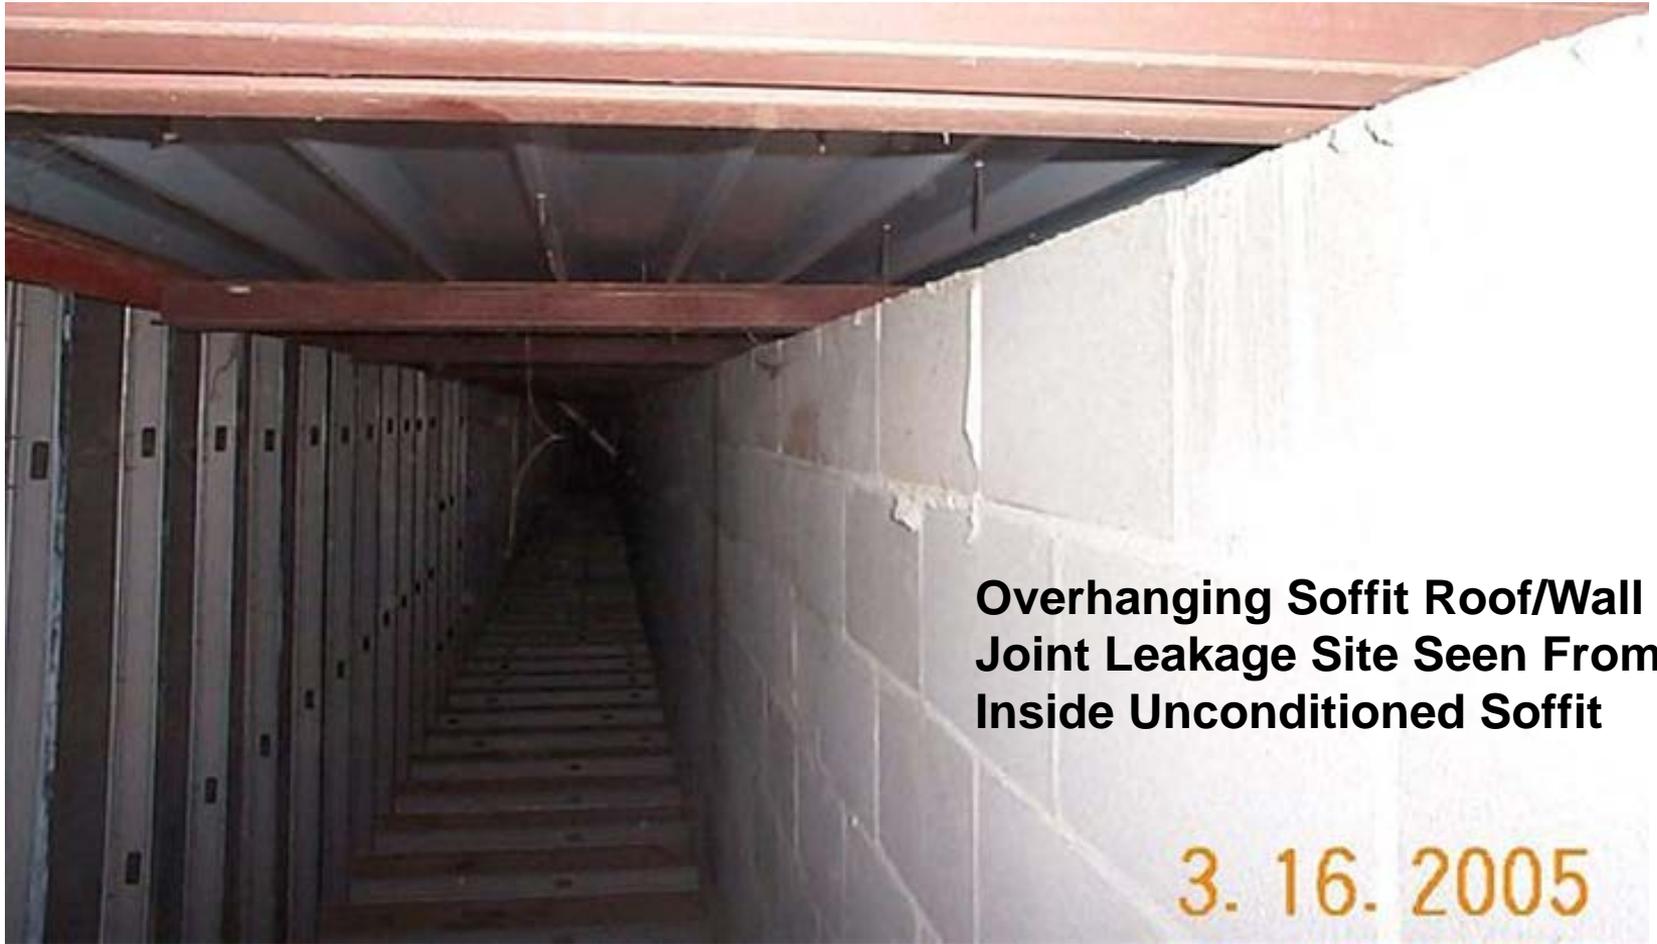
Case Study # 3

**Overhanging Soffit Roof/Wall
Joint Leakage Site Seen From
Inside Unconditioned Soffit**

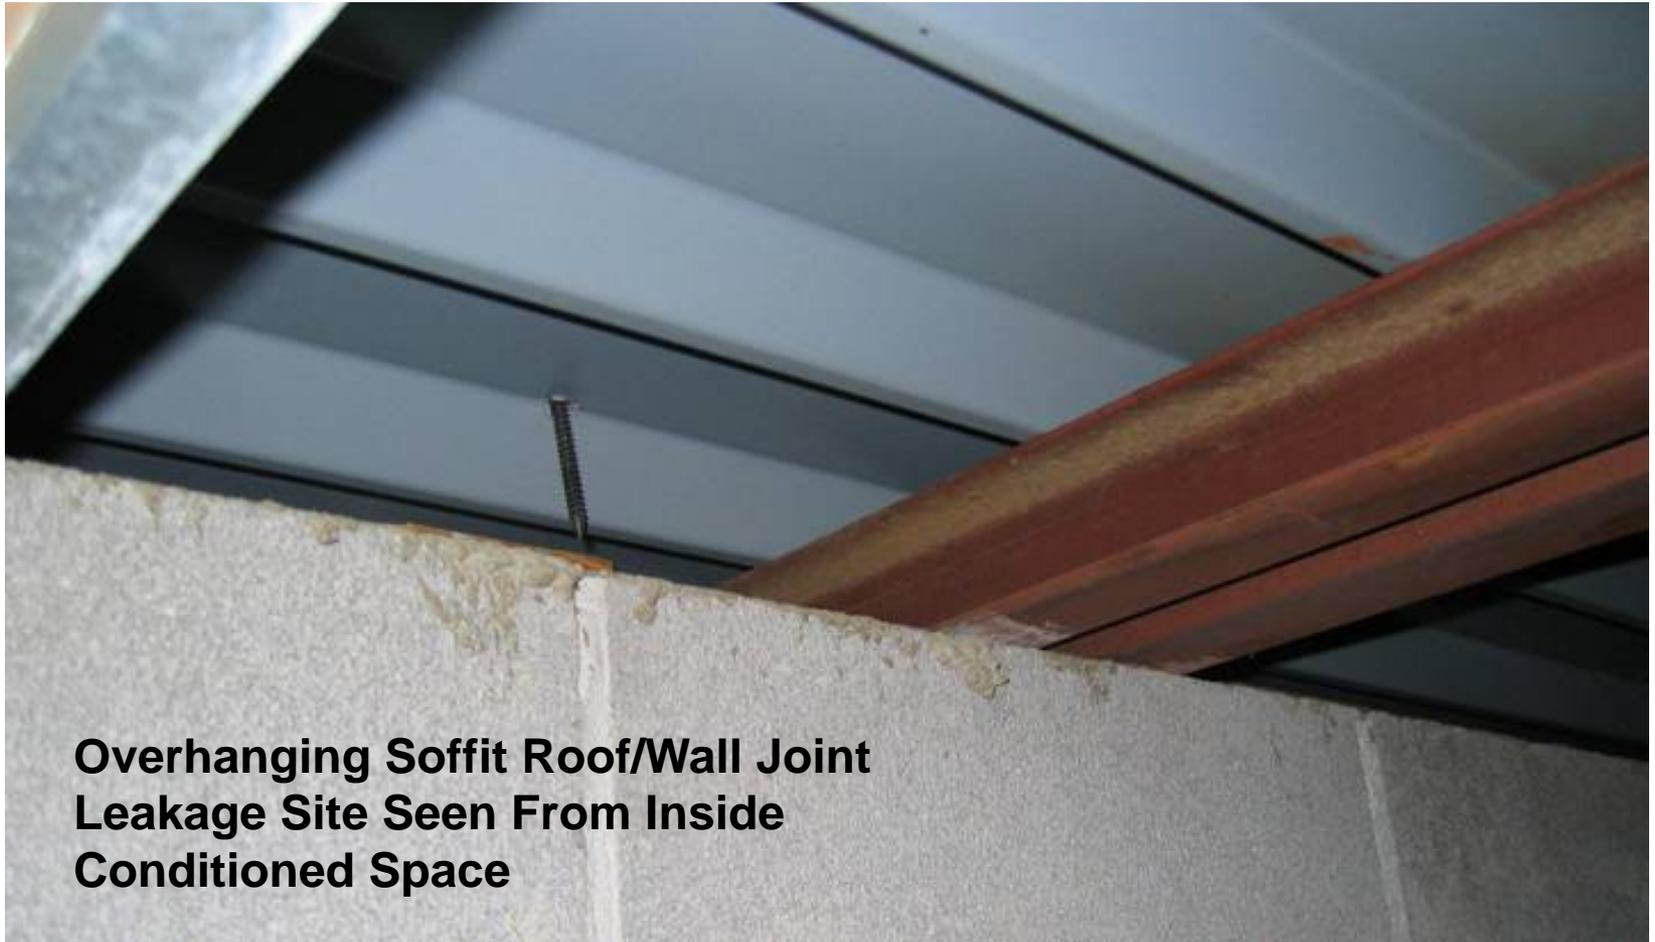
Case Study # 3

**Overhanging Soffit Roof/Wall Joint
Leakage Site Seen From Inside
Conditioned Space**

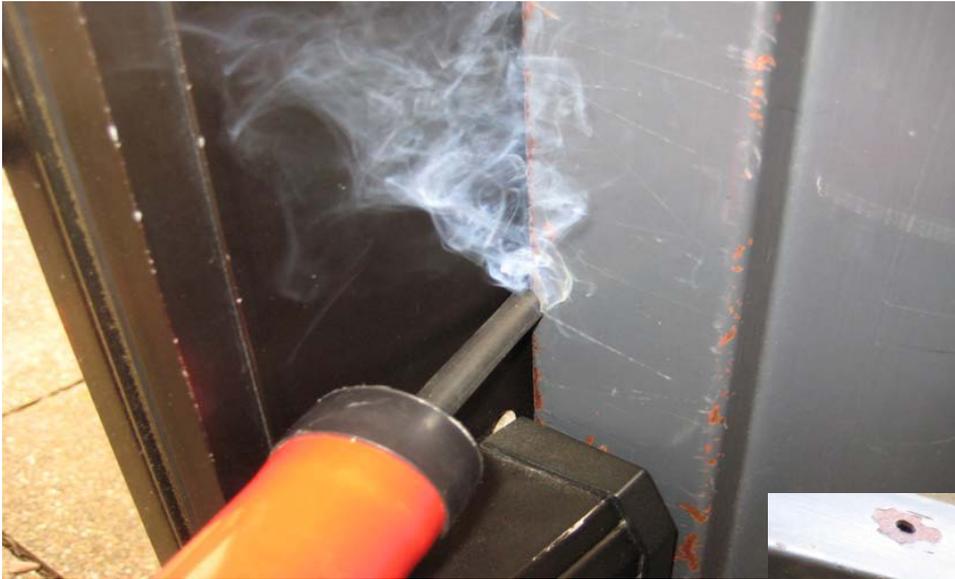
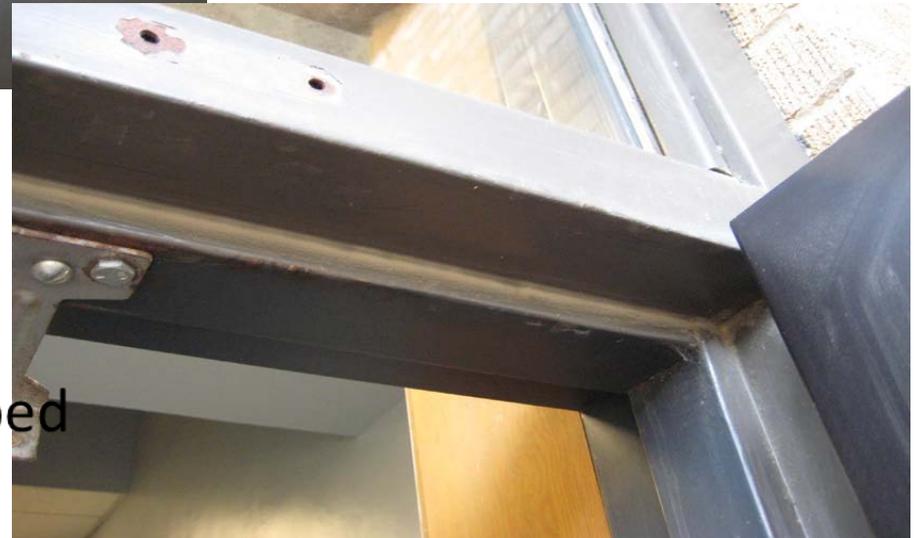
Case Study # 4

– doors weren't weather-stripped

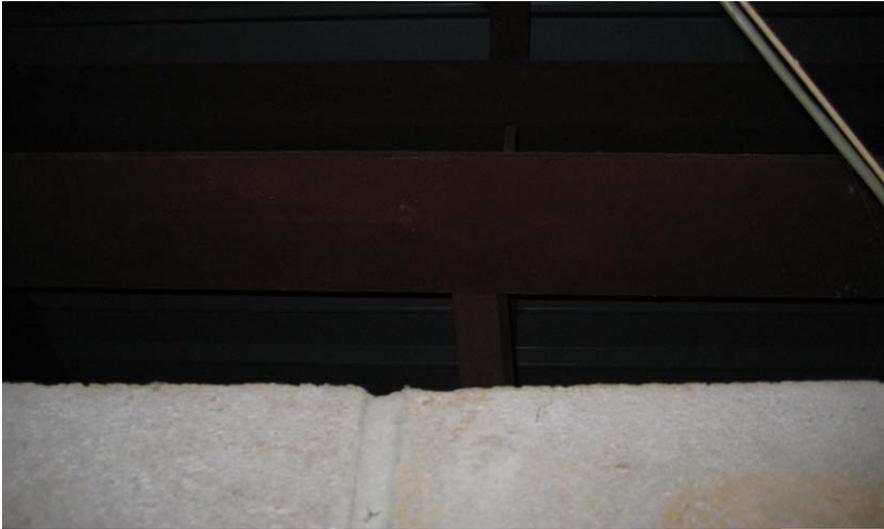
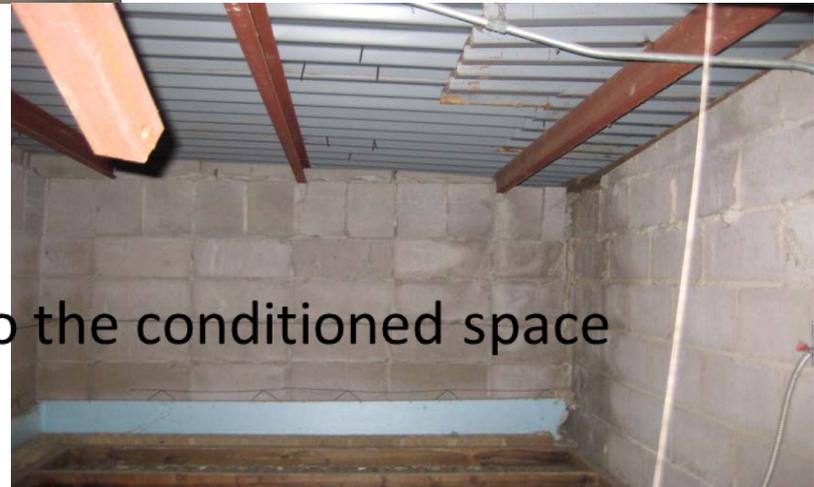
Case Study # 4

– Soffits/Overhang was open to the conditioned space

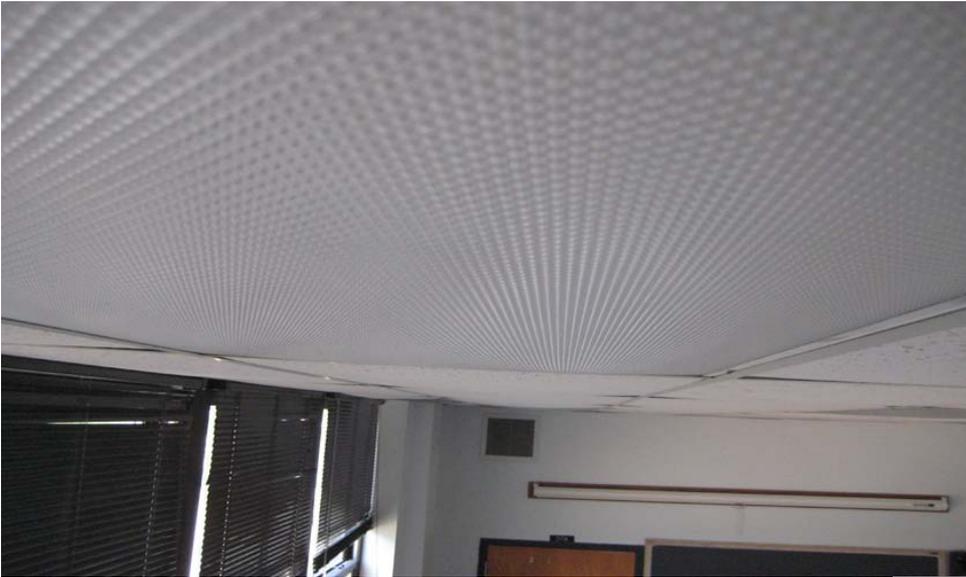
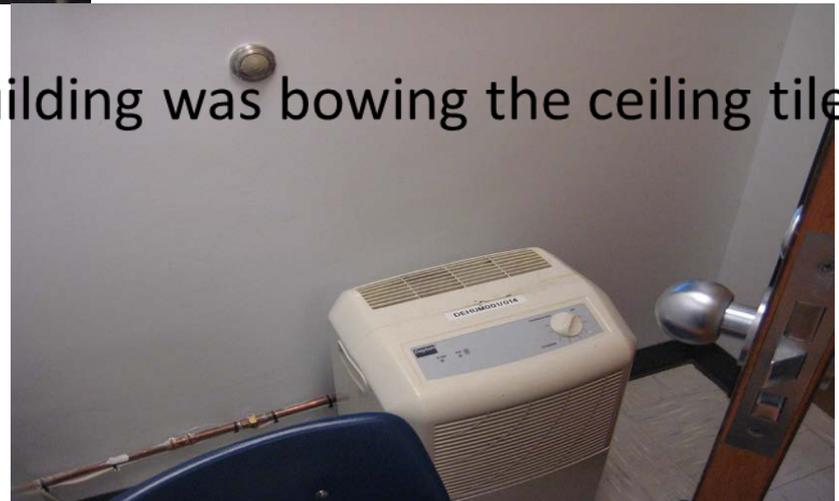
Case Study #4

– Moisture being pulled into the building was bowing the ceiling tiles
