What Does High Performance Roof Design Look Like?

PEDCO 5th Annual

High Performance Building Workshop

David Hart, LEED AP, BD+C

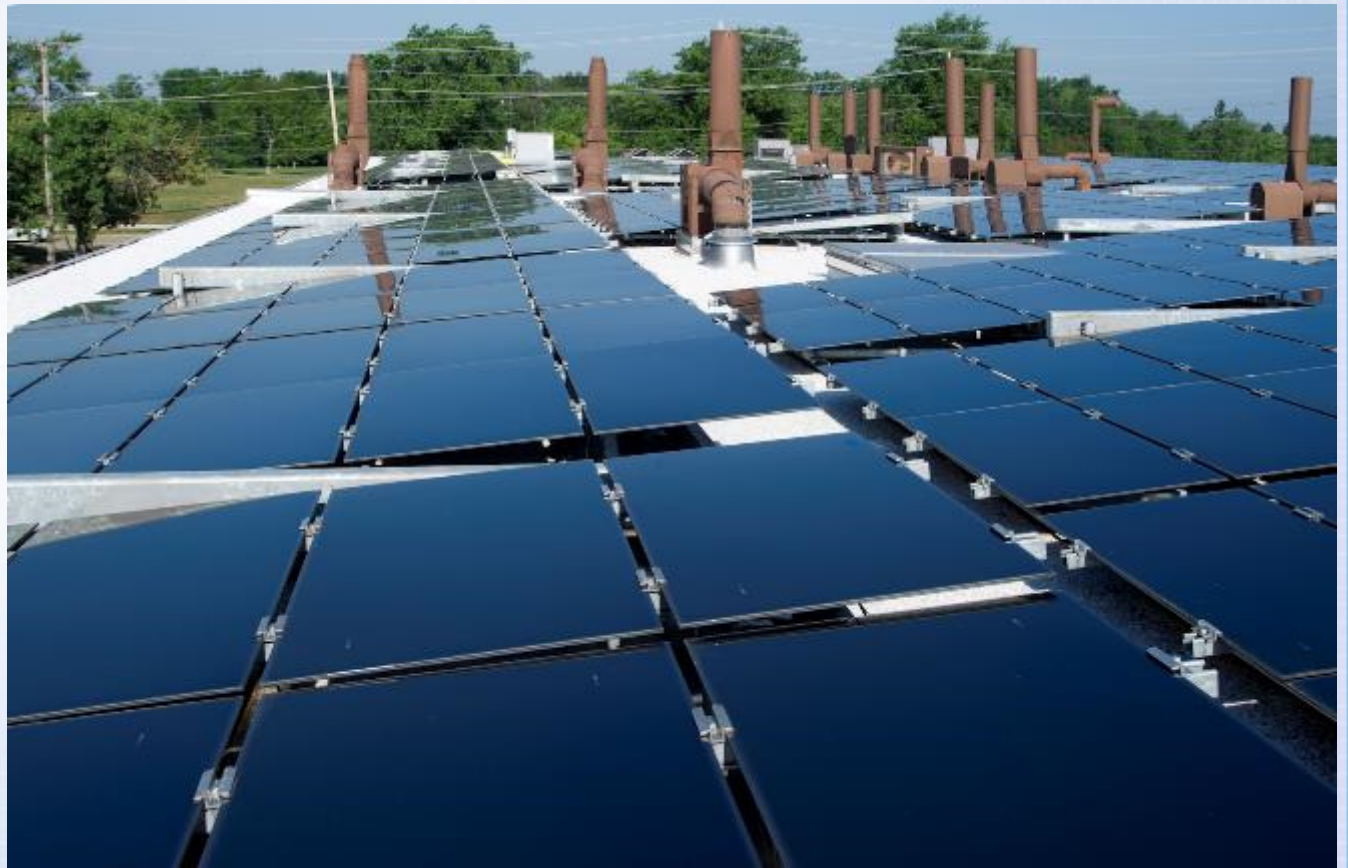
- Reflective roofing with solar.
- Grid energy shedding solution with energy atmosphere and energy cost impacts

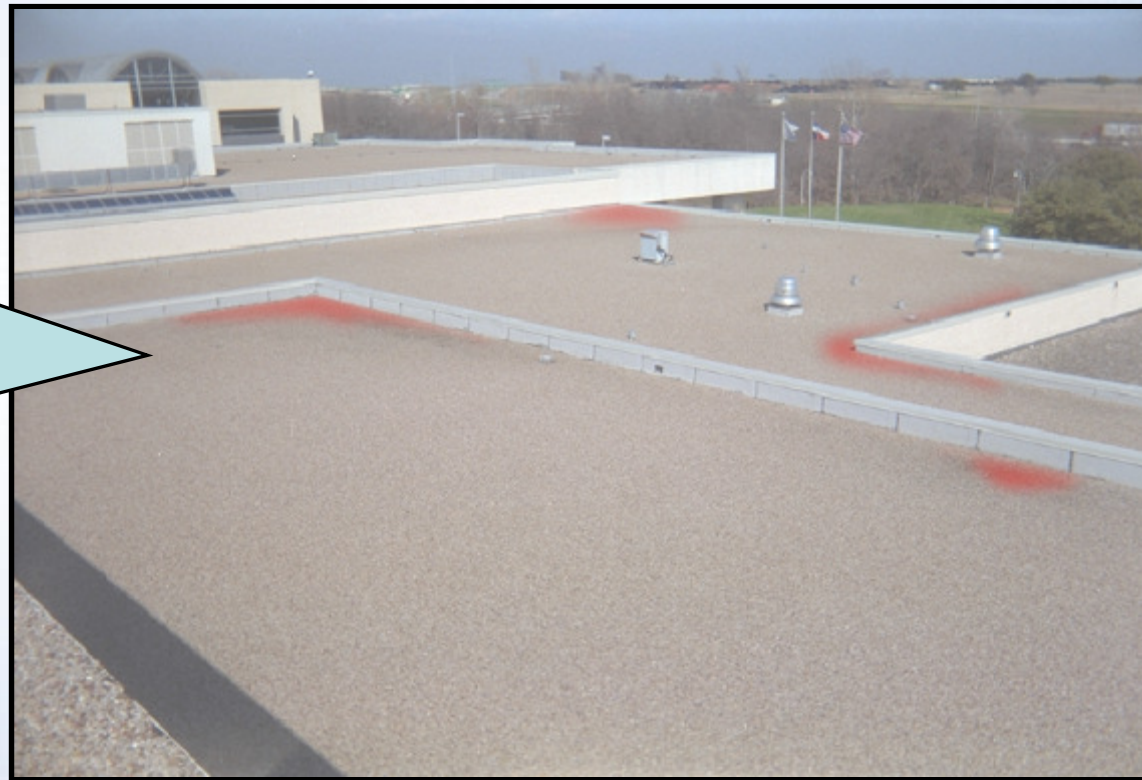
Case Study – 1996 Infrared Results

1,155 sf wet
\$10.00 / sf
\$11,550 cost

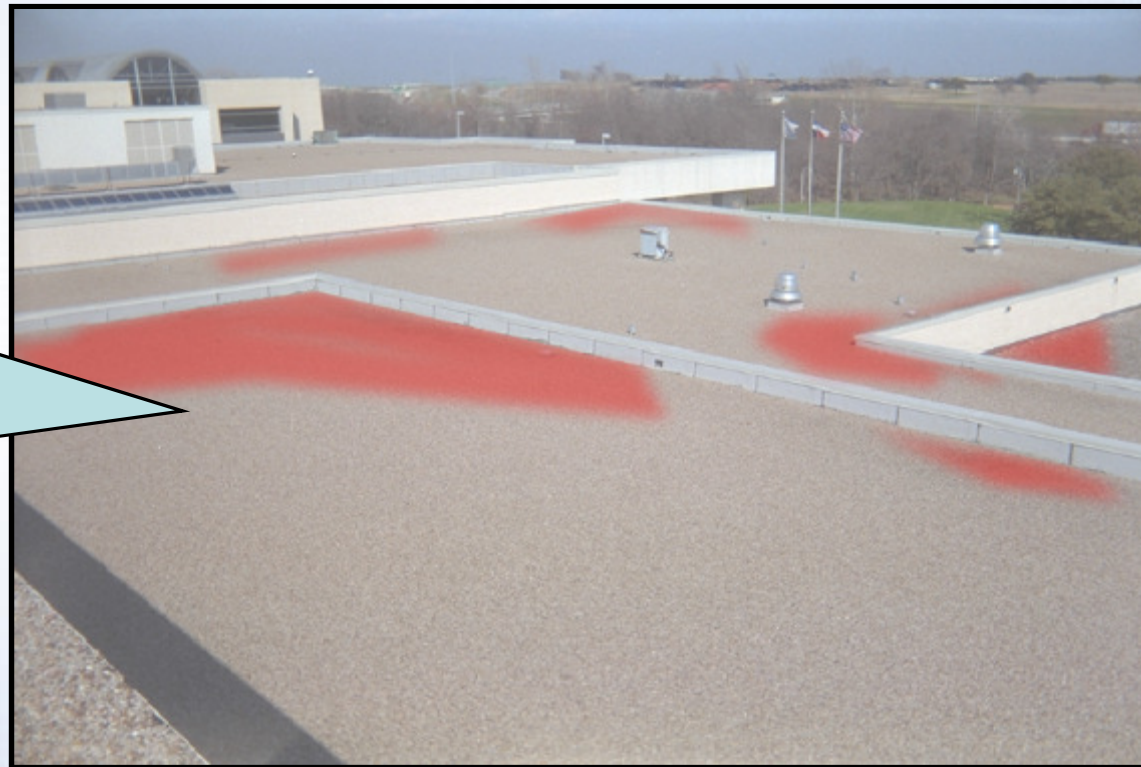
Case Study – 1999 Infrared Results

6,160 sf wet
\$12.00 / sf
\$73,920 cost

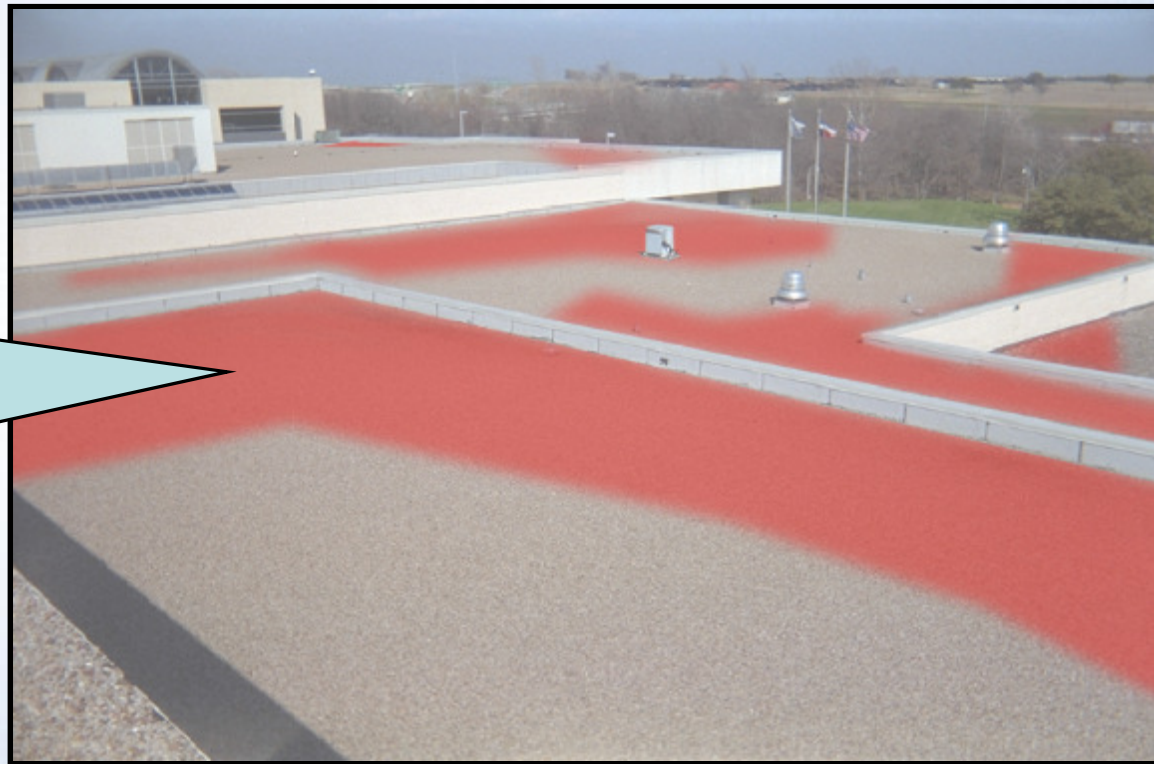
Case Study – 2001 Infrared Results

27,201 sf wet
\$14.00 / sf
\$380,814 cost

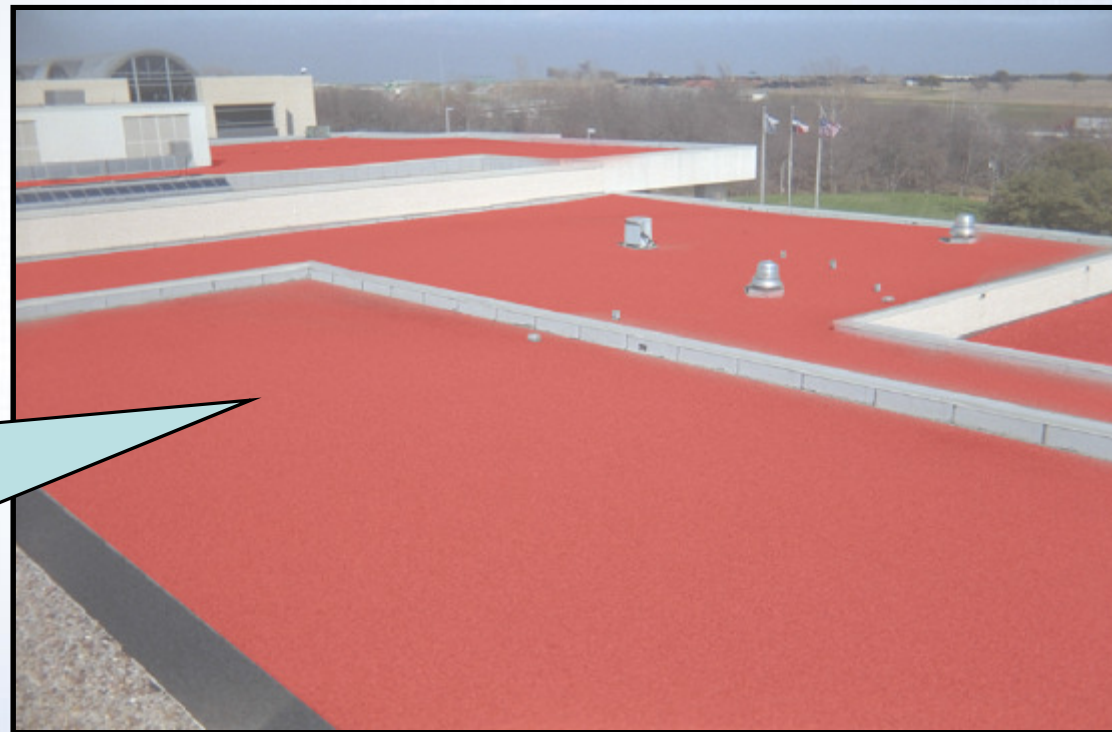
Case Study – Roof Replacement

65,000 sf wet

\$17.00 / sf

\$1,105,000

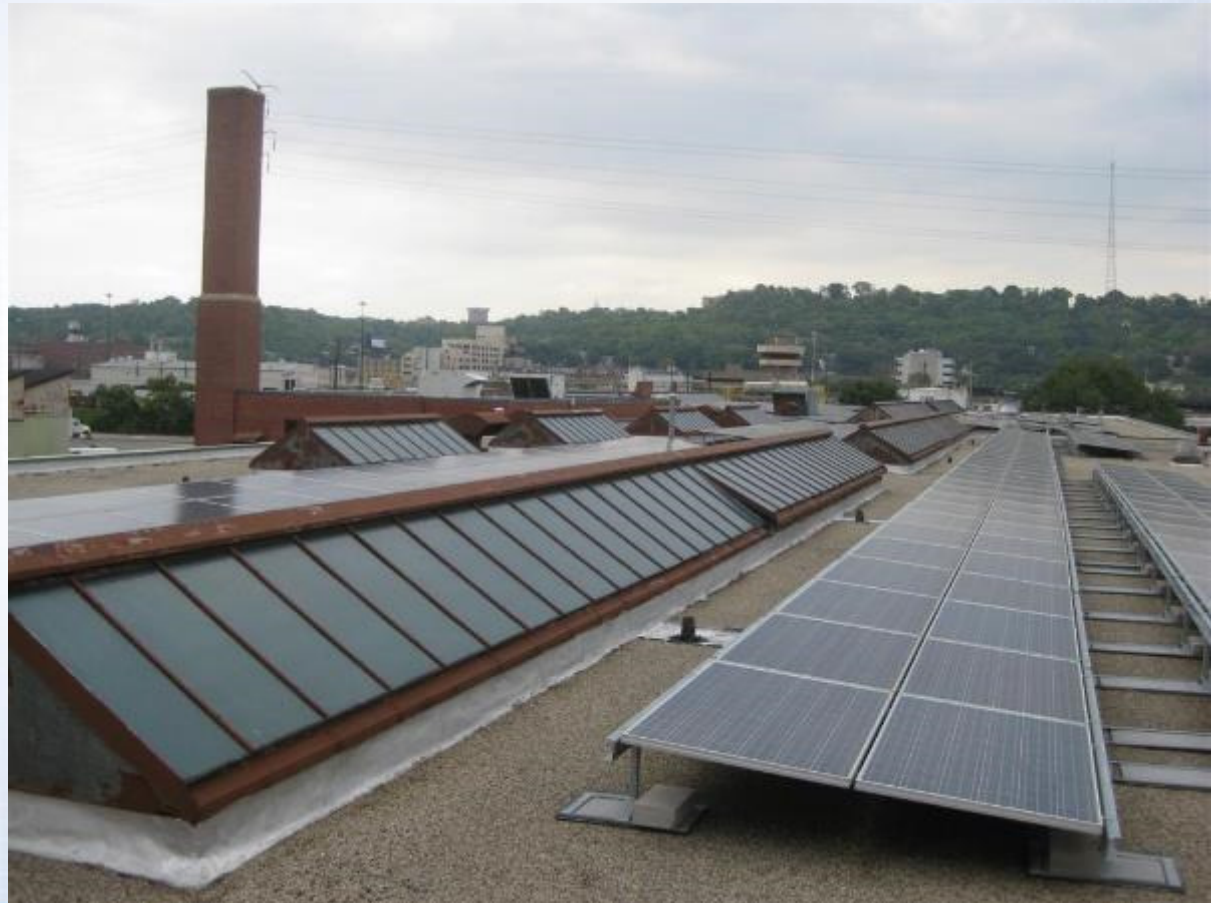
Gravel Surfaced MB BUR System Restoration

- 75 year old, gravel surfaced Cincinnati BUR
- Restored twice
- PV panels were installed at year 70.
- Replacement price was \$550,000
- Project was completed for \$200,000
- Still going strong

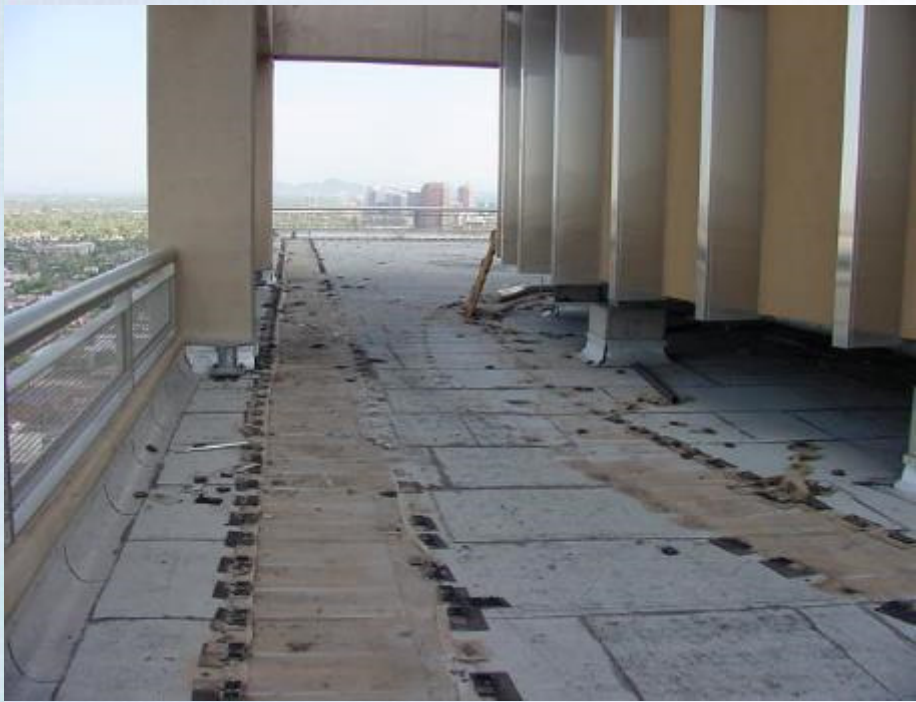
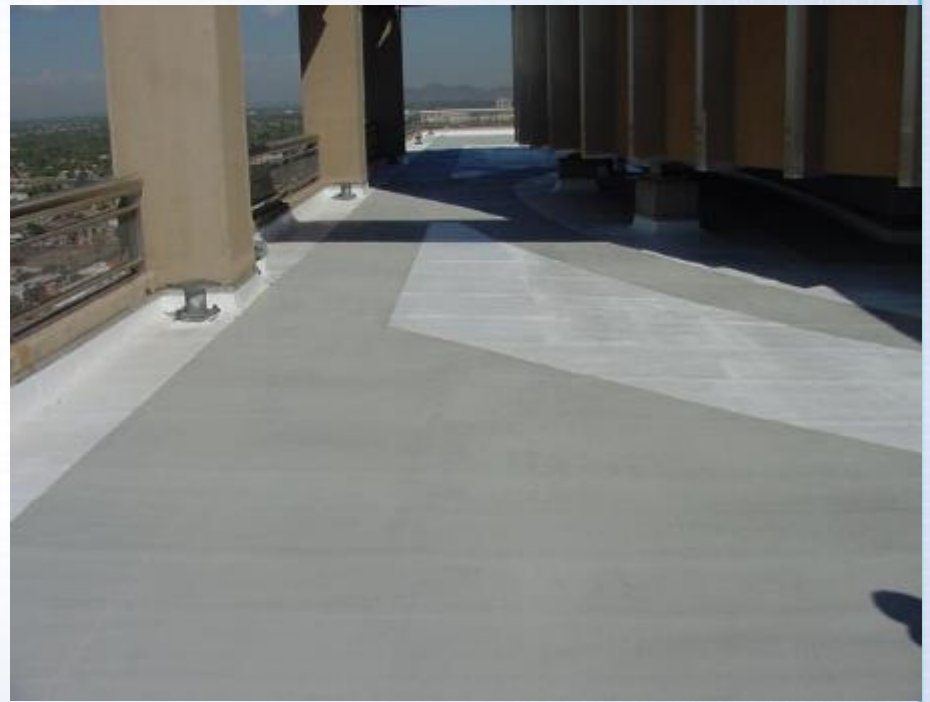
Mineral Surfaced MB System Restoration

20 Years Ago - Fluid Applied System Restoration

Before

After

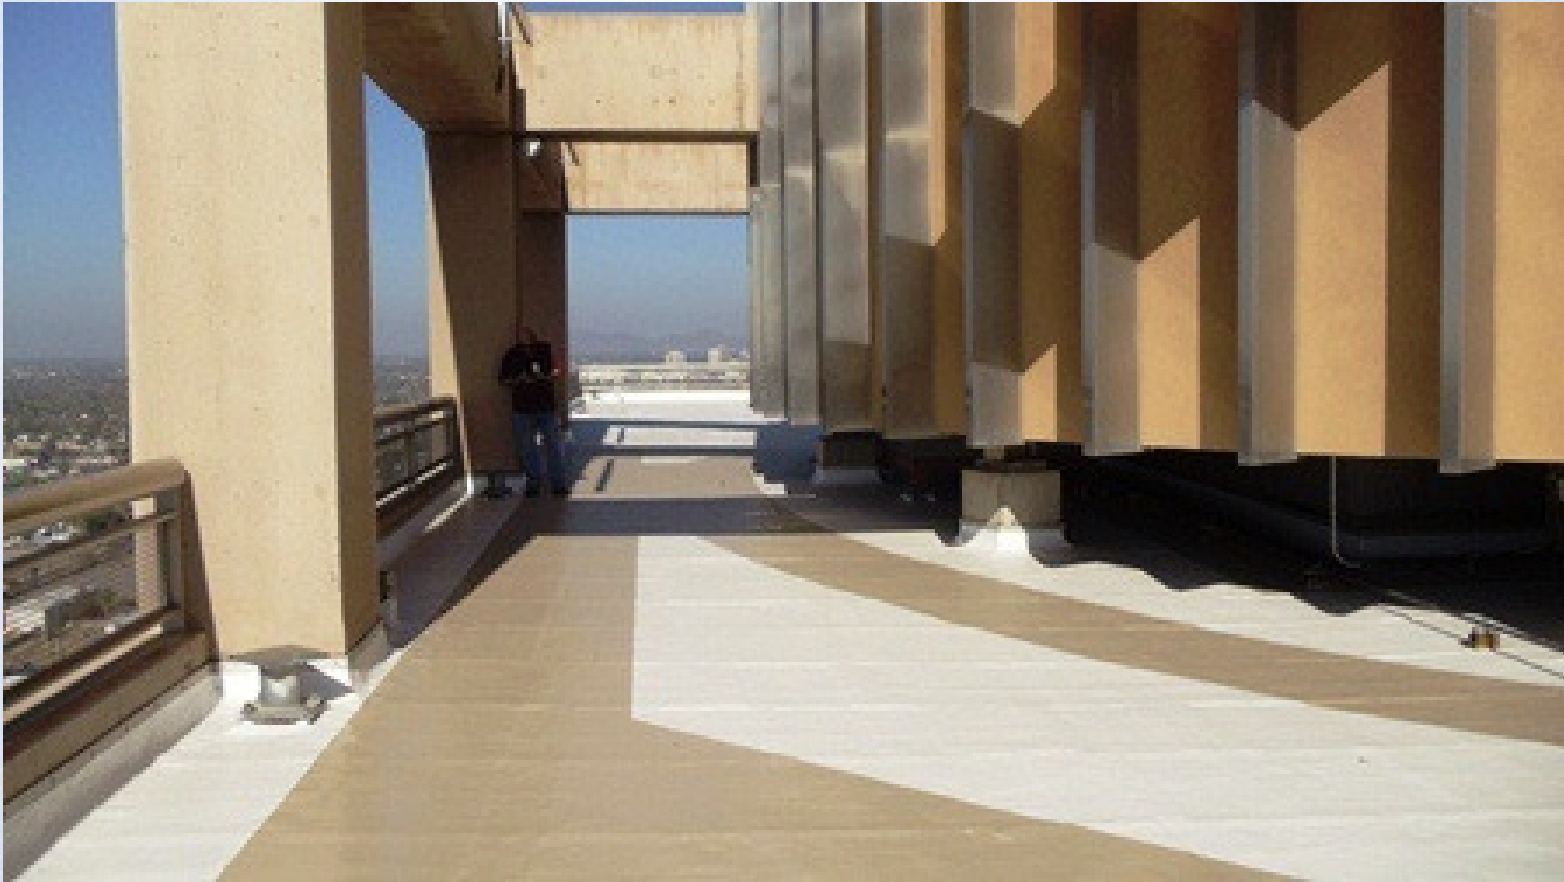
Mineral Surfaced MB System Restoration

Second Fluid System Restoration

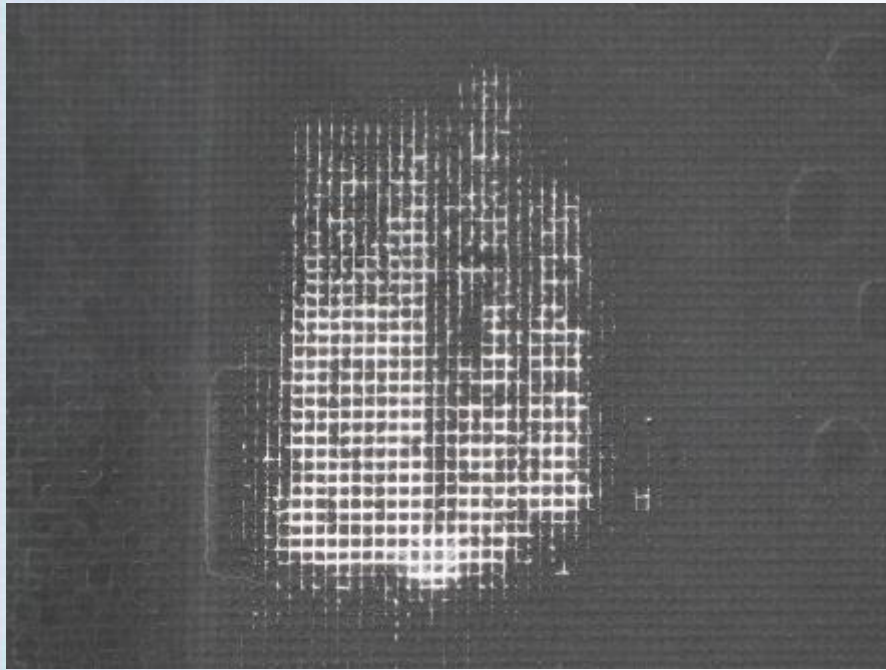
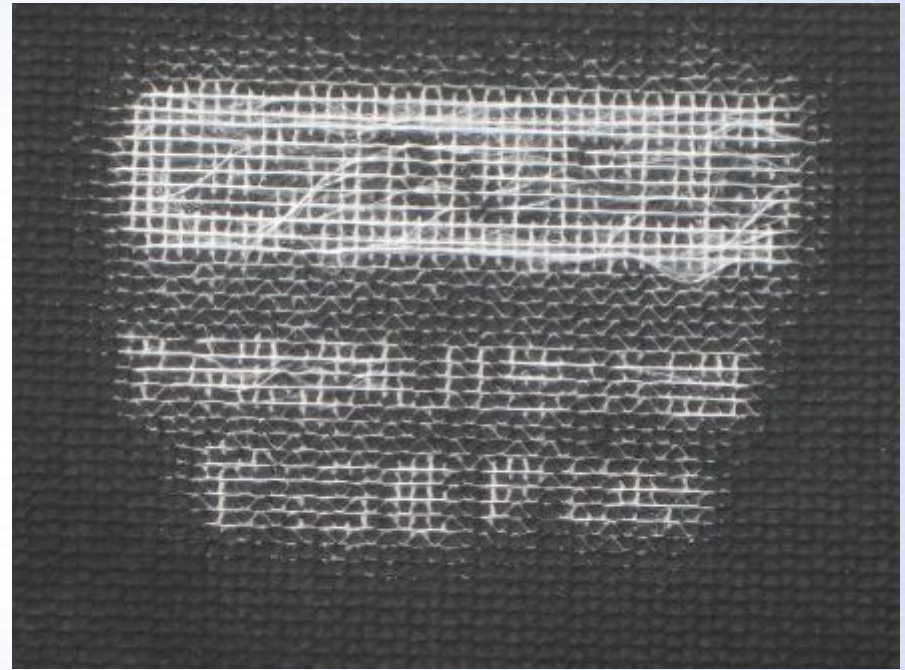
Single-Ply System Restoration

Fluid Applied Roof System Restoration – Not Coatings!

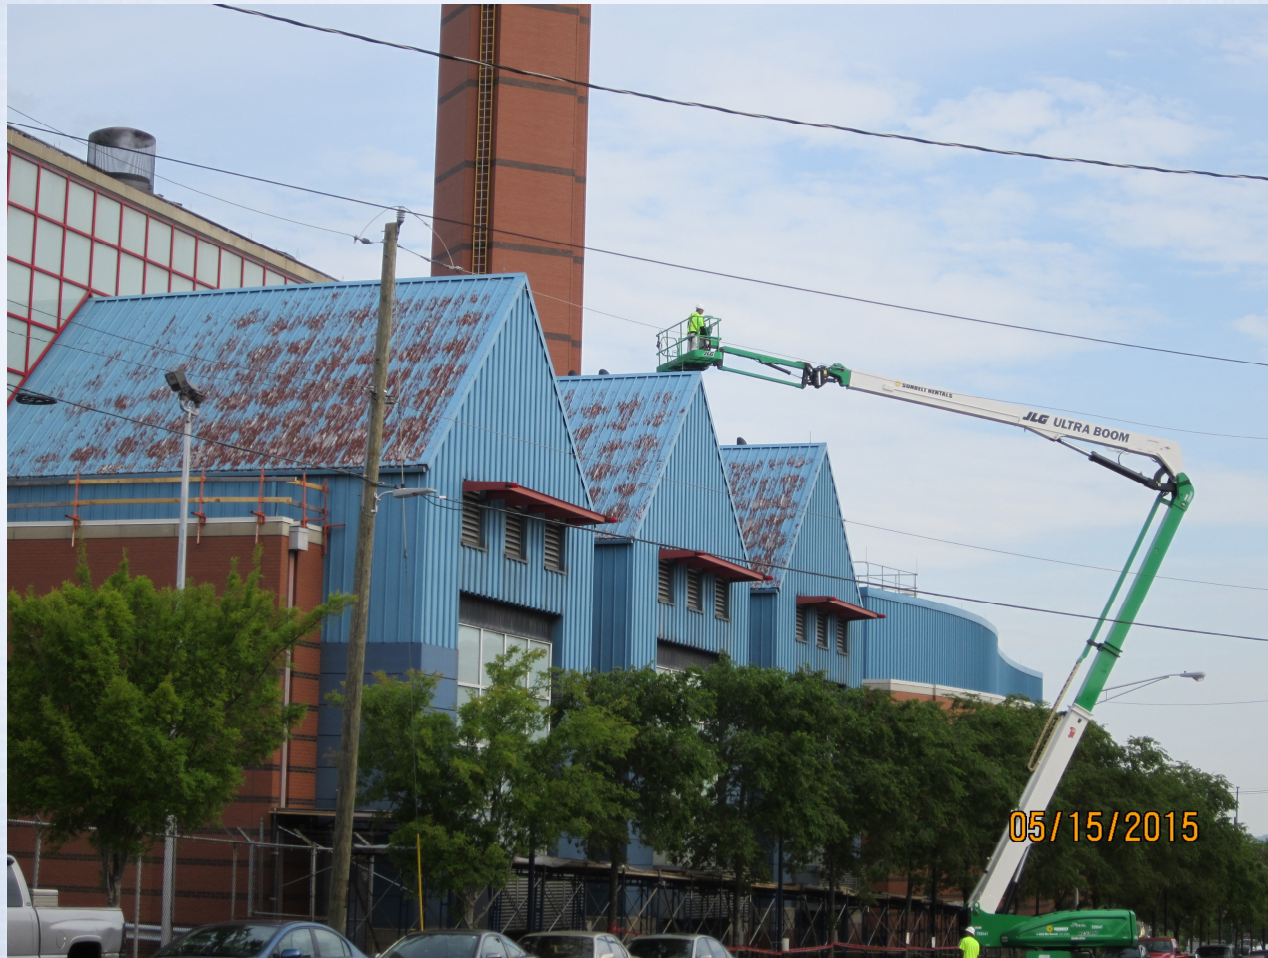
Metal Roof System Restoration

Fluid Applied Roof System Restoration

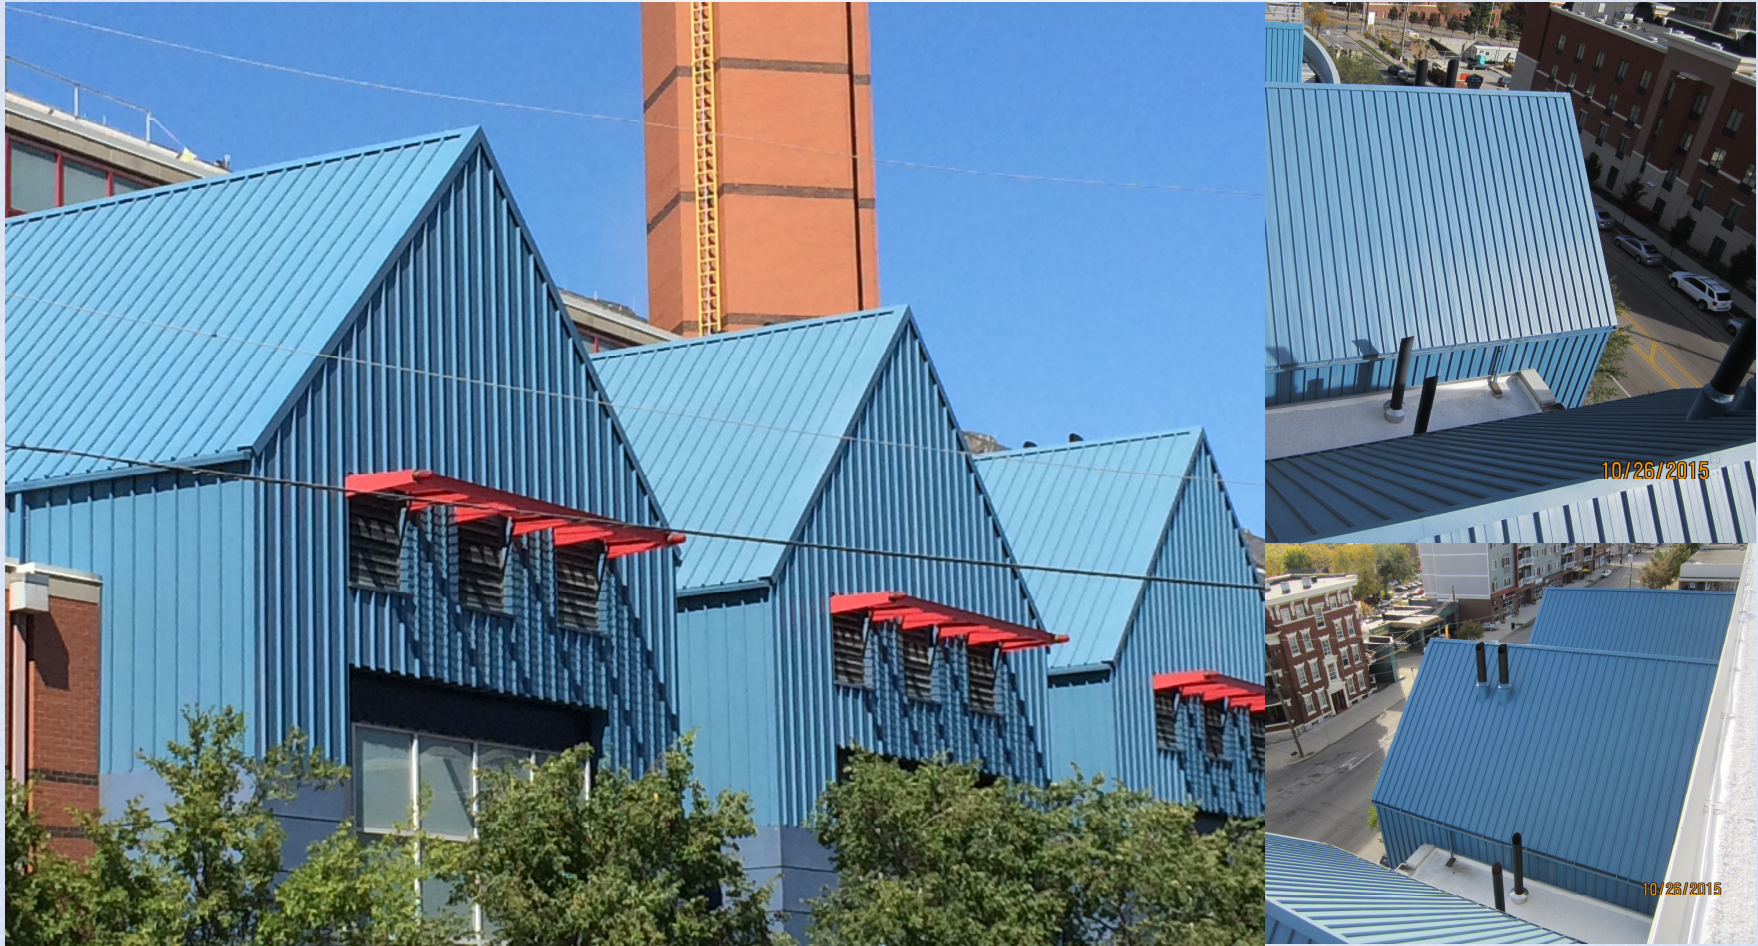
Metal Restoration

Fluid Applied Roof System Restoration
